ENTECH
ENGINEERING, INC.

WASTEWATER STUDY

Total acreage involved in the proposed development is approximately 49 acres. A total of 8 rural single-family lots are proposed. The area will be serviced by individual wells and sewage treatment systems. The Development Plan is shown on, Figure 3.

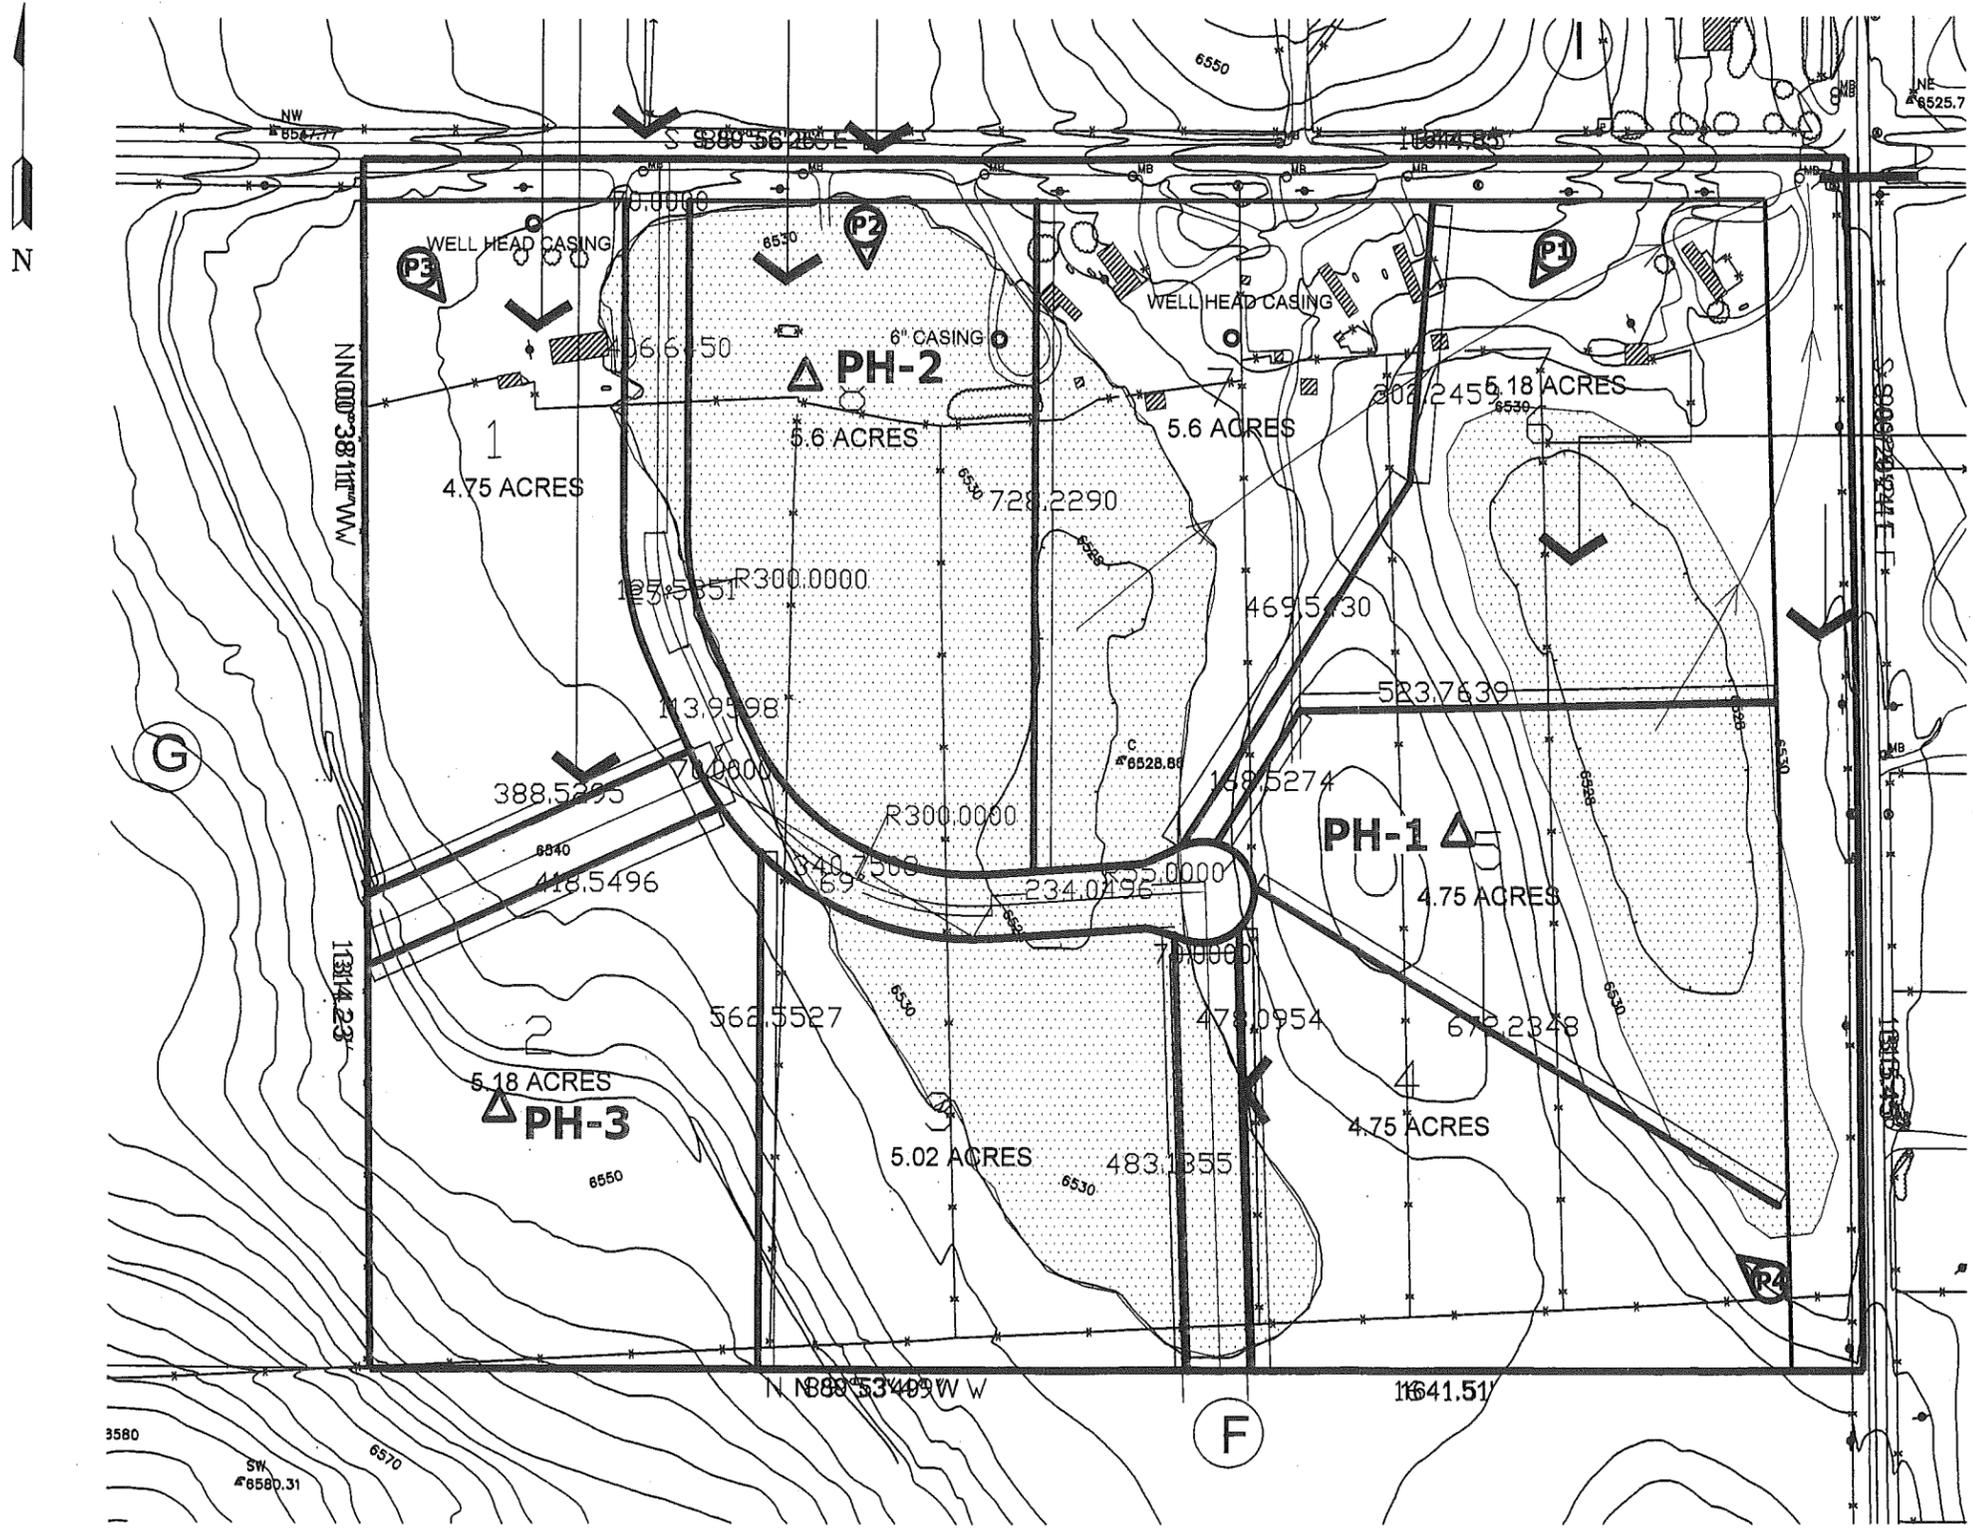
DRAWN M. WELLS
CHECKED
DATE 7/22/06
SCALE 1" = 200'
JOB NO. 42455
FIGURE No. 3

DEVELOPMENT PLAN/ PERCOLATION TEST
LOCATION PLAN
CIRTUS RD. & DAVIS RD.
EL PASO COUNTY, COLORADO
FOR: UPE

- △ P1 - approximate location of percolation test
- ⊙ P3 - approximate photograph location, direction and number.

In addition, 3 percolation tests were performed on the site to determine the general suitability of the site for the use of individual wastewater treatment systems. The locations of the percolation tests are shown on the Development Plan/Percolation Test Locations, Figure 3. Results of this testing will be discussed later in this report.

The site was evaluated for individual sewage treatment systems in accordance with El Paso Land Development Code. Three (3) percolation tests were performed on the property. Percolation tests may not be located in the exact areas of proposed systems. The approximate location of the percolation tests is shown in Figure 3 on the Geology Map, Figure 7. Table 1 presents a Summary of Percolation Test Results. The specific test results are presented in Appendix C of this report.
