**Geotechnical Evaluation  
Meridian Ranch Field House  
Falcon, Colorado  
Revised**

**Job Number: 23-8008**

**January 10, 2024**

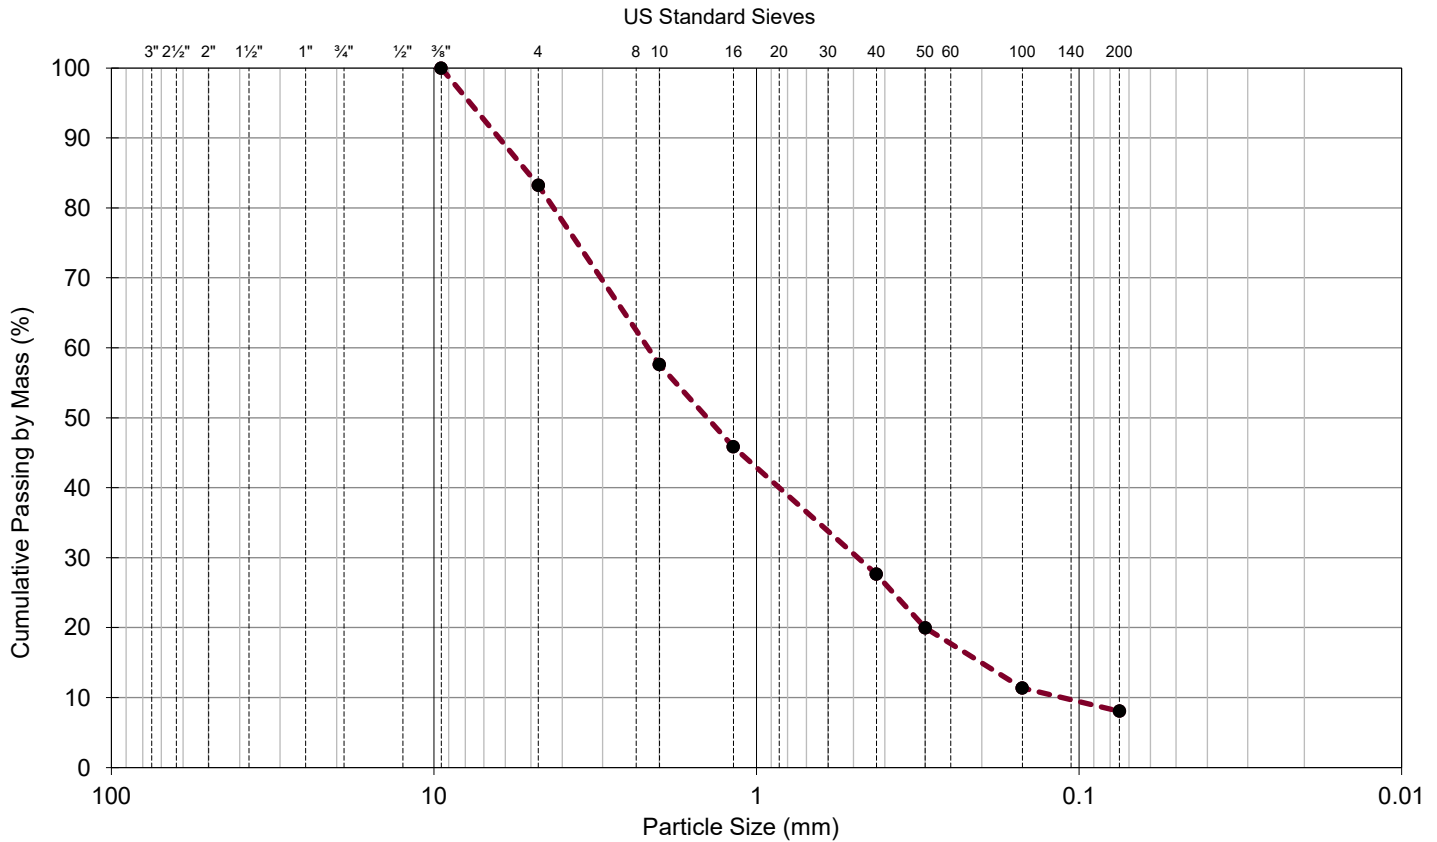
### Gradation (ASTM D422-63[2007])

Location: 5 at 14 feet  
Description: SANDSTONE Bedrock

Samples retrieved from the test holes were examined and visually classified in the laboratory by the project engineer. Laboratory testing of soil samples included standard property tests, such as natural moisture contents, dry unit weights, grain size analyses, and Atterberg limits. Swell-consolidation, water-soluble sulfate content, and a suite of corrosivity tests were completed on selected samples, as well. Laboratory tests were performed in general accordance with applicable ASTM protocols. Results of the laboratory testing program are summarized in Tables 1 and 2. Gradation plots are provided in Figures 5 through 11.
