## **SOIL AND GEOLOGY STUDY**

**Proposed Subdivision  
County Line Rd**

**EPC Schedule No. 7104200012  
El Paso County, Colorado**

**JOB NO. 199069**

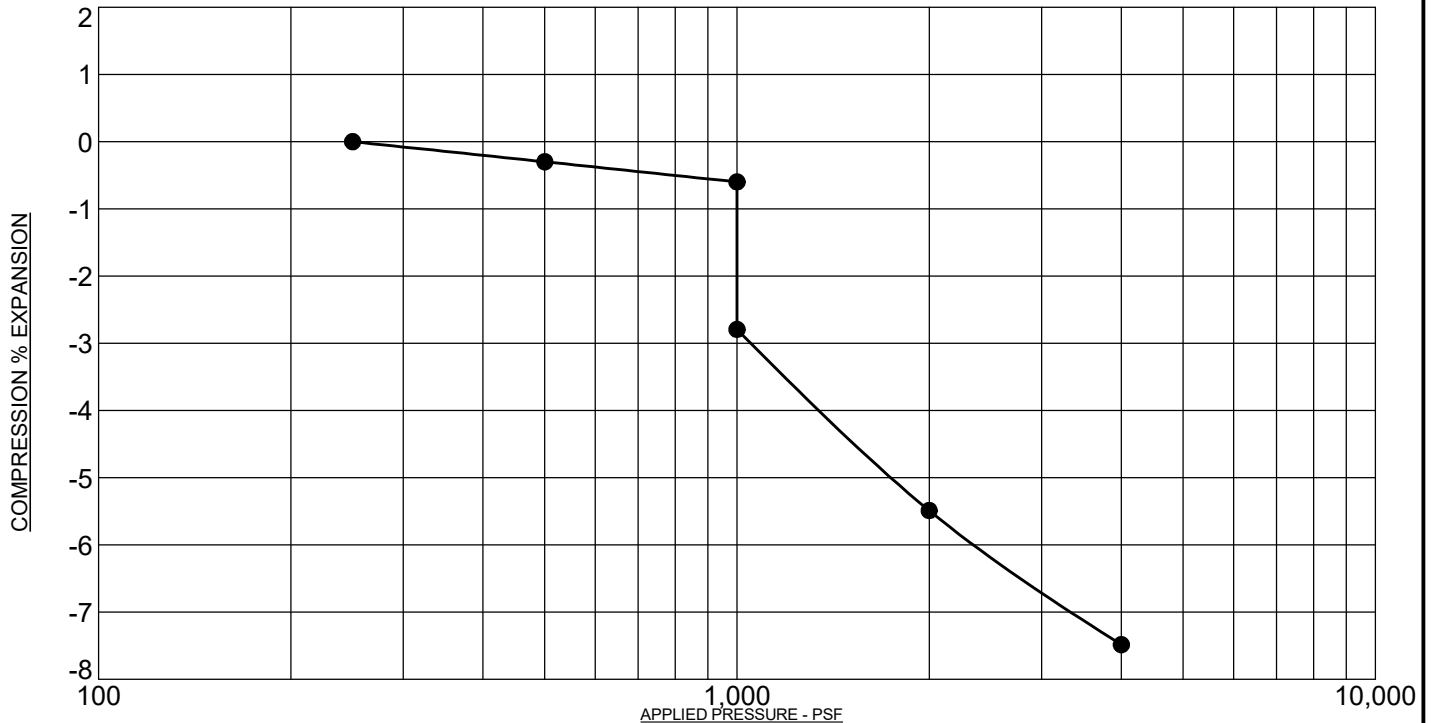
PROJECT: County Line Road, El Paso County, Colorado  
 SAMPLE DESCRIPTION: SAND, SILTY TO CLAYEY  
 NOTE: SAMPLE WAS INUNDATED WITH WATER AT 1,000 PSF

SAMPLE LOCATION: 4 @ 2 FT  
 NATURAL DRY UNIT WEIGHT: PCF  
 NATURAL MOISTURE CONTENT: 4.8%  
 PERCENT SWELL/COMPRESSION: - 2.2

The moisture content for the recovered samples was obtained in the laboratory. Grain-size analysis, Atterberg Limits, and Denver Swell/Consolidation tests were performed on selected samples for purposes of classification and to develop pertinent engineering properties. A Summary of Laboratory Test Results is presented in Figure 13. Soil Classification Data are presented in Figure 14 through 16. The Denver Swell/Consolidation tests are presented in Figures 17 and 18.
