## **SOIL AND GEOLOGY STUDY**

**Proposed Subdivision  
County Line Rd**

**EPC Schedule No. 7104200012  
El Paso County, Colorado**

**JOB NO. 199069**

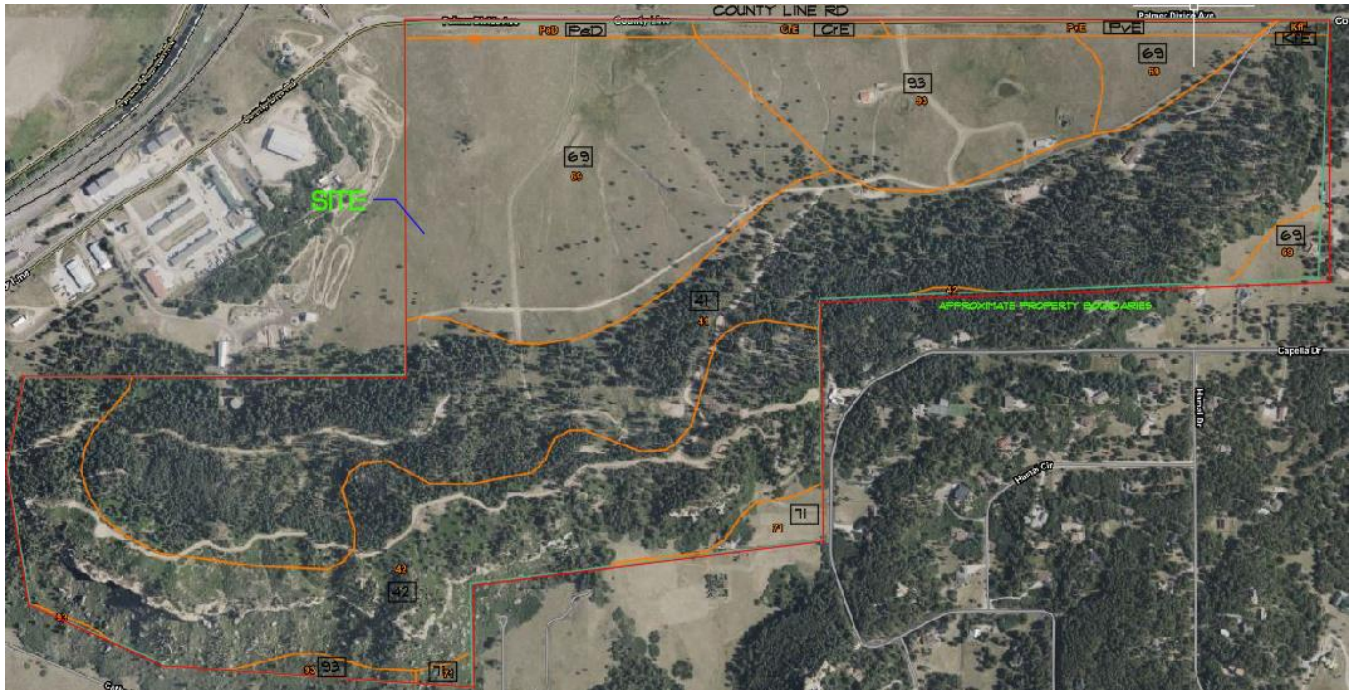
- **93 – Tomah-Crowfoot complex, 8 to 15 percent slopes.** The Tomah-Crowfoot complex was mapped by the USDA to encompass the northwest corner of the property. Properties of the Tomah-Crowfoot complex include, well-drained soils, depth of the water table is anticipated to be greater than 80 inches, runoff is anticipated to be low, frequency of flooding and ponding is none, and landforms include hills.

The USDA Soil Survey Map is presented below.

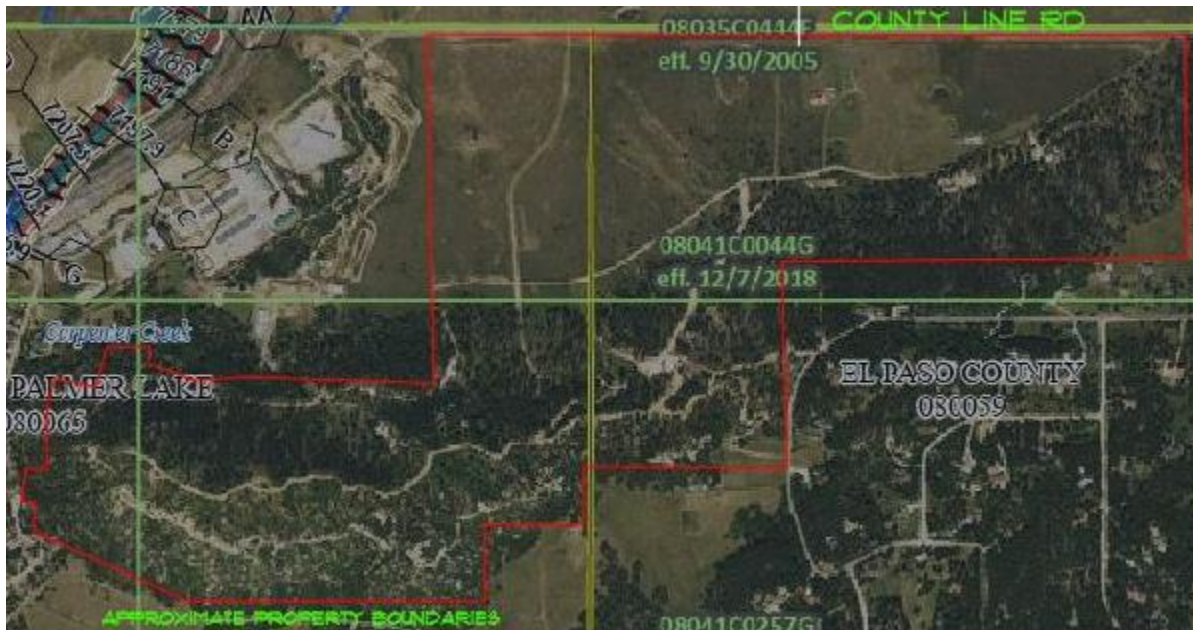
Based on our review of the Federal Emergency Management Agency (FEMA) Community Panel No. 08041C0044G and the online ArcGIS Pikes Peak Regional Floodplain Map, the entire site lies outside the 100-year and 500-year floodplains. The FEMA Map is presented below.

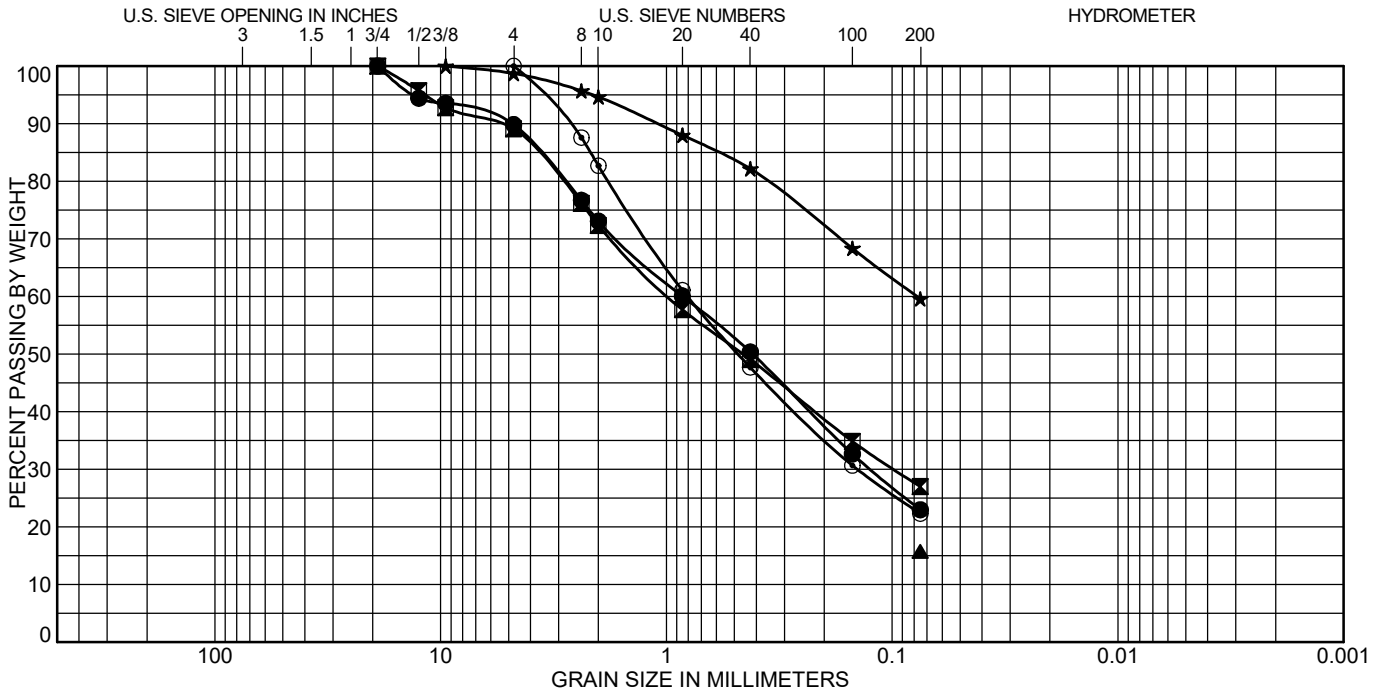
FIGURE No. 12

COBBLES	GRAVEL		SAND			SILT OR CLAY
	coarse	fine	coarse	medium	fine

Test Boring	Depth (ft)	Classification	LL	PL	PI
● 2	7.0				
☒ 3	4.0	<b>SILTY SAND(SM)</b>	<b>NP</b>	<b>NP</b>	<b>NP</b>
▲ 5	7.0				
★ 7	7.0	<b>SANDY LEAN CLAY(CL)</b>	<b>29</b>	<b>15</b>	<b>14</b>
⊙ 8	4.0

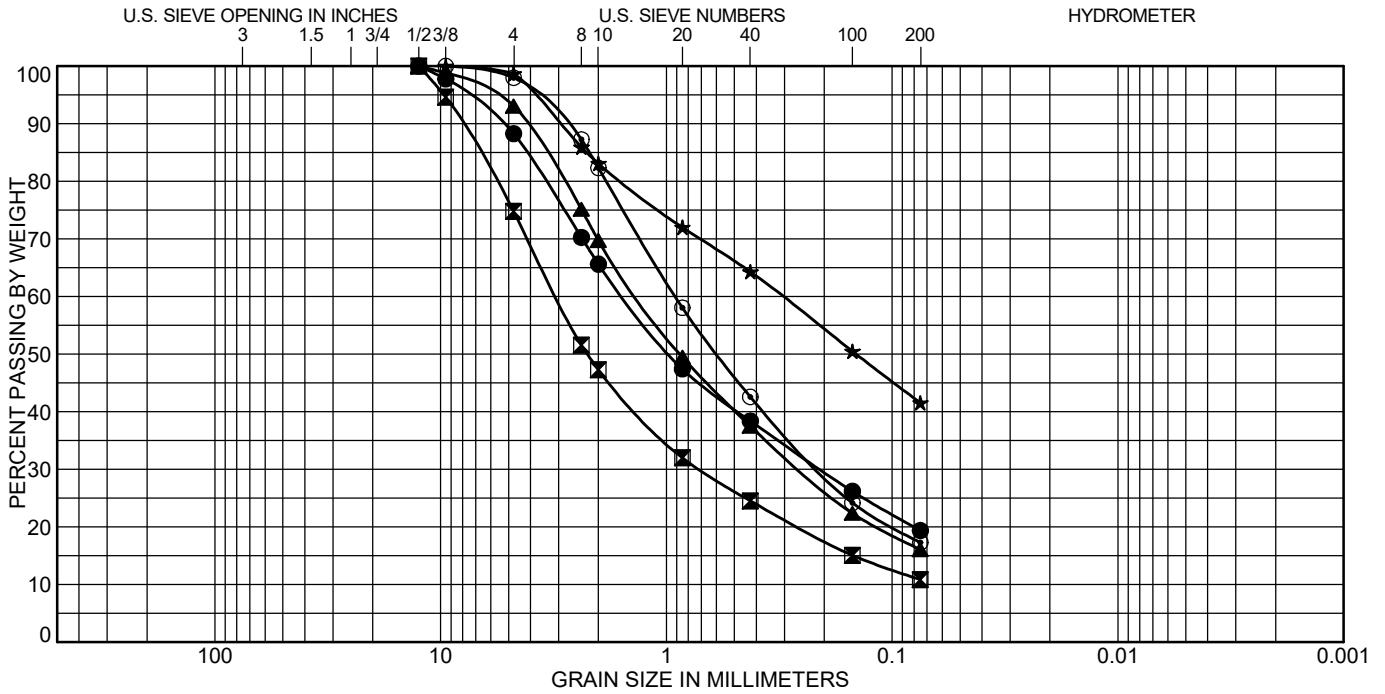
FIGURE No. 13

COBBLES	GRAVEL		SAND			SILT OR CLAY
	coarse	fine	coarse	medium	fine

Test Boring	Depth (ft)	Classification	LL	PL	PI
● 10	9.0				
☒ 11	4.0	<b>WELL-GRADED SAND with SILT and GRAVEL(SW-SM)</b>	<b>NP</b>	<b>NP</b>	<b>NP</b>
▲ 12	7.0				
★ 13	29.0				
⊙ 14	9.0	<b>CLAYEY SAND(SC)</b>	<b>24</b>	<b>14</b>	<b>10</b>

The moisture content for the recovered samples was obtained in the laboratory. Grain-size analysis, Atterberg Limits, and Denver Swell/Consolidation tests were performed on selected samples for purposes of classification and to develop pertinent engineering properties. A Summary of Laboratory Test Results is presented in Figure 13. Soil Classification Data are presented in Figure 14 through 16. The Denver Swell/Consolidation tests are presented in Figures 17 and 18.

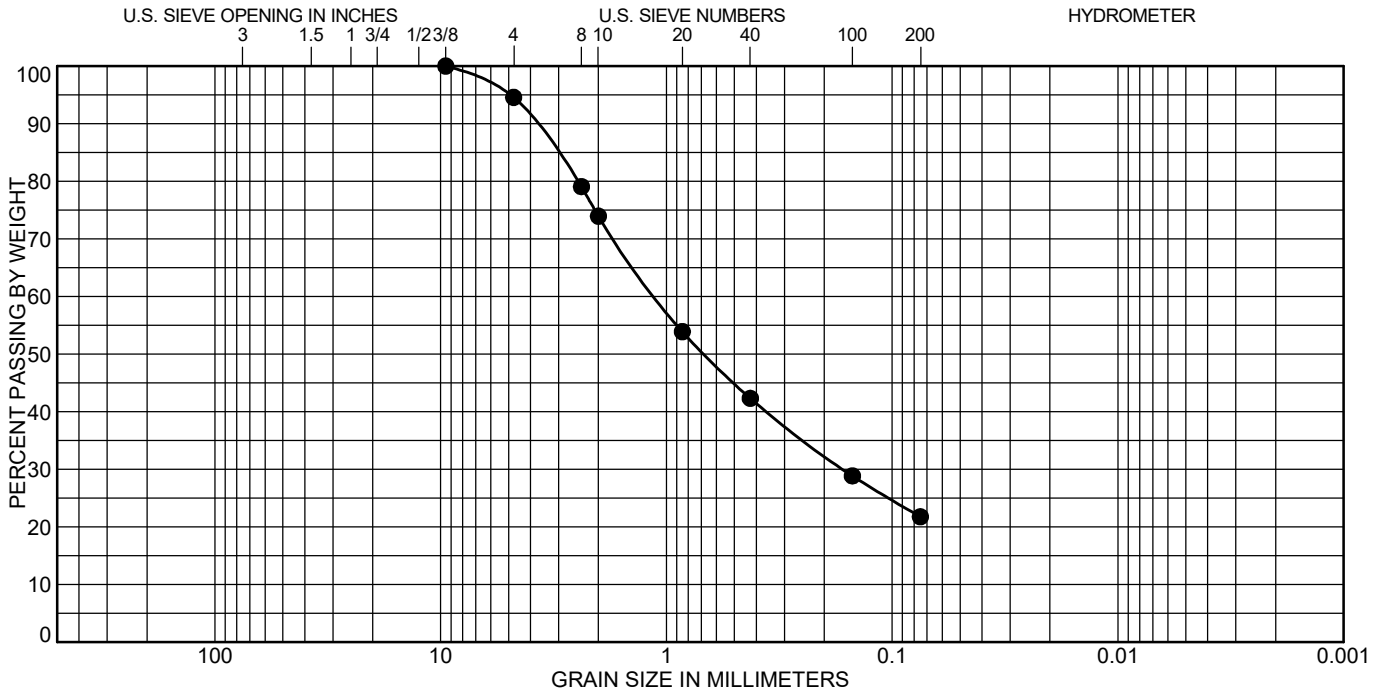
FIGURE No. 14

COBBLES	GRAVEL		SAND			SILT OR CLAY
	coarse	fine	coarse	medium	fine

Test Boring	Depth (ft)	Classification	LL	PL	PI
● 15	14.0

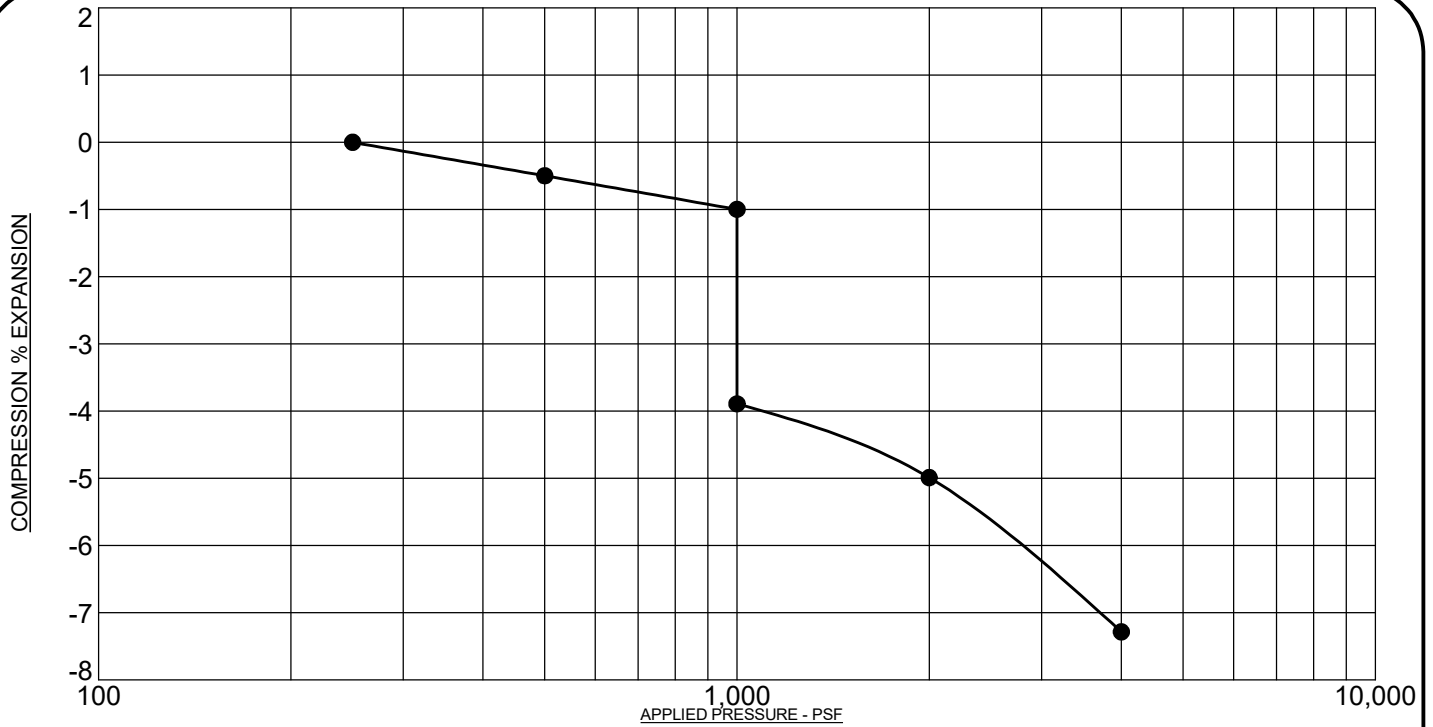
FIGURE No. 16

PROJECT: County Line Road, El Paso County, Colorado  
 SAMPLE DESCRIPTION: SAND, SILTY TO CLAYEY  
 NOTE: SAMPLE WAS INUNDATED WITH WATER AT 1,000 PSF

SAMPLE LOCATION: 1 @ 9 FT  
 NATURAL DRY UNIT WEIGHT: 117.8 PCF  
 NATURAL MOISTURE CONTENT: 7.4%  
 PERCENT SWELL/COMPRESSION: - 2.9

SAMPLE LOCATION: 4 @ 2 FT  
 NATURAL DRY UNIT WEIGHT: PCF  
 NATURAL MOISTURE CONTENT: 4.8%  
 PERCENT SWELL/COMPRESSION: - 2.2

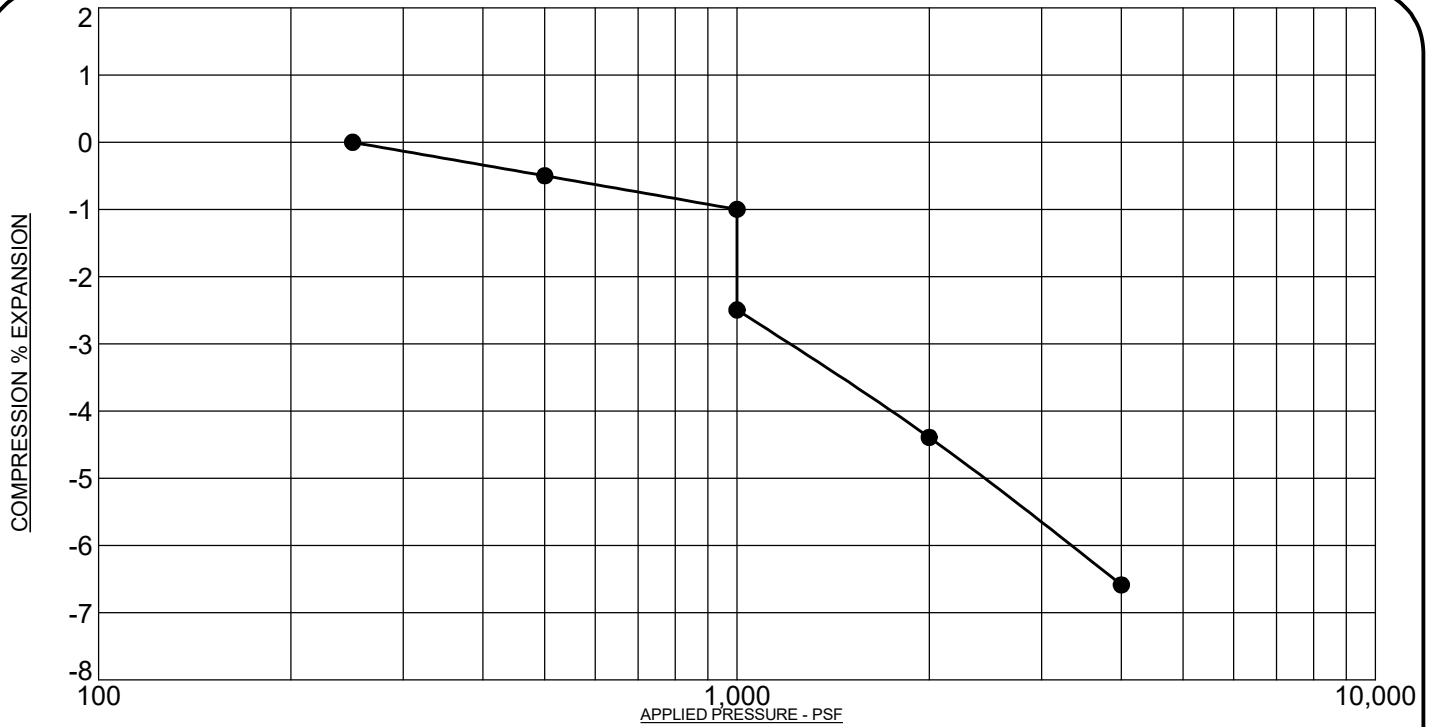
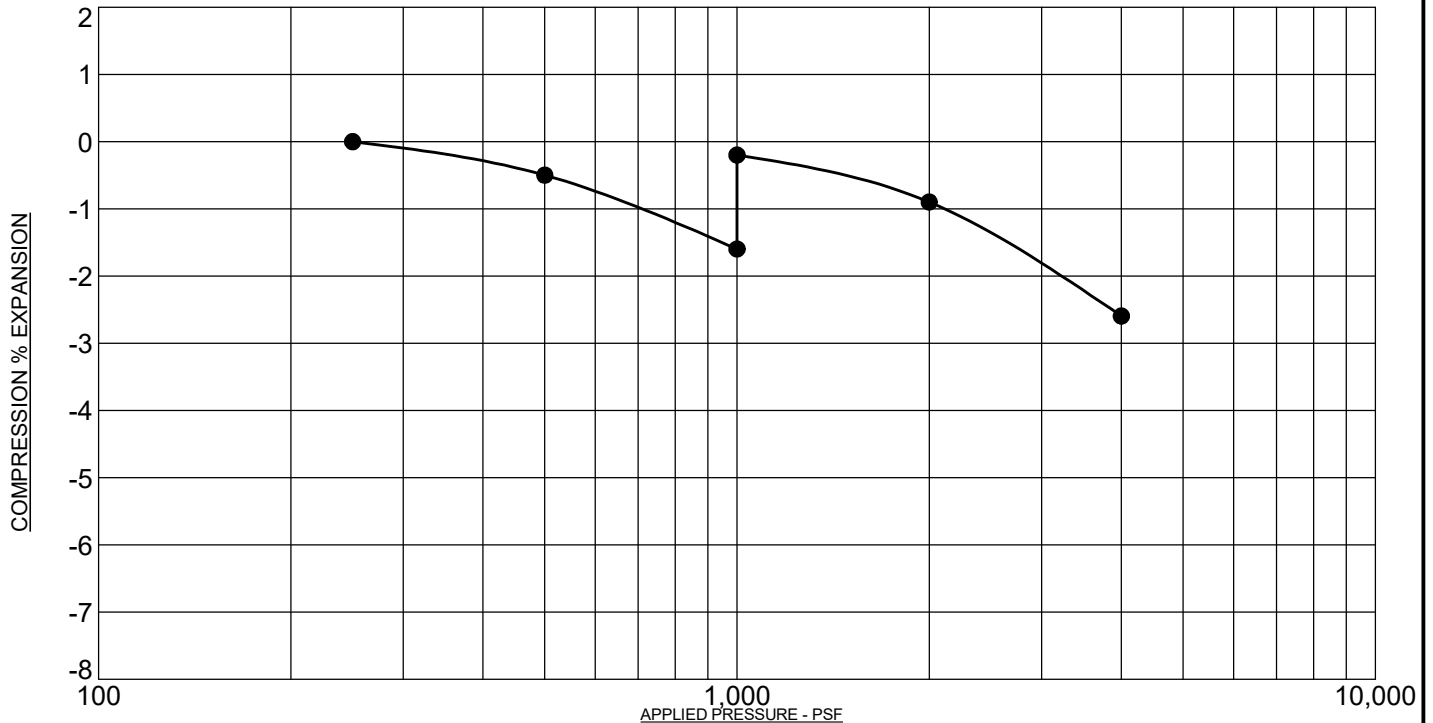
FIGURE No. 17

PROJECT: County Line Road, El Paso County, Colorado  
 SAMPLE DESCRIPTION: SAND, SILTY TO CLAYEY  
 NOTE: SAMPLE WAS INUNDATED WITH WATER AT 1,000 PSF

SAMPLE LOCATION: 8 @ 4 FT  
 NATURAL DRY UNIT WEIGHT: PCF  
 NATURAL MOISTURE CONTENT: 9.4%  
 PERCENT SWELL/COMPRESSION: - 1.5

PROJECT: County Line Road, El Paso County, Colorado  
 SAMPLE DESCRIPTION: CLAY, SANDY  
 NOTE: SAMPLE WAS INUNDATED WITH WATER AT 1,000 PSF

SAMPLE LOCATION: 13 @ 2 FT  
 NATURAL DRY UNIT WEIGHT: PCF  
 NATURAL MOISTURE CONTENT: 25.2%  
 PERCENT SWELL/COMPRESSION: 1.4

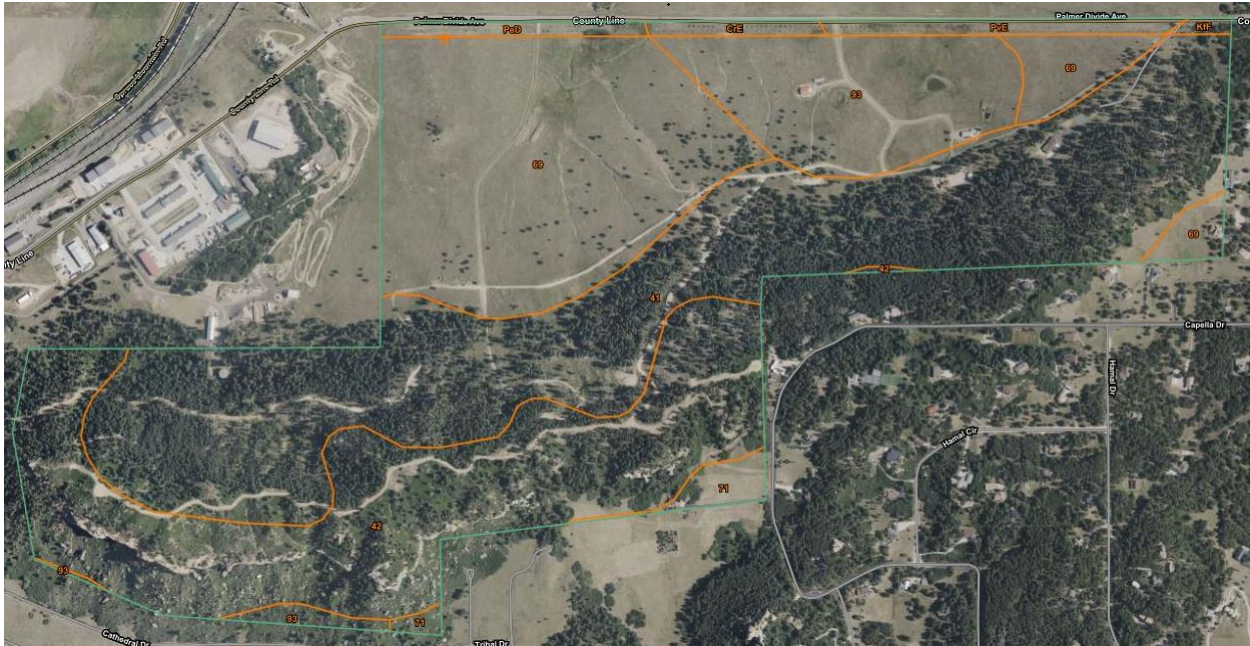
- **93 – Tomah-Crowfoot complex, 8 to 15 percent slopes.** The Tomah-Crowfoot complex was mapped by the USDA to encompass the northwest corner of the property. Properties of the Tomah-Crowfoot complex include, well-drained soils, depth of the water table is anticipated to be greater than 80 inches, runoff is anticipated to be low, frequency of flooding and ponding is none, and landforms include hills.

The USDA Soil Survey Map is presented below.
