## **SOIL AND GEOLOGY STUDY**

**Proposed Subdivision  
County Line Rd**

**EPC Schedule No. 7104200012  
El Paso County, Colorado**

**JOB NO. 199069**

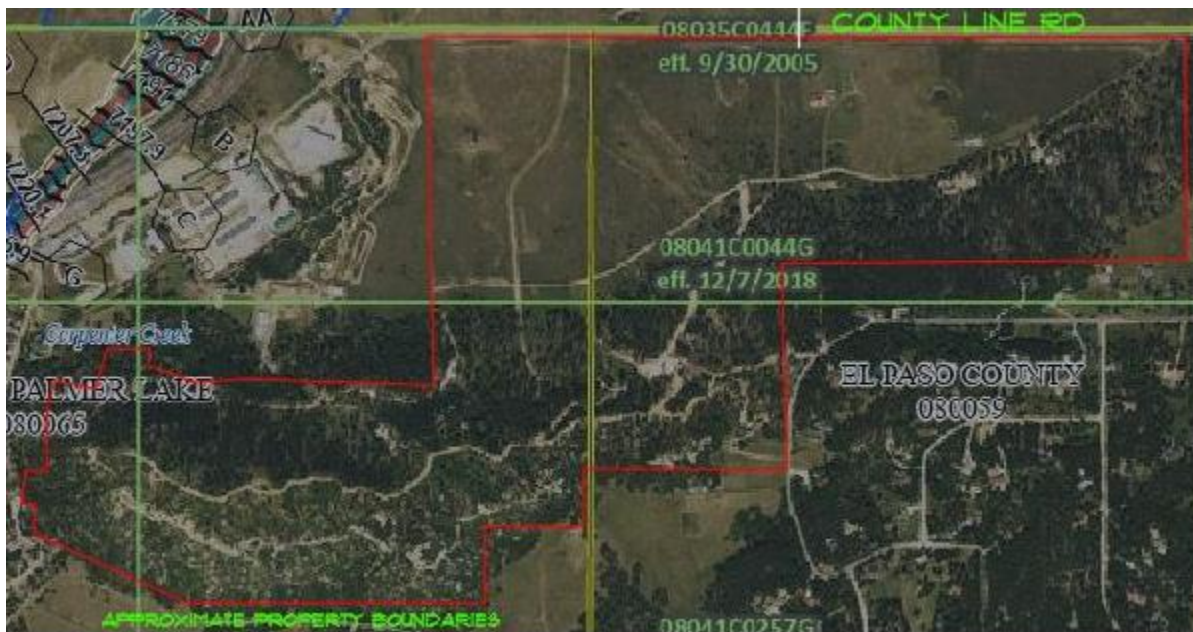
Based on our review of the Federal Emergency Management Agency (FEMA) Community Panel No. 08041C0044G and the online ArcGIS Pikes Peak Regional Floodplain Map, the entire site lies outside the 100-year and 500-year floodplains. The FEMA Map is presented below.

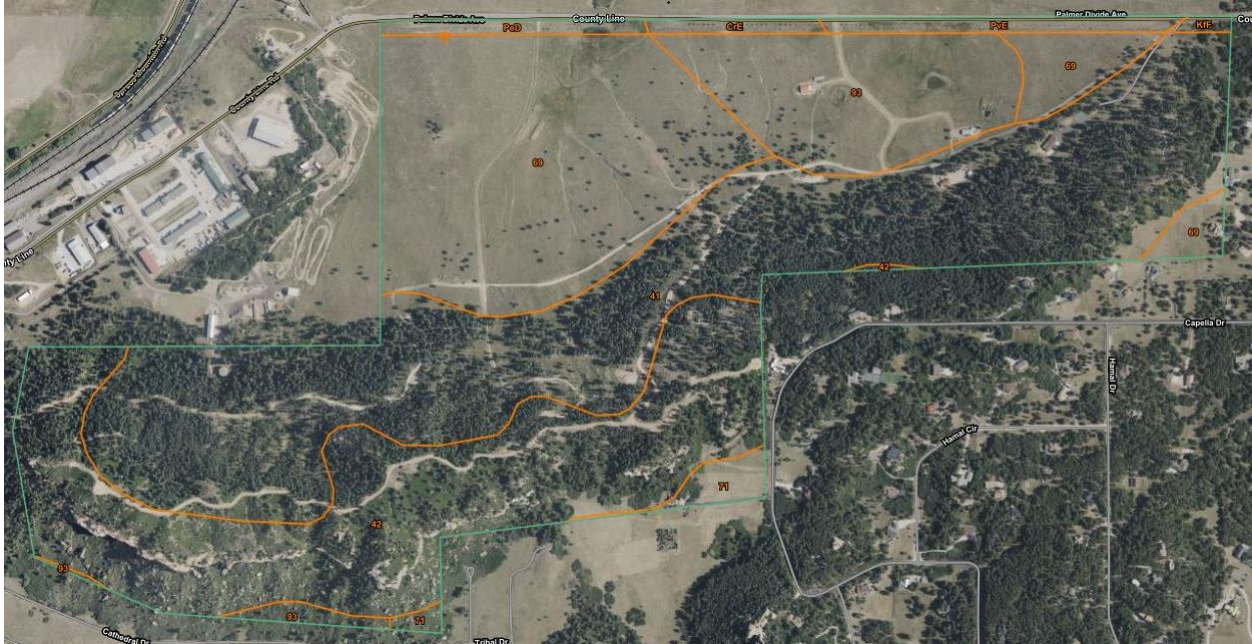
- **93 – Tomah-Crowfoot complex, 8 to 15 percent slopes.** The Tomah-Crowfoot complex was mapped by the USDA to encompass the northwest corner of the property. Properties of the Tomah-Crowfoot complex include, well-drained soils, depth of the water table is anticipated to be greater than 80 inches, runoff is anticipated to be low, frequency of flooding and ponding is none, and landforms include hills.

The USDA Soil Survey Map is presented below.
