Re: Soil, Geology, and Geologic Hazard Study

> Manley Subdivision Filing No. 2 Curtis Road and Jones Road El Paso County, Colorado

GENERAL SITE CONDITIONS AND PROJECT DESCRIPTION

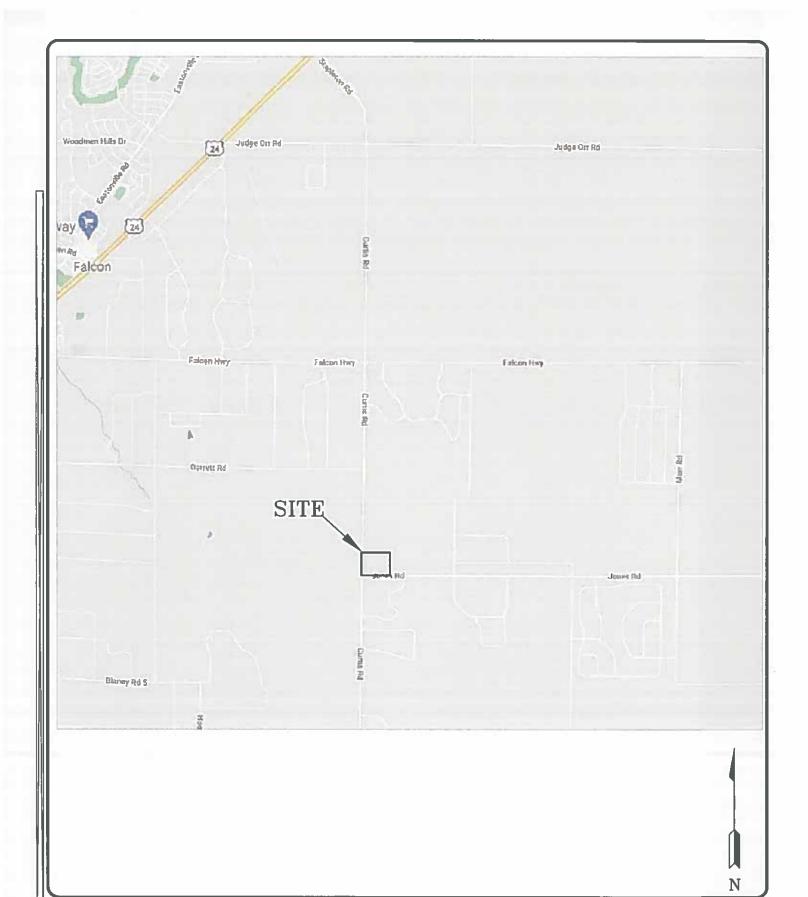
VICINITY MAP

MANLEY SUBDIVISION, FILING NO. 2

The project lies in the SW¼ of the SW¼ of Section 22, Township 13 South, Range 64 West of the 6th Principal Meridian in El Paso County, Colorado. The site is located northeast of the intersection of Curtis and Jones Roads, 3 miles southeast of Falcon, Colorado. The location of the site is as shown on the Vicinity Map, Figure 1.

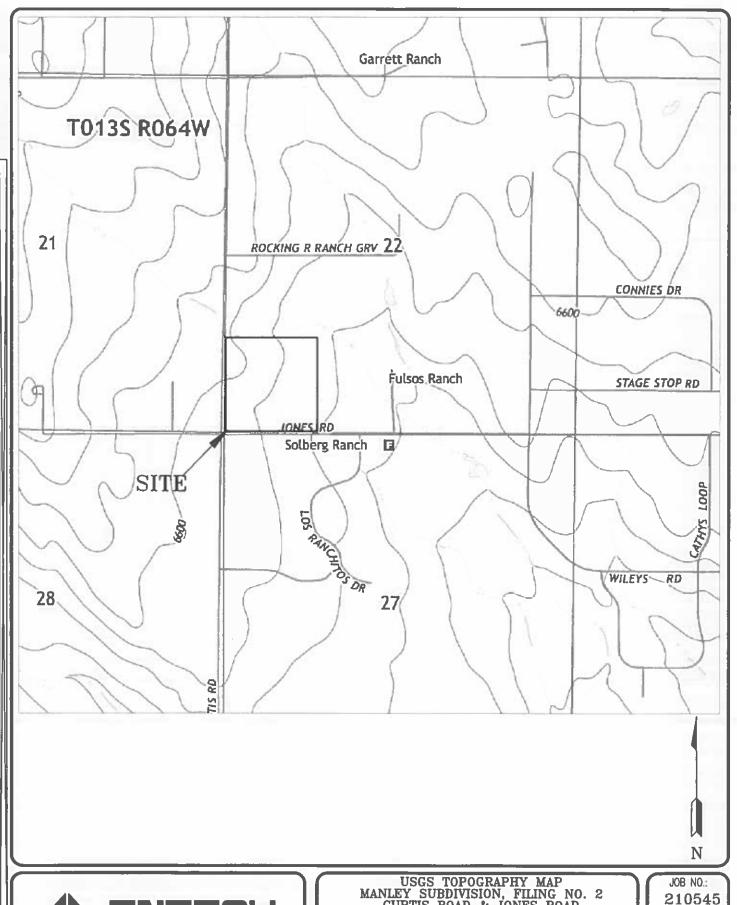
FIG NO.:

USGS TOPOGRAPHY MAP
MANLEY SUBDIVISION, FILING NO. 2
CURTIS ROAD & JONES ROAD
EL PASO COUNTY, CO.
FOR: LAND DEVELOPMENT CONSULTANTS, INC

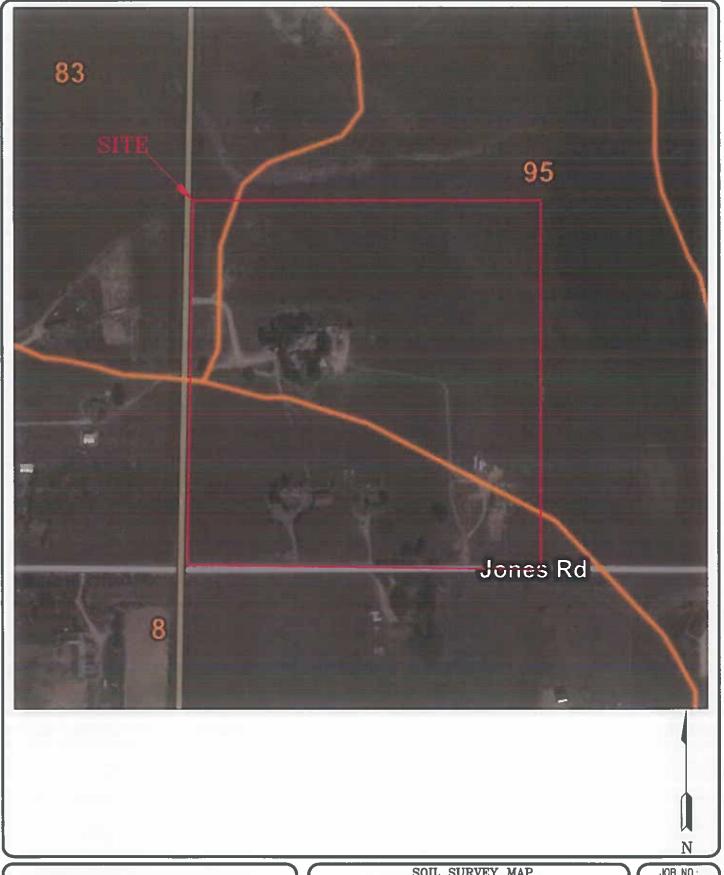
FIG NO.:

SOIL SURVEY MAP

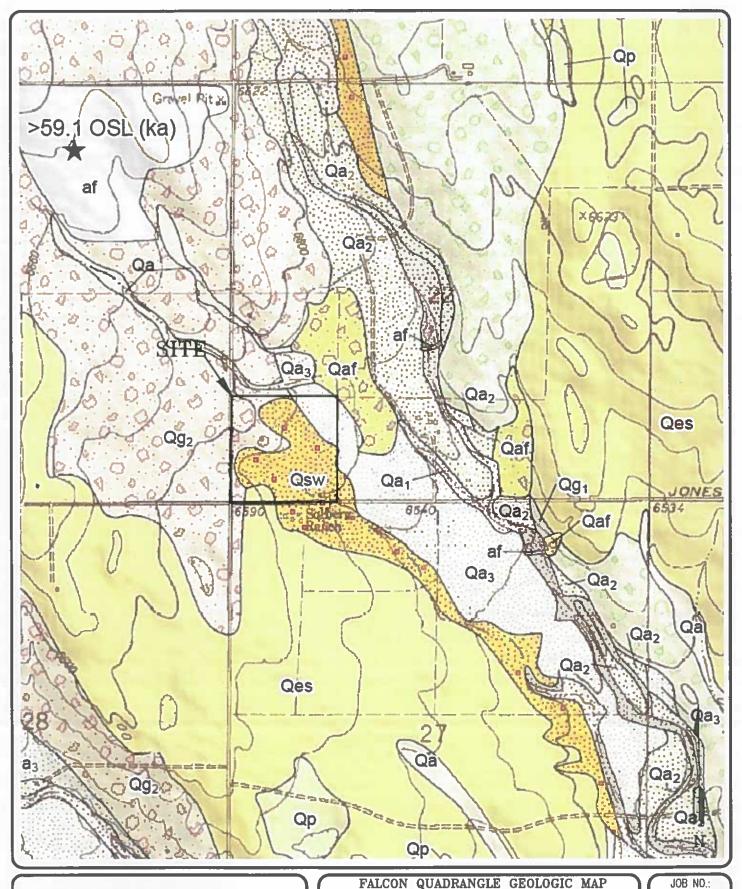
210545 FIG NO.: 5

FALCON QUADRANGLE GEOLOGIC MAP
MANLEY SUBDIVISION, FILING NO. 2
CURTIS ROAD & JONES ROAD
EL PASO COUNTY, CO.
FOR: LAND DEVELOPMENT CONSULTANTS, INC

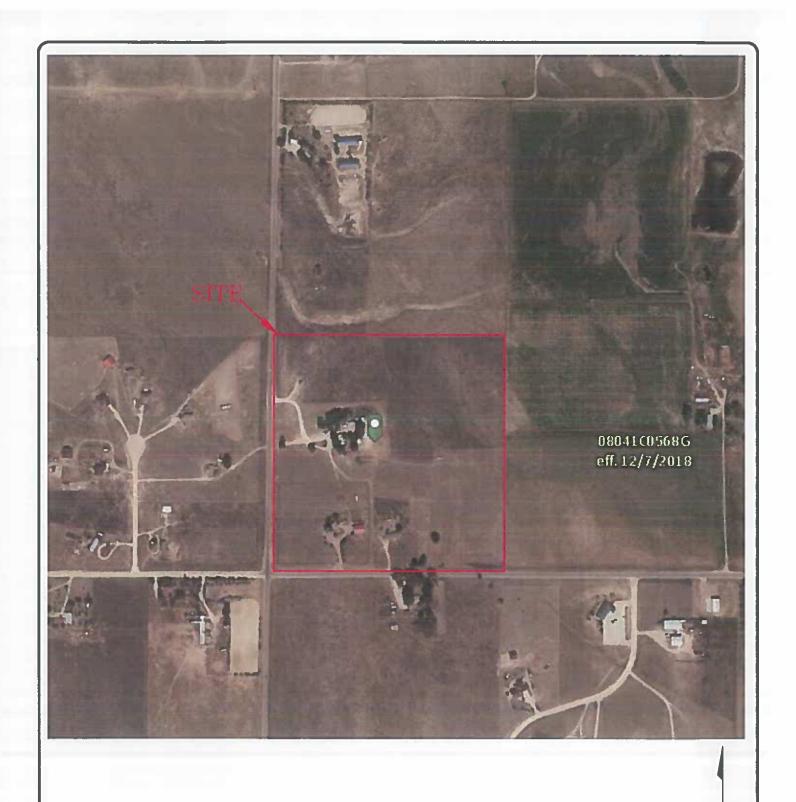
FIG NO.:

FEMA FLOODPLAIN MAP
MANLEY SUBDIVISION, FILING NO. 2
CURTIS ROAD & JONES ROAD
EL PASO COUNTY, CO.
FOR: LAND DEVELOPMENT CONSULTANTS, INC

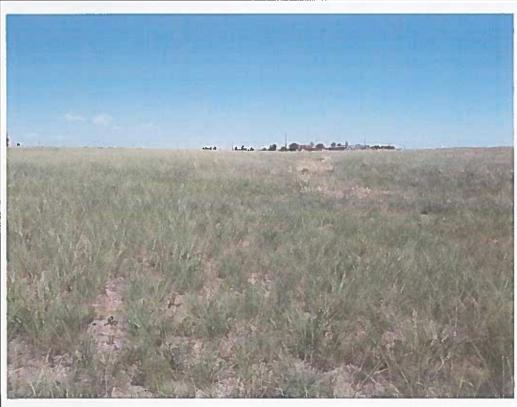
Looking northwest along minor drainage swale in the east central portion of the property.

The topography of the site is gradually to moderately sloping to the south-southeast. Minor drainage swales are located in the northern and southern portions of the property. Water was not observed in the drainages at the time of this investigation. The site boundaries are indicated on the USGS Map, Figure 2. Previous land uses have included undeveloped and rural residential/agricultural land. The site contains field grasses, weeds, and yuccas. An existing house with a water well and septic system is located on Lot 2 of the Manley Subdivision Filing No. 1. The house will remain and be replatted as Lot 1 of the Manley Subdivision Filing No. 2. An existing mobile home is located on proposed Lot 2, which will remain. Site photographs were taken and site mapping was completed on was June 16, 2021. Site photographs are included in appendix A. Test Borings and Test Pits were performed on April, 23, 2021.

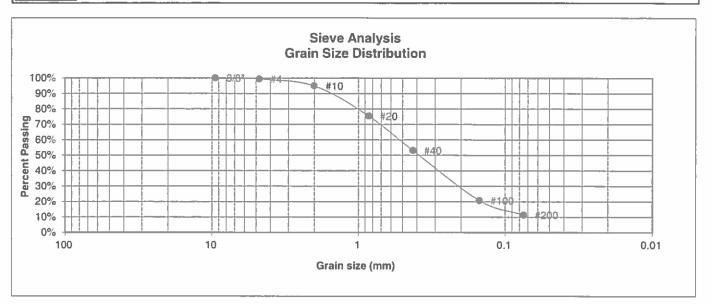
U.S. <u>Sieve #</u> 3" 1 1/2" 3/4" 1/2" 3/8"	Percent <u>Finer</u>	Atterberg <u>Limits</u> Plastic Limit Liquid Limit Plastic Index
4	99.4% 94.9%	<u>Swell</u> Moisture at start
20 40 100	75.4% 53.1% 20.7%	Moisture at finish Moisture increase Initial dry density (pcf)
200	11.4%	Swell (psf)

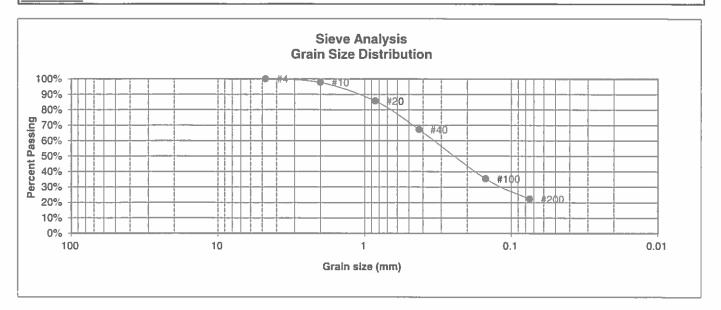
U.S. <u>Sieve #</u> 3" 1 1/2" 3/4" 1/2" 3/8"	Percent <u>Finer</u>	Atterberg <u>Limits</u> Plastic Limit Liquid Limit Plastic Index
4	100.0%	<u>Swell</u>
10	97.7%	Moisture at start
20	85.7%	Moisture at finish
40	67.2%	Moisture increase
100	35.4%	Initial dry density (pcf)
200	22.3%	Swell (psf)
