SOIL AND GEOLOGY STUDY

**Gunners Ridge
El Paso County, Colorado**

JOB NO. 192027

**February 17, 2023
Amended April 11, 2023**

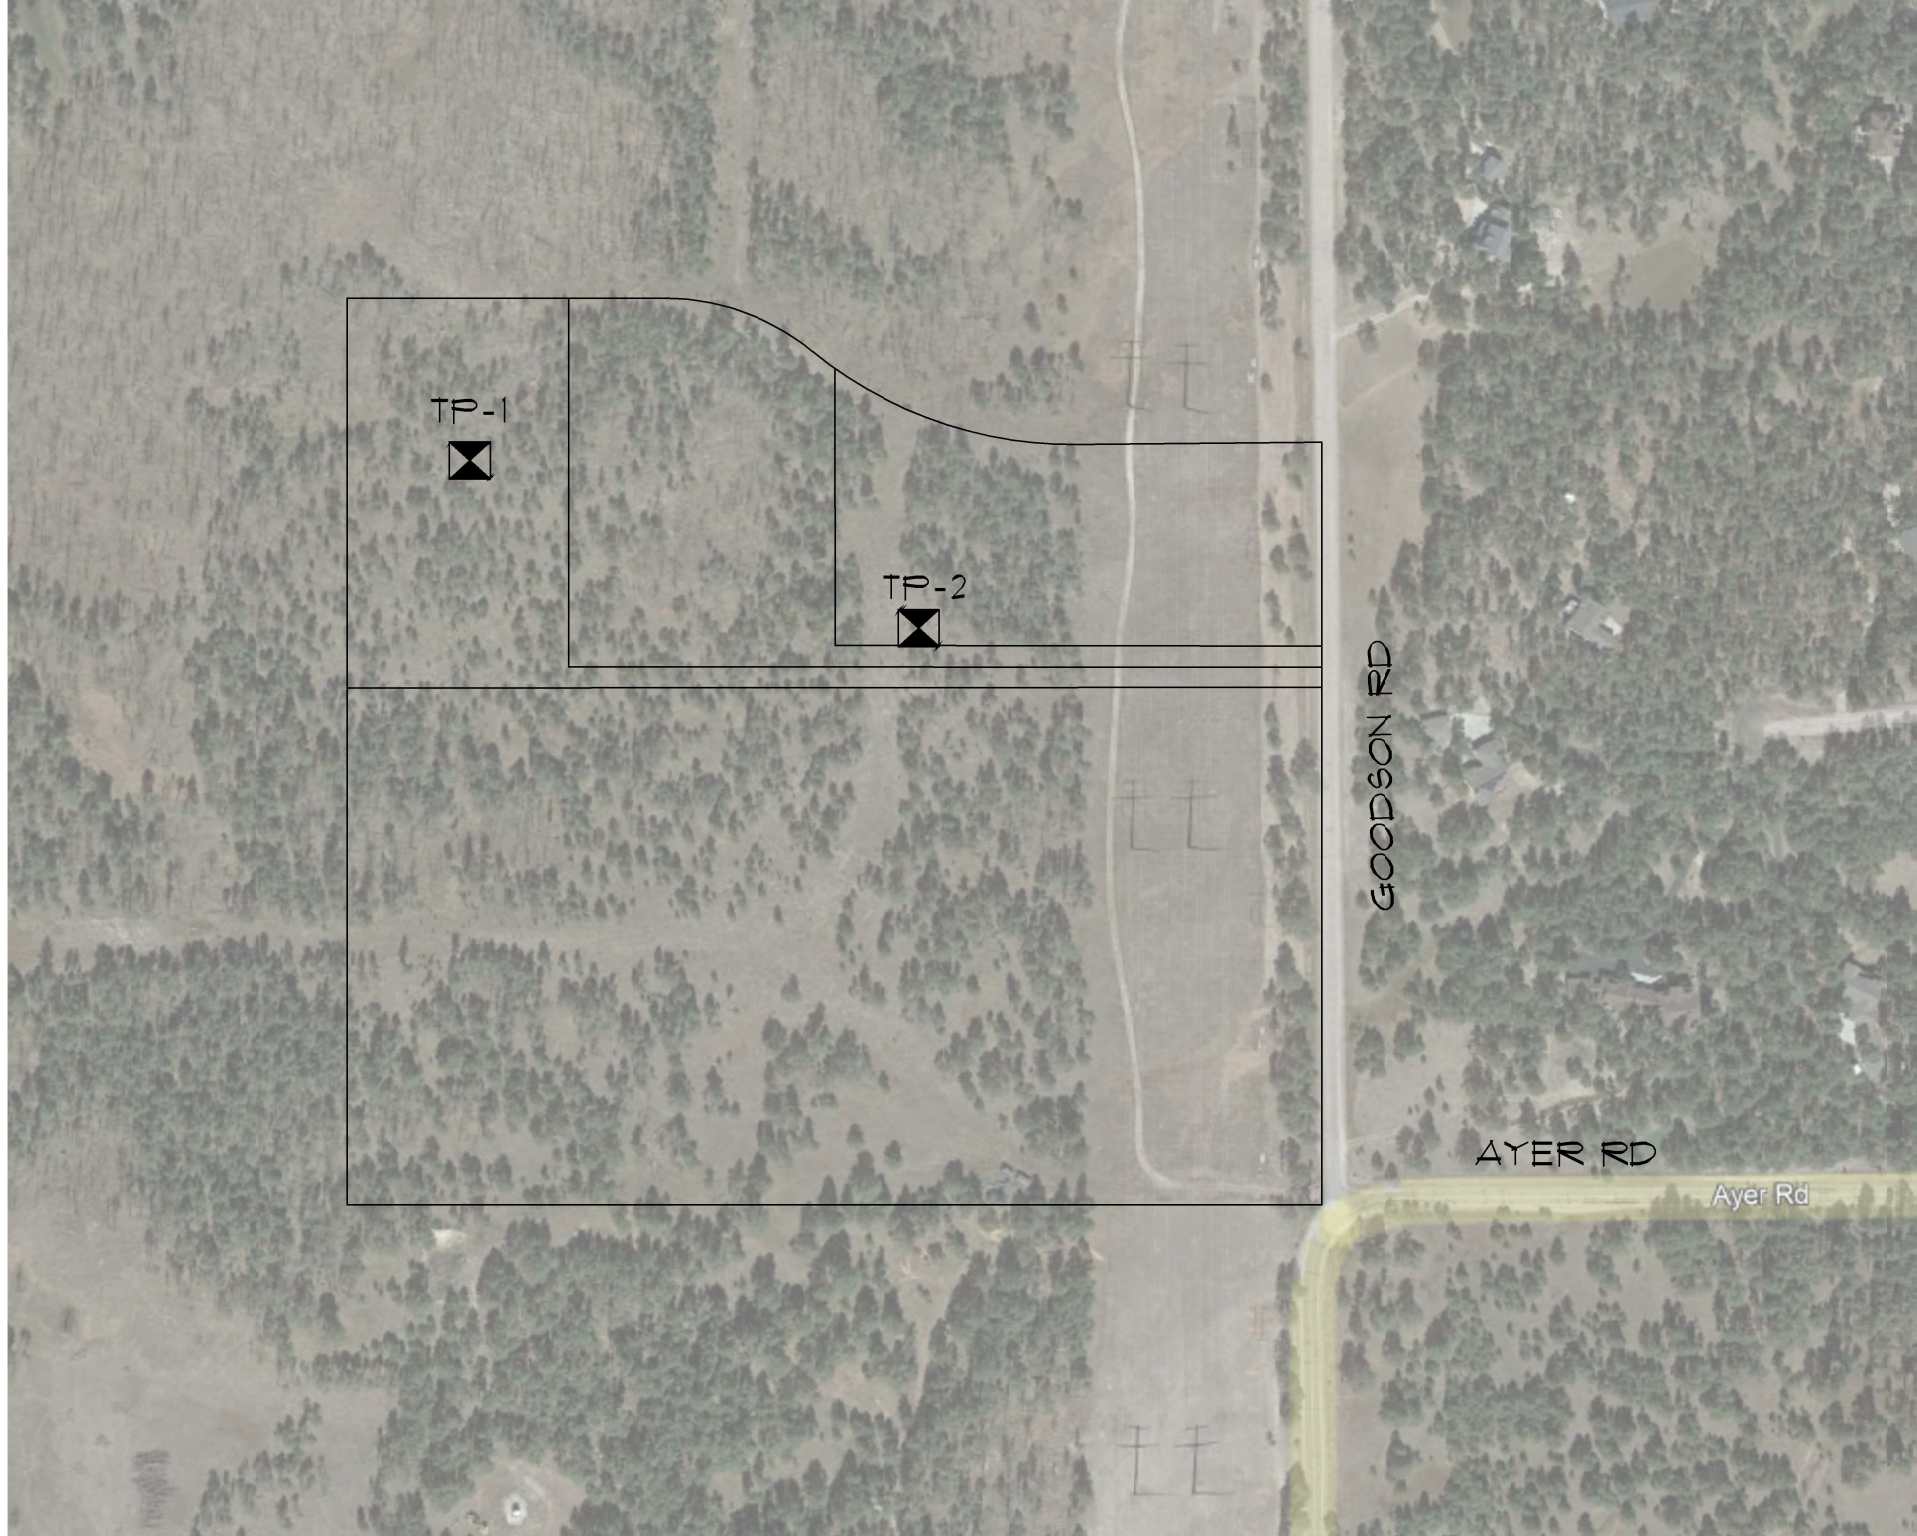
DENOTES APPROXIMATE LOCATION OF TEST PITS PERFORMED FOR THIS INVESTIGATION

The current subsurface conditions within the property were explored by drilling one (1) exploratory test boring to a depth of 20-feet below the existing ground surface on January 16 and two 8-foot deep test pits on January 17, 2023. The test pits were excavated for on-site wastewater treatment system (OWTS) purposes. RMG's previous investigation conducted in November of 2022, Job No. 191132, explored subsurface conditions on the property to the west by drilling two (2) exploratory test borings to depths of 20-feet below the existing ground surface. The total number of borings generally meets the minimum criteria as stipulated in the ECM, Section C.3.3.

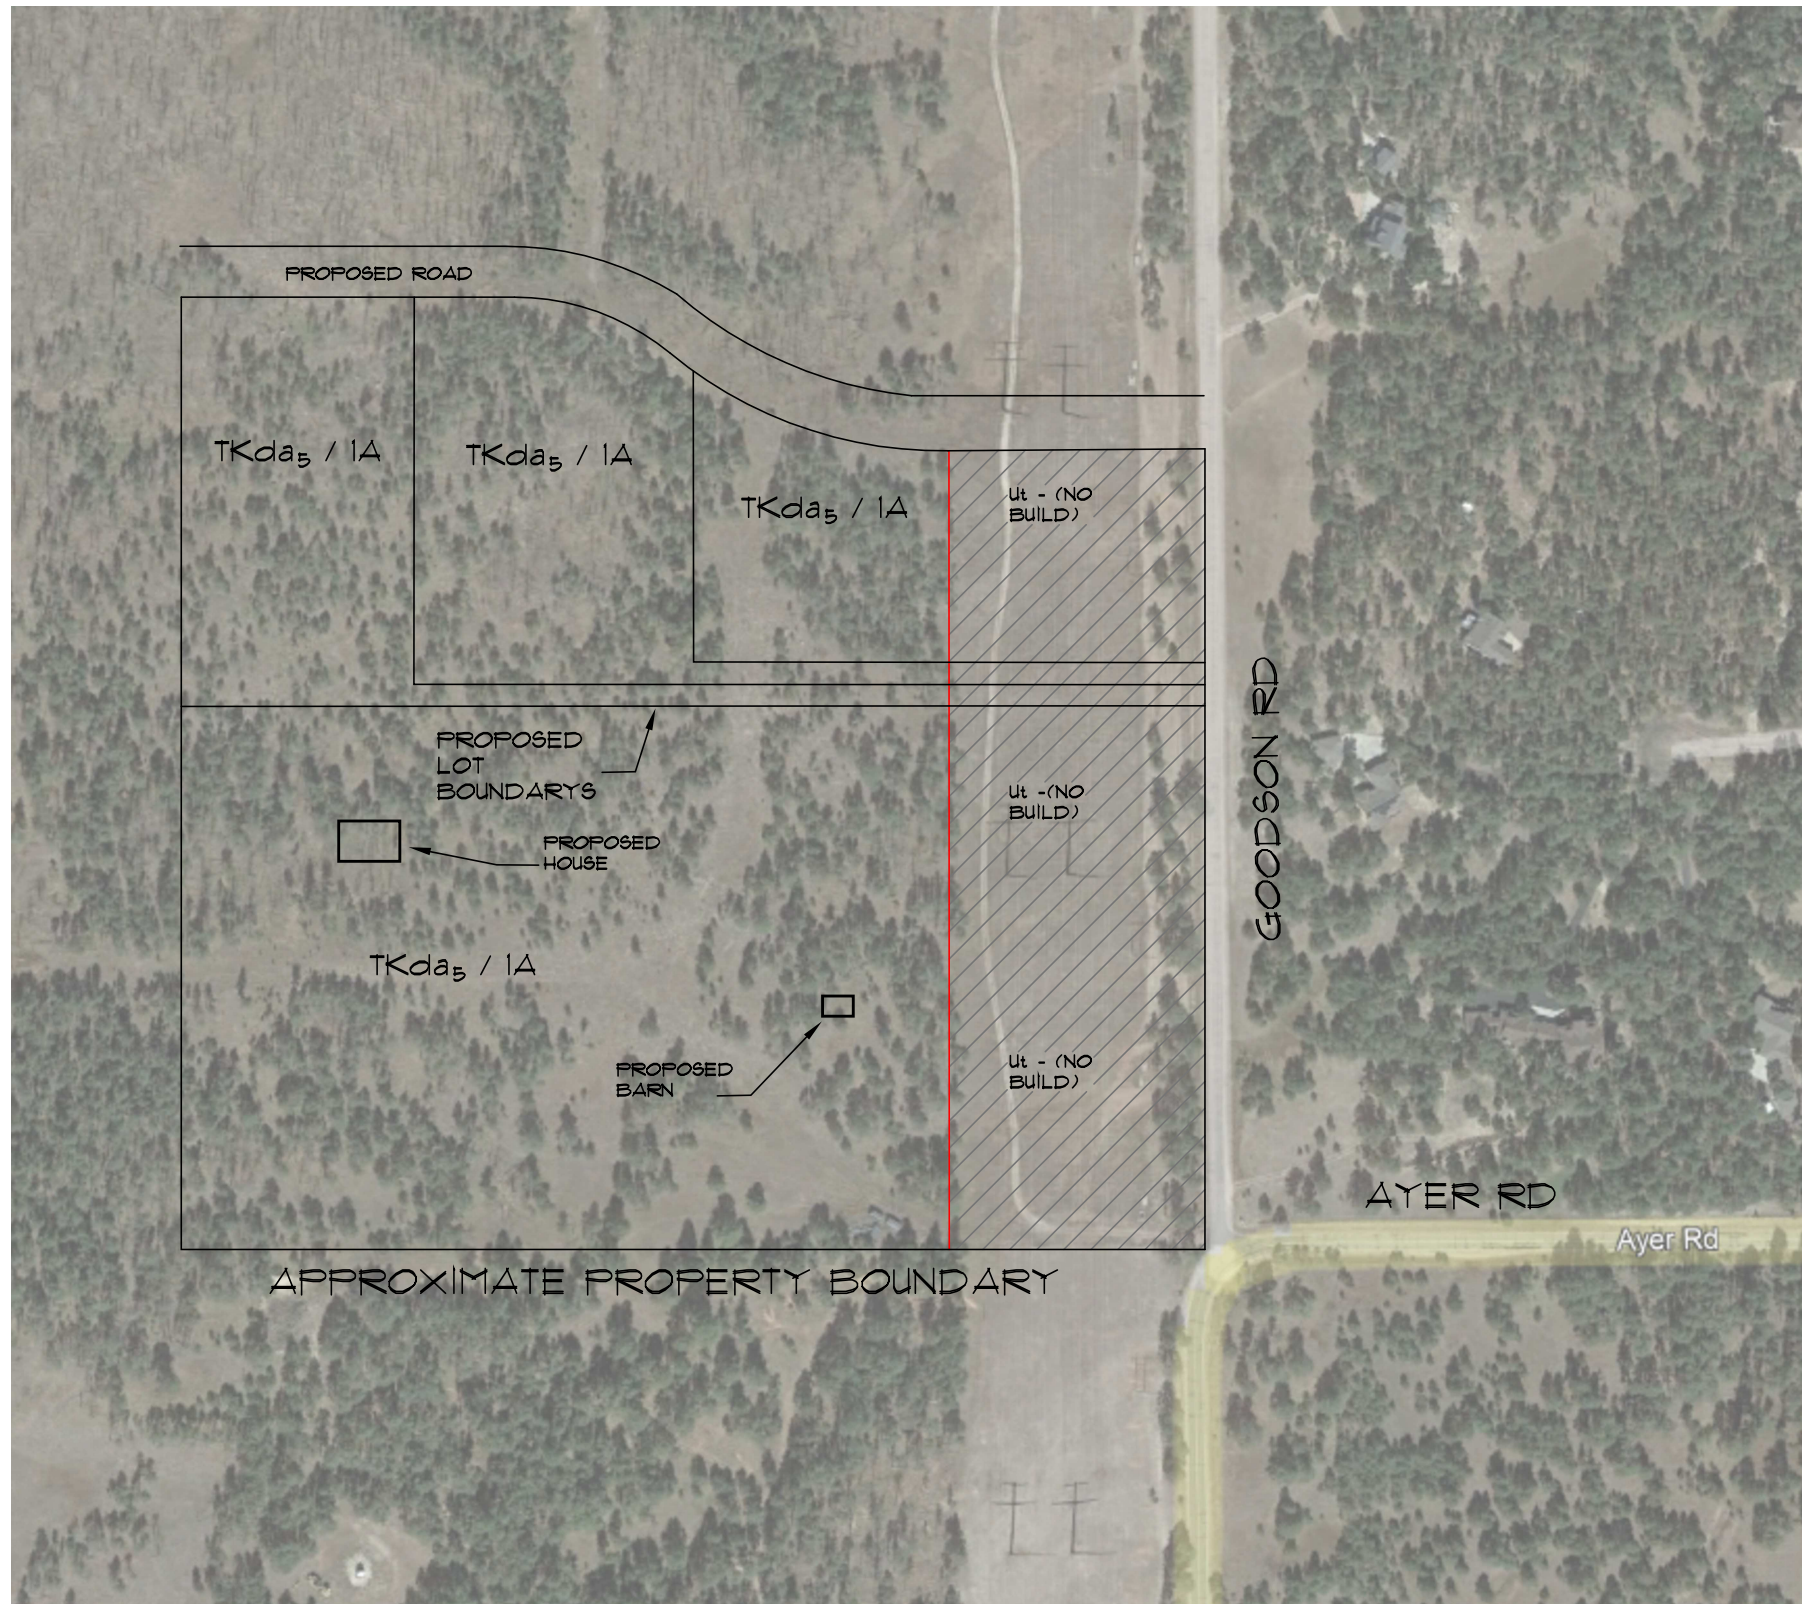
GEOLOGIC CONDITIONS

TKda₅ - DAWSON FORMATION, FACIES UNIT FIVE (EOCENE)

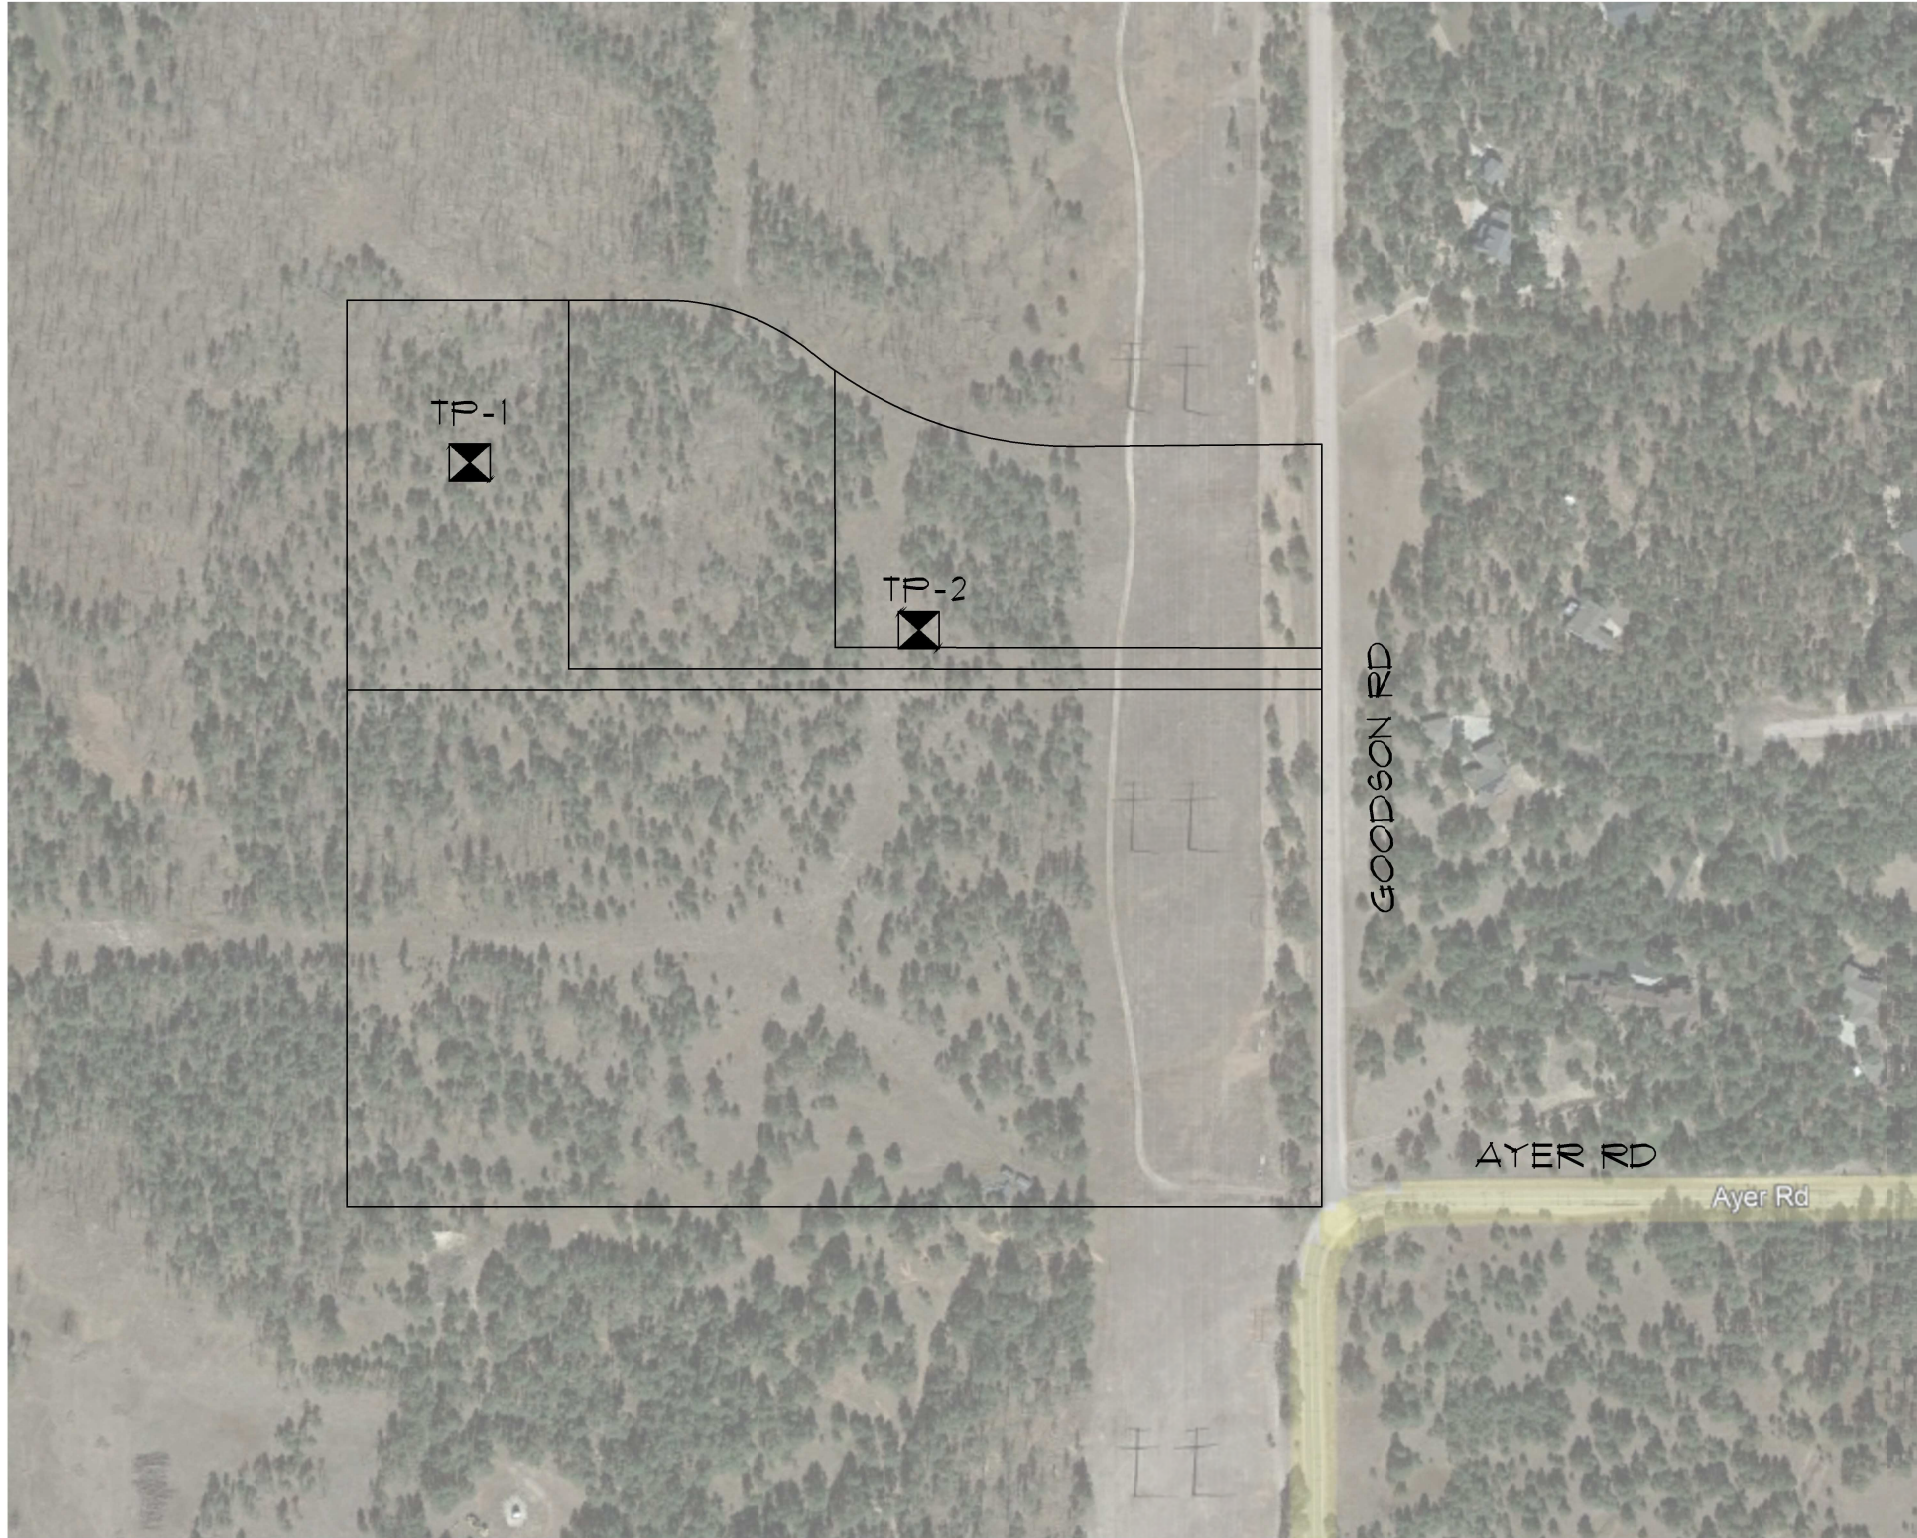
SHEET No. FIG-2

PROPOSED LOT LAYOUT

The site consists of approximately 38.83 acres and is vacant. The proposed development is to consist of 4 lots, three of which range between 4.92 and 5.03 acres. The fourth lot will comprise the remaining acreage of approximately 23.87 acres. The Proposed Lot Layout Plan is presented in Figure 2.

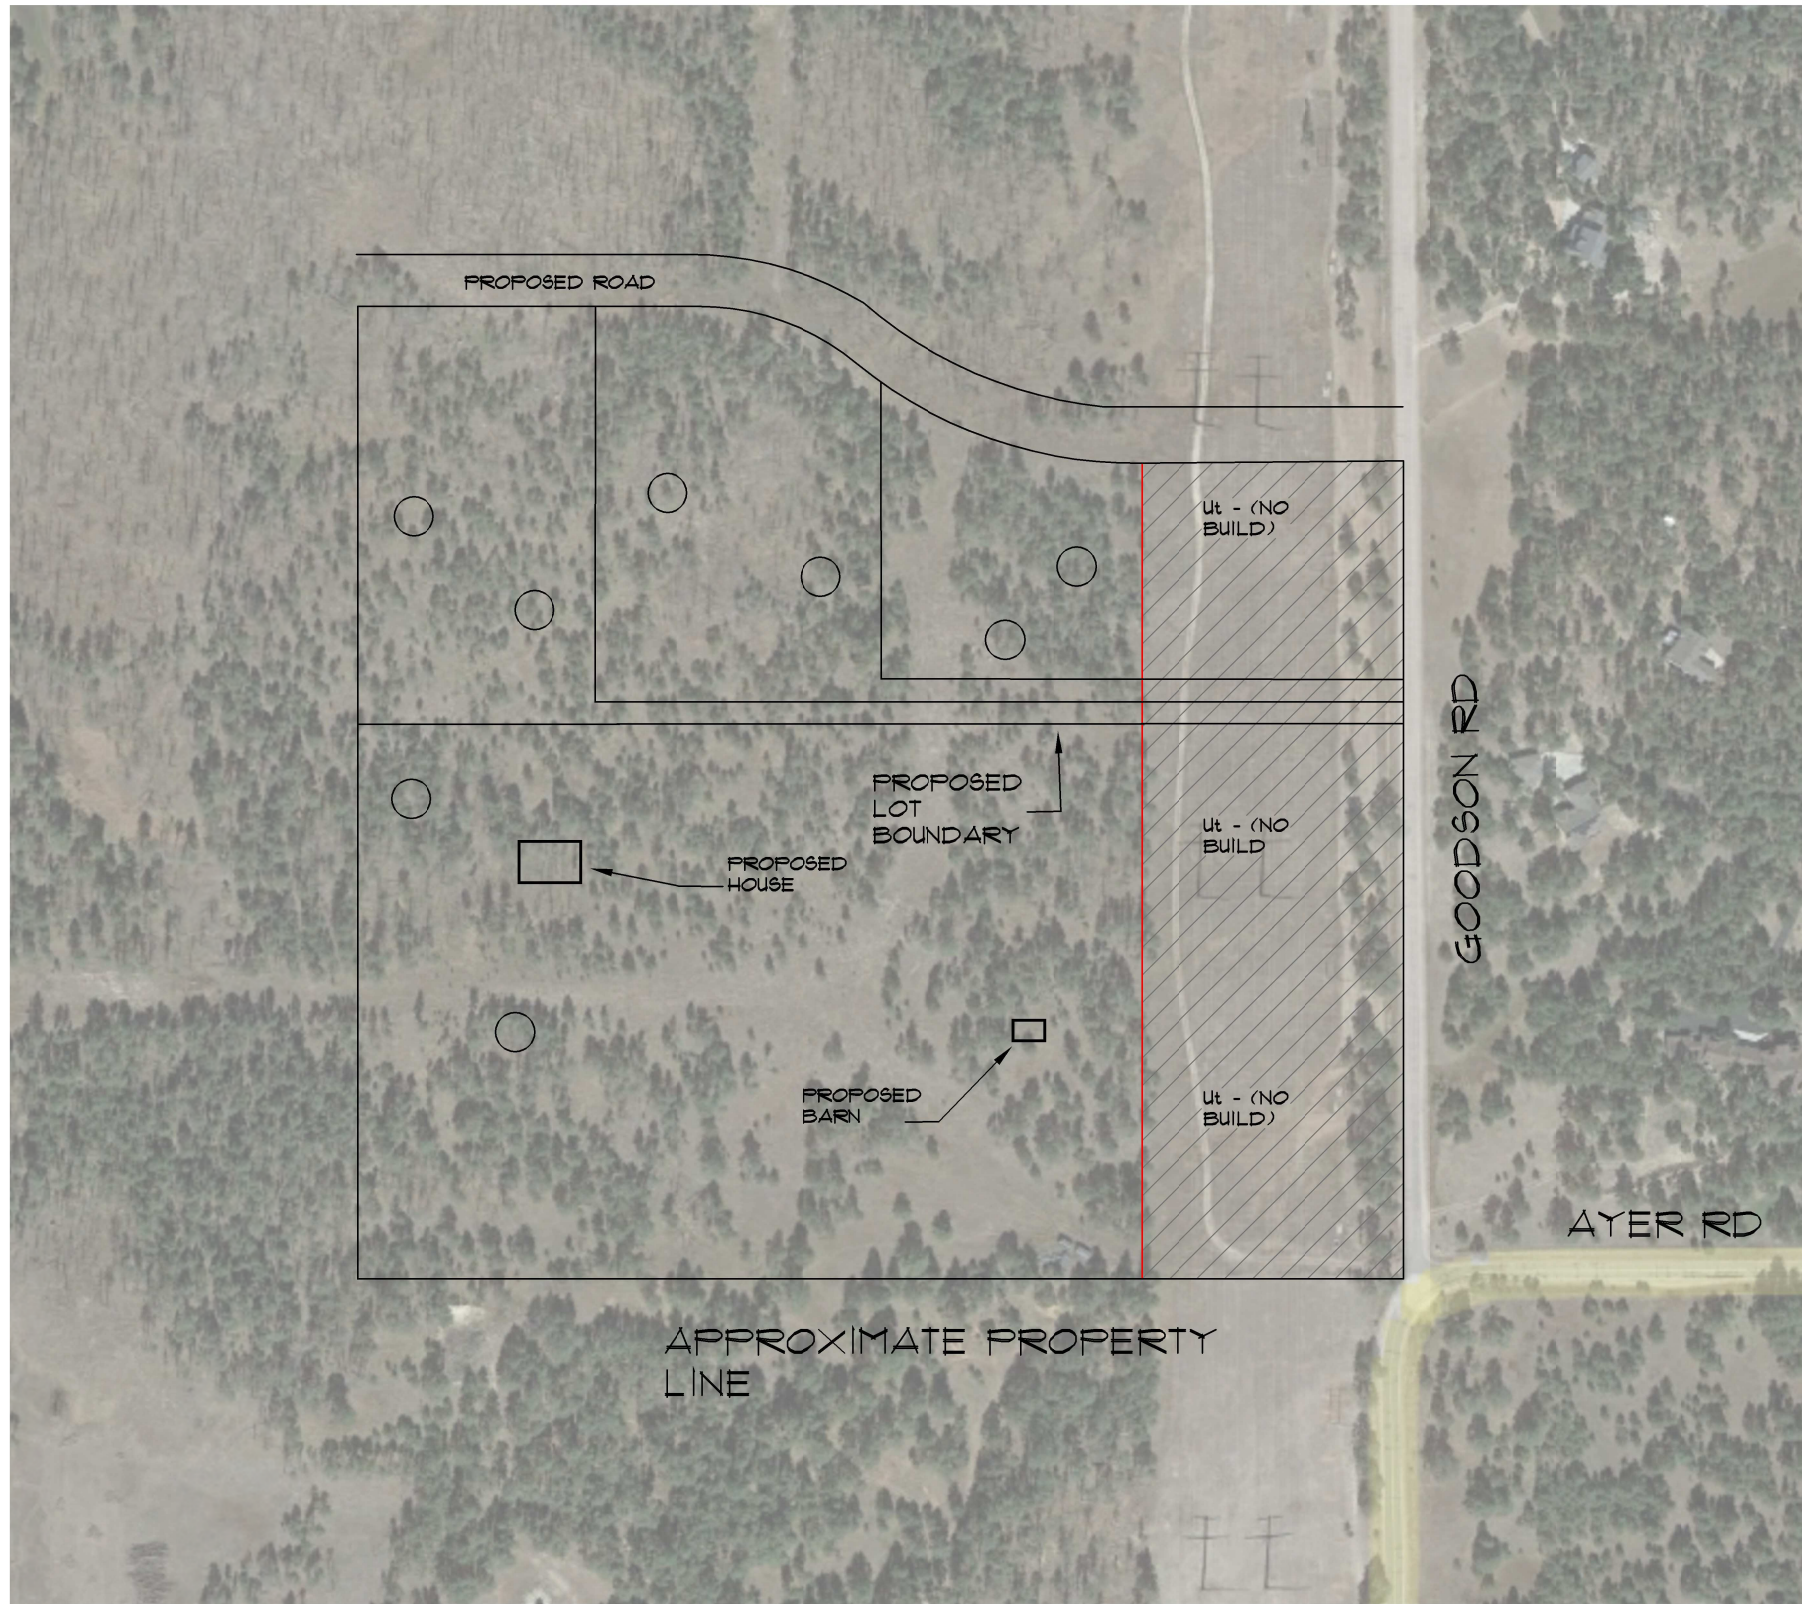
NOTE: THE CHOSEN ON-SITE WASTEWATER TREATMENT SYSTEM (OWTS) LOCATIONS ARE FOR ILLUSTRATION ONLY. IF THE EL PASO COUNTY HEALTH DEPARTMENT PHYSICAL SETBACK REQUIREMENTS ARE MET FOR EACH LOT, THERE ARE NO RESTRICTIONS ON THE PLACEMENT OF THE INDIVIDUAL OWTS.

○ DENOTES POTENTIAL OWTS LOCATIONS
