SOIL AND GEOLOGY STUDY

**Proposed Minor Subdivision
Currently addressed as: 12172 Goodson Rd.
El Paso County, Colorado**

JOB NO. 192027

February 17, 2023

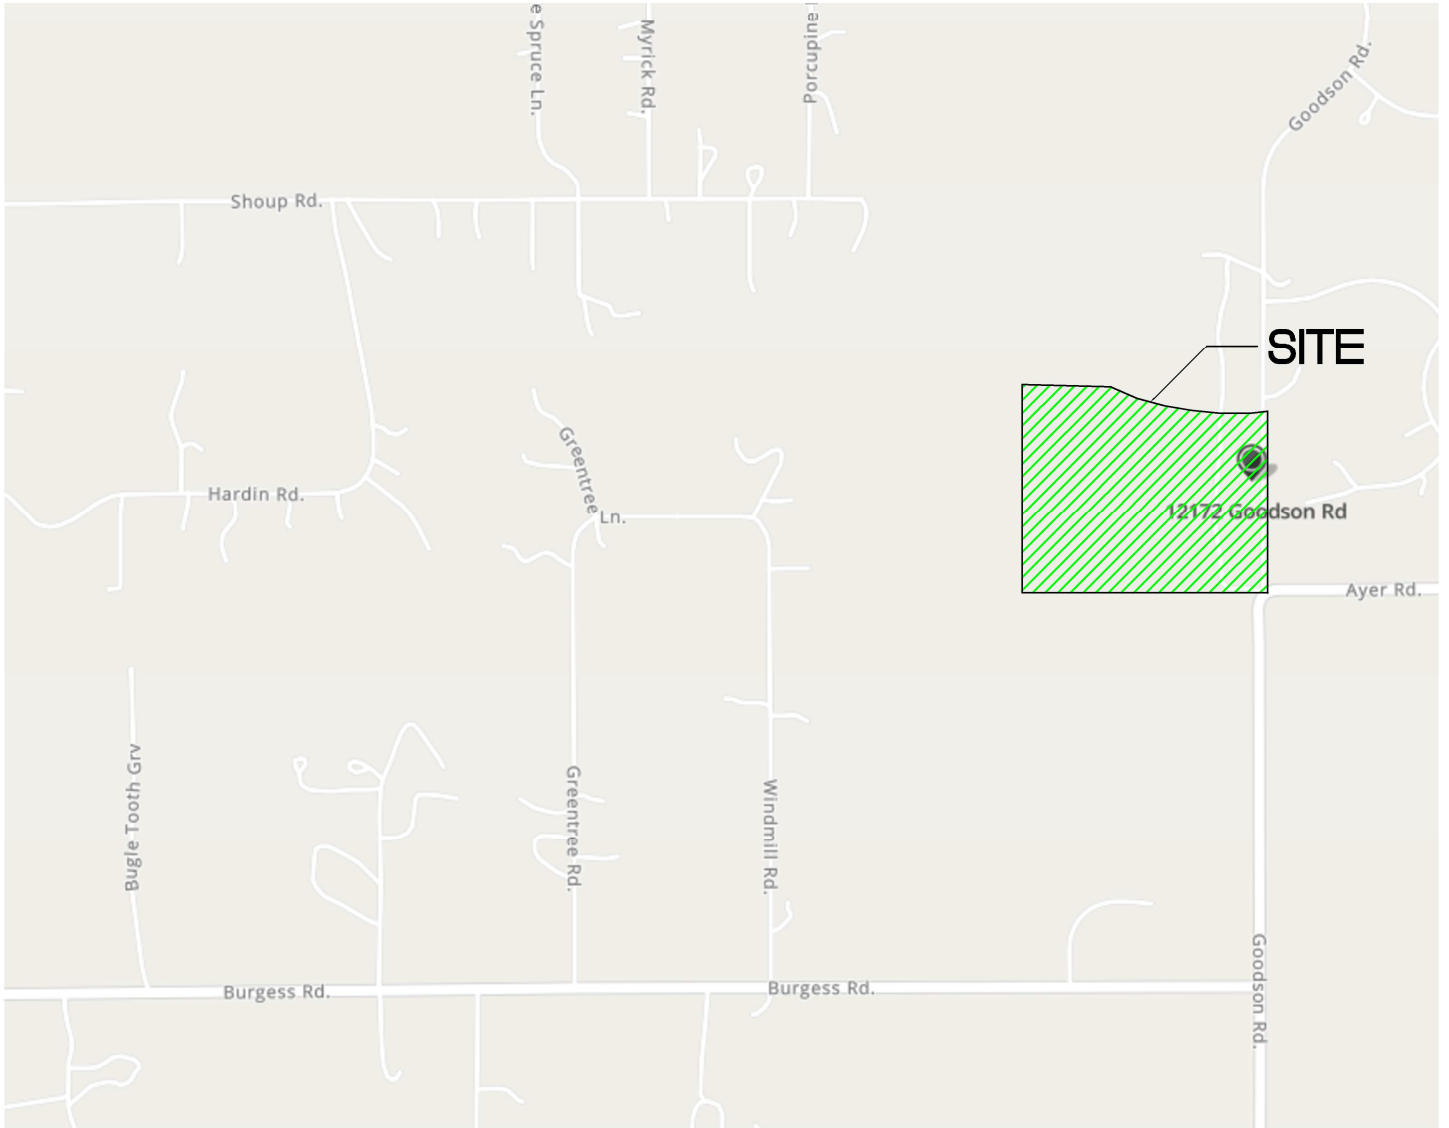
FIG No. 1

The project lies in the a portion of the northeast quarter of Section 14, Township 12 South, Range 65 west of the 6th Principle Meridian in El Paso County, Colorado, and is generally located northwest of the intersection of Rex Road and Goodson Road. The approximate location of the site is shown on the Site Vicinity Map, Figure 1.

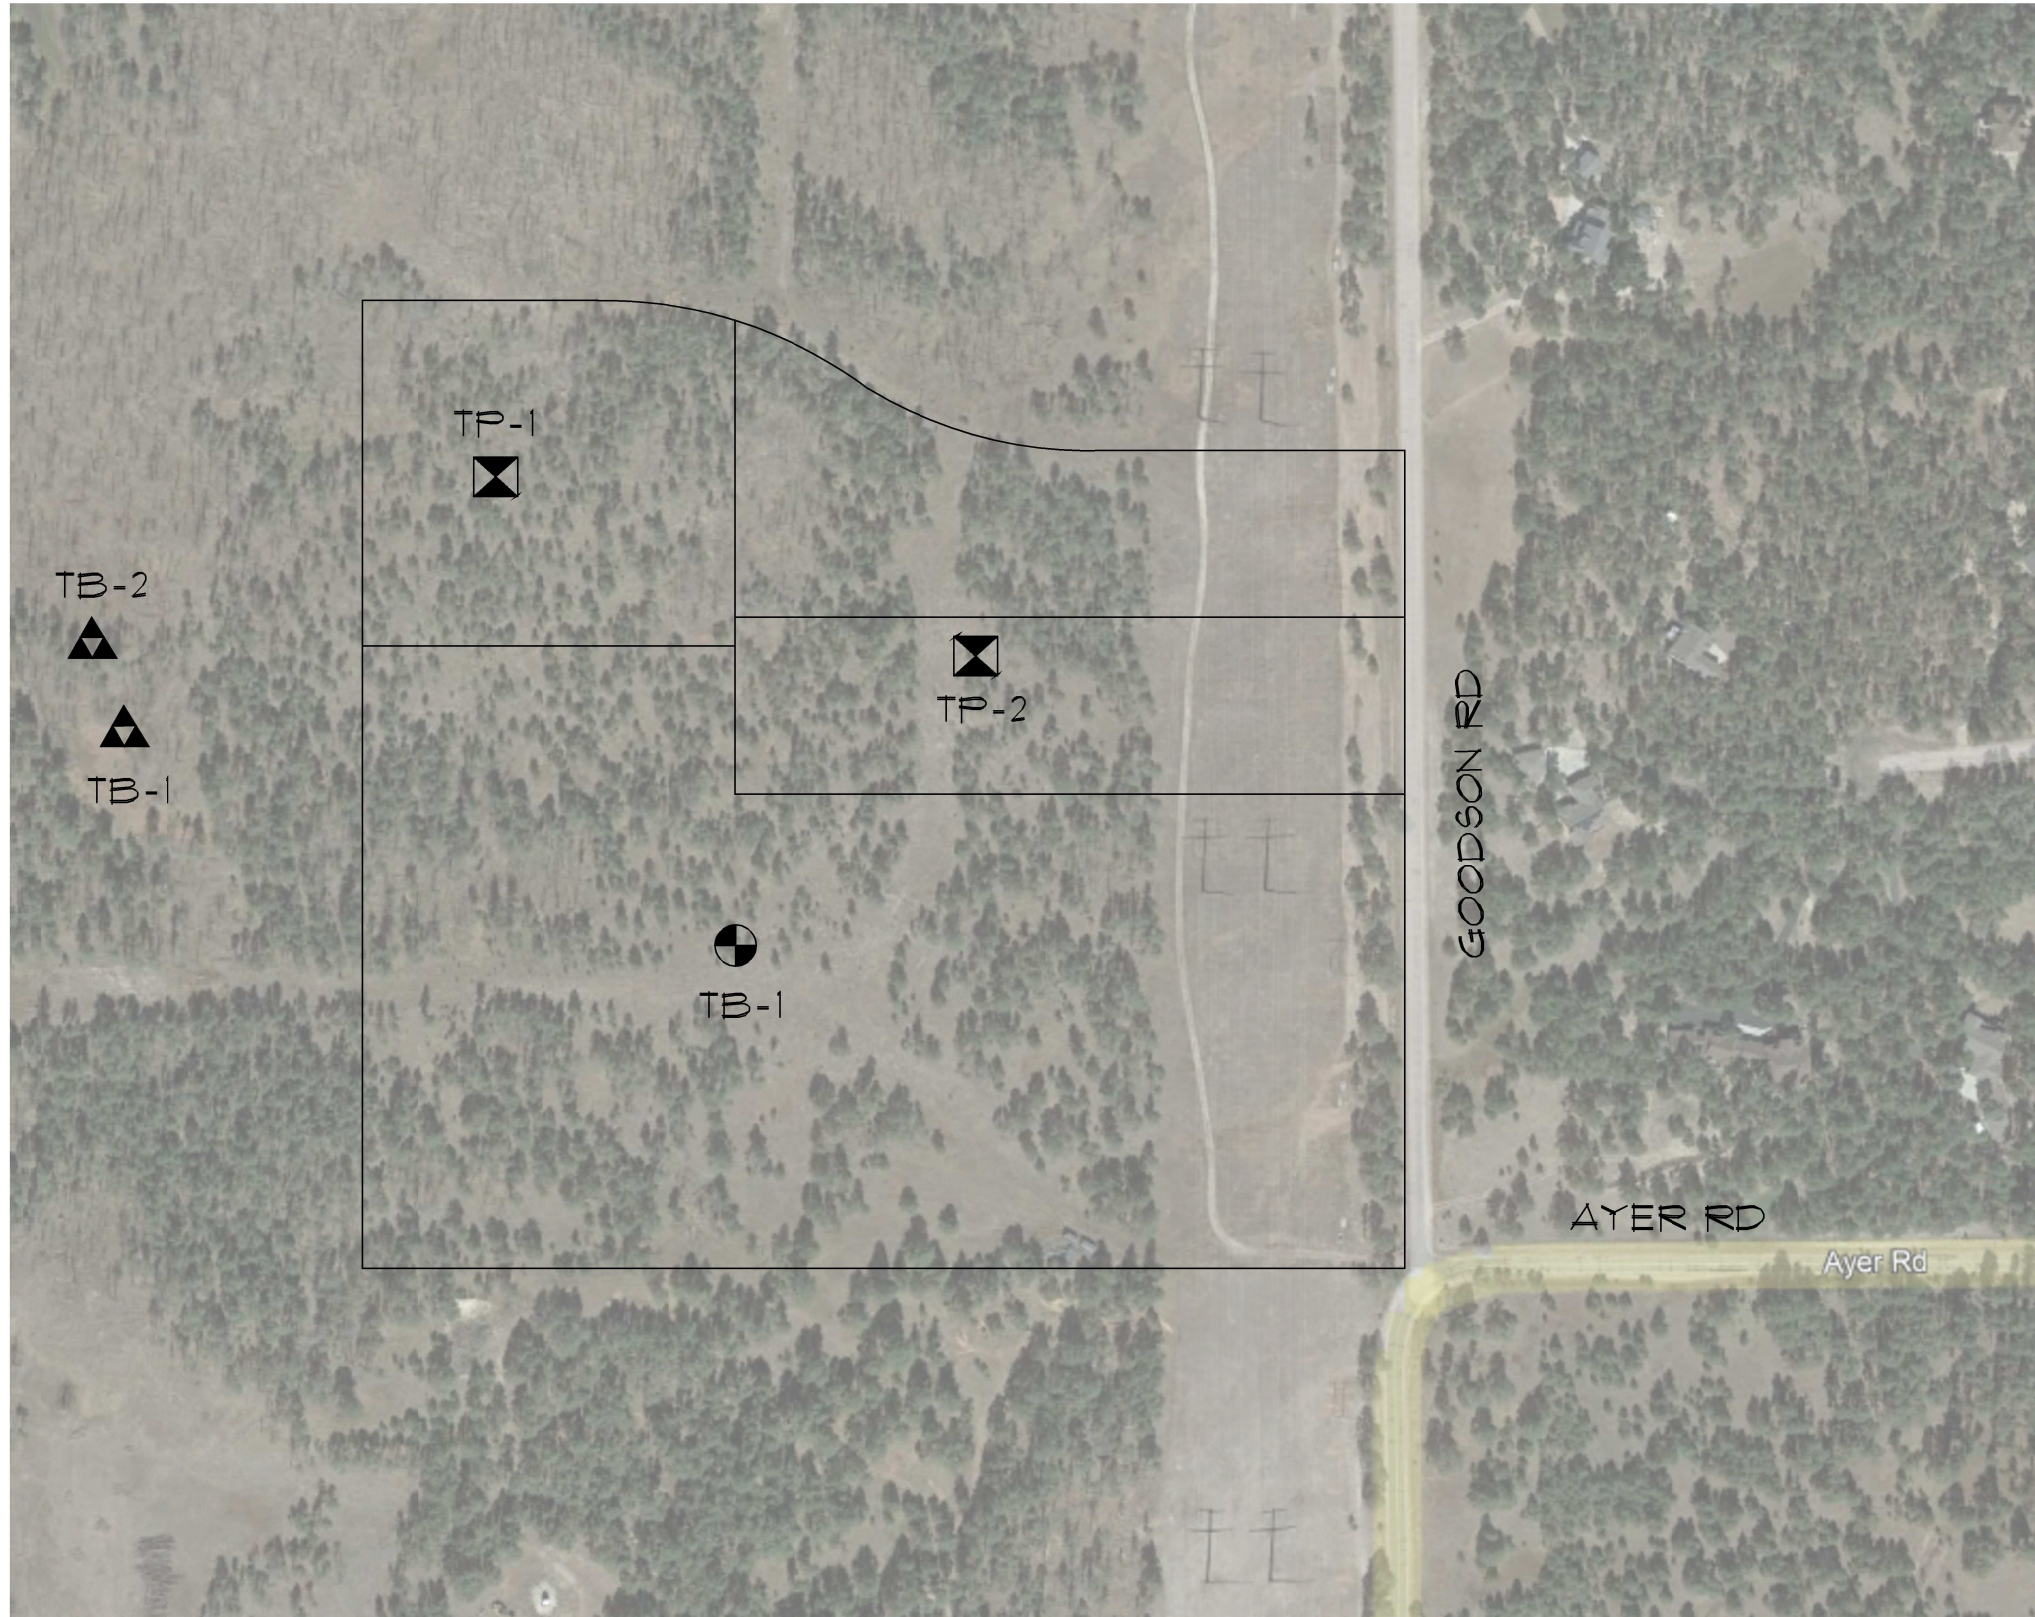
⊙ DENOTES APPROXIMATE LOCATION OF TEST BORING PERFORMED FOR THIS INVESTIGATION

⊠ DENOTES APPROXIMATE LOCATION OF TEST PITS PERFORMED FOR THIS INVESTIGATION

The current subsurface conditions within the property were explored by drilling one (1) exploratory test boring to a depth of 20-feet below the existing ground surface on January 16 and two 8-foot deep test pits on January 17, 2023. The test pits were excavated for on-site wastewater treatment system (OWTS) purposes. RMG's previous investigation conducted in November of 2022, Job No. 191132, explored subsurface conditions on the property to the west by drilling two (2) exploratory test borings to depths of 20-feet below the existing ground surface. The total number of borings generally meets the minimum criteria as stipulated in the ECM, Section C.3.3.

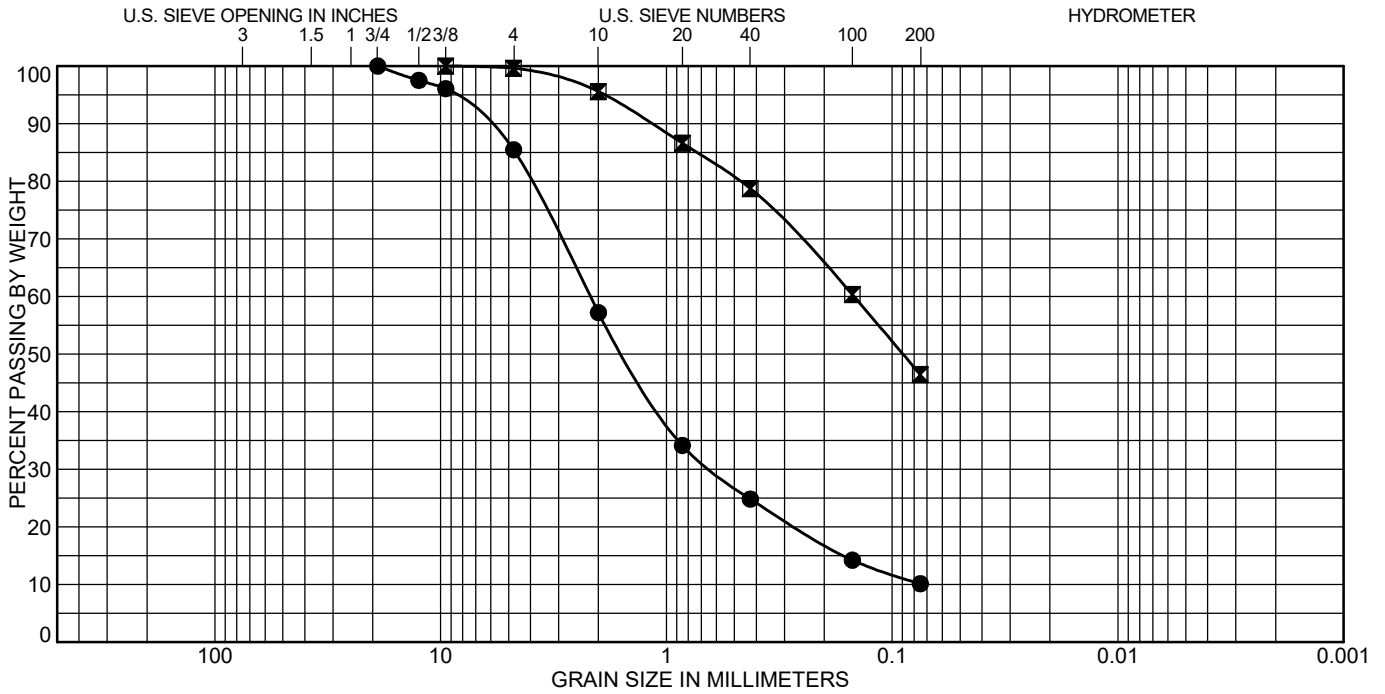
FIGURE No. 8

| COBBLES | GRAVEL | | SAND | | | SILT OR CLAY |
| | coarse | fine | coarse | medium | fine | |

Soil laboratory testing was performed as part of this investigation. Laboratory testing included moisture content, grain-size analysis and Atterberg Limits. A Summary of Laboratory Test Results is presented in Figure 7. Soil Classification Data is presented in Figure 8.

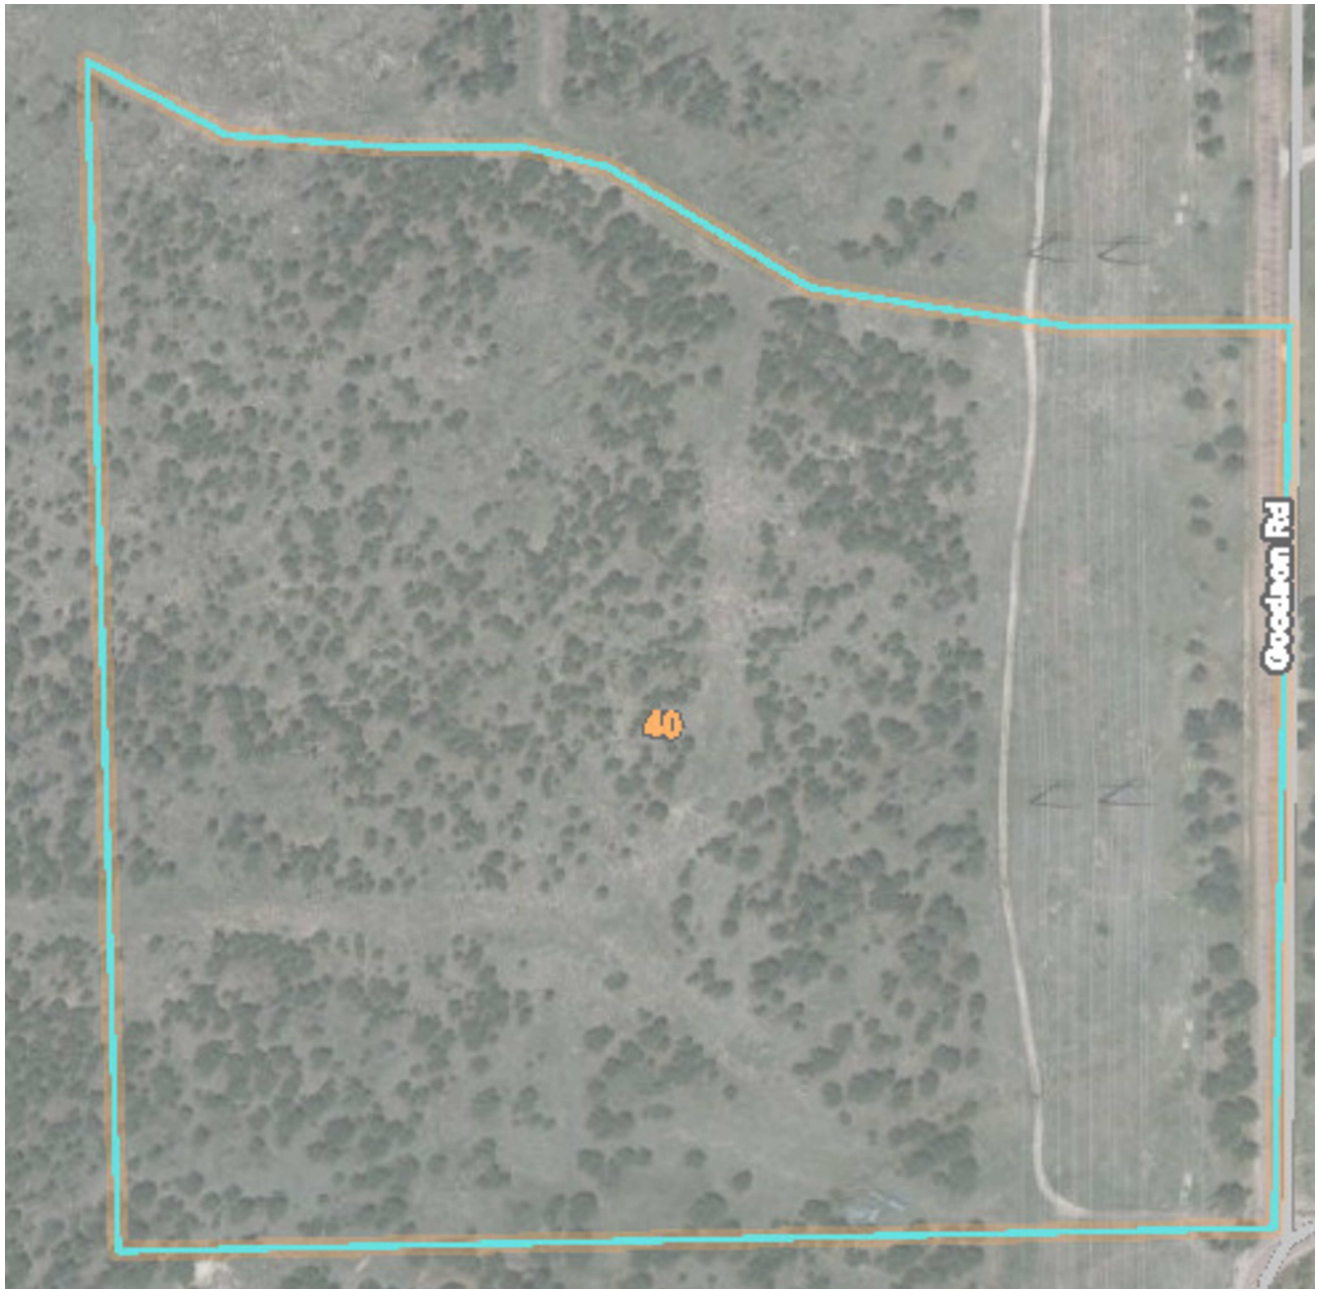
FIG No. 9

40 - Kettle Gravelly Loamy Sand, 3 to 8 percent slopes

The USDA Soil Survey Map is presented in Figure 9.

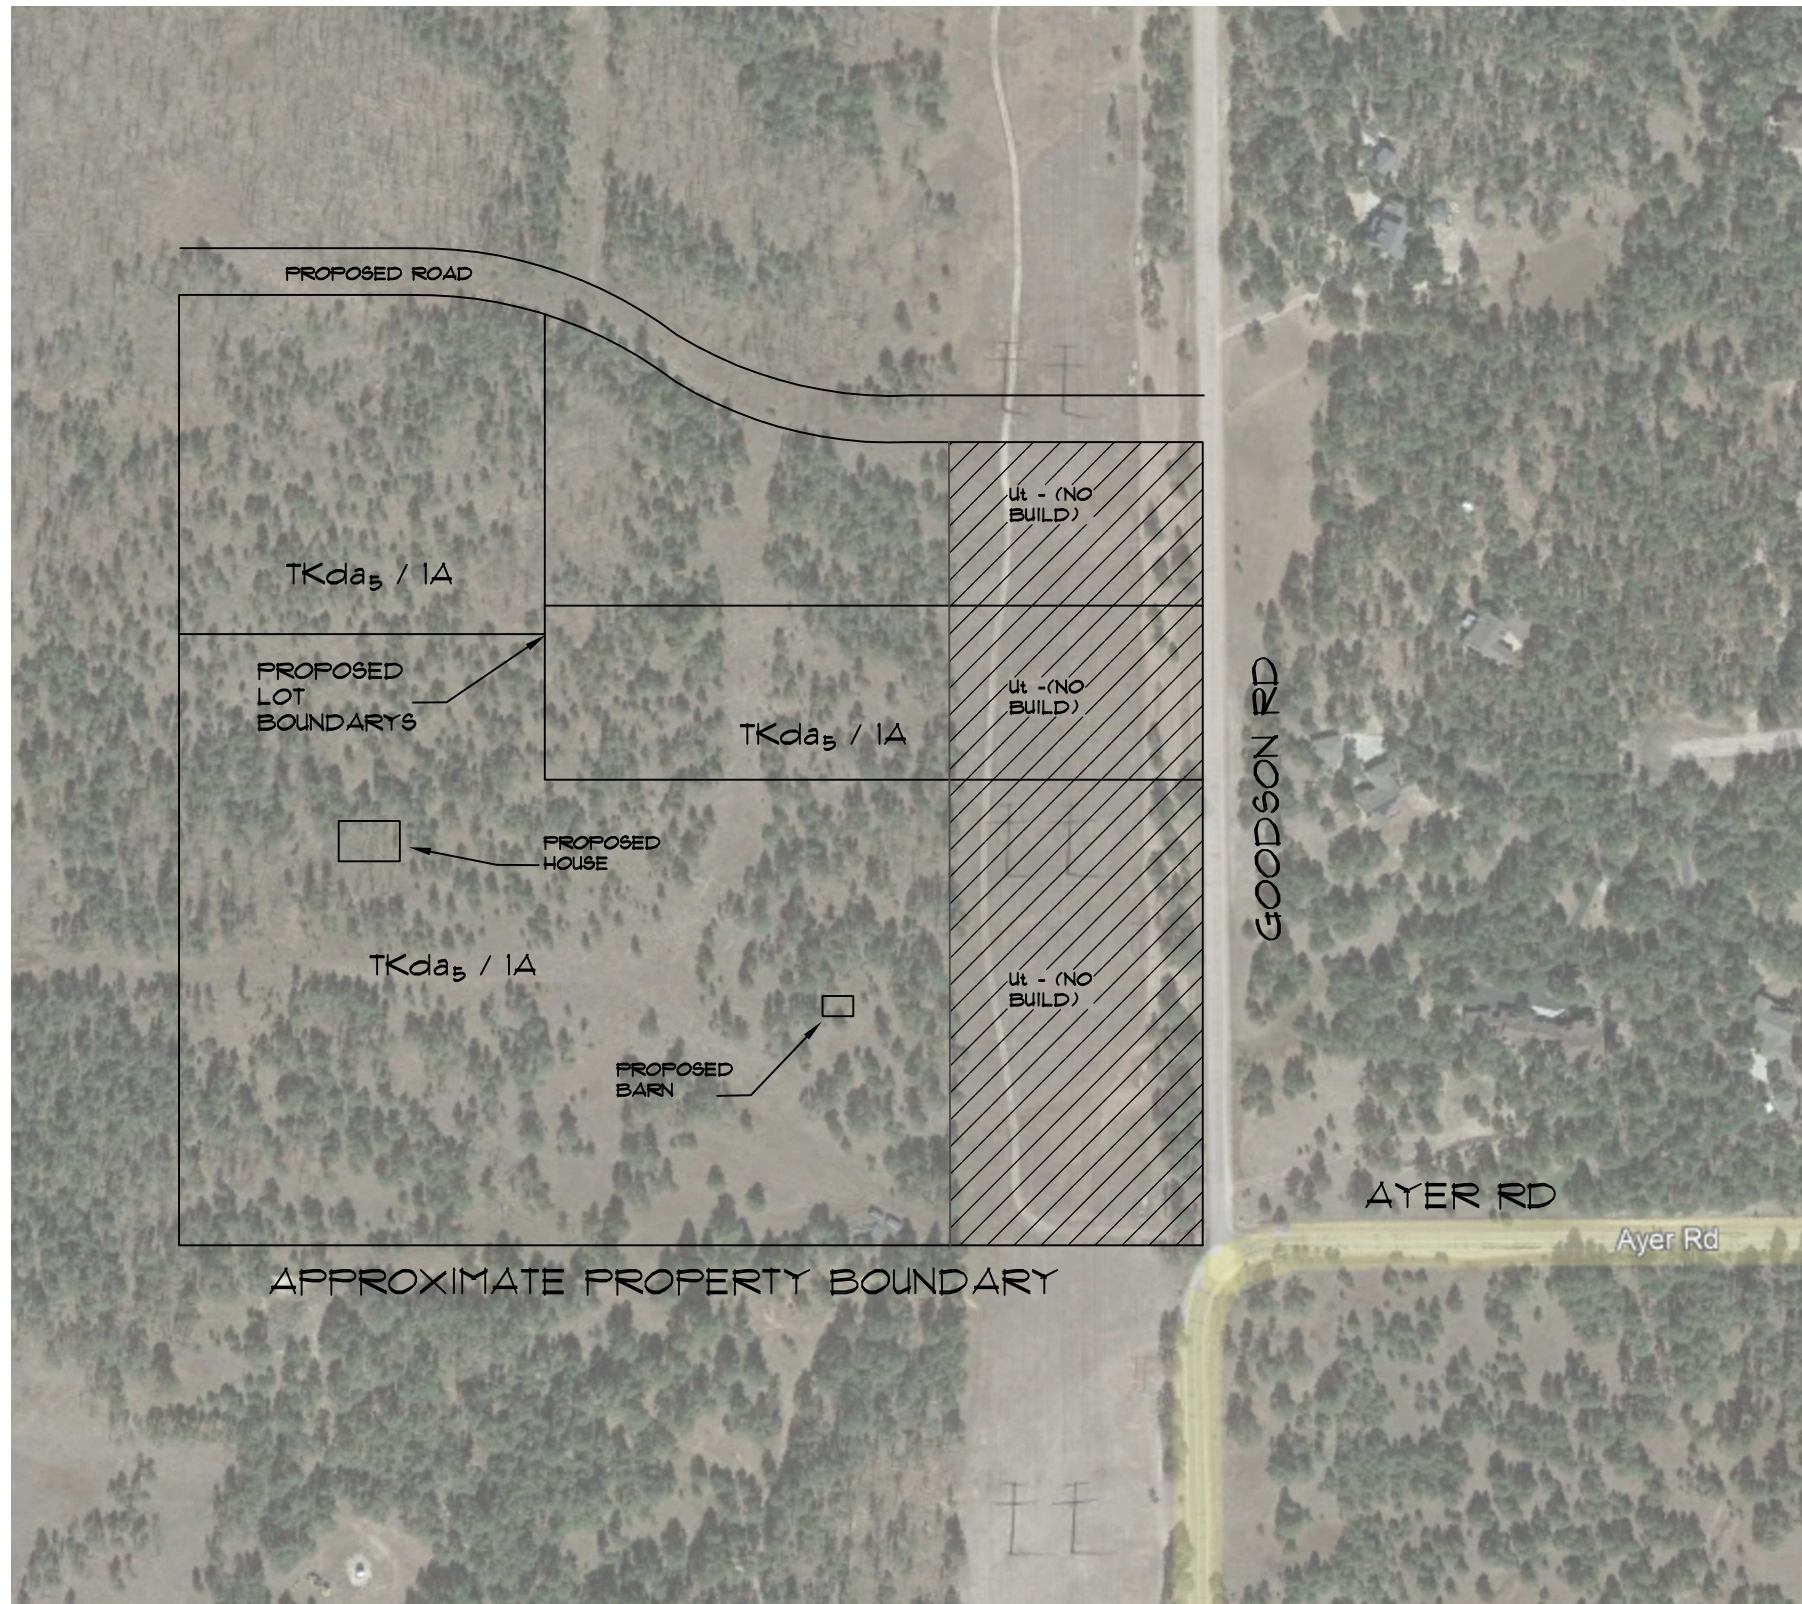
GEOLOGIC CONDITIONS

TKda₅ - DAWSON FORMATION, FACIES UNIT FIVE (EOCENE)

Bedrock was encountered in the test boring performed for this study. In general, the bedrock (as mapped by Colorado Geologic Survey - CGS) is considered part of the Dawson formation and consists of silty sandstone with interbedded layers of claystone. The Dawson formation is thick-bedded to massive, generally light colored arkose, pebbly, and pebble conglomerate. The sandstone is generally poorly sorted with various amounts of clay content. The sandstone is generally permeable, well drained, and has good foundation characteristics. The claystone is generally well sorted with high sand content. The claystone is less permeable than the sandstone and is generally not suitable for direct bearing of shallow foundations. Bedrock is anticipated in the excavations and utility trenches for the proposed development.

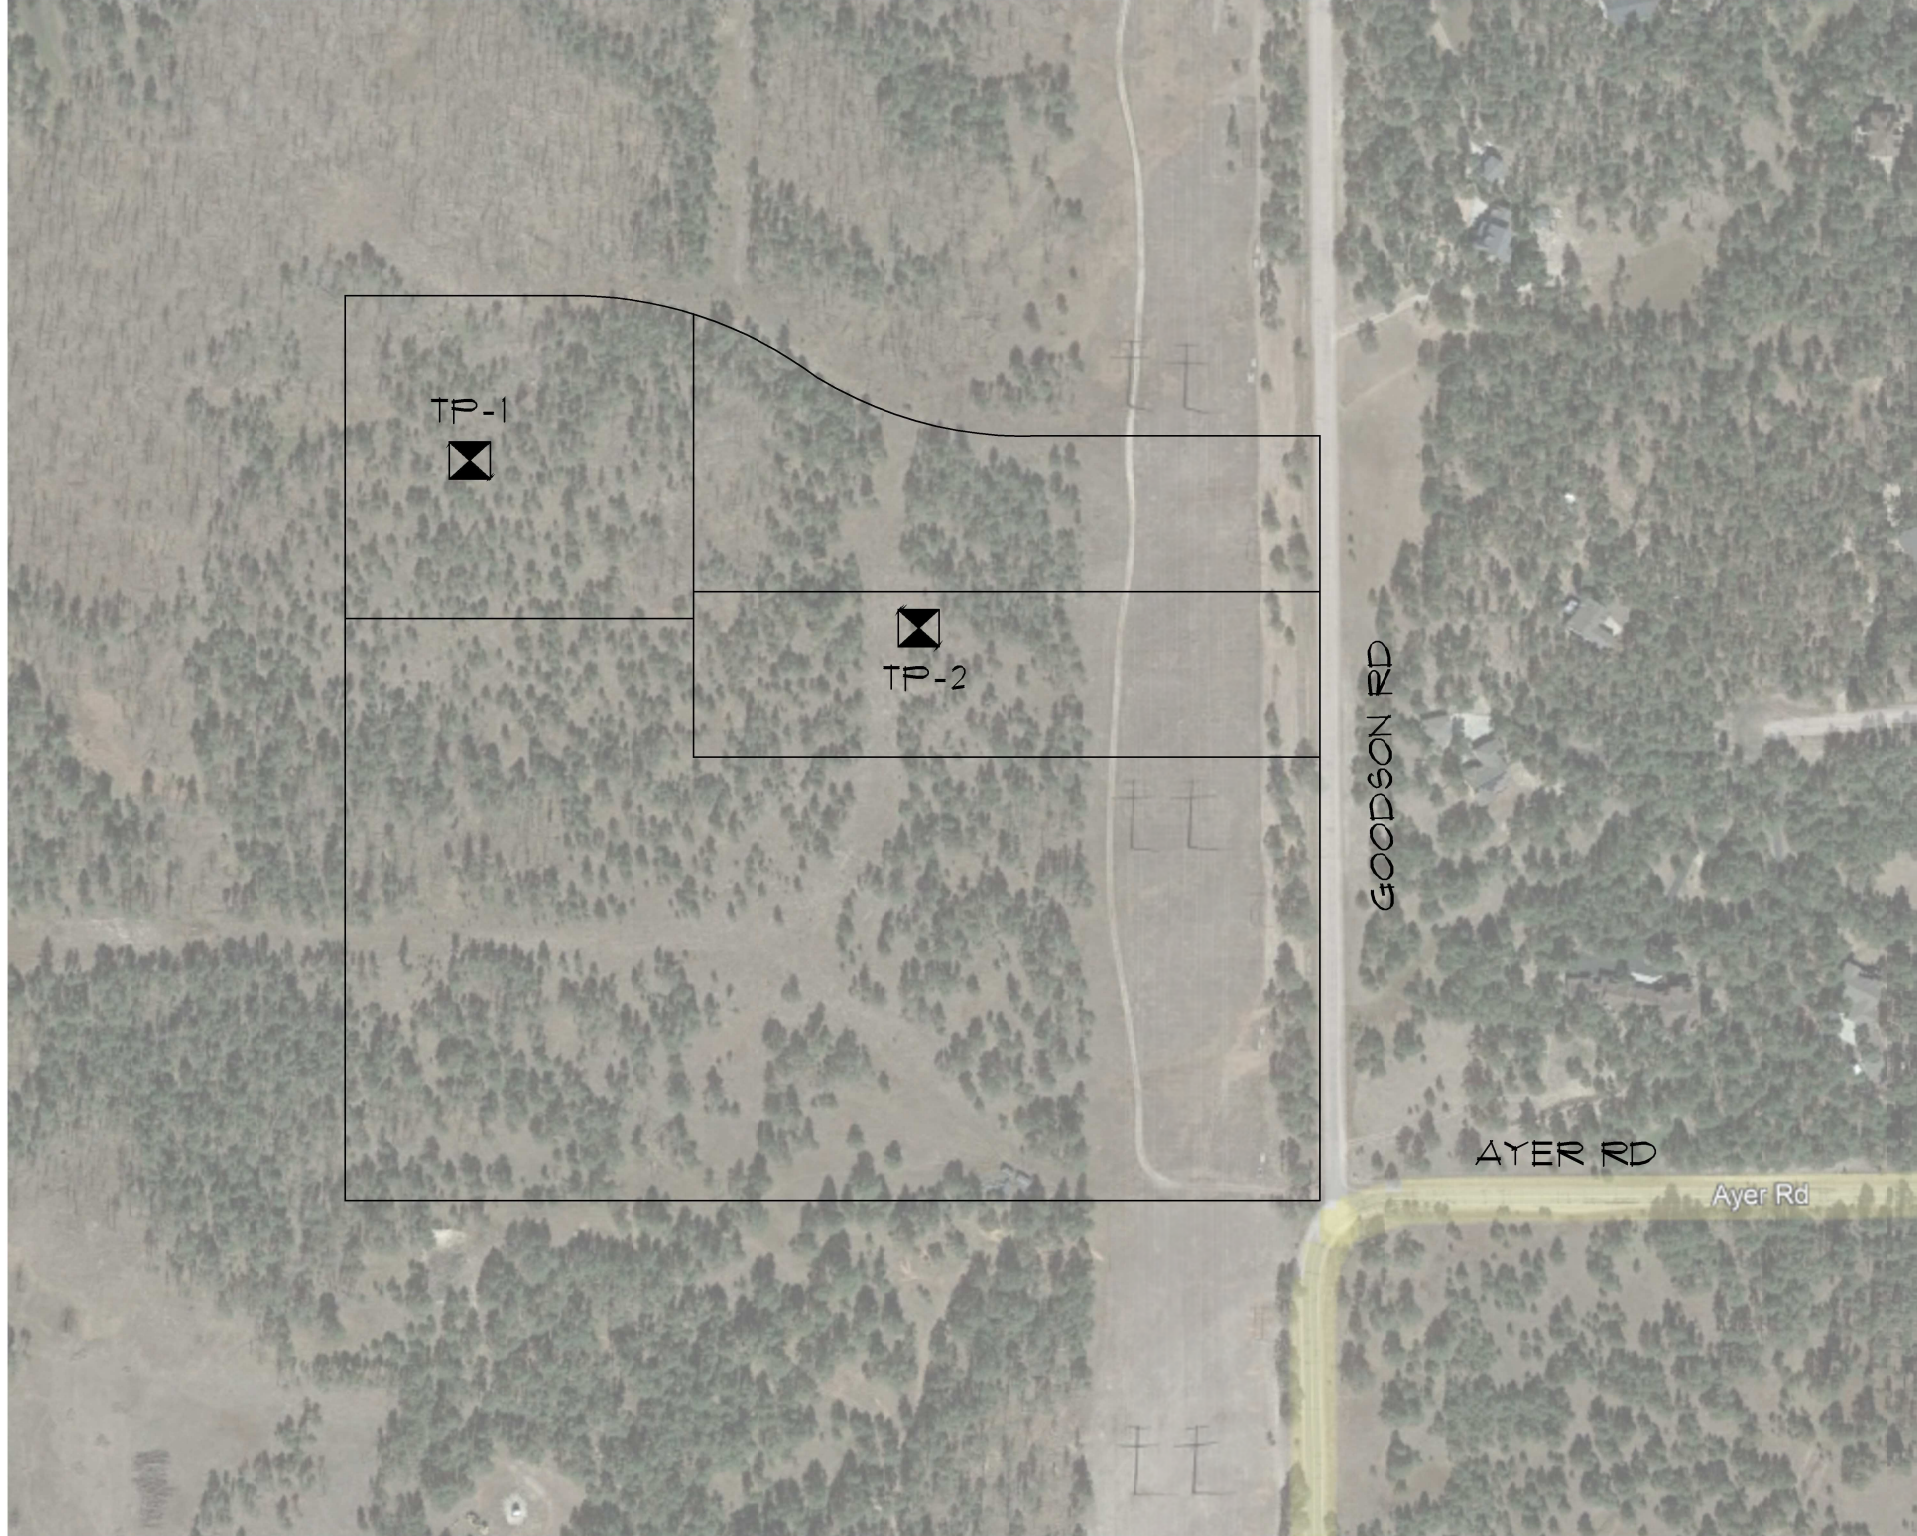
DENOTES APPROXIMATE
 LOCATION OF TEST PITS
 PERFORMED FOR THIS
 INVESTIGATION

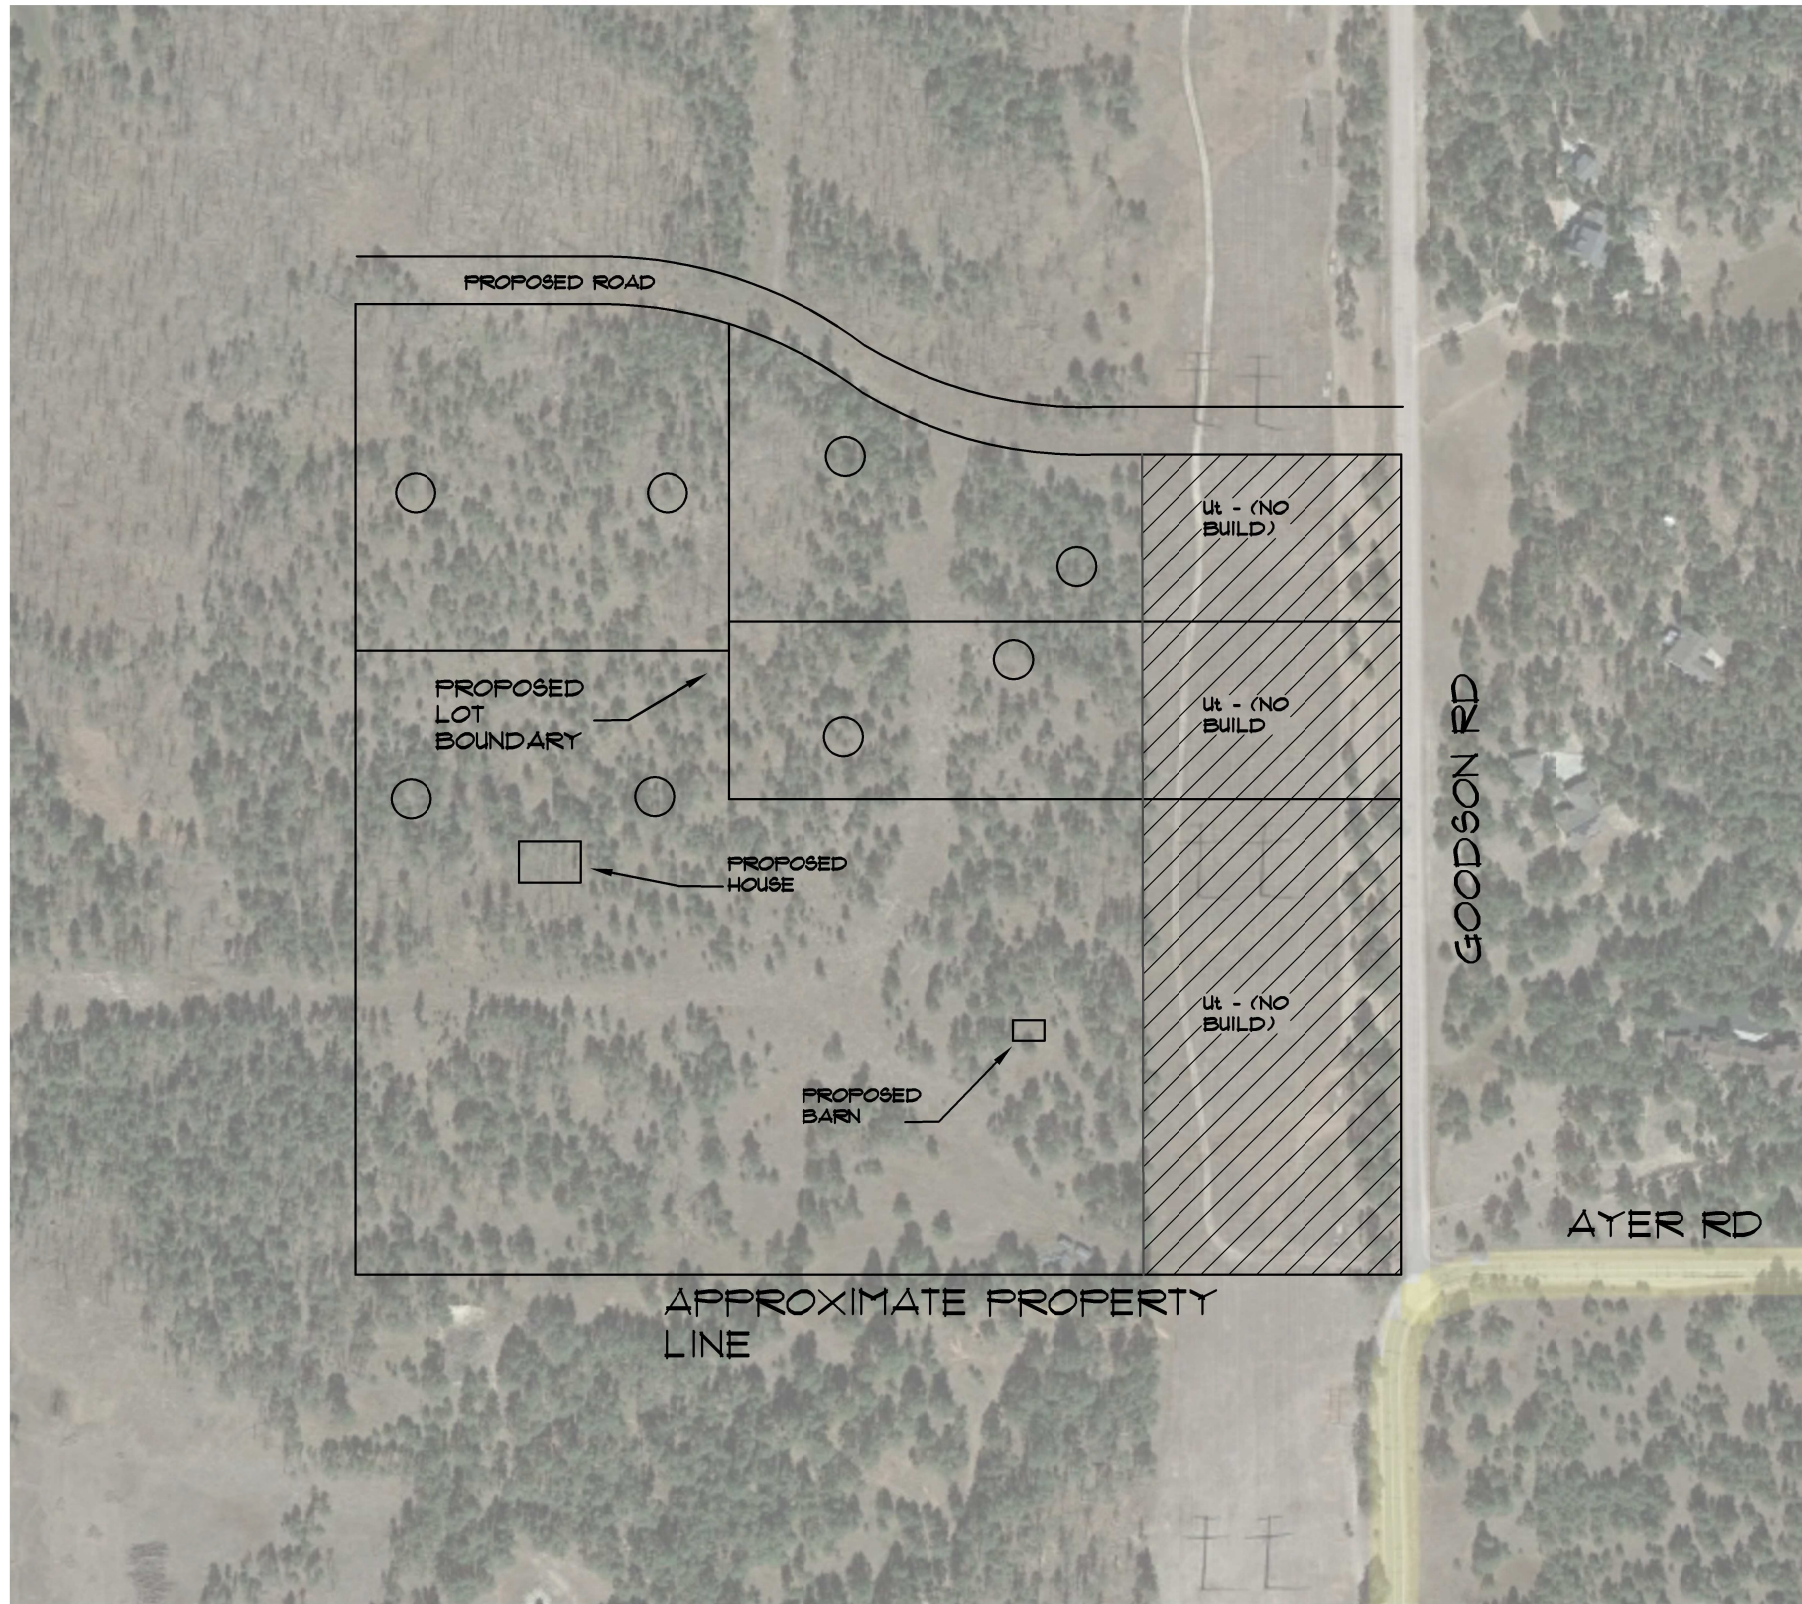
NOTE: THE CHOSEN ON-SITE WASTEWATER TREATMENT SYSTEM (OWTS) LOCATIONS ARE FOR ILLUSTRATION ONLY. IF THE EL PASO COUNTY HEALTH DEPARTMENT PHYSICAL SETBACK REQUIREMENTS ARE MET FOR EACH LOT, THERE ARE NO RESTRICTIONS ON THE PLACEMENT OF THE INDIVIDUAL OWTS.

○ DENOTES POTENTIAL OWTS LOCATIONS
