## **GEOLOGY AND SOILS REPORT with Wastewater Study**

**Lot 10, Lot K, Lot L, Springs Crest Subdivison  
El Paso County, Colorado**

**JOB NO. 162650**

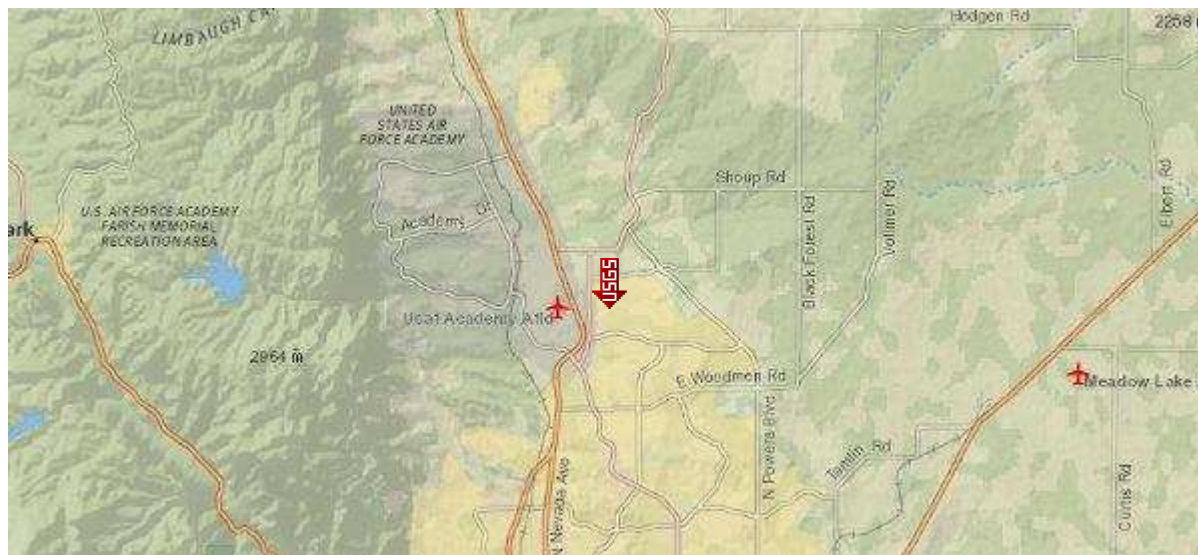
## USGS-Provided Output

**Site Soil Classification** Site Class C – “Very Dense Soil and Soft Rock”

**Risk Category** I/II/III

$$\begin{array}{lll} \mathbf{S_s} = & 0.182 \text{ g} & \mathbf{S_{MS}} = & 0.218 \text{ g} & \mathbf{S_{DS}} = & 0.145 \text{ g} \\ \mathbf{S_1} = & 0.060 \text{ g} & \mathbf{S_{M1}} = & 0.102 \text{ g} & \mathbf{S_{D1}} = & 0.068 \text{ g} \end{array}$$
