ROCKY MOUNTAIN GROUP

GEOLOGY AND SOILS REPORT with Wastewater Study

**Lot 10, Lot K, Lot L, Springs Crest Subdivison
El Paso County, Colorado**

**JOB NO. 162650
PUD File No. VR-18-014**

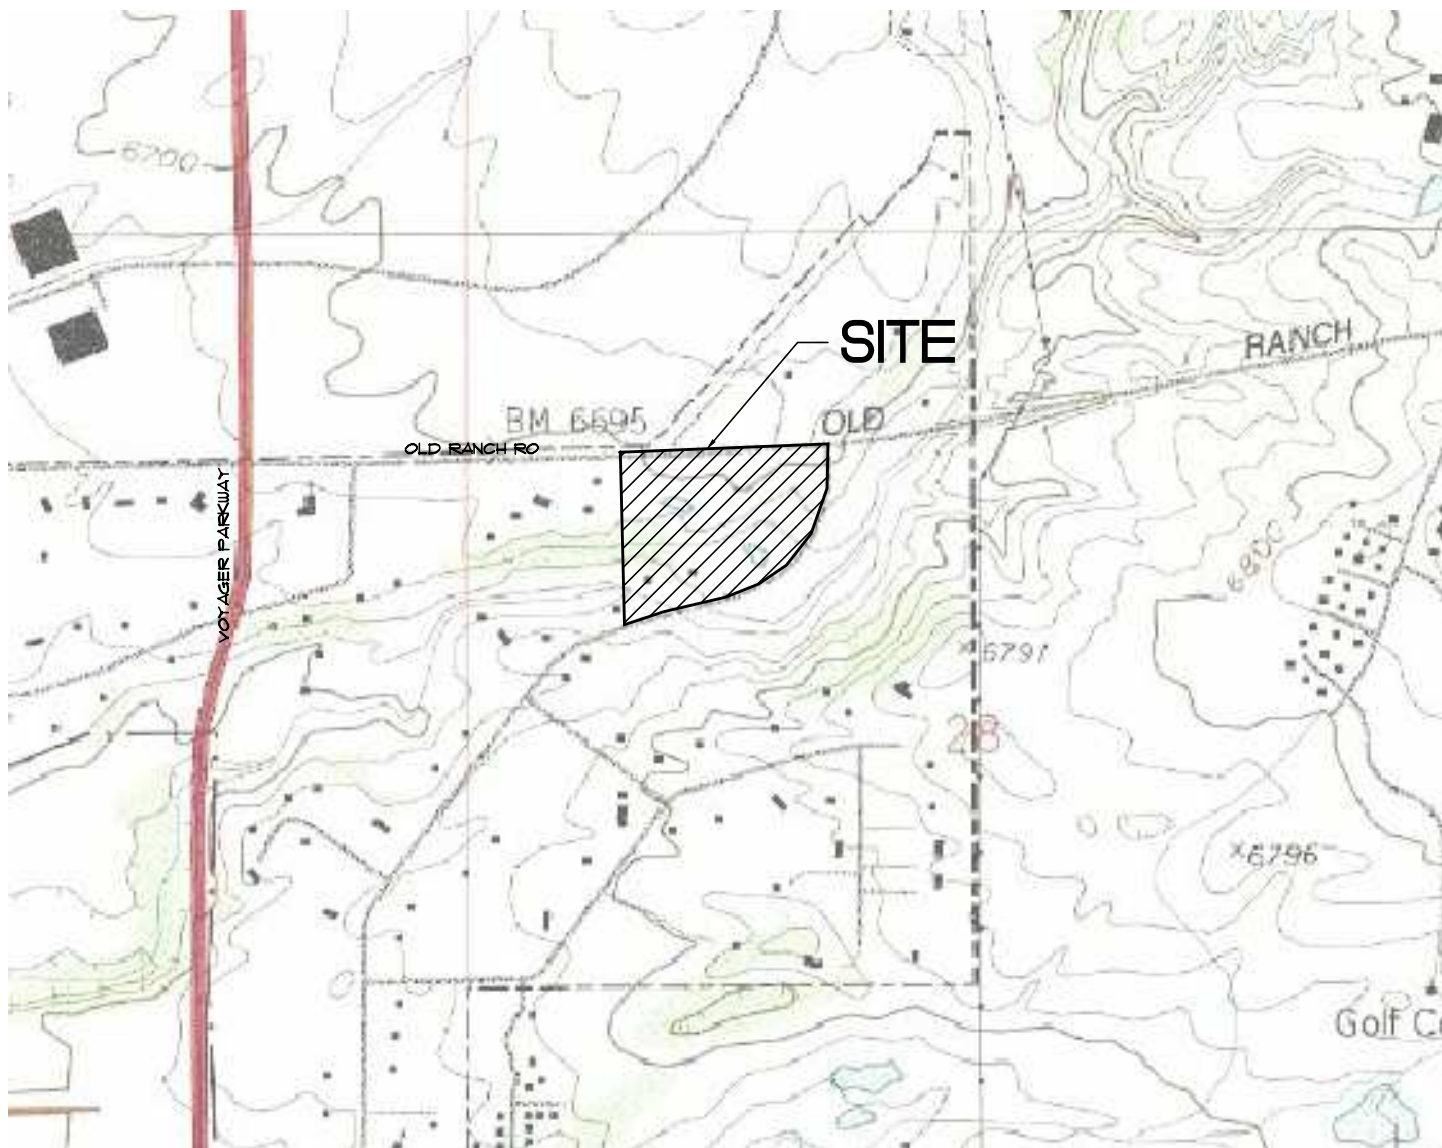
FIG No. 2

REFERENCE
NOT TO SCALE

BASE MAP PROVIDED BY USGS

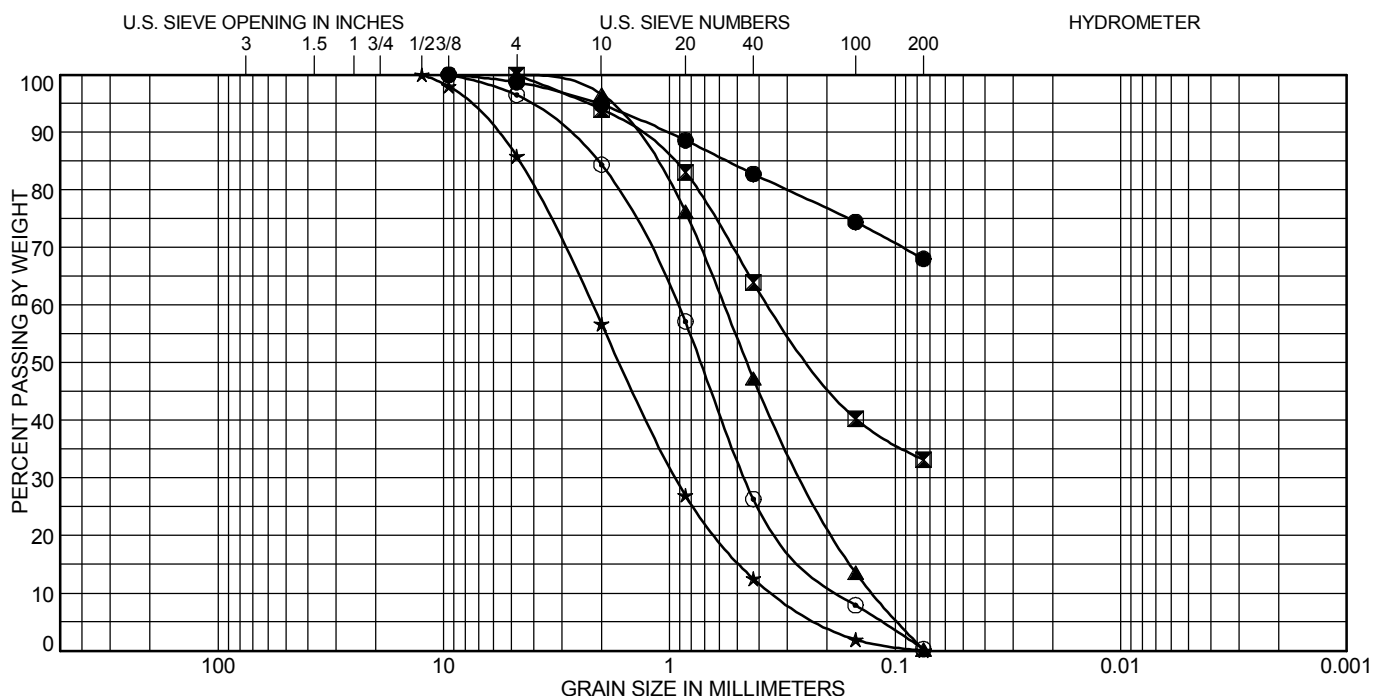
FIGURE No. 10

COBBLES	GRAVEL		SAND			SILT OR CLAY
	coarse	fine	coarse	medium	fine

Test Boring	Depth (ft)	Classification	LL	PL	PI	Cc	Cu
● 1	4.0	SANDY FAT CLAY(CH)	72	26	46		
⊠ 1	14.0	CLAYEY SAND(SC)	47	17	30		
▲ 2	9.0	POORLY GRADED SAND(SP)	68	31	37	0.9	4.6
★ 3	4.0	WELL-GRADED SAND(SW)	NP	NP	NP	1.2	6.6
⊙ 3	14.0	POORLY GRADED SAND(SP)	NP	NP	NP	1.4	5.5

Test Boring	Depth (ft)	%Gravel	%Sand	%Silt	%Clay
● 1	4.0	1.3	30.7	68.0	
⊠ 1	14.0	0.0	66.8	33.2	
▲ 2	9.0	0.0	99.8	0.2	
★ 3	4.0	14.1	85.9	0.0	
⊙ 3	14.0	3.5	96.2	0.3

SOIL CLASSIFICATION DATA

Soil laboratory testing was performed as part of this investigation. The laboratory tests included moisture content, dry density, grain-size analyses, Atterberg Limits and Swell/Consolidation tests. A Summary of Laboratory Test Results is presented in Figure 9. Soils Classification Data is presented in Figure 10. Swell/Consolidation tests are presented in Figure 11.

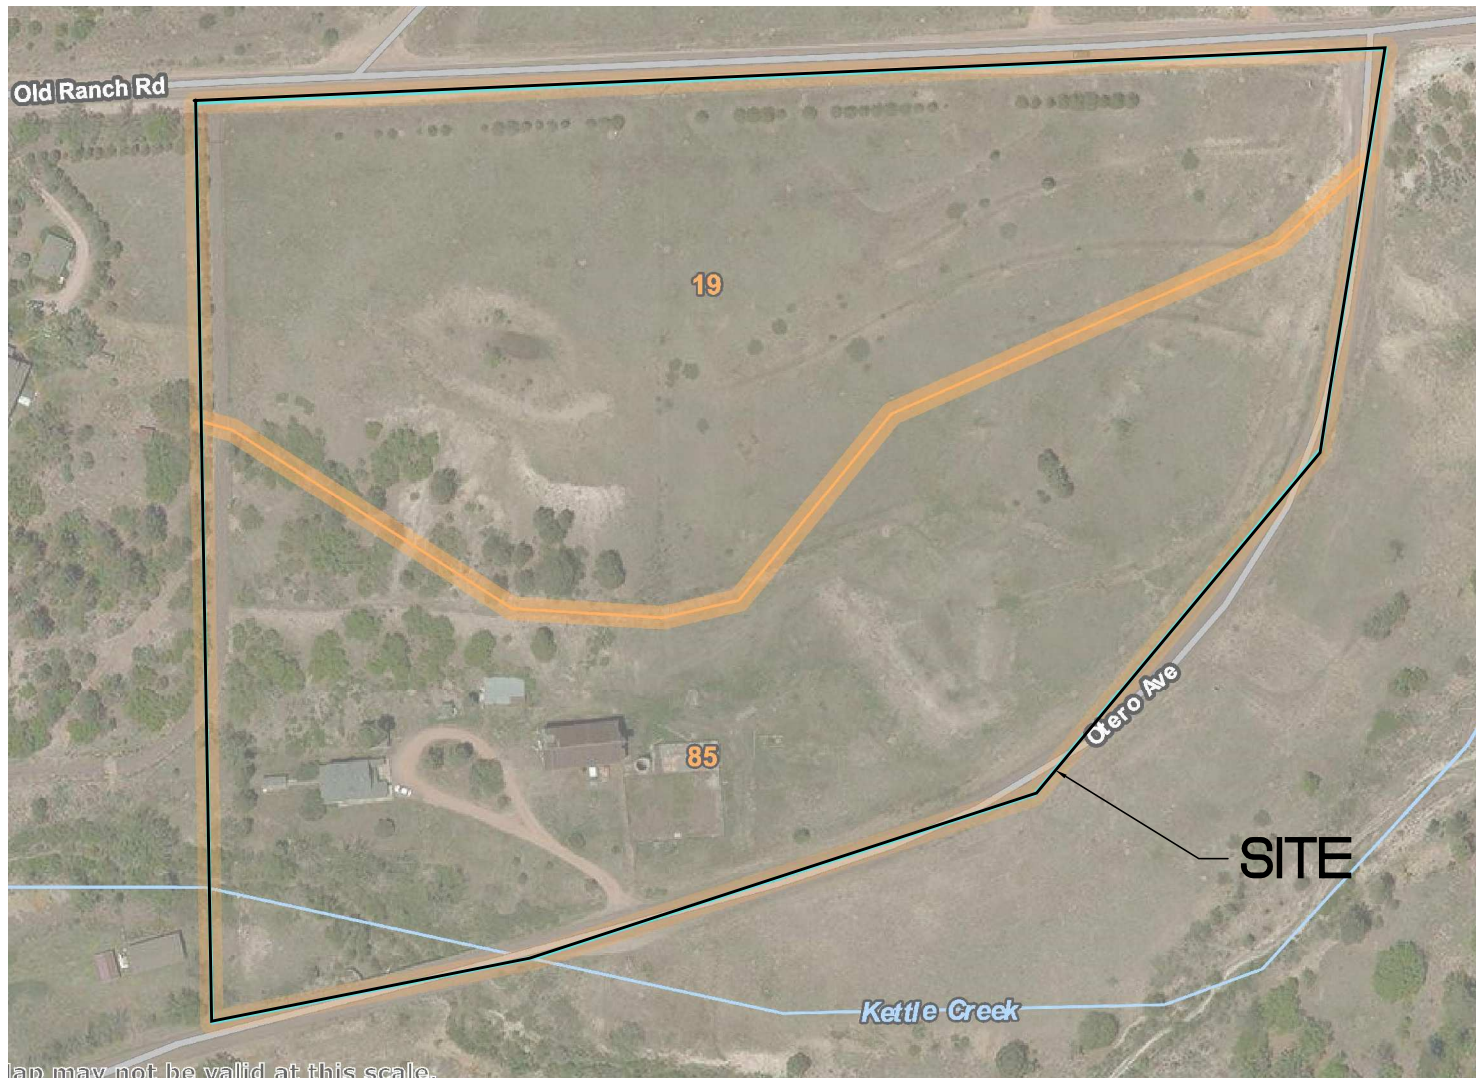
FIG No. 12

- 19 - Coumbine gravelly sandy loam
 85 - Stapleton-Bernal sandy loams

The USDA Soil Survey Map is presented in Figure 12.

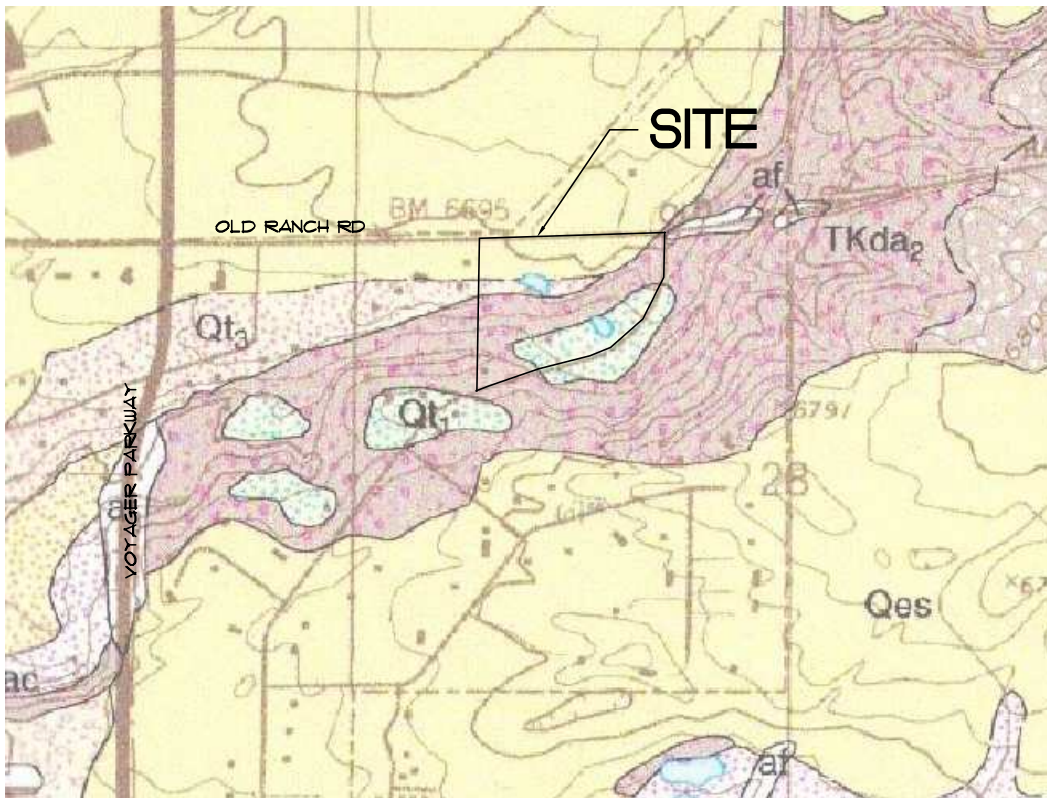
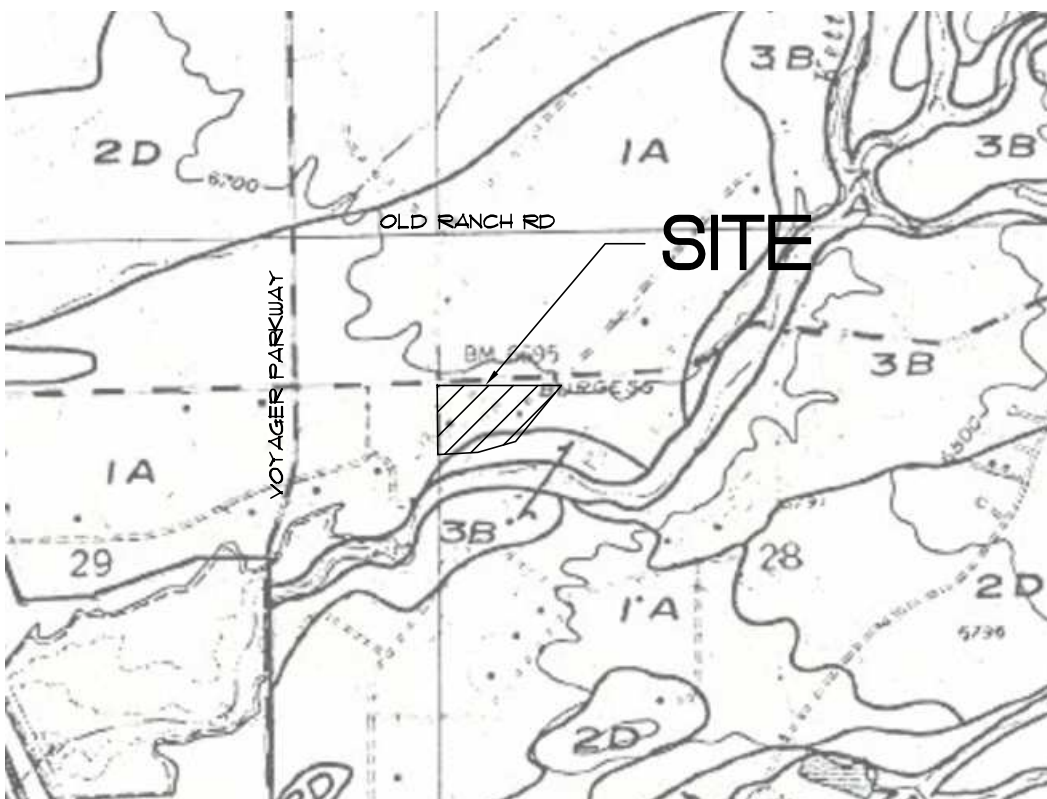
FIG No. 13

GEOLOGY MAP

Qes - Eolian Sand
 Qt1 - Terrace alluvium one
 TKda2 - Dawson Formation

ENGINEERING
 GEOLOGY MAP

1A - Stable alluvium
 colluvium and bedrock
 3B - Expansive and
 potentially expansive
 soil

The General Geology and Engineering Geology Map is presented in Figure 13.

The Engineering Geology is presented in the General Geology and Engineering Geology Map in Figure 13.

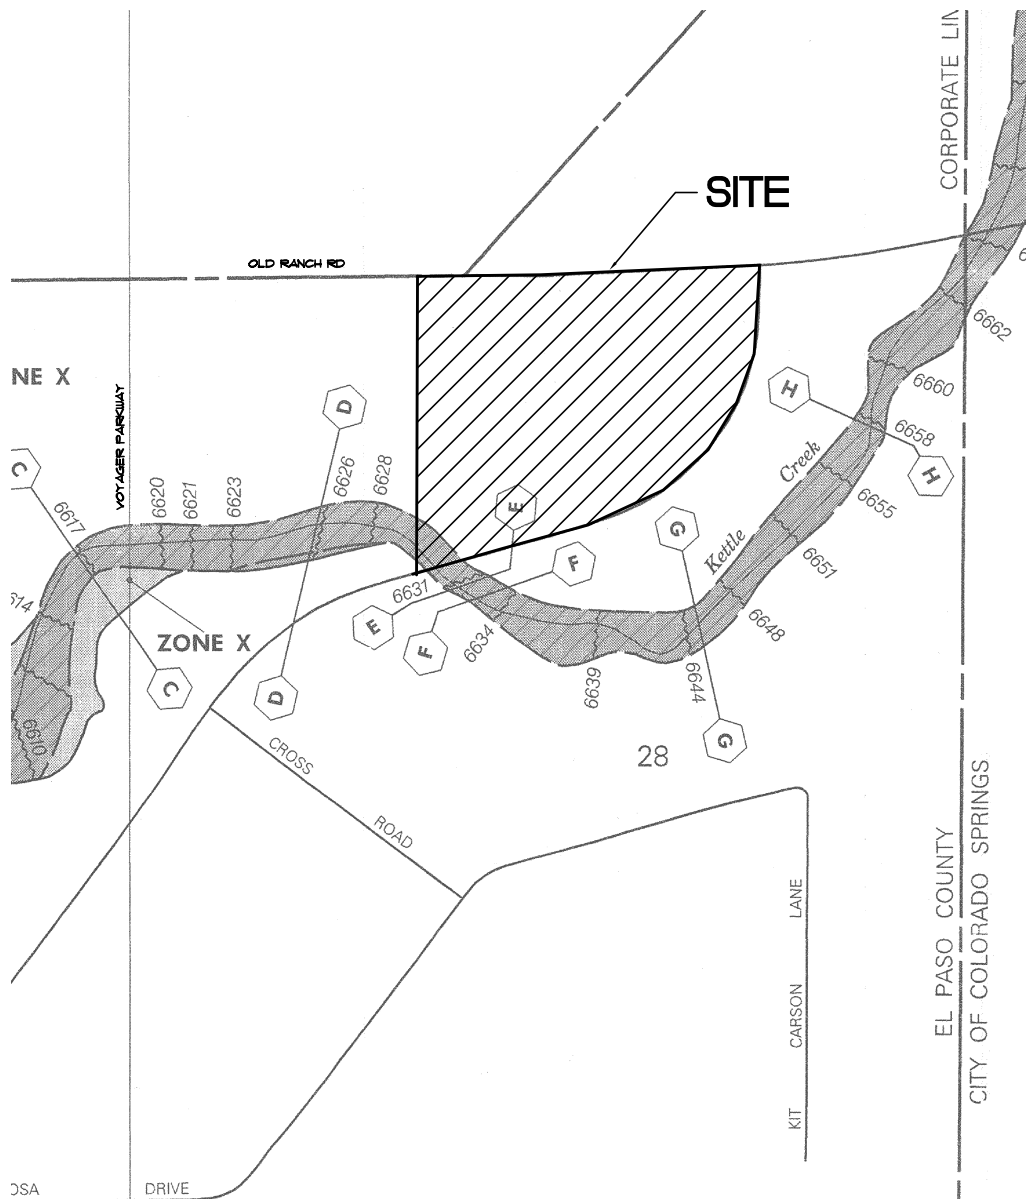
APPROXIMATE SCALE IN FEET
500 0 500

NATIONAL FLOOD INSURANCE PROGRAM
