## **GEOLOGY AND SOILS REPORT with Wastewater Study**

**Lot 10, Lot K, Lot L, Springs Crest Subdivison  
El Paso County, Colorado**

**JOB NO. 162650**

**May 18, 2018**

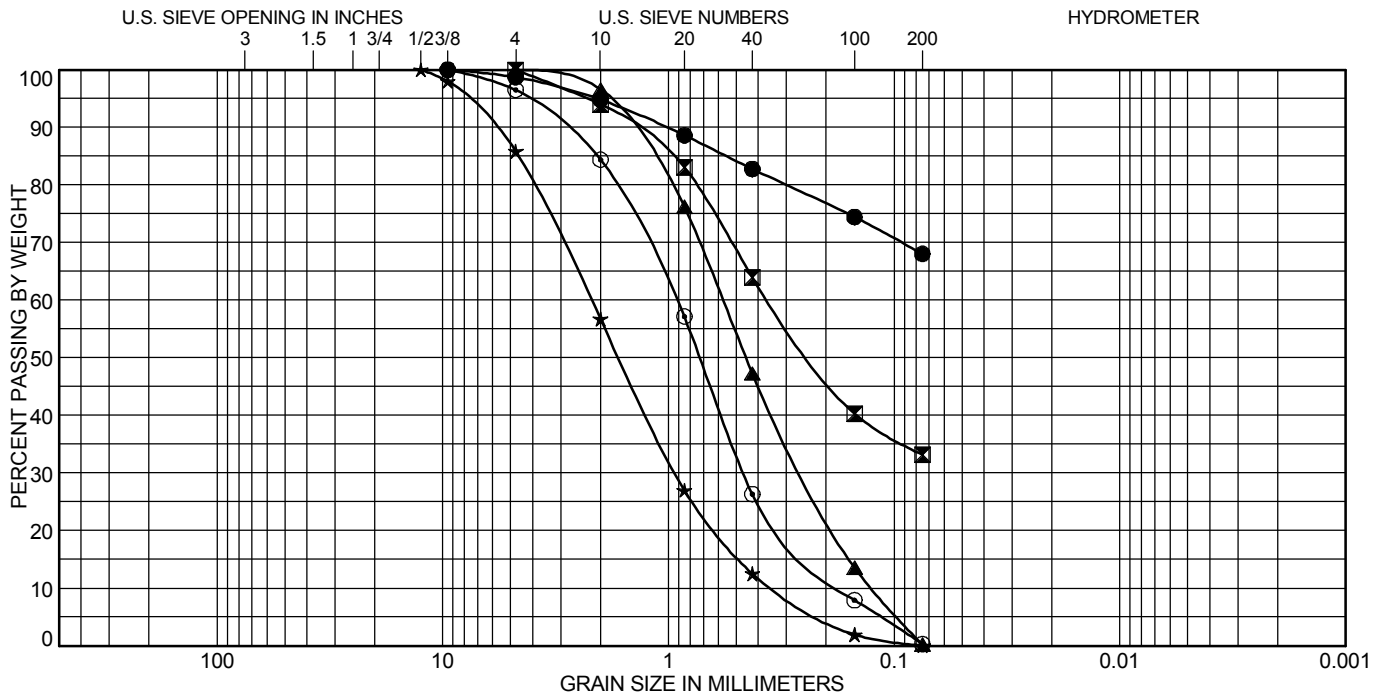
FIGURE No. 10

Test Boring	Depth (ft)	Classification	LL	PL	PI	Cc	Cu
● 1	4.0	SANDY FAT CLAY(CH)	72	26	46		
☒ 1	14.0	CLAYEY SAND(SC)	47	17	30		
▲ 2	9.0	POORLY GRADED SAND(SP)	68	31	37	0.9	4.6
★ 3	4.0	WELL-GRADED SAND(SW)	NP	NP	NP	1.2	6.6
⊙ 3	14.0	POORLY GRADED SAND(SP)	NP	NP	NP	1.4	5.5

Test Boring	Depth (ft)	%Gravel	%Sand	%Silt	%Clay
● 1	4.0	1.3	30.7	68.0	
☒ 1	14.0	0.0	66.8	33.2	
▲ 2	9.0	0.0	99.8	0.2	
★ 3	4.0	14.1	85.9	0.0	
⊙ 3	14.0	3.5	96.2	0.3

Soil laboratory testing was performed as part of this investigation. The laboratory tests included moisture content, dry density, grain-size analyses, Atterberg Limits and Swell/Consolidation tests. A Summary of Laboratory Test Results is presented in Figure 9. Soils Classification Data is presented in Figure 10. Swell/Consolidation tests are presented in Figure 11.

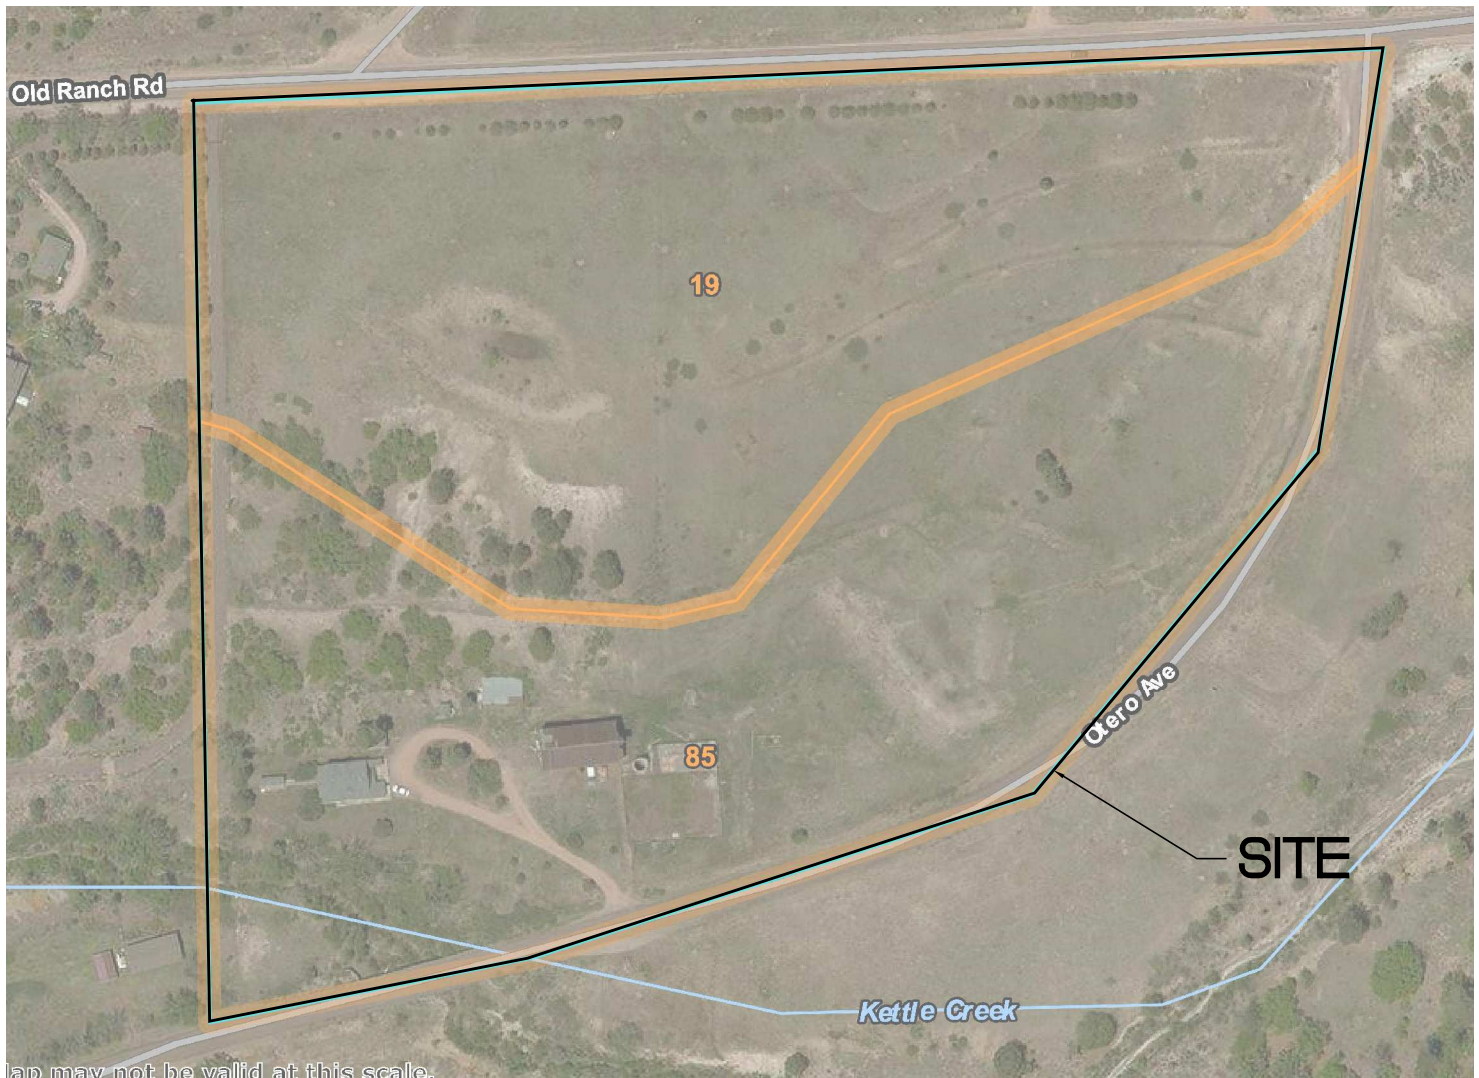
FIG No. 12

19 - Coumbine gravelly sandy loam  
 85 - Stapleton-Bernal sandy loams

*The USDA Soil Survey Map is presented in Figure 12.*

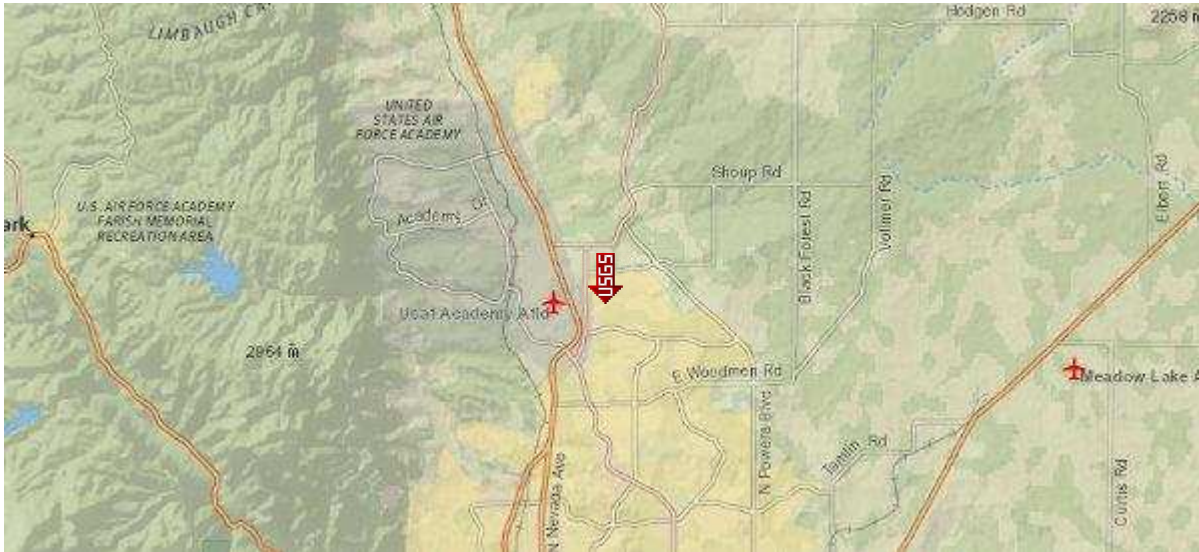
## USGS-Provided Output

$$\begin{array}{lll}
 S_s = 0.182 \text{ g} & S_{MS} = 0.218 \text{ g} & S_{DS} = 0.145 \text{ g} \\
 S_1 = 0.060 \text{ g} & S_{M1} = 0.102 \text{ g} & S_{D1} = 0.068 \text{ g}
 \end{array}$$
