GEOLOGY AND SOILS REPORT with Wastewater Study

Lot 10, Lot K, Lot L, Springs Crest Subdivison
El Paso County, Colorado

JOB NO. 162650
PUD File No. VR-18-014

May 18, 2018
Revised November 28, 2018

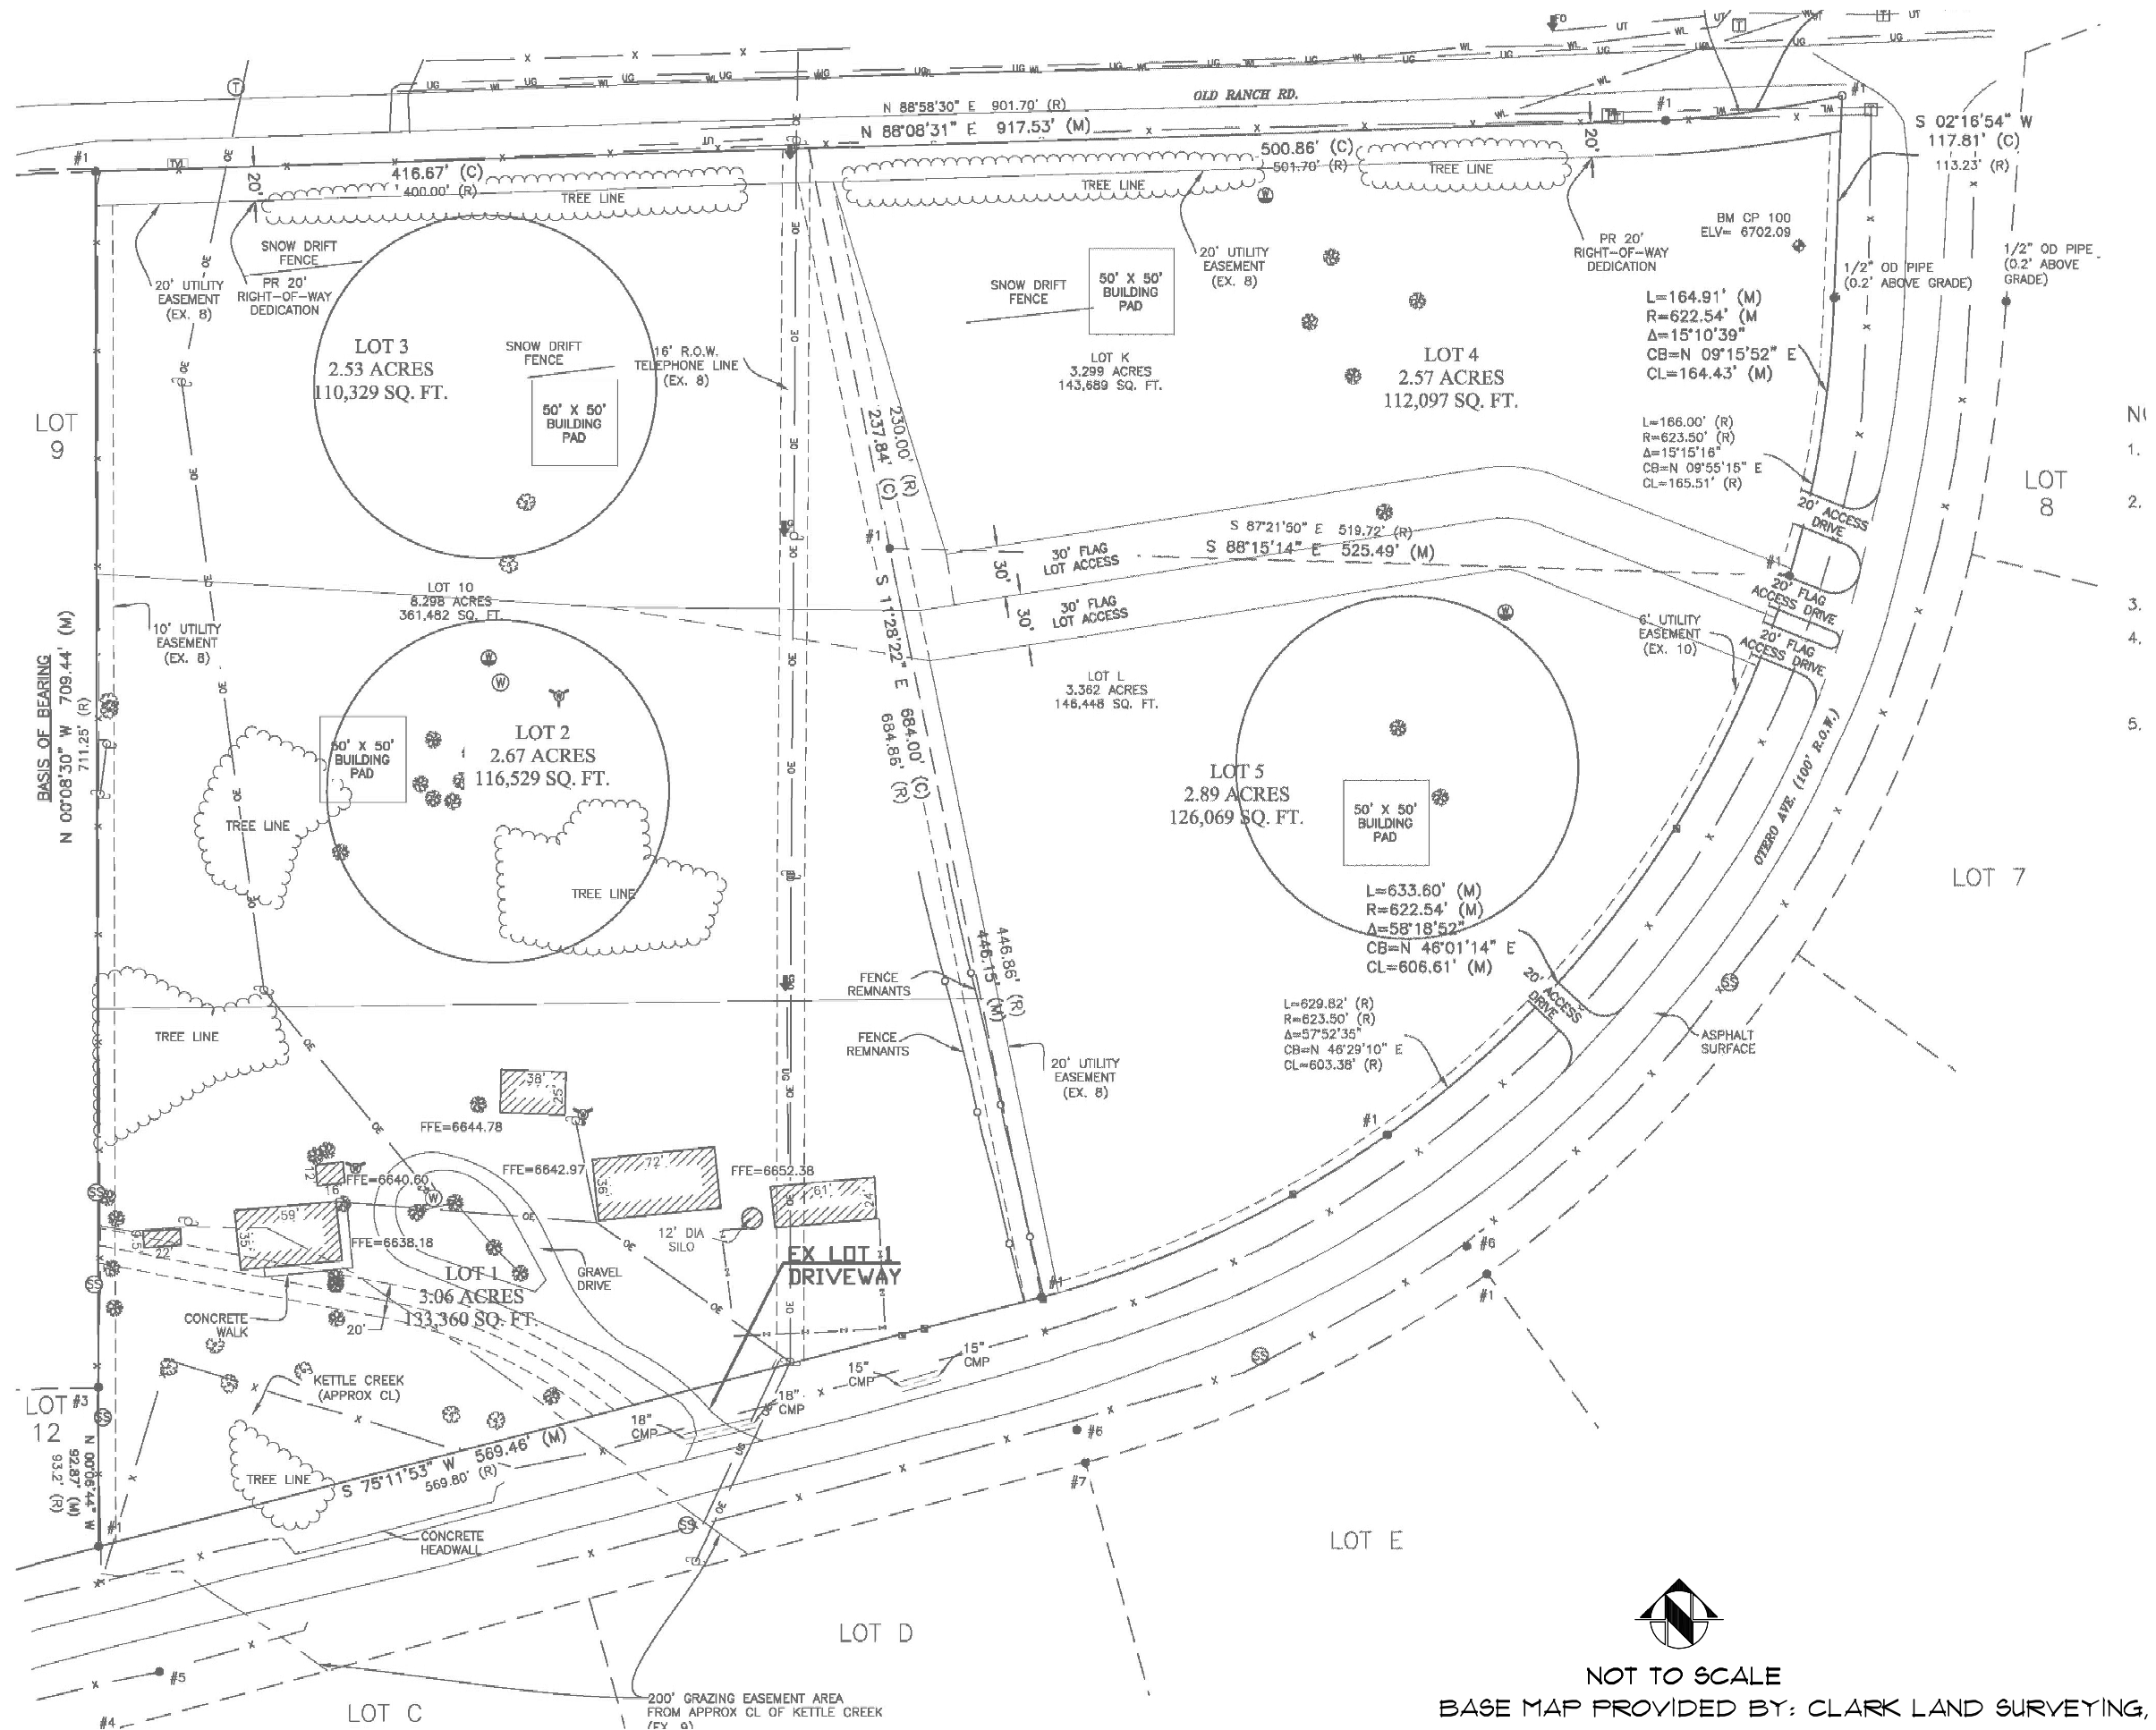
SHEET No.
FIG-3

NOT TO SCALE
 BASE MAP PROVIDED BY: CLARK LAND SURVEYING, INC.

PRELIMINARY
 CONCEPT PLAN

- Each lot shall be designed to insure that a minimum of 2 sites are appropriate for a OWTS and do not fall within the restricted areas identified on the Preliminary Concept Plan, Figure 3, (e.g. utility easements, right of ways);

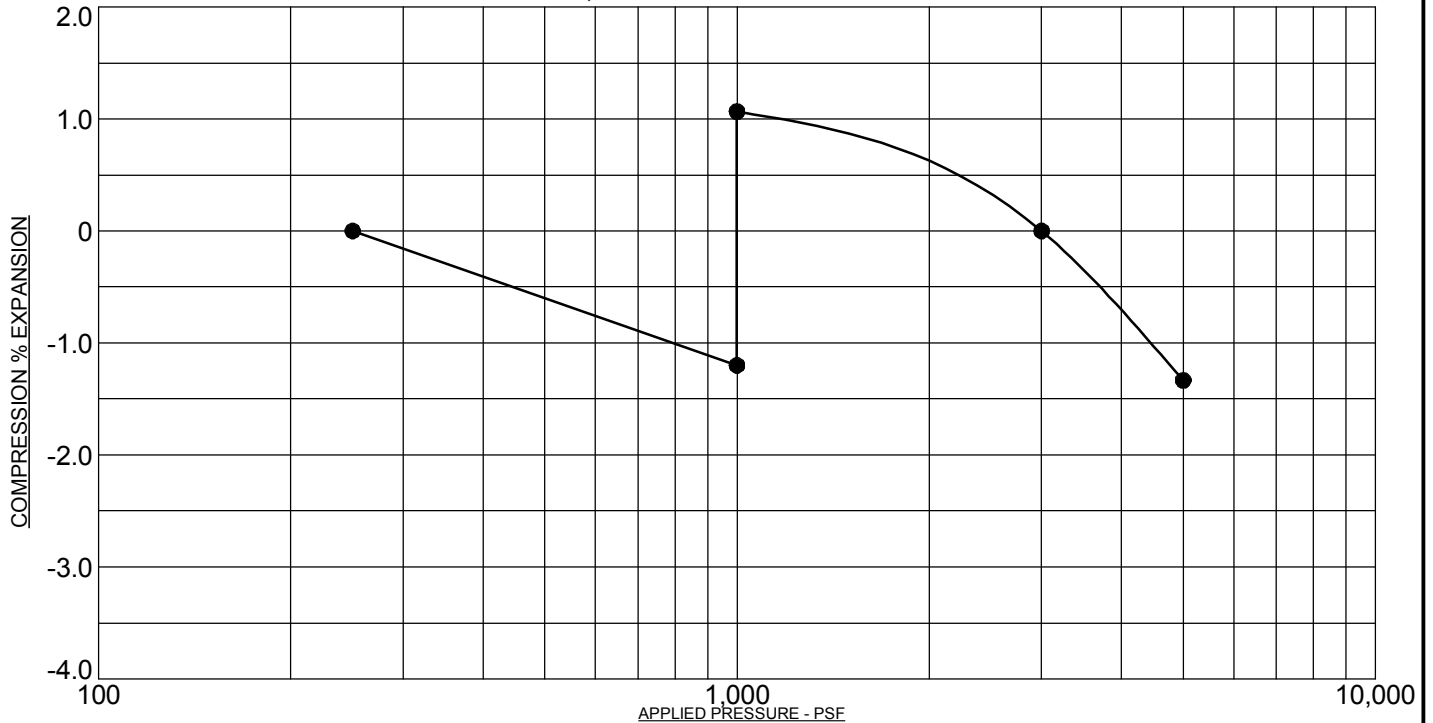
FIGURE No. 11

PROJECT: Old Ranch Road, Colorado Springs, Colorado
 RMG SOIL TYPE:
 SAMPLE DESCRIPTION: CLAY, SANDY
 NOTE: SAMPLE WAS INUNDATED WITH WATER AT 1,000 PSF

SAMPLE LOCATION: 1 @ 4 FT
 NATURAL DRY UNIT WEIGHT: 94.3 PCF
 NATURAL MOISTURE CONTENT: 20.7%
 PERCENT SWELL/COMPRESSION: 3.1

SAMPLE LOCATION: 2 @ 9 FT
 NATURAL DRY UNIT WEIGHT: 91.4 PCF
 NATURAL MOISTURE CONTENT: 30.6%
 PERCENT SWELL/COMPRESSION: 2.3

**SWELL/CONSOLIDATION
 TEST RESULTS**

Soil laboratory testing was performed as part of this investigation. The laboratory tests included moisture content, dry density, grain-size analyses, Atterberg Limits and Swell/Consolidation tests. A Summary of Laboratory Test Results is presented in Figure 9. Soils Classification Data is presented in Figure 10. Swell/Consolidation tests are presented in Figure 11.
