GEOLOGY AND SOILS REPORT with Wastewater Study

Lot 10, Lot K, Lot L, Springs Crest Subdivison
El Paso County, Colorado

JOB NO. 162650
PUD File No. VR-18-014

May 18, 2018
Revised November 28, 2018

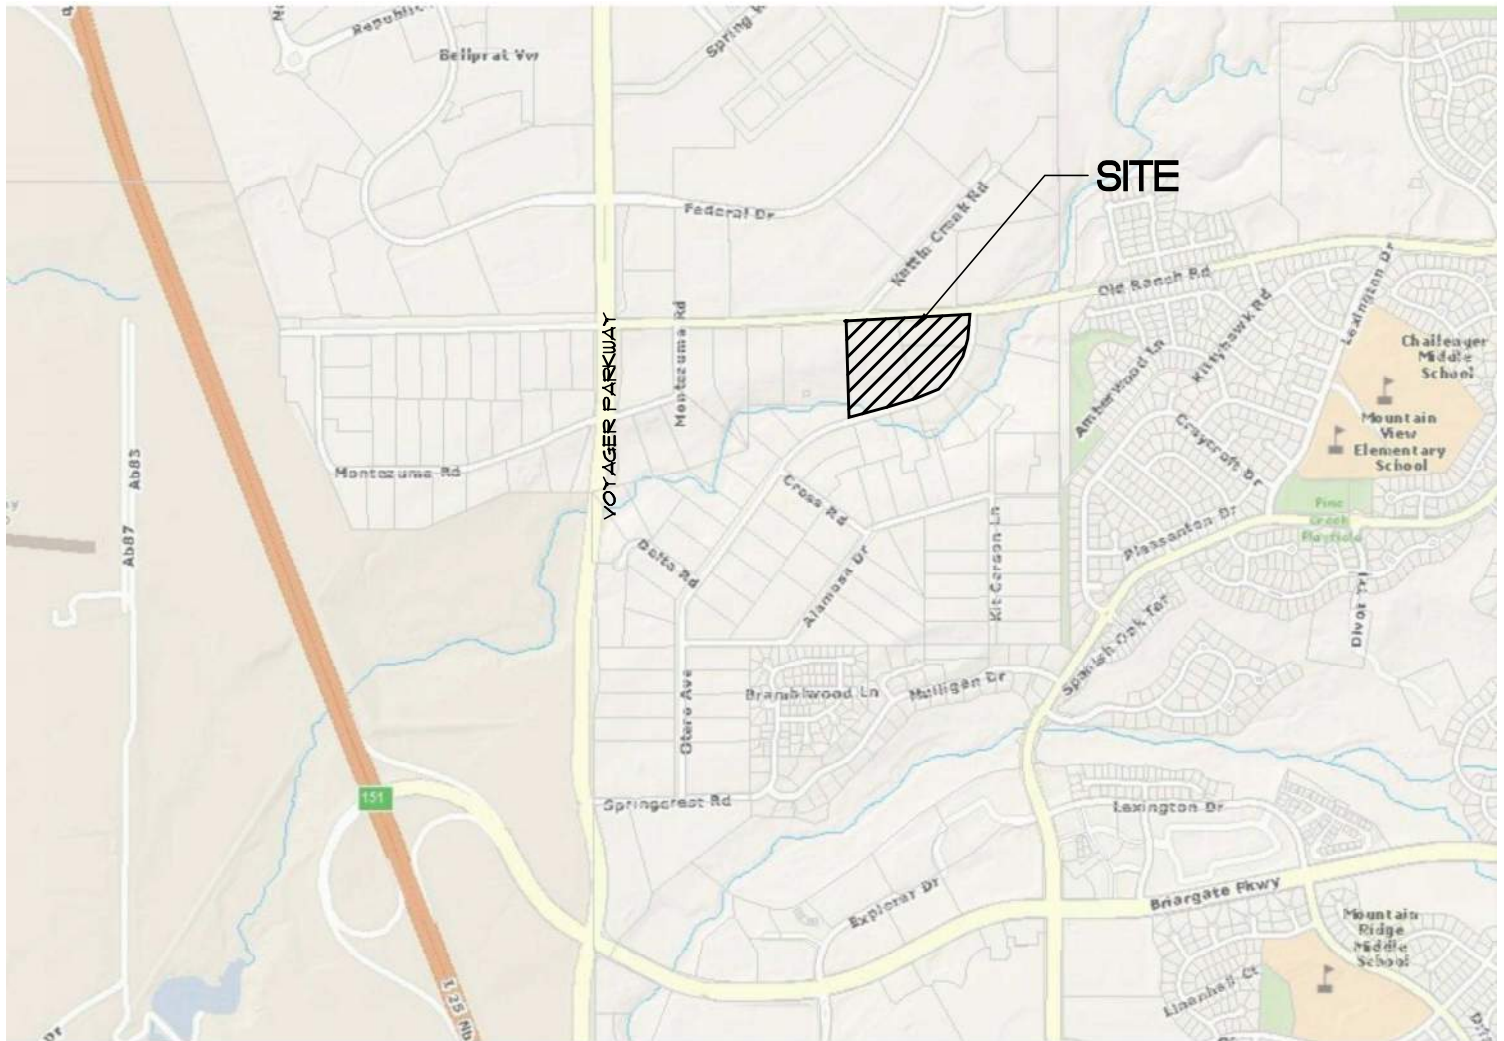
FIG No. 1

REFERENCE
NOT TO SCALE

The project lies in the northeast portion of Section 28, Township 12 South, Range 66 West of the 6th Principal Meridian in El Paso County, Colorado. The approximate location of the site is shown on the Site Vicinity Map, Figure 1.

The site is generally located south and west of the intersection of Otero Avenue and Old Ranch Road, Colorado Springs, El Paso County. The site includes three parcels and has a combined total acreage of approximately 14.959 acres, on which there are multiple existing structures. It is proposed the combined existing 14.959 acres be subdivided into five 2.5 to 3.3 acre parcels. Figure 1 presents the general boundaries of our investigation.

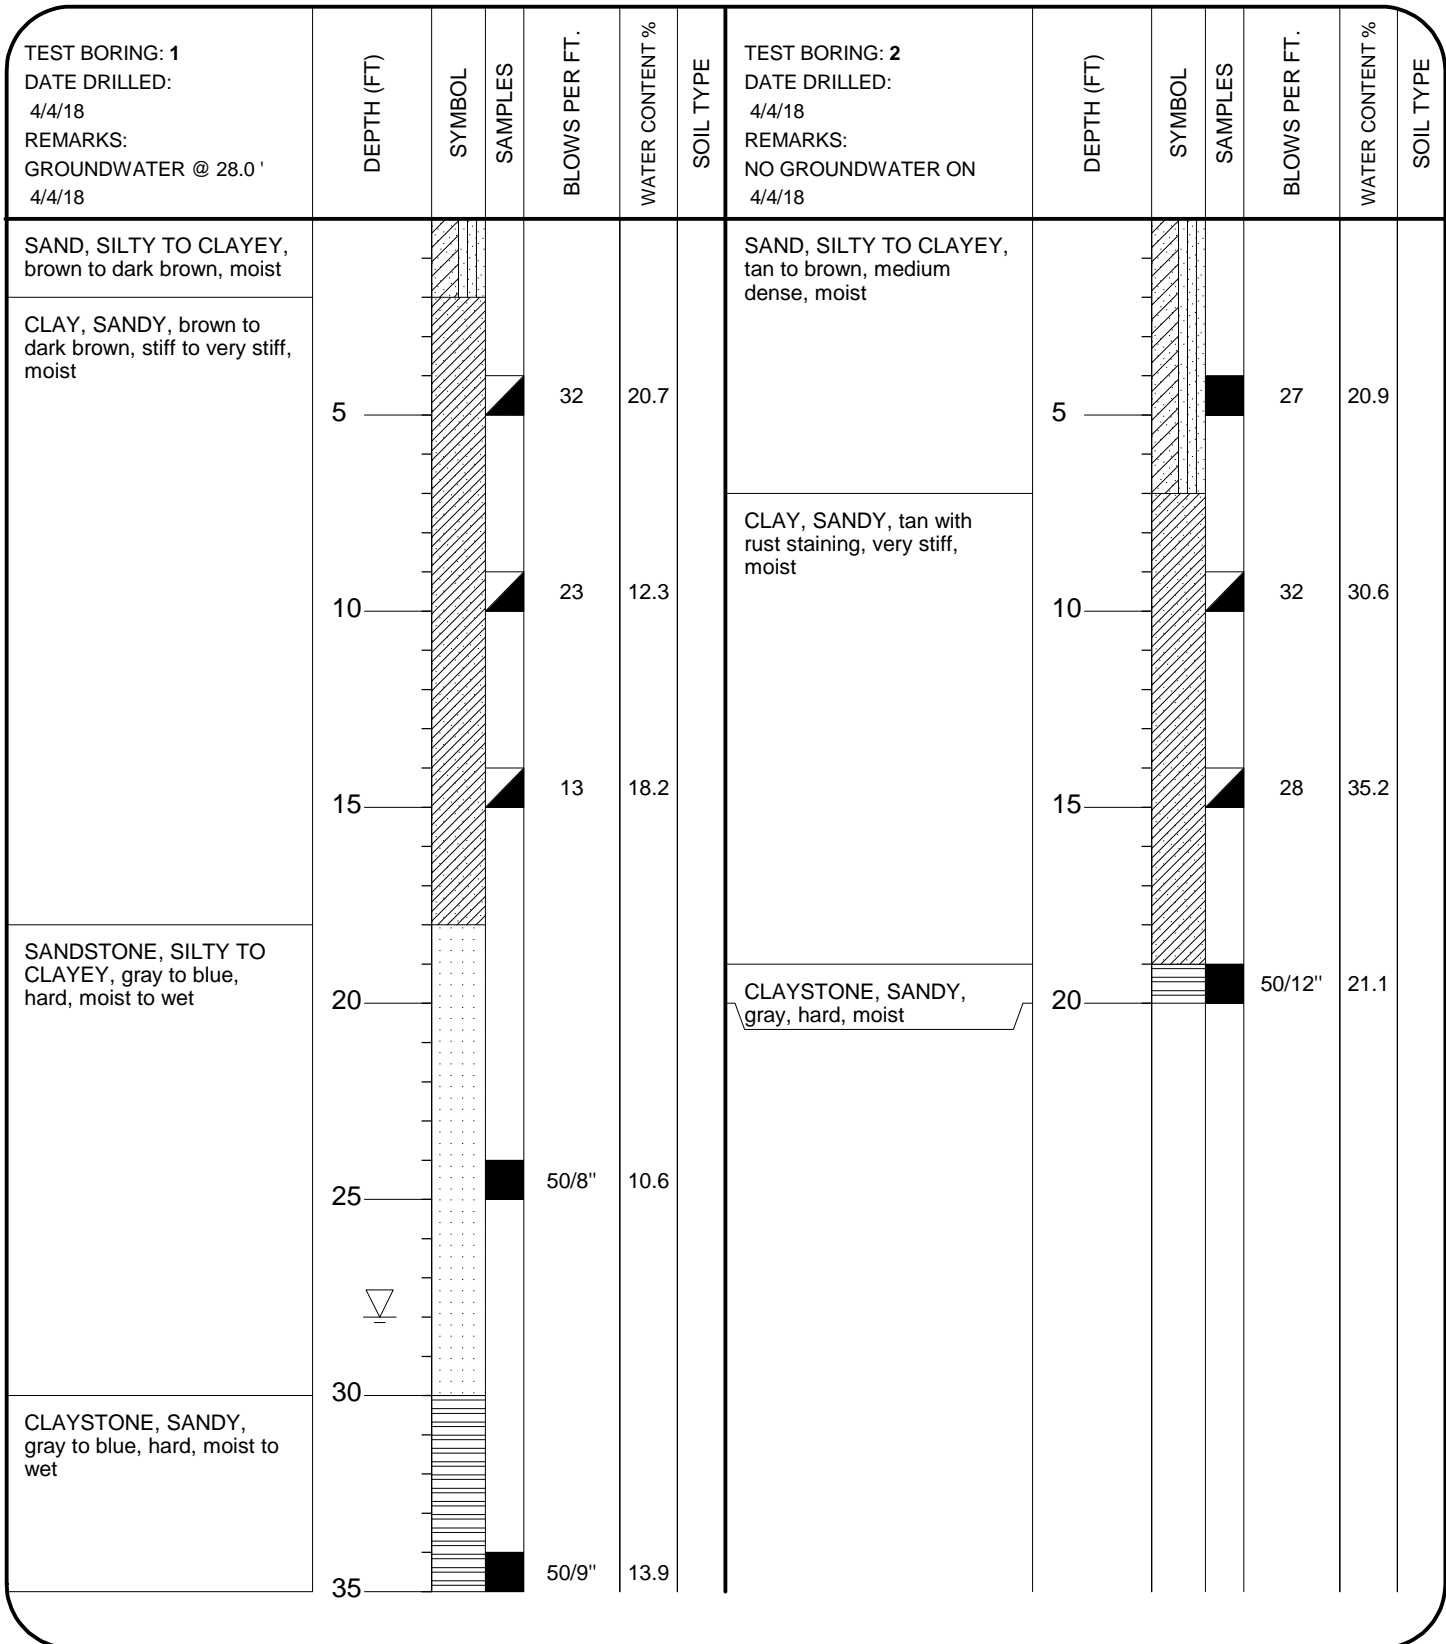
EXPLANATION OF TEST BORING LOGS

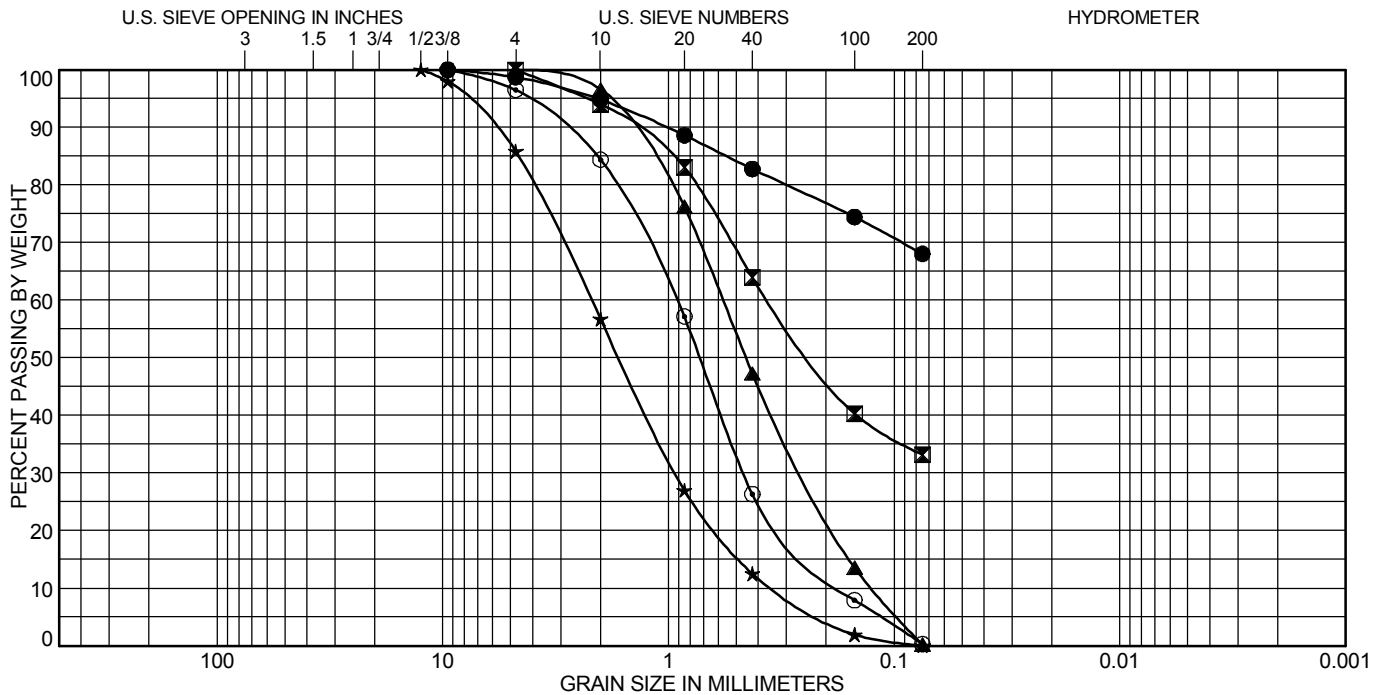
JOB No. 162650
 FIGURE No. 9
 PAGE 1 OF 1
 DATE 5/17/18

Test Boring No.	Depth	Water Content (%)	Dry Density (pcf)	Liquid Limit	Plasticity Index	% Retained No.4 Sieve	% Passing No. 200 Sieve	FHA Expansion Pressure (psf)	% Swell @ 1000 psf	USCS Classification
1	4.0	20.7	94.3	72	46	1.3	68.0			CH
1	9.0	12.3								
1	14.0	18.2		47	30	0.0	33.2			SC
1	24.0	10.6								
1	34.0	13.9								
2	4.0	20.9								
2	9.0	30.6	91.4	68	37	0.0	0.2			SP
2	14.0	35.2								
2	19.0	21.1								
3	4.0	2.6		NP	NP	14.1	0.0			SW
3	9.0	16.7								
3	14.0	13.9		NP	NP	3.5	0.3			SP
3	19.0	16.9

**SUMMARY OF
 LABORATORY TEST
 RESULTS**

Soil laboratory testing was performed as part of this investigation. The laboratory tests included moisture content, dry density, grain-size analyses, Atterberg Limits and Swell/Consolidation tests. A Summary of Laboratory Test Results is presented in Figure 9. Soils Classification Data is presented in Figure 10. Swell/Consolidation tests are presented in Figure 11.

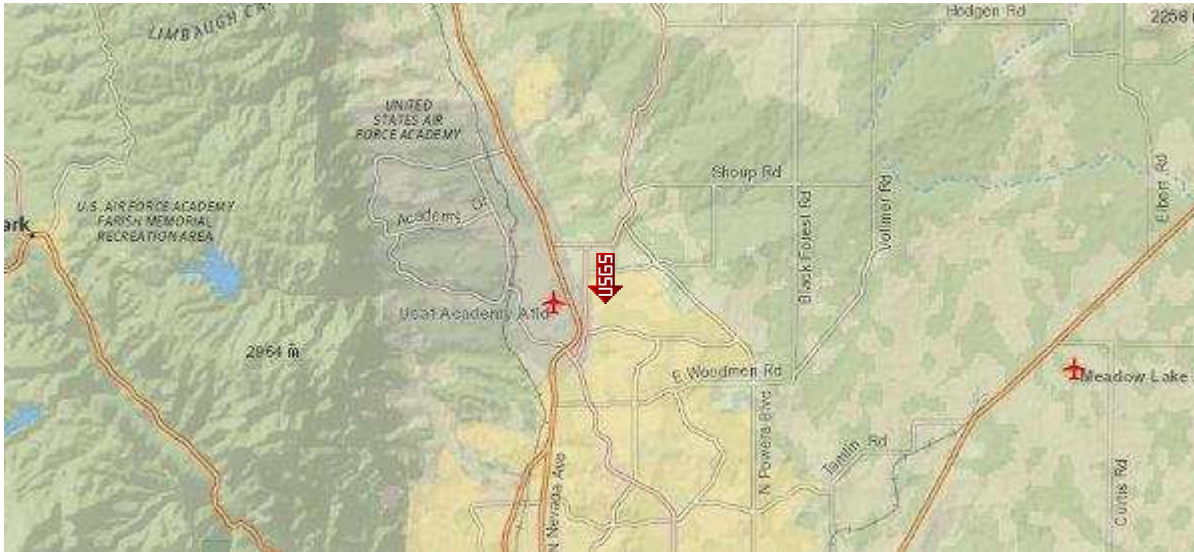
Site Soil Classification Site Class C – “Very Dense Soil and Soft Rock”

USGS-Provided Output

$$\begin{array}{lll}
 S_s = 0.182 \text{ g} & S_{MS} = 0.218 \text{ g} & S_{DS} = 0.145 \text{ g} \\
 S_1 = 0.060 \text{ g} & S_{M1} = 0.102 \text{ g} & S_{D1} = 0.068 \text{ g}
 \end{array}$$
