GEOLOGY AND SOILS REPORT with Wastewater Study

**Lot 10, Lot K, Lot L, Springs Crest Subdivison
El Paso County, Colorado**

**Hunsinger Development Corporation
4406 College Park Court
Colorado Springs, CO 80918**

JOB NO. 162650

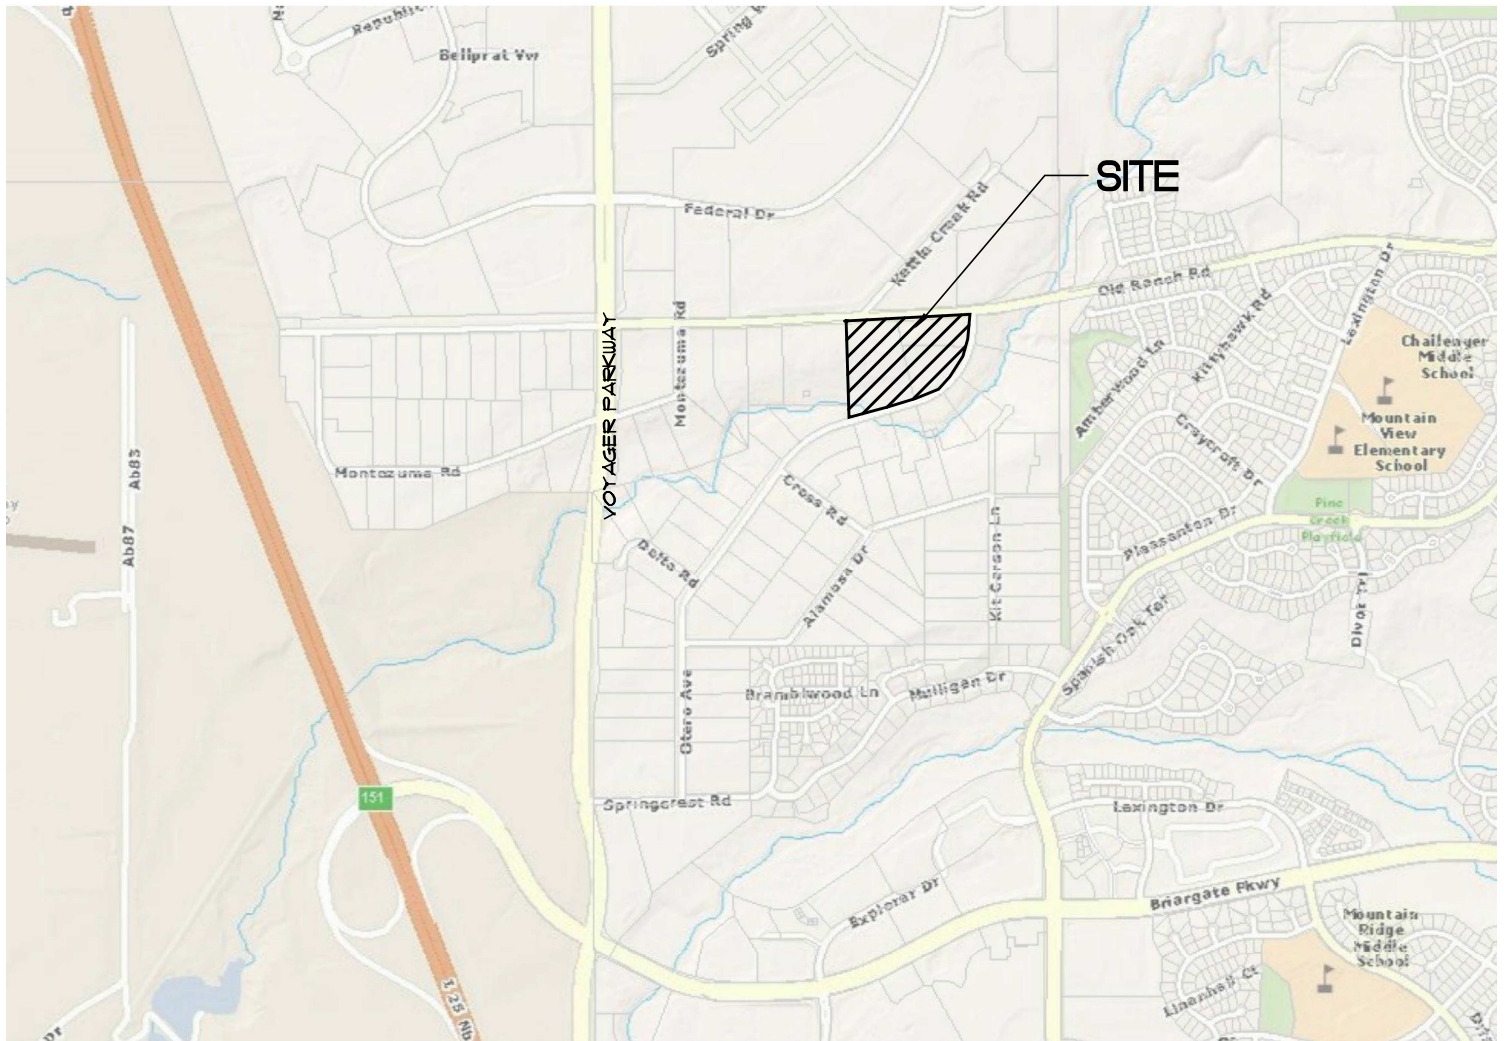
FIG No. 1

REFERENCE
NOT TO SCALE

The project lies in the northeast portion of Section 28, Township 12 South, Range 66 West of the 6th Principal Meridian in El Paso County, Colorado. The approximate location of the site is shown on the Site Vicinity Map, Figure 1.

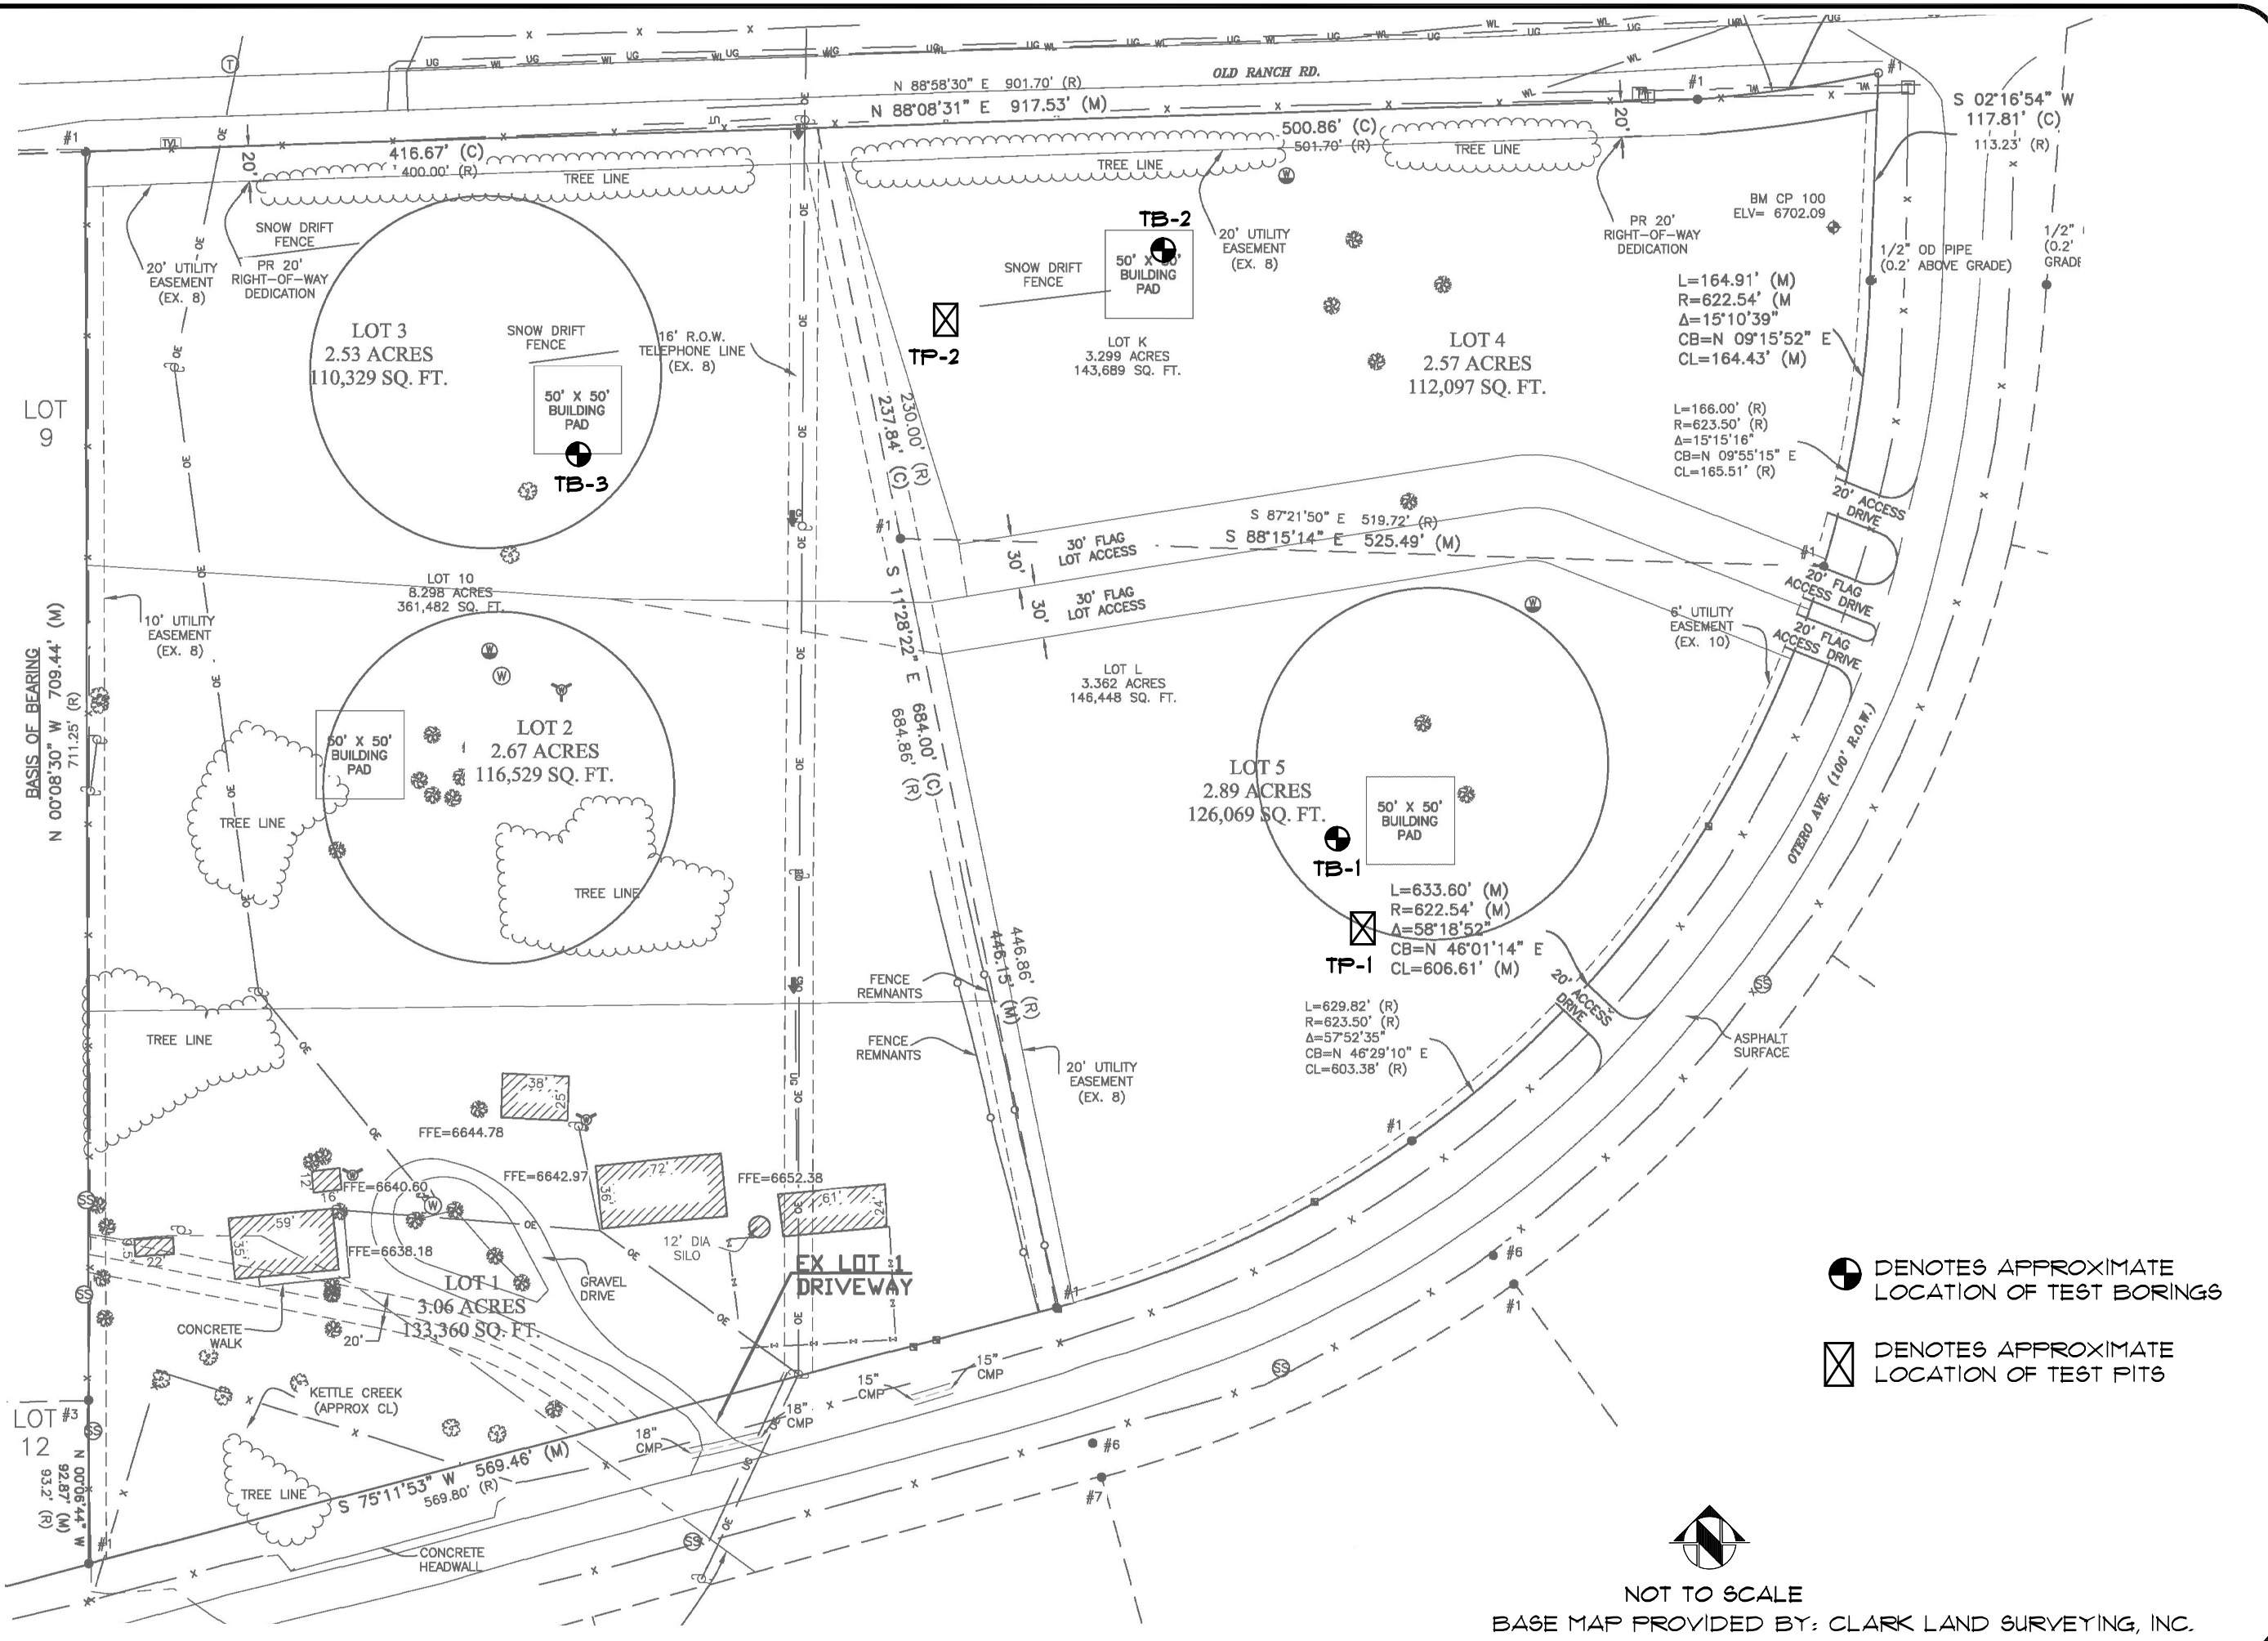
⊙ DENOTES APPROXIMATE LOCATION OF TEST BORINGS

⊠ DENOTES APPROXIMATE LOCATION OF TEST PITS

The subsurface conditions within the property were explored by drilling three exploratory borings on March 4, 2018 extending to depths of approximately 20 to 35 feet below the existing ground surface. The test borings were performed to explore the subsurface soils underlying the proposed site. The number of borings is in excess of the minimum one test boring per 10 acres of development up to 100
