ENTECH
ENGINEERING, INC.

December 11, 2023
Revised September 6, 2024

Re: Soils and Geology Study
Lazy Y and Rockin' J Subdivision
12960 North Peyton Highway
Parcel No. 63070-00-007
El Paso County, Colorado
Entech Job No. 230520

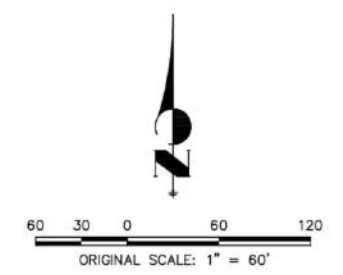
JOB NO.
 230520
FIG. 6

Legend:
 Qc/TKd - Colluvial and Residual Soils of Quaternary Age overlying the Dawson Formation of Tertiary to Cretaceous Age: older fan and rockfall deposits
 er - area of erosion

GEOLOGY / ENGINEERING MAP
 12960 NORTH PEYTON HIGHWAY
 EL PASO COUNTY, COLORADO
 LAZY Y AND ROCKIN' J

The geology of the site was evaluated using the *Bedrock Geologic Map of the Denver Basin*, distributed by CGS in 2011, (Reference 4, Figure 5). The Geology Map for the site is presented in Figure 6. One mappable unit was identified on this site which is described as follows:

The soils listed above were mapped from site-specific mapping, the *Geologic Map of the Cheyenne Mountain Quadrangle* distributed by the Colorado Geologic Survey in 2003 (Reference 4, Figure 5), The *Geologic Map of the Colorado Springs-Castle Rock Area*, distributed by the US Geological Survey in 1979 (Reference 5), and the *Geologic Map of the Pueblo 1° x 2° Quadrangle*, distributed by the US Geological Survey in 1978 (Reference 6). The test borings and test pits were used in evaluating the site and is included in Appendix B. The Geology Map prepared for the site is presented in Figure 6.

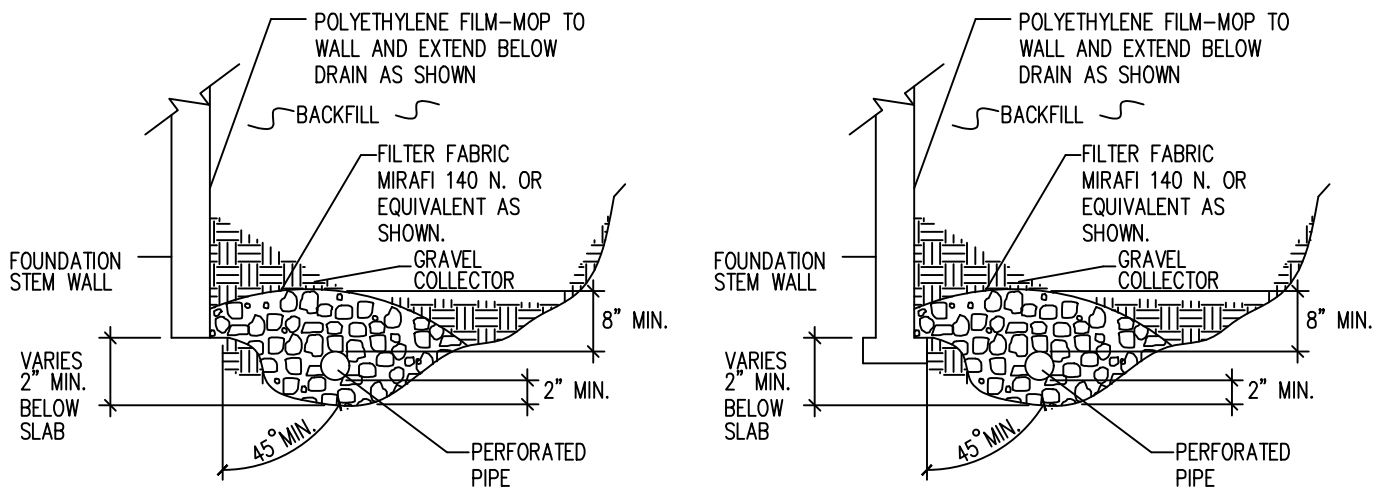
FIG. 8

-GRAVEL SIZE IS RELATED TO DIAMETER OF PIPE PERFORATIONS-85% GRAVEL GREATER THAN 2x PERFORATION DIAMETER.

Mitigation: Foundations must have a minimum 30-inch depth for frost protection. In areas where high subsurface moisture conditions are anticipated periodically, subsurface perimeter drains are recommended to help prevent the intrusion of water into areas below grade. Typical drain details are presented in Figure 8. If shallow groundwater is encountered, underslab drains or interceptor drains may be necessary Figures 9 and 10. Specific drainage details and recommendations should be made once building locations and plans are finalized. Any grading in these areas should be done to direct surface flow around construction to avoid areas of ponded water. All organic material would be completely removed prior to any fill placement.

Subsurface perimeter drains are recommended for structures with below grade usable areas. Typical drain details are presented in Figure 8. If shallow groundwater is encountered, underslab drains or interceptor drains may be necessary Figures (9 and 10). Specific drainage details and recommendations should be made once building locations and plans are finalized. Any grading around structures should be done to direct surface flow around construction to avoid areas of ponded water. All organic material should be completely removed prior to any fill placement. Specific drainage studies are beyond the scope of this report. The site is not mapped within any floodplains according to the FEMA Map No. 80841C0320G (Figure 7, Reference 7).

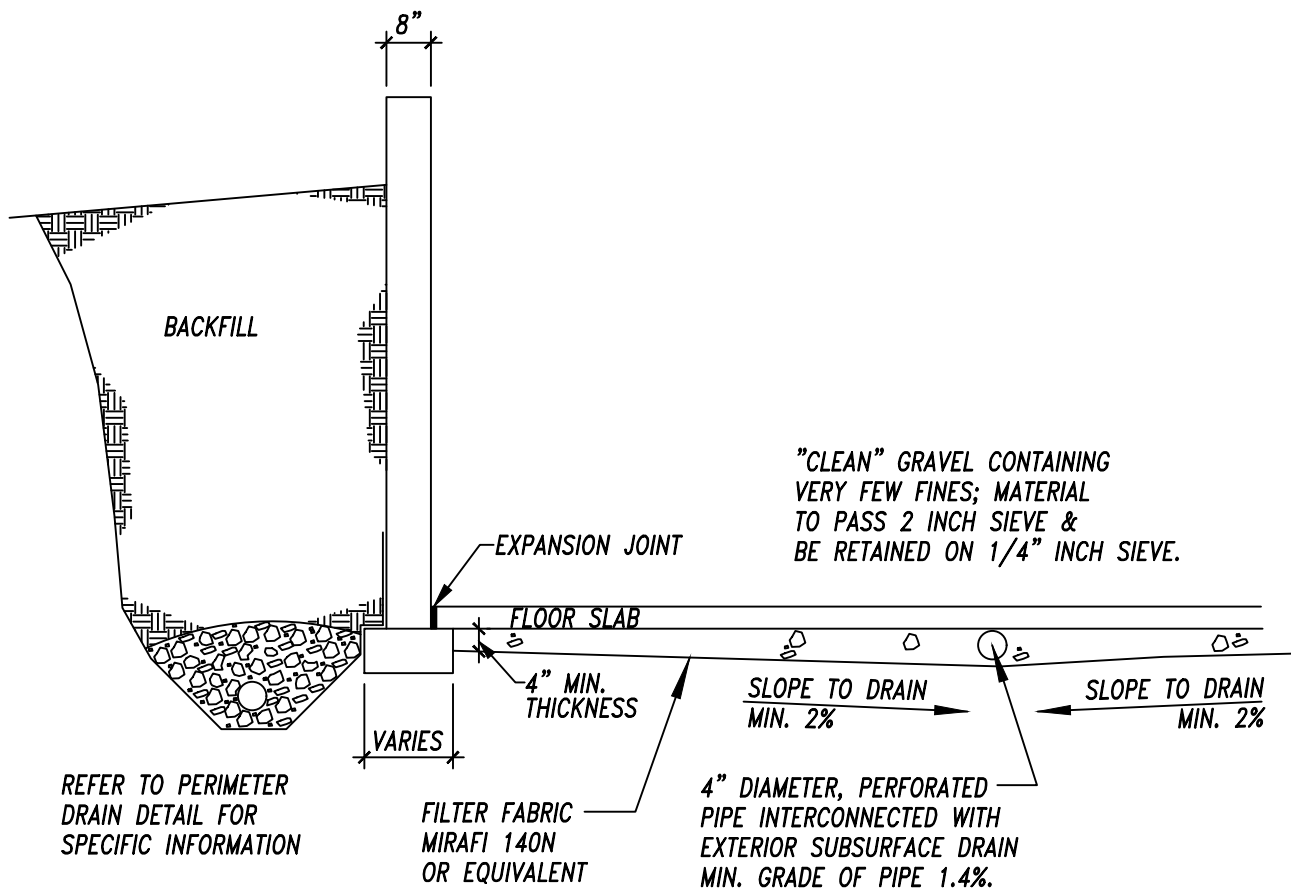
FIG. 9

**TYP. UNDERSLAB DRAINAGE LAYER
(CAPILLARY BREAK)**
12960 NORTH PEYTON HIGHWAY
EL PASO COUNTY, COLORADO
LAZY Y AND ROCKIN' J

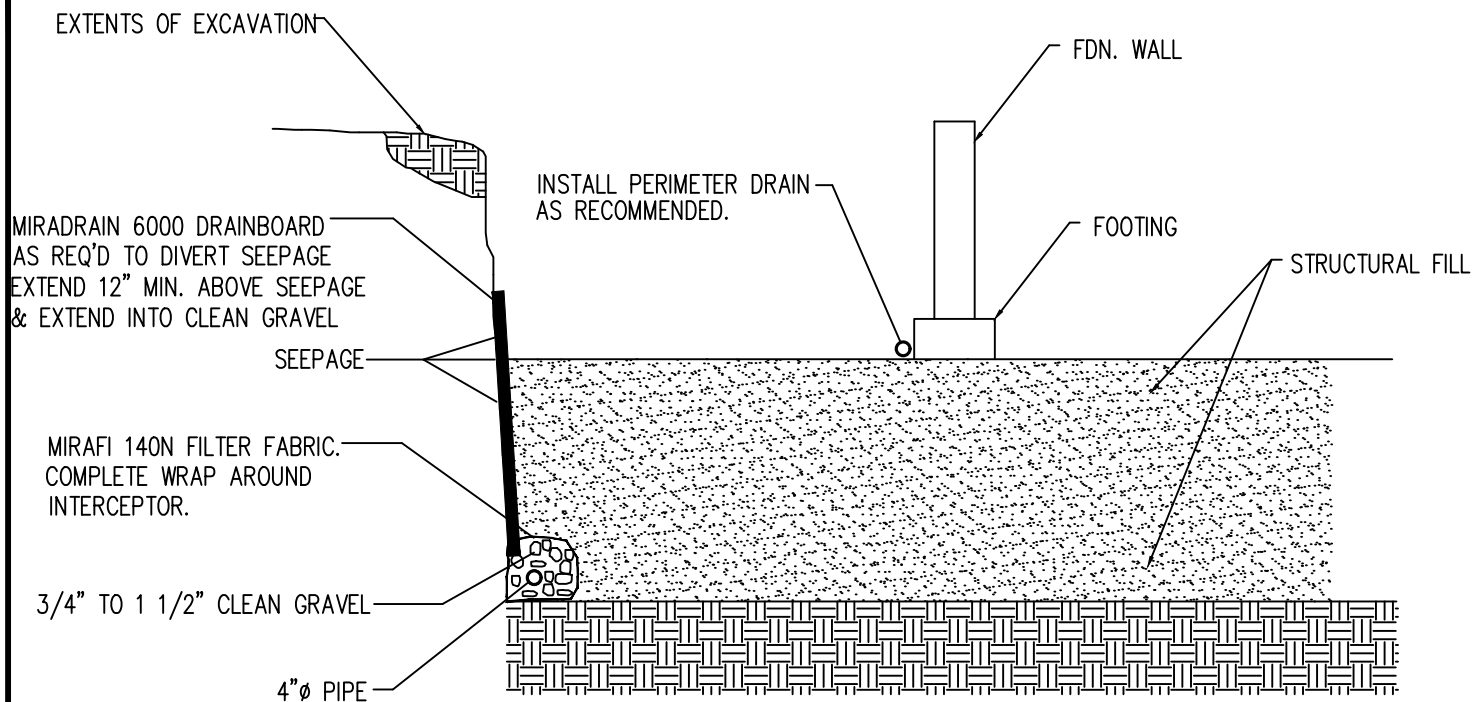
FIG. 10

NOTE:
EXTEND INTERCEPTOR DRAIN TO UNDERDRAIN OR TO SUMP.
BENCH DRAIN INTO NATIVE SOILS 12 INCHES MINIMUM.

INTERCEPTOR DRAIN DETAIL

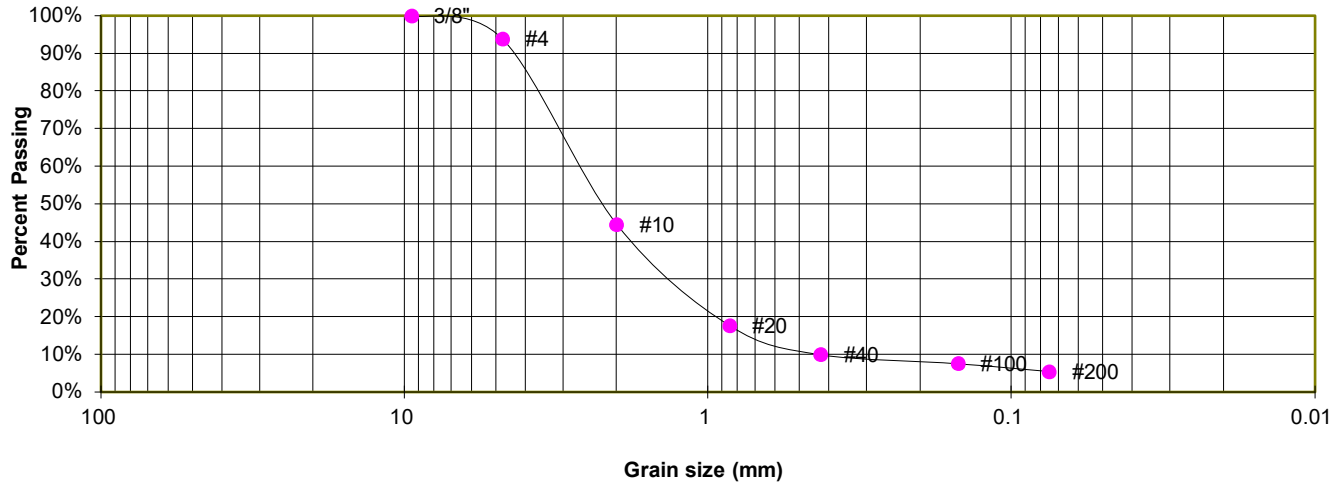
SOIL DESCRIPTION SAND, WITH SILT
SOIL TYPE 1

GRAIN SIZE ANALYSIS

U.S. Sieve #	Percent Finer
3"	
1 1/2"	
3/4"	
1/2"	
3/8"	100.0%
4	93.8%
10	44.5%
20	17.7%
40	10.0%
100	7.6%
200	5.4%

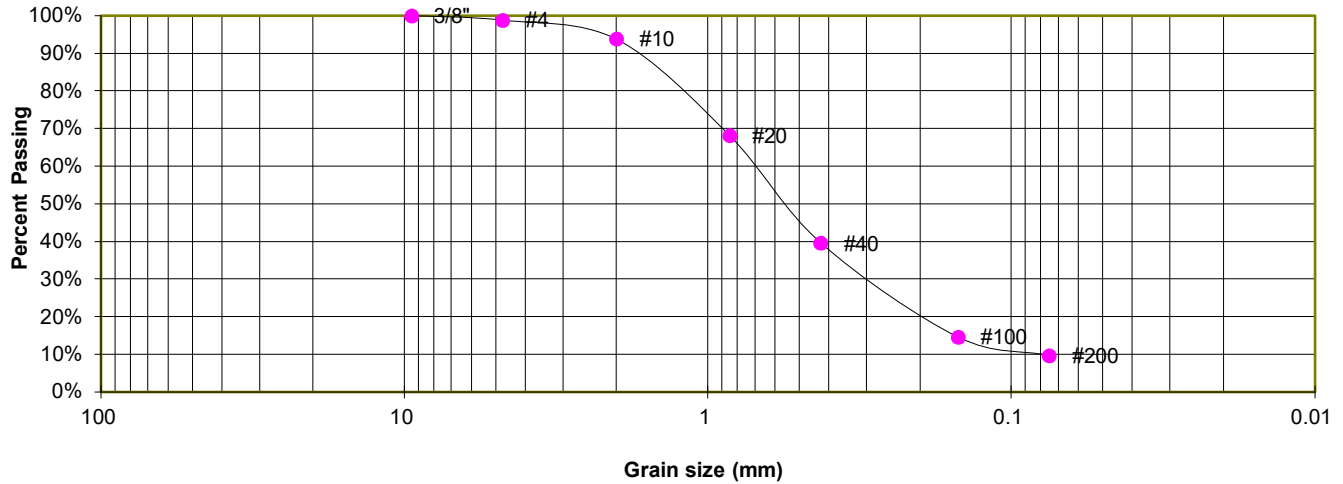
SOIL DESCRIPTION SAND, WITH SILT
SOIL TYPE 1

GRAIN SIZE ANALYSIS

U.S. Sieve #	Percent Finer
3"	
1 1/2"	
3/4"	
1/2"	
3/8"	100.0%
4	98.9%
10	93.8%
20	68.2%
40	39.6%
100	14.7%
200	9.7%

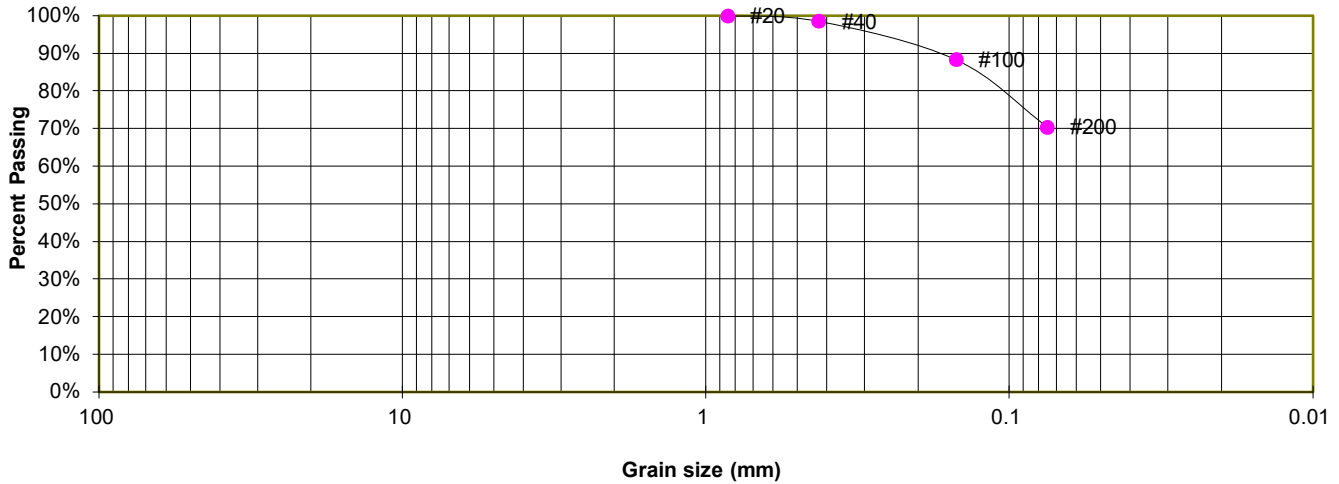
SOIL DESCRIPTION	CLAY, WITH SAND
SOIL TYPE	2

GRAIN SIZE ANALYSIS

U.S. Sieve #	Percent Finer
3"	
1 1/2"	
3/4"	
1/2"	
3/8"	
4	
10	
20	100.0%
40	98.5%
100	88.4%
200	70.4%

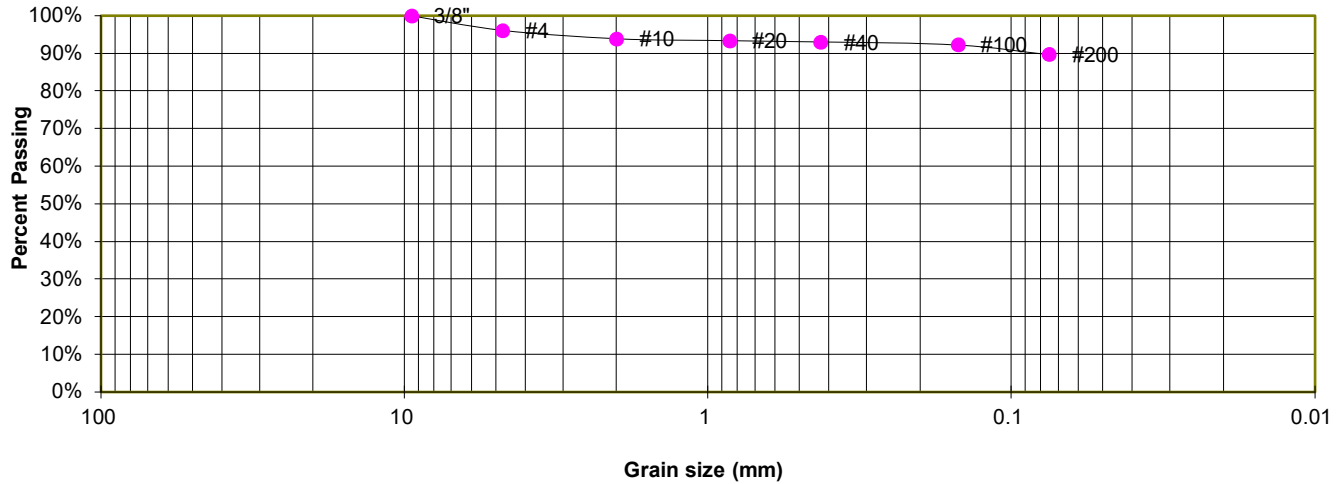
SOIL DESCRIPTION CLAY, SLIGHTLY SANDY
SOIL TYPE 2

GRAIN SIZE ANALYSIS

U.S. Sieve #	Percent Finer
3"	
1 1/2"	
3/4"	
1/2"	
3/8"	100.0%
4	96.1%
10	93.9%
20	93.4%
40	93.0%
100	92.3%
200	89.7%

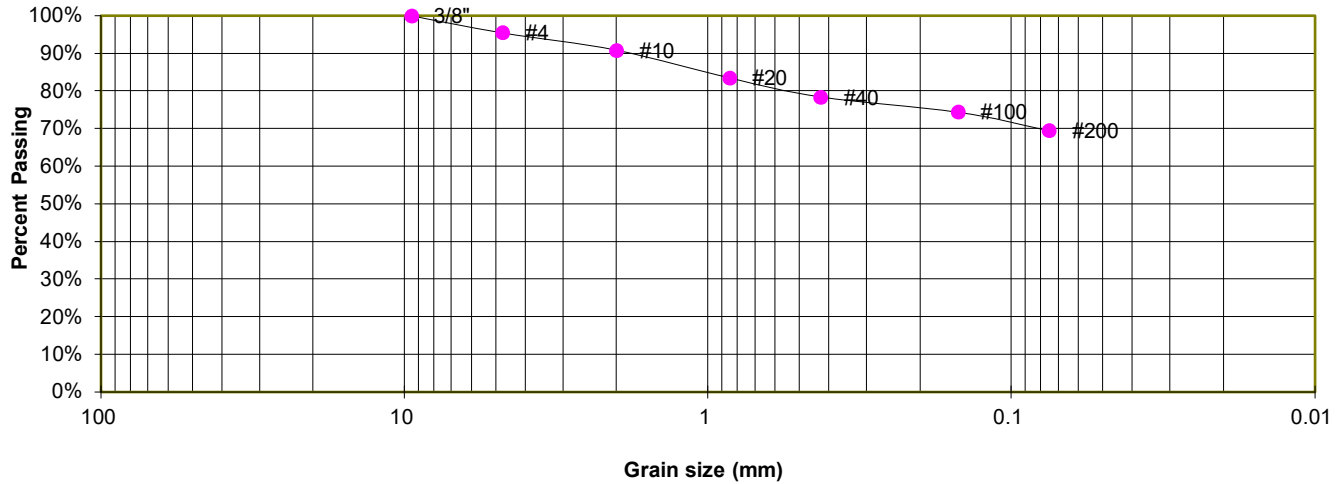
SOIL DESCRIPTION CLAY, SANDY
SOIL TYPE 2

GRAIN SIZE ANALYSIS

U.S. Sieve #	Percent Finer
3"	
1 1/2"	
3/4"	
1/2"	
3/8"	100.0%
4	95.5%
10	90.9%
20	83.5%
40	78.4%
100	74.4%
200	69.5%

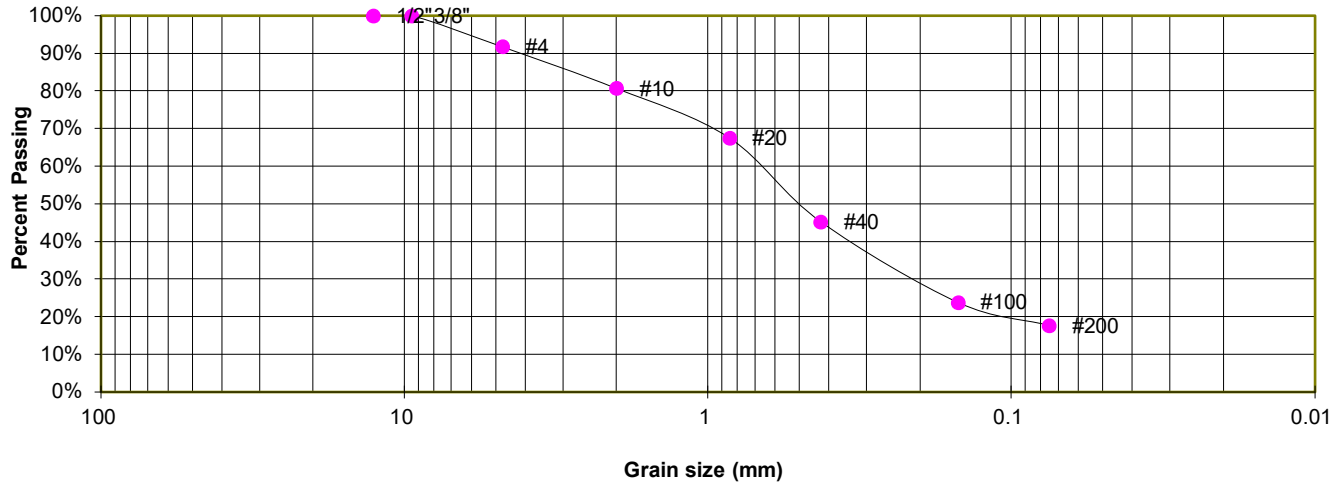
SOIL DESCRIPTION SANDSTONE (SAND, SILTY)
SOIL TYPE 3

GRAIN SIZE ANALYSIS

U.S. Sieve #	Percent Finer
3"	
1 1/2"	
3/4"	
1/2"	100.0%
3/8"	100.0%
4	91.8%
10	80.7%
20	67.6%
40	45.2%
100	23.9%
200	17.7%

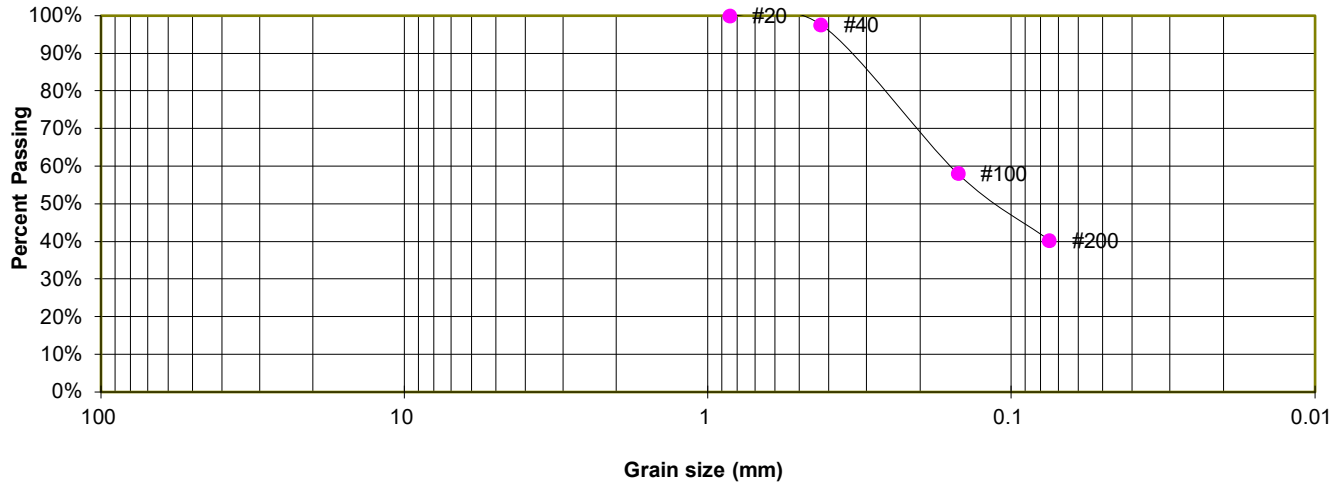
SOIL DESCRIPTION SANDSTONE (SAND, SILTY)
SOIL TYPE 3

GRAIN SIZE ANALYSIS

U.S. Sieve #	Percent Finer
3"	
1 1/2"	
3/4"	
1/2"	
3/8"	
4	
10	
20	100.0%
40	97.6%
100	58.1%
200	40.3%

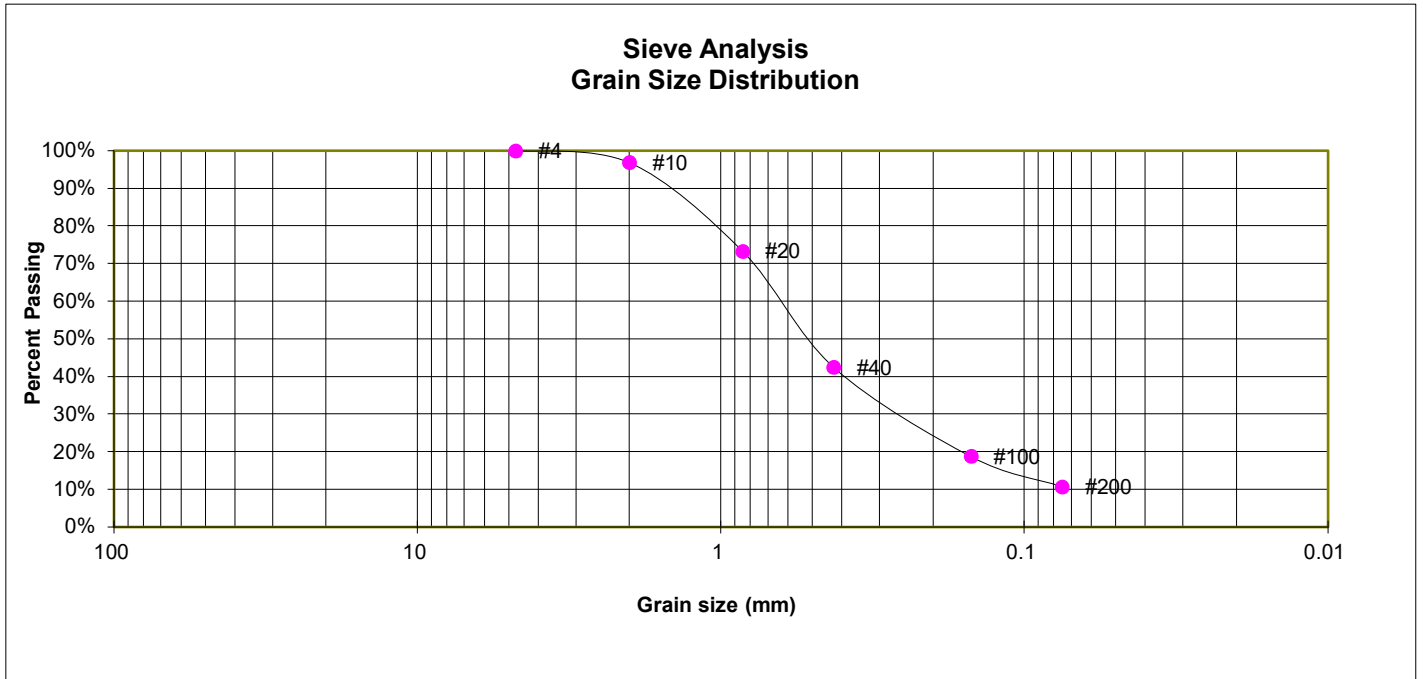
TEST BORING P-1
DEPTH (FT) 15

SOIL DESCRIPTION SANDSTONE (SAND, WITH SILT)
SOIL TYPE 3

GRAIN SIZE ANALYSIS

U.S. Sieve #	Percent Finer
3"	
1 1/2"	
3/4"	
1/2"	
3/8"	
4	100.0%
10	96.9%
20	73.3%
40	42.4%
100	18.8%
200	10.7%

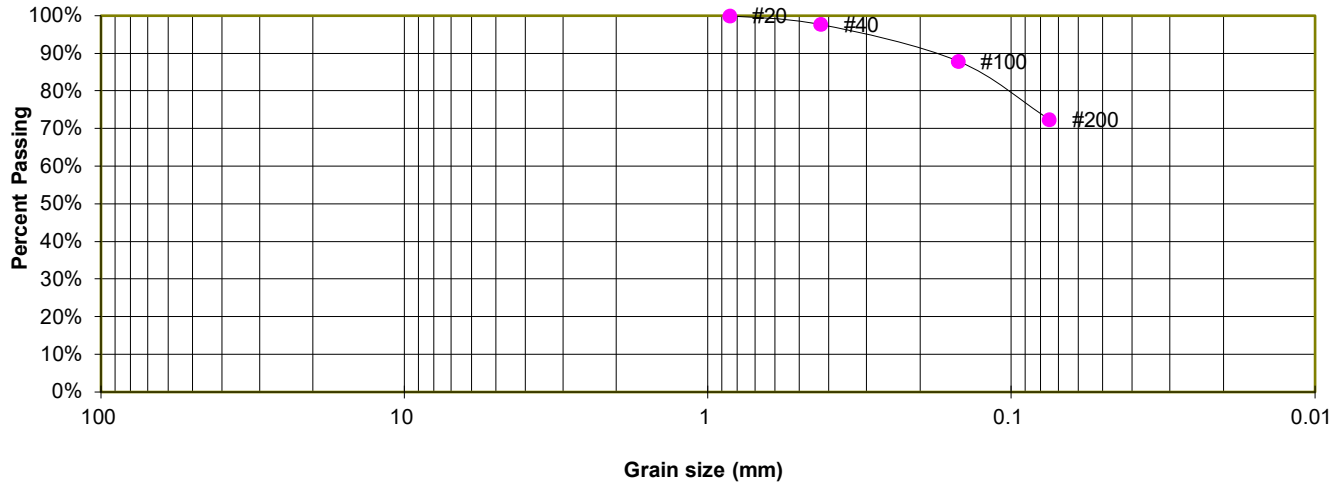
SOIL DESCRIPTION CLAYSTONE (CLAY, WITH SAND)
SOIL TYPE 4

GRAIN SIZE ANALYSIS

U.S. Sieve #	Percent Finer
3"	
1 1/2"	
3/4"	
1/2"	
3/8"	
4	
10	
20	100.0%
40	97.7%
100	88.0%
200	72.5%

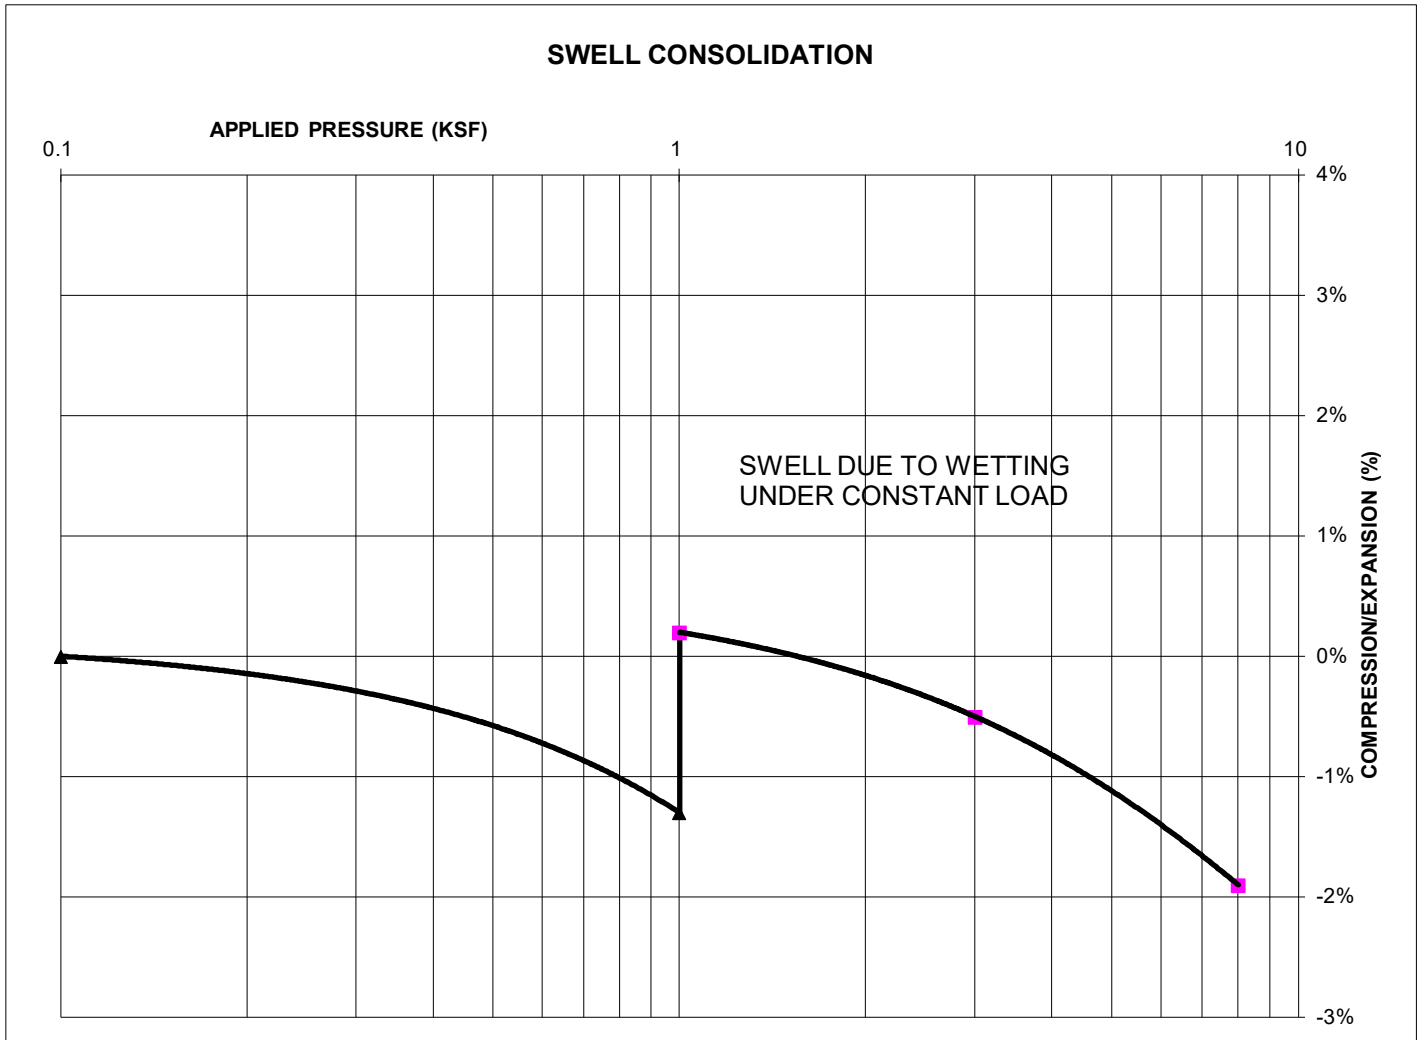
FIG. C-10

TEST BORING 1
DEPTH (FT) 5

SOIL DESCRIPTION CLAY, SLIGHTLY SANDY
SOIL TYPE 2

SWELL/CONSOLIDATION TEST RESULTS

NATURAL UNIT DRY WEIGHT (PCF): 117
NATURAL MOISTURE CONTENT: 14.0%
SWELL/CONSOLIDATION (%): 1.5%

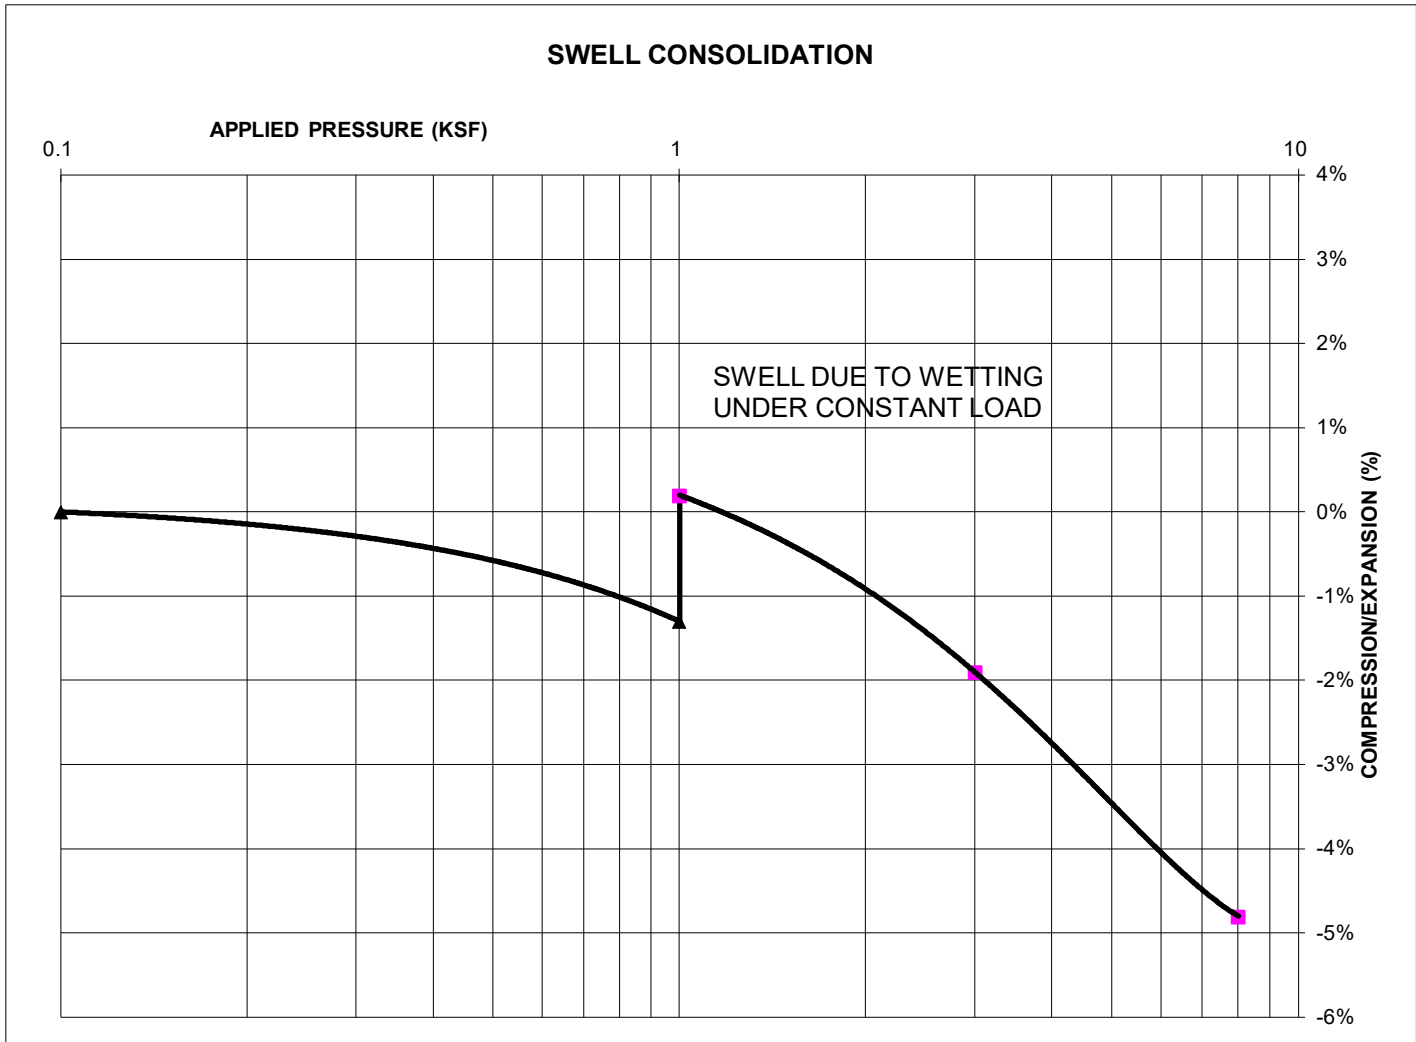
FIG. C-11

TEST BORING	TP-1	SOIL DESCRIPTION	CLAY, SLIGHTLY SANDY
DEPTH (FT)	5	SOIL TYPE	2

SWELL/CONSOLIDATION TEST RESULTS

NATURAL UNIT DRY WEIGHT (PCF): 100
NATURAL MOISTURE CONTENT: 17.0%
SWELL/CONSOLIDATION (%): 1.5%

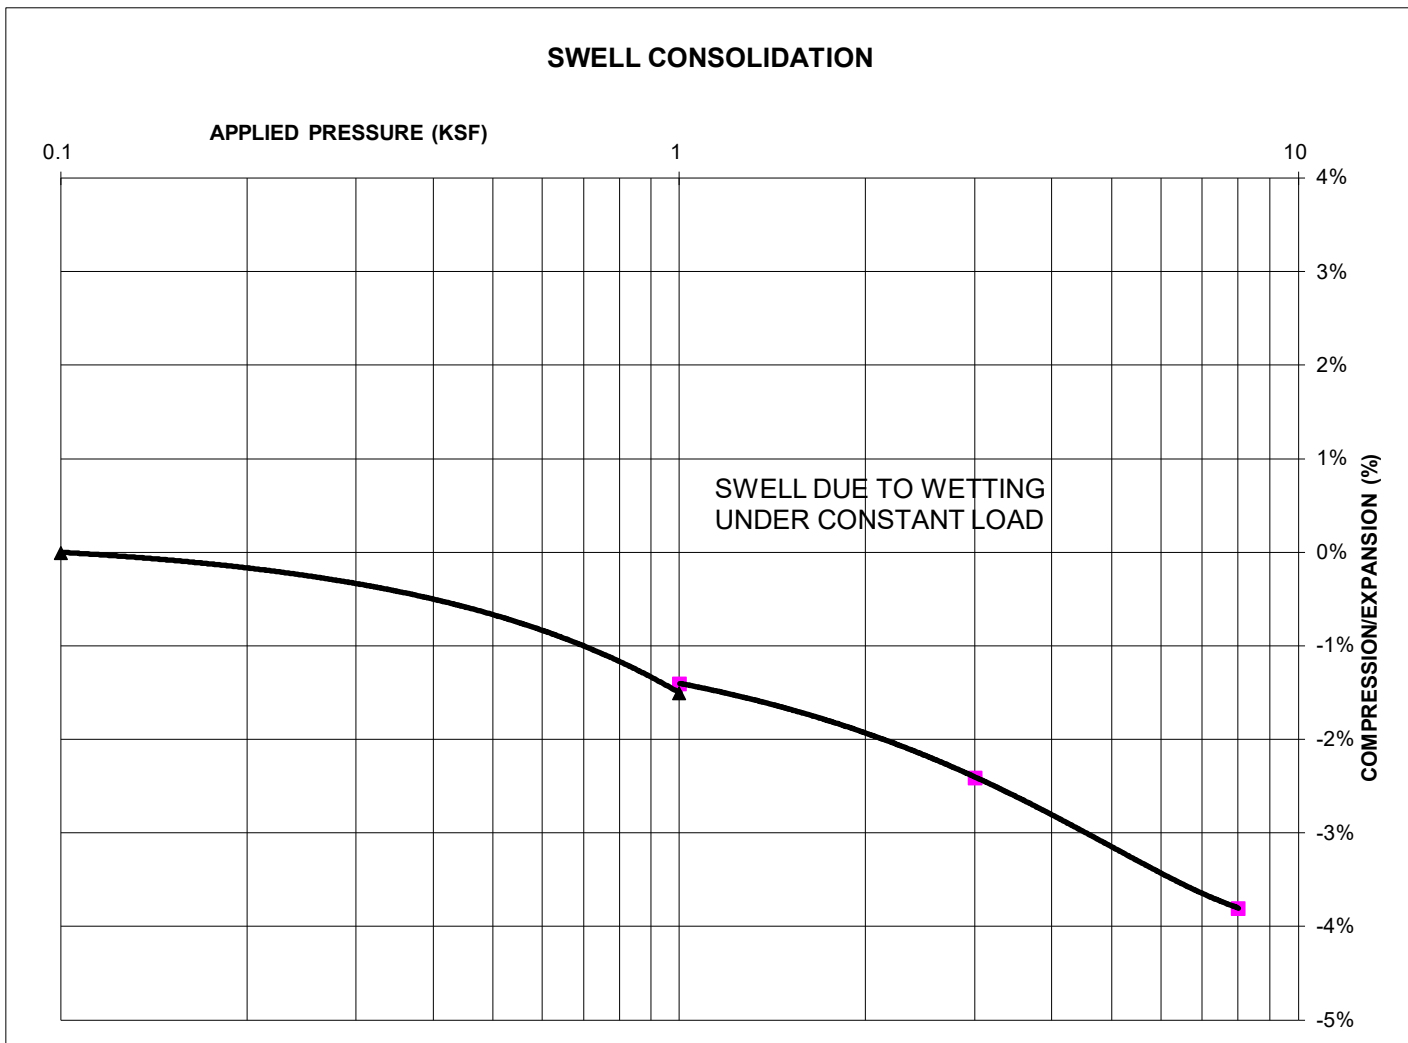
TEST BORING	4	SOIL DESCRIPTION	SANDSTONE (SAND, SILTY)
DEPTH (FT)	20	SOIL TYPE	3

SWELL/CONSOLIDATION TEST RESULTS

NATURAL UNIT DRY WEIGHT (PCF): 114
 NATURAL MOISTURE CONTENT: 14.3%
 SWELL/CONSOLIDATION (%): 0.1%

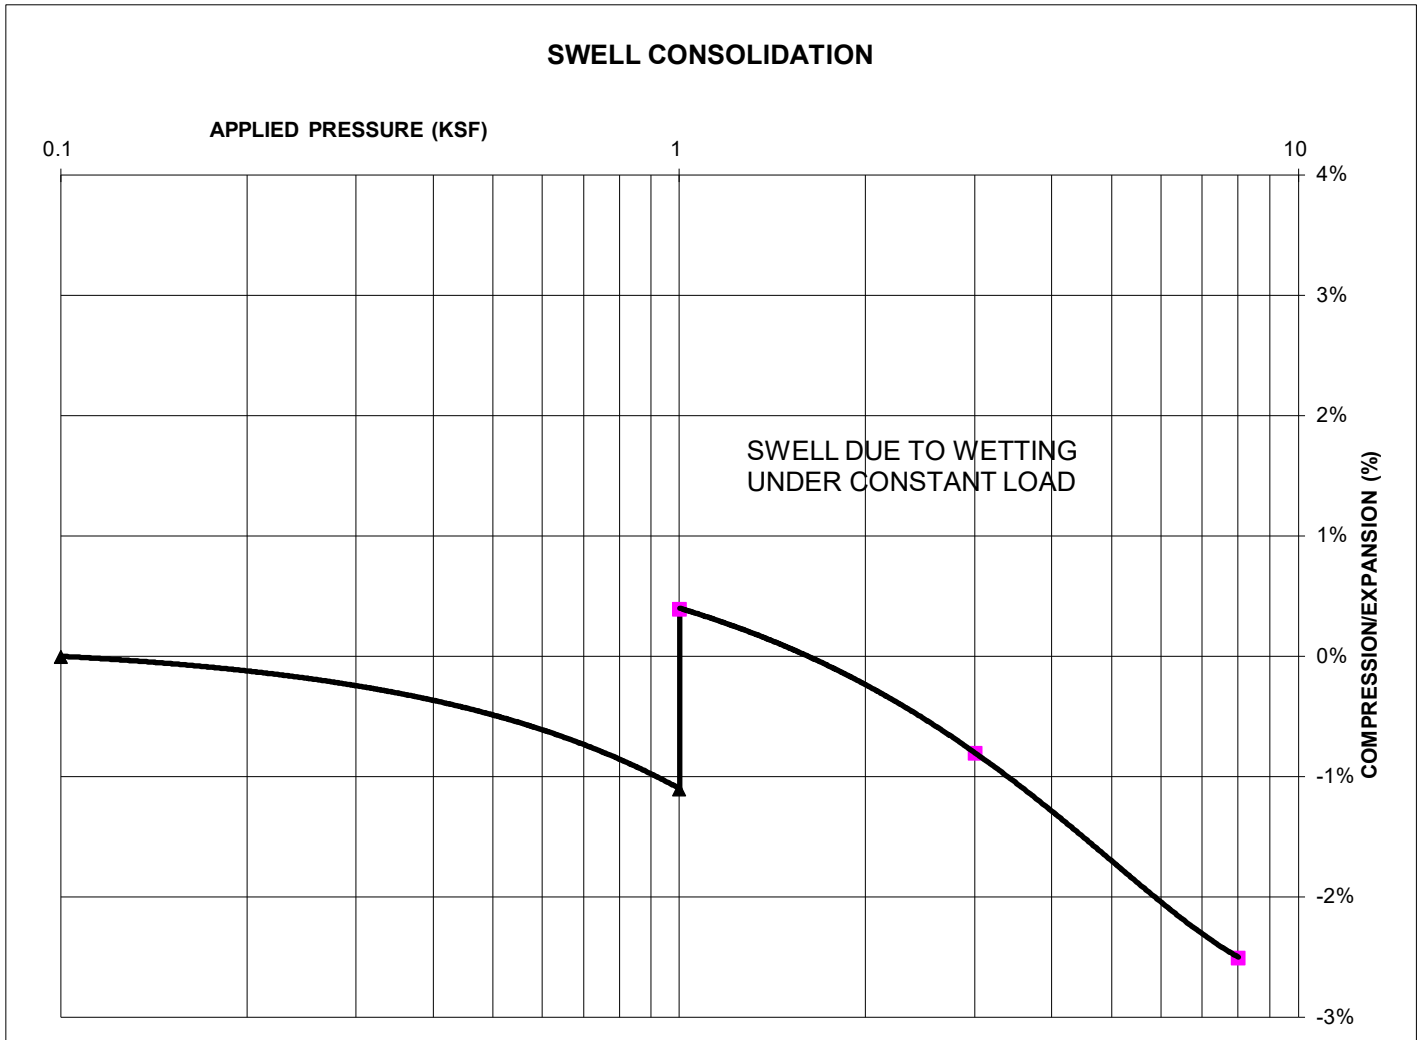
TEST BORING TP-1
DEPTH (FT) 35

SOIL DESCRIPTION CLAYSTONE (CLAY, SANDY)
SOIL TYPE 4

SWELL/CONSOLIDATION TEST RESULTS

NATURAL UNIT DRY WEIGHT (PCF): 113
NATURAL MOISTURE CONTENT: 14.0%
SWELL/CONSOLIDATION (%): 1.5%

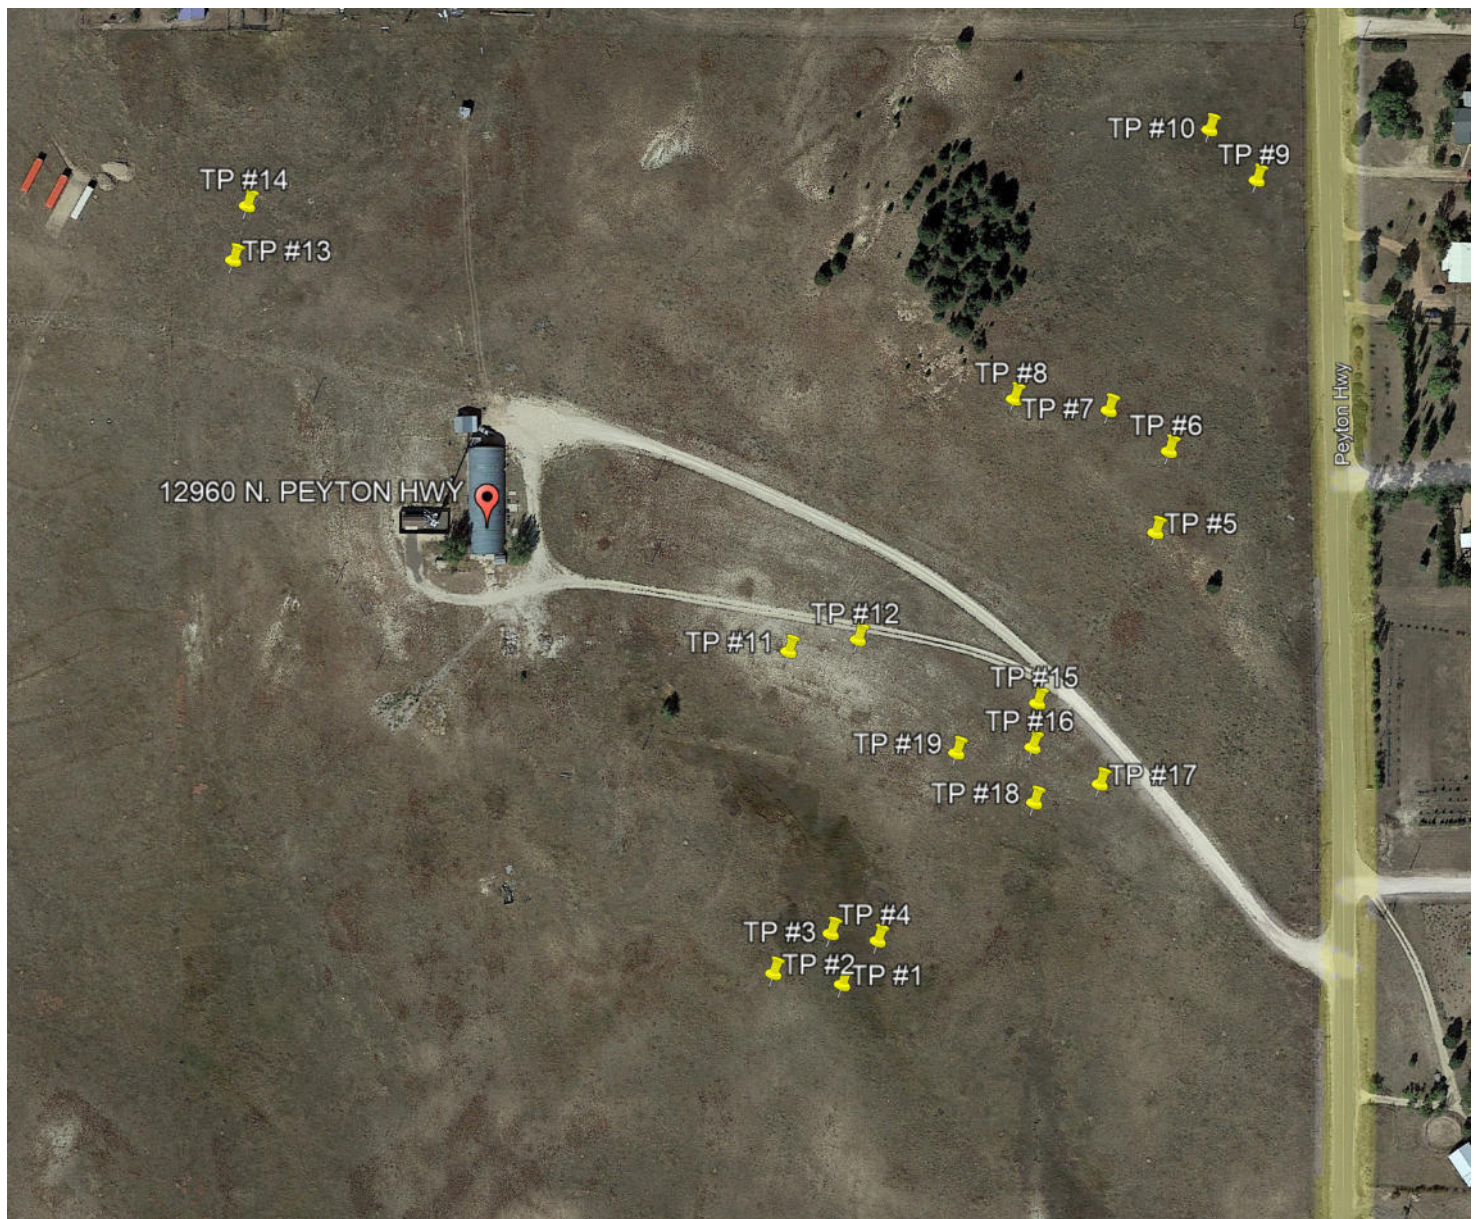
T.P. LOCATION MAP

SCALE: 1" = 210'

The test pits were excavated on April 13, 2023, April 14, 2023, and May 9, 2023 to approximate depths of 2.5 to 8-feet. The locations of the test pits are shown in Figure 1. Soils encountered in Test Pit Nos. 1, 2, 3 and 4 consisted of sandy clay to sandy clay loam with underlying sandy clay bedrock. Soils encountered in Test Pit Nos. 5, 6, 7, and 8 consisted of sandy clay to gravelly sandy clay loam with underlying sandy clay bedrock. Soils encountered in Test Pit Nos. 9 and 10 consisted of sandy clay to sandy clay loam with underlying bedrock. Soils encountered in Test Pit Nos. 11 and 12 consisted of sandy clay loam with gravel with underlying sandy clay. Soils encountered in Test Pit Nos. 13 and 14 consisted of sandy loam with gravel overlying sandy clay bedrock. Soils encountered in Test Pit Nos. 15, 16, 17, 18 and 19 consisted of gravelly sandy clay loam, sandy clay with underlying sandy loam to sandy clay loam bedrock (in Test Pit No. 15), gravelly sandy clay loam with underlying sandy clay, and sandy loam with underlying gravelly sandy clay loam.

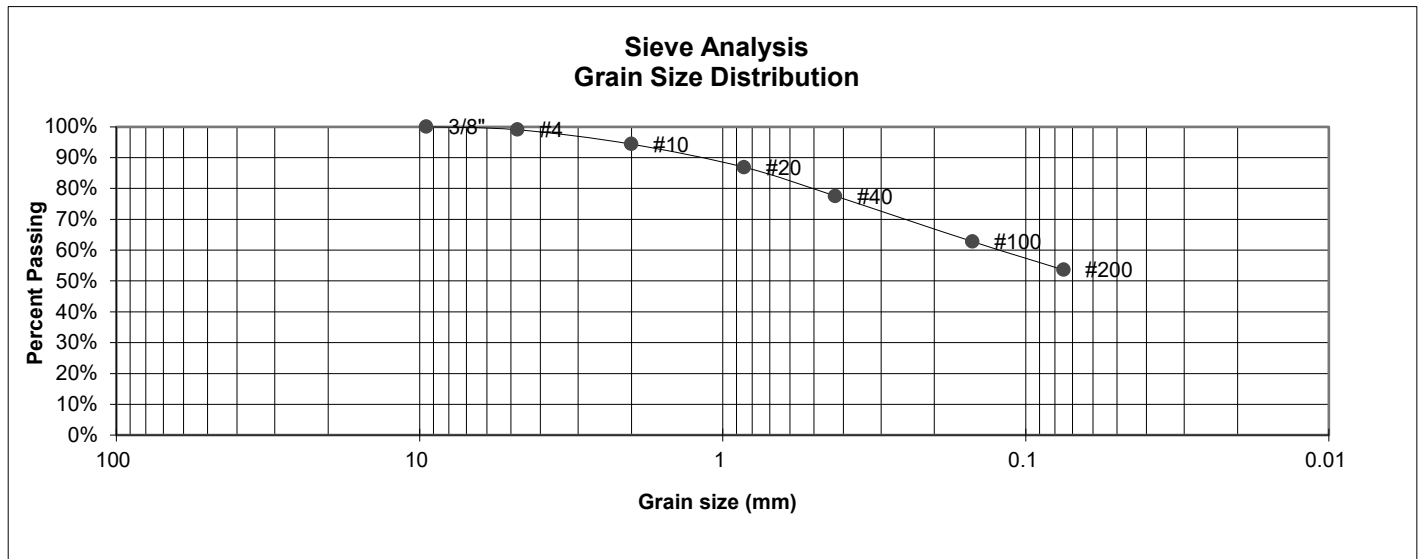
<u>UNIFIED CLASSIFICATION</u>	CL	<u>CLIENT</u>	LAZY Y AND ROCKIN' J
<u>SOIL TYPE #</u>	4A	<u>PROJECT</u>	12960 NORTH PEYTON HIGHWAY
<u>TEST BORING #</u>	TP-1	<u>JOB NO.</u>	230520
<u>DEPTH (FT)</u>	4	<u>TEST BY</u>	BL

<u>U.S. Sieve #</u>	<u>Percent Finer</u>
3"	
1 1/2"	
3/4"	
1/2"	
3/8"	100.0%
4	99.1%
10	94.4%
20	86.8%
40	77.5%
100	62.8%
200	53.6%

The Test Pit Logs and Laboratory Test Results are shown in Figures 2 through 31 and Tables 1 and 2. Refusal due to bedrock was encountered at various depths throughout the site from 2.5 to 8.0 feet below grade (termination of Test Pit). No bedrock was encountered near Test Pit Nos. 11, 12, 16, 17, 18, or 19. Redoximorphic features were encountered at 7.0 to 7.5 feet below grade in Test Pit Nos. 11, 12, and 16, and at 6.0 feet below grade in Test Pit No. 18.

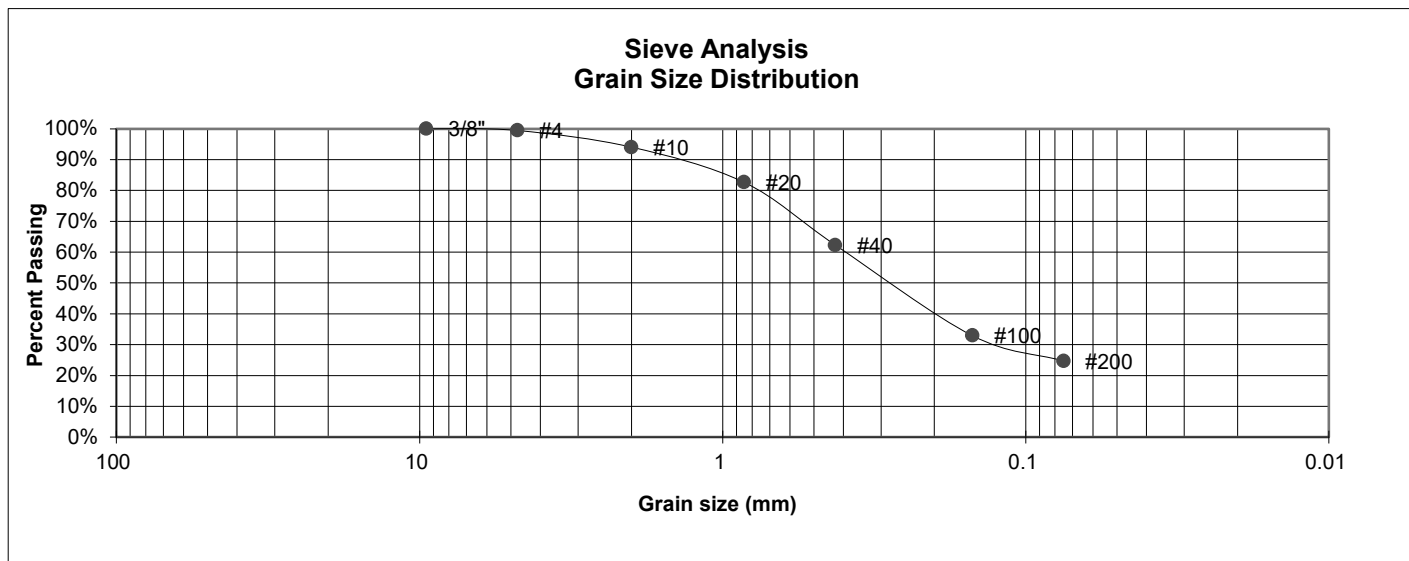
13

UNIFIED CLASSIFICATION	SC	CLIENT	LAZY Y AND ROCKIN' J
SOIL TYPE #	3	PROJECT	12960 NORTH PEYTON HIGHWAY
TEST BORING #	TP-3	JOB NO.	230520
DEPTH (FT)	2	TEST BY	BL

<u>U.S. Sieve #</u>	<u>Percent Finer</u>
3"	
1 1/2"	
3/4"	
1/2"	
3/8"	100.0%
4	99.4%
10	94.0%
20	82.6%
40	62.3%
100	32.9%
200	24.7%

Seventeen test pits were excavated across the site to identify suitable soil treatment areas for the RV Park OWTS. The OWTS Site Evaluation completed by Entech dated May 25, 2023 is included in Appendix D. The location of the test pits, Figures 1 – 1A, Test Pit Logs, Figures 2 – 11, and Grain-Size Analysis results, Figures 12 – 31 are included in Appendix D.

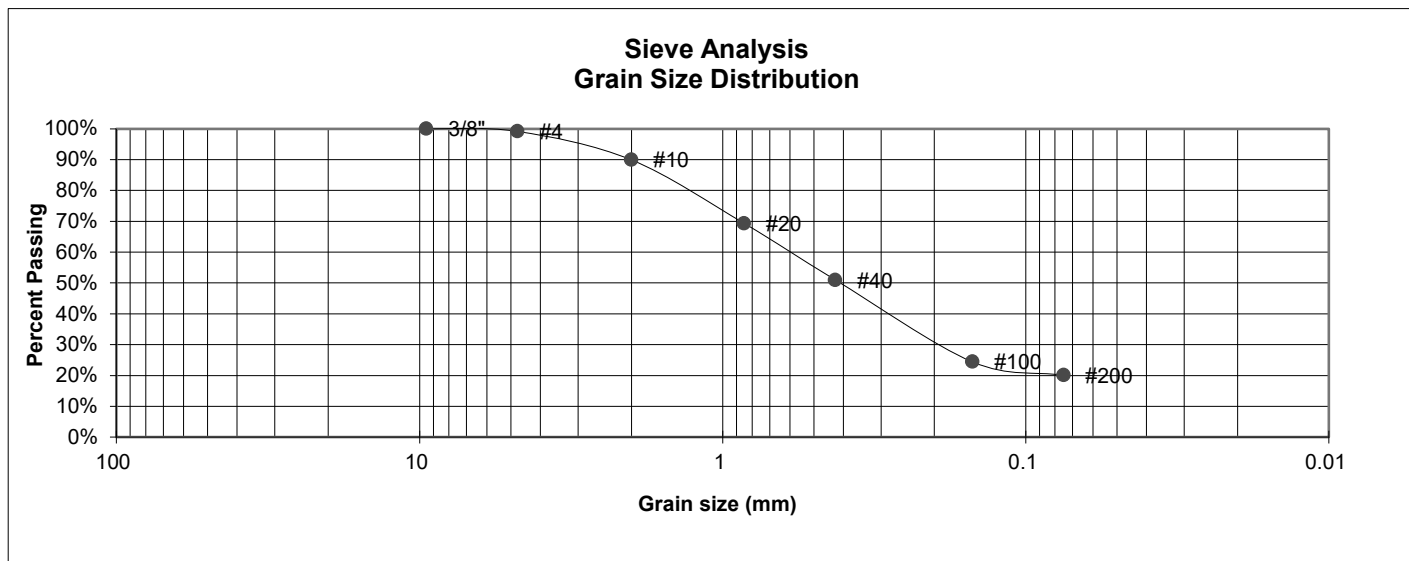
JOB NO.
230520
FIG NO.
15

<u>UNIFIED CLASSIFICATION</u>	SC	<u>CLIENT</u>	LAZY Y AND ROCKIN' J
<u>SOIL TYPE #</u>	3	<u>PROJECT</u>	12960 NORTH PEYTON HIGHWAY
<u>TEST BORING #</u>	TP-5	<u>JOB NO.</u>	230520
<u>DEPTH (FT)</u>	3	<u>TEST BY</u>	BL

<u>U.S. Sieve #</u>	<u>Percent Finer</u>
3"	
1 1/2"	
3/4"	
1/2"	
3/8"	100.0%
4	99.2%
10	89.9%
20	69.3%
40	50.9%
100	24.4%
200	20.1%

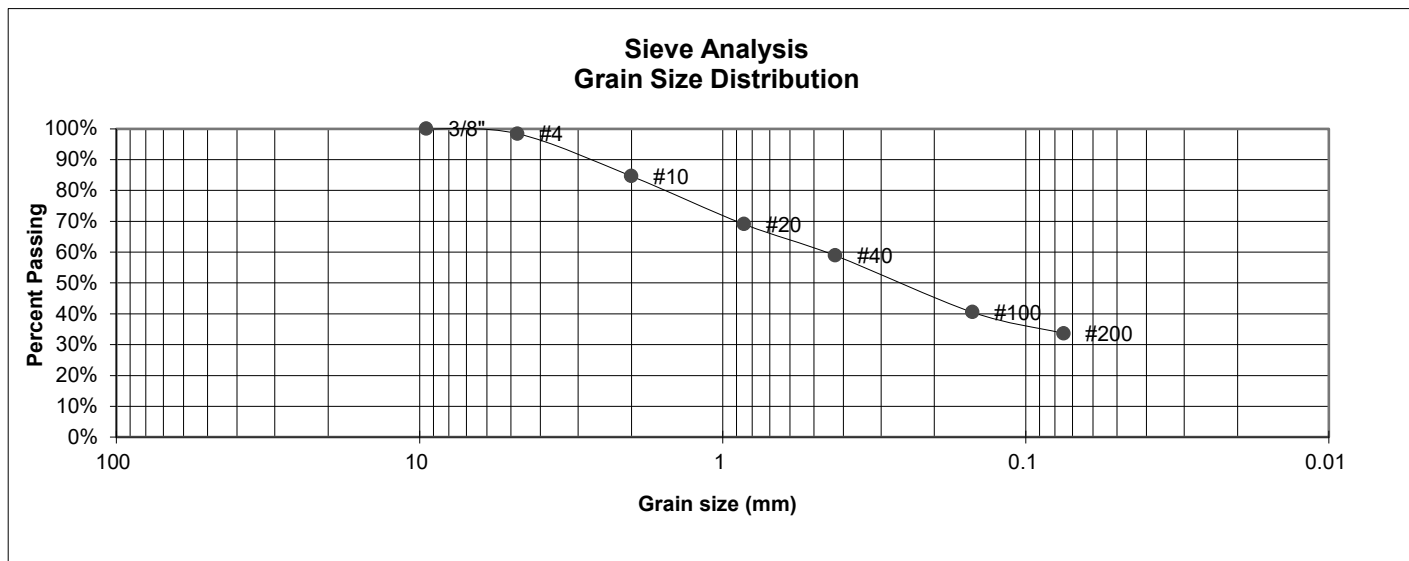
JOB NO.
230520
FIG NO.
16

<u>UNIFIED CLASSIFICATION</u>	SC	<u>CLIENT</u>	LAZY Y AND ROCKIN' J
<u>SOIL TYPE #</u>	4A	<u>PROJECT</u>	12960 NORTH PEYTON HIGHWAY
<u>TEST BORING #</u>	TP-6	<u>JOB NO.</u>	230520
<u>DEPTH (FT)</u>	3.5	<u>TEST BY</u>	BL

<u>U.S. Sieve #</u>	<u>Percent Finer</u>
3"	
1 1/2"	
3/4"	
1/2"	
3/8"	100.0%
4	98.4%
10	84.6%
20	69.0%
40	58.9%
100	40.5%
200	33.6%
