ENTECH
ENGINEERING, INC.

December 11, 2023
Revised September 6, 2024

Re: Soils and Geology Study
Lazy Y and Rockin' J Subdivision
12960 North Peyton Highway
Parcel No. 63070-00-007
El Paso County, Colorado
Entech Job No. 230520

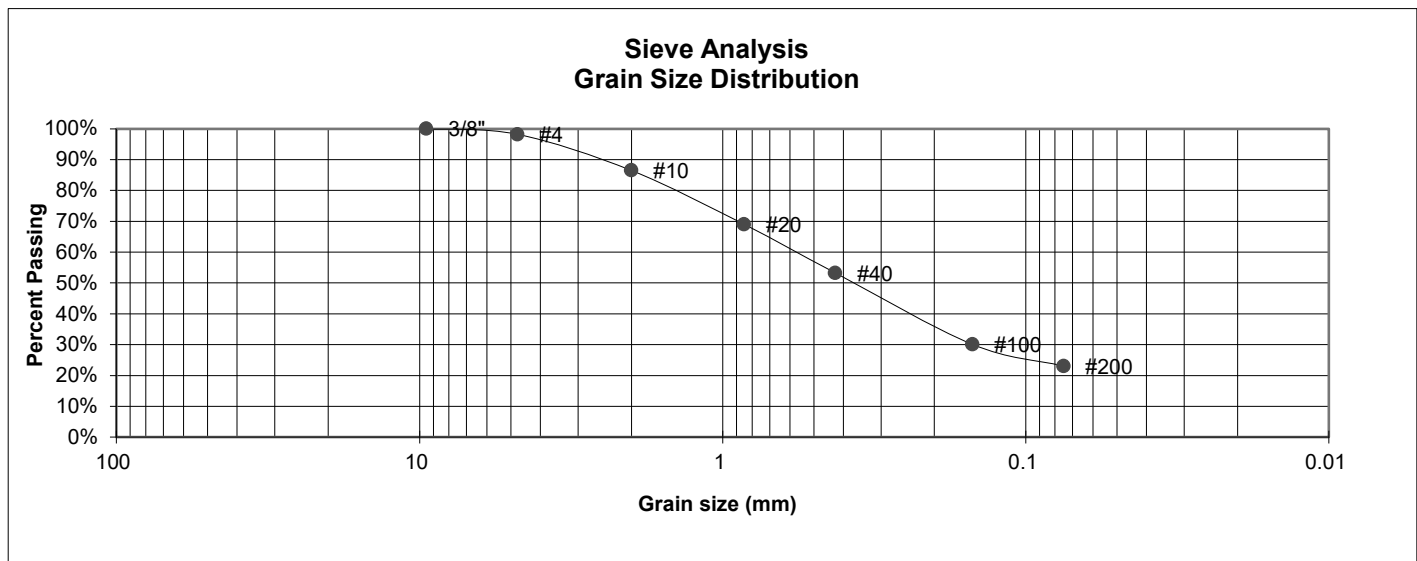
JOB NO.
230520
FIG NO.
17

<u>UNIFIED CLASSIFICATION</u>	SC	<u>CLIENT</u>	LAZY Y AND ROCKIN' J
<u>SOIL TYPE #</u>	4A	<u>PROJECT</u>	12960 NORTH PEYTON HIGHWAY
<u>TEST BORING #</u>	TP-7	<u>JOB NO.</u>	230520
<u>DEPTH (FT)</u>	2.5	<u>TEST BY</u>	BL

<u>U.S. Sieve #</u>	<u>Percent Finer</u>
3"	
1 1/2"	
3/4"	
1/2"	
3/8"	100.0%
4	98.2%
10	86.5%
20	69.0%
40	53.2%
100	30.1%
200	23.1%

Seventeen test pits were excavated across the site to identify suitable soil treatment areas for the RV Park OWTS. The OWTS Site Evaluation completed by Entech dated May 25, 2023 is included in Appendix D. The location of the test pits, Figures 1 – 1A, Test Pit Logs, Figures 2 – 11, and Grain-Size Analysis results, Figures 12 – 31 are included in Appendix D.

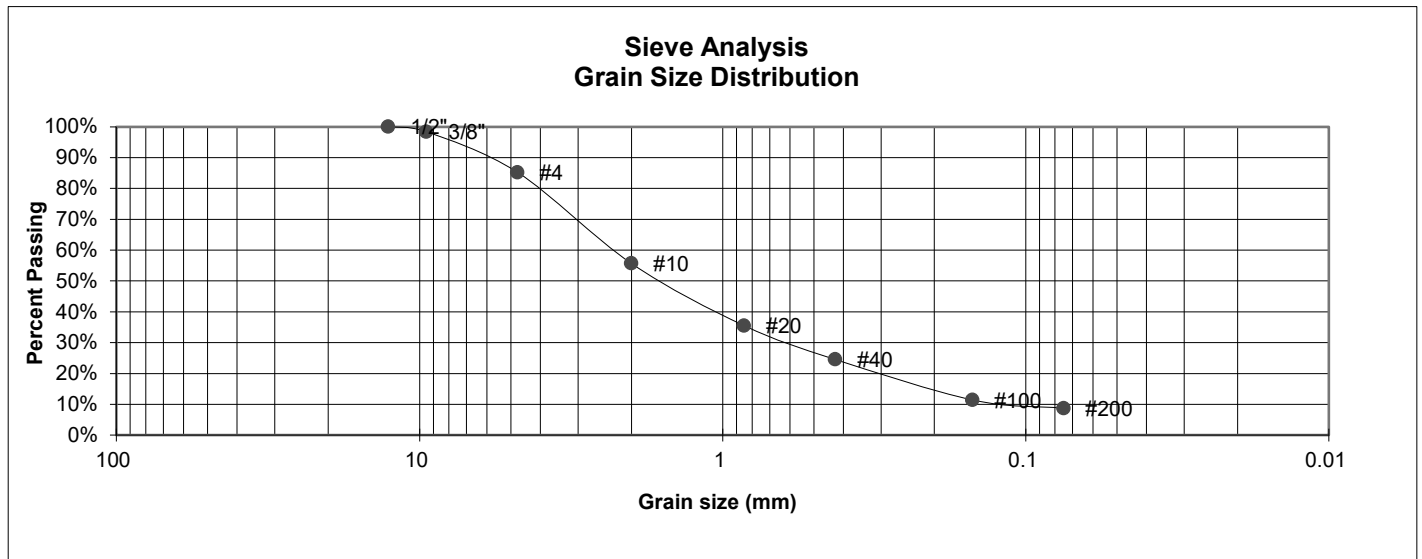
JOB NO.
230520
FIG NO.
18

<u>UNIFIED CLASSIFICATION</u>	SM-SW	<u>CLIENT</u>	LAZY Y AND ROCKIN' J
<u>SOIL TYPE #</u>	3A/R1	<u>PROJECT</u>	12960 NORTH PEYTON HIGHWAY
<u>TEST BORING #</u>	TP-8	<u>JOB NO.</u>	230520
<u>DEPTH (FT)</u>	1.5	<u>TEST BY</u>	BL

<u>U.S. Sieve #</u>	<u>Percent Finer</u>
3"	
1 1/2"	
3/4"	
1/2"	100.0%
3/8"	98.4%
4	85.2%
10	55.7%
20	35.5%
40	24.6%
100	11.4%
200	8.7%

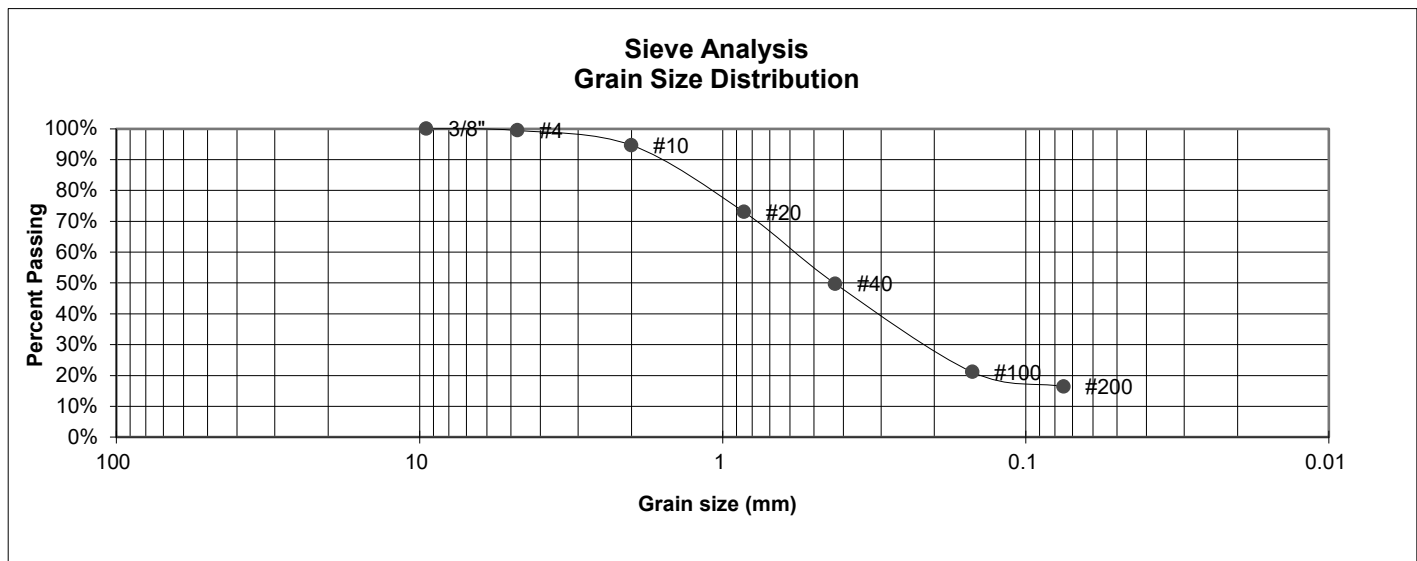
JOB NO.
230520
FIG NO.
19

<u>UNIFIED CLASSIFICATION</u>	SC	<u>CLIENT</u>	LAZY Y AND ROCKIN' J
<u>SOIL TYPE #</u>	3A	<u>PROJECT</u>	12960 NORTH PEYTON HIGHWAY
<u>TEST BORING #</u>	TP-9	<u>JOB NO.</u>	230520
<u>DEPTH (FT)</u>	2	<u>TEST BY</u>	BL

<u>U.S. Sieve #</u>	<u>Percent Finer</u>
3"	
1 1/2"	
3/4"	
1/2"	
3/8"	100.0%
4	99.5%
10	94.6%
20	73.0%
40	49.7%
100	21.1%
200	16.4%

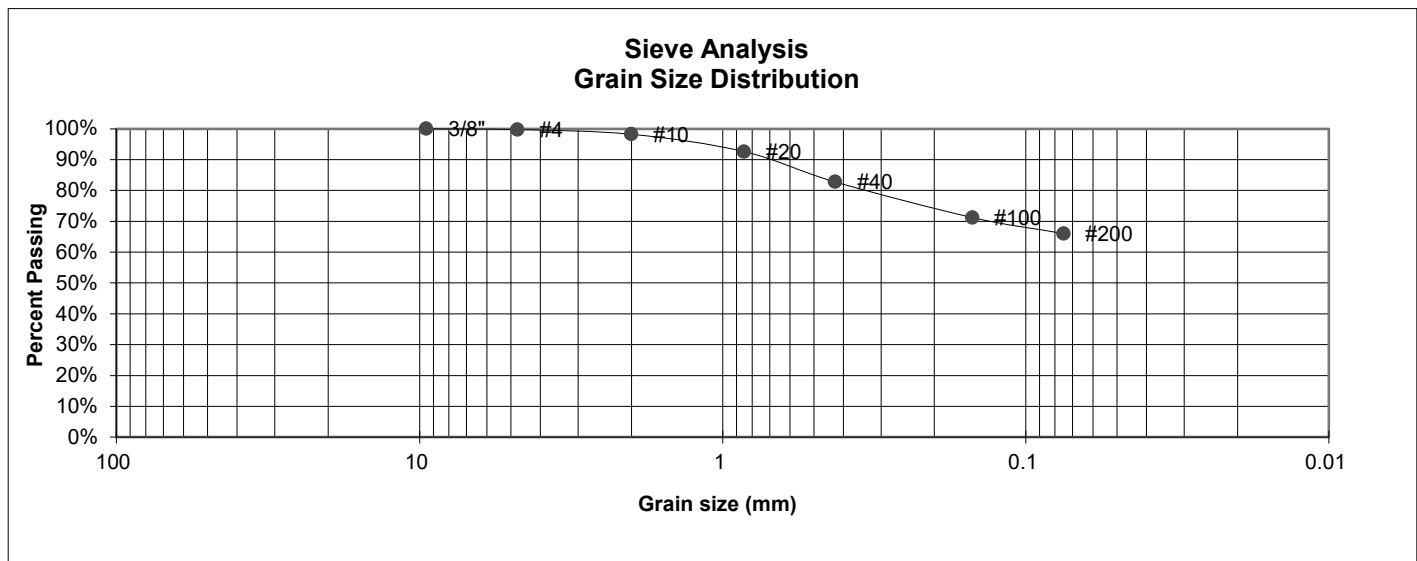
JOB NO.
230520
FIG NO.
20

<u>UNIFIED CLASSIFICATION</u>	CL	<u>CLIENT</u>	LAZY Y AND ROCKIN' J
<u>SOIL TYPE #</u>	4A	<u>PROJECT</u>	12960 NORTH PEYTON HIGHWAY
<u>TEST BORING #</u>	TP-10	<u>JOB NO.</u>	230520
<u>DEPTH (FT)</u>	2	<u>TEST BY</u>	BL

<u>U.S. Sieve #</u>	<u>Percent Finer</u>
3"	
1 1/2"	
3/4"	
1/2"	
3/8"	100.0%
4	99.7%
10	98.2%
20	92.6%
40	82.8%
100	71.2%
200	66.0%

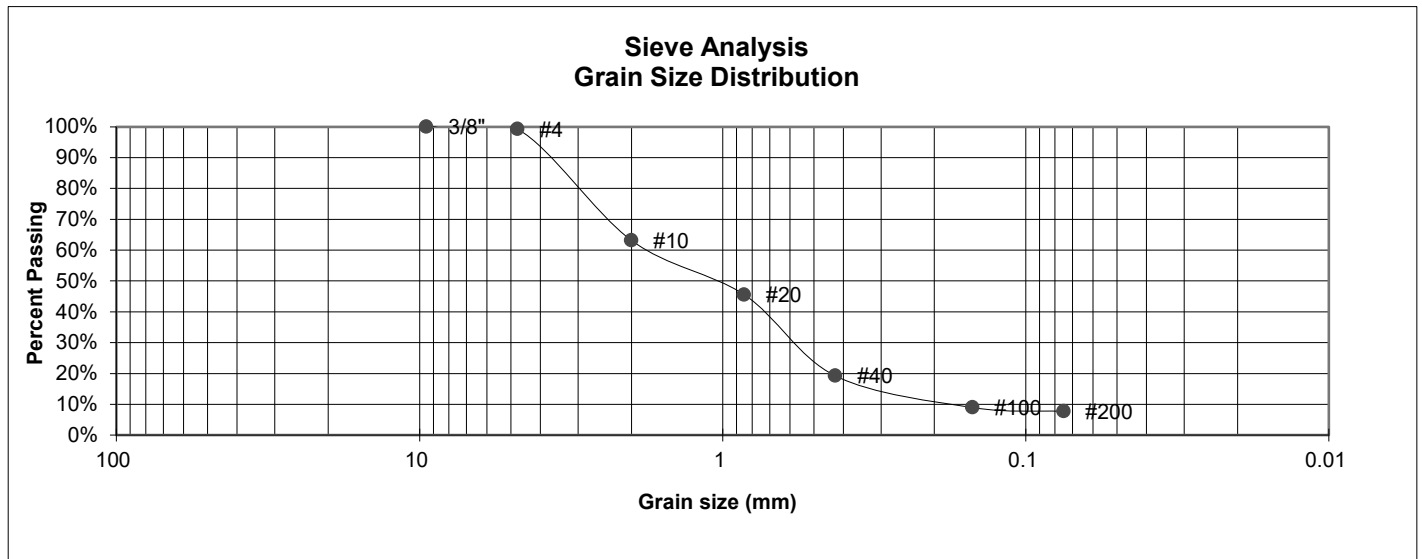
JOB NO.
230520
FIG NO.
21

UNIFIED CLASSIFICATION	SM-SW	CLIENT	LAZY Y AND ROCKIN' J
SOIL TYPE #	3/R1	PROJECT	12960 NORTH PEYTON HIGHWAY
TEST BORING #	TP-11	JOB NO.	230520
DEPTH (FT)	4	TEST BY	BL

U.S. Sieve #	Percent Finer
3"	
1 1/2"	
3/4"	
1/2"	
3/8"	100.0%
4	99.3%
10	63.2%
20	45.6%
40	19.2%
100	9.0%
200	7.7%

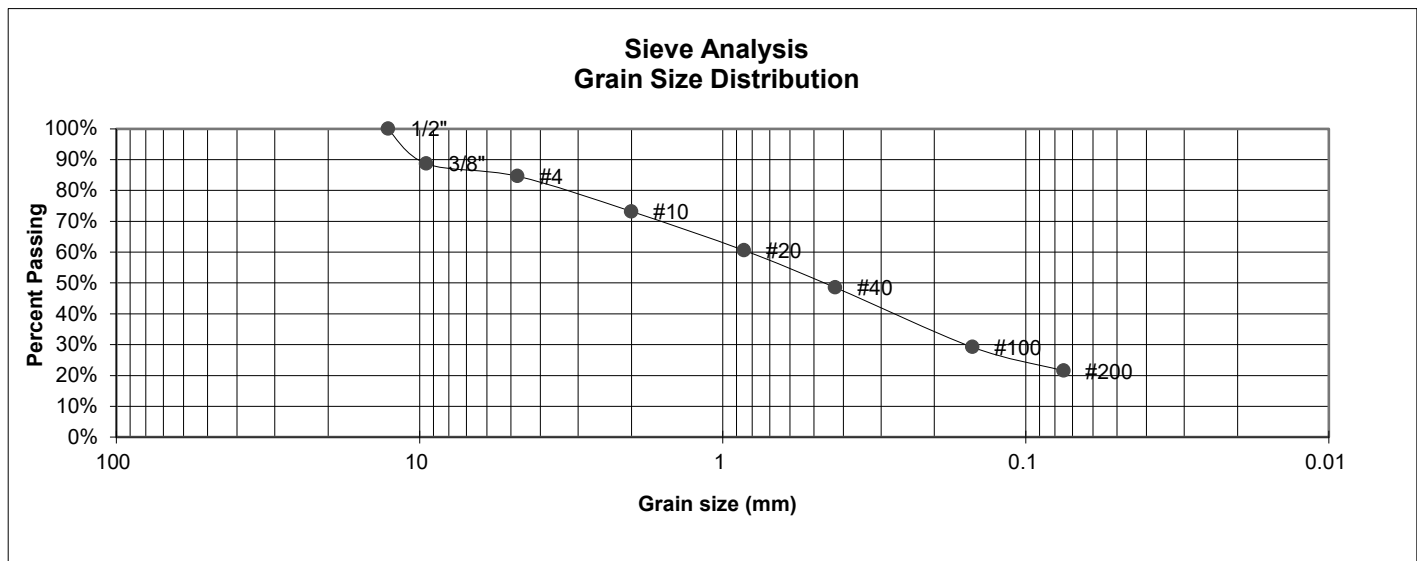
JOB NO.
230520
FIG NO.
22

<u>UNIFIED CLASSIFICATION</u>	SC	<u>CLIENT</u>	LAZY Y AND ROCKIN' J
<u>SOIL TYPE #</u>	4A	<u>PROJECT</u>	12960 NORTH PEYTON HIGHWAY
<u>TEST BORING #</u>	TP-12	<u>JOB NO.</u>	230520
<u>DEPTH (FT)</u>	7.5	<u>TEST BY</u>	BL

<u>U.S. Sieve #</u>	<u>Percent Finer</u>
3"	
1 1/2"	
3/4"	
1/2"	100.0%
3/8"	88.7%
4	84.6%
10	73.2%
20	60.6%
40	48.5%
100	29.2%
200	21.5%

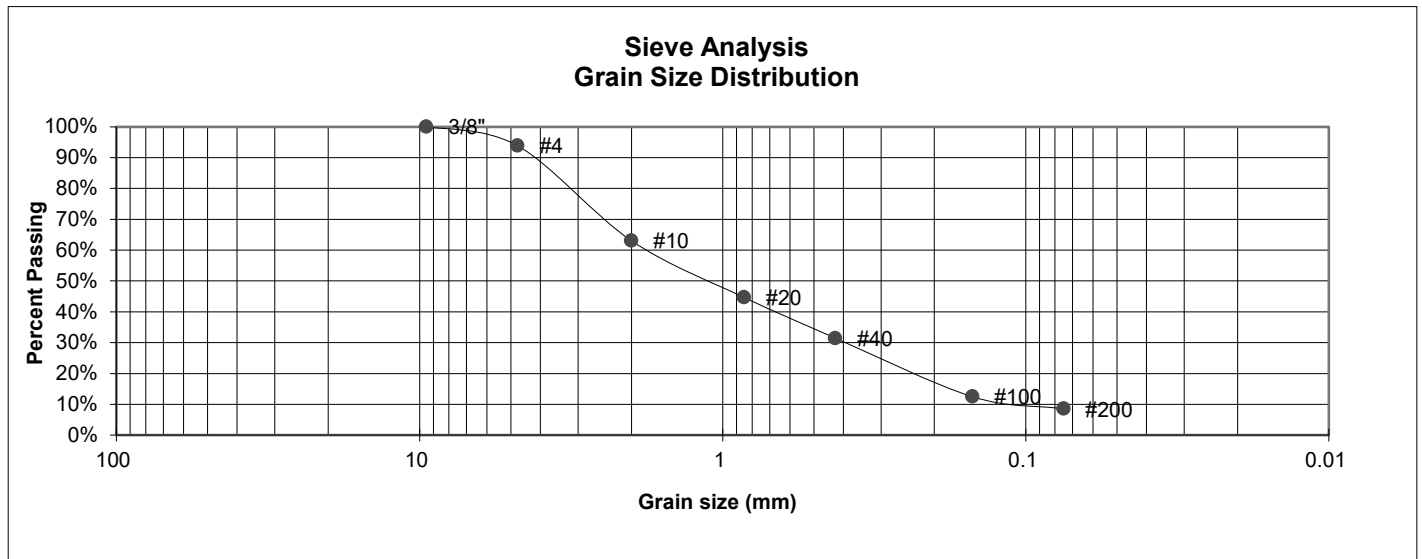
JOB NO.
230520
FIG NO.
23

<u>UNIFIED CLASSIFICATION</u>	SM-SW	<u>CLIENT</u>	LAZY Y AND ROCKIN' J
<u>SOIL TYPE #</u>	2/R1	<u>PROJECT</u>	12960 NORTH PEYTON HIGHWAY
<u>TEST BORING #</u>	TP-13	<u>JOB NO.</u>	230520
<u>DEPTH (FT)</u>	3	<u>TEST BY</u>	BL

<u>U.S. Sieve #</u>	<u>Percent Finer</u>
3"	
1 1/2"	
3/4"	
1/2"	
3/8"	100.0%
4	93.9%
10	63.0%
20	44.7%
40	31.5%
100	12.5%
200	8.5%

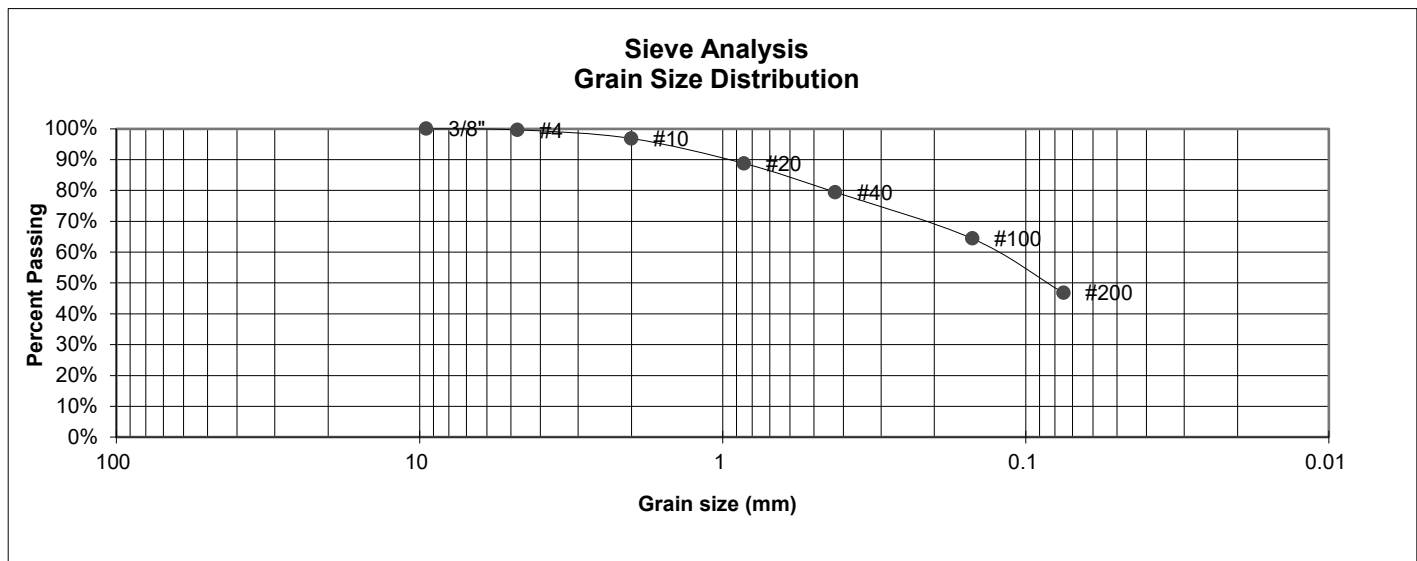
JOB NO.
230520
FIG NO.
24

<u>UNIFIED CLASSIFICATION</u>	SC	<u>CLIENT</u>	LAZY Y AND ROCKIN' J
<u>SOIL TYPE #</u>	4A	<u>PROJECT</u>	12960 NORTH PEYTON HIGHWAY
<u>TEST BORING #</u>	TP-14	<u>JOB NO.</u>	230520
<u>DEPTH (FT)</u>	5	<u>TEST BY</u>	BL

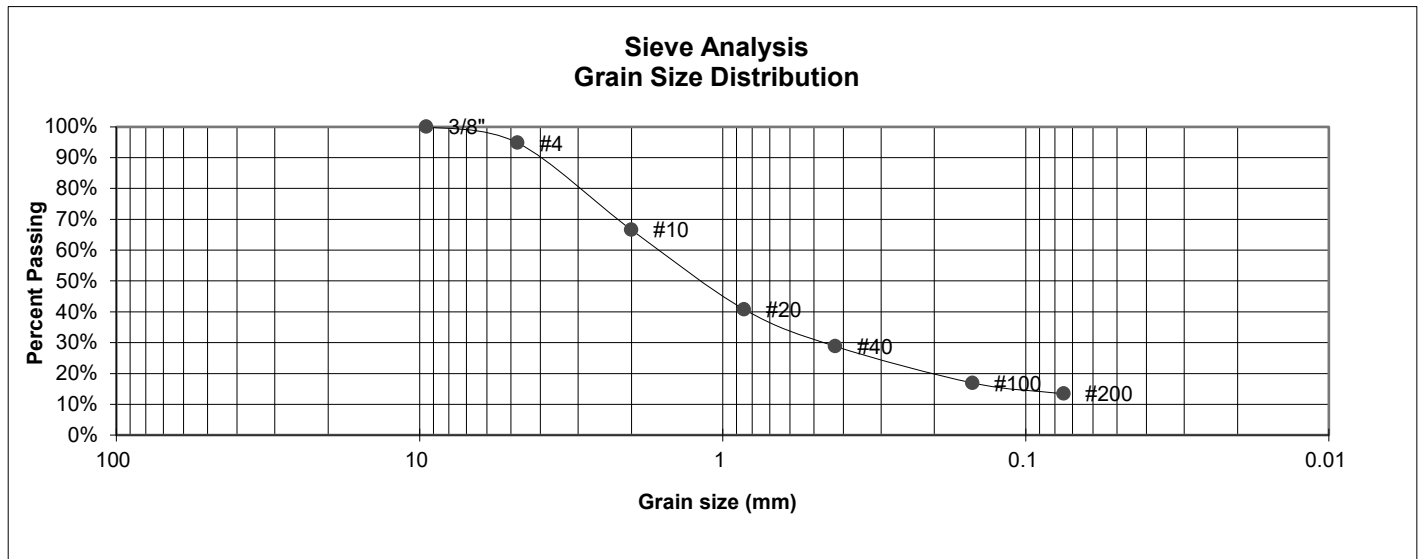
25

<u>UNIFIED CLASSIFICATION</u>	SC	<u>CLIENT</u>	LAZY Y AND ROCKIN' J
<u>SOIL TYPE #</u>	3A/R1	<u>PROJECT</u>	12960 NORTH PEYTON HIGHWAY
<u>TEST BORING #</u>	15	<u>JOB NO.</u>	230520
<u>DEPTH (FT)</u>	3.5	<u>TEST BY</u>	BL

<u>U.S. Sieve #</u>	<u>Percent Finer</u>
3"	
1 1/2"	
3/4"	
1/2"	
3/8"	100.0%
4	94.8%
10	66.6%
20	40.8%
40	28.8%
100	16.9%
200	13.4%

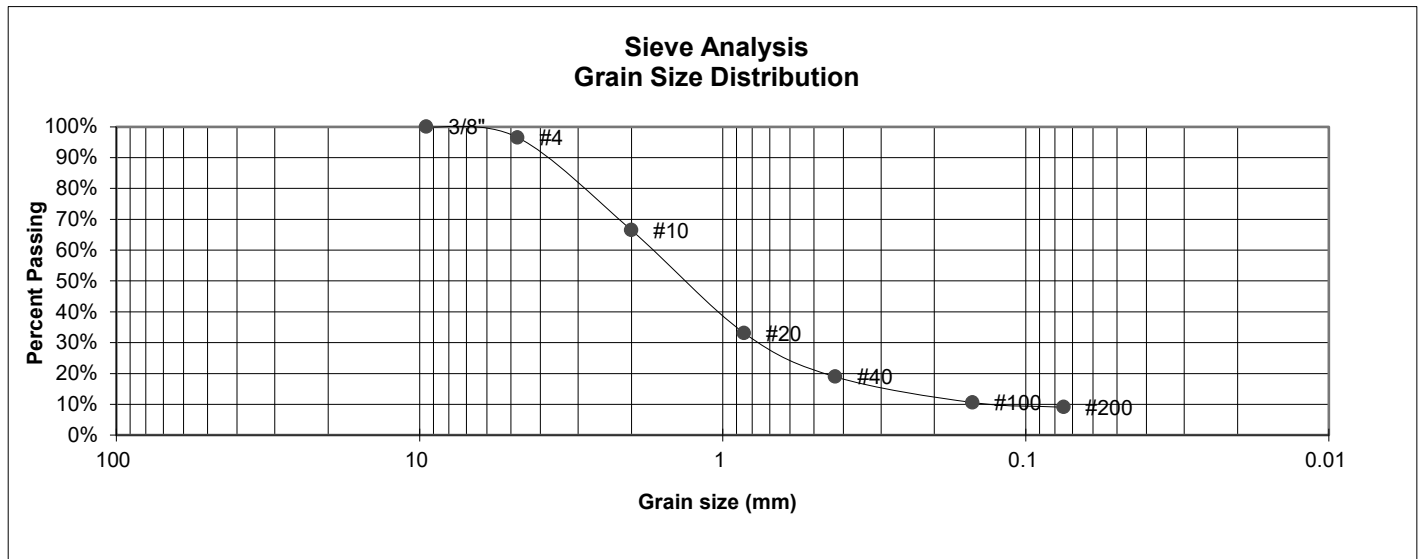
JOB NO.
230520
FIG NO.
26

<u>UNIFIED CLASSIFICATION</u>	SC-SW	<u>CLIENT</u>	LAZY Y AND ROCKIN' J
<u>SOIL TYPE #</u>	3A/R1	<u>PROJECT</u>	12960 NORTH PEYTON HIGHWAY
<u>TEST BORING #</u>	16	<u>JOB NO.</u>	230520
<u>DEPTH (FT)</u>	3	<u>TEST BY</u>	BL

<u>U.S. Sieve #</u>	<u>Percent Finer</u>
3"	
1 1/2"	
3/4"	
1/2"	
3/8"	100.0%
4	96.5%
10	66.5%
20	33.1%
40	18.9%
100	10.6%
200	9.1%

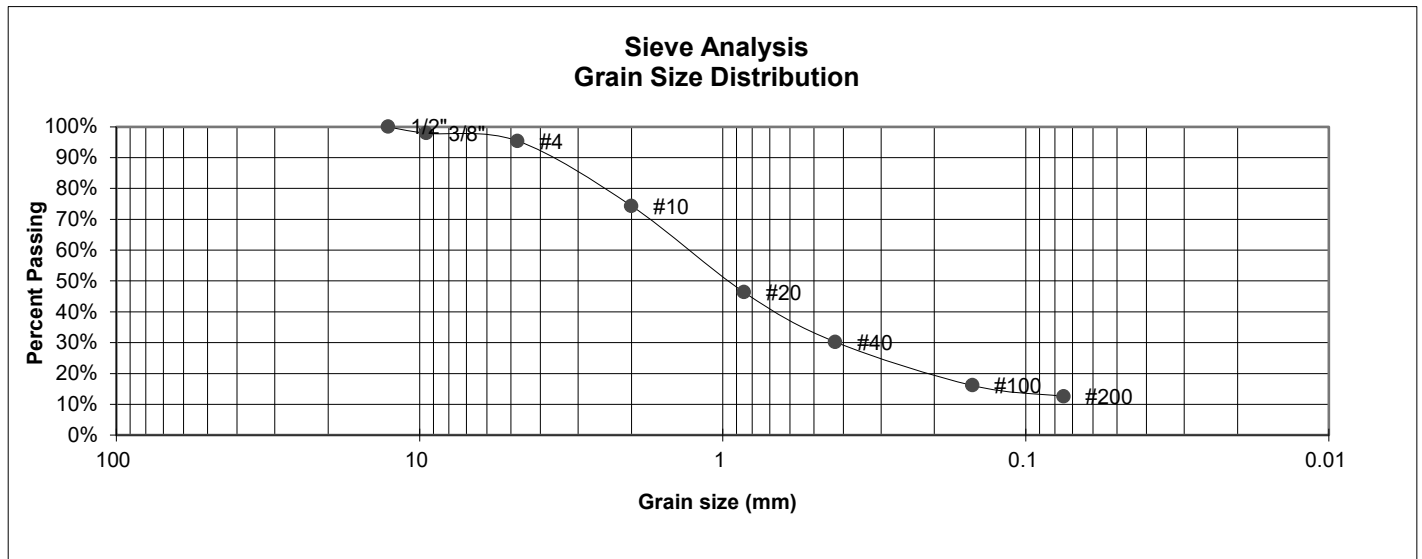
JOB NO.
230520
FIG NO.
27

<u>UNIFIED CLASSIFICATION</u>	SC	<u>CLIENT</u>	LAZY Y AND ROCKIN' J
<u>SOIL TYPE #</u>	3	<u>PROJECT</u>	12960 NORTH PEYTON HIGHWAY
<u>TEST BORING #</u>	16	<u>JOB NO.</u>	230520
<u>DEPTH (FT)</u>	6.5	<u>TEST BY</u>	BL

<u>U.S. Sieve #</u>	<u>Percent Finer</u>
3"	
1 1/2"	
3/4"	
1/2"	100.0%
3/8"	97.9%
4	95.4%
10	74.3%
20	46.3%
40	30.2%
100	16.1%
200	12.6%

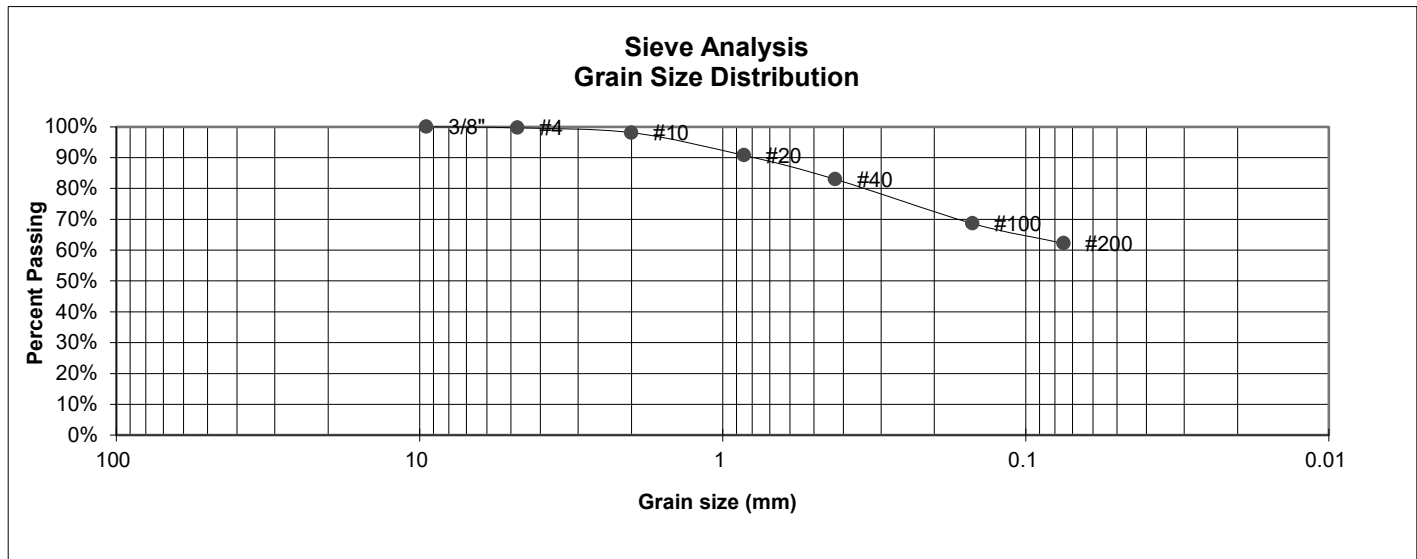
JOB NO.
230520
FIG NO.
28

<u>UNIFIED CLASSIFICATION</u>	CL	<u>CLIENT</u>	LAZY Y AND ROCKIN' J
<u>SOIL TYPE #</u>	4A	<u>PROJECT</u>	12960 NORTH PEYTON HIGHWAY
<u>TEST BORING #</u>	17	<u>JOB NO.</u>	230520
<u>DEPTH (FT)</u>	3	<u>TEST BY</u>	BL

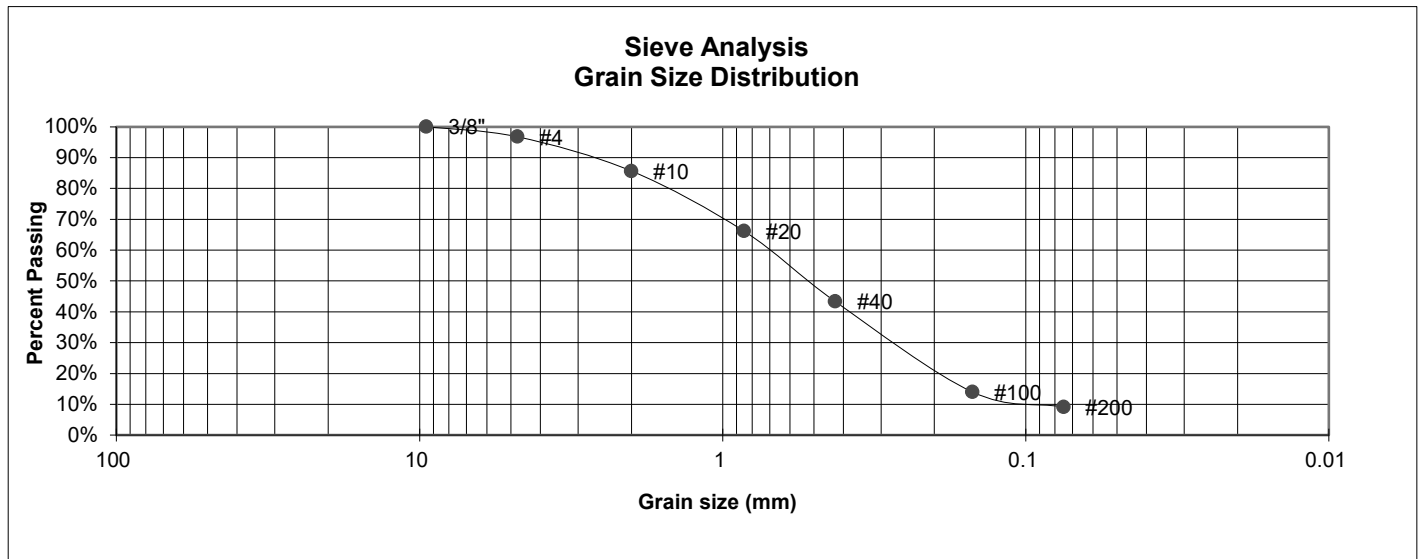
29

UNIFIED CLASSIFICATION	SC-SW	CLIENT	LAZY Y AND ROCKIN' J
SOIL TYPE #	3/R1	PROJECT	12960 NORTH PEYTON HIGHWAY
TEST BORING #	18	JOB NO.	230520
DEPTH (FT)	4	TEST BY	BL

U.S. Sieve #	Percent Finer
3"	
1 1/2"	
3/4"	
1/2"	
3/8"	100.0%
4	96.7%
10	85.6%
20	66.2%
40	43.3%
100	14.0%
200	9.2%

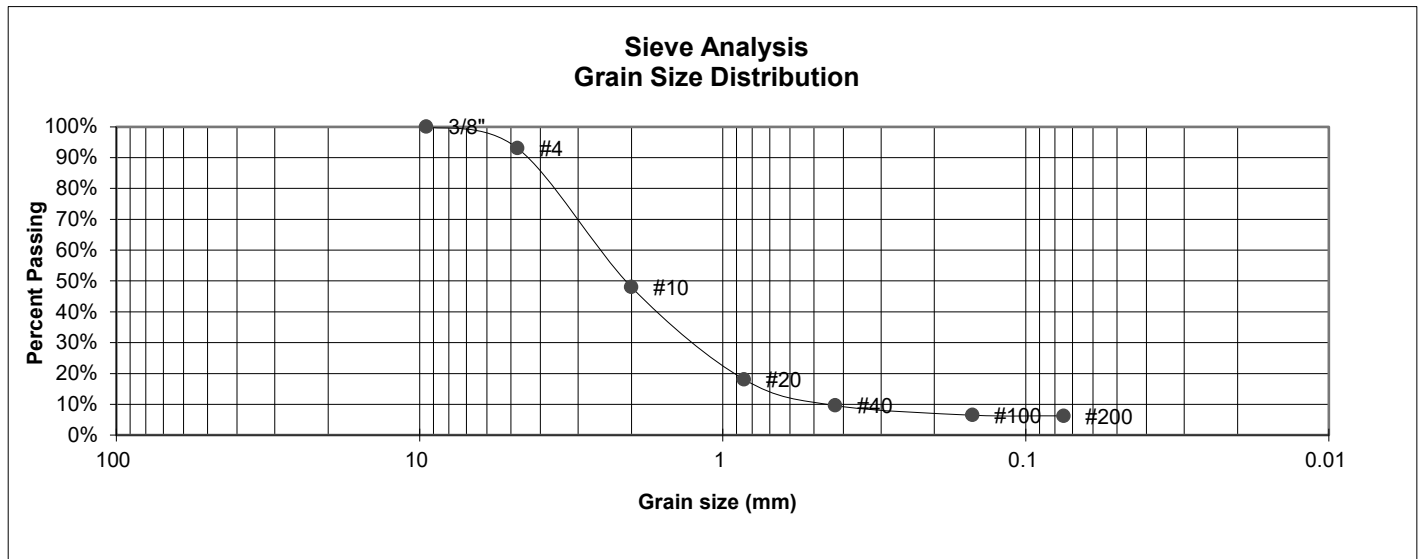
JOB NO.
230520
FIG NO.
30

<u>UNIFIED CLASSIFICATION</u>	SC-SW	<u>CLIENT</u>	LAZY Y AND ROCKIN' J
<u>SOIL TYPE #</u>	3/R1	<u>PROJECT</u>	12960 NORTH PEYTON HIGHWAY
<u>TEST BORING #</u>	19	<u>JOB NO.</u>	230520
<u>DEPTH (FT)</u>	4	<u>TEST BY</u>	BL

<u>U.S. Sieve #</u>	<u>Percent Finer</u>
3"	
1 1/2"	
3/4"	
1/2"	
3/8"	100.0%
4	93.0%
10	48.0%
20	18.0%
40	9.6%
100	6.5%
200	6.2%
