Job No. 197925

November 1, 2024

Re: Addendum to Soils and Geology Study
Falcon Highlands South, Filing No. 1, Phase 1
El Paso County, Colorado

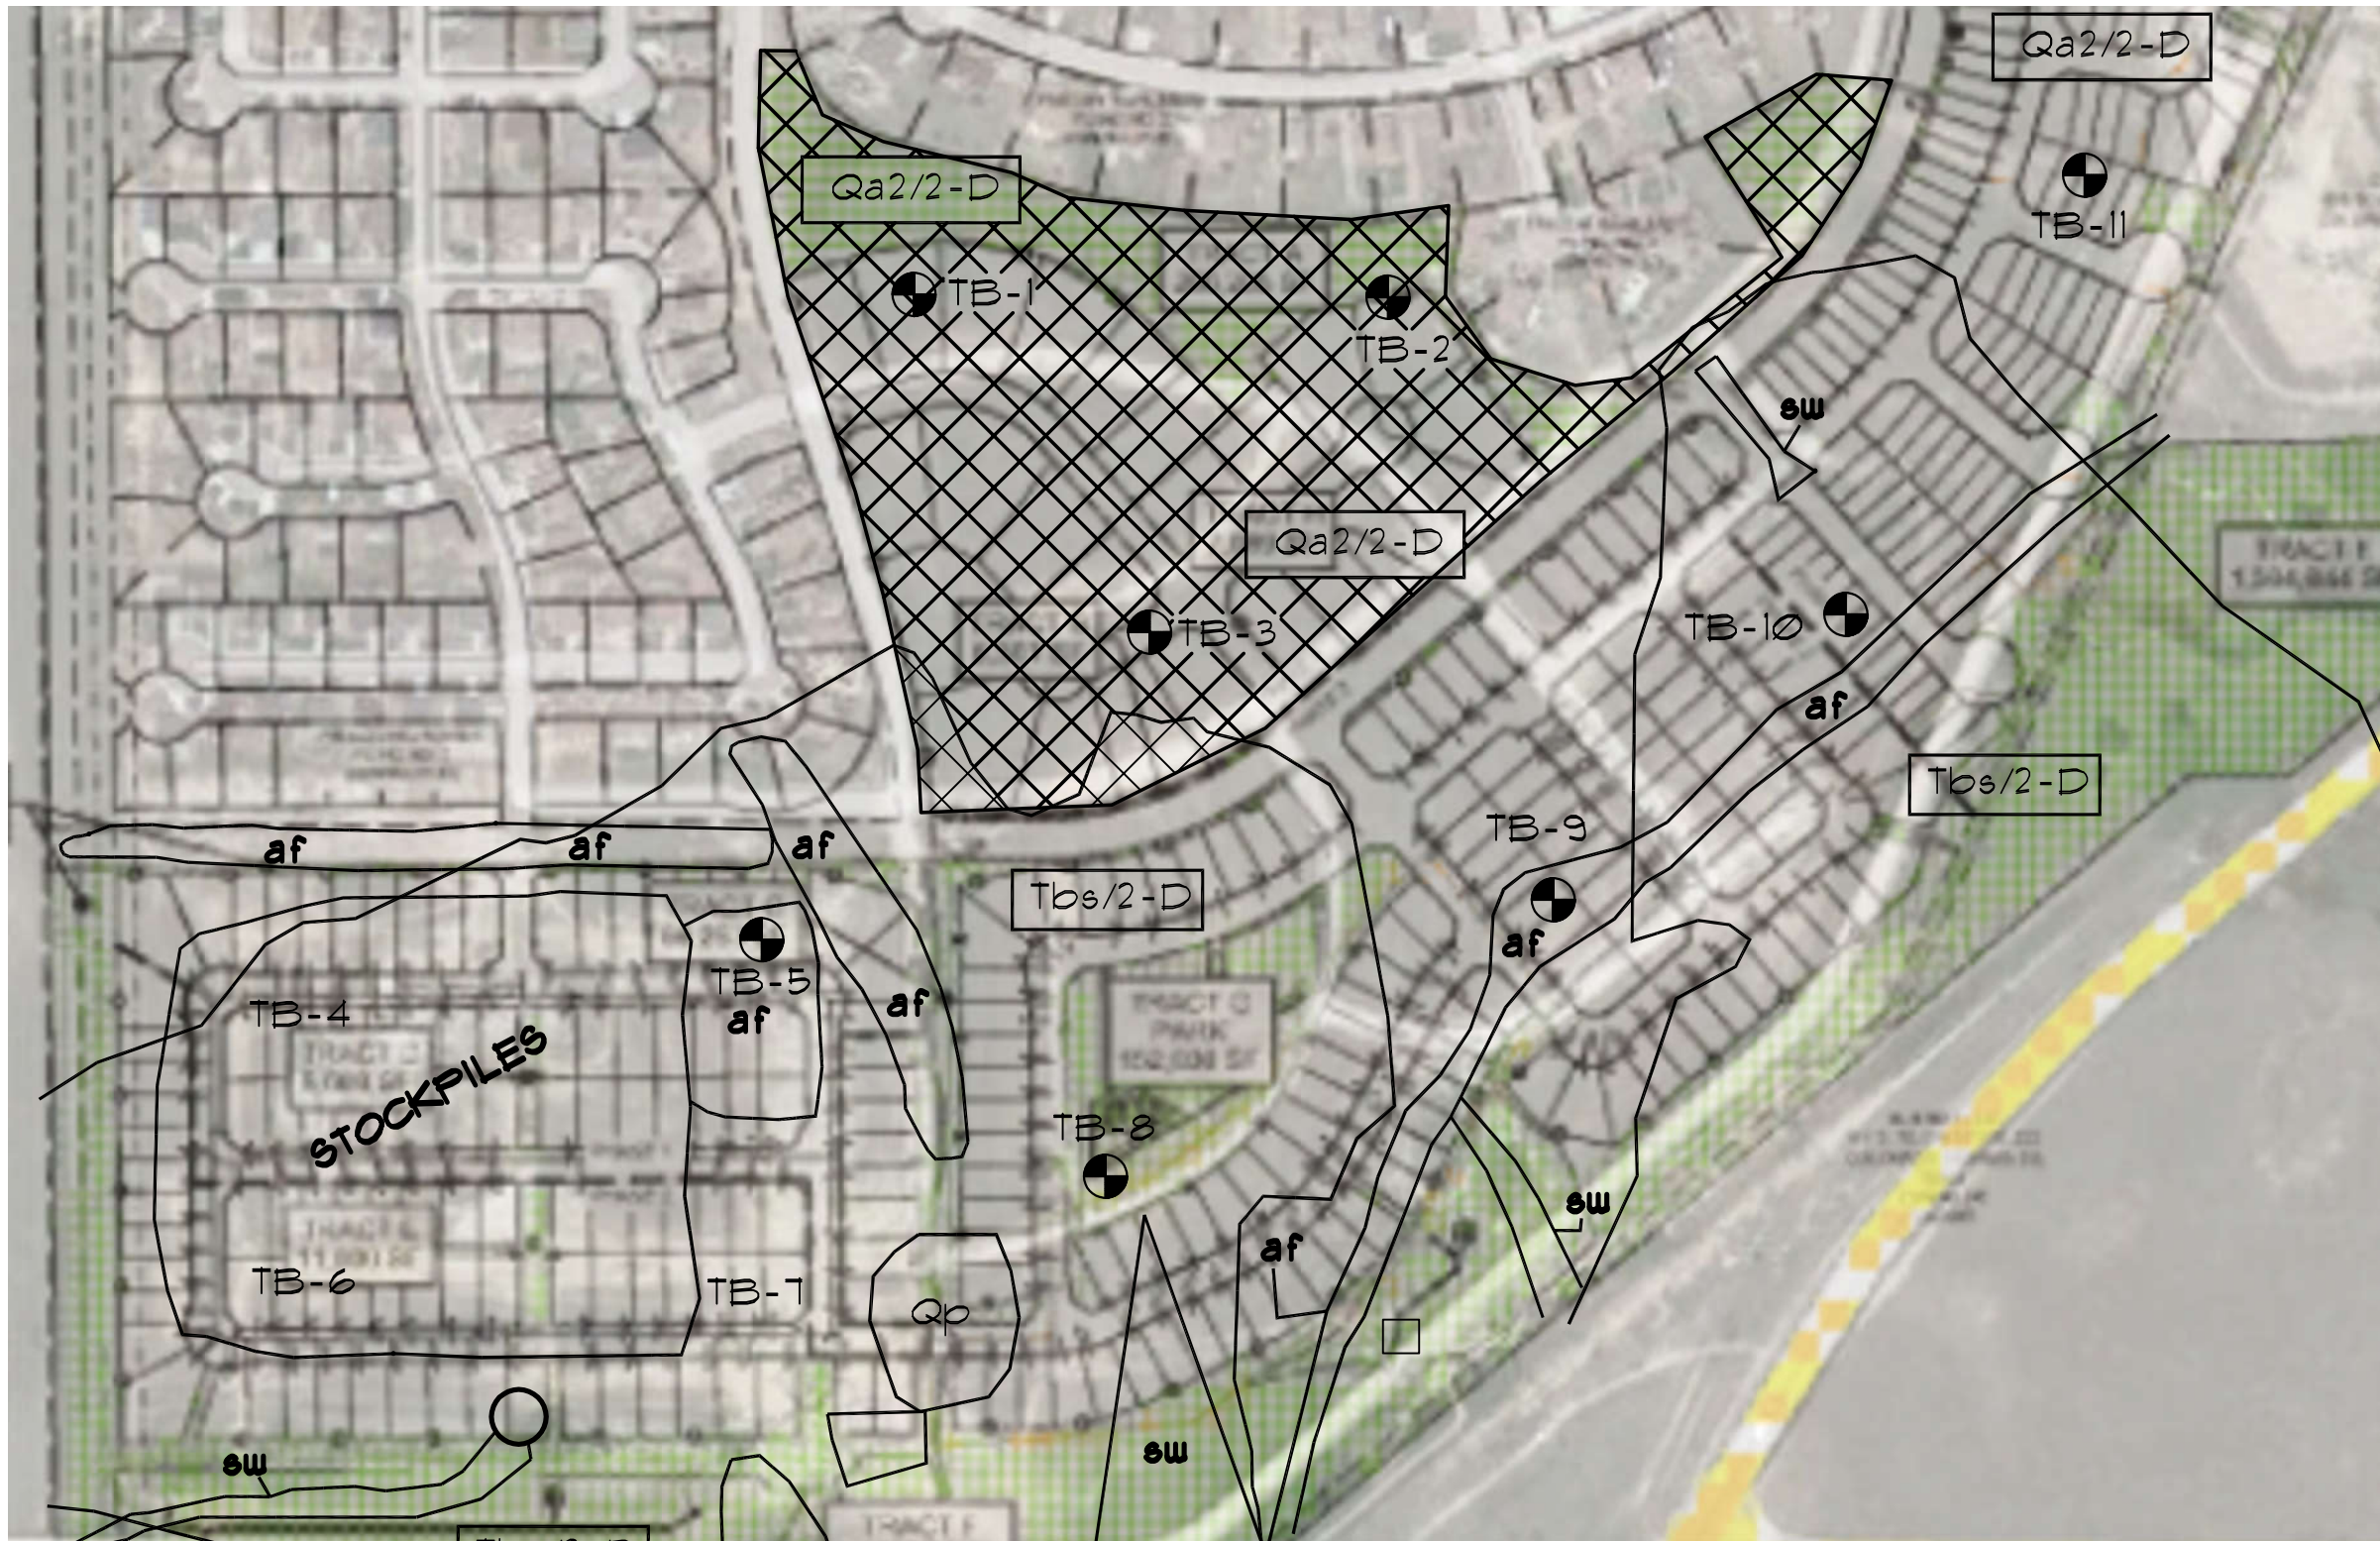
⊕ DENOTES APPROXIMATE LOCATION OF TEST BORINGS AS PERFORMED FOR OUR ORIGINAL SOILS AND GEOLOGY STUDY, JOB NO. 184041, LAST DATED SEPTEMBER 7, 2022

DENOTES AREA INCLUDED IN THIS STUDY

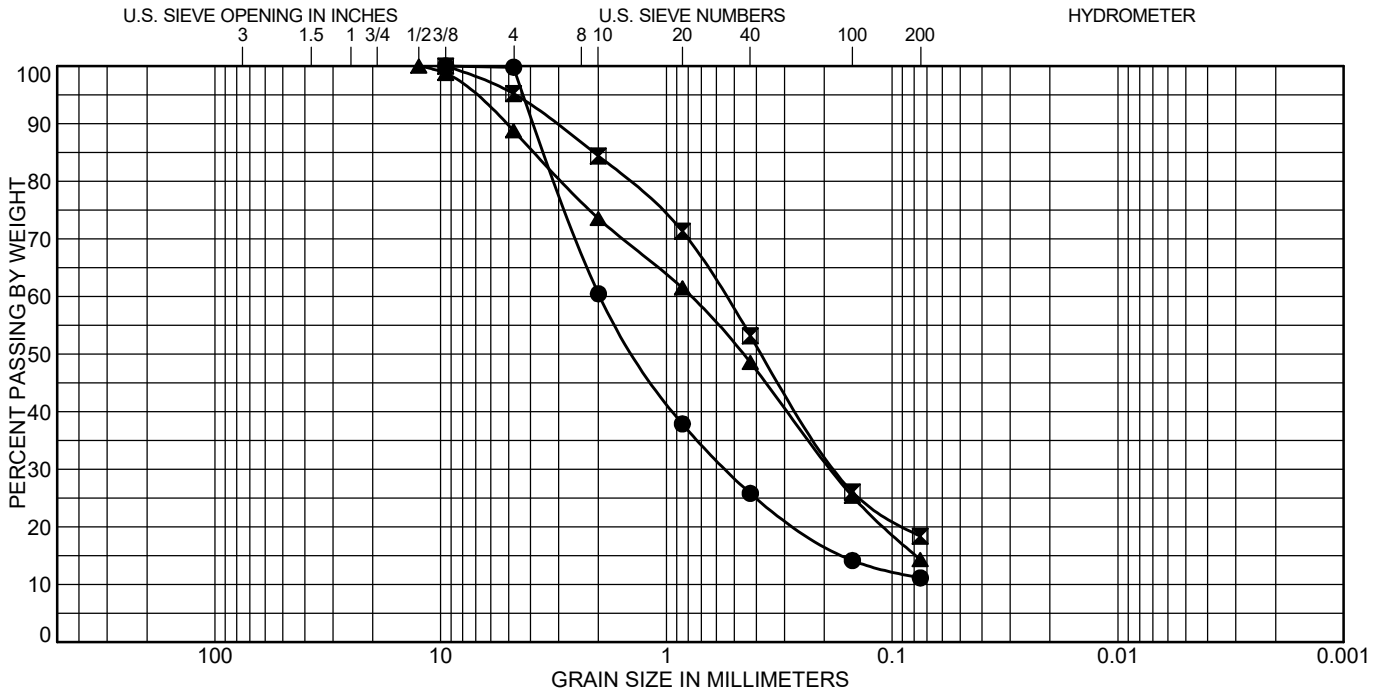
COBBLES	GRAVEL		SAND			SILT OR CLAY
	coarse	fine	coarse	medium	fine

Test Boring	Depth (ft)	Classification	LL	PL	PI
● 1	9.0	WELL-GRADED SAND with SILT(SW-SM)	NP	NP	NP
☒ 2	4.0	SILTY SAND(SM)	NP	NP	NP
▲ 3	9.0	CLAYEY SAND(SC)	30	19	11
