## SOILS AND GEOLOGY STUDY

**Phases 1-4, Falcon Highlands  
El Paso County, Colorado**

**JOB NO. 184041**

**October 8, 2021  
Amended September 7, 2022**

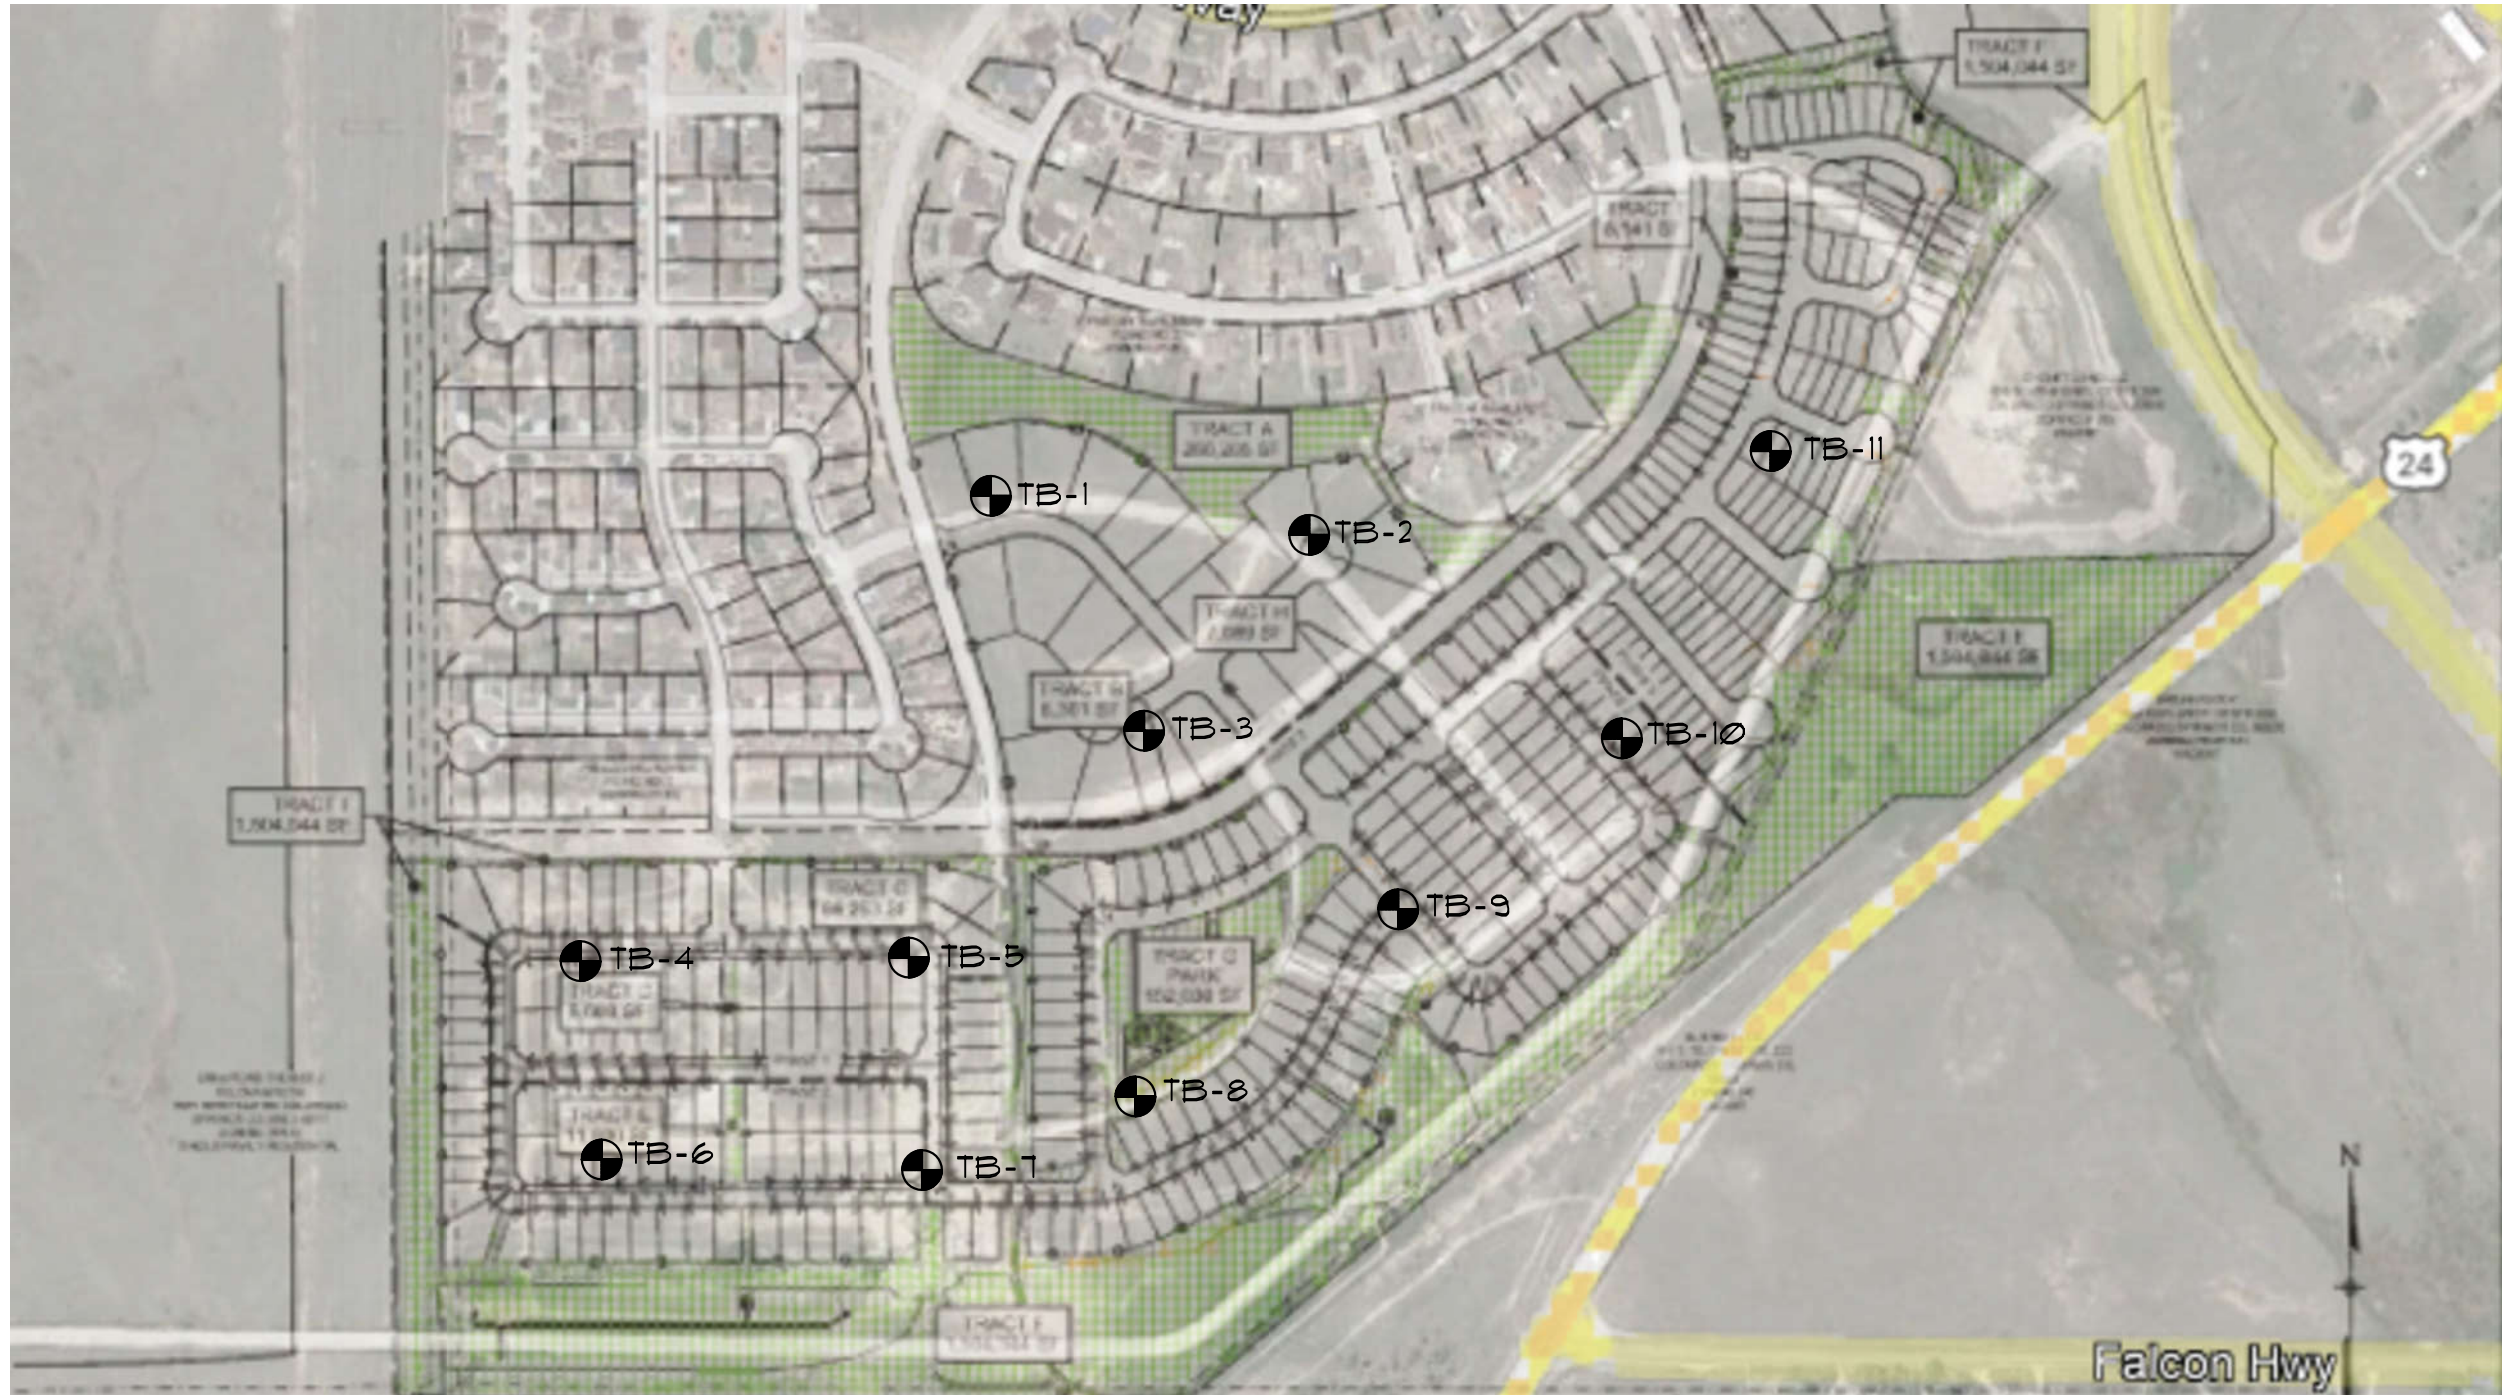
DENOTES APPROXIMATE  
 LOCATION OF TEST BORINGS

PHASE 1-4, FALCON HIGHLANDS  
 ANTELOPE MEADOWS CIRCLE  
 EL PASO COUNTY, COLORADO  
 CHALLENGER COLORADO, LLC

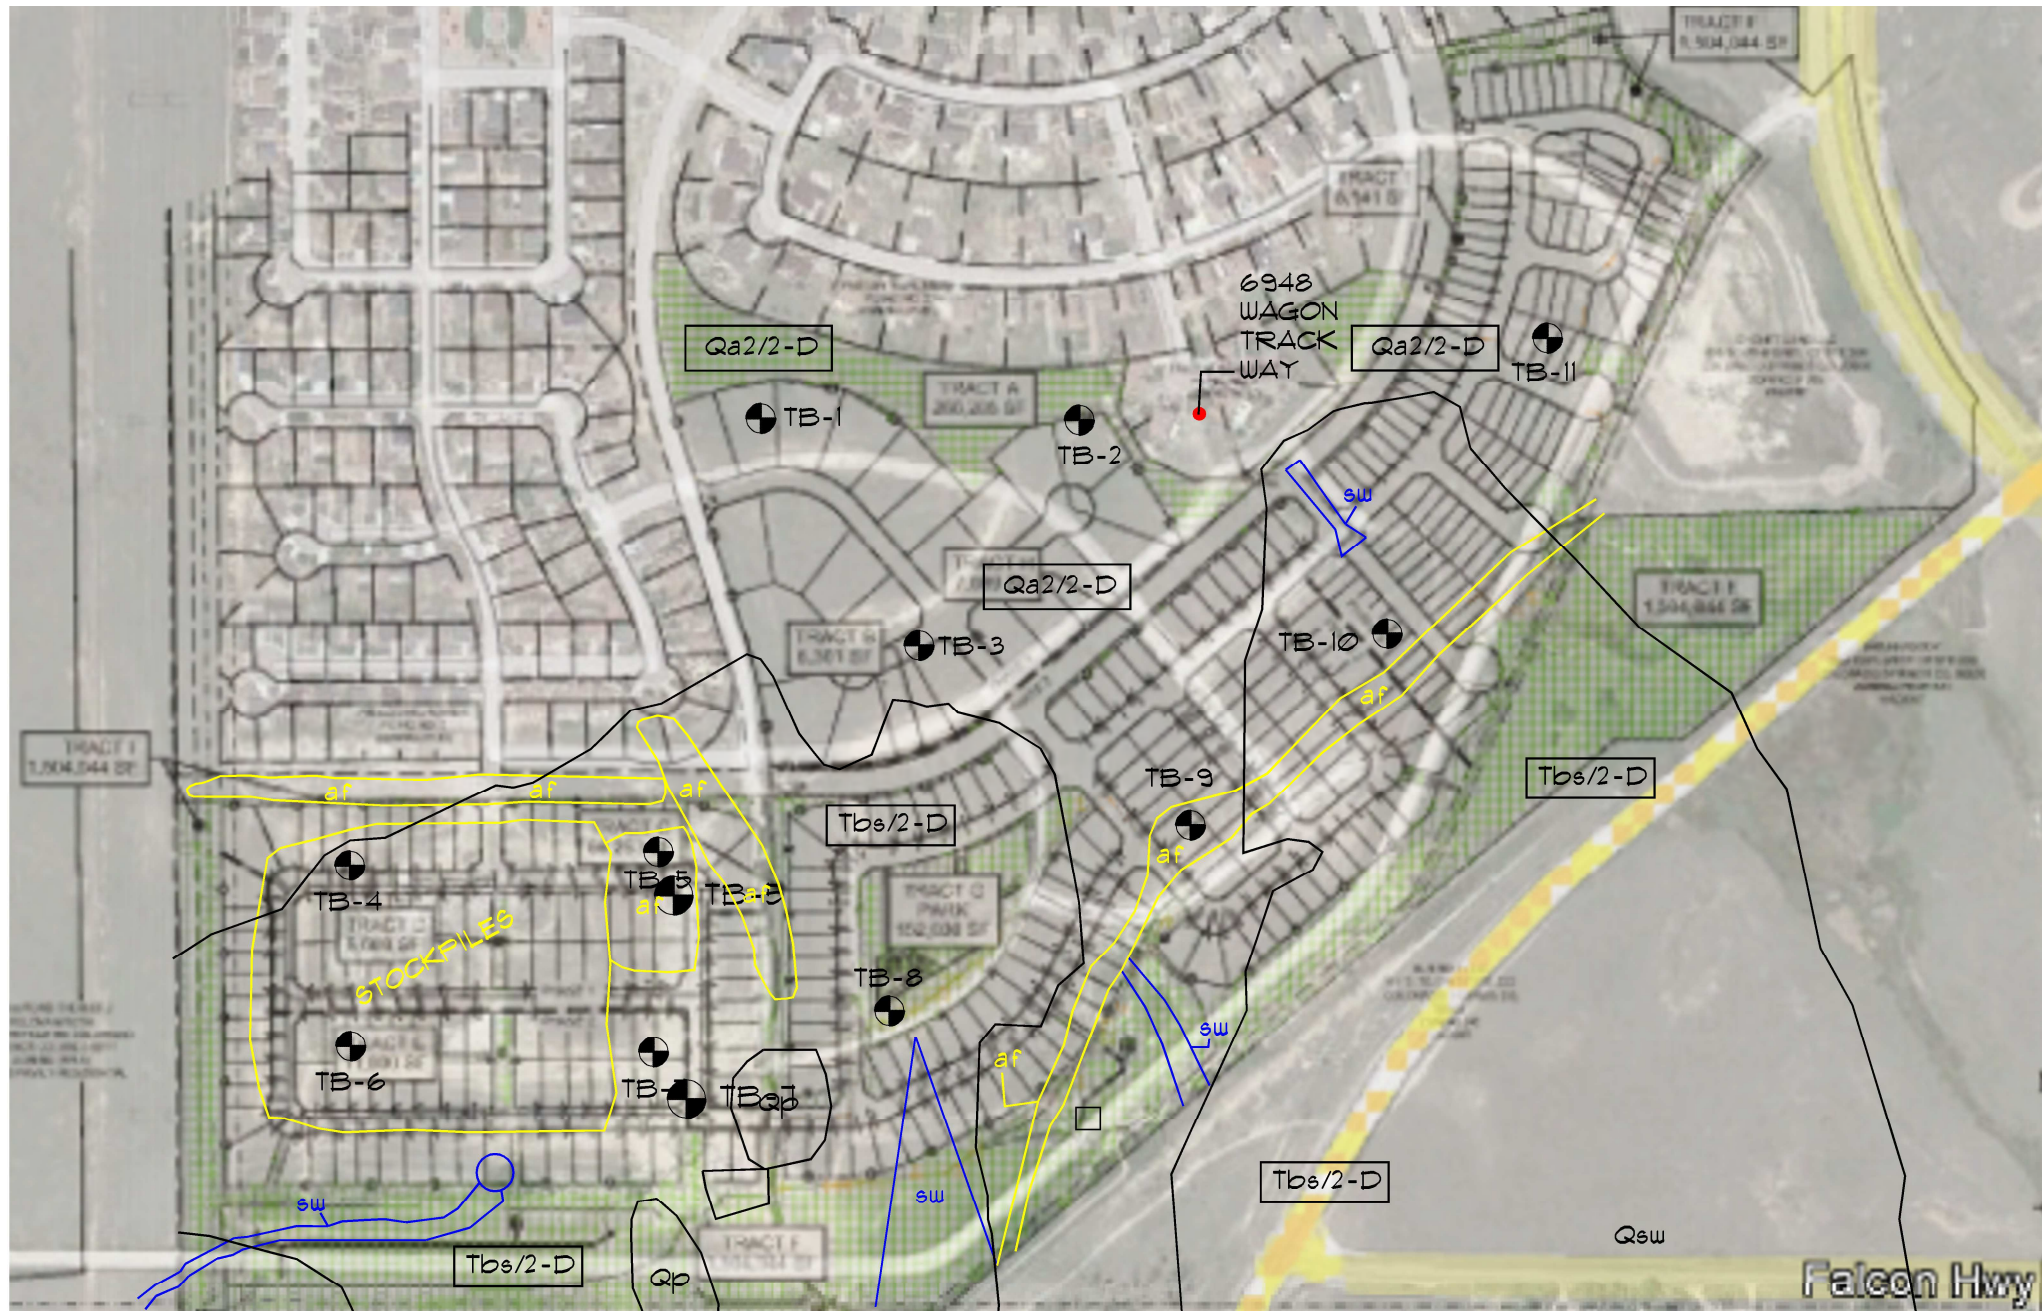
**FIG-17**

General Geologic Conditions

- Qa2 - Alluvium two (lower Holocene) - Dark gray to brown, poorly to well sorted, moderately consolidated, silt, sand, gravel, and minor clay and occasional boulders in stream terrace deposits approximately 6-12 feet above the modern flood plain or as non-terrace forming alluvium in valley headwaters. Unit is subject to occasional flooding. Maximum exposed thickness locally exceeds 20 feet.

*The general geology is presented in the Engineering and Geology Map, Figure 17.*

The engineering geology is presented in the Engineering and Geology Map, Figure 17.

An "Unnamed Tributary" resides along the eastern and southern portion of the proposed development. Per the Flood Insurance Study report and Flood Insurance Rate Map for FEMA Map Number 08041C0516G dated December 7, 2018, the "Unnamed Tributary" resides in Zone AE, which is defined by FEMA as areas subject to inundation by the 1-percent-annual chance-flood event determined by detailed methods. This area is shown hatched on the Engineering and Geology Map, Figure 17.

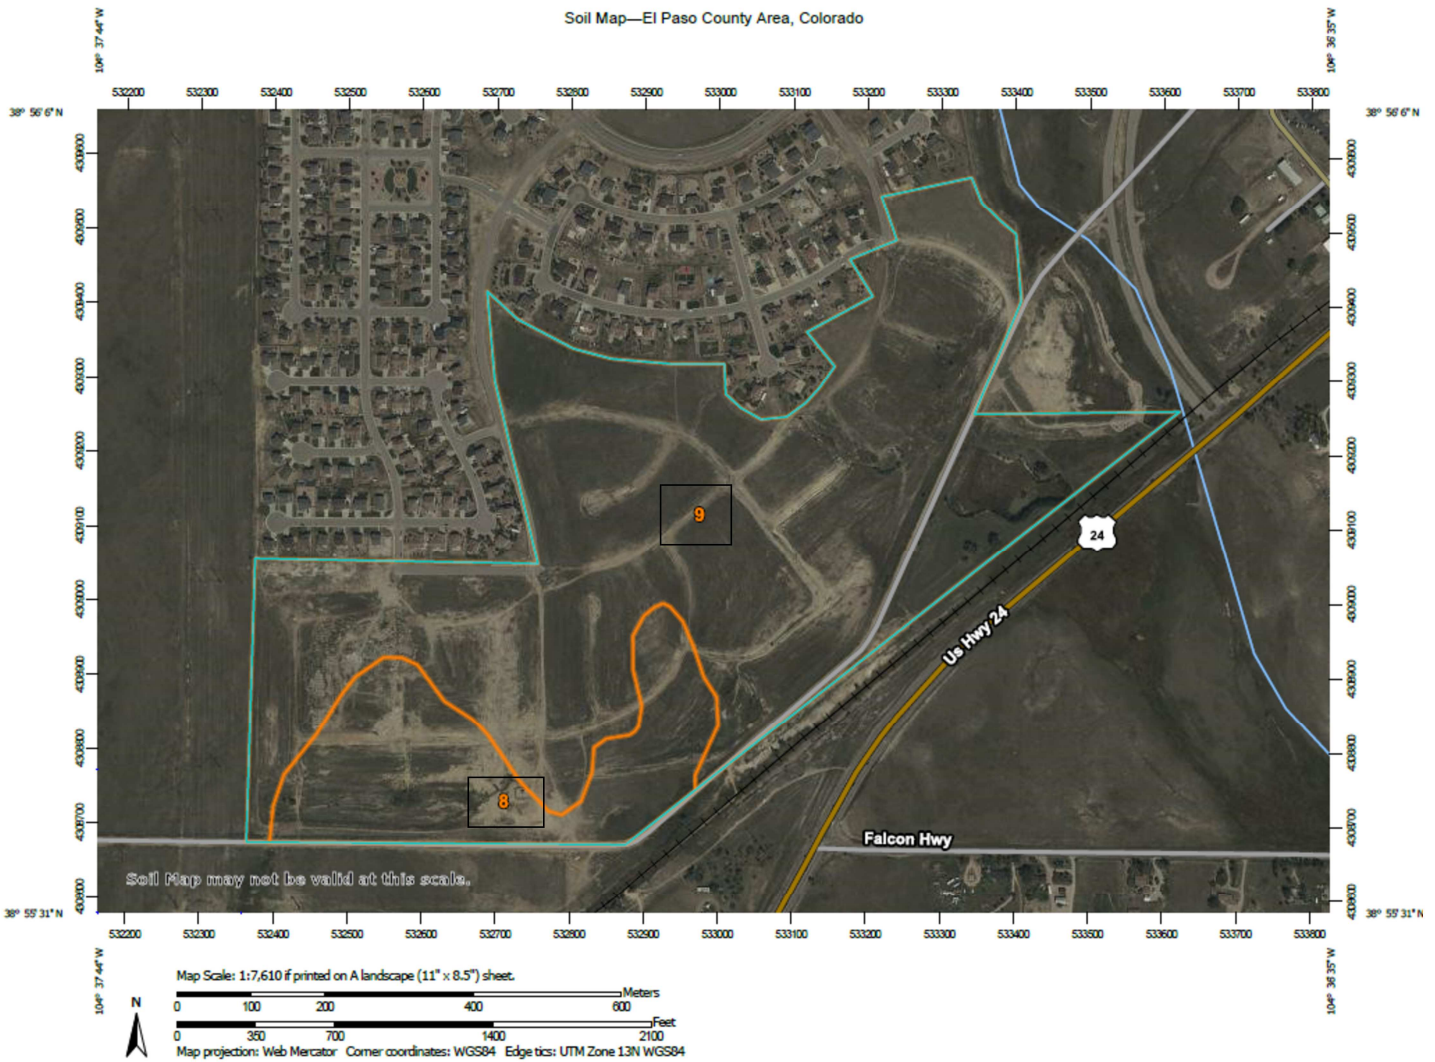
FIG No. 18

Soil Map—El Paso County Area, Colorado

*The USDA Soil Survey Map is presented in Figure 18.*
