SOILS AND GEOLOGY STUDY

**Phases 1-4, Falcon Highlands
El Paso County, Colorado**

**Challenger Colorado, LLC
8605 Explorer Drive, Suite 250
Colorado Springs, CO 80920**

JOB NO. 184041

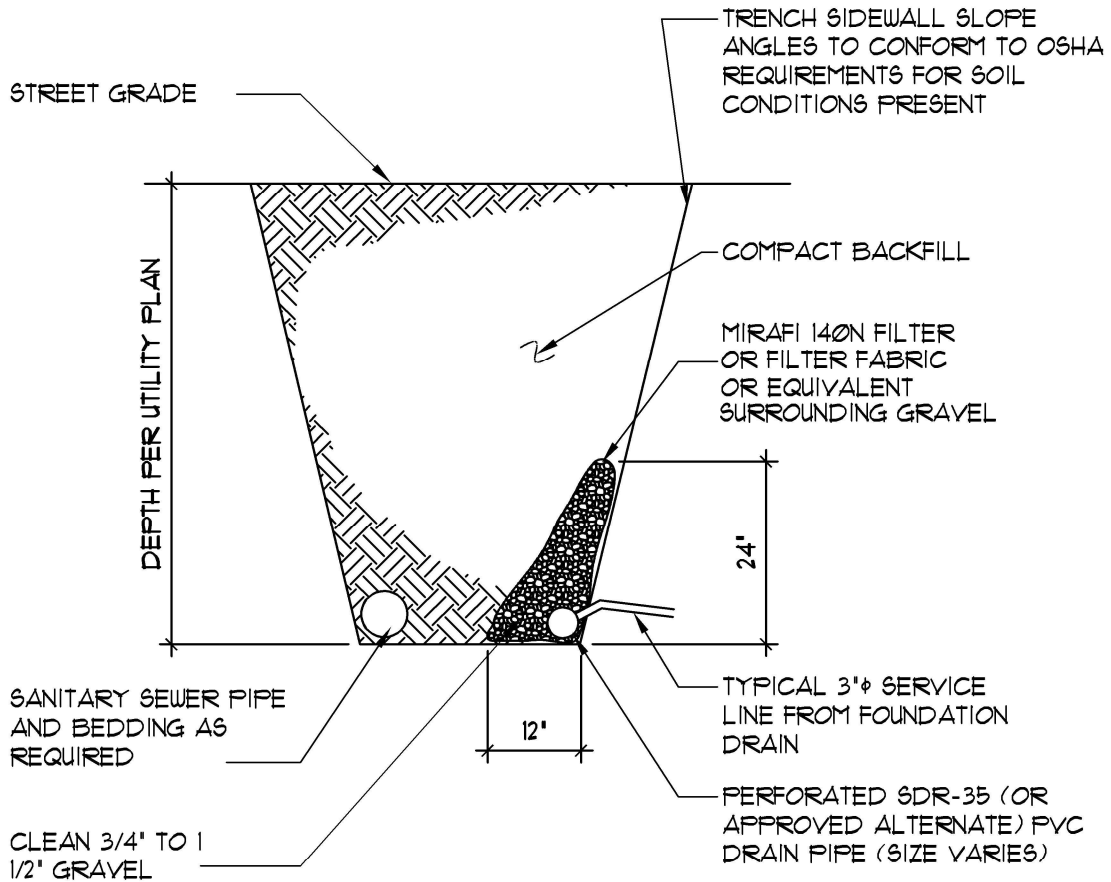
FIG No. 23

NOTE: TO BE USED IN CASES WHERE
GROUNDWATER IS FOUND DURING TRENCHING
OR WHERE SHALLOW GROUNDWATER IS KNOWN
TO EXIST

It is a common local practice for underdrains to be placed at the bottom of sanitary sewer trenches within drive lanes. Underdrains placed in the sanitary sewer trenches in areas where groundwater is anticipated will likely be the "active" type, which uses a perforated drain pipe. In areas where groundwater is not anticipated, "passive" type underdrains may be used. The outfall for the sanitary sewer trench underdrain was not known at the time of this investigation because the development plan and grading plan were not available for our review. Typical underdrain details are presented in Figures 23 and 24.
