SOILS AND GEOLOGY STUDY

**Phases 1-4, Falcon Highlands
El Paso County, Colorado**

JOB NO. 184041

**October 8, 2021
Amended September 7, 2022**

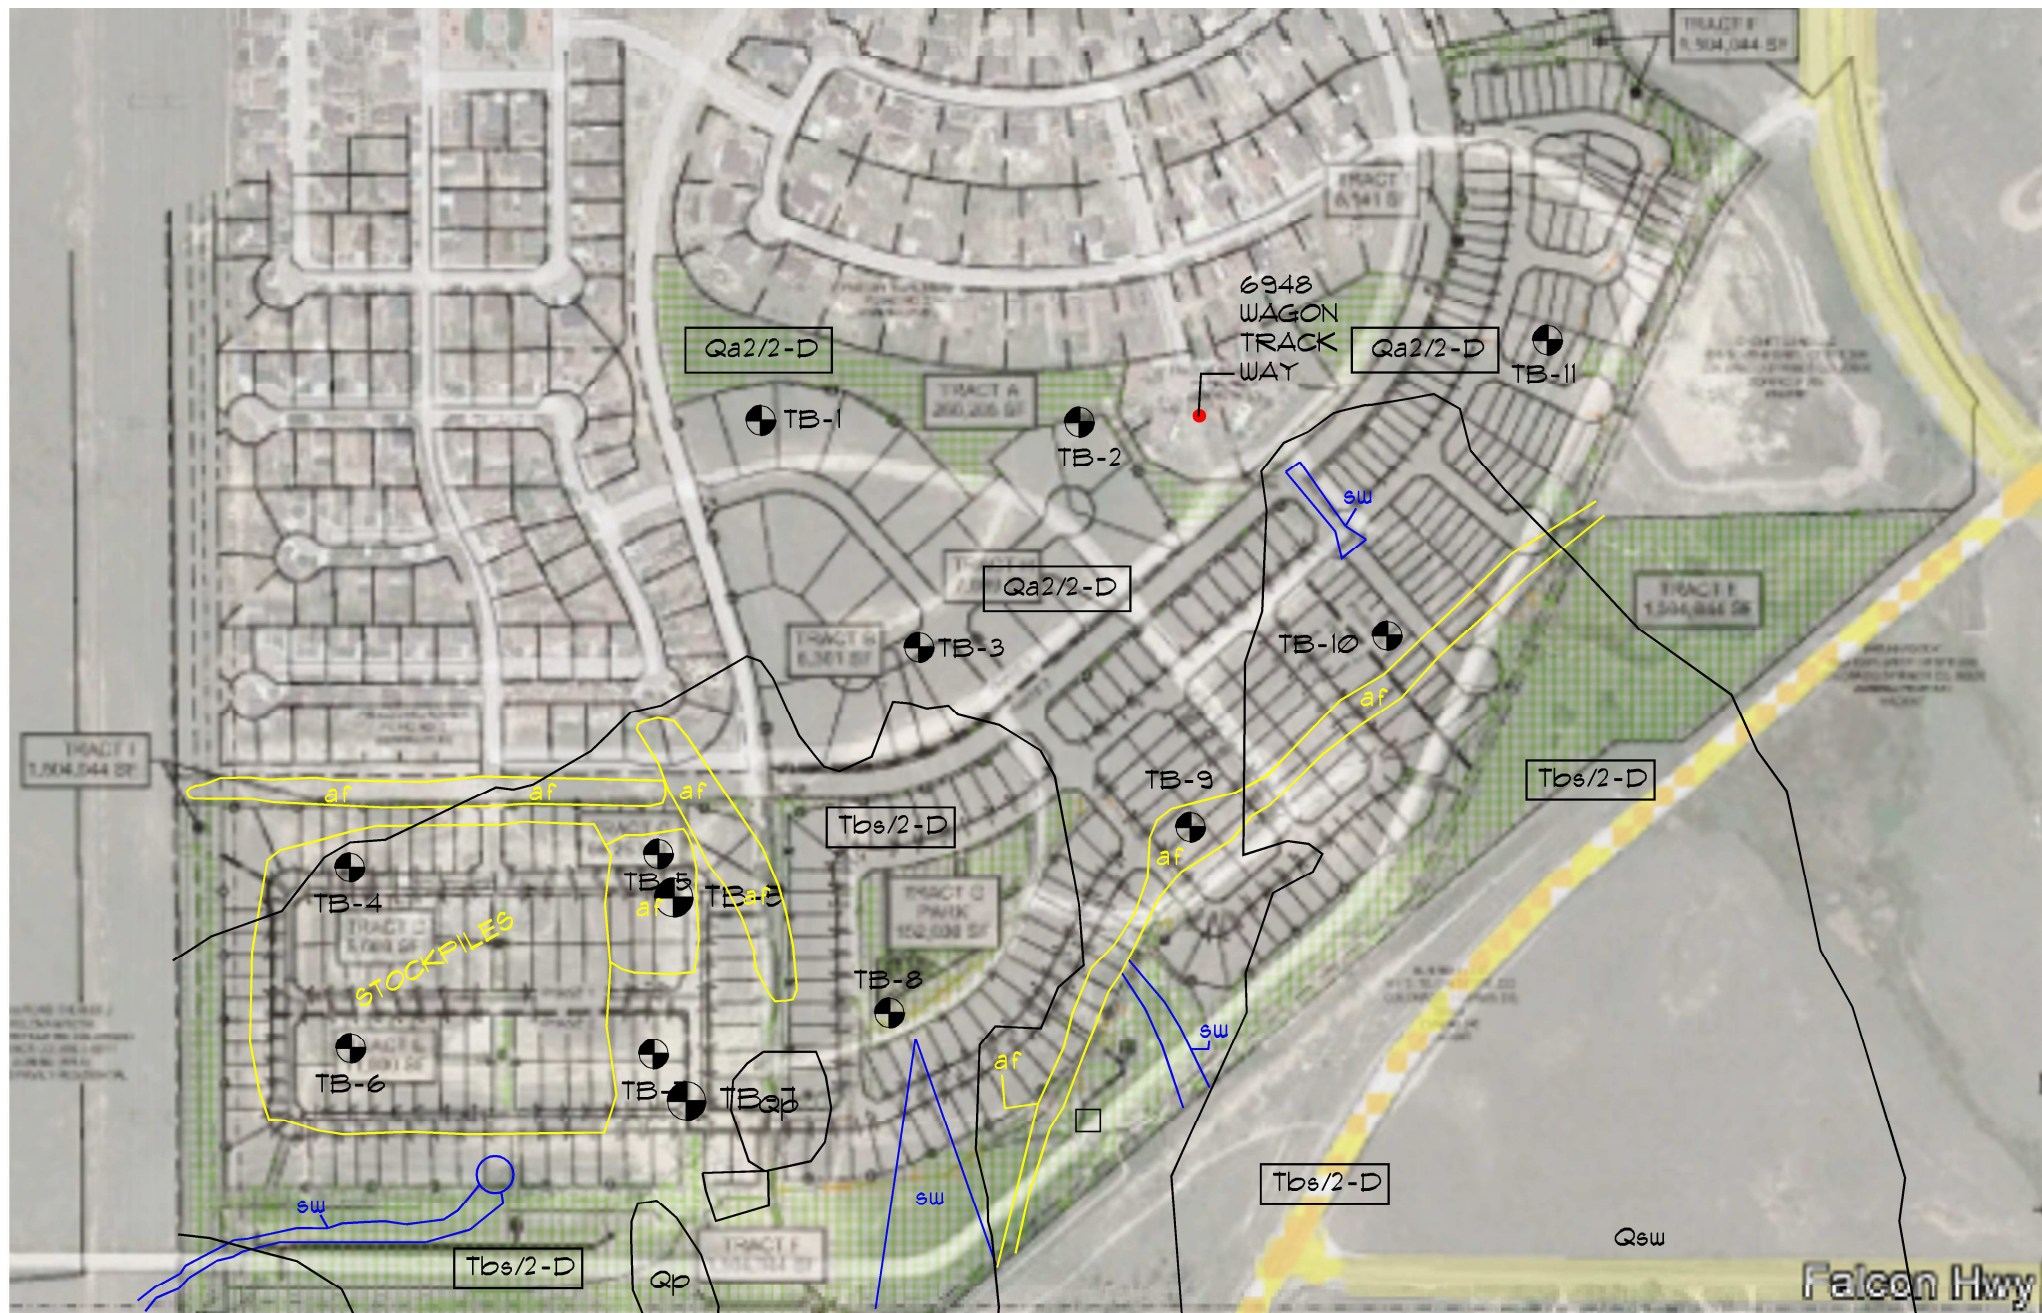
General Geologic Conditions

- Qa2 - Alluvium two (lower Holocene) - Dark gray to brown, poorly to well sorted, moderately consolidated, silt, sand, gravel, and minor clay and occasional boulders in stream terrace deposits approximately 6-12 feet above the modern flood plain or as non-terrace forming alluvium in valley headwaters. Unit is subject to occasional flooding. Maximum exposed thickness locally exceeds 20 feet.
