WASTEWATER DISPOSAL REPORT

***SMH Consultants
Porcelain Pines Subdivision***

EPC Parcel – Tax ID #: 8322200018

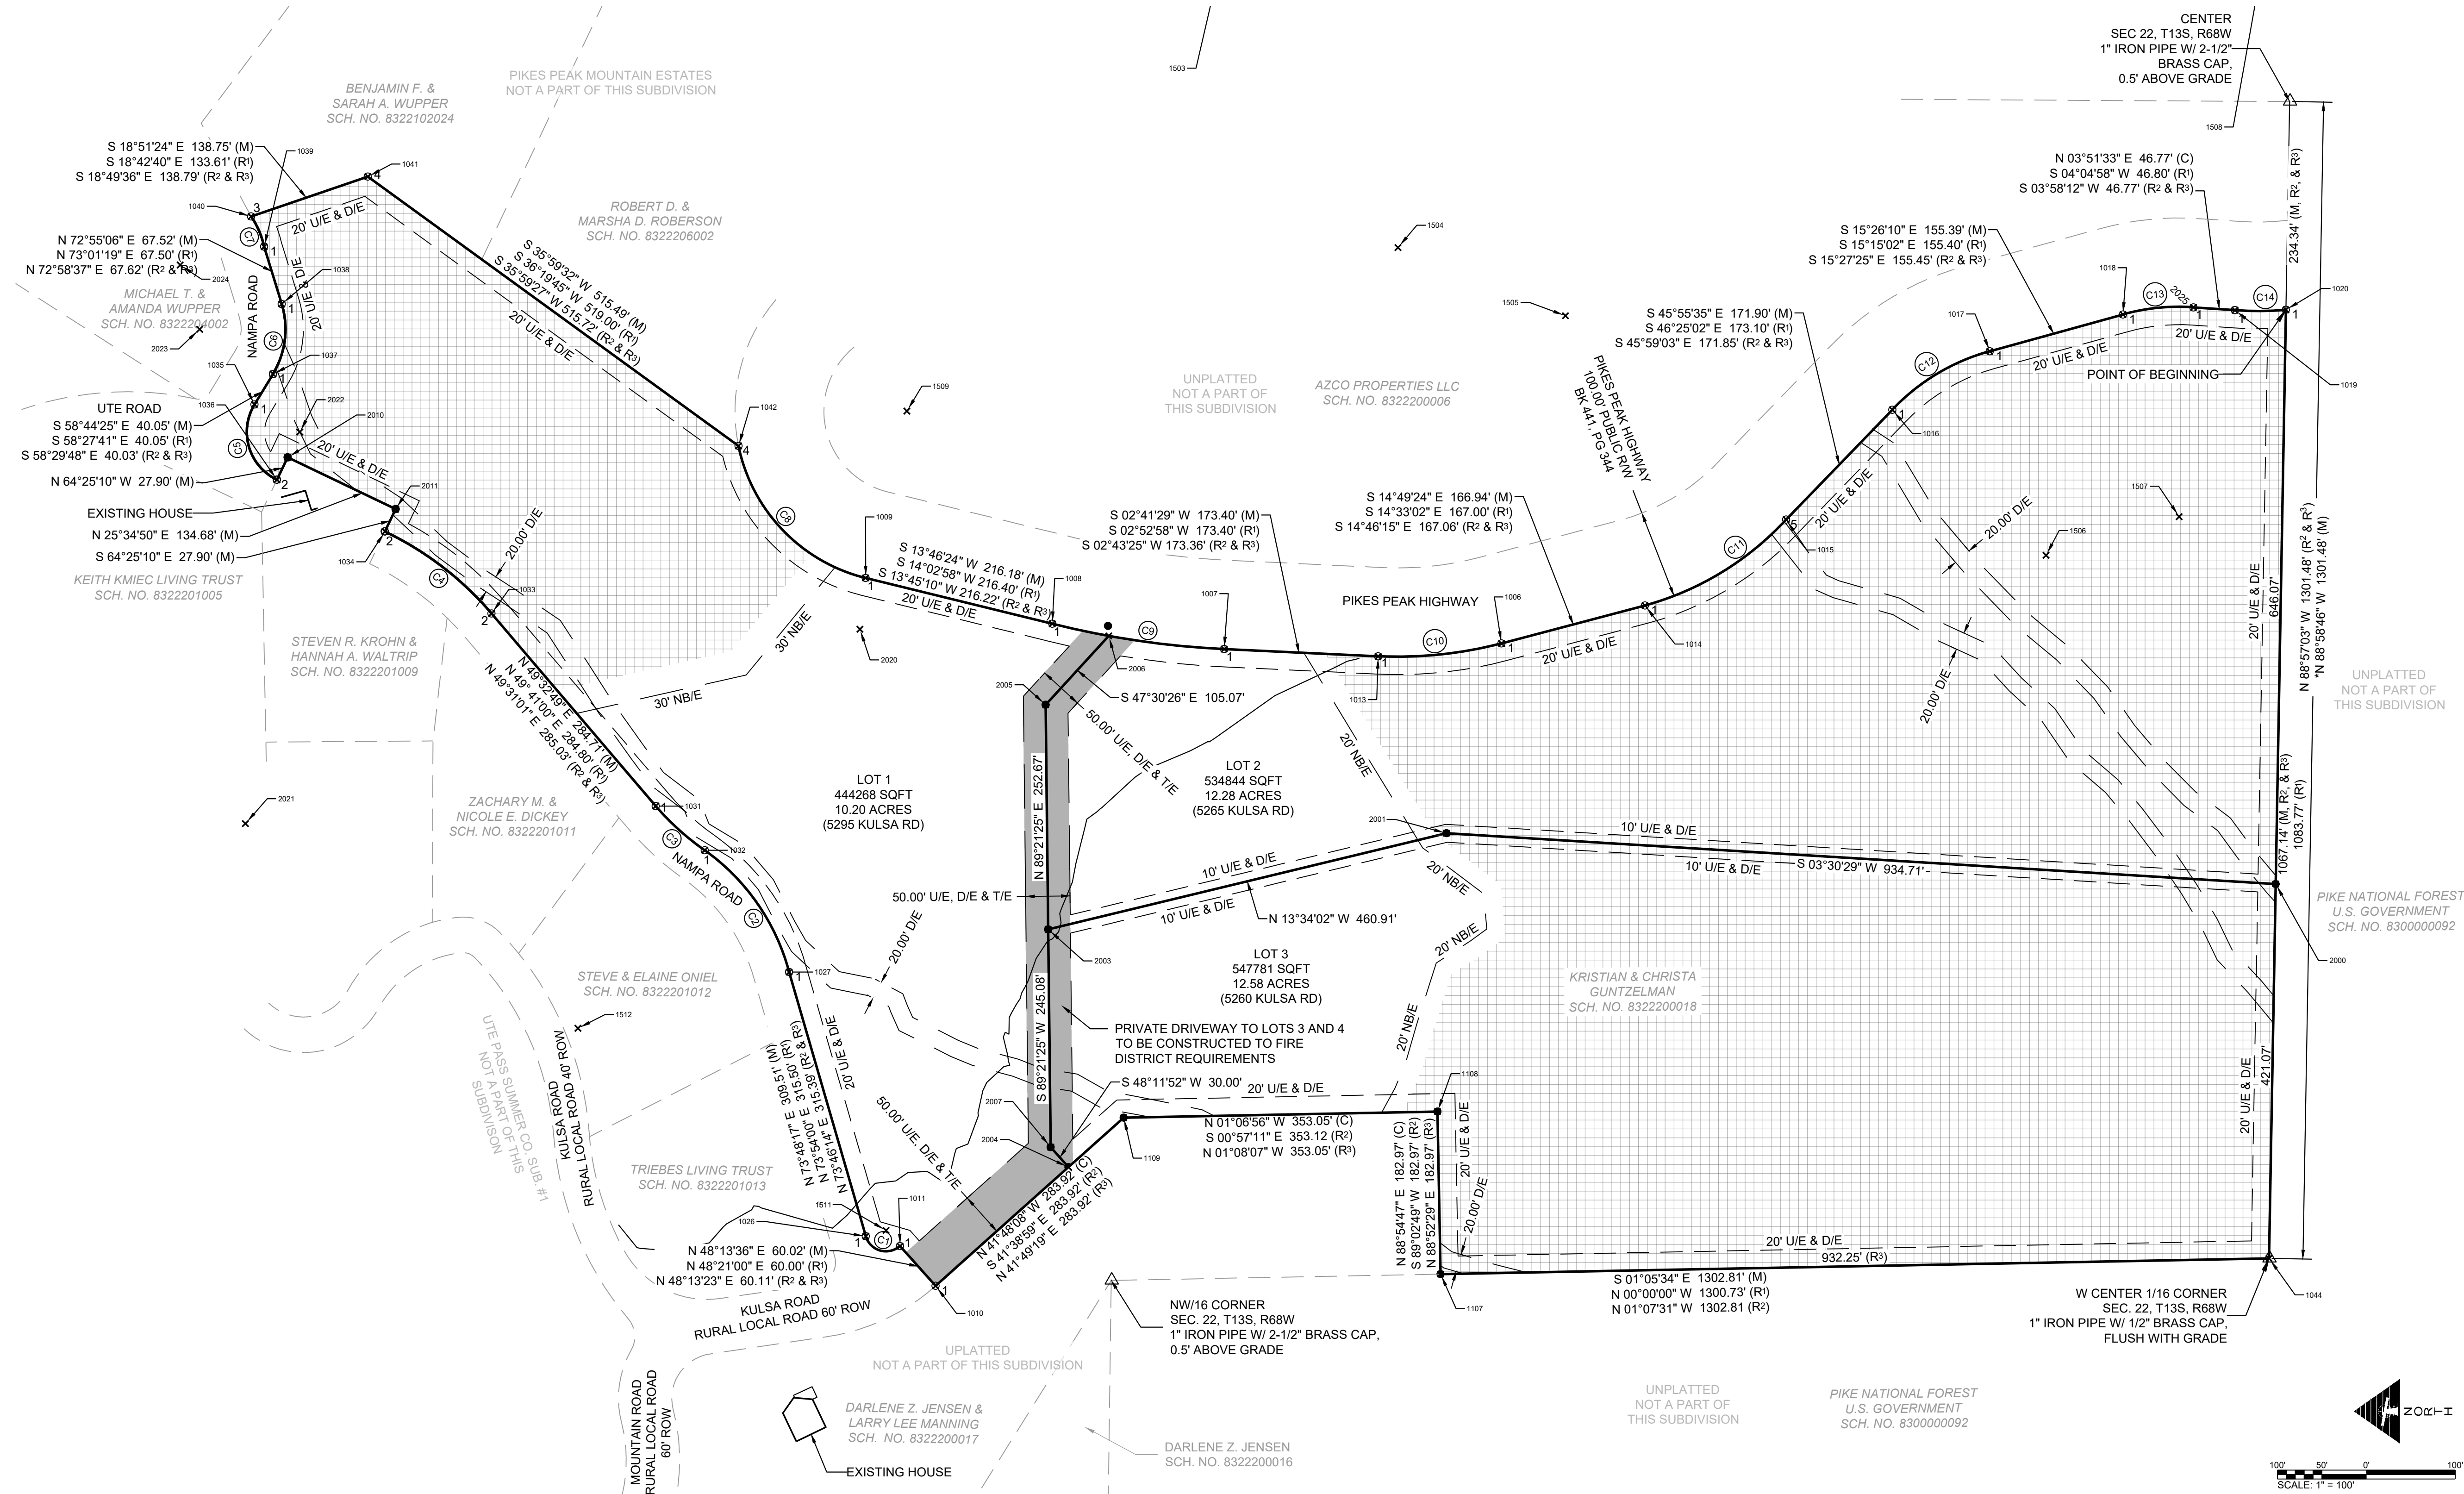
GUNTZELMAN PORCELAIN PINES SUBDIVISION

PART OF THE NORTHWEST 1/4 OF SECTION 22, TOWNSHIP 13 SOUTH, RANGE 68 WEST OF
THE SIXTH PRINCIPAL MERIDIAN, COUNTY OF EL PASO, STATE OF COLORADO

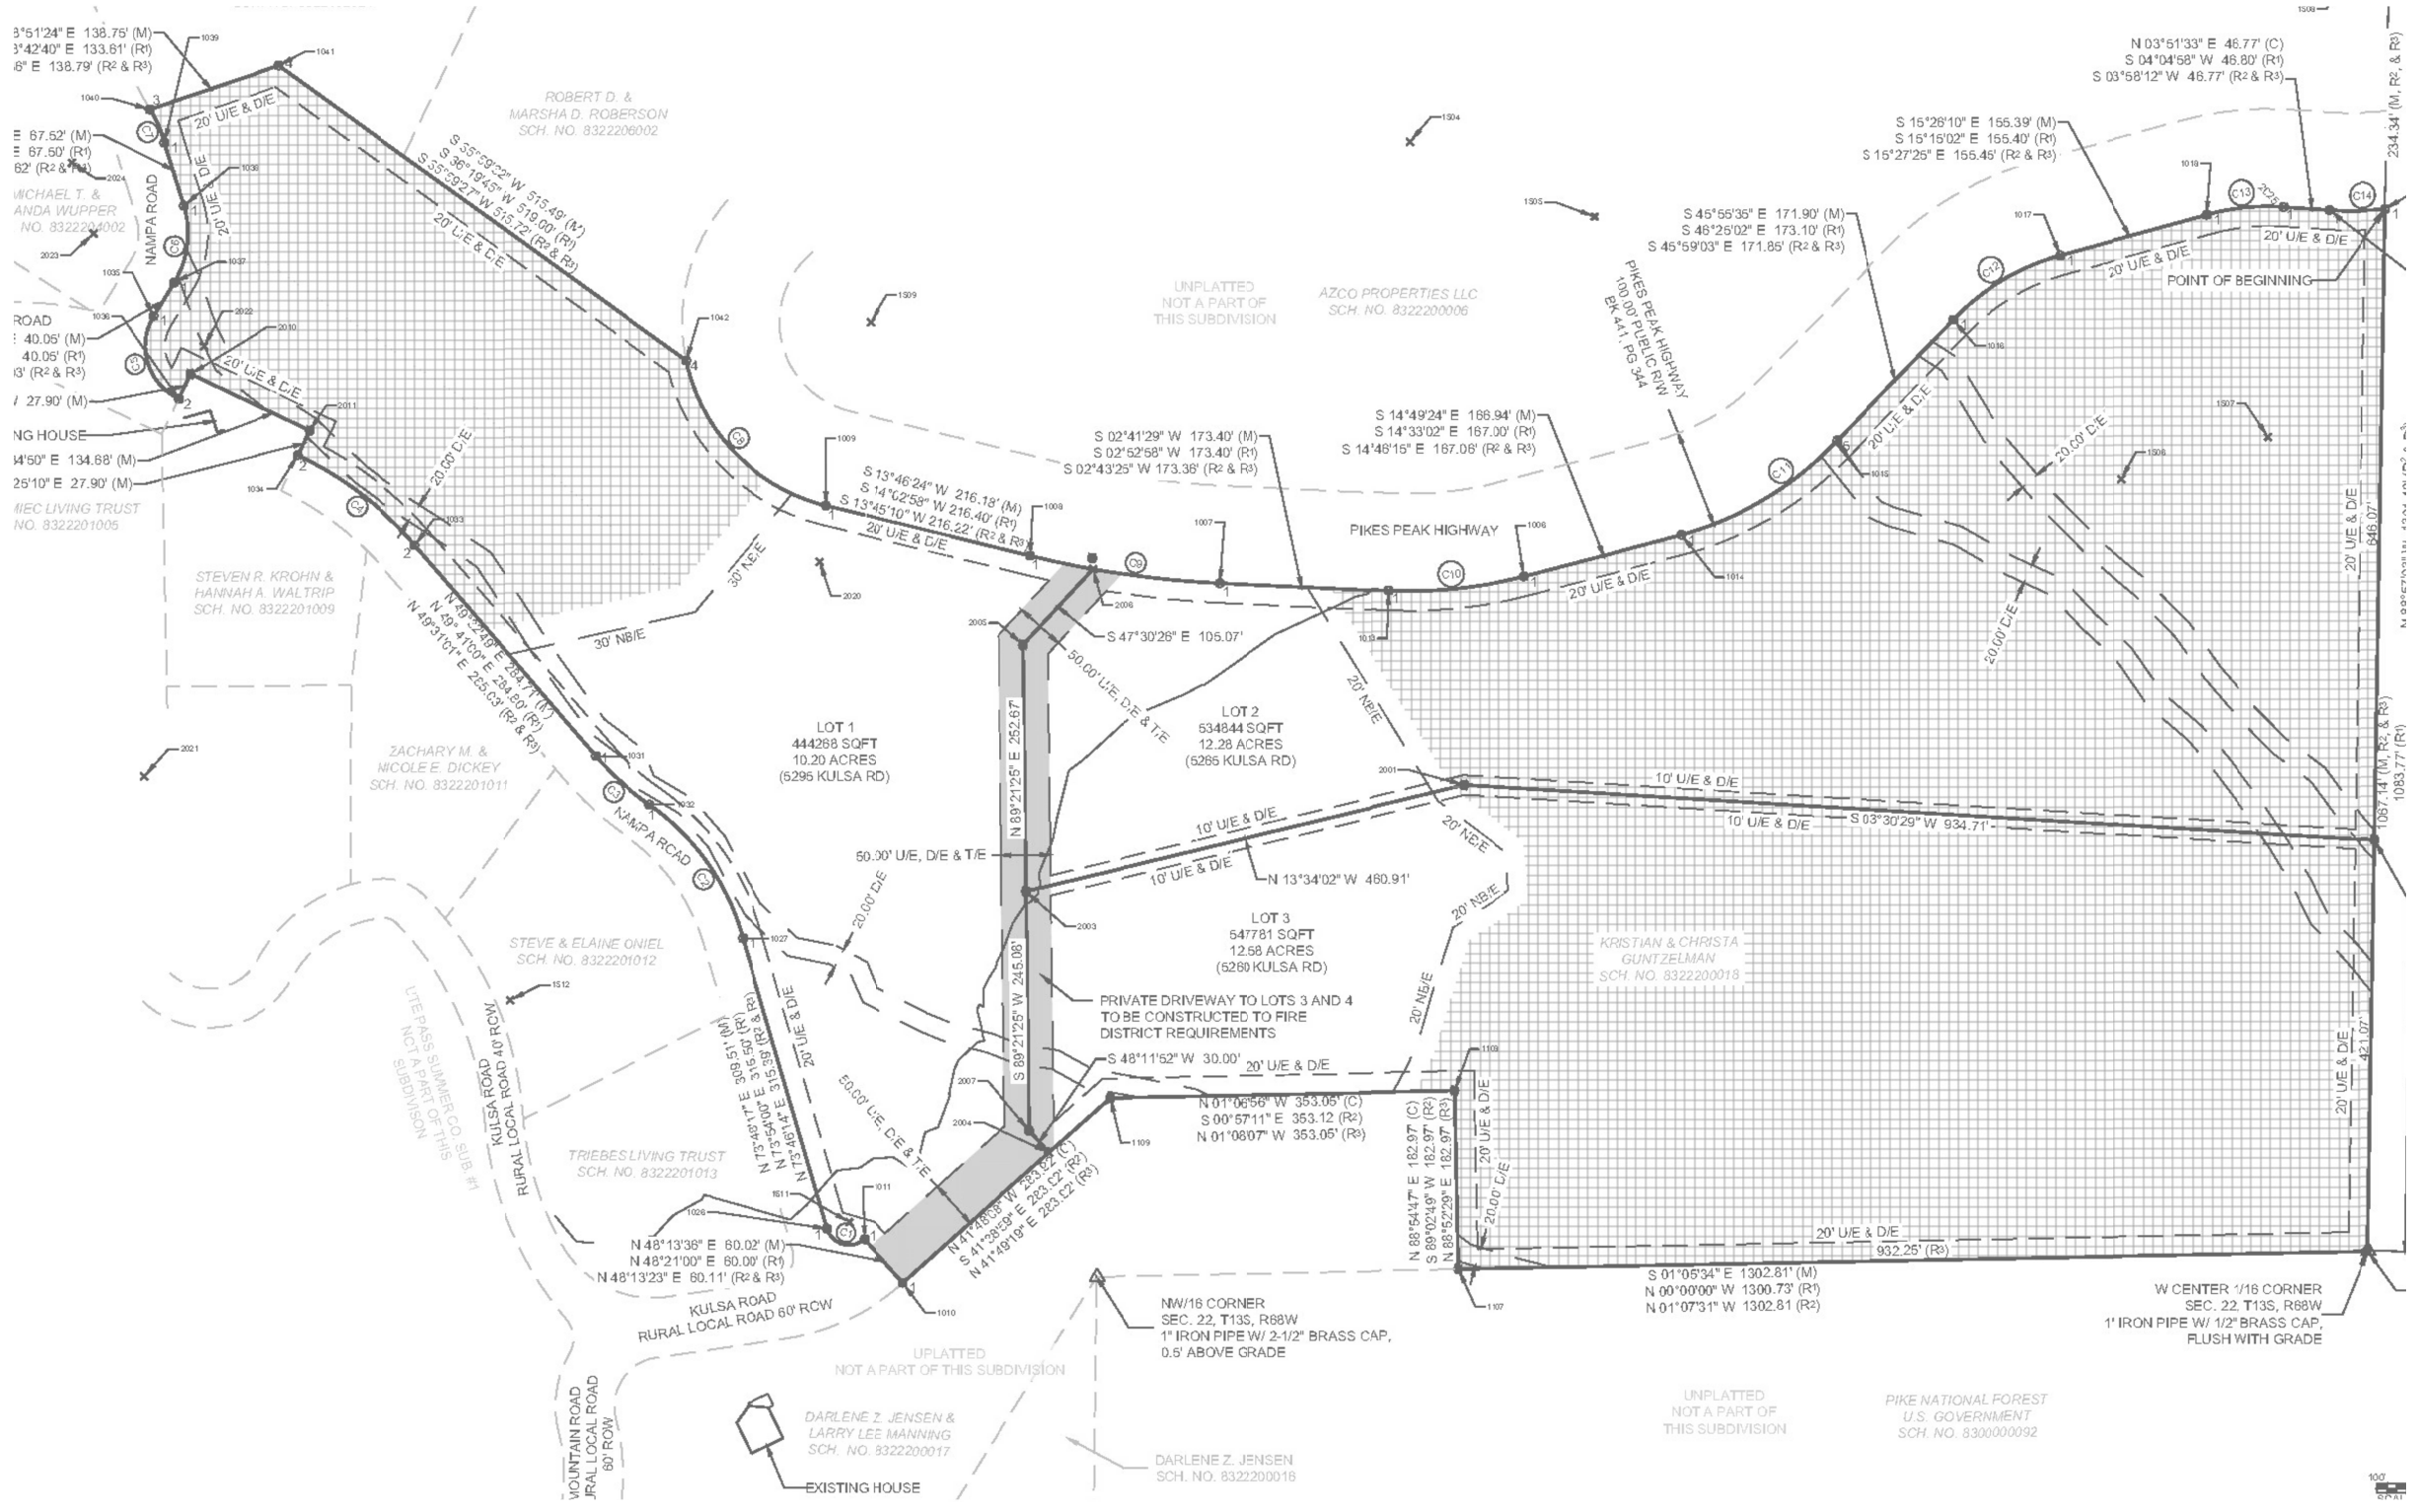
SHEET No.
FIG-2

Base map provided by SMH Consultants

**PROPOSED LOT
LAYOUT**

The site is currently undeveloped. It is our understanding the existing 35.16 acres is to be subdivided into a total of three lots. The lots are to range between 10.20 acres and 12.58 acres. Each new lot is to contain a single-family residence with an on-site wastewater treatment system. Water is to be provided to each lot by Colorado Springs Utilities. The Proposed Lot Layout is presented in Figure 2.

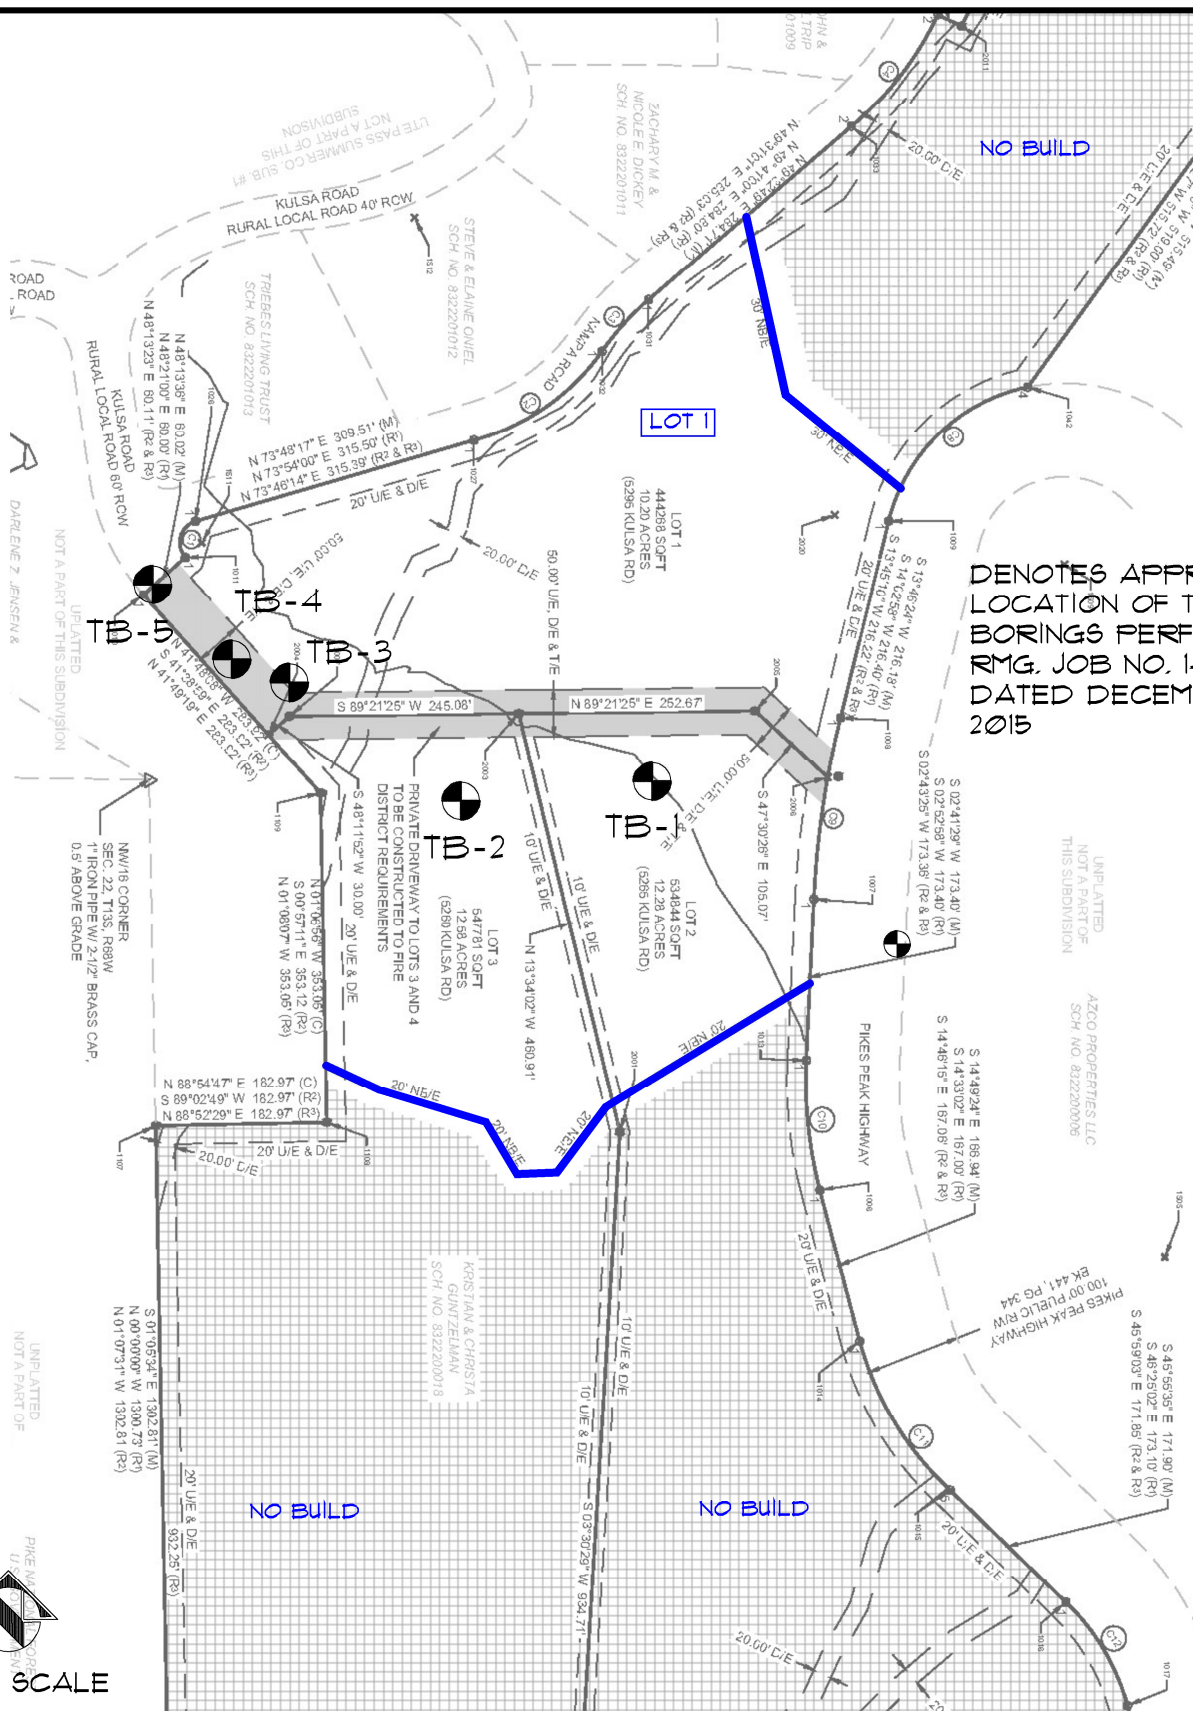
DENOTES APPROXIMATE LOCATION OF TEST BORINGS PERFORMED BY RMG, JOB NO. 147611, DATED DECEMBER 22, 2015

Personnel of RMG performed a soil evaluation to include five 20 to 25-foot-deep test borings, on December 22, 2015. Soil laboratory testing was performed as a part of the previous investigation and included moisture content, grain-size analyses and Atterberg Limits. The test borings were drilled in areas that appeared most likely to be used for residential construction per the original concept plan dated September 8, 2021. Since the issuance of this study the lot layout has changed. Additional test borings were not drilled to accommodate the Final Plat lot layout, as the soils encountered onsite were fairly uniform. The test boring logs and laboratory test results are presented in the *Preliminary Subsurface Soil Investigation and the Soils and Geology Study*. A Septic Suitability map is presented in Figure 4.

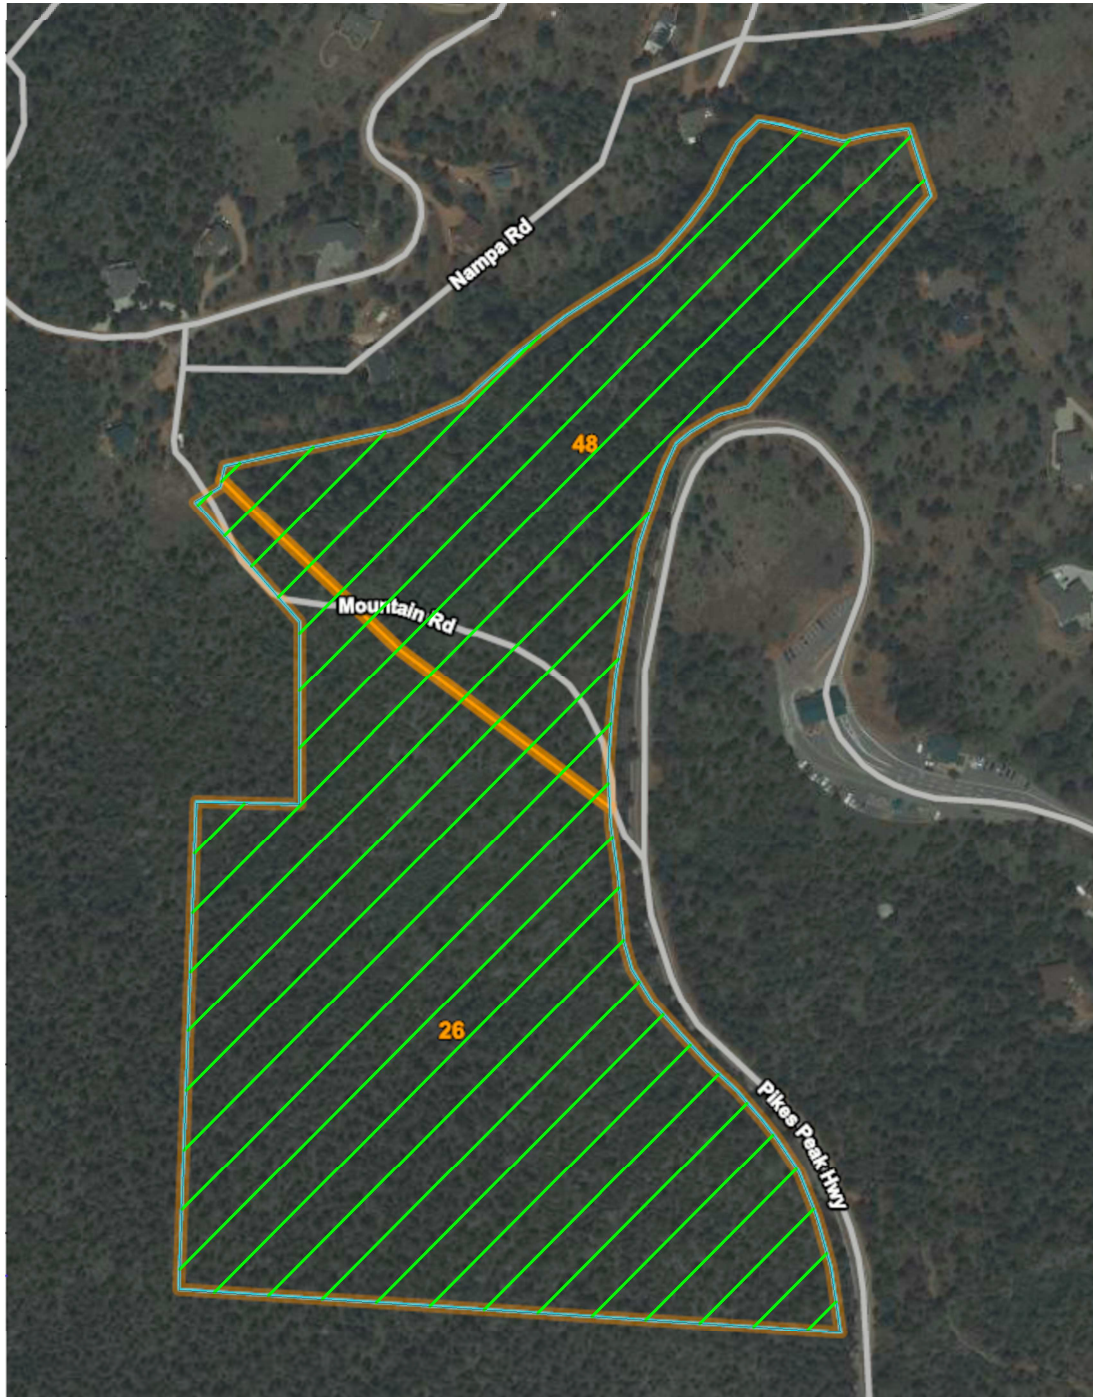
FIG No. 5

26 - Legault-Rock Outcrop Complex, 15 to 65 percent slopes

48 - Tecolote very gravelly sandy loam, 15 to 40 percent slopes, very stony

The USDA Soil Survey Map is presented in Figure 5.

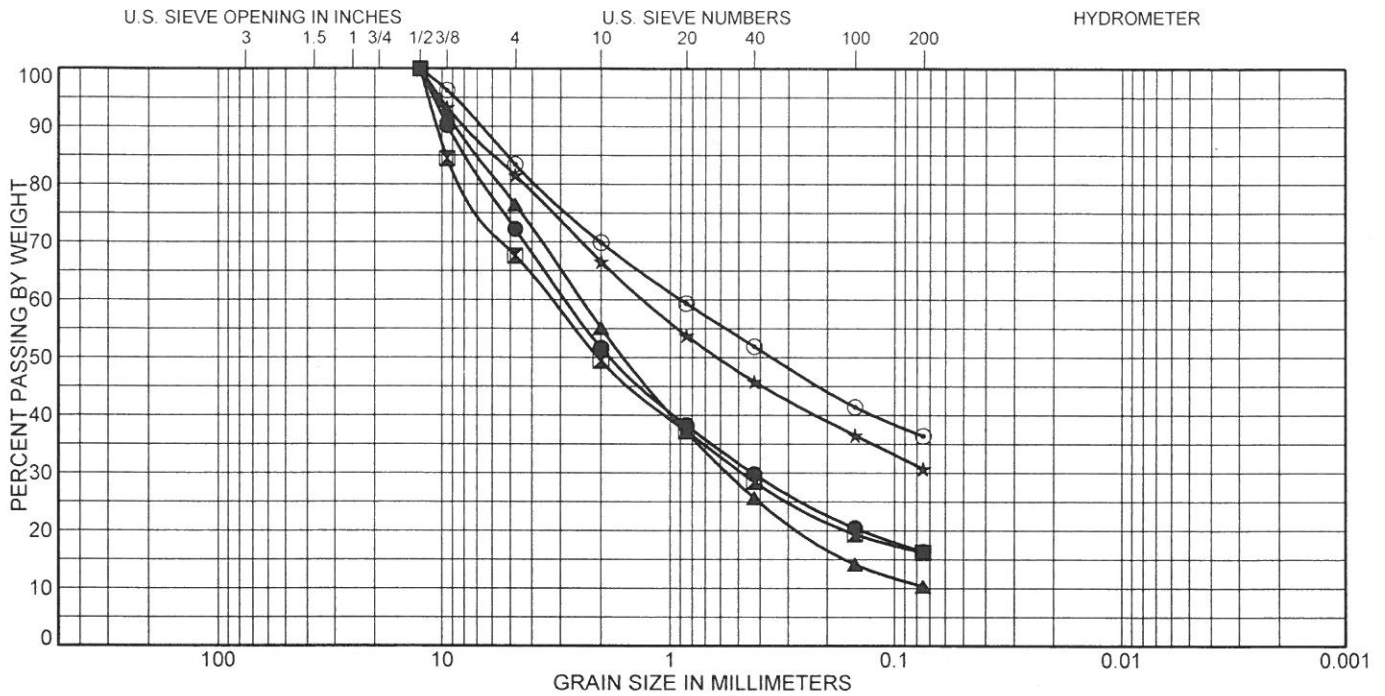
FIGURE No. 8

Test Boring	Depth (ft)	Classification	LL	PL	PI
● 1	9.0	SILTY SAND with GRAVEL(SM)	NP	NP	NP
⊠ 2	14.0	SILTY SAND with GRAVEL(SM)	NP	NP	NP
▲ 2	24.0	WELL-GRADED SAND with SILT and GRAVEL(SW-SM)	NP	NP	NP
★ 3	4.0	SILTY SAND with GRAVEL(SM)	NP	NP	NP
⊙ 3	9.0	CLAYEY SAND with GRAVEL(SC)	39	13	26

Test Boring	Depth (ft)	%Gravel	%Sand	%Silt	%Clay
● 1	9.0	27.8	55.9	16.3	
⊠ 2	14.0	32.4	51.4	16.2	
▲ 2	24.0	23.5	66.1	10.4	
★ 3	4.0	18.5	50.8	30.7	
⊙ 3	9.0	16.6	47.0	36.4

SOIL CLASSIFICATION DATA

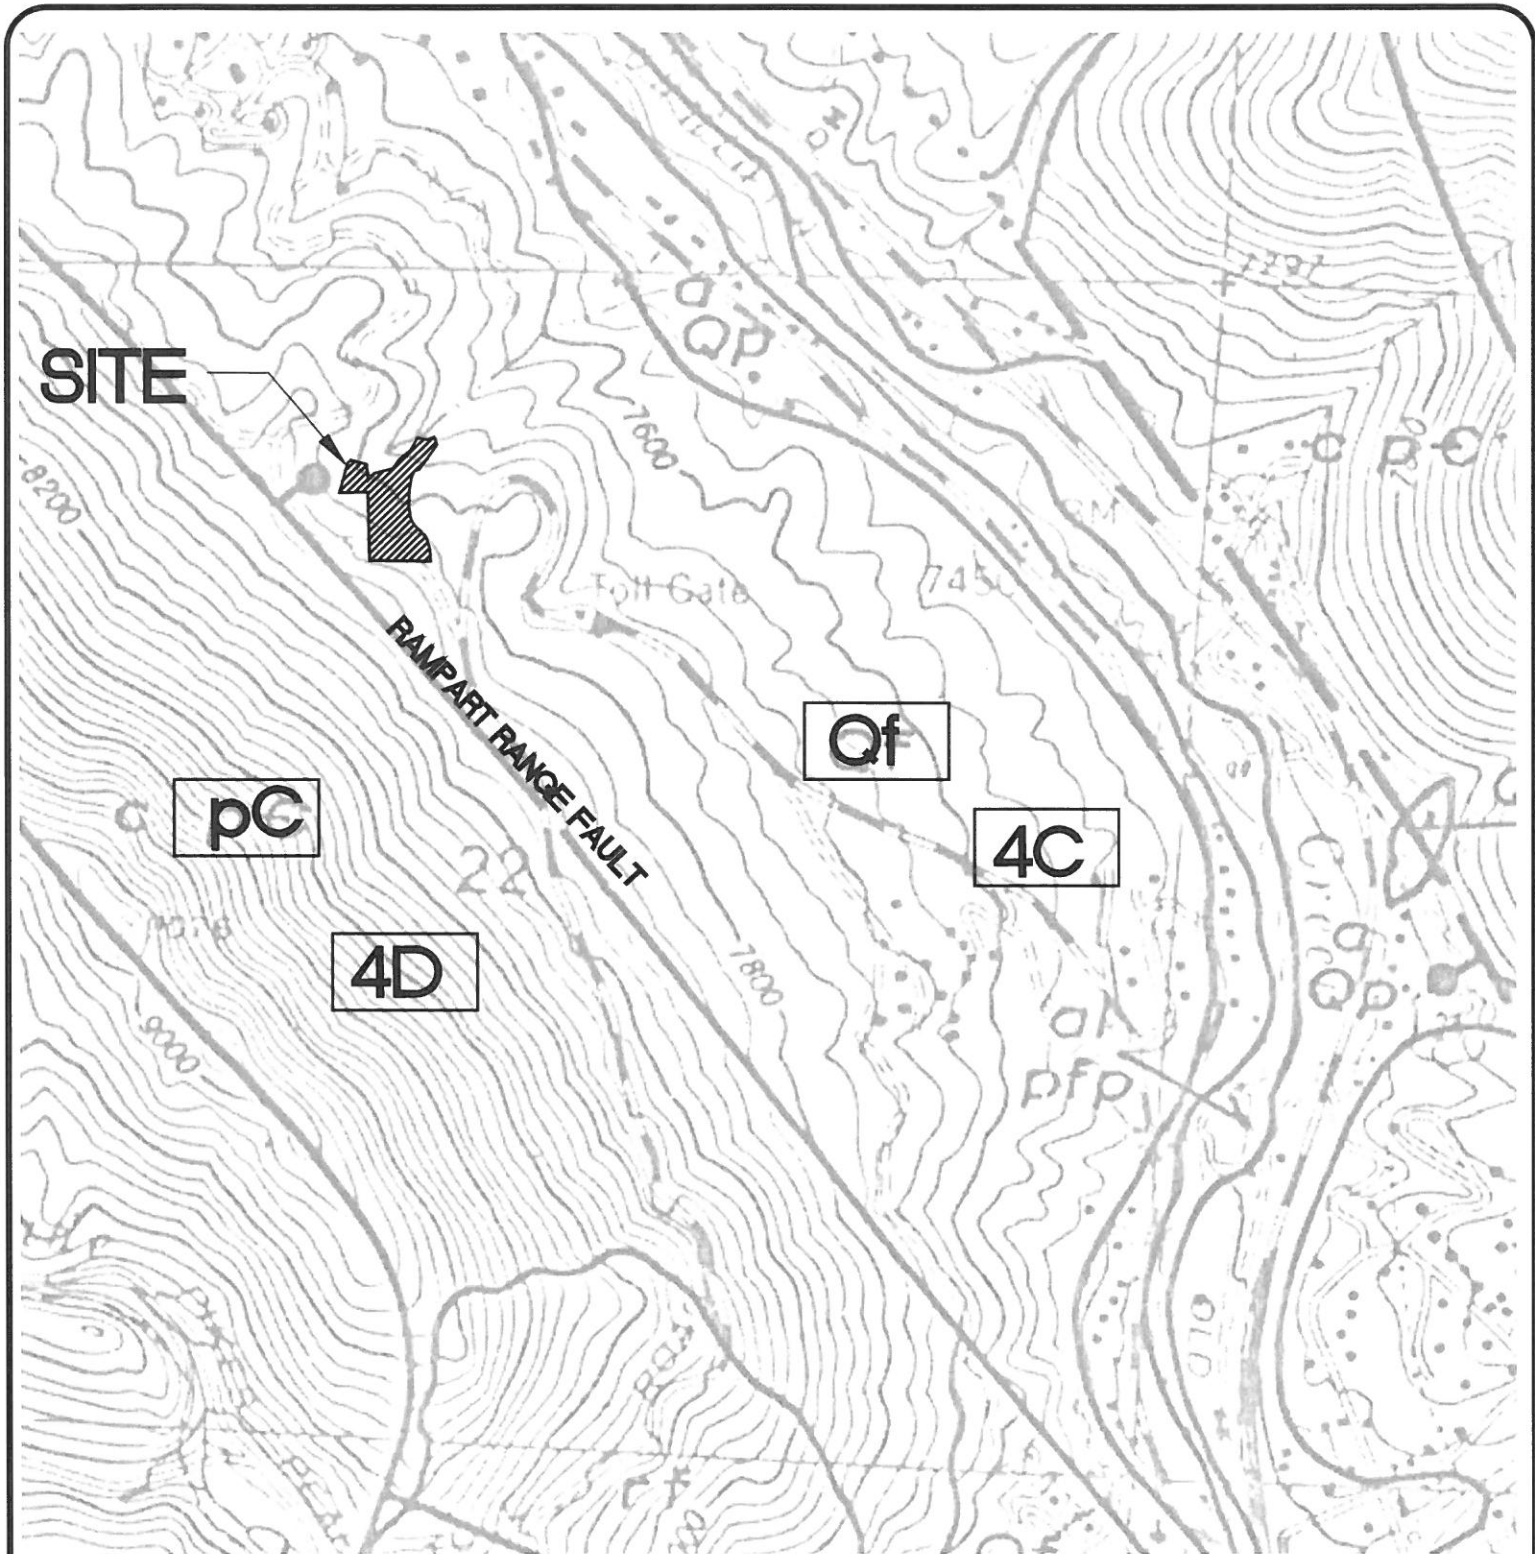
FIG No. 10

BASE MAP PROVIDED BY:
USGS

In general, the geology at the site consists of older fan deposits and alluvium soils. A General Engineering Geology Map is presented in Figure 10. One geologic unit and one environmental engineering unit were mapped at the site as:

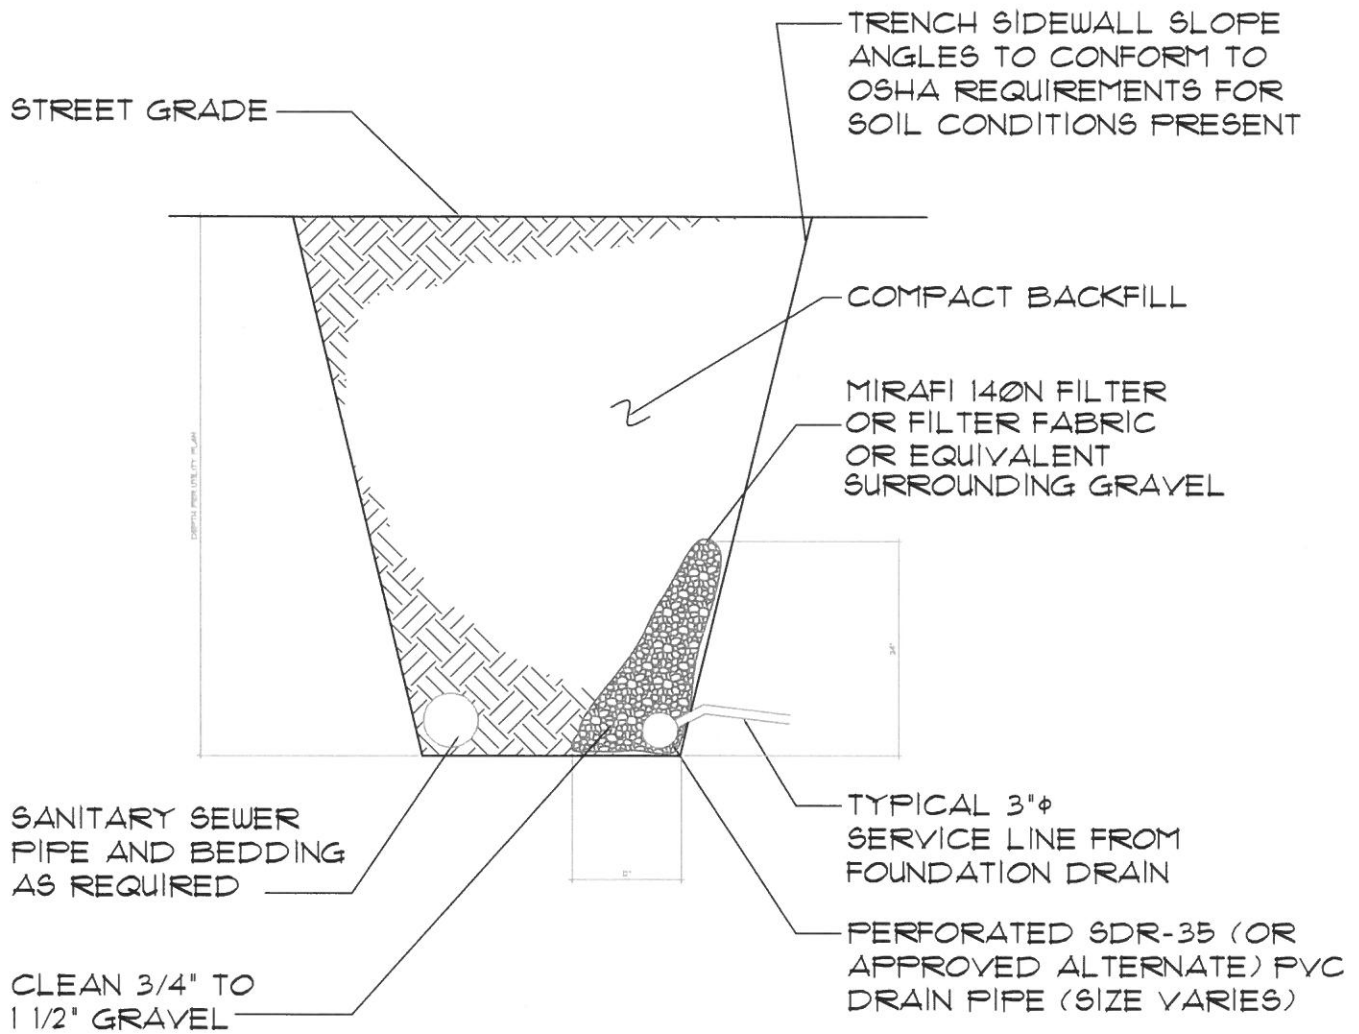
FIG No. 12

NOTE: TO BE USED IN CASES WHERE
GROUNDWATER IS FOUND DURING
TRENCHING OR WHERE SHALLOW
GROUNDWATER IS KNOWN TO EXIST

It is a common local practice for underdrains to be placed at the bottom of sanitary sewer trenched within drive lanes. Underdrains placed in the sanitary sewer trenches in areas where groundwater is anticipated will likely be the "active" type, which uses a perforated drain pipe. In areas where groundwater is not anticipated, "passive" type underdrains may be used. The outfall for the sanitary sewer trench underdrain was not known at the time of this investigation because the development plan and grading plan were not available for our review. Typical underdrain details are presented in Figures 12 and 13.

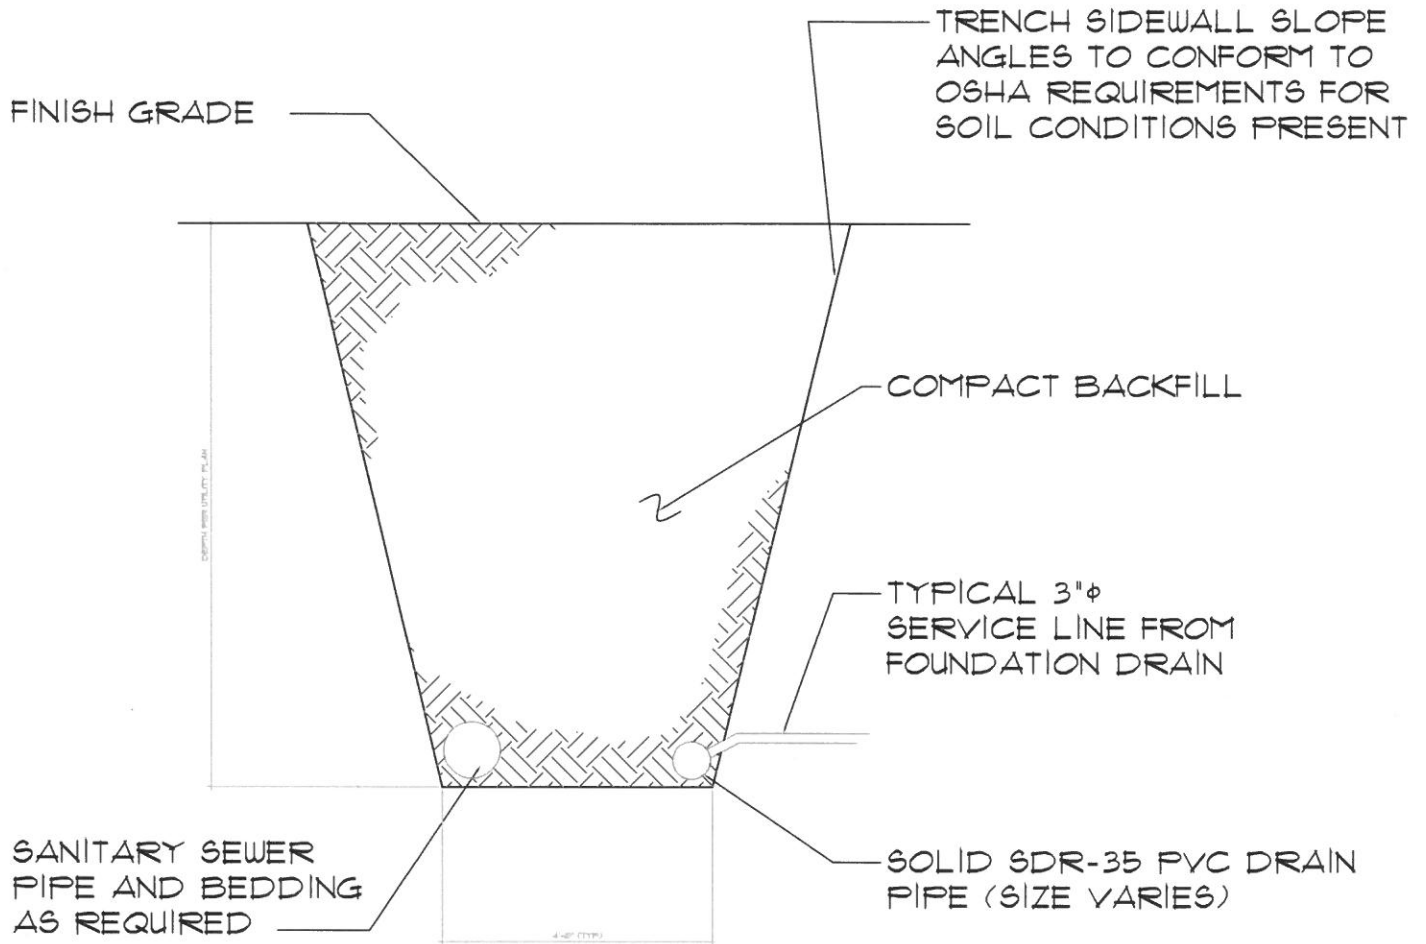
NOTE: TO BE USED WHERE NO SHALLOW GROUNDWATER IS KNOWN TO EXIST
