WASTEWATER DISPOSAL REPORT

***SMH Consultants
Porcelain Pines Subdivision***

EPC Parcel – Tax ID #: 8322200018

January 2023

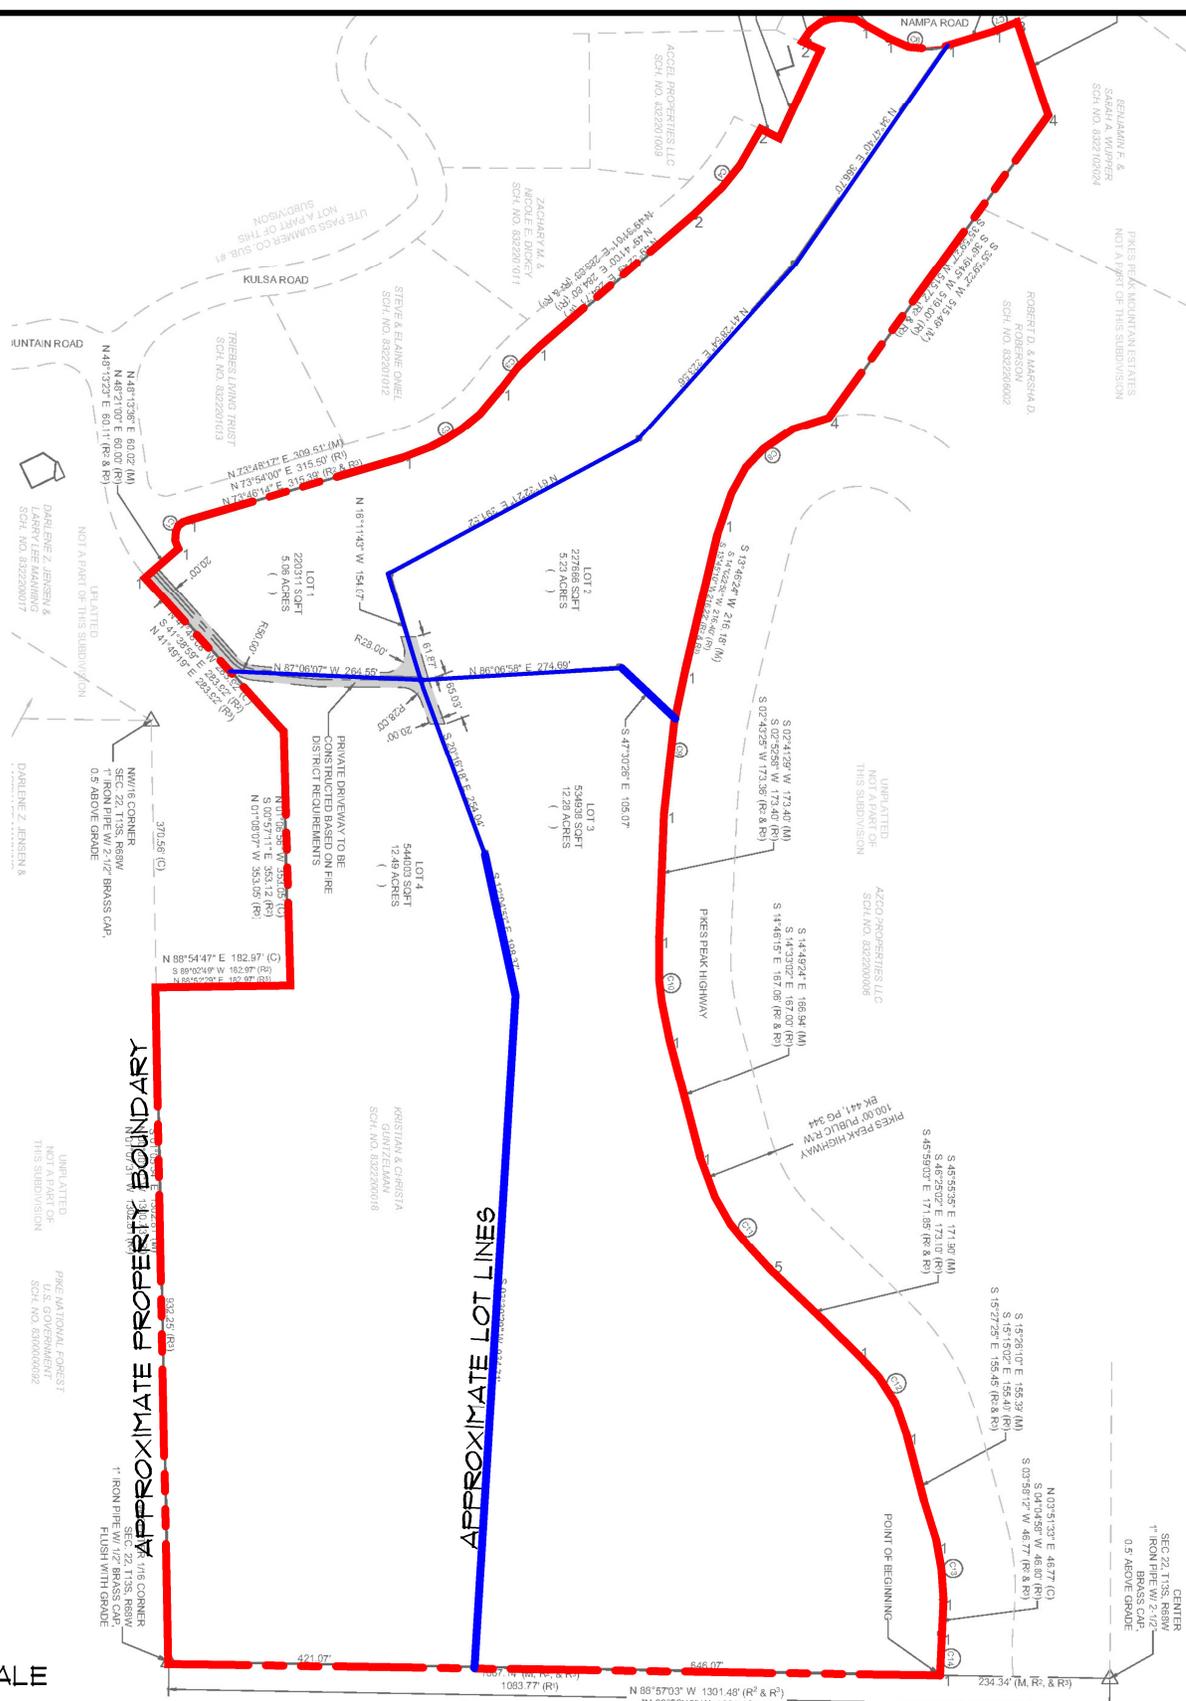
FIG No. 2

APPROXIMATE PROPERTY BOUNDARY

APPROXIMATE LOT LINES

The site consists of approximately 35.16 acres and is undeveloped, vacant land. It is our understanding the existing 35.16 acres is to be subdivided into a total of four lots. The lots are to range between approximately 5.06 acres and 12.49 acres each. The Proposed Lot Layout is included as Figure 2.

The information provided in this report is based upon the subsurface conditions observed from drilling five test borings and accepted engineering procedures. The subsurface conditions encountered in the test borings for the treatment area may vary from those encountered in the test pit excavations. Therefore, depth to limiting or restrictive conditions, bedrock, and groundwater may be different from the results reported in this letter. The proposed residences and OWTS should be located outside of the no-build area slopes as indicated in the Proposed Lot Layout included as Figure 2.

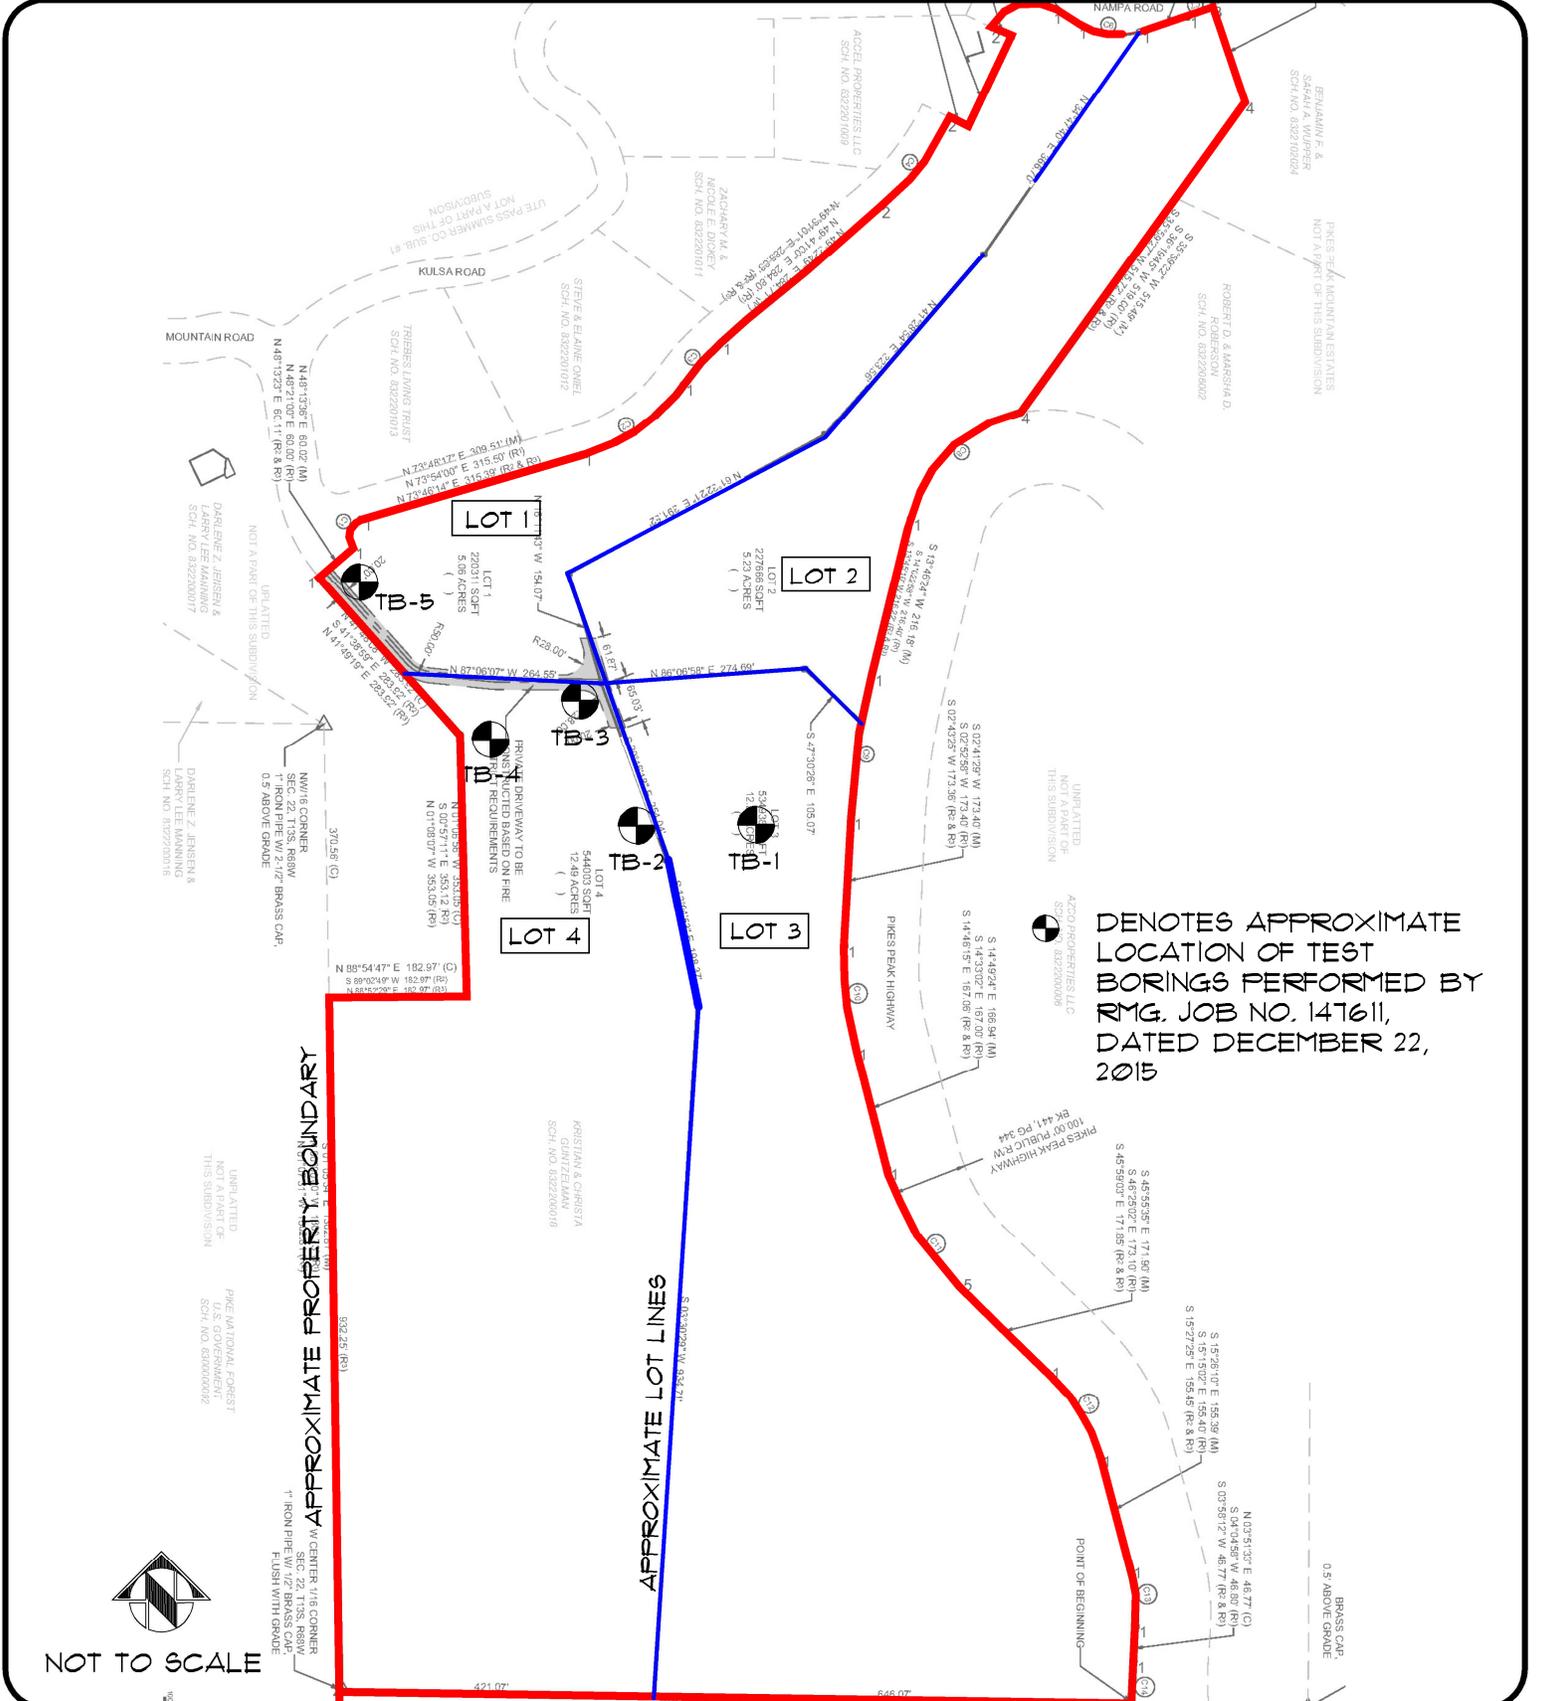
JOB No. 188050
 FIG No. 3
 DATE 3-18-2022
 REV 1-05-2023

DENOTES APPROXIMATE LOCATION OF TEST BORINGS PERFORMED BY RMG, JOB NO. 147611, DATED DECEMBER 22, 2015

**TEST BORING
 LOCATION PLAN**
 MOUNTAIN ROAD
 GUNTZELMAN PORCELAIN
 PINES SUBDIVISION
 EL PASO COUNTY, COLORADO
 KRISTIAN GUNTZELMAN

Personnel of RMG performed a reconnaissance visit on February 22, 2022. The purpose of the reconnaissance visit was to evaluate the site surface characteristics including landscape position, topography, vegetation, natural and cultural features, and current and historic land uses. Five test borings were drilled to depths of approximately 20 to 25 feet below the existing ground surface on December 22, 2015 for the 2016 report referenced above. A Test Boring Location Plan is presented in Figure 3.

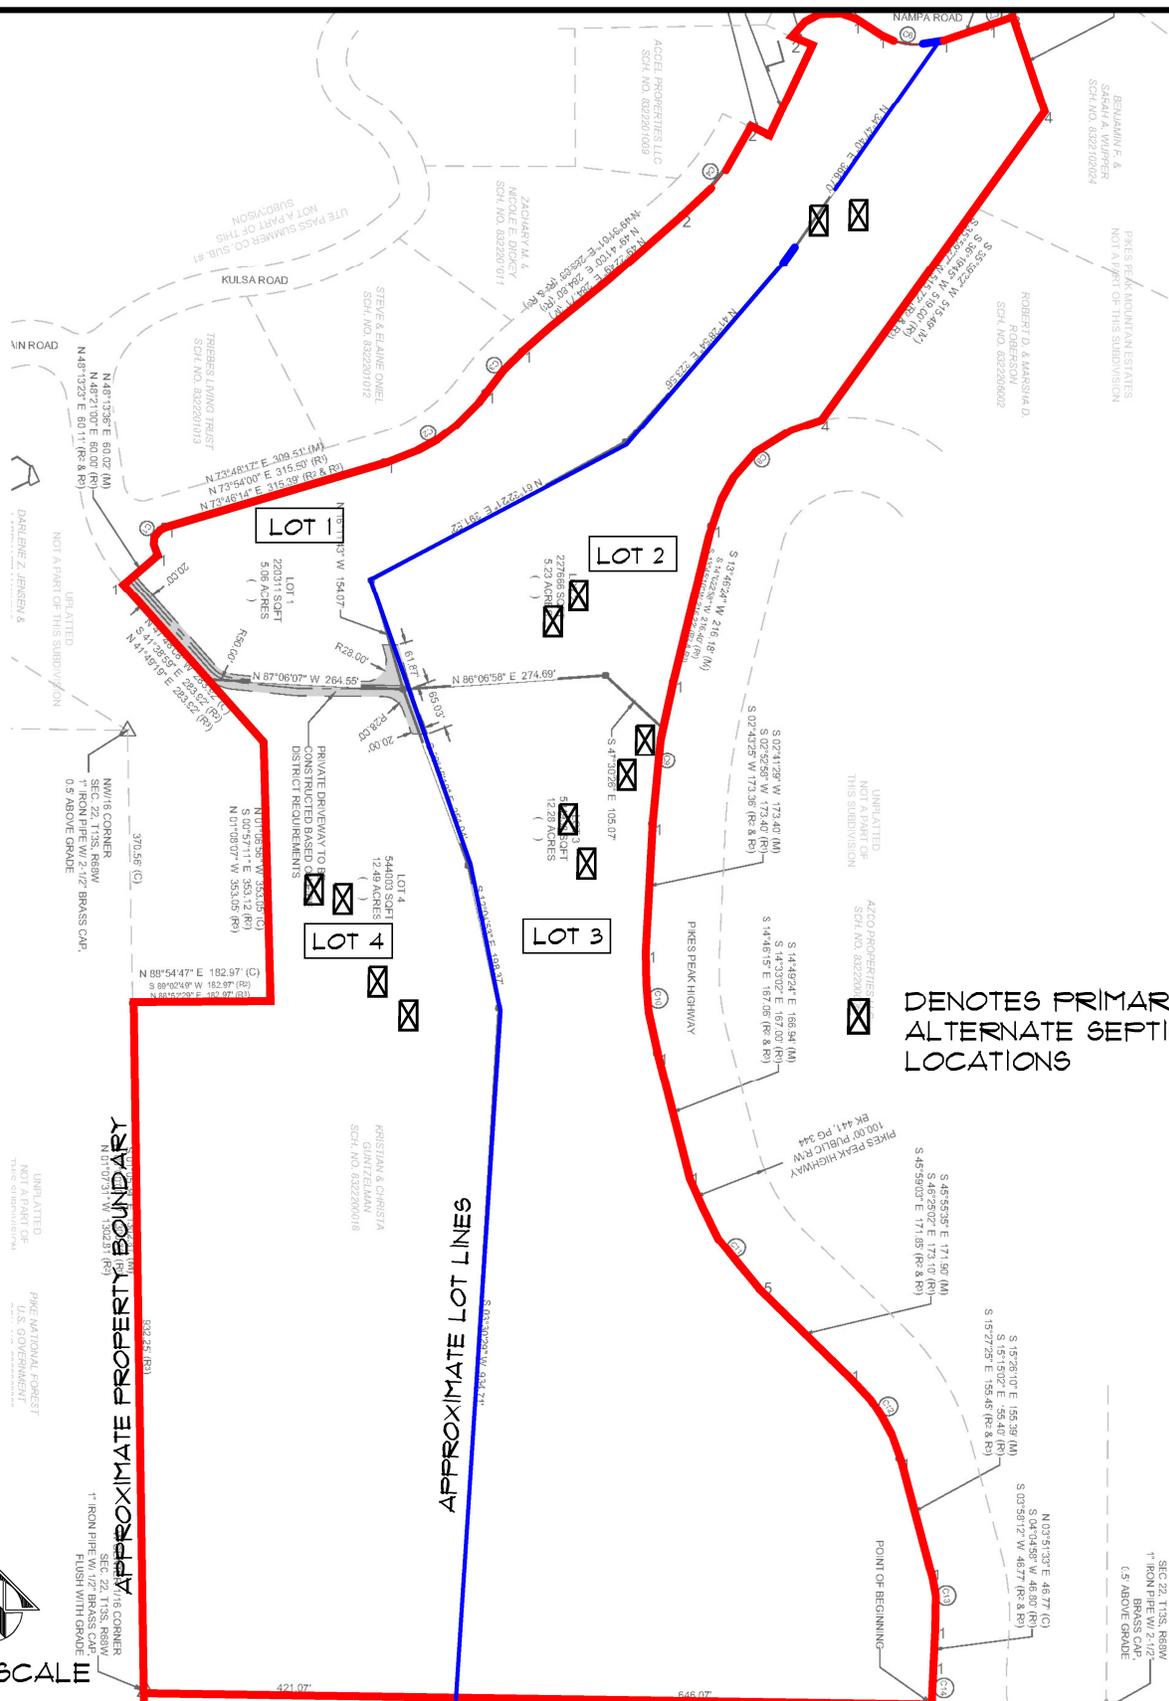
FIG No. 4

X DENOTES PRIMARY AND ALTERNATE SEPTIC LOCATIONS

APPROXIMATE PROPERTY BOUNDARY

Personnel of RMG performed a soil evaluation to include five approximately 20 to 25 foot deep test borings, on December 22, 2015. Soil laboratory testing was performed as a part of the previous investigation and included moisture content, grain-size analyses and Atterberg Limits. The test borings were drilled in areas that appeared most likely to be used for residential construction per the original concept plan dated September 8, 2021. Since the issuance of this study the lot layout has changed. Additional test borings were not drilled to accommodate the Final Plat lot layout, as the soils encountered onsite were fairly uniform. The test boring logs and laboratory test results are presented in the *Preliminary Subsurface Soil Investigation and the Soils and Geology Study*. A Septic Suitability map is presented in Figure 4.

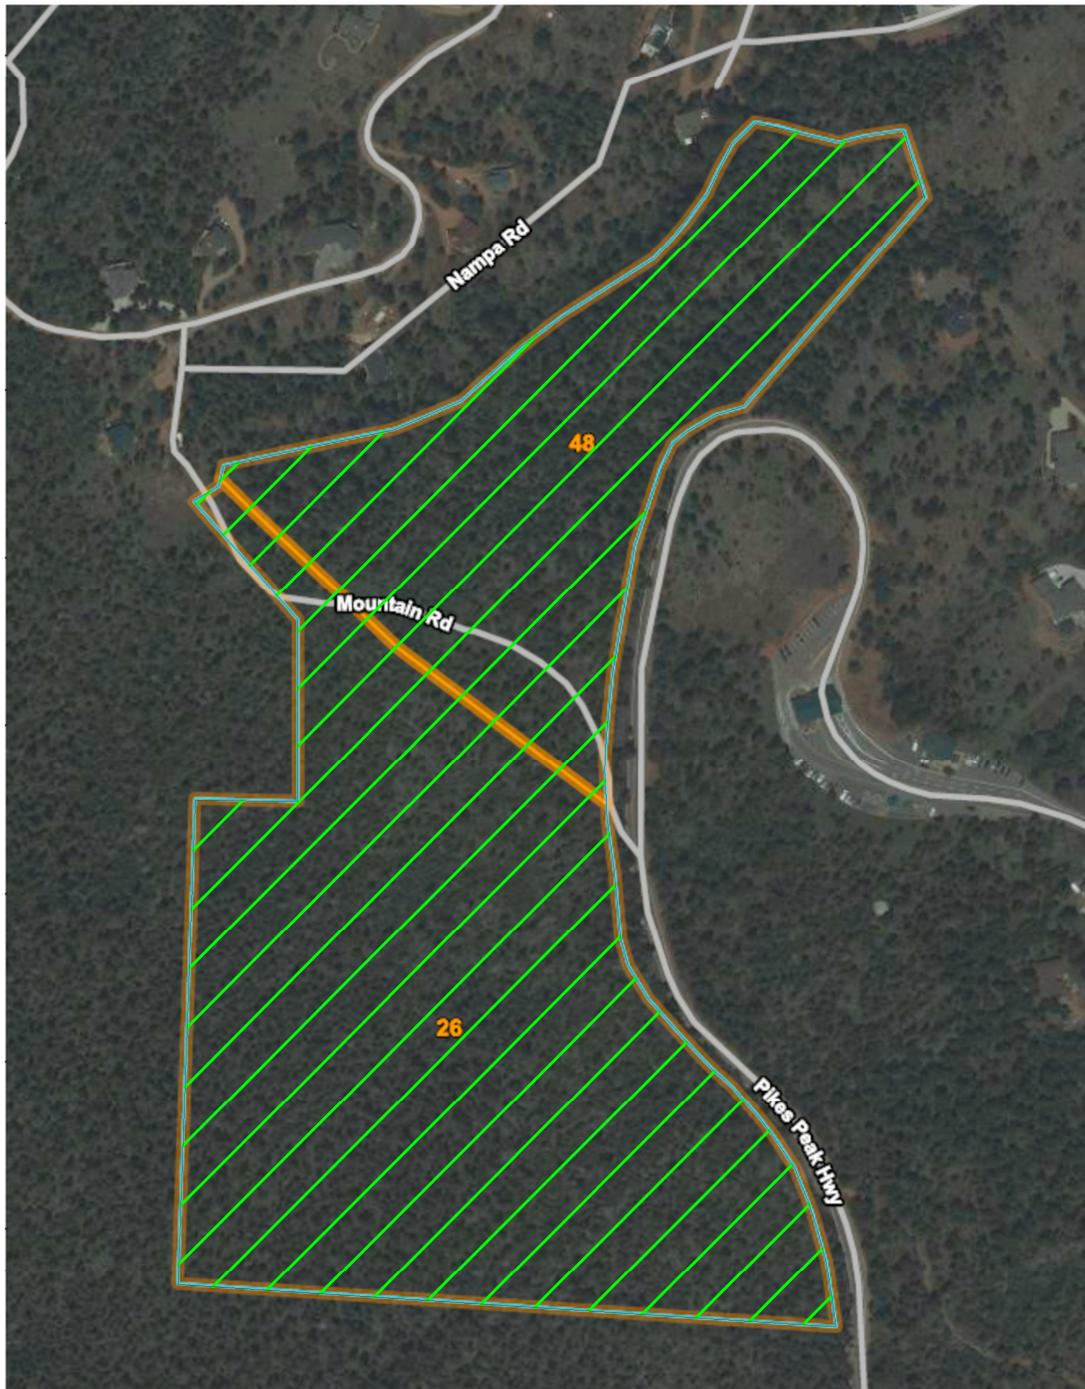
26 - Legault-Rock Outcrop Complex, 15 to 65 percent slopes

48 - Tecolote very gravelly sandy loam, 15 to 40 percent slopes, very stony

The USDA Soil Survey Map is presented in Figure 5.

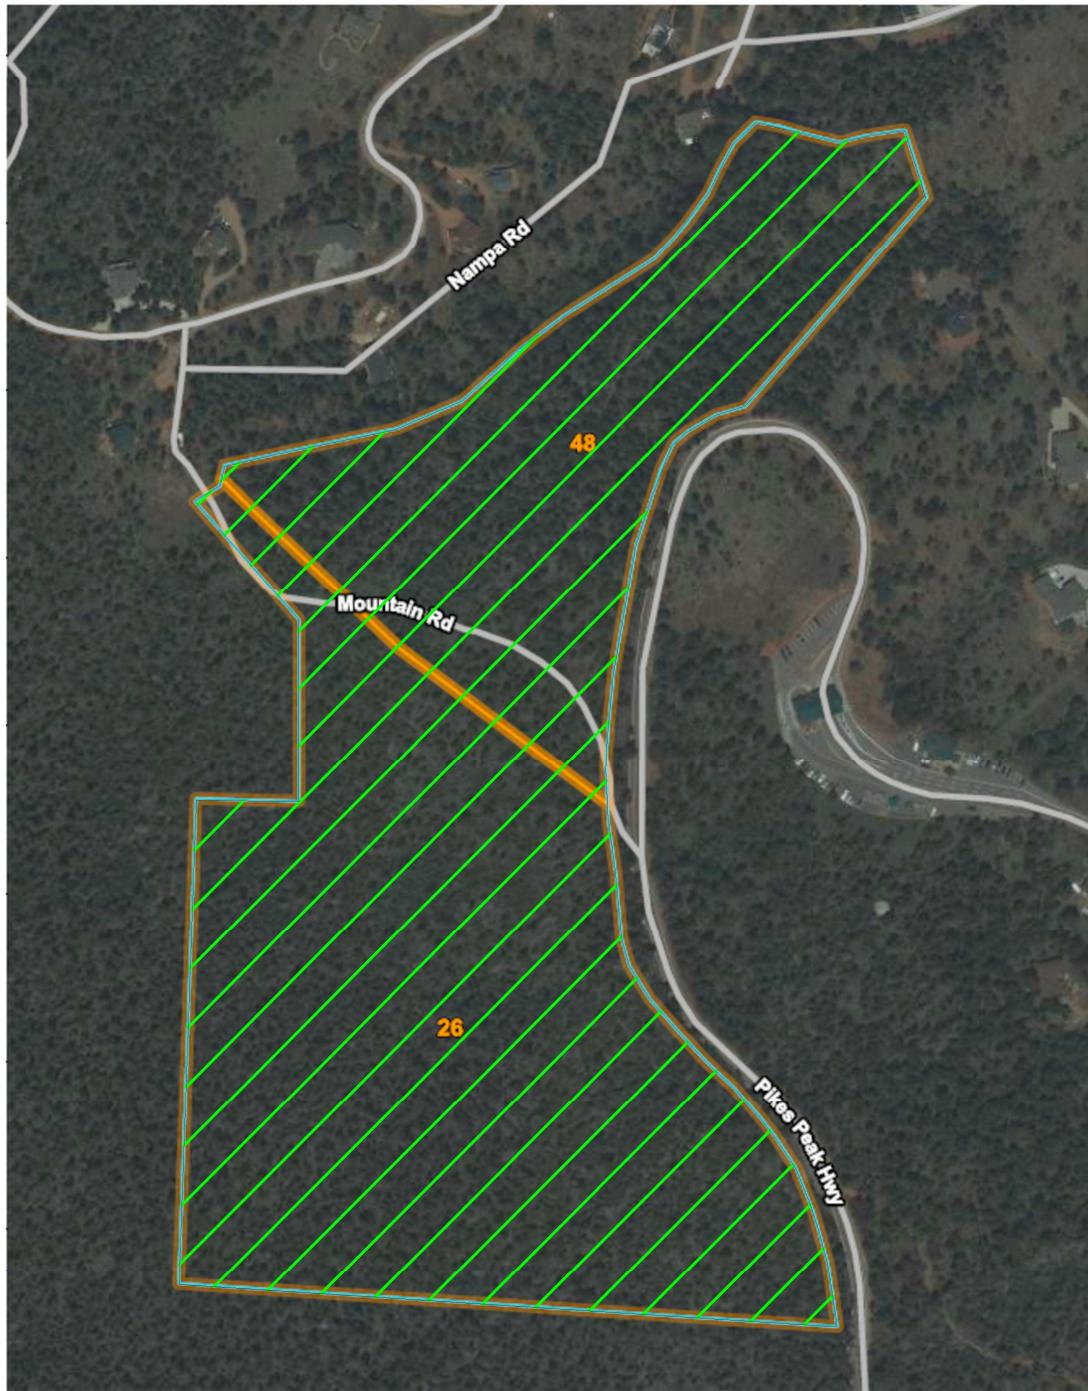
FIG No. 4

26 - Legault-Rock Outcrop Complex, 15 to 65 percent slopes

48 - Tecolote very gravelly sandy loam, 15 to 40 percent slopes, very stony

The USDA Soil Survey Map is presented in Figure 4.

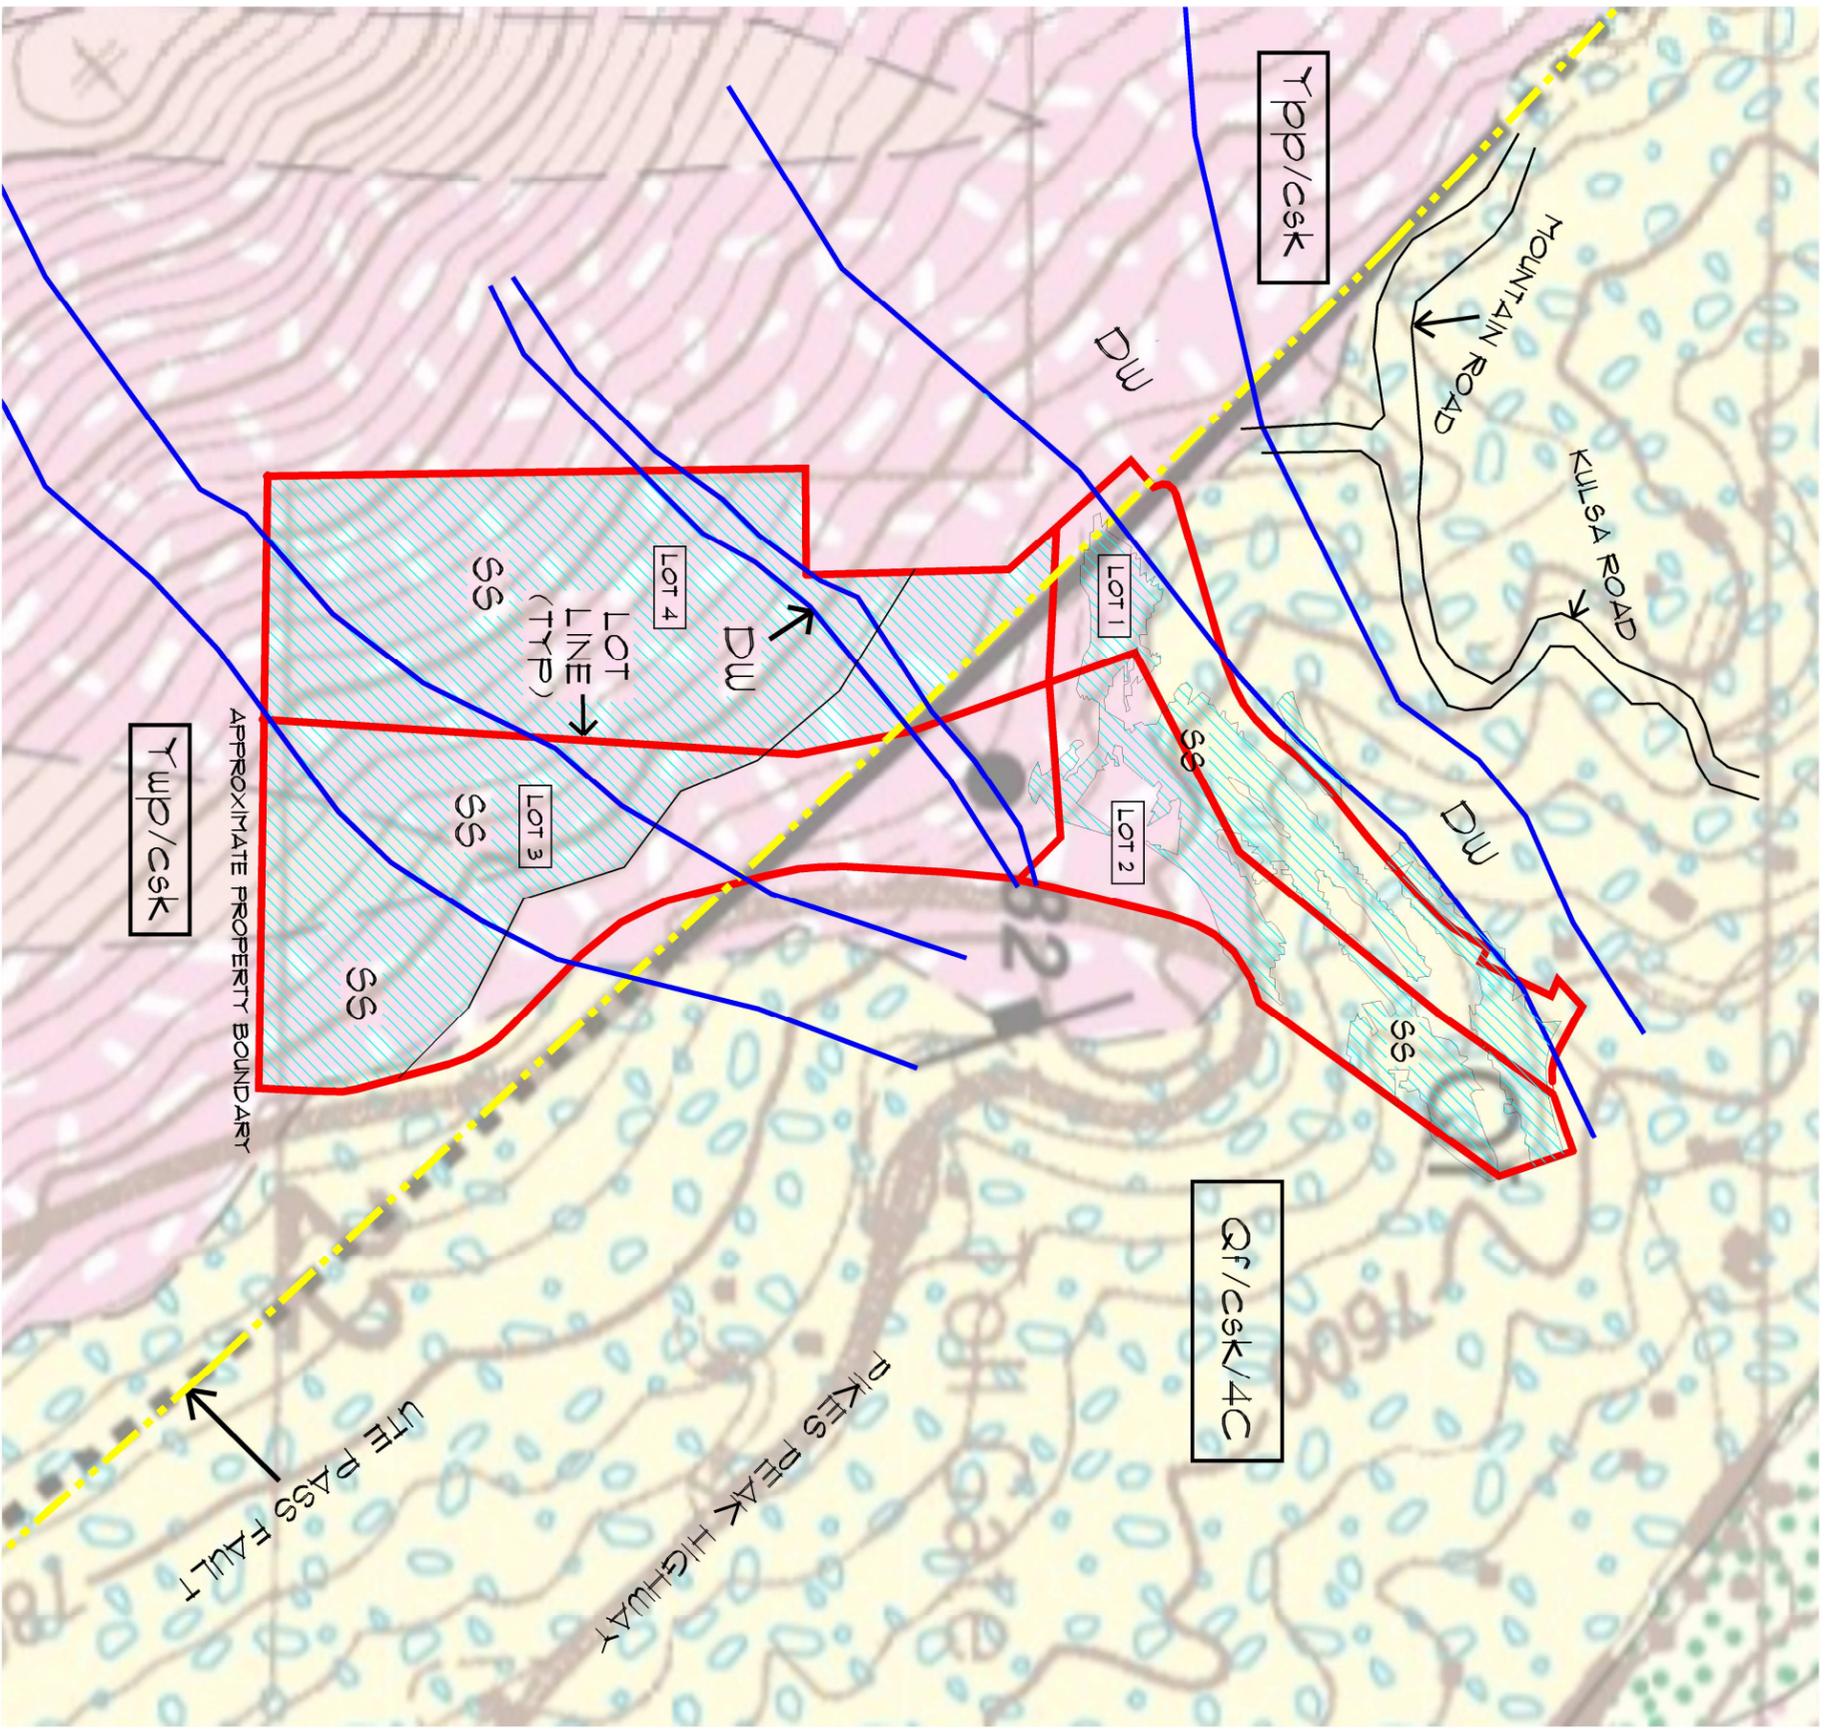
SHEET NO.
FIG-5

Geologic Conditions

- QR - Alluvial fan deposits (Holocene to late Pleistocene)
- Twp - Pikes Peak Granite (Middle Proterozoic)
- Twp - Windy Point Granite (Middle Proterozoic)
- csk - Gneiss, crystalline-class colluvium, alluvium, and rock outcrop
- SS - Steep Slopes, in excess of 30%, designated as "no-build" zones
- DW - Drainageway

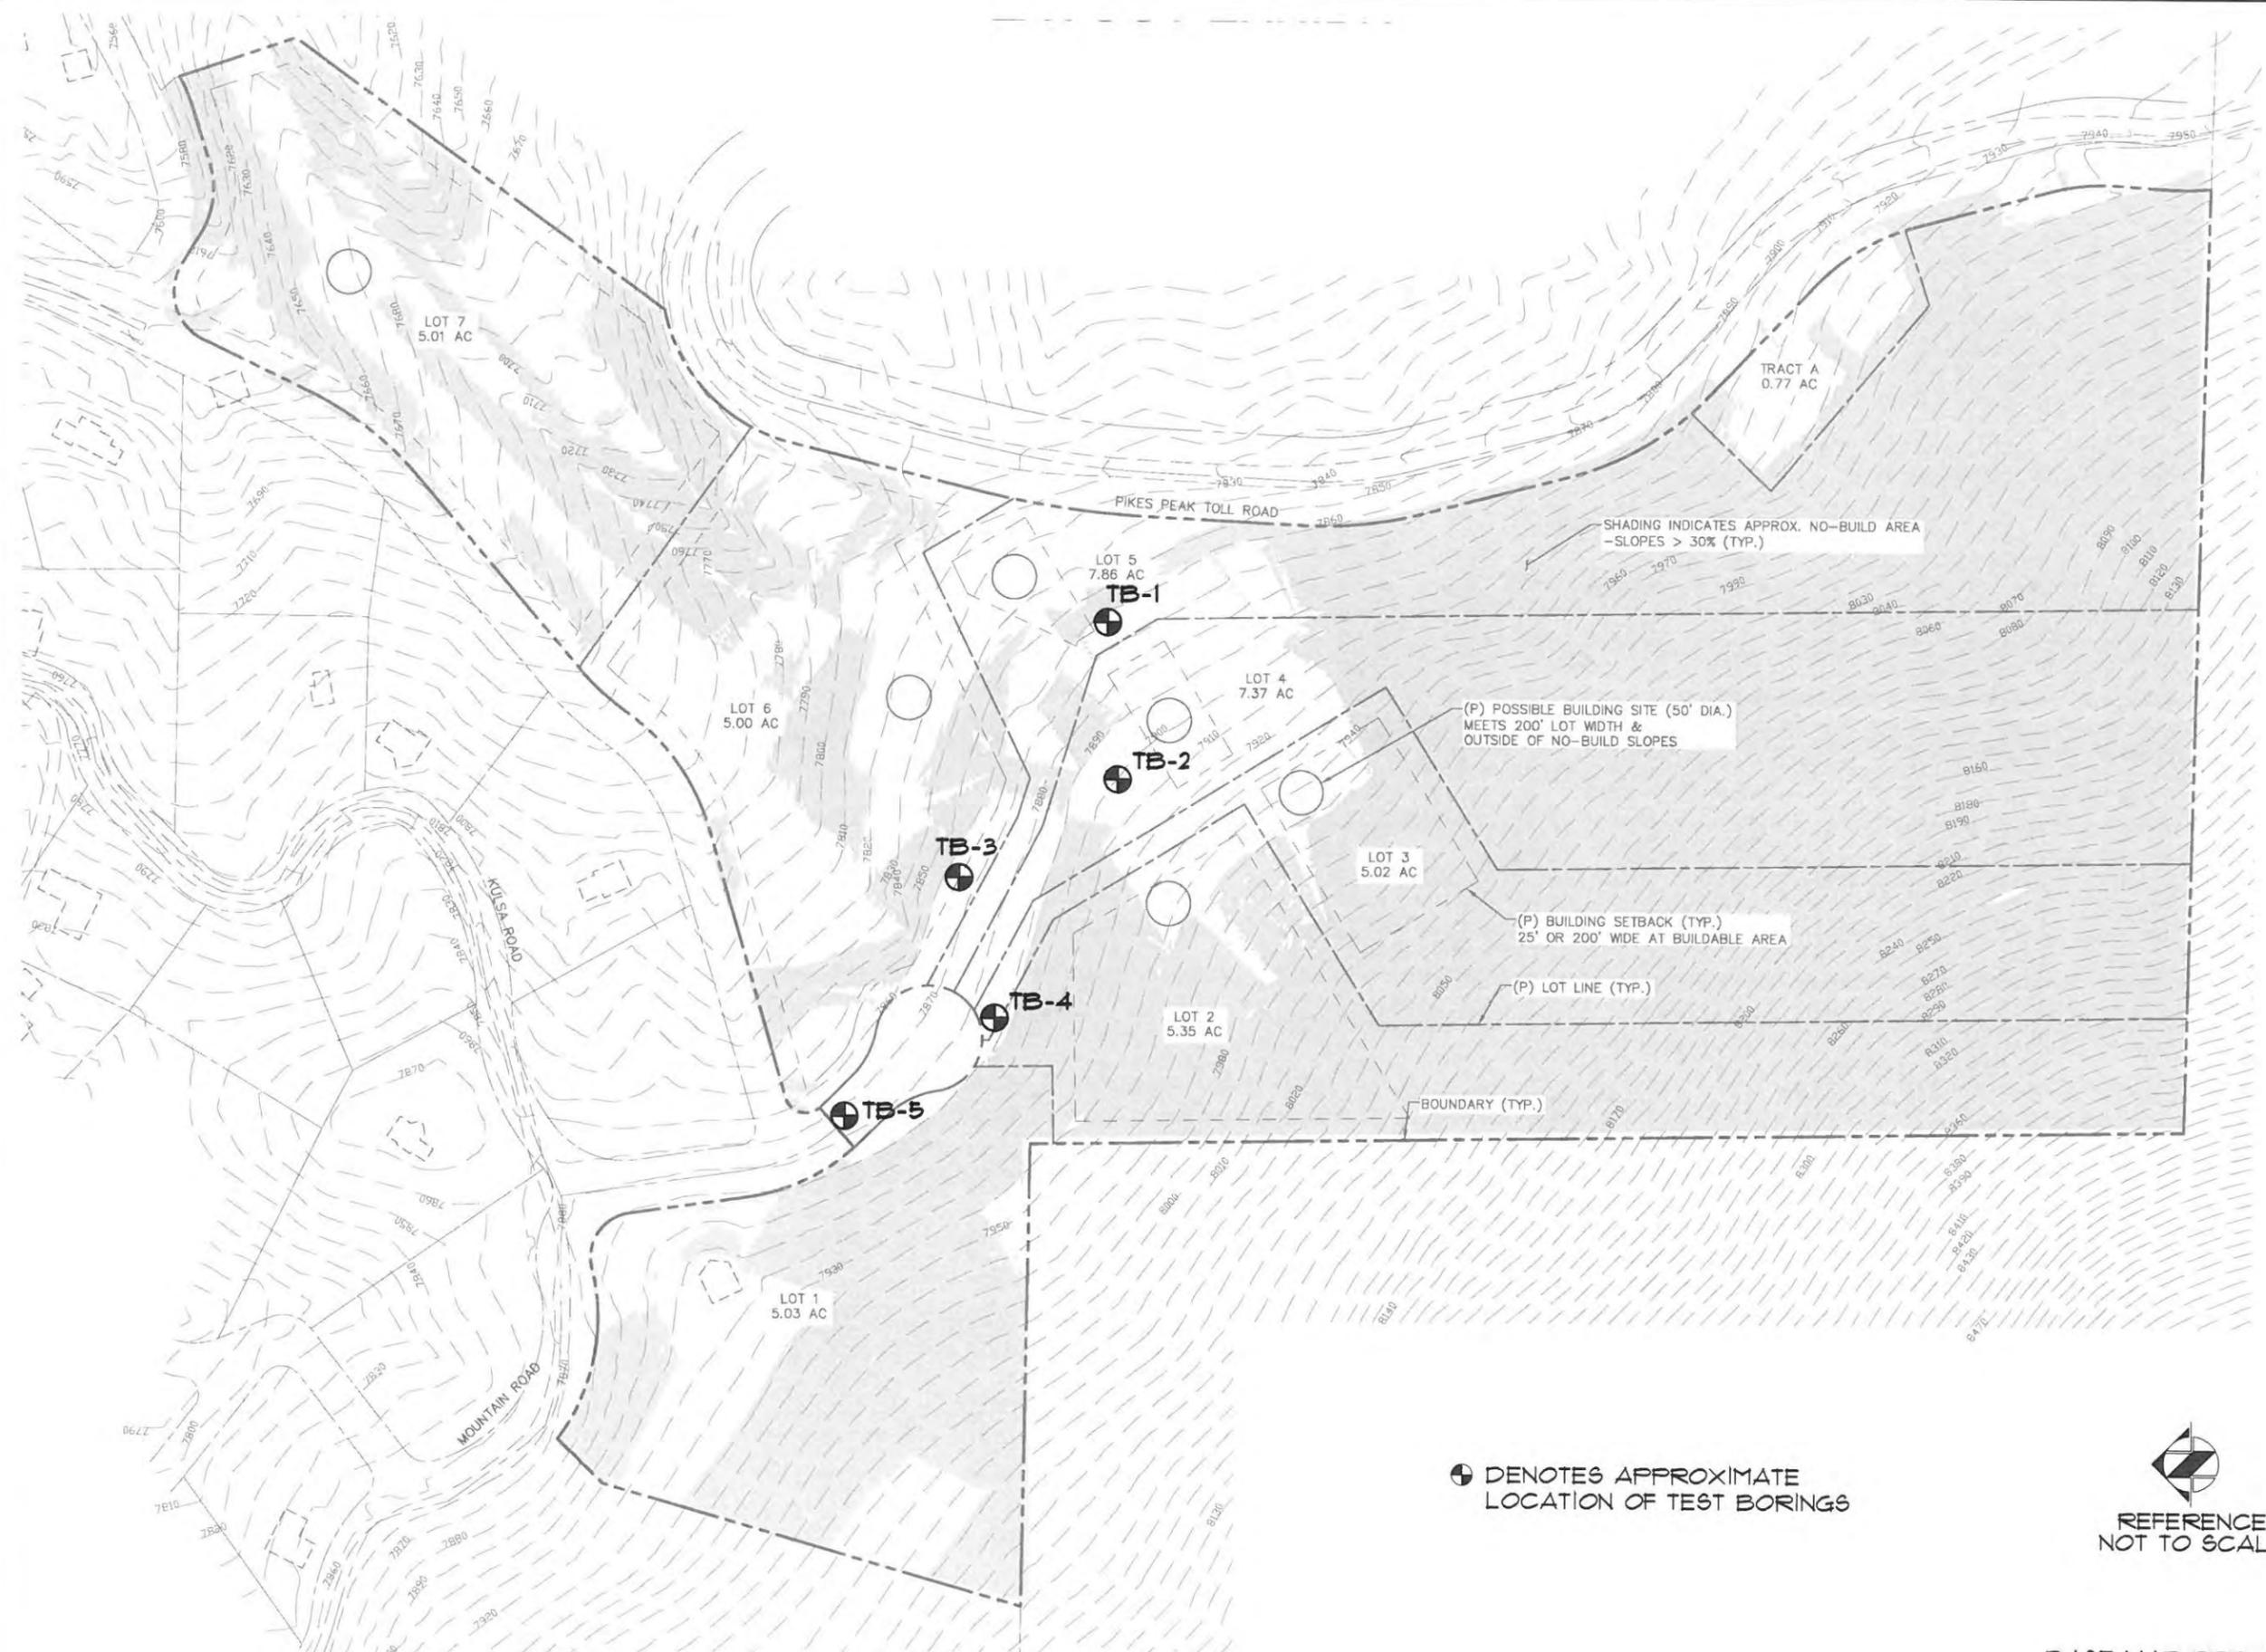
⊕ DENOTES APPROXIMATE LOCATION OF TEST BORINGS

The existing topography is presented in Figure 2, the Topographic Test Boring Location Plan (Ref. 4). In general, the site is considered to be moderately steep to steep. The site slopes generally to the north and east with approximately 800 feet of elevation difference from the southwest corner to the northeast corner of the site.

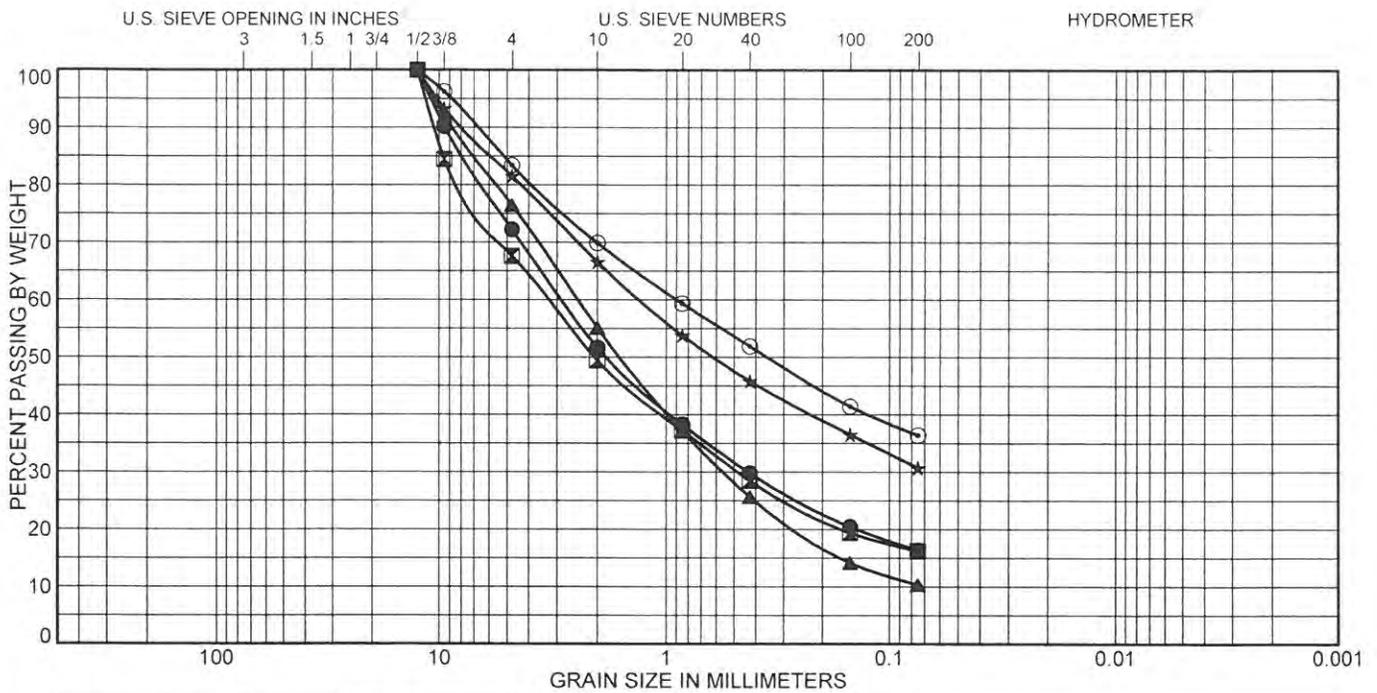
FIGURE No. 8

COBBLES	GRAVEL		SAND			SILT OR CLAY
	coarse	fine	coarse	medium	fine

Test Boring	Depth (ft)	Classification	LL	PL	PI
● 1	9.0	SILTY SAND with GRAVEL(SM)	NP	NP	NP
⊠ 2	14.0	SILTY SAND with GRAVEL(SM)	NP	NP	NP
▲ 2	24.0	WELL-GRADED SAND with SILT and GRAVEL(SW-SM)	NP	NP	NP
★ 3	4.0	SILTY SAND with GRAVEL(SM)	NP	NP	NP
⊙ 3	9.0	CLAYEY SAND with GRAVEL(SC)	39	13	26

Test Boring	Depth (ft)	%Gravel	%Sand	%Silt	%Clay
● 1	9.0	27.8	55.9	16.3	
⊠ 2	14.0	32.4	51.4	16.2	
▲ 2	24.0	23.5	66.1	10.4	
★ 3	4.0	18.5	50.8	30.7	
⊙ 3	9.0	16.6	47.0	36.4

SOIL CLASSIFICATION DATA

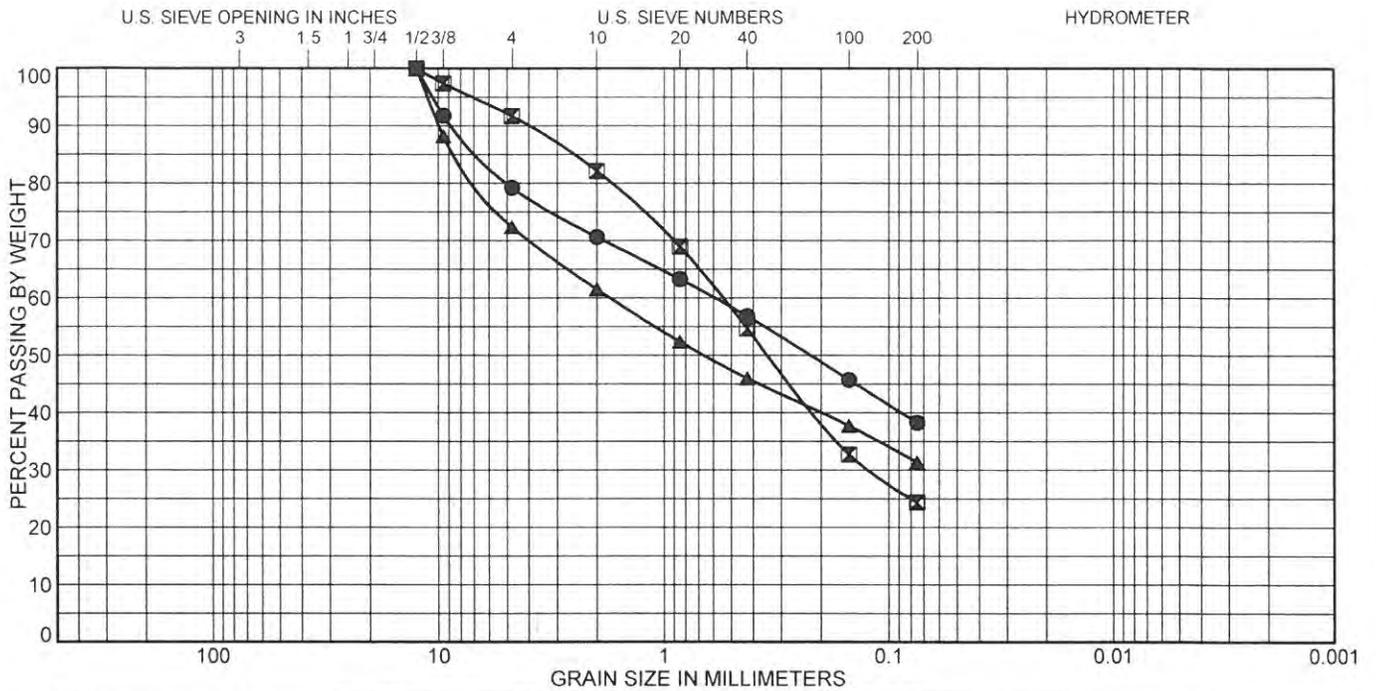
FIGURE No. 9

COBBLES	GRAVEL		SAND			SILT OR CLAY
	coarse	fine	coarse	medium	fine

Test Boring	Depth (ft)	Classification	LL	PL	PI
● 4	9.0	CLAYEY SAND with GRAVEL(SC)	36	13	23
☒ 4	14.0	SILTY SAND(SM)	NP	NP	NP
▲ 5	4.0	CLAYEY SAND with GRAVEL(SC)	34	13	21

Test Boring	Depth (ft)	%Gravel	%Sand	%Silt	%Clay
● 4	9.0	20.8	41.0	38.3	
☒ 4	14.0	8.3	67.3	24.4	
▲ 5	4.0	27.6	41.0	31.4

SOIL CLASSIFICATION DATA

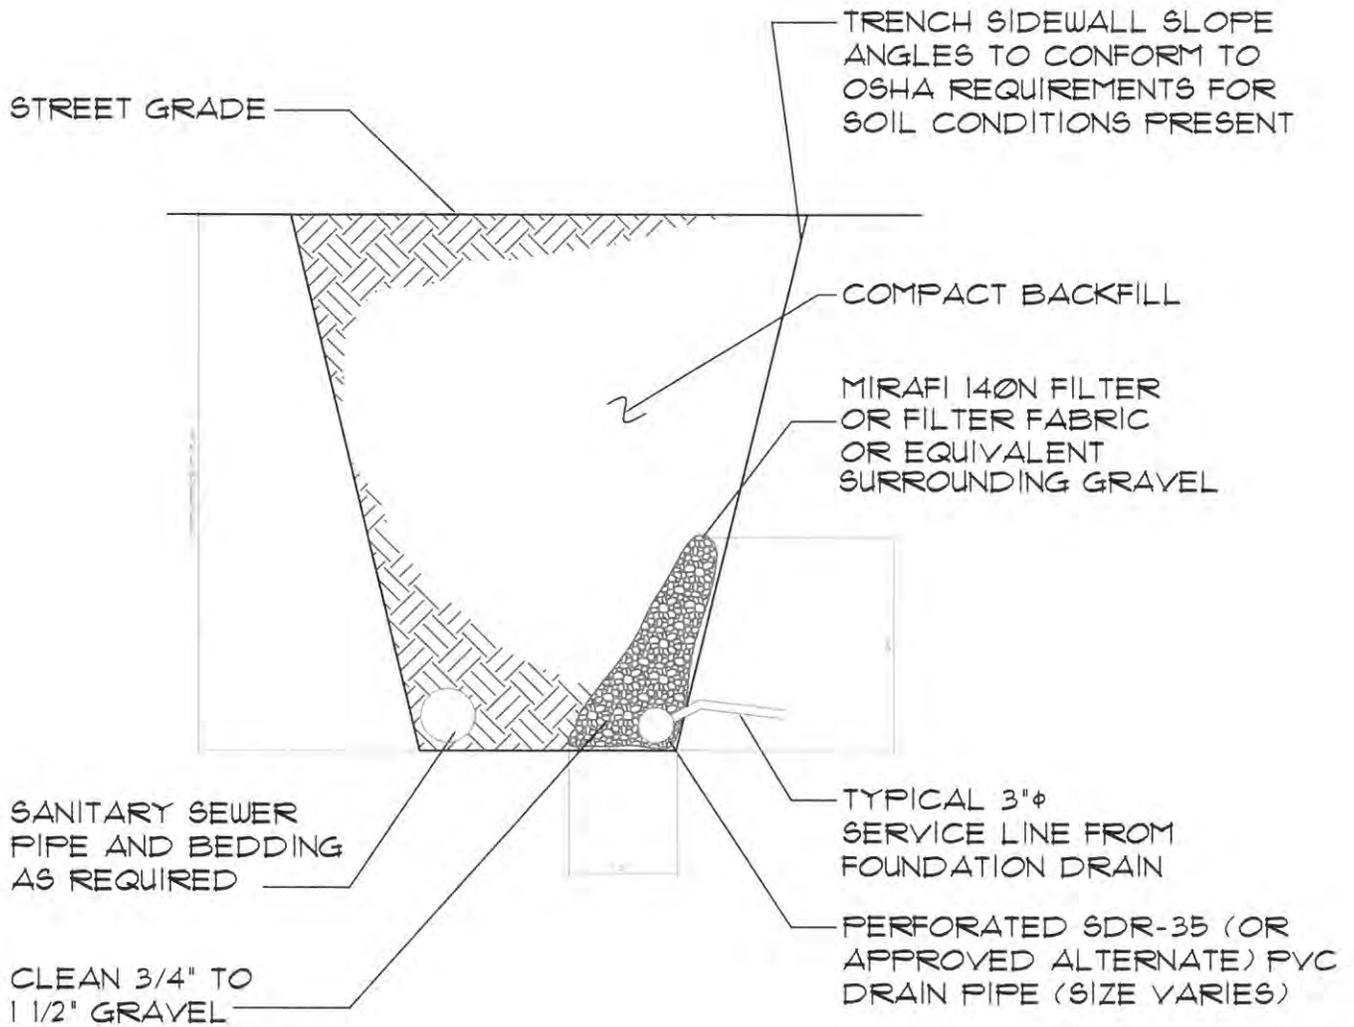
FIG No. 12

NOTE: TO BE USED IN CASES WHERE
GROUNDWATER IS FOUND DURING
TRENCHING OR WHERE SHALLOW
GROUNDWATER IS KNOWN TO EXIST

It is a common local practice for underdrains to be placed at the bottom of sanitary sewer trenched within drive lanes. Underdrains placed in the sanitary sewer trenches in areas where groundwater is anticipated will likely be the "active" type, which uses a perforated drain pipe. In areas where groundwater is not anticipated, "passive" type underdrains may be used. The outfall for the sanitary sewer trench underdrain was not known at the time of this investigation because the development plan and grading plan were not available for our review. Typical underdrain details are presented in Figures 12 and 13.

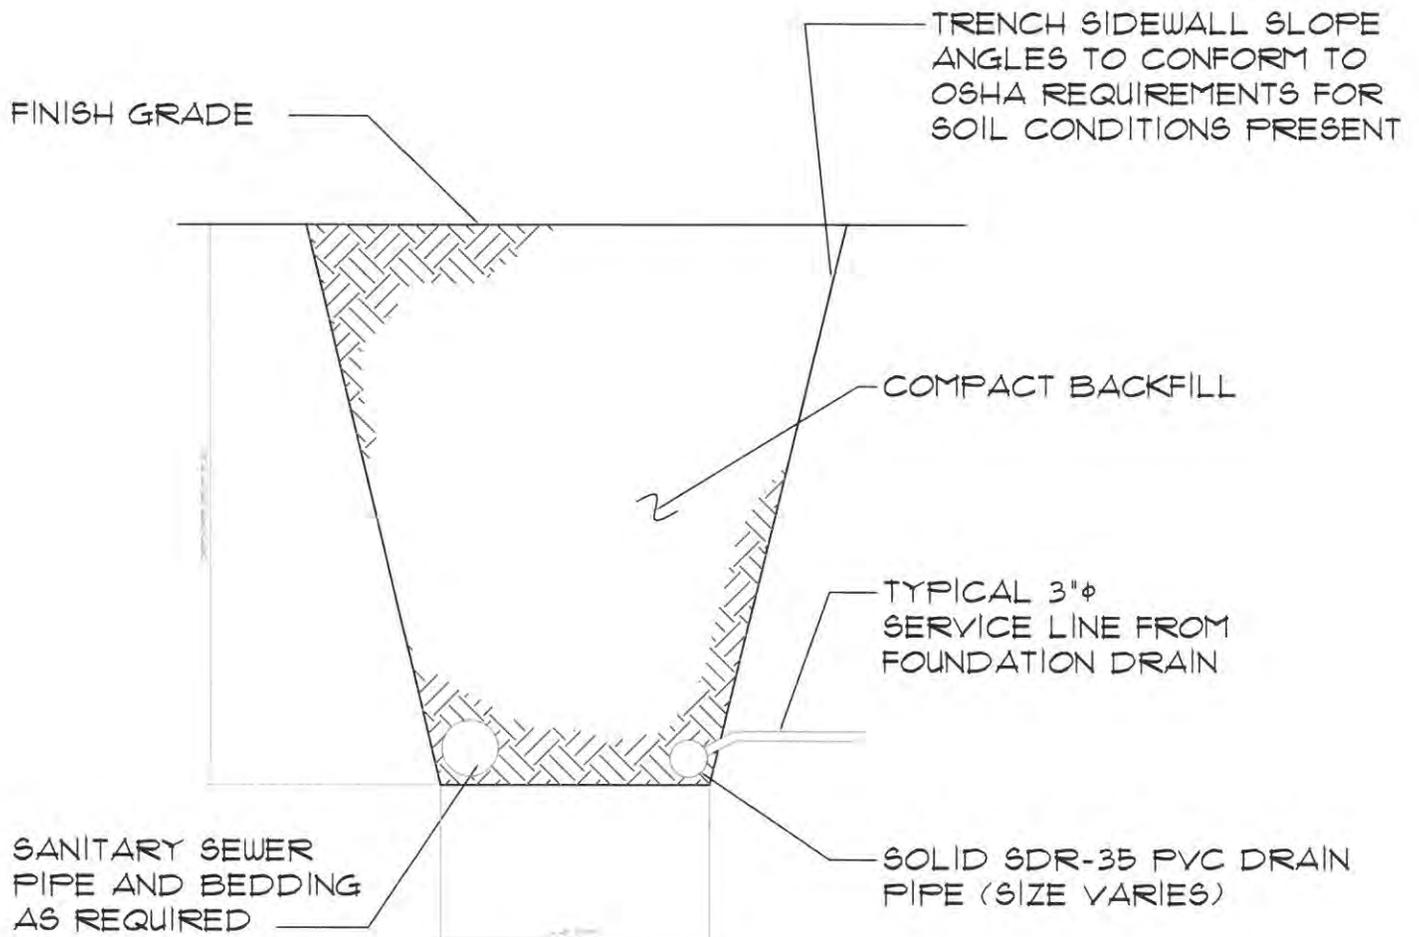
NOTE: TO BE USED WHERE NO
SHALLOW GROUNDWATER IS KNOWN TO
EXIST

PASSIVE DRAIN IN
SANITARY SEWER TRENCH
