SOIL AND GEOLOGY STUDY

**Mountain Road
Guntzelman Porcelain Pines Subdivision
El Paso County, Colorado**

JOB NO. 188050

**March 18, 2022
Amended January 10, 2023**

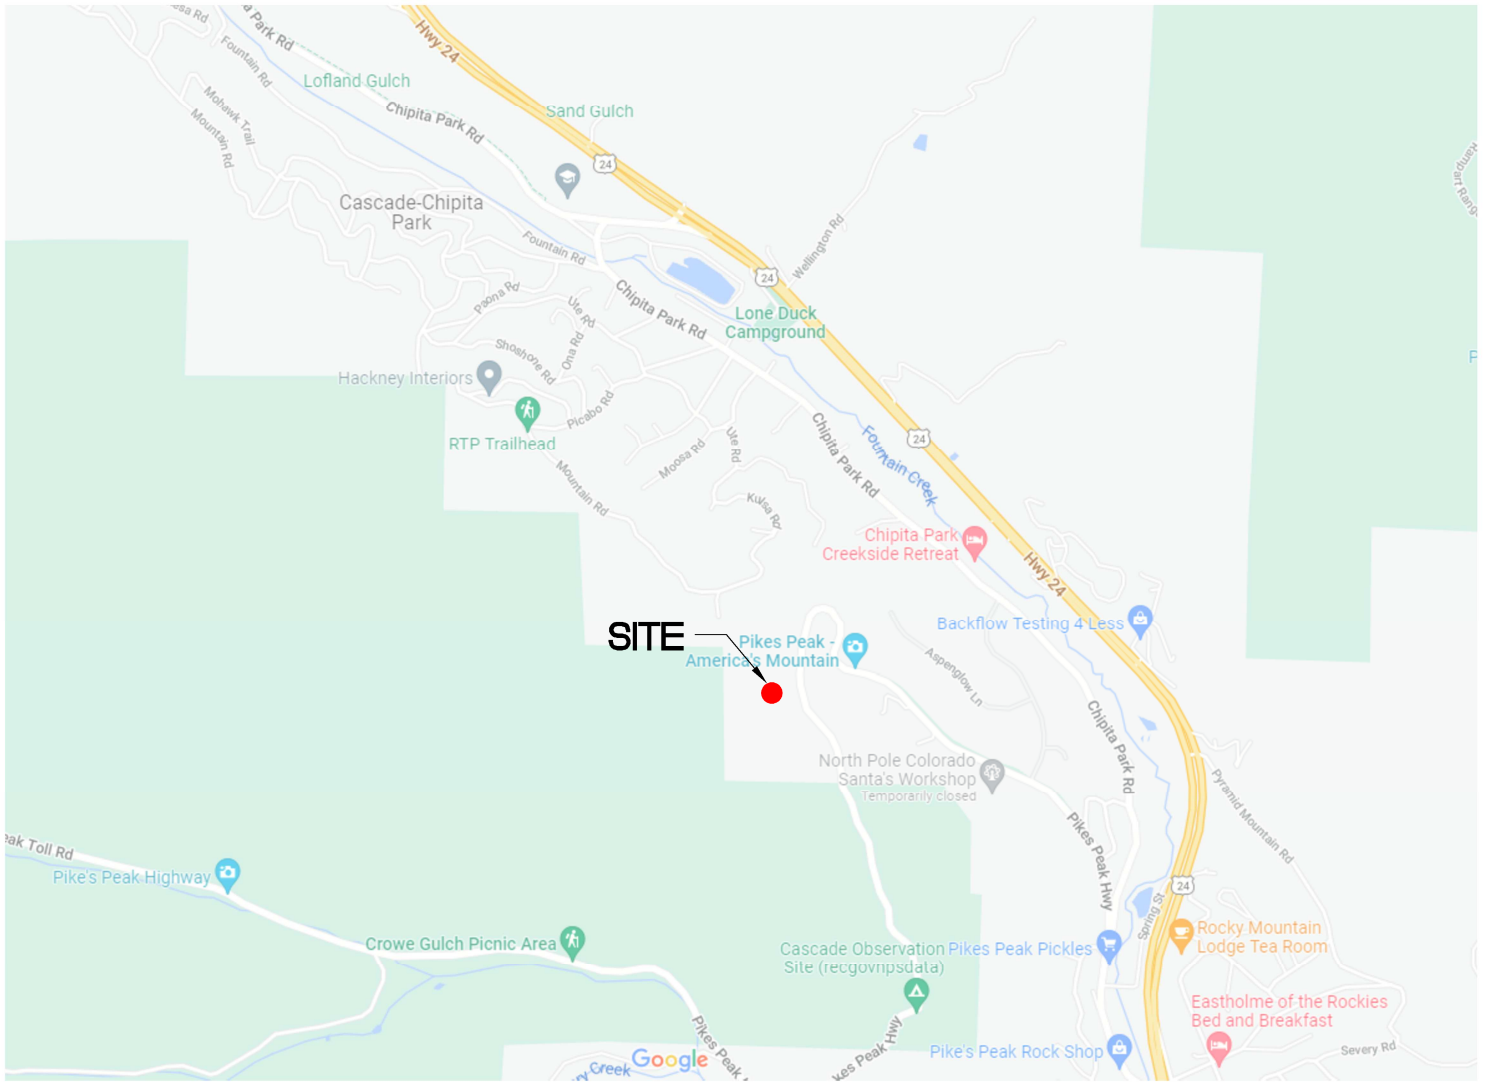
FIG No. 1

NOT TO SCALE

The project lies in Section 22, Township 13 South, Range 68 West of the 6th Principal Meridian in El Paso County, Colorado, and is generally located southeast of Chipita Park, Colorado near the intersection of Mountain Road and Kulsa Road. The approximate location of the site is shown on the Site Vicinity Map, Figure 1.

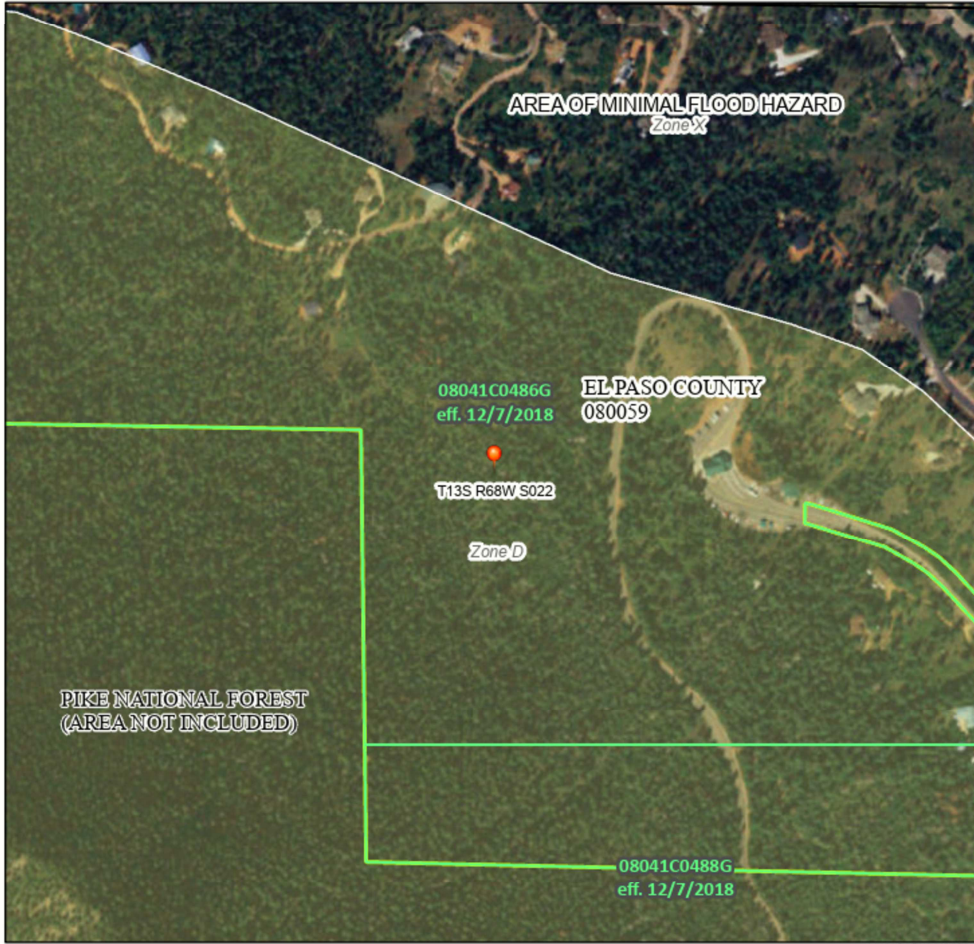
FIG No. 6

0 250 500 1,000 1,500 2,000 Feet 1:6,000

Basemap: USGS National Map; Orthoimagery; Data refreshed October, 2020

Based on our review of the Federal Emergency Management Agency (FEMA) Community Panel No. 08041C0486 and the online ArcGIS El Paso County Risk Map, the entire site lies outside of identified 100 or 500-year floodplains. The site lies in Zone X and Zone D. Zone X is defined by FEMA as an area of minimal flood hazard that is determined to be outside the Special Flood Hazard Area and higher than the elevation of the 0.2-percent-annual-chance (or 500-year) flood. Zone D is defined by FEMA as an Area of Undetermined Flood Hazard. The FEMA Map is presented in Figure 6.

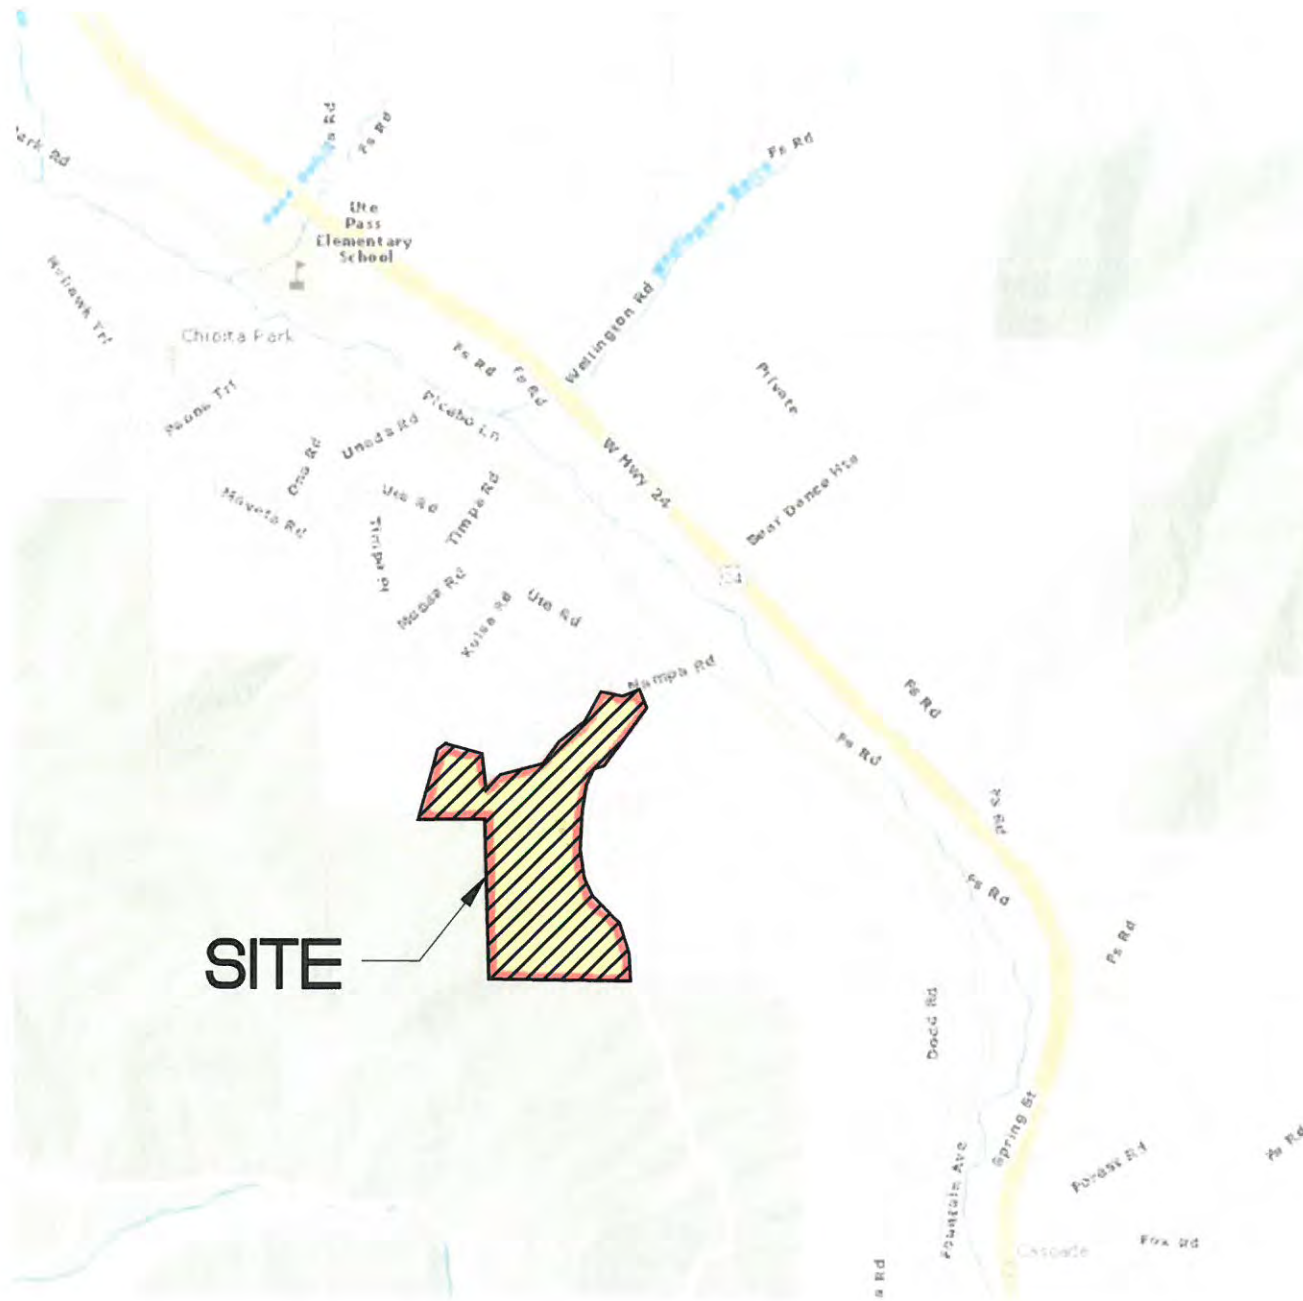
FIG No. 1

SITE

The project lies in Section 22, Township 13 South, Range 68 West of the 6th Principal Meridian in El Paso County, Colorado. The site is generally located southeast of Chipita Park, Colorado near the intersection of Mountain Road and Kulsa Road. The approximate location of the site is shown on the Site Vicinity Map, Figure 1 (Ref. 1).
