Re: Wastewater Study

Mountain Rd

Guntzelman Porcelain Pines Subdivision

El Paso County, Colorado

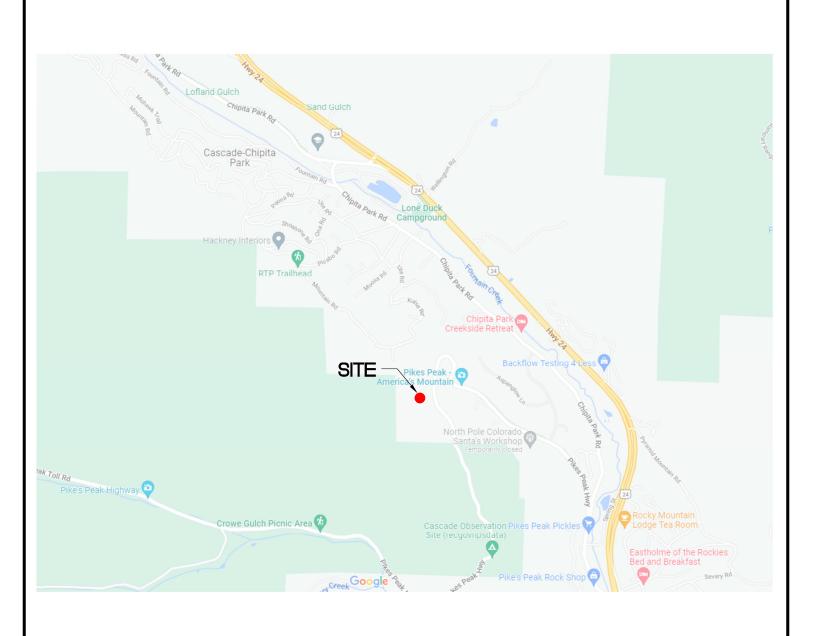
FIG No. 1

Each new lot is to be serviced by an on-site wastewater treatment system (OWTS), and all four lots are reportedly to be serviced by a "communal" water supply well. The site is to be accessed from Mountain Road which is to be extended for the proposed subdivision. A Site Vicinity Map is included as Figure 1.

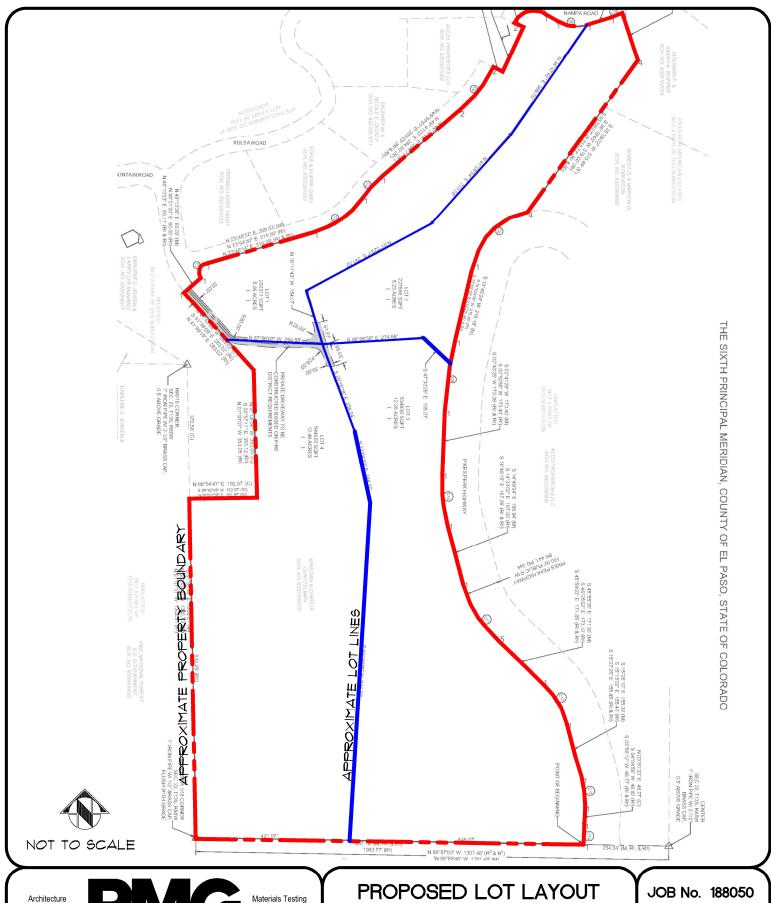
FIG No. 2

The site consists of approximately 35.16 acres and is undeveloped, vacant land. It is our understanding the existing 35.16 acres is to be subdivided into a total of four lots. The lots are to range between approximately 5.06 acres and 12.49 acres each. The Proposed Lot Layout is included as Figure 2.

March 18, 2022 Amended January 10, 2023 Comments have been provided on Figure 2 map sheet.

The information provided in this report is based upon the subsurface conditions observed from drilling five test borings and accepted engineering procedures. The subsurface conditions encountered in the test borings for the treatment area may vary from those encountered in the test pit excavations. Therefore, depth to limiting or restrictive conditions, bedrock, and groundwater may be different from the results reported in this letter. The proposed residences and OWTS should be located outside of the no-build area slopes as indicated in the Proposed Lot Layout included as Figure 2.

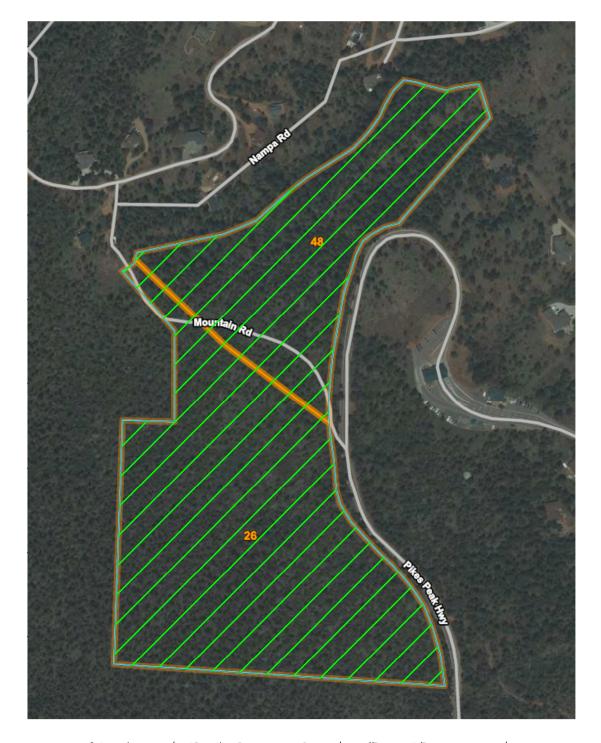
26 - Legault-Rock Outcrop Complex, 15 to 65 percent slopes

Personnel of RMG performed a soil evaluation to include five approximately 20 to 25 foot deep test borings, on December 22, 2015. Soil laboratory testing was performed as a part of the previous investigation and included moisture content, grain-size analyses and Atterberg Limits. The test borings were drilled in areas that appeared most likely to be used for residential construction per the original concept plan dated September 8, 2021. Since the issuance of this study the lot layout has changed. Additional test borings were not drilled to accommodate the Final Plat lot layout, as the soils encountered onsite were fairly uniform. The test boring logs and laboratory test results are presented in the *Preliminary Subsurface Soil Investigation and the Soils and Geology Study*. A Septic Suitability map is presented in Figure 4.
