SOIL AND GEOLOGY STUDY

**Lots 1-3
Guntzelman Porcelain Pines Subdivision
El Paso County, Colorado**

JOB NO. 188050

**March 18, 2022
Last Amended December 15, 2023**

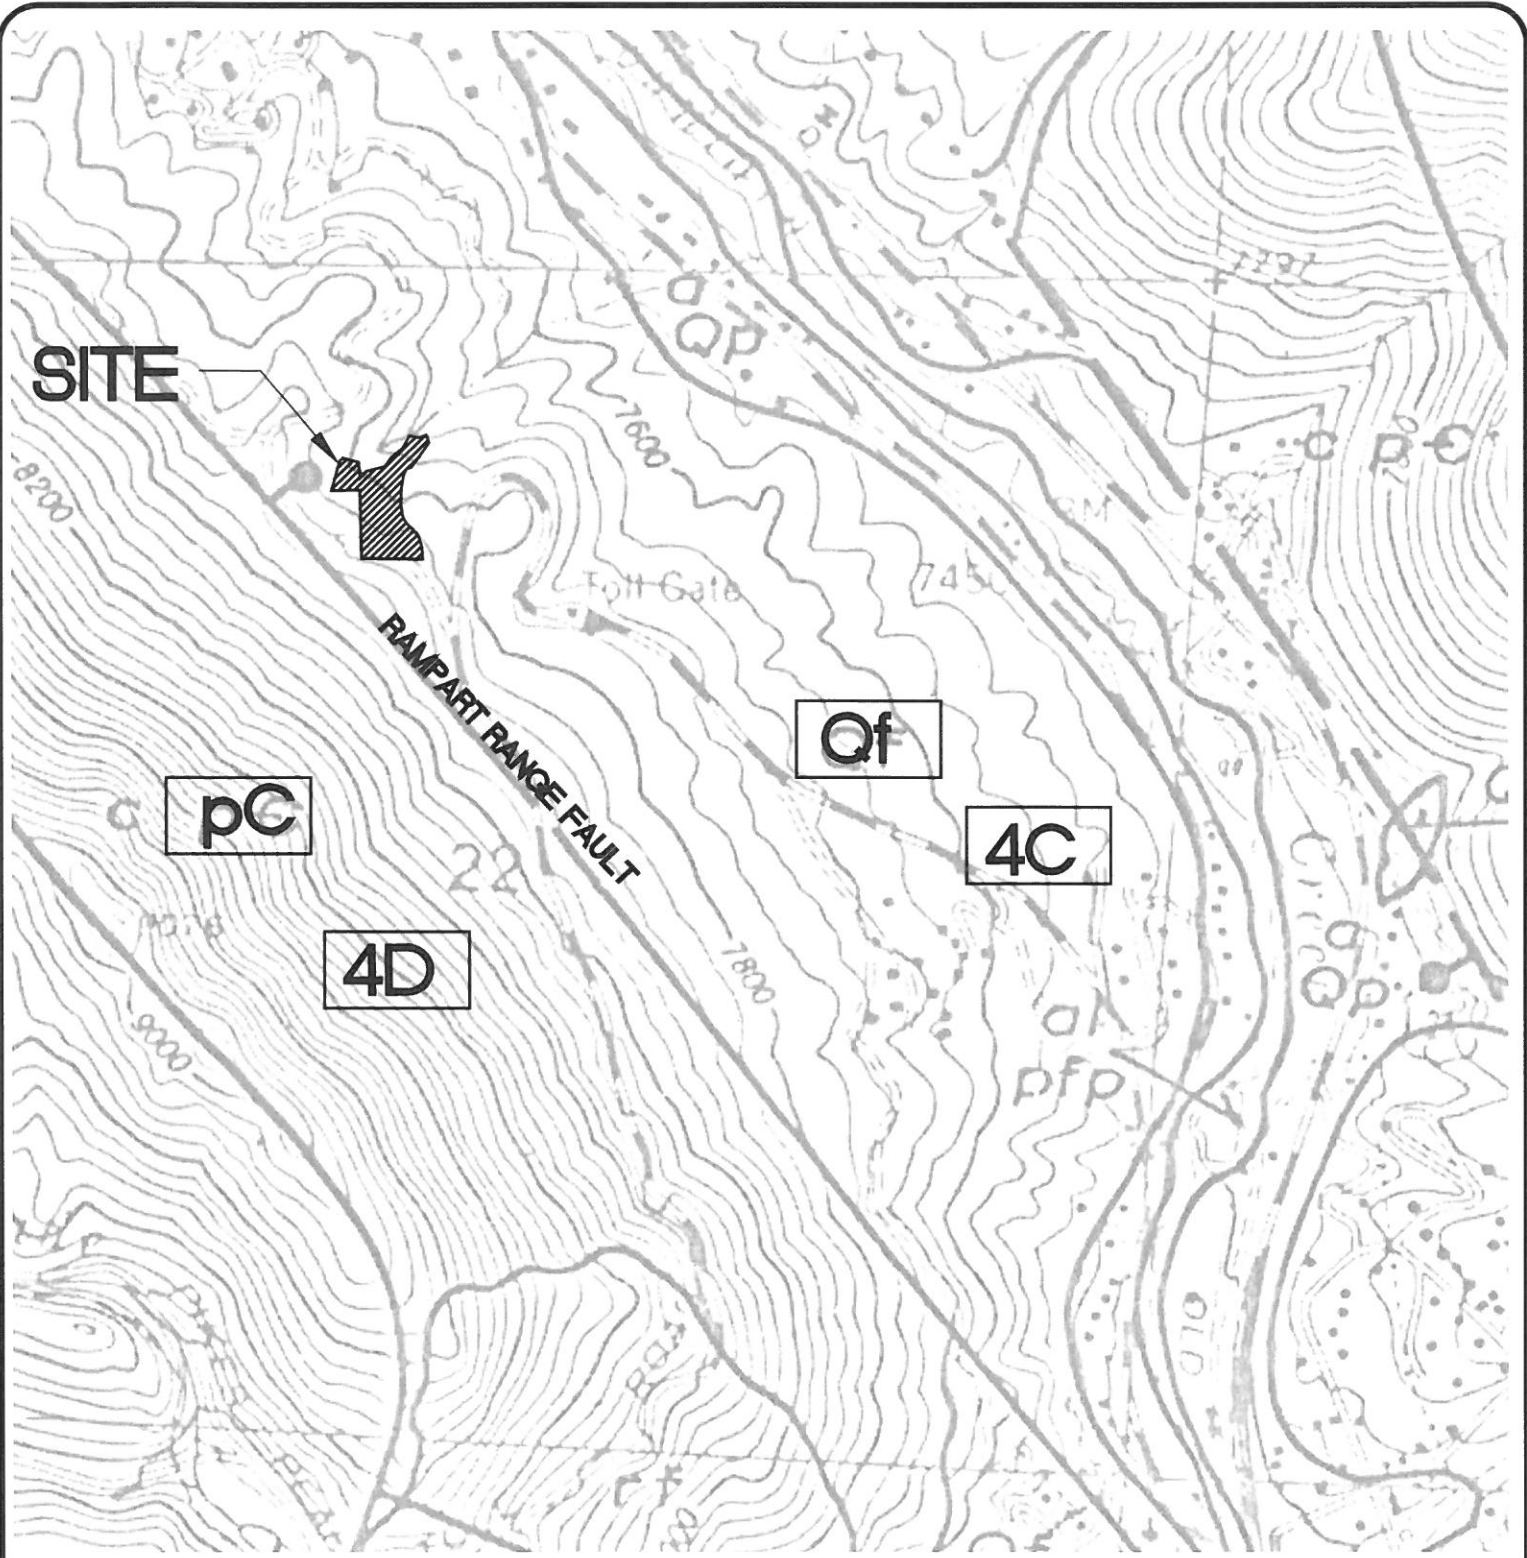
FIG No. 10

BASE MAP PROVIDED BY:
USGS

In general, the geology at the site consists of older fan deposits and alluvium soils. A General Engineering Geology Map is presented in Figure 10. One geologic unit and one environmental engineering unit were mapped at the site as:
