**SOILS AND GEOLOGY STUDY  
LIFE CHURCH AT BENT GRASS NORTH  
PARCEL NOS. 53010-00-026 and 53010-00-033  
EL PASO COUNTY, COLORADO**

Entech Job No. 241719  
LLL/JCG

**PCD No. SF268**

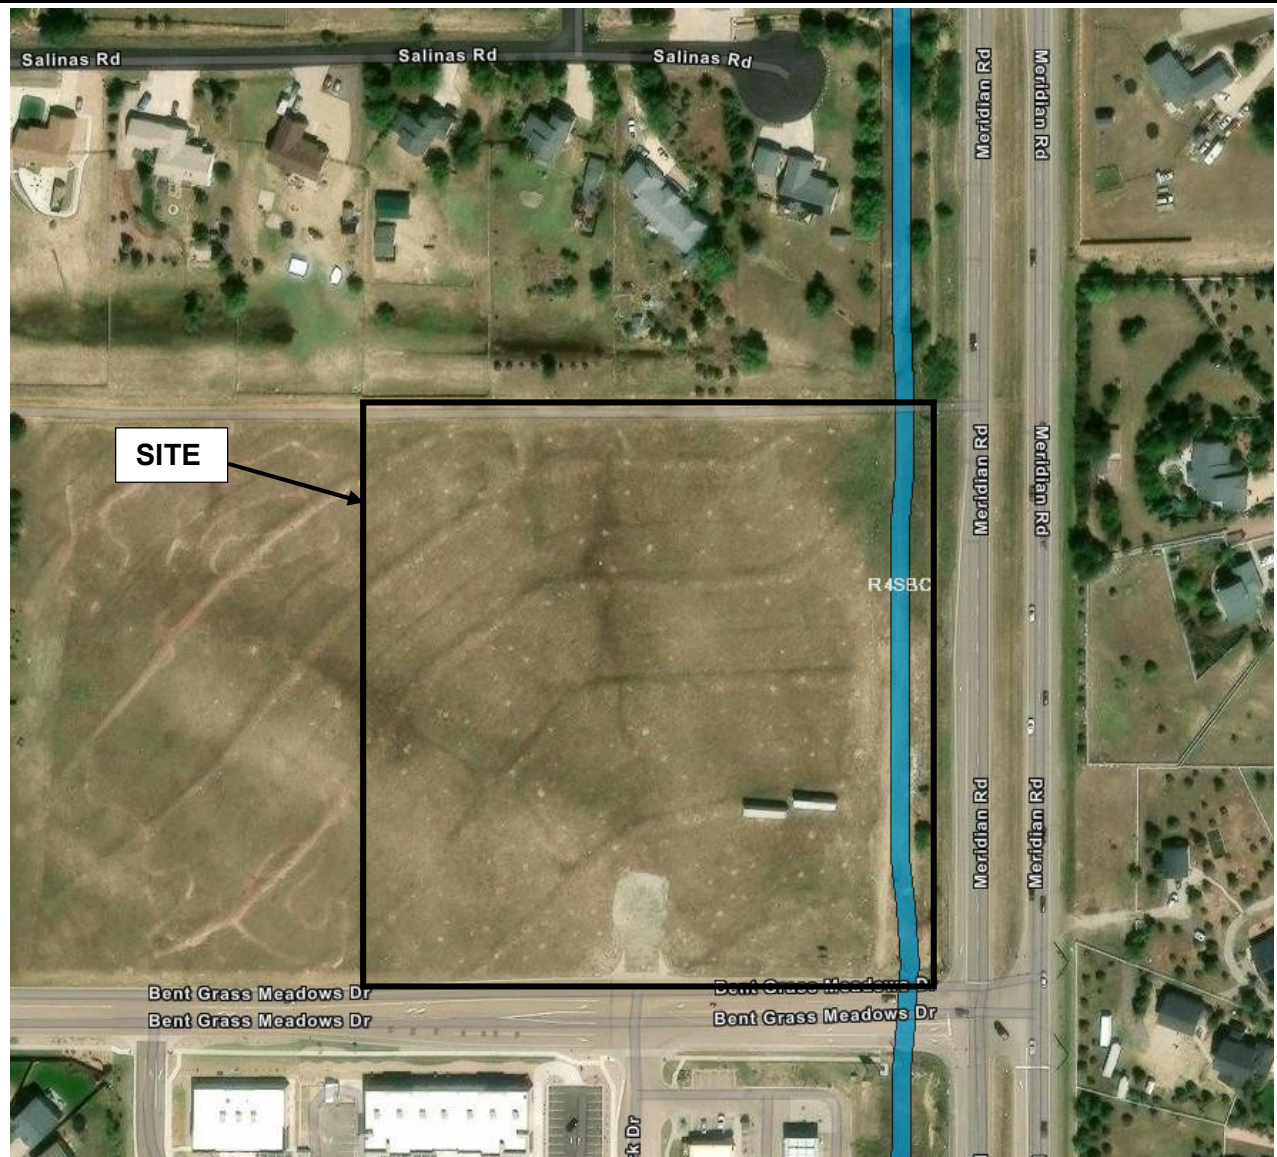
## Exhibit 6: USFWS National Wetlands Inventory

The drainage along the eastern boundary of the site has been included in the National Wetland Inventory as Freshwater Emergent Wetland habitats classified as **R4SBC** (Riverine – R, Intermittent – 4, Stream Bed – SB, Seasonally Flooded – C) (Reference 10). The wetlands map is shown in Exhibit 6. This area has been identified as a potential seasonal shallow groundwater area and will be avoided with construction of the church building.

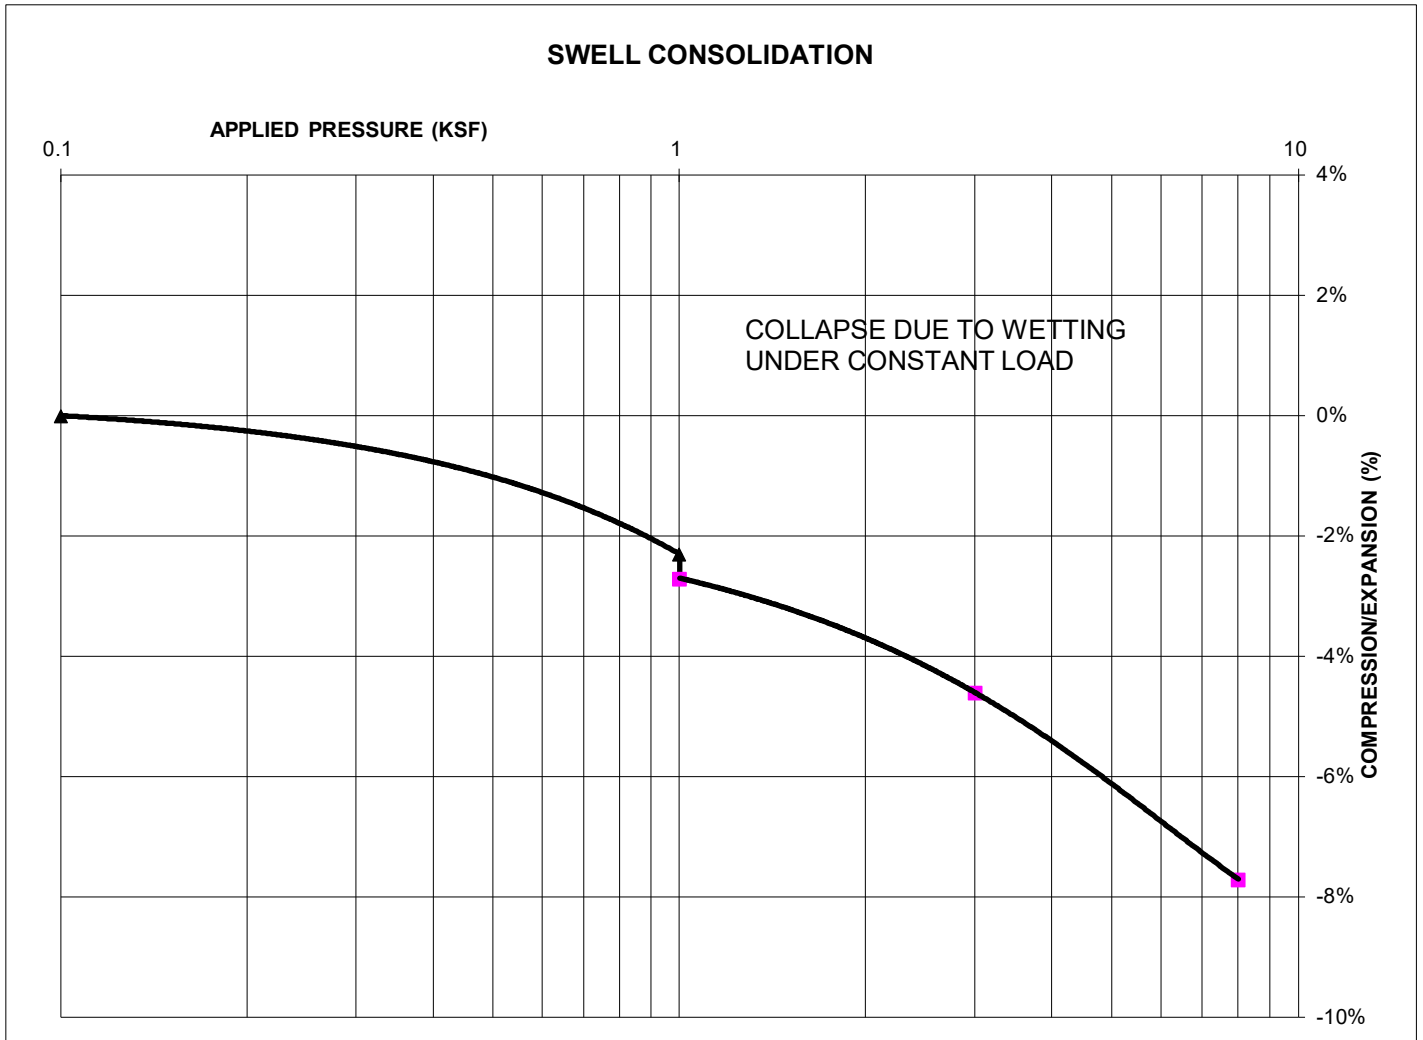
**SWELL/COLLAPSE TEST RESULTS**

TEST BORING 4  
DEPTH (FT) 5

SOIL DESCRIPTION SAND, CLAYEY  
SOIL TYPE 1

NATURAL UNIT DRY WEIGHT (PCF): 115  
NATURAL MOISTURE CONTENT: 11.1%  
SWELL/COLLAPSE (%): -0.4%

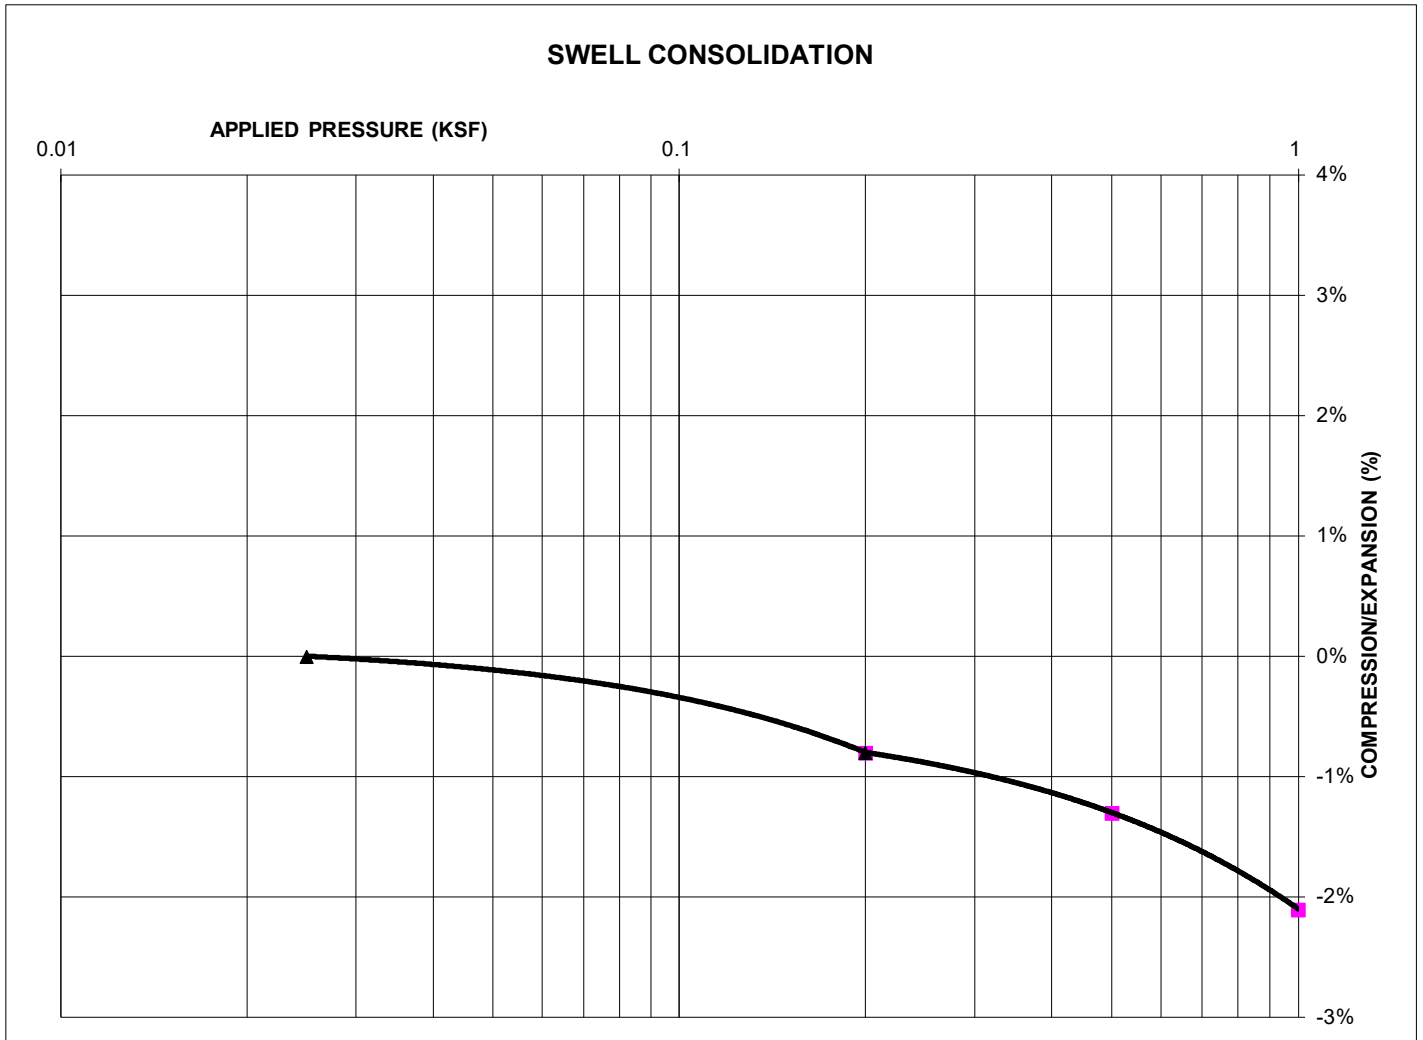
**SWELL/COLLAPSE TEST RESULTS**

TEST BORING 6  
DEPTH (FT) 10

SOIL DESCRIPTION SAND, CLAYEY  
SOIL TYPE 1

NATURAL UNIT DRY WEIGHT (PCF): 102  
NATURAL MOISTURE CONTENT: 21.0%  
SWELL/COLLAPSE (%): 0.0%
