**SOIL, GEOLOGY, GEOLOGIC HAZARD STUDY
EAGLE RISING
PARCEL NOS. 52290-00-034 AND 52290-00-035
EL PASO COUNTY, COLORADO**

Casas Limited Partnership #4
P.O. Box 2076
Colorado Springs, Colorado 80901

June 29, 2022

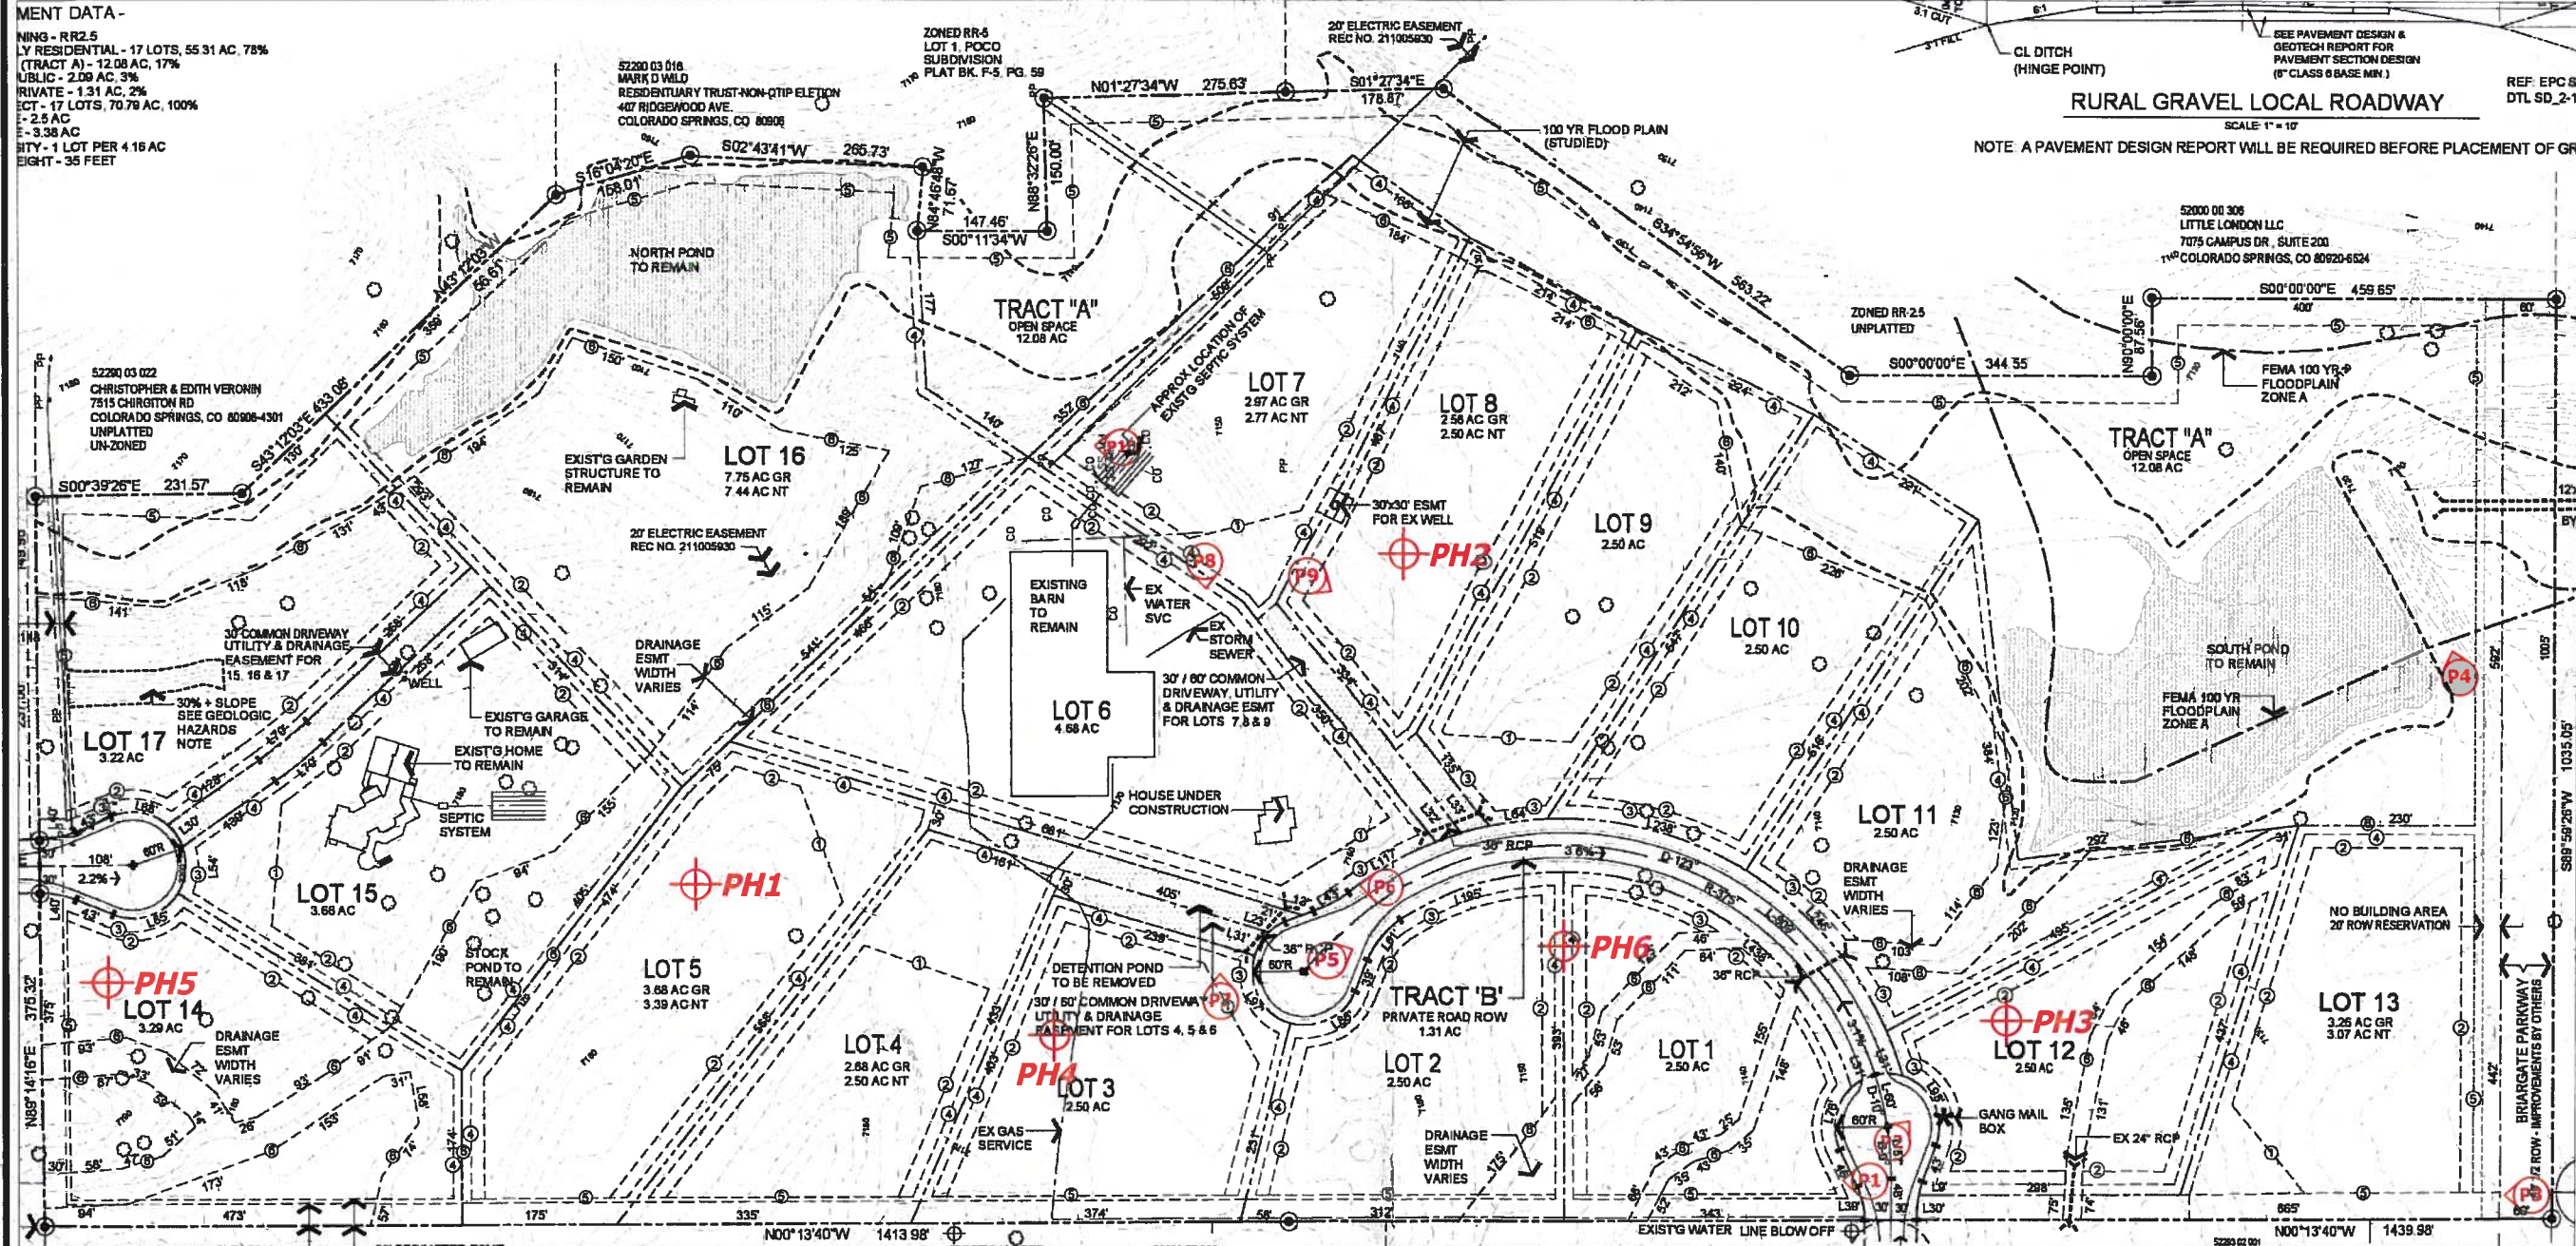
DRAWN LLL CHECKED
DATE 6/22/22
SCALE AS SHOWN
JOB NO. 221458
FIGURE NO. 3

RURAL GRAVEL LOCAL ROADWAY
 SCALE 1" = 10'
 NOTE: A PAVEMENT DESIGN REPORT WILL BE REQUIRED BEFORE PLACEMENT OF GR

DEVELOPMENT PLAN / TEST BORING
 LOCATION MAP
 SEAGLE RISING
 EL PASO COUNTY, COLORADO, CO.
 FOR: CASAS LIMITED PARTNERSHIP #4

Total acreage involved in the proposed development is approximately 70 acres. Seventeen single-family rural residential lots are proposed with areas of open space along Cottonwood Creek. Lot sizes range from 2.5 acres to 7.14 acres. The area will be serviced by central water and individual on-site wastewater treatment systems. The proposed Development Plan by Land Resource Associates is presented in Figure 3.

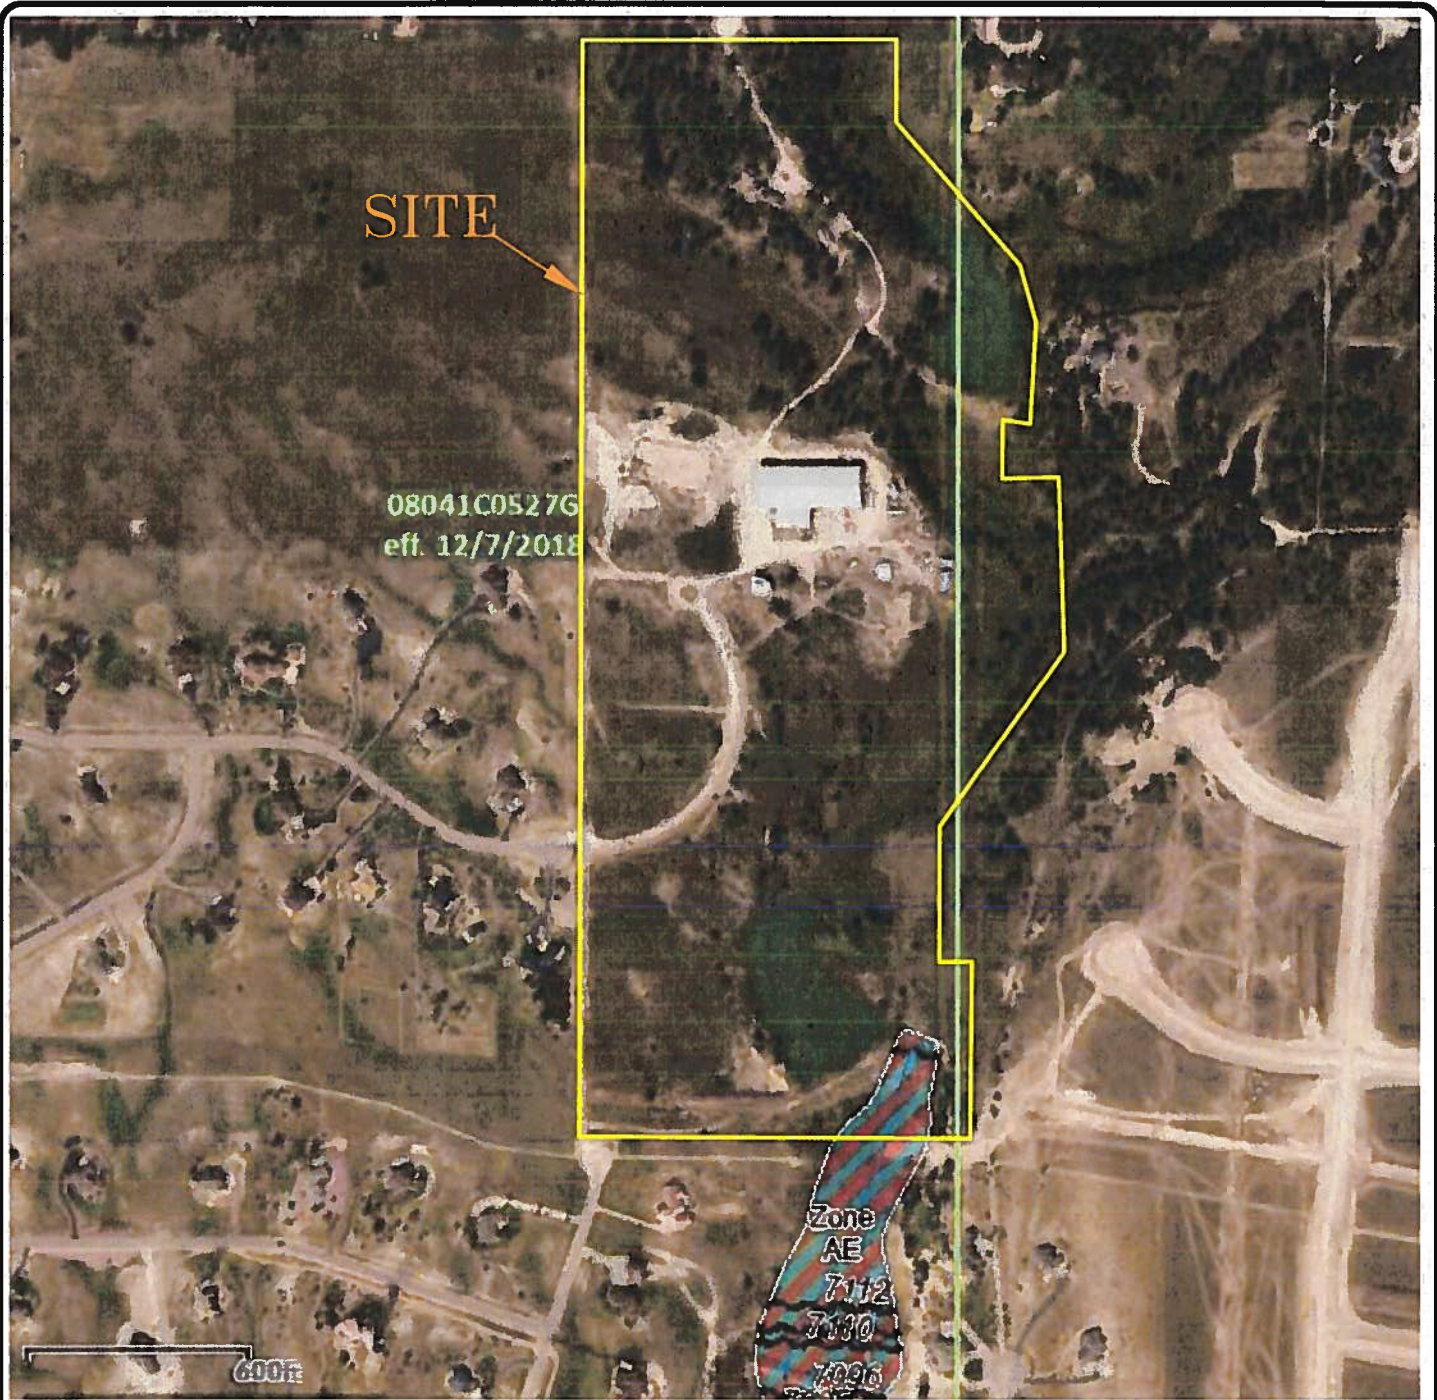
FIG NO.:
 7

FLOODPLAIN MAP
EAGLE RISING
EL PASO COUNTY, COLORADO, CO.
FOR: CASAS LIMITED PARTNERSHIP #4

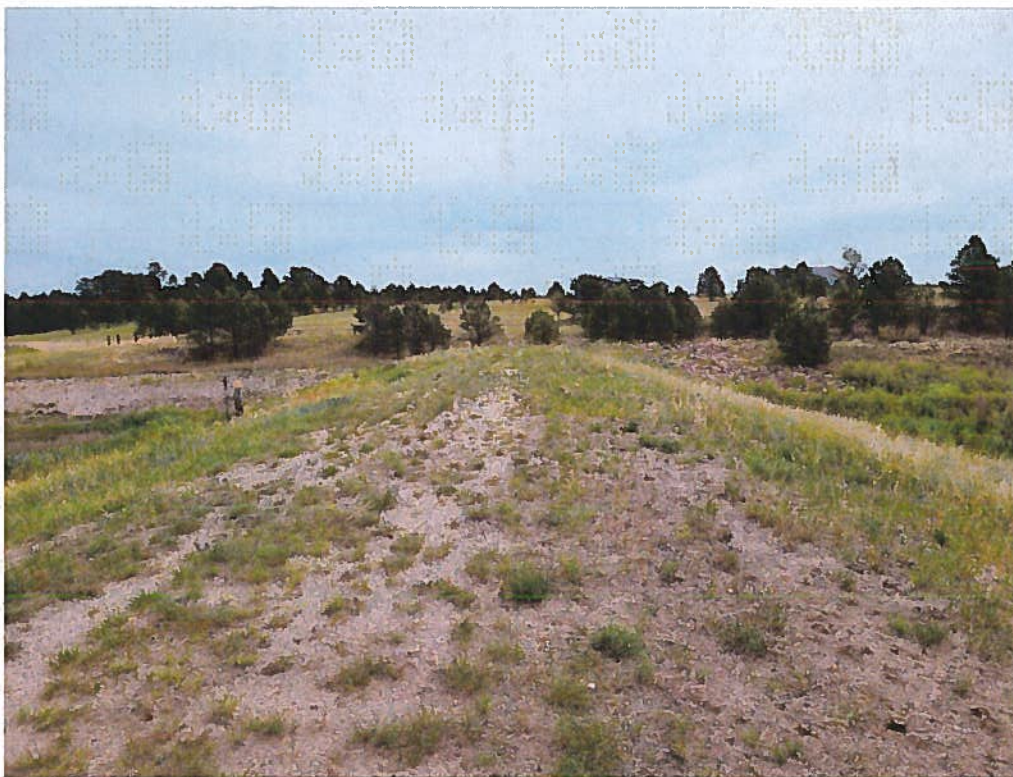
Looking east along earthen dam in the southern portion of the site.

Areas of fill were observed on site associated with dams, fill piles and existing buildings and development. The majority of the dams are located in open space and it is anticipated the dams will be avoided by development. The willows on the northern dam have been removed and the soft soils recompacted. The small steeper portion of the downstream face of the northern dam at the western end has also been regraded to no steeper than 2.5:1. The repair work of the dam was observed by personnel of Entech Engineering, Inc., and density testing performed on the embankment fill. The southern dams downstream face is 2:1 and has loose soils and some willows. The willows have been removed and the downstream face recompacted and regraded to no steeper than 2.5:1. Wet, soft soils should be expected at the toe of the dam and stabilization may be necessary. Well-defined spillways should be maintained for both dams. It is anticipated other areas of fill will be removed during site grading or construction of individual structures. Any uncontrolled fill encountered beneath foundations should be removed and recompacted at a minimum of 95% of its maximum Modified Proctor Dry Density, ASTM D-1557.
