Job No. 184041

Re: Response to:
Colorado Geological Survey Review Comments, dated June 29, 2022, and
El Paso County Planning and Community Development Comments, dated July 15, 2022.

RMG - Rocky Mountain Group prepared the *"Soil and Geology Study, Phase 1-4, Falcon Highlands"* (RMG Job No. 184041, last dated August 30, 2022) for the proposed development project comprising 380 single-family residential lots on approximately 126 acres east of the intersection of Highway 24 and Meridian Road in El Paso County, Colorado. The report was reviewed by personnel of the Colorado Geological Survey (CGS). The purpose of this letter is to provide our response to the CGS review comments. The responses and modifications noted herein have been incorporated into our amended report.

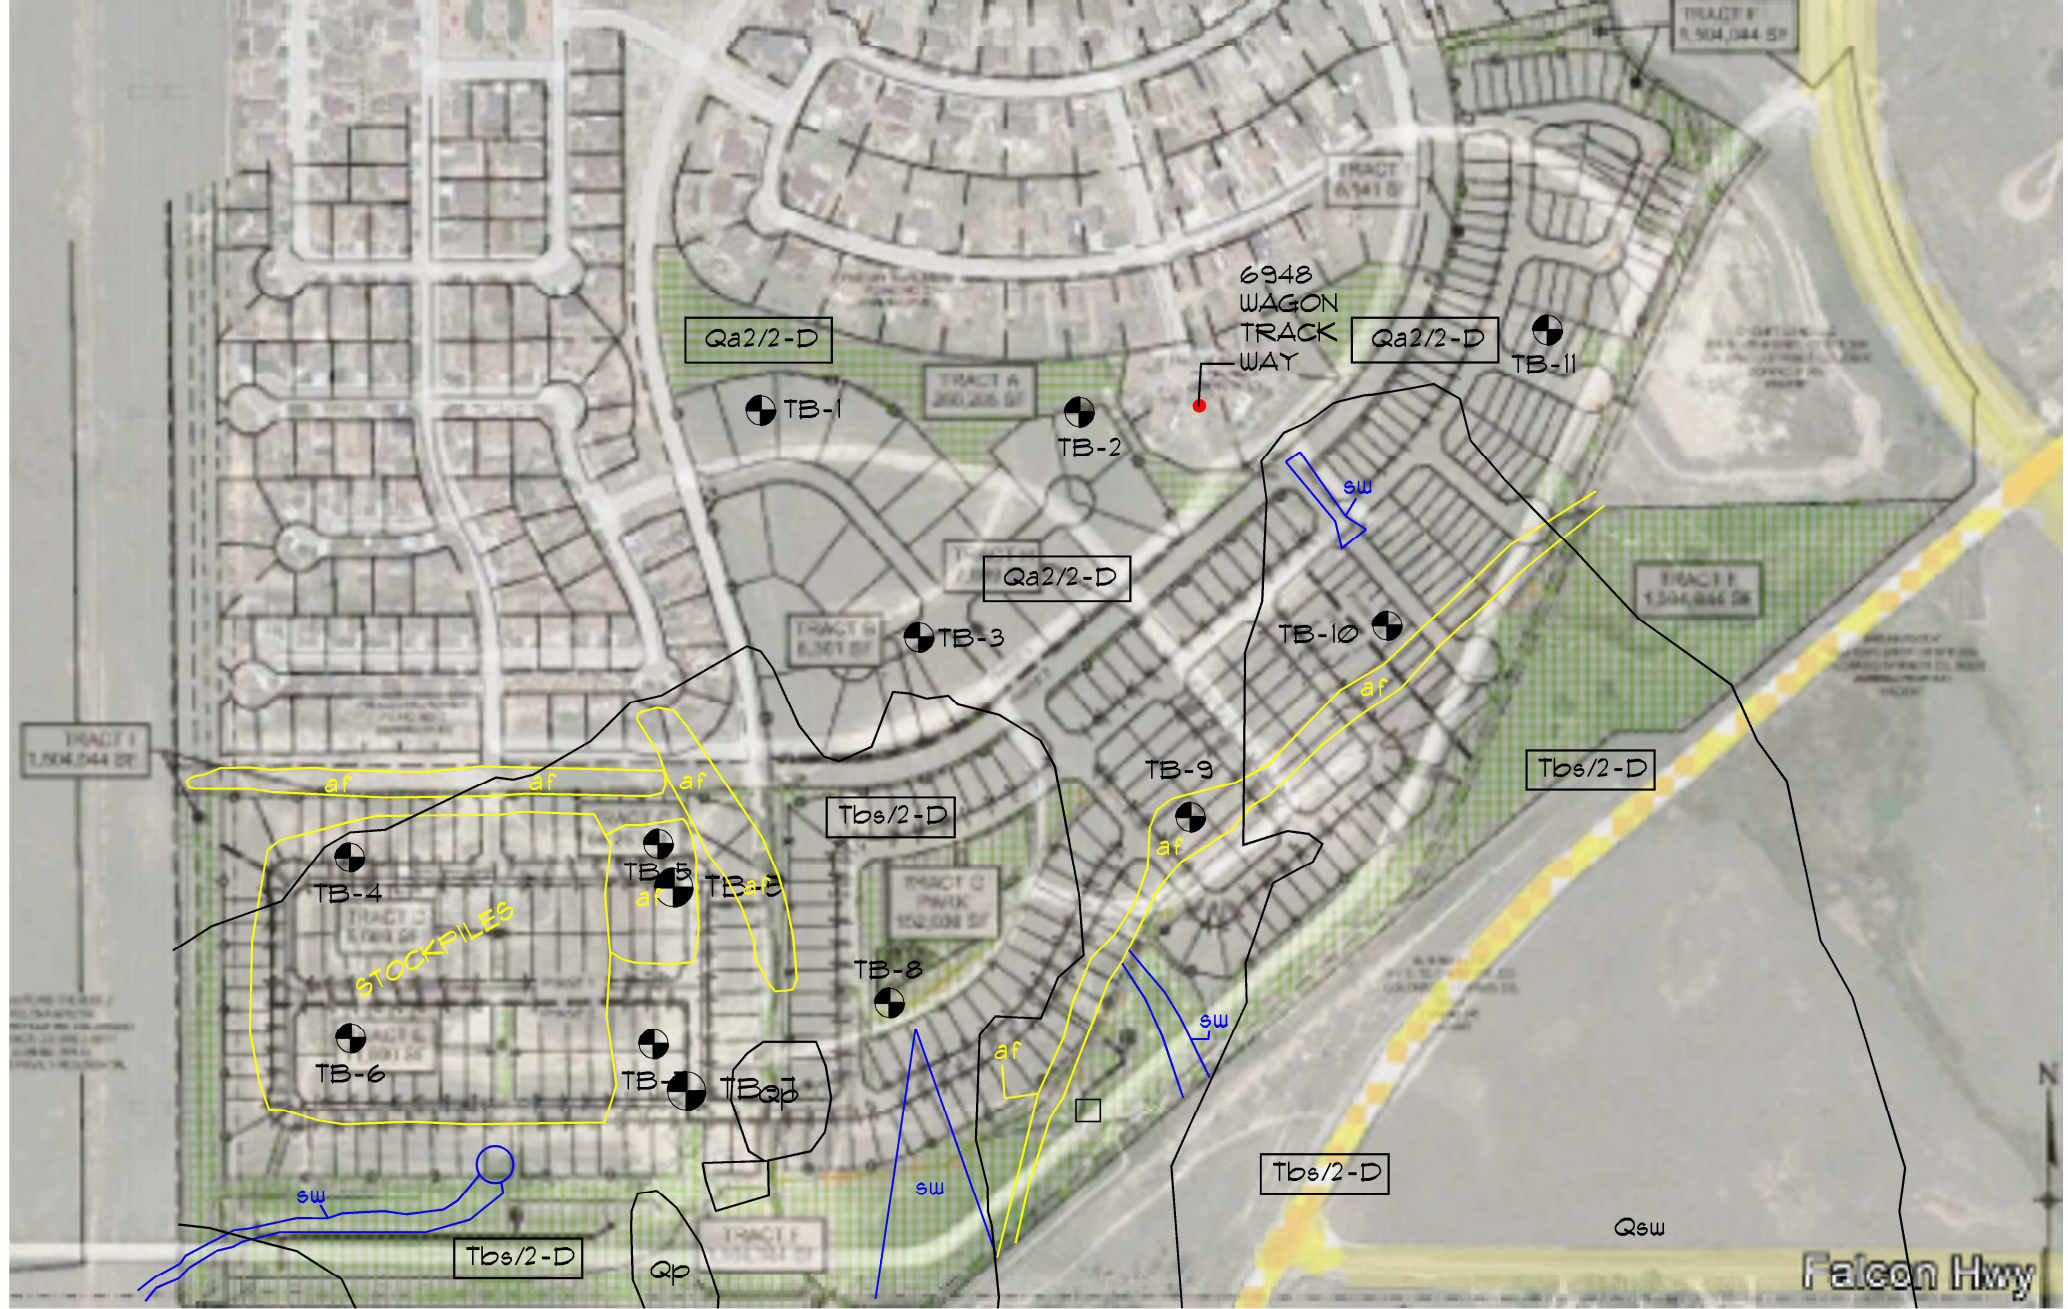
SHEET No.
FIG-17

General Geologic Conditions

- Qa2 - Alluvium two (lower Holocene) - Dark gray to brown, poorly to well sorted, moderately consolidated, silt, sand, gravel, and minor clay and occasional boulders in stream terrace deposits approximately 6-12 feet above the modern flood plain or as non-terrace forming alluvium in valley headwaters. Unit is subject to occasional flooding. Maximum exposed thickness locally exceeds 20 feet.

ENGINEERING AND
GEOLOGY MAP

The general geology is presented in the Engineering and Geology Map, Figure 17.

The engineering geology is presented in the Engineering and Geology Map, Figure 17.

An "Unnamed Tributary" resides along the eastern and southern portion of the proposed development. Per the Flood Insurance Study report and Flood Insurance Rate Map for FEMA Map Number 08041C0516G dated December 7, 2018, the "Unnamed Tributary" resides in Zone AE, which is defined by FEMA as areas subject to inundation by the 1-percent-annual chance-flood event determined by detailed methods. This area is shown hatched on the Engineering and Geology Map, Figure 17.

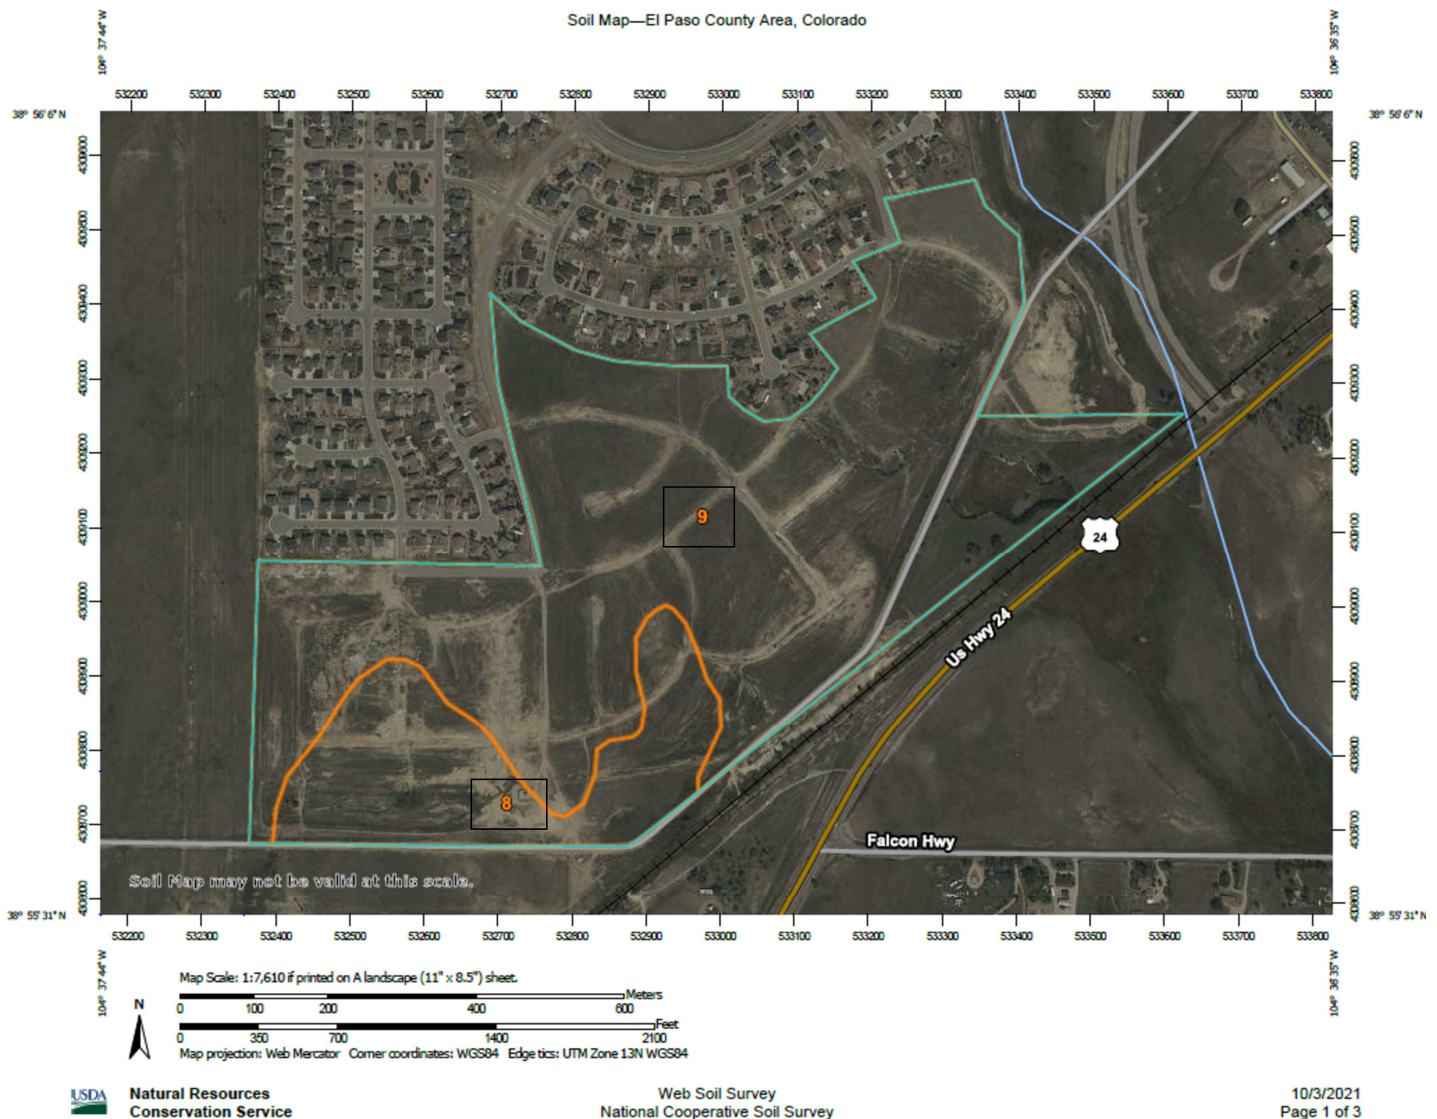
FIG No. 18

8 - Blakeland loamy sand, 1 to 9 percent slopes

9 - Blakeland-Fluvaquentic Haplaquolls

The USDA Soil Survey Map is presented in Figure 18.

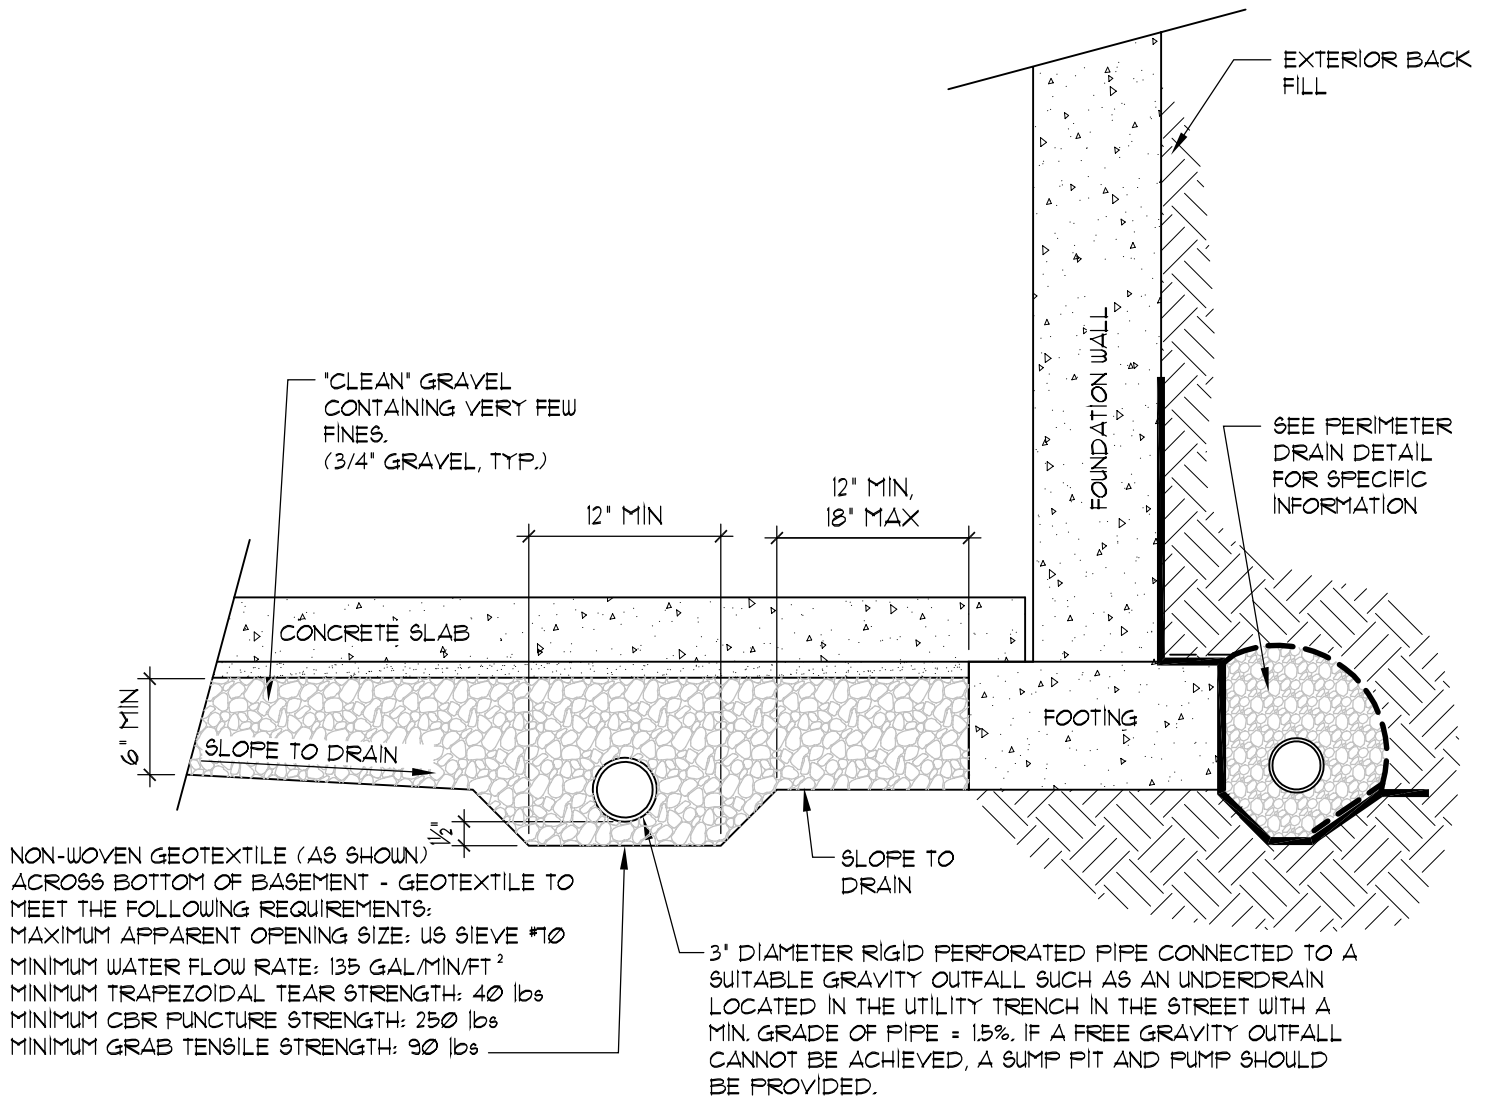
FIG No. 22

1. ALL DRAIN PIPE SHALL BE PERFORATED PLASTIC, WITH THE EXCEPTION OF THE DISCHARGE PORTION WHICH SHALL BE SOLID, NON-PERFORATED PIPE.
2. DRAIN PIPE SHALL HAVE POSITIVE FALL THROUGHOUT.
3. DRAIN PIPE SHALL BE PROVIDED WITH A FREE GRAVITY OUTFALL, IF POSSIBLE. IF A GRAVITY OUTFALL CANNOT BE ACHIEVED, THEN A SUMP PIT AND PUMP SHALL BE USED. THE OUTFALL SHOULD EXTEND PAST BACKFILL ZONES AND DISCHARGE TO A LOCATION THAT IS GRADED TO DIRECT WATER OFF-SITE.
4. ALL DRAIN COMPONENTS SHALL BE RATED/APPROVED BY THE MANUFACTURER FOR THE INSTALLED DEPTH AND APPLICATION
5. DRAIN SYSTEM, INCLUDING THE OUTFALL OF THE DRAIN, SHALL BE OBSERVED BY QUALIFIED PERSONNEL PRIOR TO BACKFILLING TO VERIFY INSTALLATION.

One such system is an underslab drainage layer to help intercept groundwater before it enters the slab area should the groundwater levels rise. In general, if groundwater was encountered within 4 to 6 feet of the proposed basement slab elevation, an underslab drain should be anticipated. An Underslab Drain detail is presented in Figure 22. Another such system would consist of a subsurface drain and/or vertical drain board placed around the perimeter of the overexcavation to help intercept groundwater and allow for proper placement and compaction of the replacement structural fill. Careful attention should be paid to grade and discharge of the drain pipes of these systems.

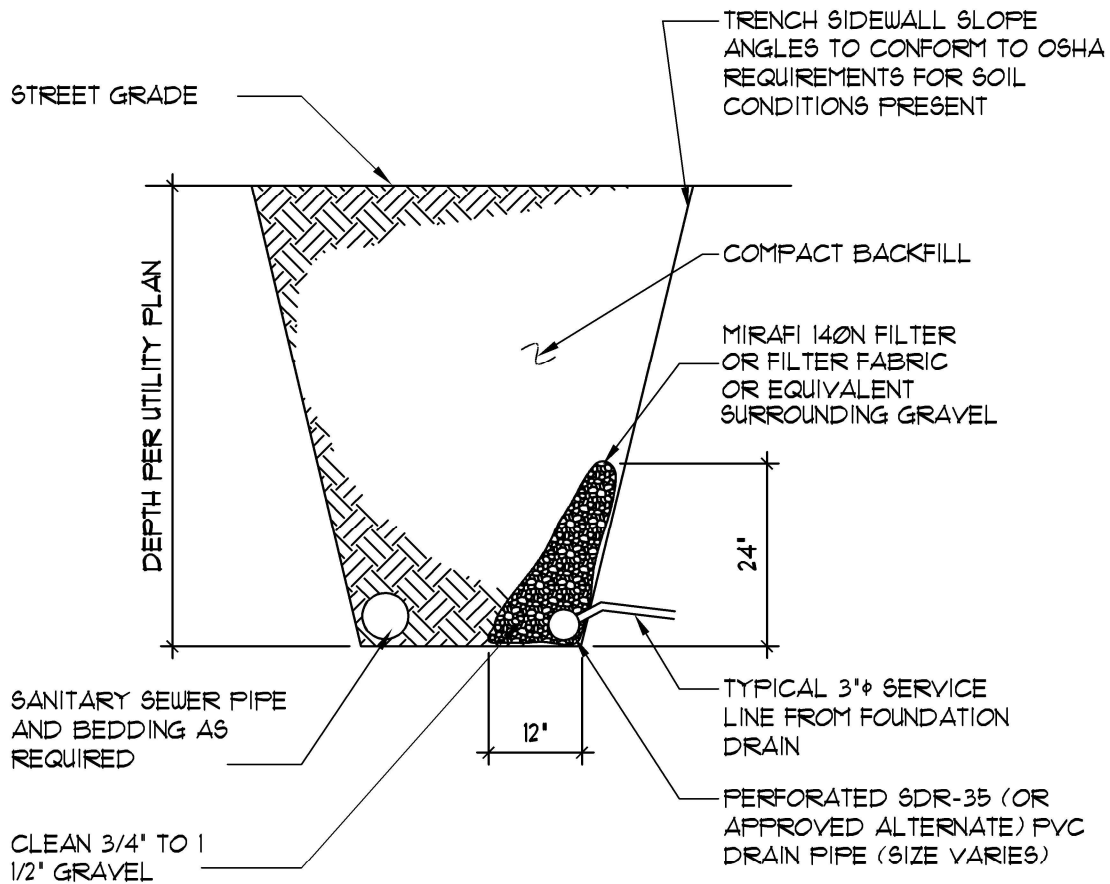
FIG No. 23

NOTE: TO BE USED IN CASES WHERE
GROUNDWATER IS FOUND DURING TRENCHING
OR WHERE SHALLOW GROUNDWATER IS KNOWN
TO EXIST

It is a common local practice for underdrains to be placed at the bottom of sanitary sewer trenches within drive lanes. Underdrains placed in the sanitary sewer trenches in areas where groundwater is anticipated will likely be the "active" type, which uses a perforated drain pipe. In areas where groundwater is not anticipated, "passive" type underdrains may be used. The outfall for the sanitary sewer trench underdrain was not known at the time of this investigation because the development plan and grading plan were not available for our review. Typical underdrain details are presented in Figures 23 and 24.
