**GEOLOGIC HAZARDS EVALUATION AND  
PRELIMINARY GEOTECHNICAL INVESTIGATION  
WOODMOOR BEACH/SOUTH BEACH SUBDIVISION  
LAKE WOODMOOR DRIVE AND LOWER LAKE ROAD  
MONUMENT, COLORADO**

**Project No. CS18677-115**

**December 13, 2016**

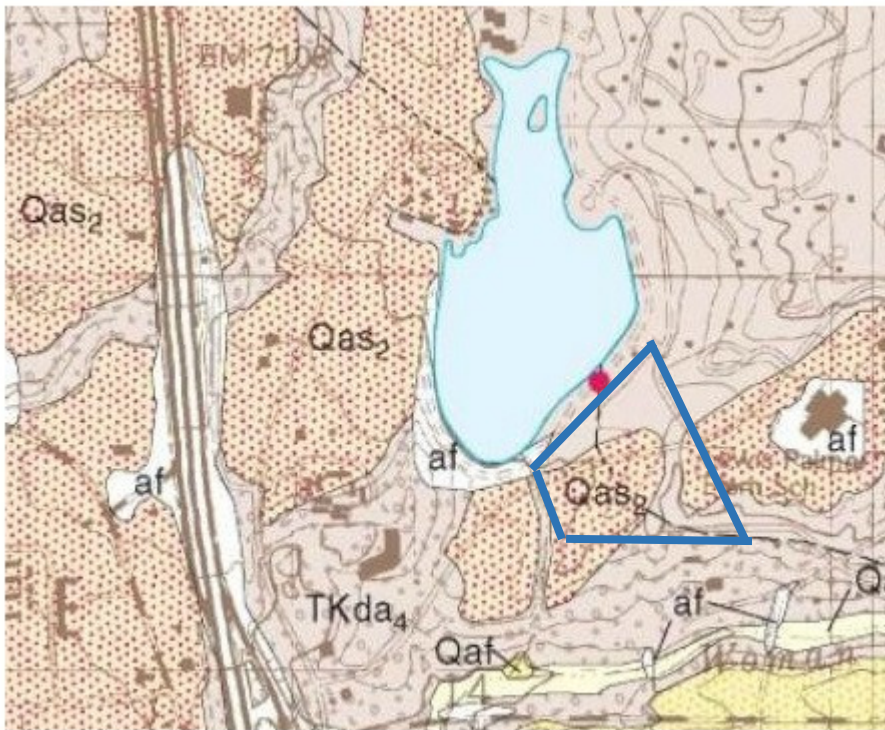
Excerpt from CGS 2004 Geologic Map of the Monument Quadrangle.

The geology of the Woodmoor Beach/South Beach parcel was evaluated through the review of published geologic maps, field reconnaissance, and the drilling of ten exploratory borings. Information from these sources was used to produce our interpretation of surficial geologic conditions. An excerpt from the “Geologic Map of the Monument Quadrangle” published by the Colorado Geologic Survey (CGS) in 2004 is presented below. The area outlined in blue identifies the approximate location of Woodmoor Beach/South Beach. Our observations imply the CGS geologic map is accurate. A list of references is included at the end of this report. The following sections discuss the mapped units.

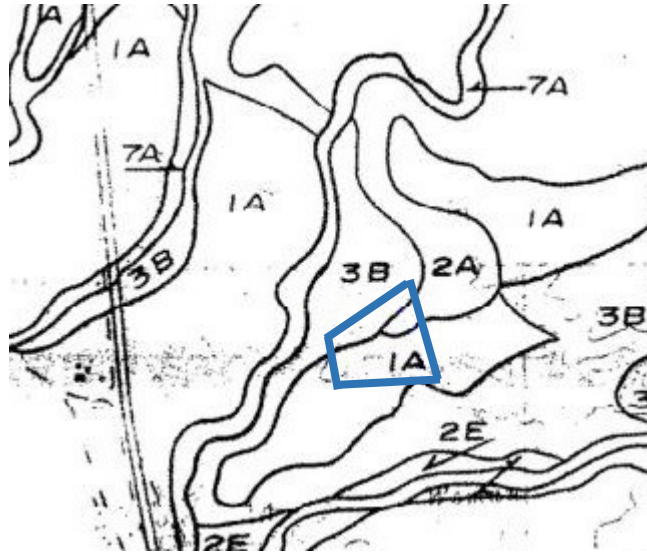
Excerpt from Robinson's Sheet 2B showing Woodmoor Beach/South Beach is within Unit 1A, Unit 2-A, and Unit 3B

Map Unit 1-A depicts stable alluvium, colluvium underlain predominantly by sandstone bedrock, with some expansive claystone lenses, on flat to gentle slopes. The South Beach parcel is within this unit.

Our interpretation of the engineering geologic conditions that may impact development of the sites is presented in the figure below and refers to the classification system by Robinson (1977). The engineering geology conditions described below are based on our review of Robinson's "Potential Geologic Hazards and Surficial Deposits, Environmental and Engineering Geologic Maps and Tables for Land Use."

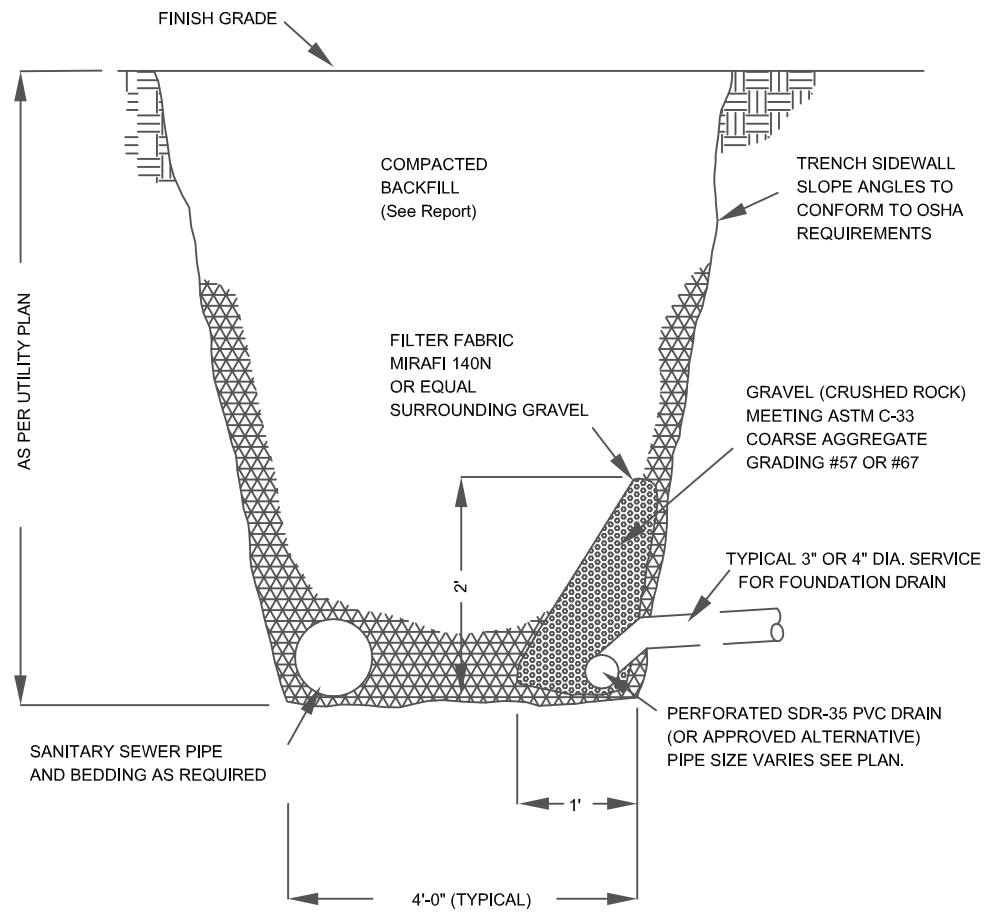
**FIG. 2 – ACTIVE DRAIN BESIDE SEWER**

Grading Requirements for Coarse Aggregates per ASTM C-33								
Size Number	Nominal Size (Sieves with Square Openings)	Amounts Finer than Each Laboratory Sieve (Square Openings), Weight Percent						
		1 1/2 in. (37.5 mm)	1 in. (25.0 mm)	3/4 in. (19.0 mm)	1/2 in. (12.5 mm)	3/8 in. (9.5 mm)	No. 4 (4.5 mm)	No. 8 (2.36 mm)
67	3/4 in. to No. 4 (19.0 to 4.75 mm)	--	100	90 to 100	--	20 to 55	0 to 10	0 to 5
57	1 in. to No. 4 (25.0 to 9.5 mm)	100	95 to 100	--	25 to 60	--	0 to 10	0 to 5

NOTE:  
TO BE USED IN CASES WHERE GROUND WATER IS  
FOUND DURING TRENCHING OR WHERE SHALLOW  
GROUND WATER IS KNOWN TO EXIST.

If wet conditions or active groundwater seepage are encountered in the sanitary sewer trenches, we recommend an active underdrain system with perforated or slotted pipe for these areas. A positive cutoff collar (concrete) should be constructed around the sewer pipe and underdrain pipe immediately downstream of the point the underdrain pipe exits the sewer trench or changes from active to passive. Solid pipe should be used down gradient of this cutoff collar to the point of discharge from the pipe.

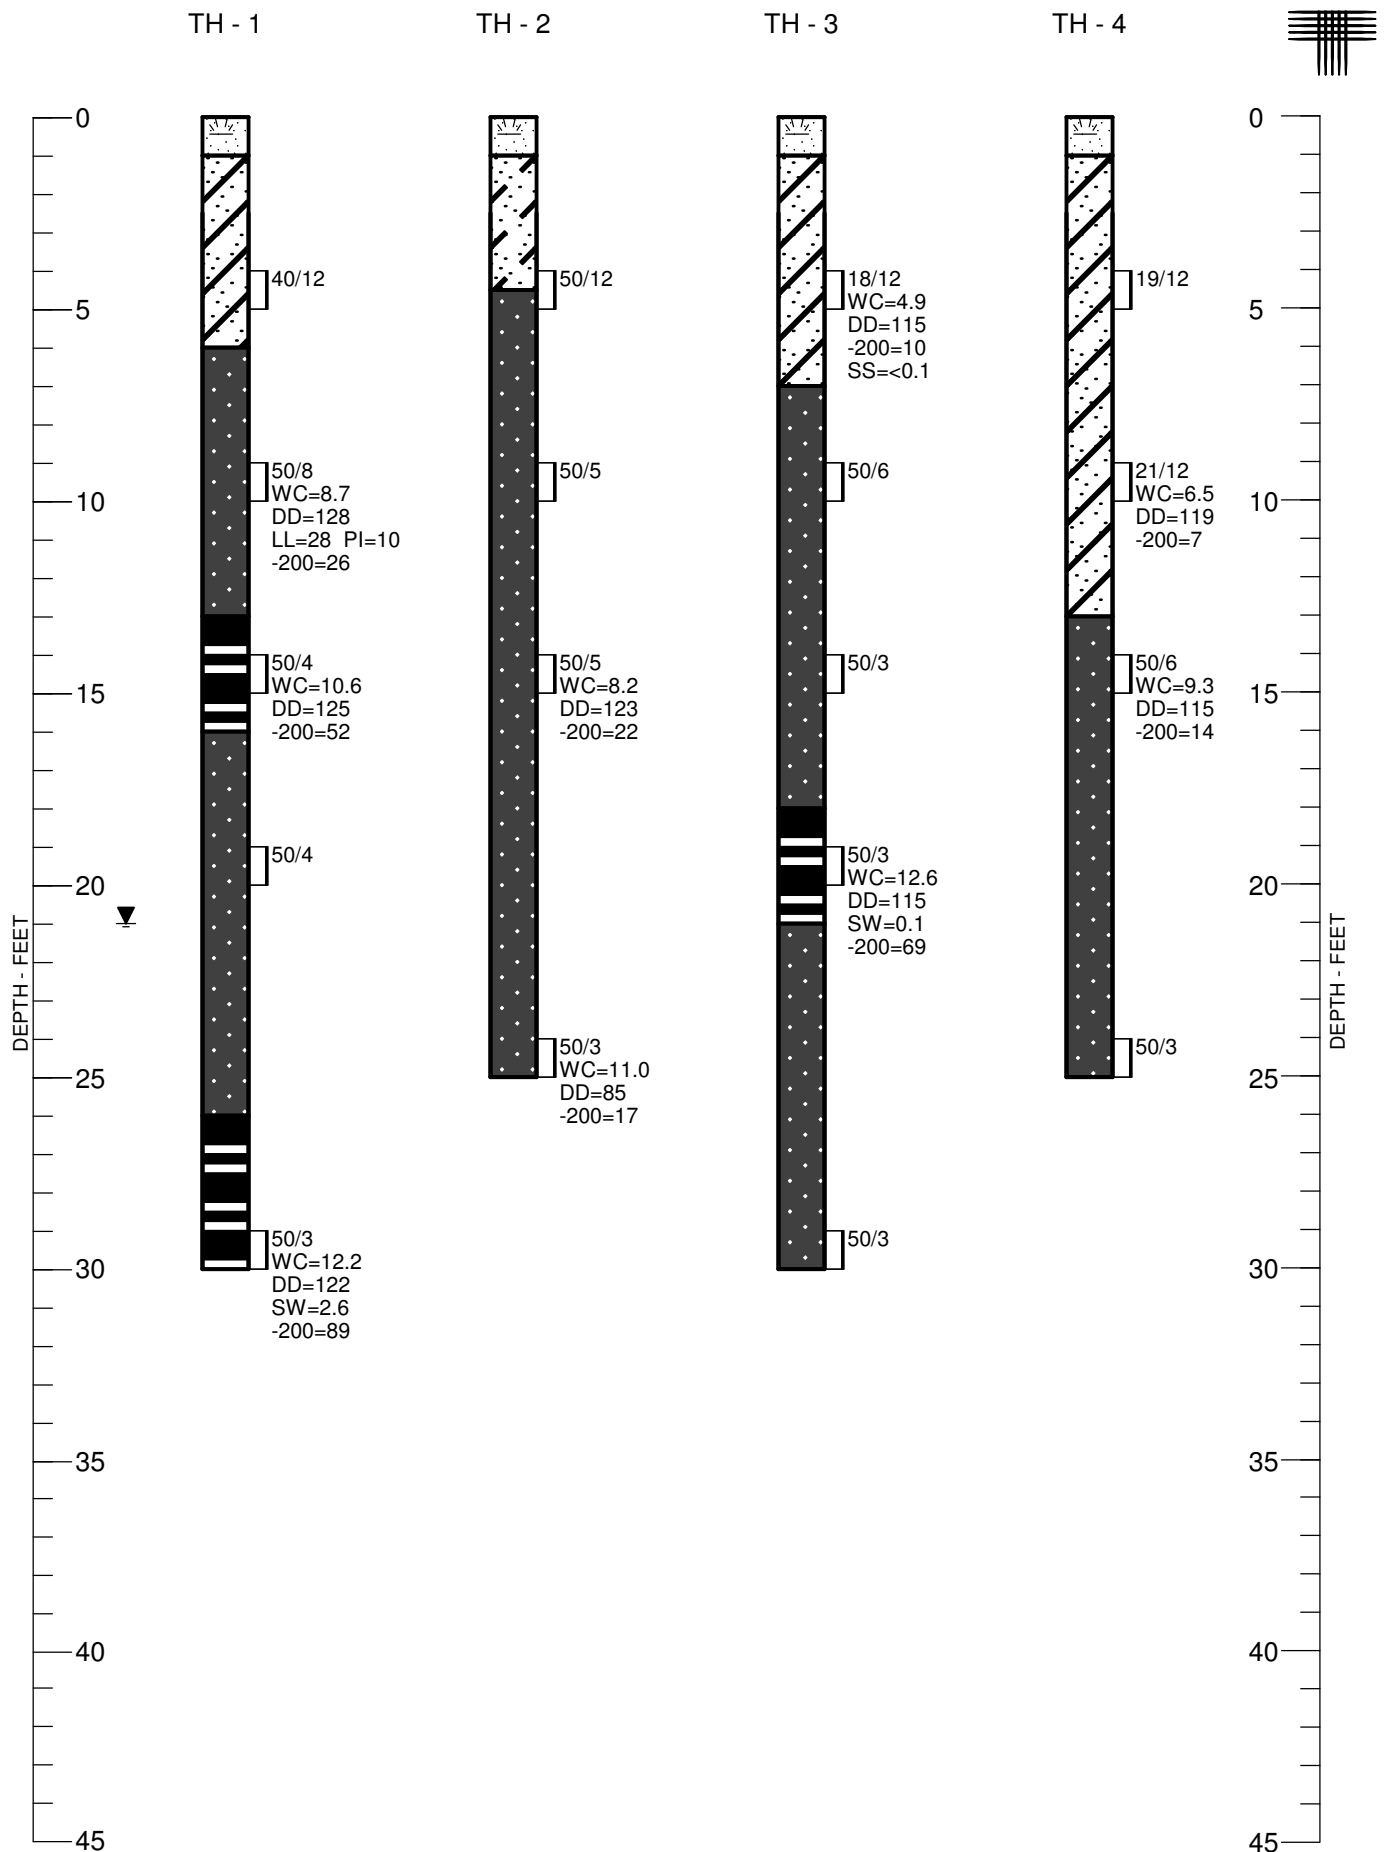
### **SUMMARY LOGS OF EXPLORATORY BORINGS**

- LEGEND:**
- TOPSOIL, SAND, CLAYEY, MOIST, DARK BROWN.
  - SAND, SLIGHTLY SILTY TO SILTY, MOIST, LOOSE TO VERY DENSE, LIGHT BROWN. (SP, SP-SM, SM)
  - SAND, CLAYEY, MOIST, MEDIUM DENSE, GRAY. (SC)

- BEDROCK. SANDSTONE, CLAY TO VERY CLAYEY, MOIST, HARD, TO VERY HARD, YELLOWISH BROWN, MEDIUM BROWN, GRAY.
  - BEDROCK. CLAYSTONE, SANDY TO VERY SANDY, MOIST, HARD TO VERY HARD, GRAY TO DARK GRAY.

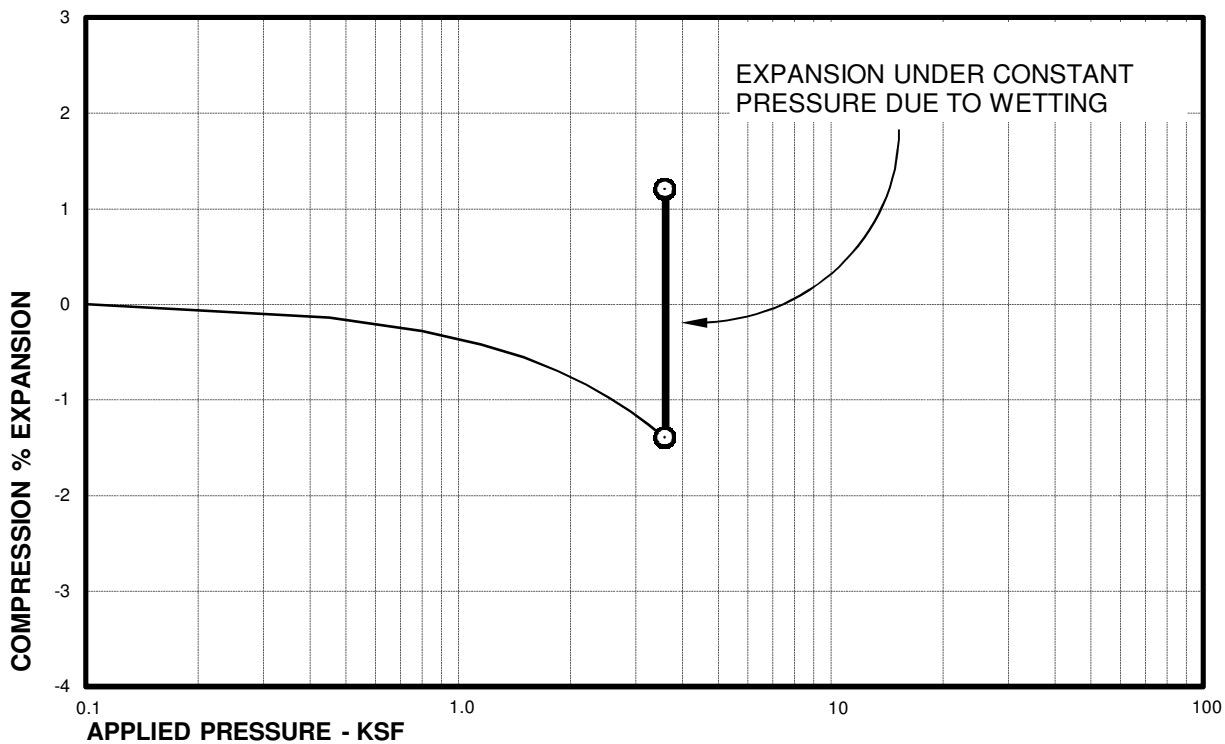
Sample of CLAYSTONE, SLIGHTLY SANDY  
From TH-1 AT 29 FEET

DRY UNIT WEIGHT= 122 PCF  
MOISTURE CONTENT= 12.2 %

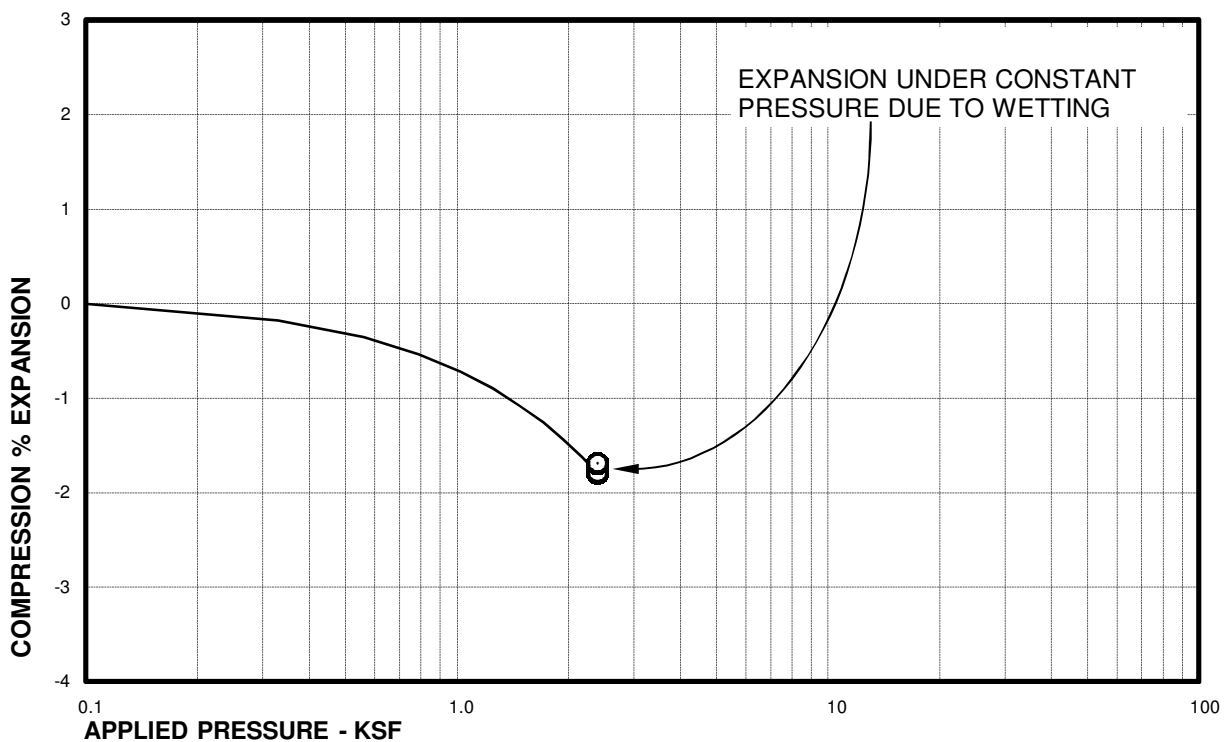
Sample of CLAYSTONE, SANDY  
From TH-3 AT 19 FEET

DRY UNIT WEIGHT= 115 PCF  
MOISTURE CONTENT= 12.6 %

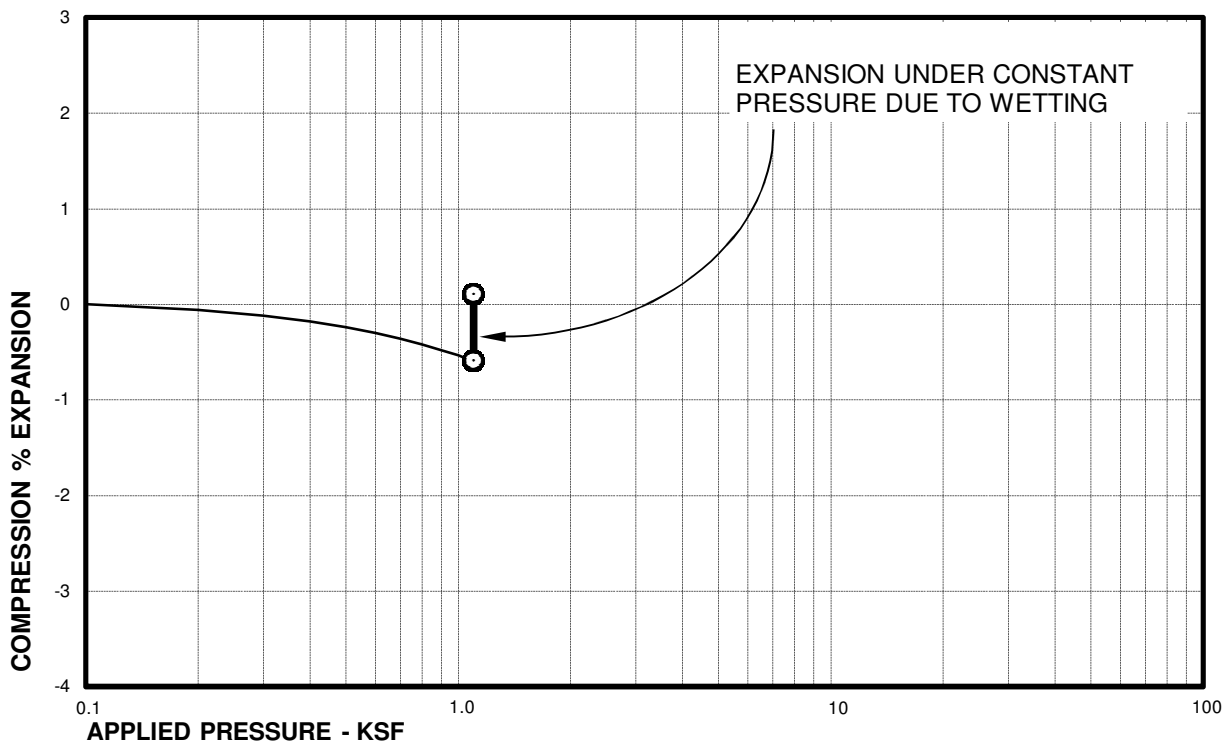
Sample of CLAYSTONE, VERY SANDY  
From TH-5 AT 9 FEET

DRY UNIT WEIGHT= 115 PCF  
MOISTURE CONTENT= 14.2 %

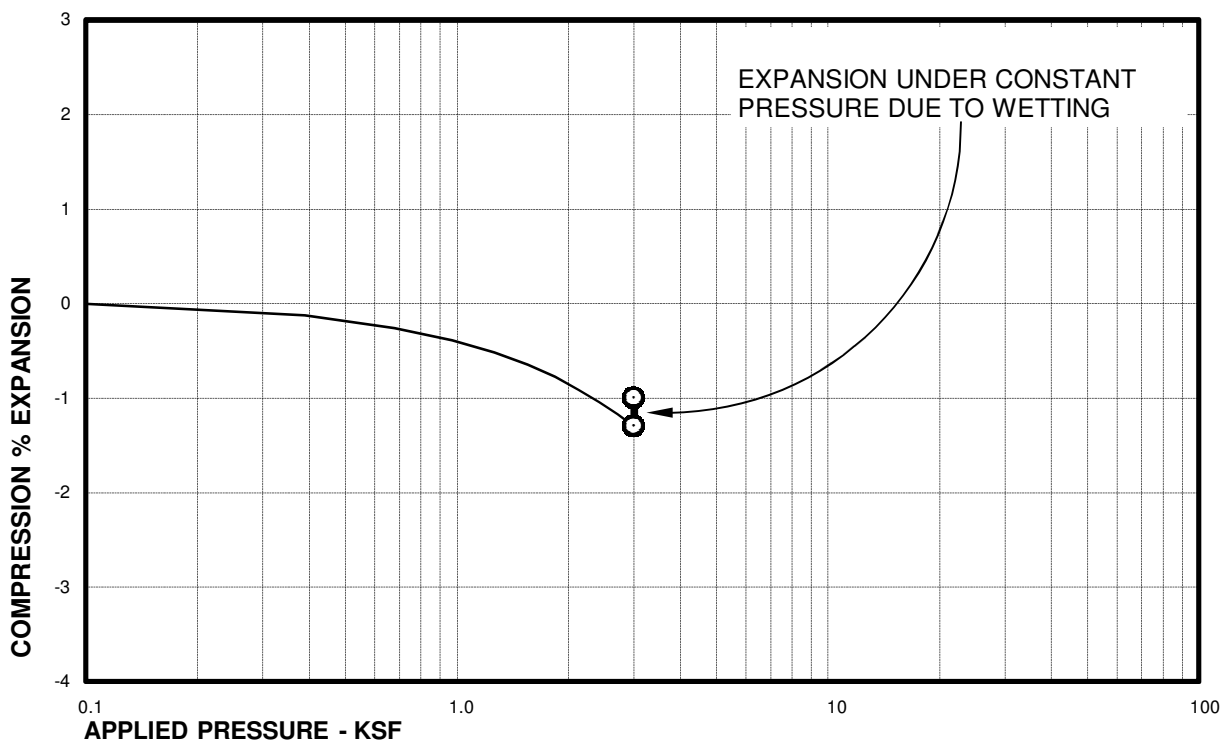
Sample of CLAYSTONE, VERY SANDY  
From TH-5 AT 24 FEET

DRY UNIT WEIGHT= 122 PCF  
MOISTURE CONTENT= 11.3 %

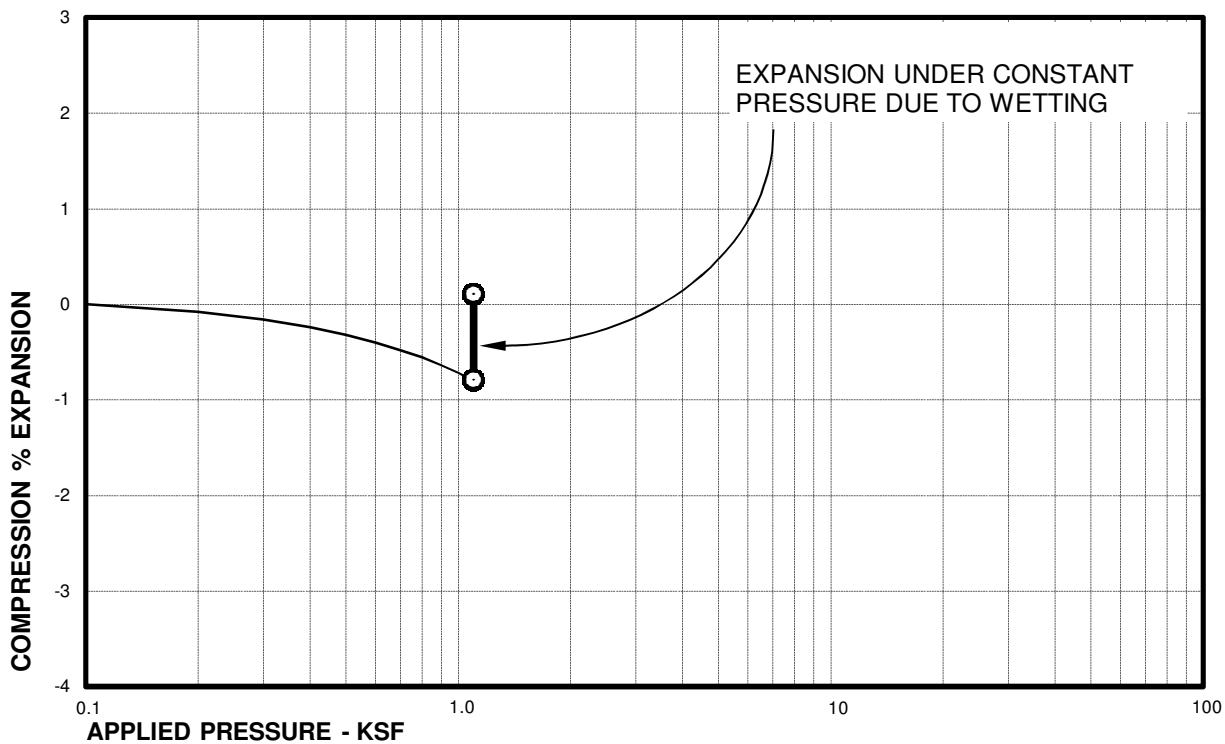
Sample of SANDSTONE, VERY CLAYEY  
From TH-7 AT 9 FEET

DRY UNIT WEIGHT= 118 PCF  
MOISTURE CONTENT= 13.6 %

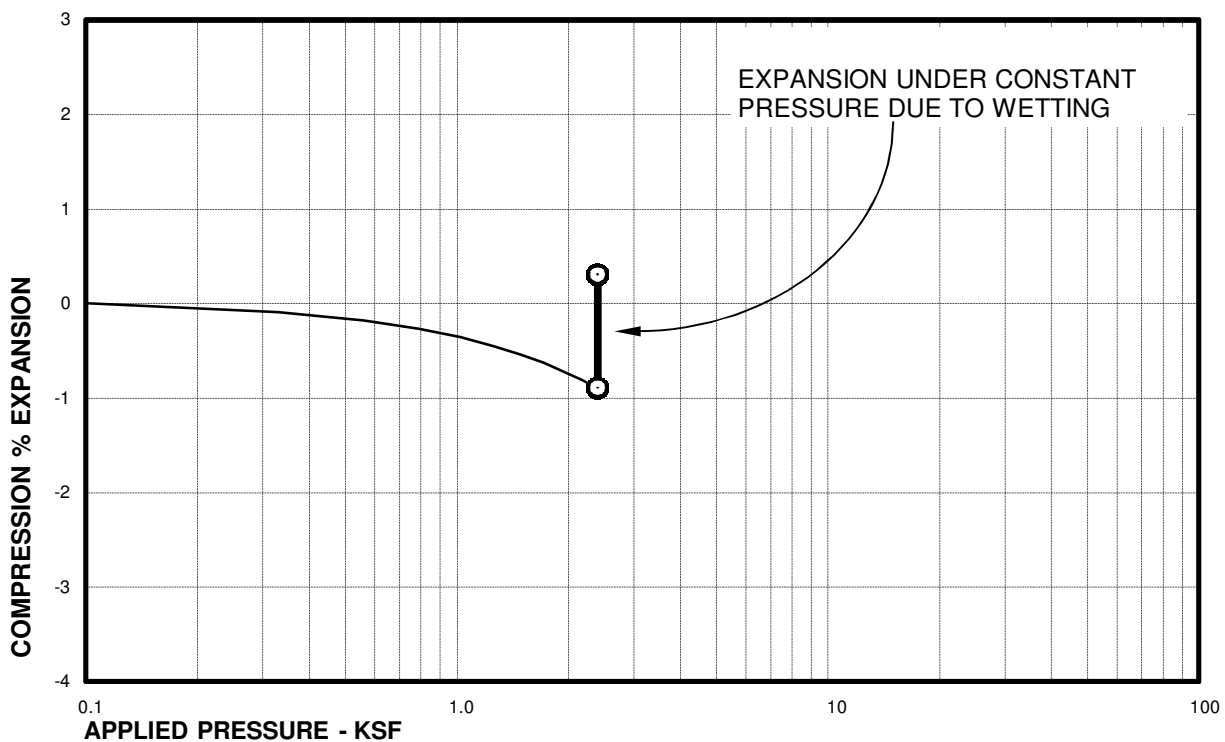
Sample of CLAYSTONE, VERY SANDY  
From TH-8 AT 19 FEET

DRY UNIT WEIGHT= 114 PCF  
MOISTURE CONTENT= 15.4 %

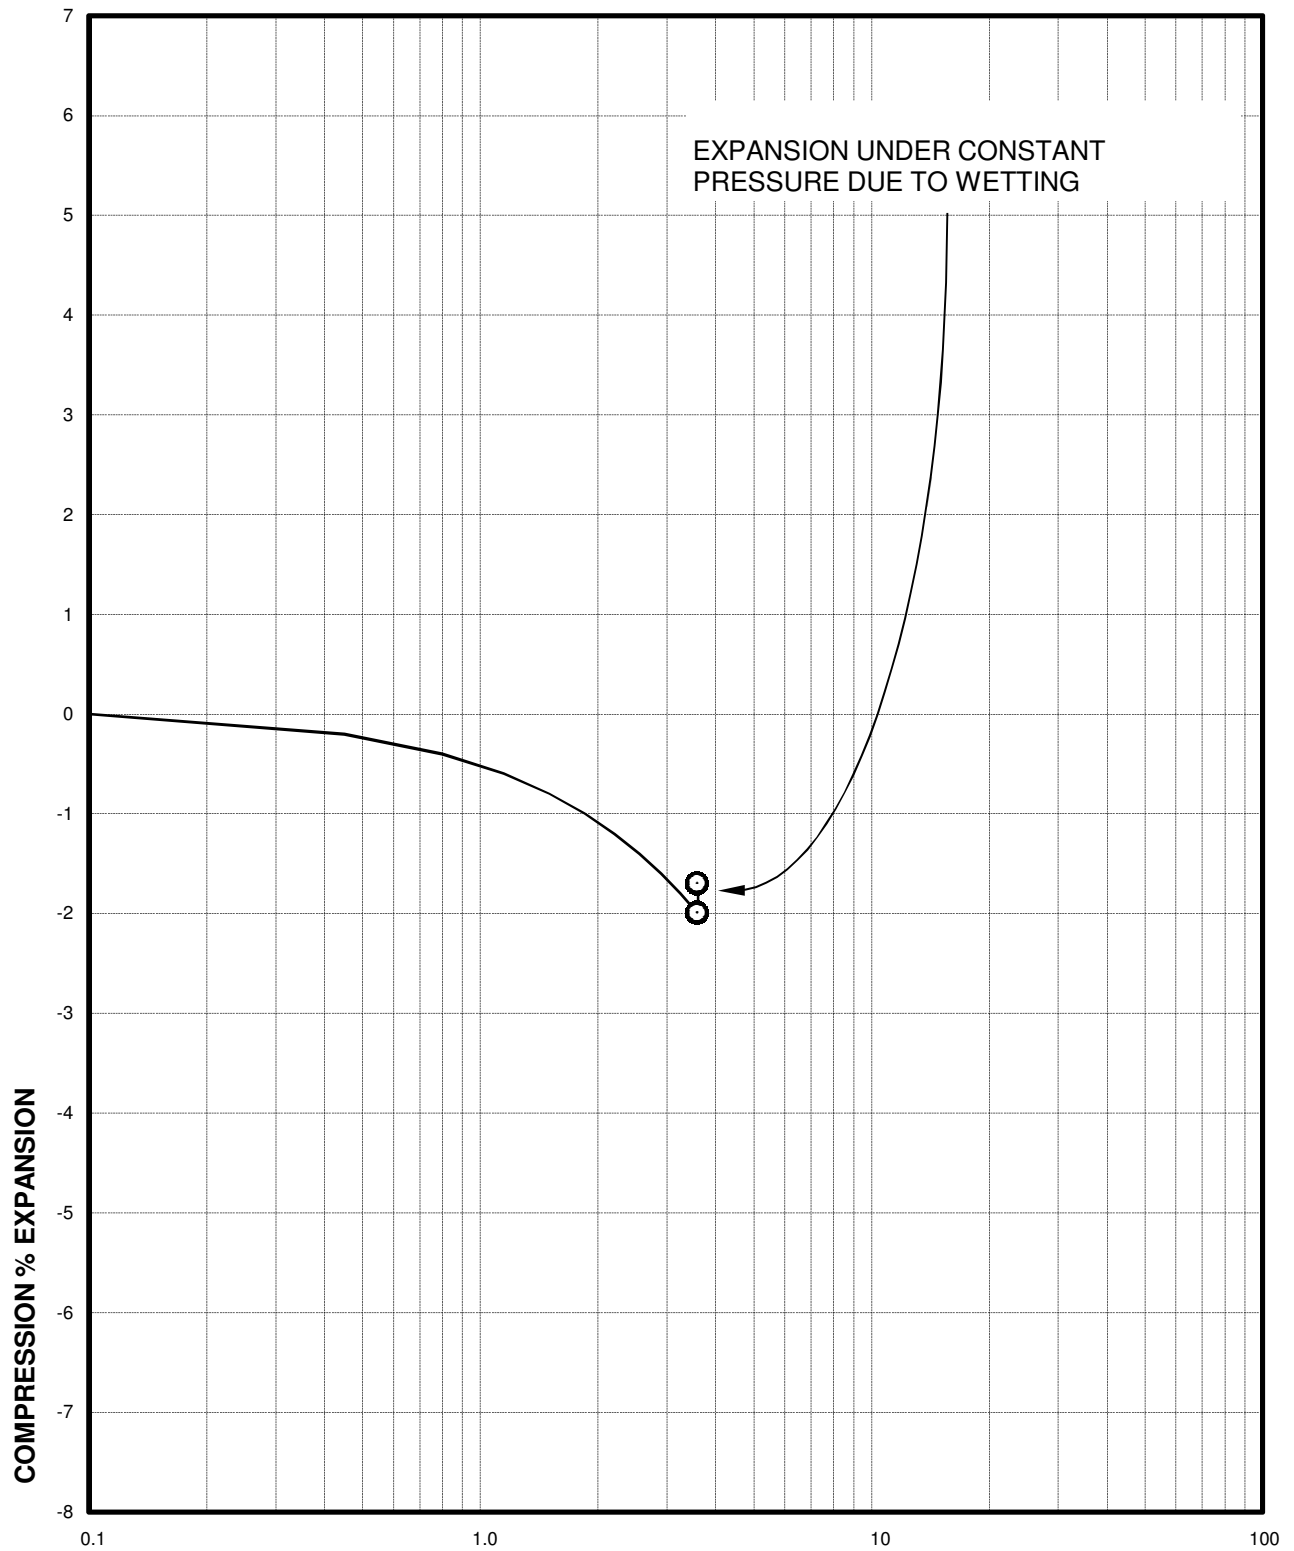
**APPLIED PRESSURE - KSF**  
Sample of CLAYSTONE, SANDY  
From TH-9 AT 29 FEET

DRY UNIT WEIGHT= 127 PCF  
MOISTURE CONTENT= 9.5 %

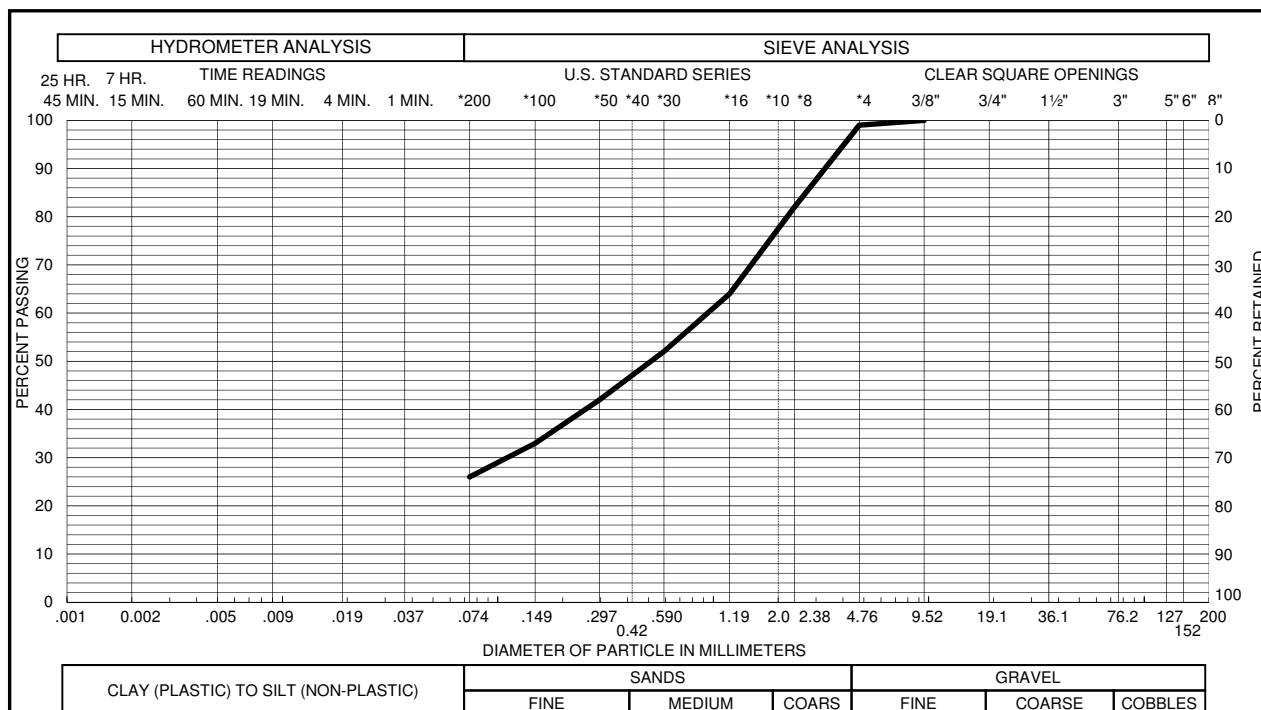
Sample of SAND, SILTY (SM)  
From TH - 1 AT 9 FEET

GRAVEL 1 % SAND 73 %  
SILT & CLAY 26 % LIQUID LIMIT 28 %  
PLASTICITY INDEX 10 %

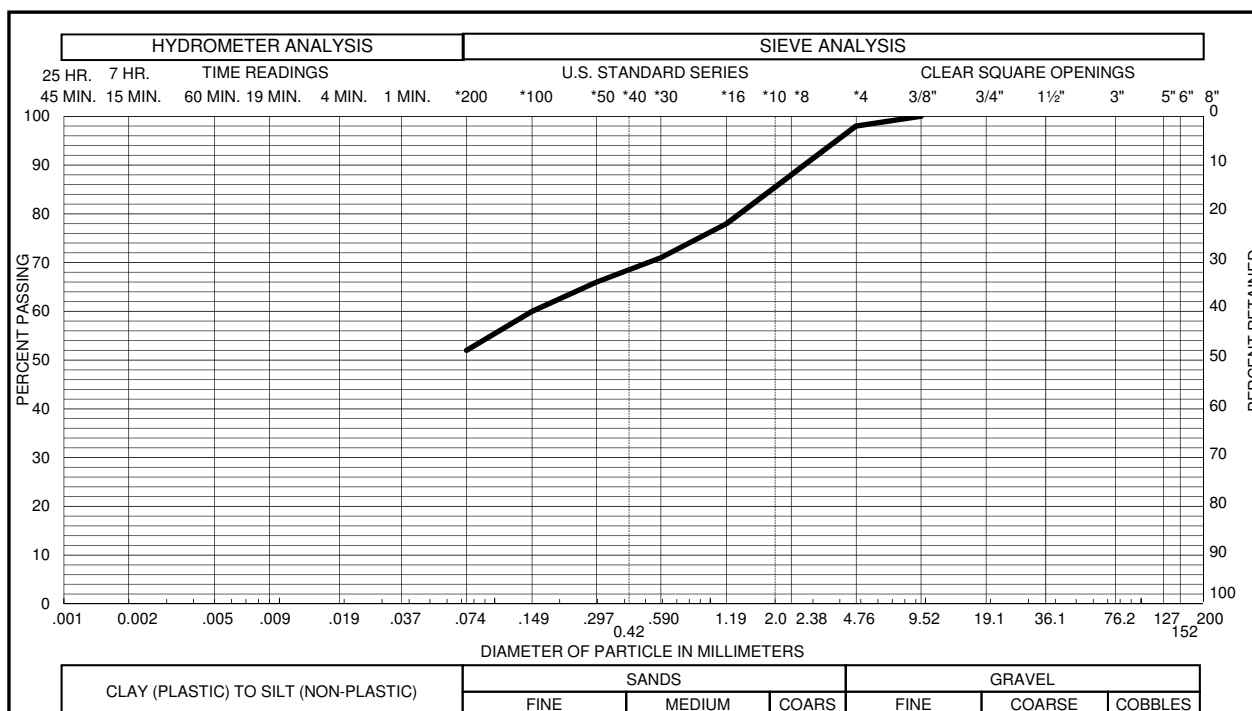
Sample of CLAYSTONE, VERY SANDY  
From TH - 1 AT 14 FEET

GRAVEL 2 % SAND 46 %  
SILT & CLAY 52 % LIQUID LIMIT %  
PLASTICITY INDEX %

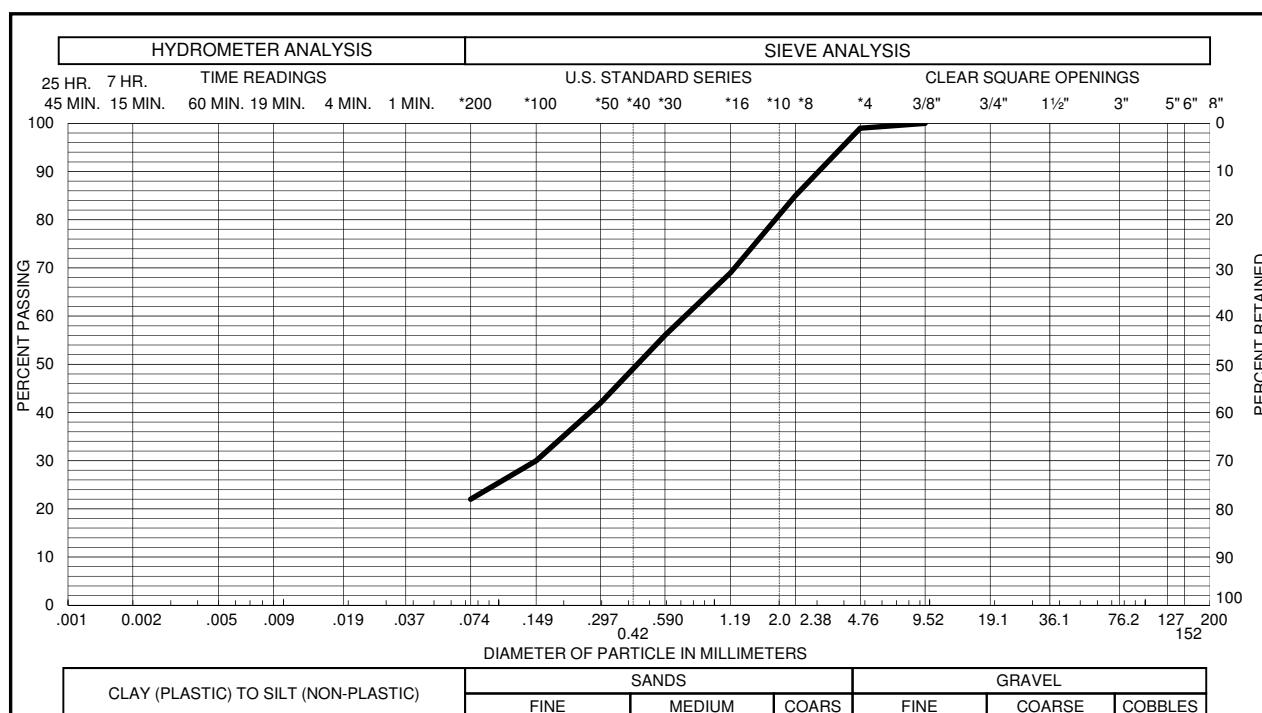
Sample of SANDSTONE, CLAYEY GRAVEL 1 % SAND 77 %  
From TH - 2 AT 14 FEET SILT & CLAY 22 % LIQUID LIMIT      %  
PLASTICITY INDEX      %

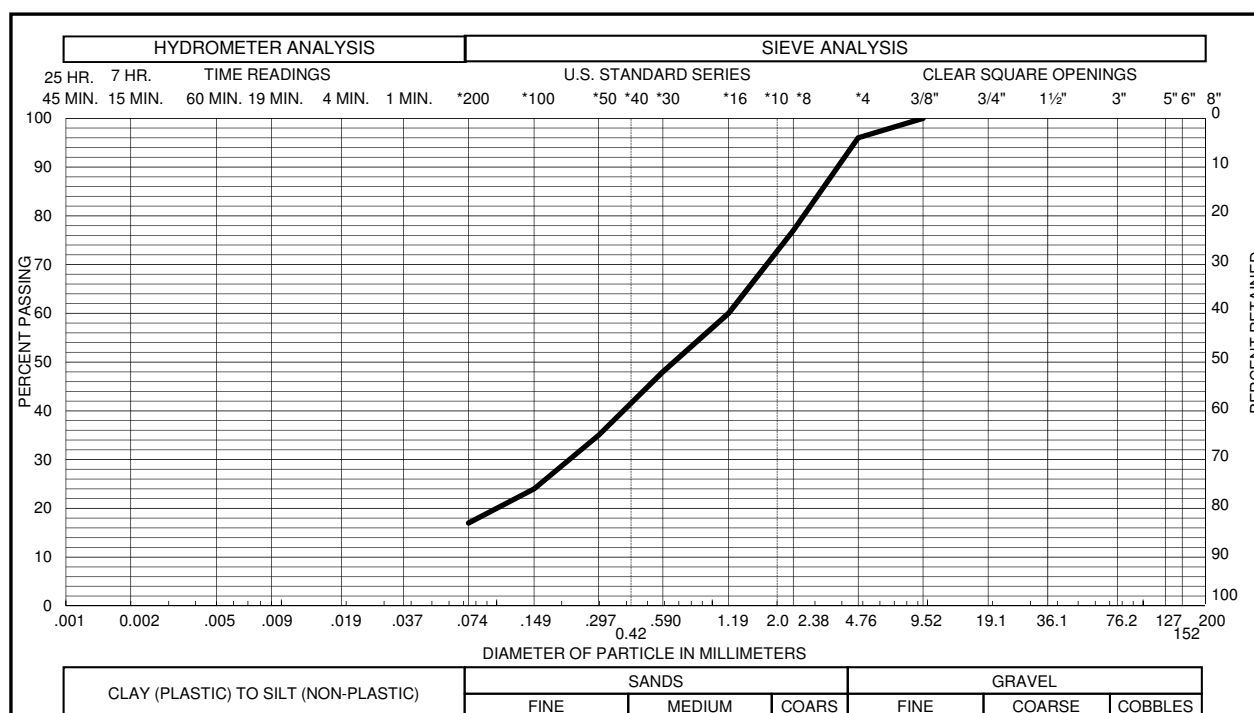
Sample of SANDSTONE, CLAYEY GRAVEL 4 % SAND 79 %  
From TH - 2 AT 24 FEET SILT & CLAY 17 % LIQUID LIMIT      %  
PLASTICITY INDEX      %

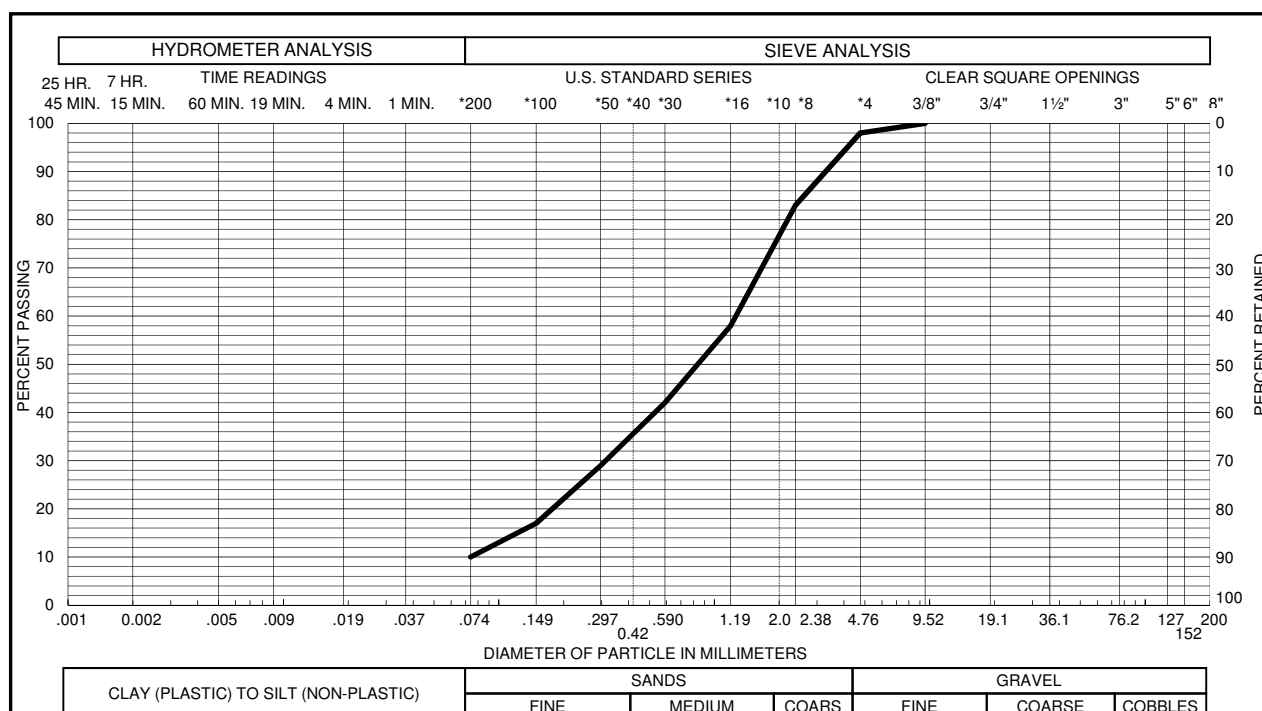
Sample of SAND, SLIGHTLY SILTY (SP-SM) GRAVEL 2 % SAND 88 %  
From TH - 3 AT 4 FEET SILT & CLAY 10 % LIQUID LIMIT        %  
PLASTICITY INDEX        %

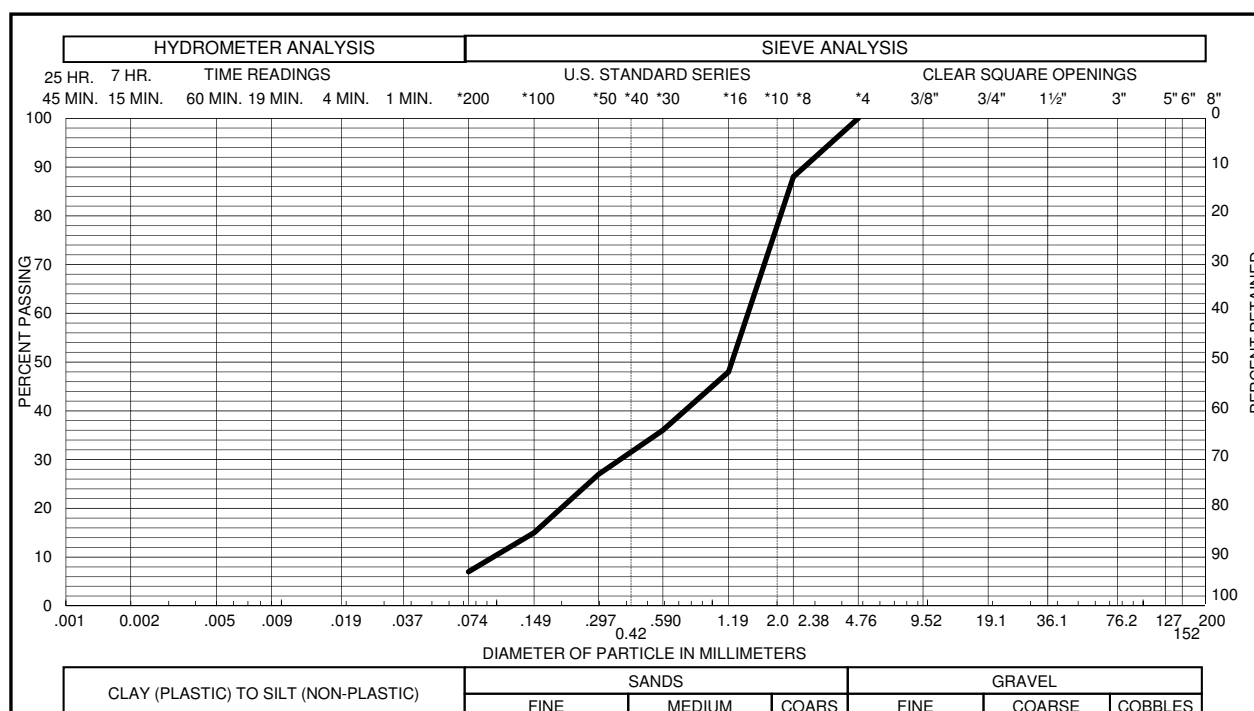
Sample of SAND, SLIGHTLY SILTY (SP-SM) GRAVEL 0 % SAND 93 %  
From TH - 4 AT 9 FEET SILT & CLAY 7 % LIQUID LIMIT        %  
PLASTICITY INDEX        %

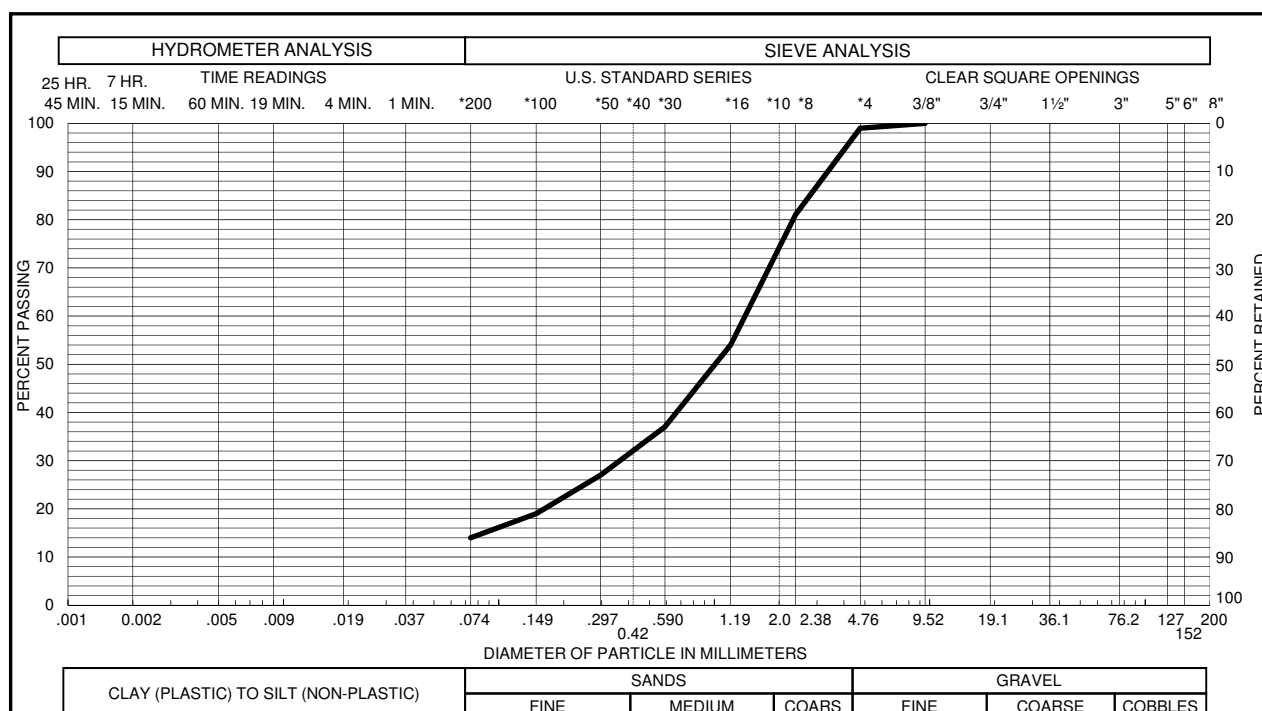
Sample of SANDSTONE, CLAYEY GRAVEL 1 % SAND 85 %  
From TH - 4 AT 14 FEET SILT & CLAY 14 % LIQUID LIMIT      %  
PLASTICITY INDEX      %

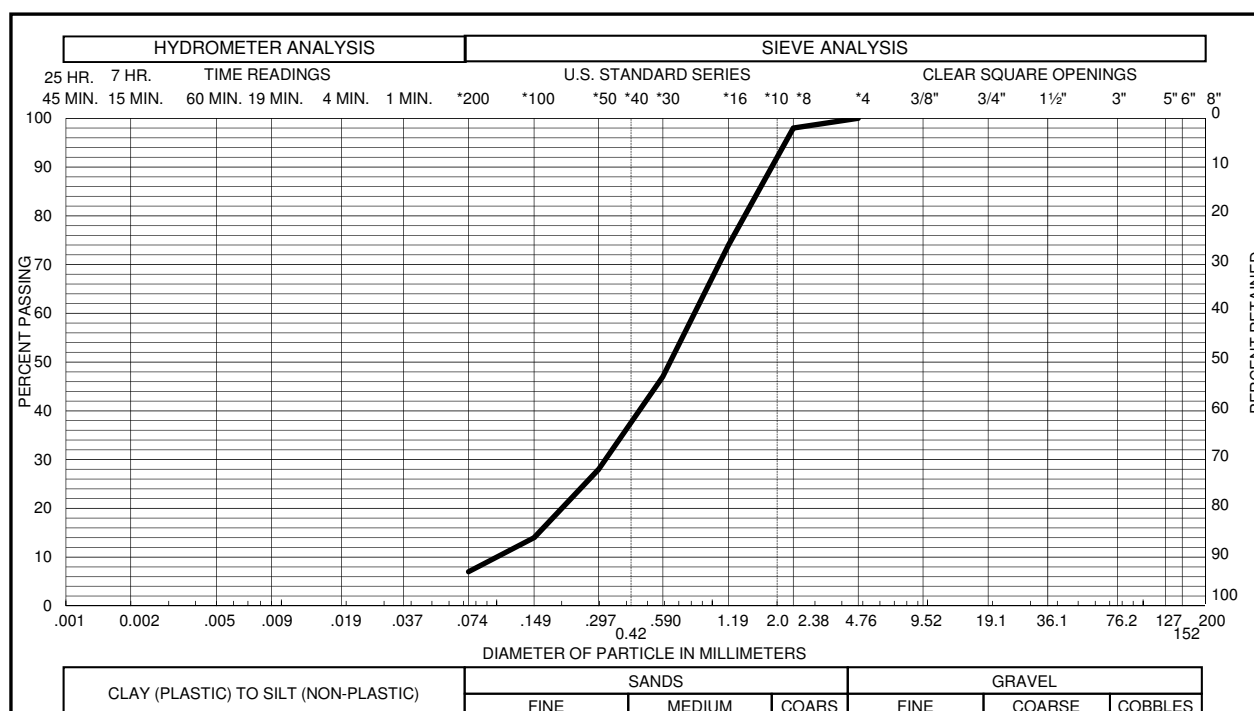
Sample of SAND, SLIGHTLY SILTY (SP-SM) GRAVEL 0 % SAND 93 %  
From TH - 6 AT 4 FEET SILT & CLAY 7 % LIQUID LIMIT      %  
PLASTICITY INDEX      %

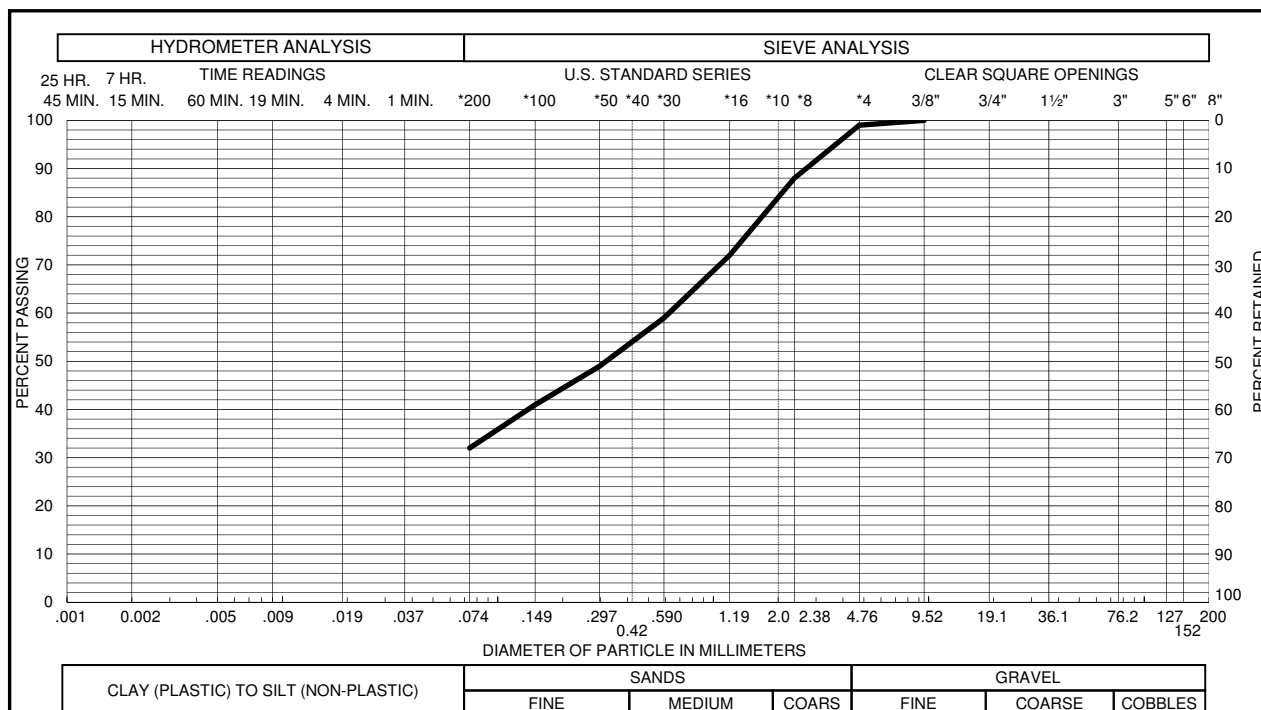
Sample of SANDSTONE, CLAYEY GRAVEL 1 % SAND 67 %  
From TH - 6 AT 19 FEET SILT & CLAY 32 % LIQUID LIMIT        %  
PLASTICITY INDEX        %

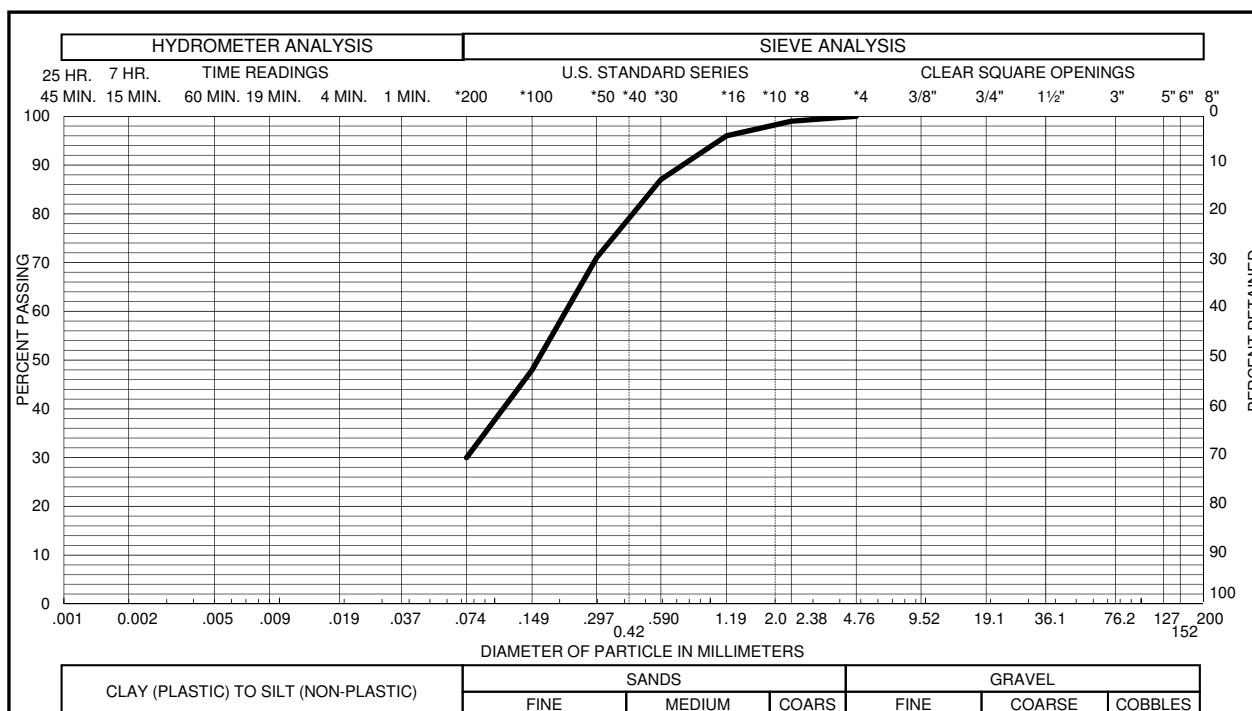
Sample of SANDSTONE, CLAYEY GRAVEL 0 % SAND 70 %  
From TH - 7 AT 29 FEET SILT & CLAY 30 % LIQUID LIMIT        %  
PLASTICITY INDEX        %
