**GEOLOGIC HAZARDS EVALUATION AND  
PRELIMINARY GEOTECHNICAL INVESTIGATION  
WOODMOOR BEACH/SOUTH BEACH SUBDIVISION  
LAKE WOODMOOR DRIVE AND LOWER LAKE ROAD  
MONUMENT, COLORADO**

**Project No. CS18677-115**

**December 13, 2016**

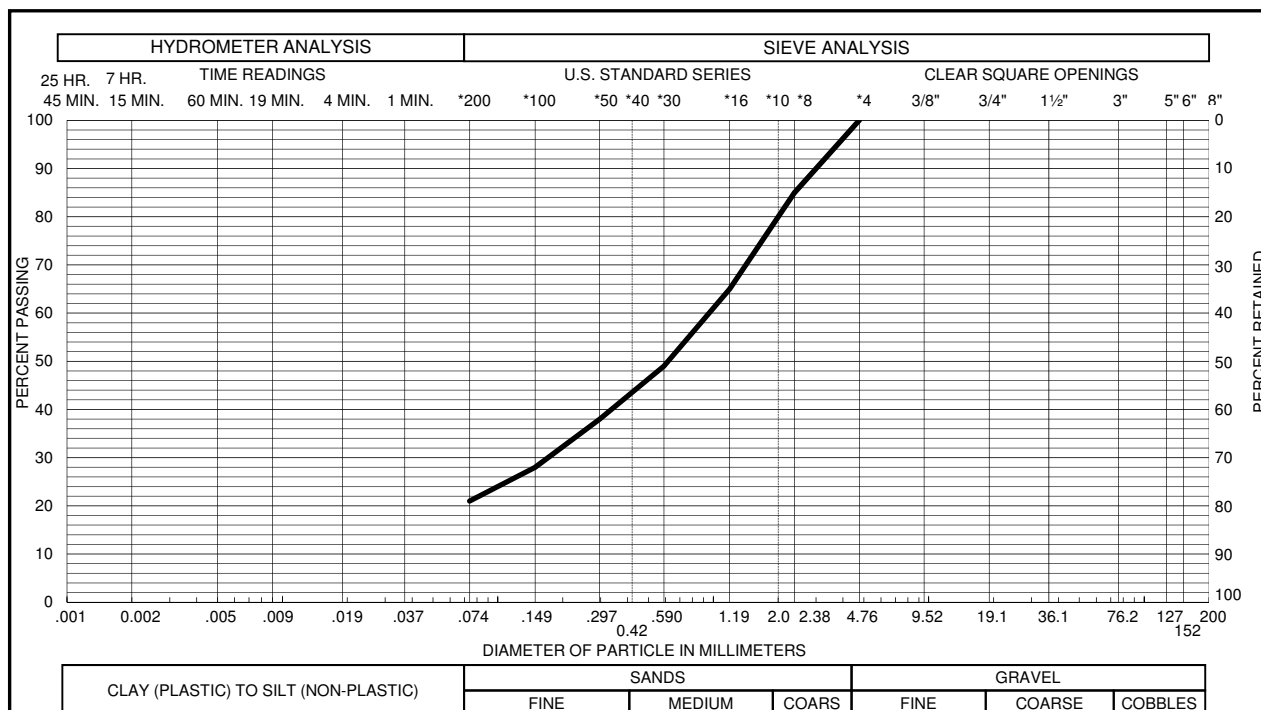
Sample of SAND, CLAYEY (SC) GRAVEL 0 % SAND 79 %  
From TH - 8 AT 14 FEET SILT & CLAY 21 % LIQUID LIMIT      %  
PLASTICITY INDEX      %

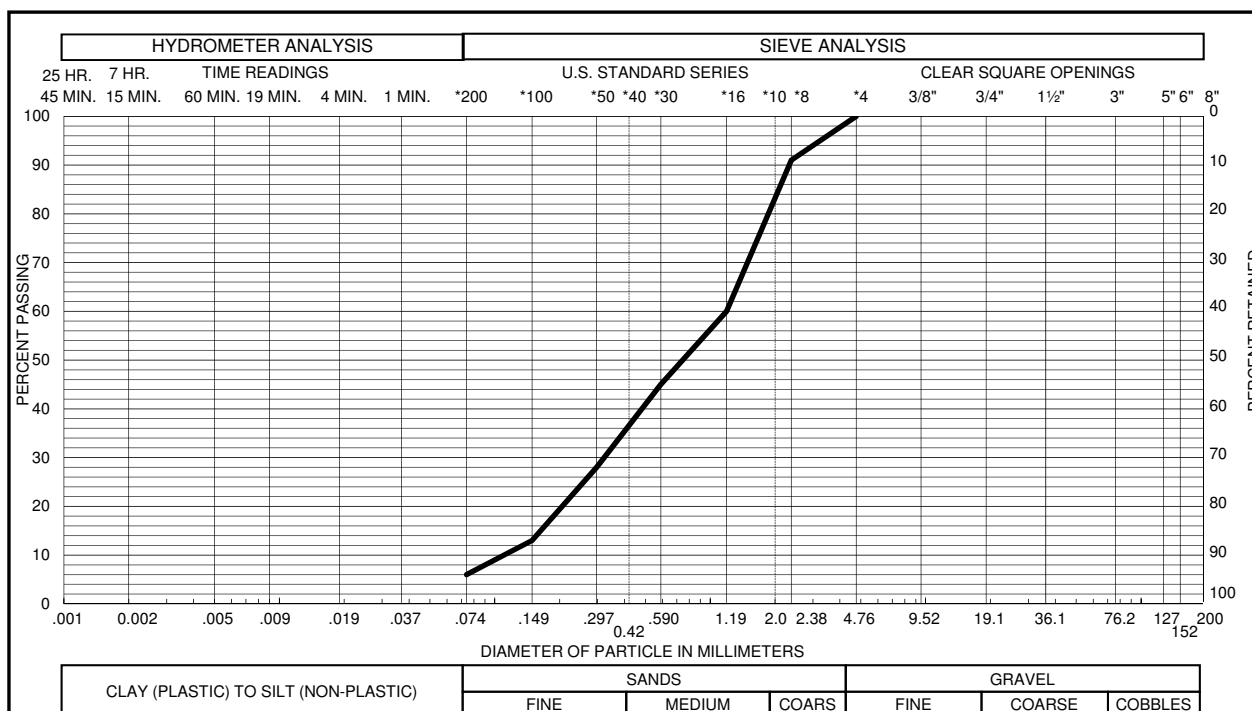
Sample of SAND, SILTY (SM) GRAVEL 0 % SAND 94 %  
From TH - 9 AT 9 FEET SILT & CLAY 6 % LIQUID LIMIT      %  
PLASTICITY INDEX      %

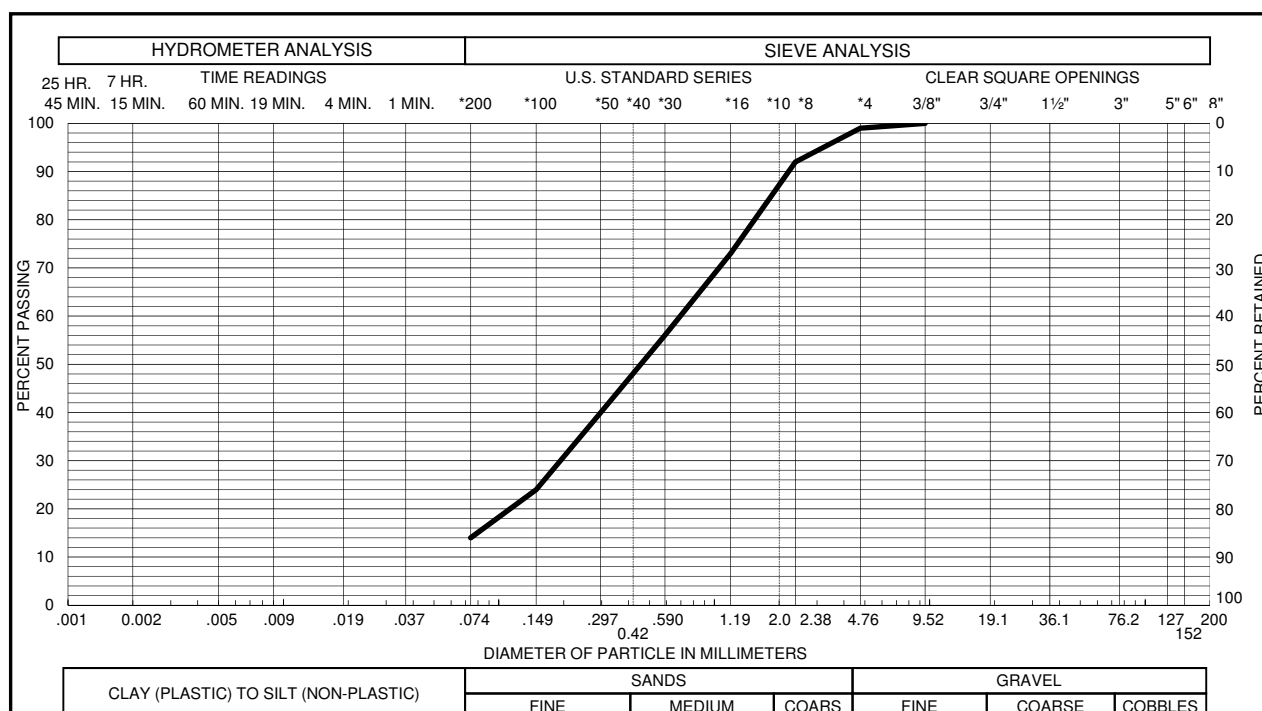
Sample of SAND, CLAYEY (SC) GRAVEL 1 % SAND 85 %  
From TH - 9 AT 24 FEET SILT & CLAY 14 % LIQUID LIMIT      %  
PLASTICITY INDEX      %

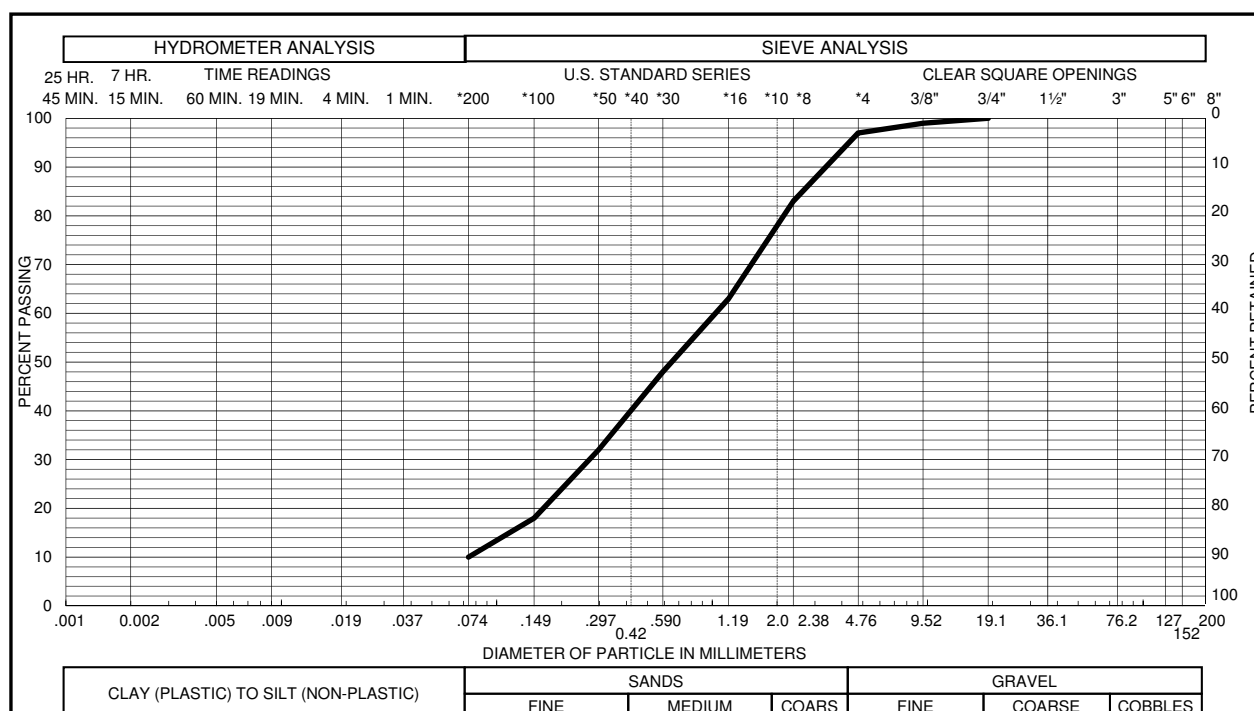
Sample of SAND, SLIGHTLY SILTY (SP-SM) GRAVEL 3 % SAND 87 %  
From TH - 10 AT 4 FEET SILT & CLAY 10 % LIQUID LIMIT      %  
PLASTICITY INDEX      %
