ENTECH
ENGINEERING, INC.

**SOIL, GEOLOGY, AND GEOLOGIC HAZARD STUDY
THE VILLAS AT CLAREMONT RANCH
CLAREMONT RANCH FILING NO. 7
1250 MEADOWBROOK PARKWAY
EL PASO COUNTY, COLORADO**

September 22, 2017

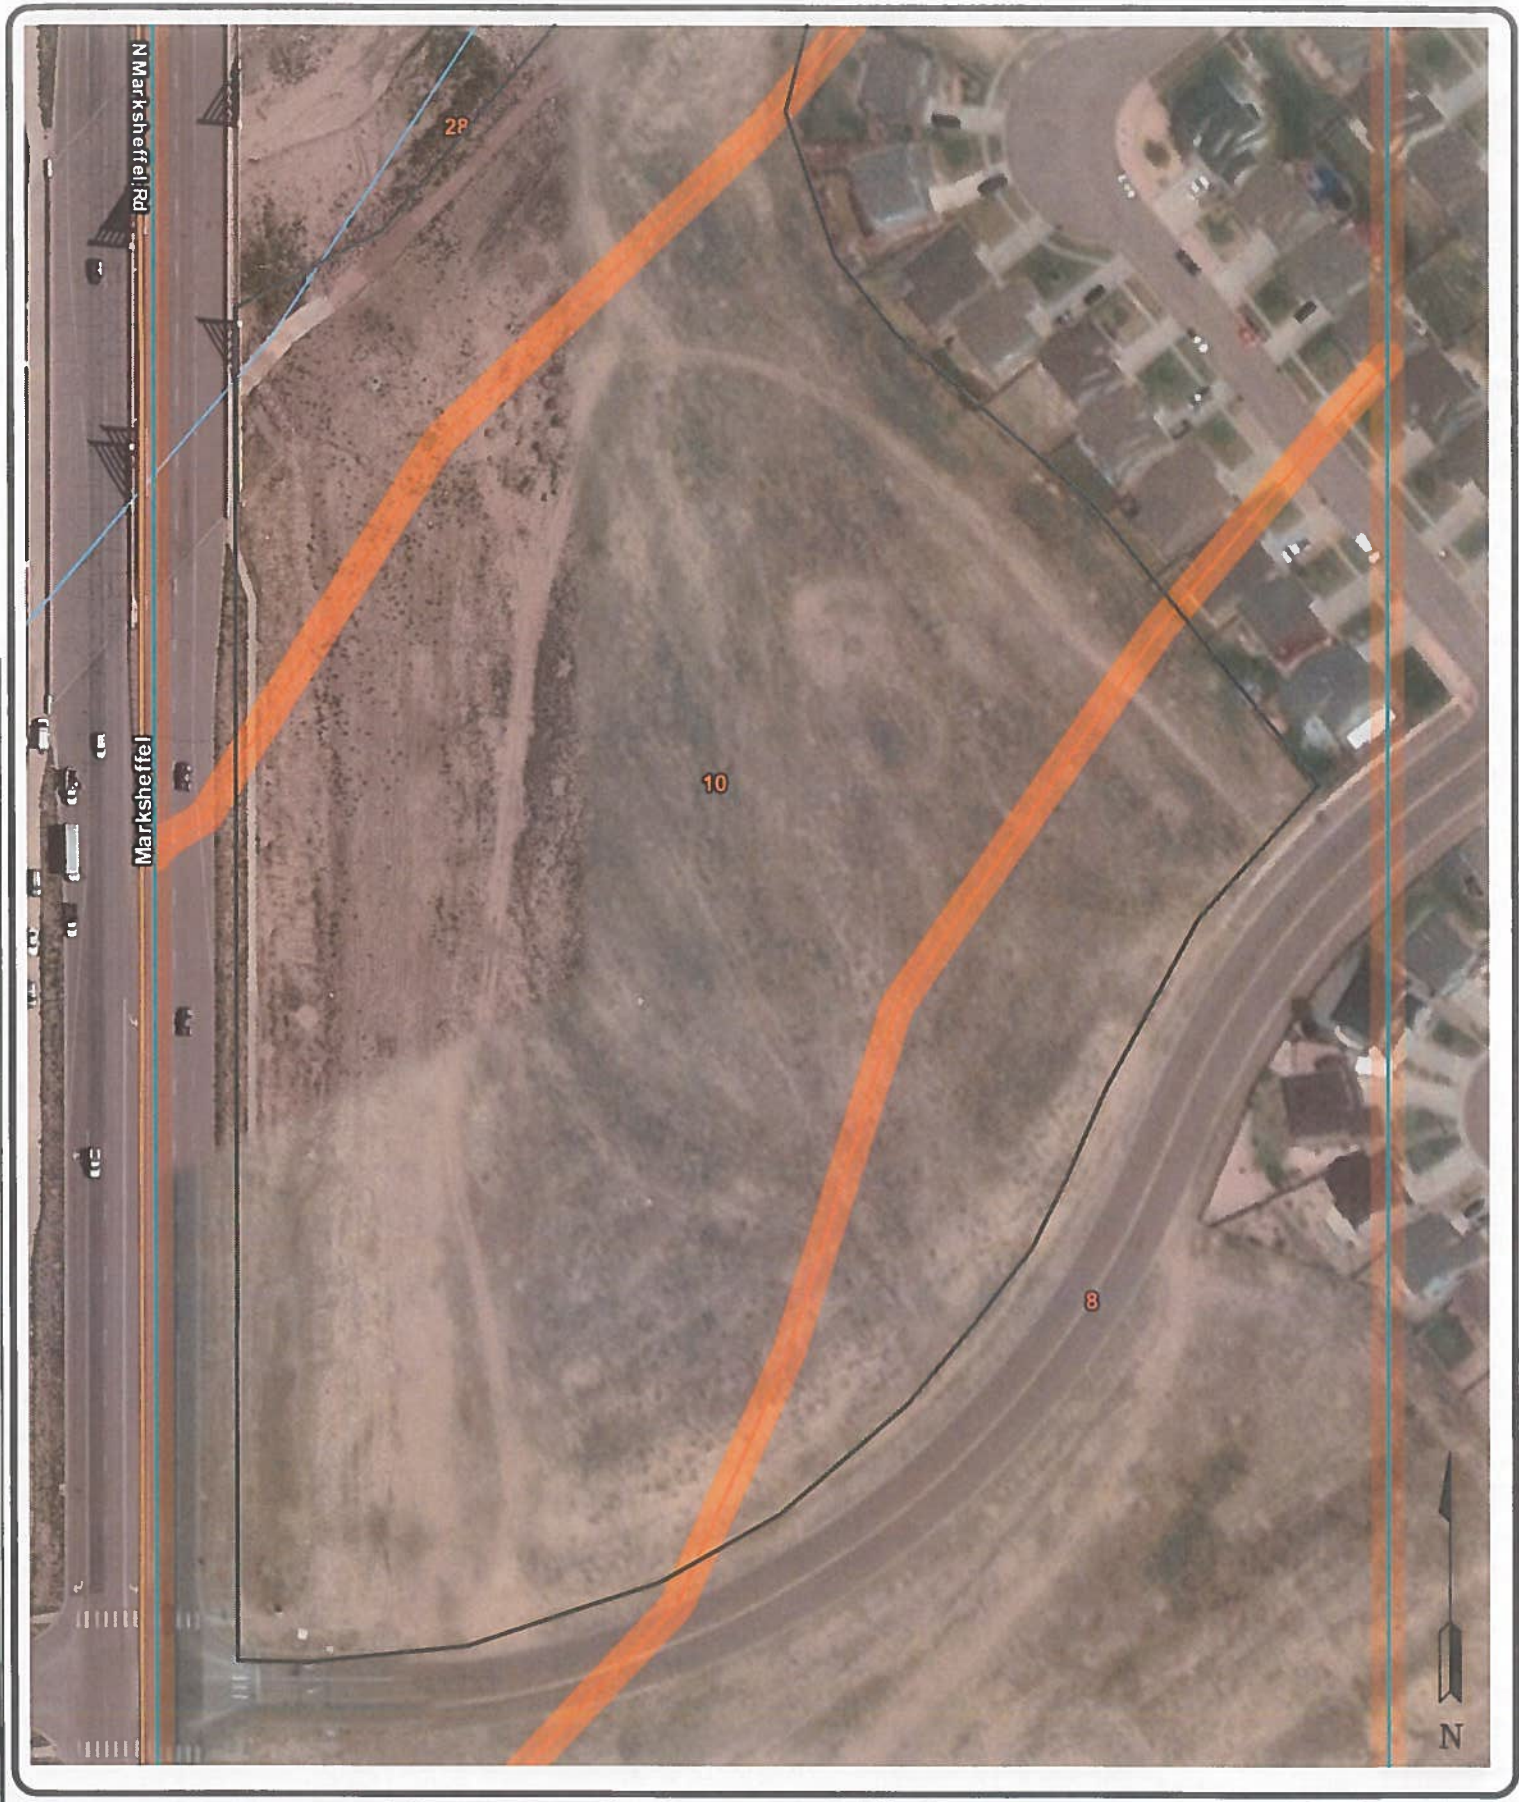
FIG NO.:
 4

SOIL SURVEY MAP
THE VILLAS AT CLAREMONT RANCH
1250 MEADOWBROOK PARKWAY
EL PASO COUNTY, CO.
FOR: ENGINEERING AND SURVEYING, INC.

Complete descriptions of each soil type are presented in Appendix D. The soils have generally been described to have moderate to moderately rapid permeabilities. Possible hazards with soil

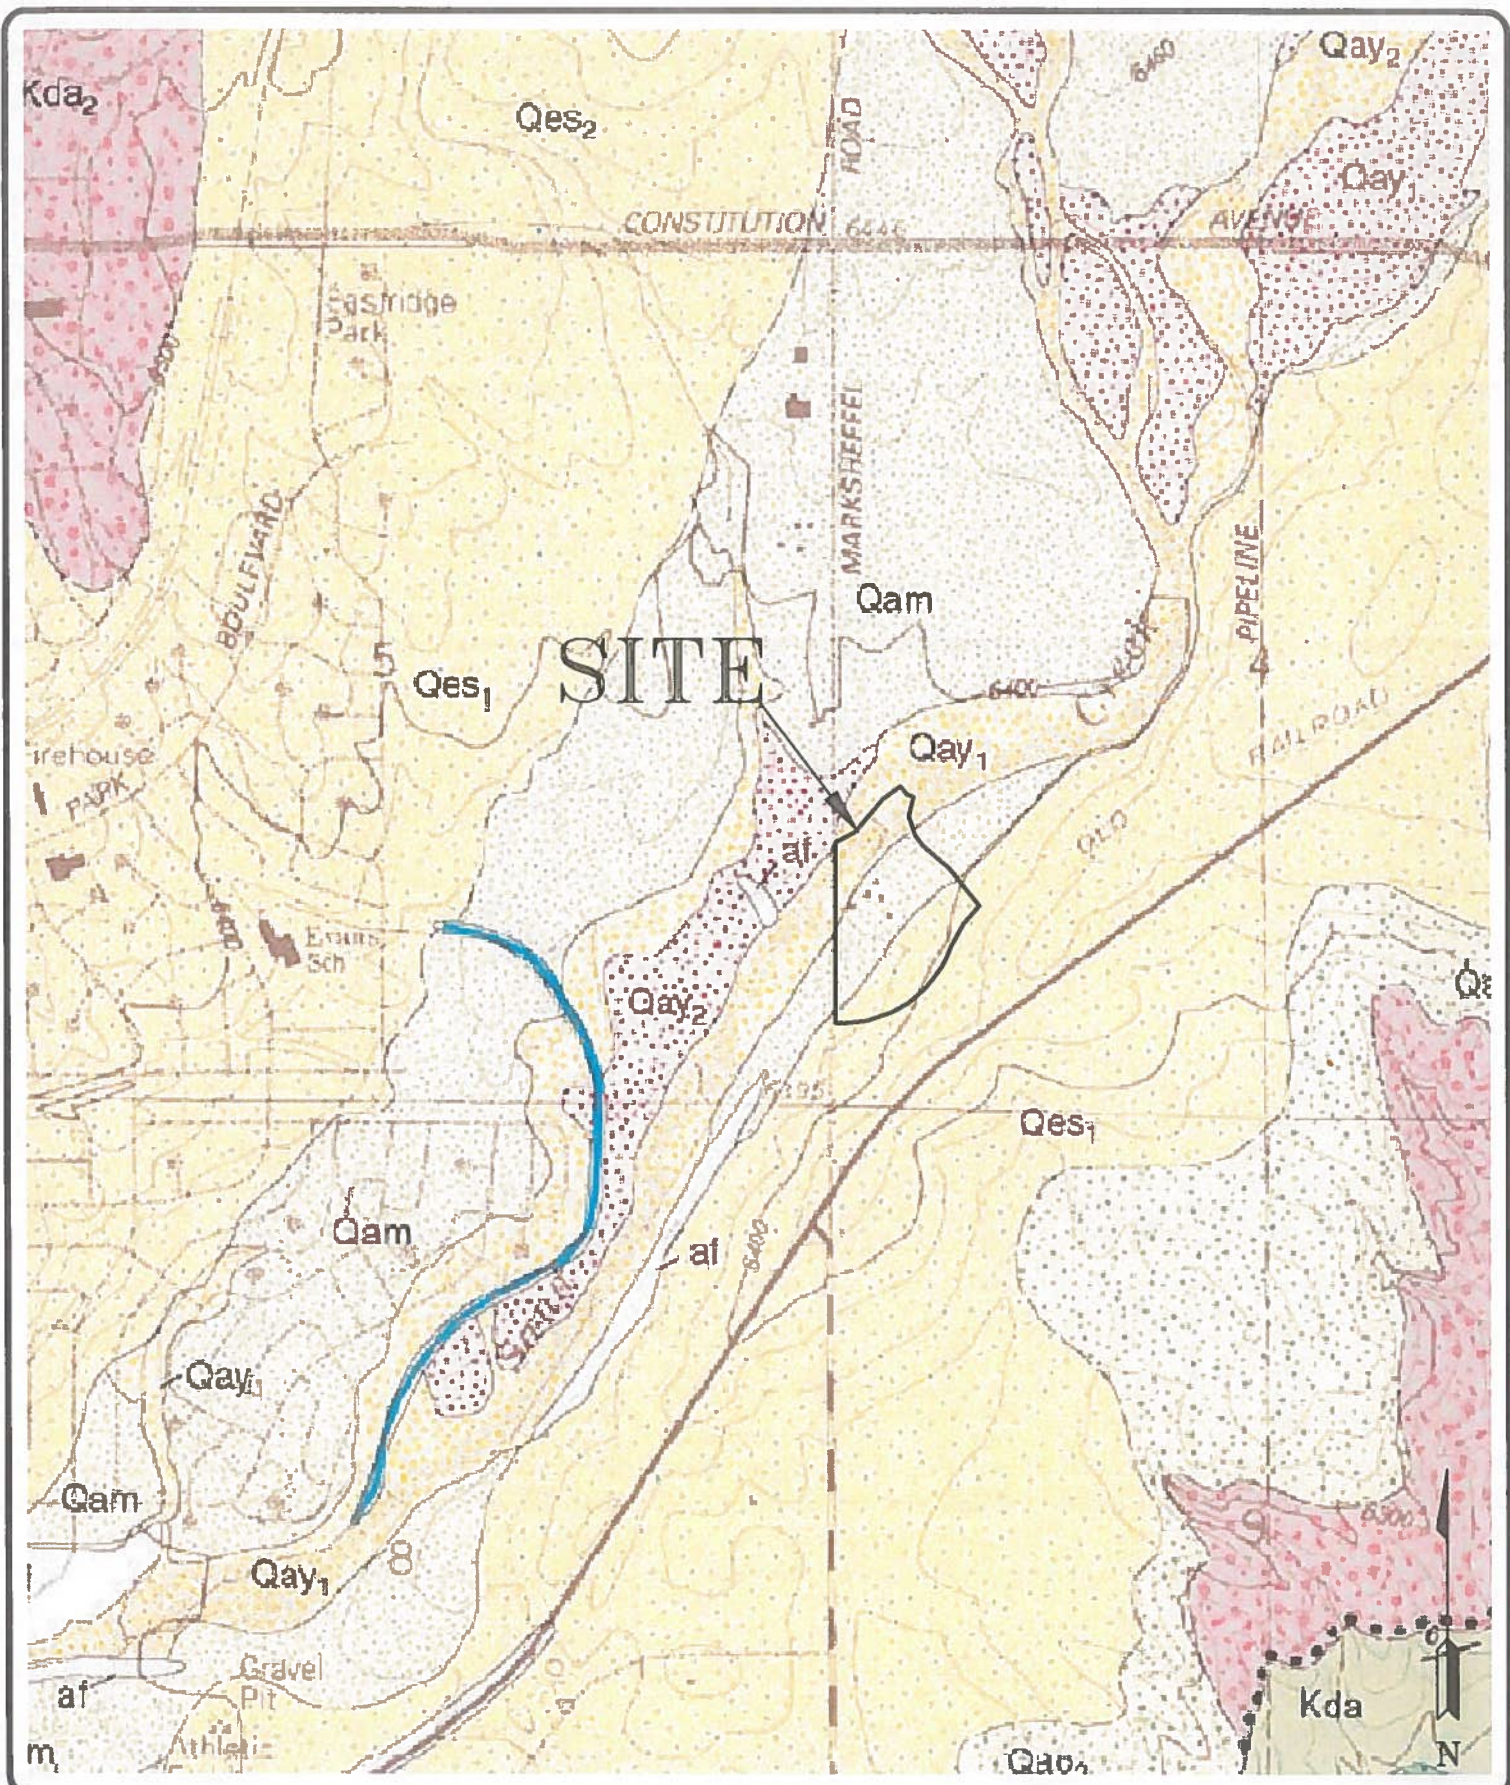
FIG NO.:
5

ELSMERE QUADRANGLE GEOLOGY MAP
THE VILLAS AT CLAREMONT RANCH
1250 MEADOWBROOK PARKWAY
EL PASO COUNTY, CO.
FOR: ENGINEERING AND SURVEYING, INC.

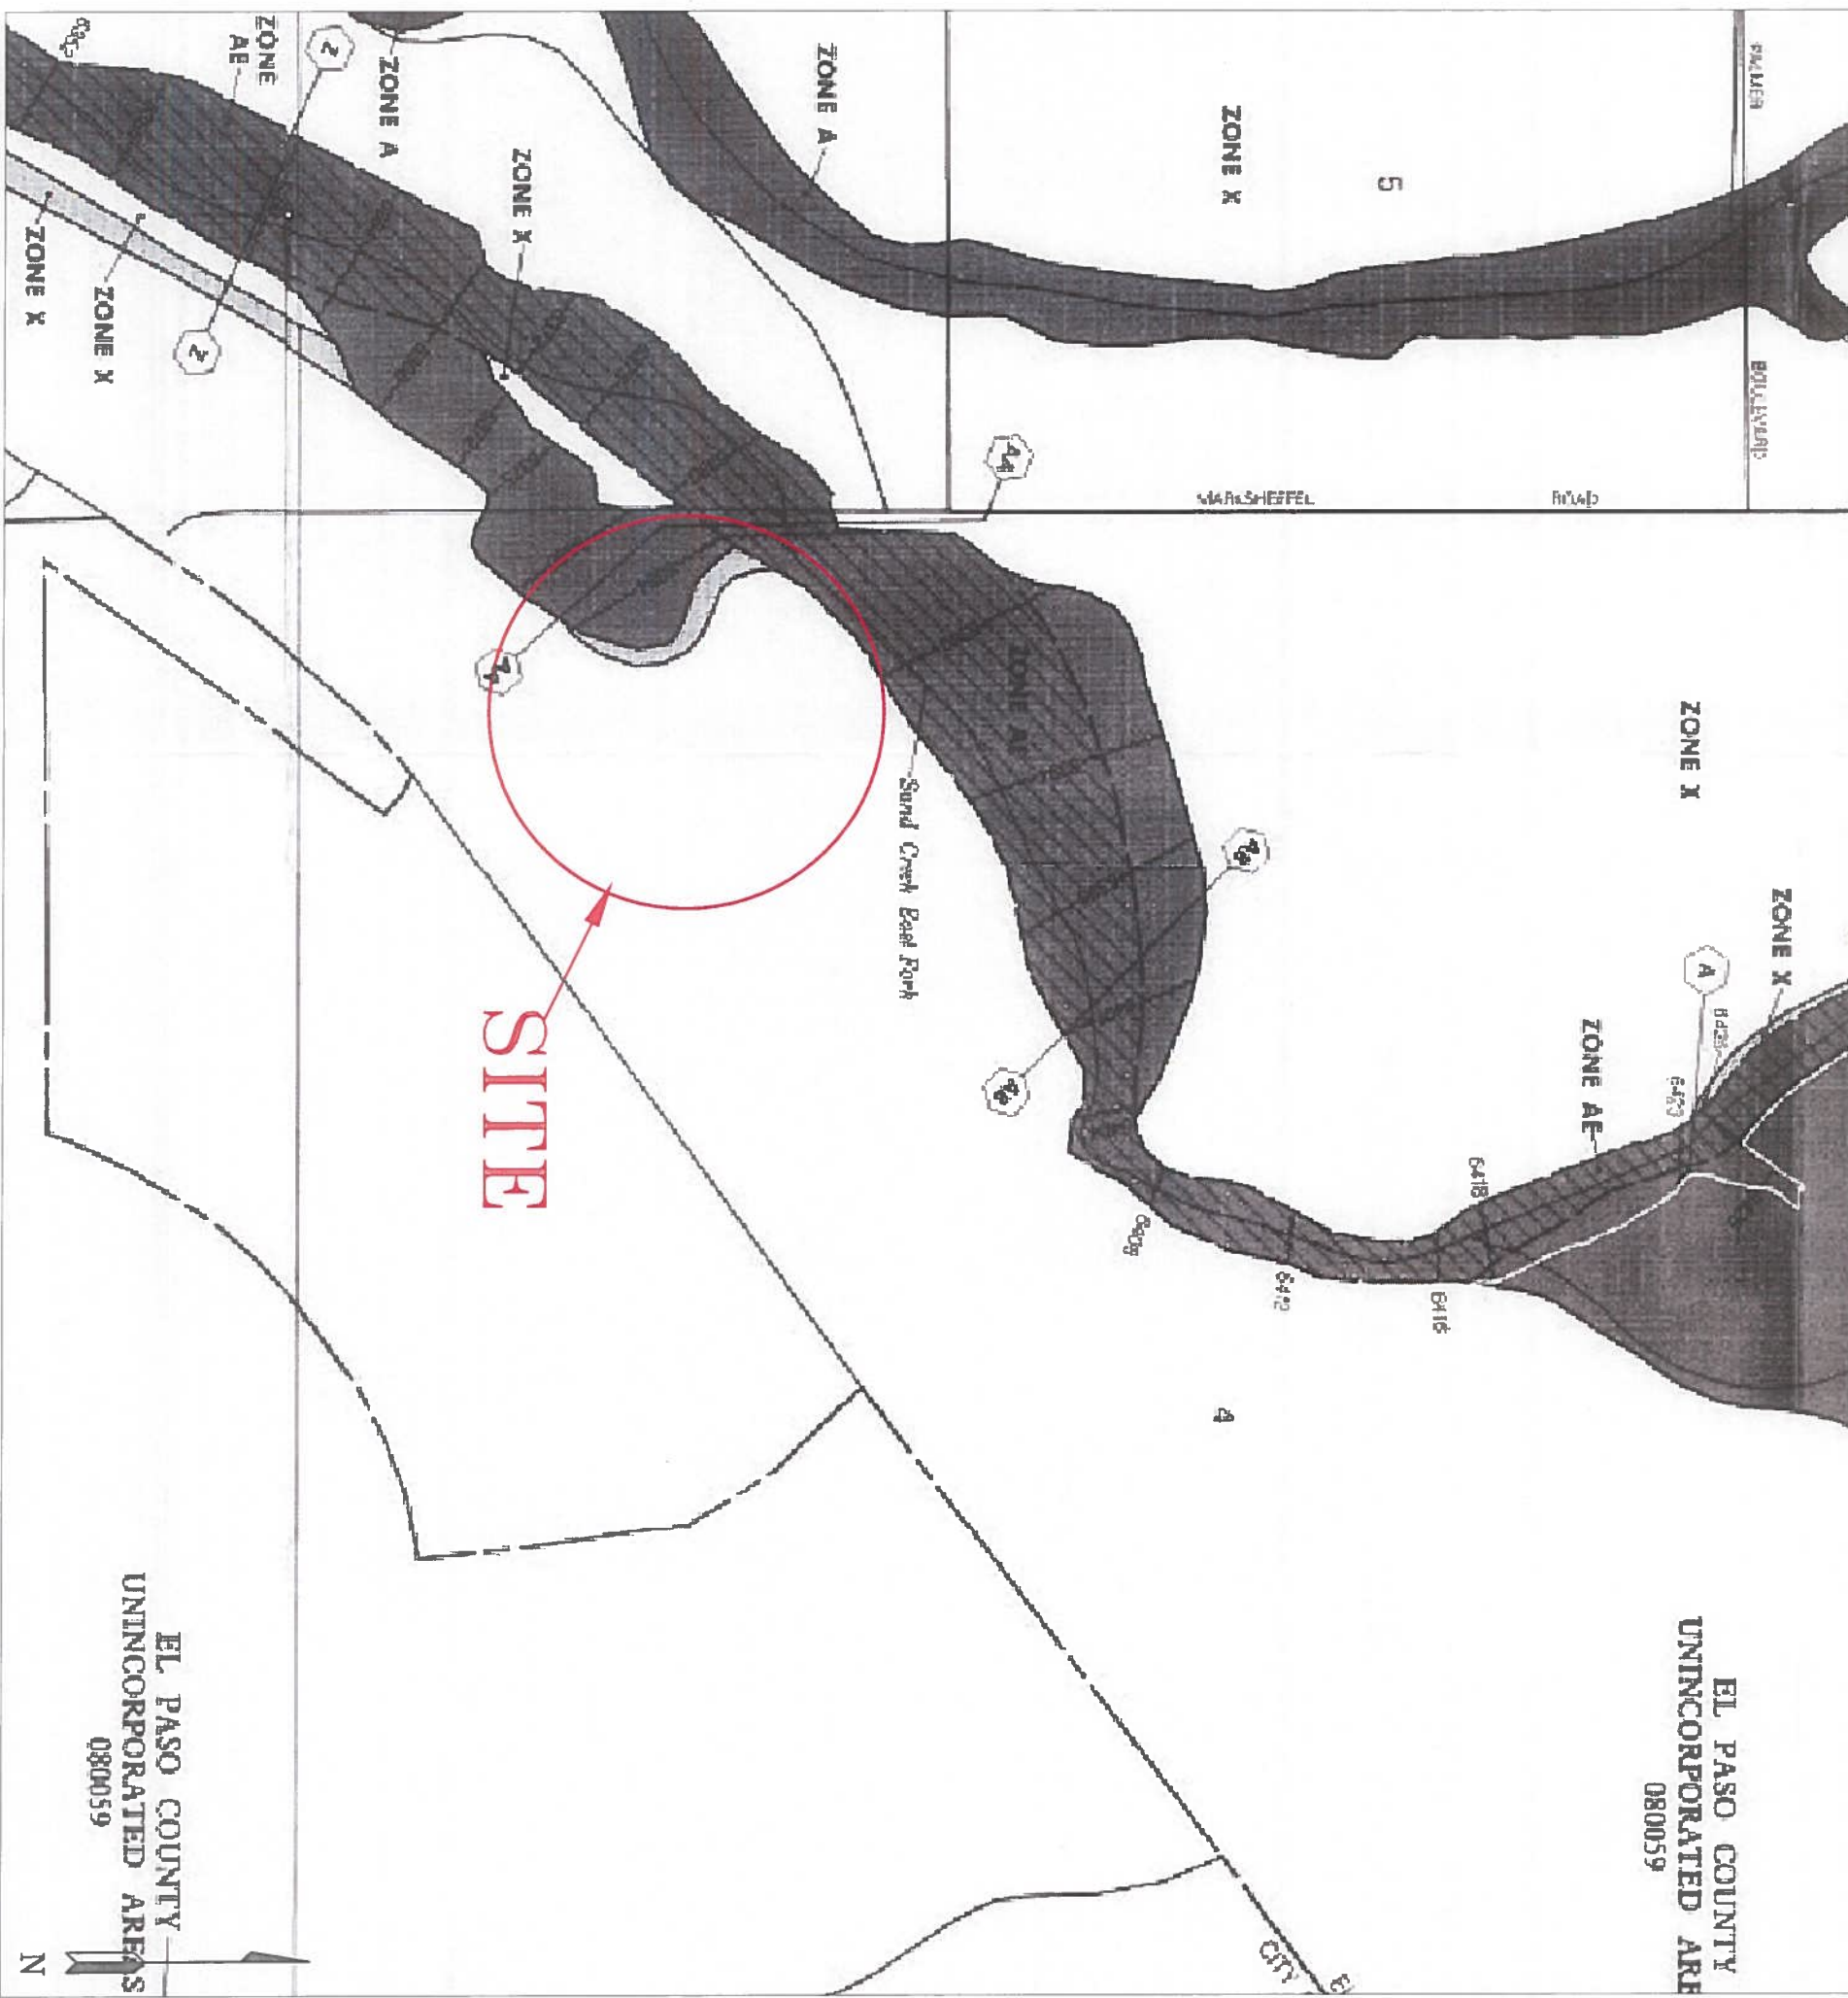
FLOODPLAIN MAP
THE VILLAS AT CLAREMONT RANCH
 1250 MEADOWBROOK PARKWAY
 EL PASO COUNTY, CO.
 FOR: ENGINEERING AND SURVEYING, INC.

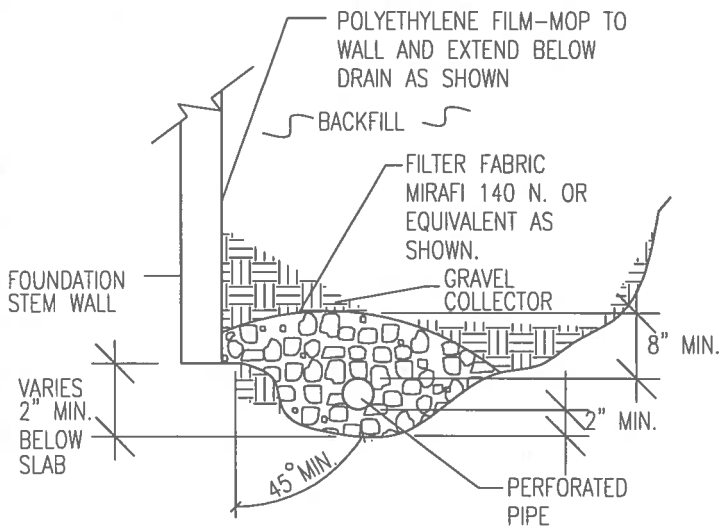
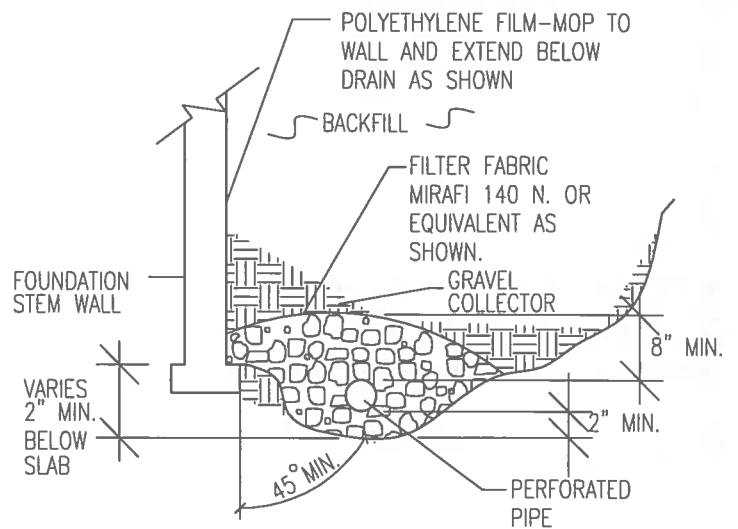
-GRAVEL SIZE IS RELATED TO DIAMETER OF PIPE PERFORATIONS-85% GRAVEL GREATER THAN 2x PERFORATION DIAMETER.

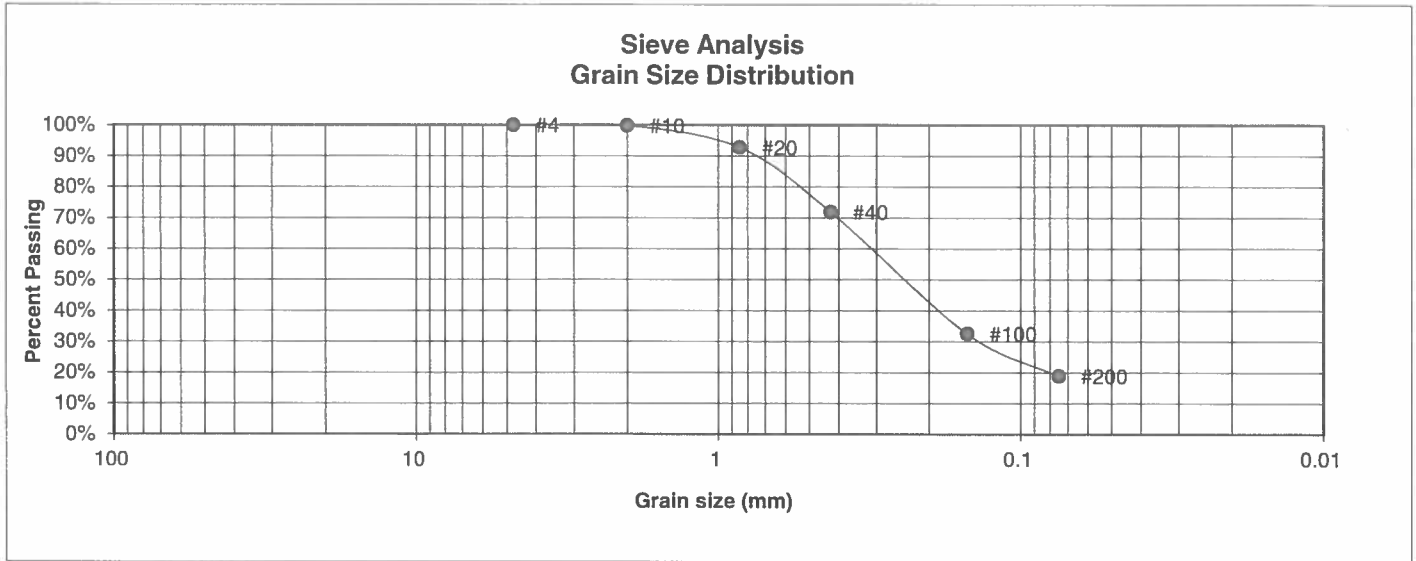
C-1

UNIFIED CLASSIFICATION	SM	CLIENT	ENGINEERING AND SURVEYING
SOIL TYPE #	1	PROJECT	1250 MEADOWBROOK PARKWAY
TEST BORING #	1	JOB NO.	171247
DEPTH (FT)	2-3	TEST BY	BL

U.S. Sieve #	Percent Finer
3"	
1 1/2"	
3/4"	
1/2"	
3/8"	
4	100.0%
10	99.8%
20	92.7%
40	71.9%
100	32.5%
200	18.8%

Atterberg Limits	
Plastic Limit	NP
Liquid Limit	NV
Plastic Index	NP

Soil Type 1 silty sand fill (SM), encountered in all of Test Borings at the existing ground surface and extending to depths ranging from 7 feet to 9 feet bgs. These soils were encountered at medium dense states and at moist conditions. Samples tested had 12 to 19 percent passing the No. 200 Sieve. Atterberg Limits Testing resulted in the sand fill being non-plastic. Sulfate

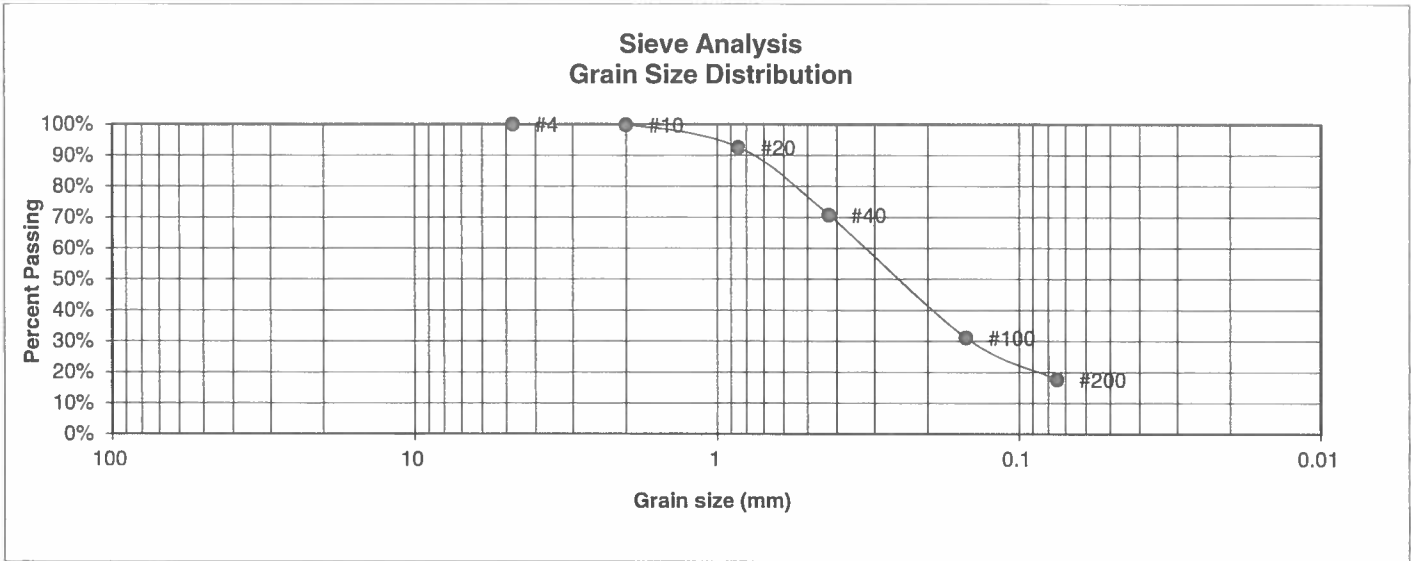
FIG NO.:
C-2

<u>UNIFIED CLASSIFICATION</u>	SM	<u>CLIENT</u>	ENGINEERING AND SURVEYING
<u>SOIL TYPE #</u>	1	<u>PROJECT</u>	1250 MEADOWBROOK PARKWAY
<u>TEST BORING #</u>	3	<u>JOB NO.</u>	171247
<u>DEPTH (FT)</u>	2-3	<u>TEST BY</u>	BL

<u>U.S. Sieve #</u>	<u>Percent Finer</u>
3"	
1 1/2"	
3/4"	
1/2"	
3/8"	
4	100.0%
10	99.8%
20	92.6%
40	70.8%
100	31.1%
200	17.7%

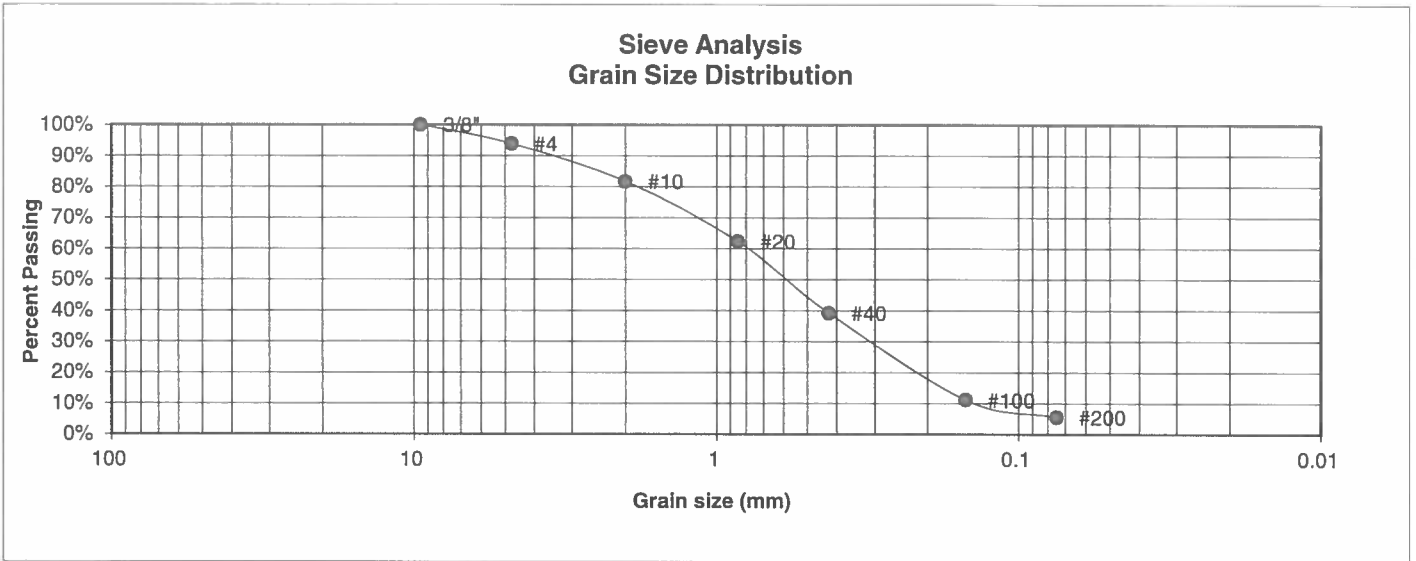
<u>UNIFIED CLASSIFICATION</u>	SM-SW	<u>CLIENT</u>	ENGINEERING AND SURVEYING
<u>SOIL TYPE #</u>	2	<u>PROJECT</u>	1250 MEADOWBROOK PARKWAY
<u>TEST BORING #</u>	1	<u>JOB NO.</u>	171247
<u>DEPTH (FT)</u>	15	<u>TEST BY</u>	BL

U.S. Sieve #	Percent Finer
3"	
1 1/2"	
3/4"	
1/2"	
3/8"	100.0%
4	93.9%
10	81.8%
20	62.3%
40	39.2%
100	11.1%
200	5.6%

Soil Type 2 native slightly silty to silty sand (SM-SW, SM), encountered in all of the test borings at depths ranging from 7 to 10 feet bgs, and extending to the termination of the test borings (20 feet). These soils were encountered at loose to medium dense states and moist to wet conditions. Samples tested had 6 to 13 percent passing the No. 200 Sieve. Sulfate testing resulted in less than 0.01 to 0.01 percent sulfate by weight indicating the clay exhibits negligible potential for below grade concrete degradation.

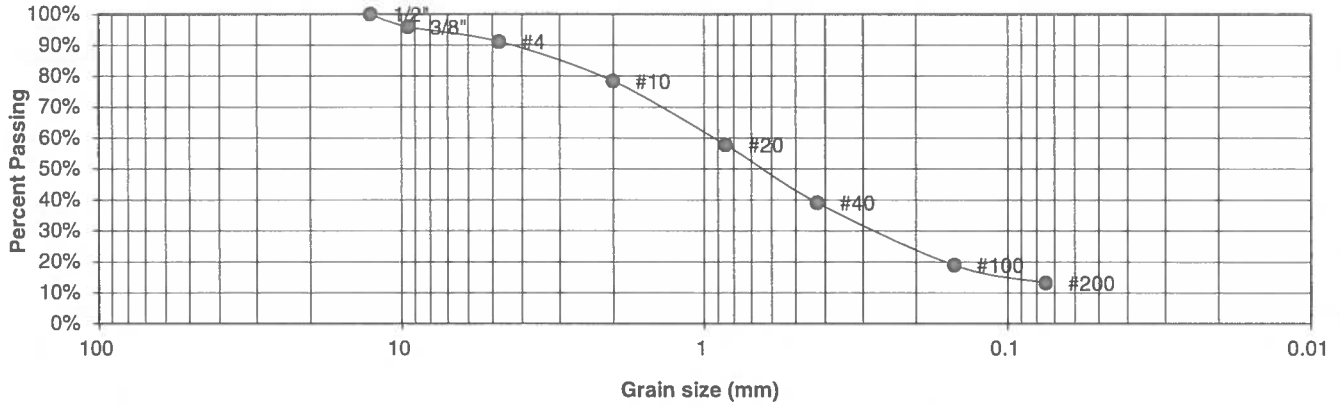
**Sieve Analysis
Grain Size Distribution**

U.S. Sieve #	Percent Finer
3"	
1 1/2"	
3/4"	
1/2"	100.0%
3/8"	95.9%
4	91.1%
10	78.4%
20	57.8%
40	39.1%
100	18.9%
200	13.2%

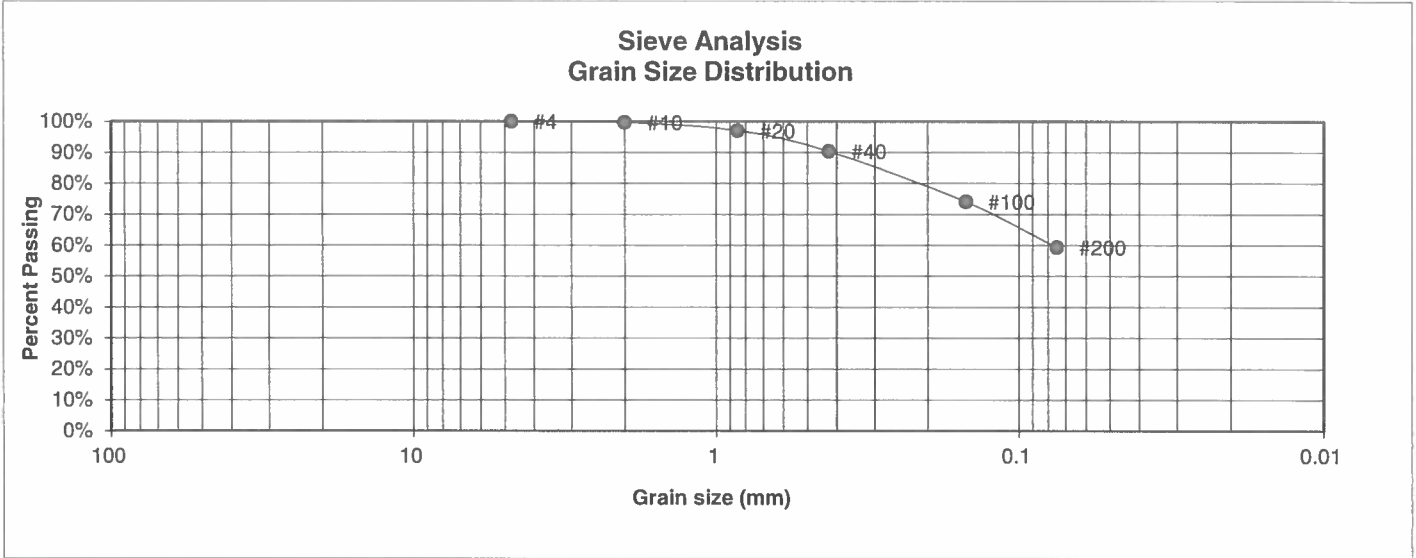
FIG NO.:
 C-6

UNIFIED CLASSIFICATION	CL
SOIL TYPE #	3
TEST BORING #	2
DEPTH (FT)	10

U.S. Sieve #	Percent Finer
3"	
1 1/2"	
3/4"	
1/2"	
3/8"	
4	100.0%
10	99.7%
20	97.1%
40	90.4%
100	74.0%
200	59.4%

Soil Type 3 native very sandy clay and very clayey sand (CL, SC), encountered in Test Boring Nos. 2, 3, and 6 at depths ranging from 7 to 8 feet bgs and extending to depths of 10 to 11 feet bgs. The very sandy clay and very clayey sand were encountered at soft consistencies and at moist conditions. Samples tested had 40 to 59 percent passing the No. 200 Sieve. Atterberg Limits Testing resulted in a liquid limit of 22 and a plastic index of 11. Swell/Consolidation Testing resulted in a consolidation of 0.5 percent, which indicates a low to moderate consolidation potential.

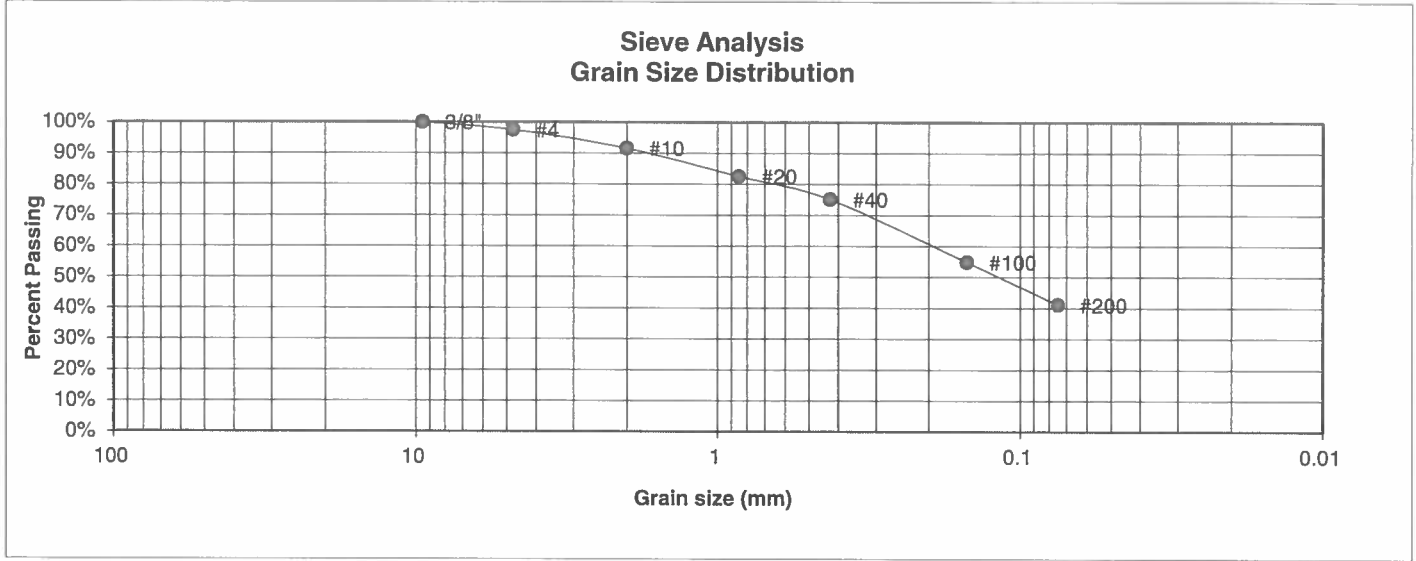
JOB NO.: 171247
 FIG NO.: C-7

UNIFIED CLASSIFICATION	SC	CLIENT	ENGINEERING AND SURVEYING
SOIL TYPE #	3	PROJECT	1250 MEADOWBROOK PARKWAY
TEST BORING #	3	JOB NO.	171247
DEPTH (FT)	10	TEST BY	BL

U.S. Sieve #	Percent Finer
3"	
1 1/2"	
3/4"	
1/2"	
3/8"	100.0%
4	97.5%
10	91.6%
20	82.6%
40	75.1%
100	54.9%
200	41.1%

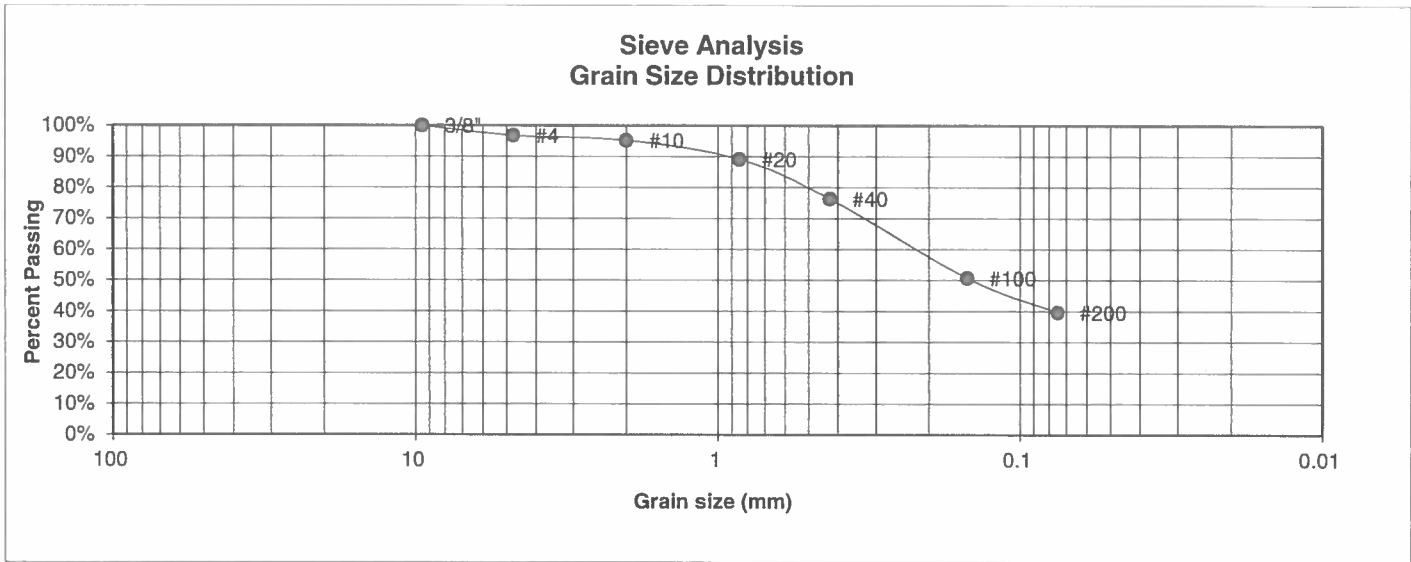
<u>UNIFIED CLASSIFICATION</u>	SC	<u>CLIENT</u>	ENGINEERING AND SURVEYING
<u>SOIL TYPE #</u>	3	<u>PROJECT</u>	1250 MEADOWBROOK PARKWAY
<u>TEST BORING #</u>	6	<u>JOB NO.</u>	171247
<u>DEPTH (FT)</u>	10	<u>TEST BY</u>	BL

<u>U.S. Sieve #</u>	<u>Percent Finer</u>
3"	
1 1/2"	
3/4"	
1/2"	
3/8"	100.0%
4	96.8%
10	95.2%
20	89.1%
40	76.4%
100	50.7%
200	39.6%

<u>Atterberg Limits</u>	
Plastic Limit	11
Liquid Limit	22
Plastic Index	11

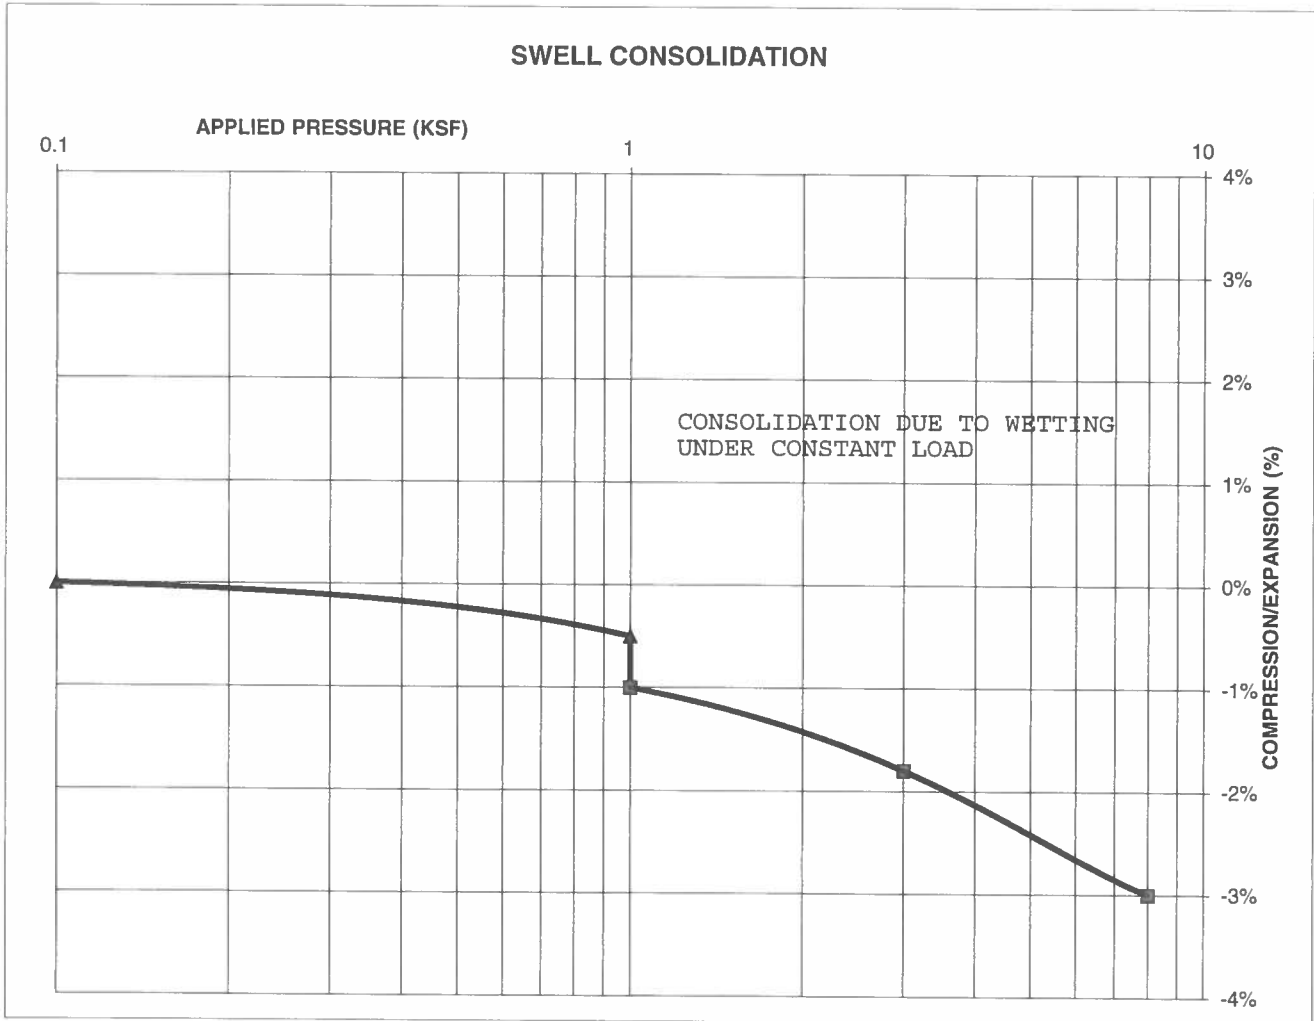
TEST BORING #	3	DEPTH(ft)	10
DESCRIPTION	SC	SOIL TYPE	3
NATURAL UNIT DRY WEIGHT (PCF)			110
NATURAL MOISTURE CONTENT			15.0%
SWELL/CONSOLIDATION (%)			-0.5%

SWELL CONSOLIDATION TEST RESULTS
