**SOIL, GEOLOGY, GEOLOGIC HAZARD,  
AND WASTEWATER STUDY  
MOUNTAINS TO VIEW ESTATES  
11150 NORTH ELLICOTT HIGHWAY  
EL PASO COUNTY, COLORADO**

**Avalar Real Estate**  
7495 McLaughlin Road, Suite 101  
Falcon, Colorado 80831

April 16, 2018

Entech Job No. 180343

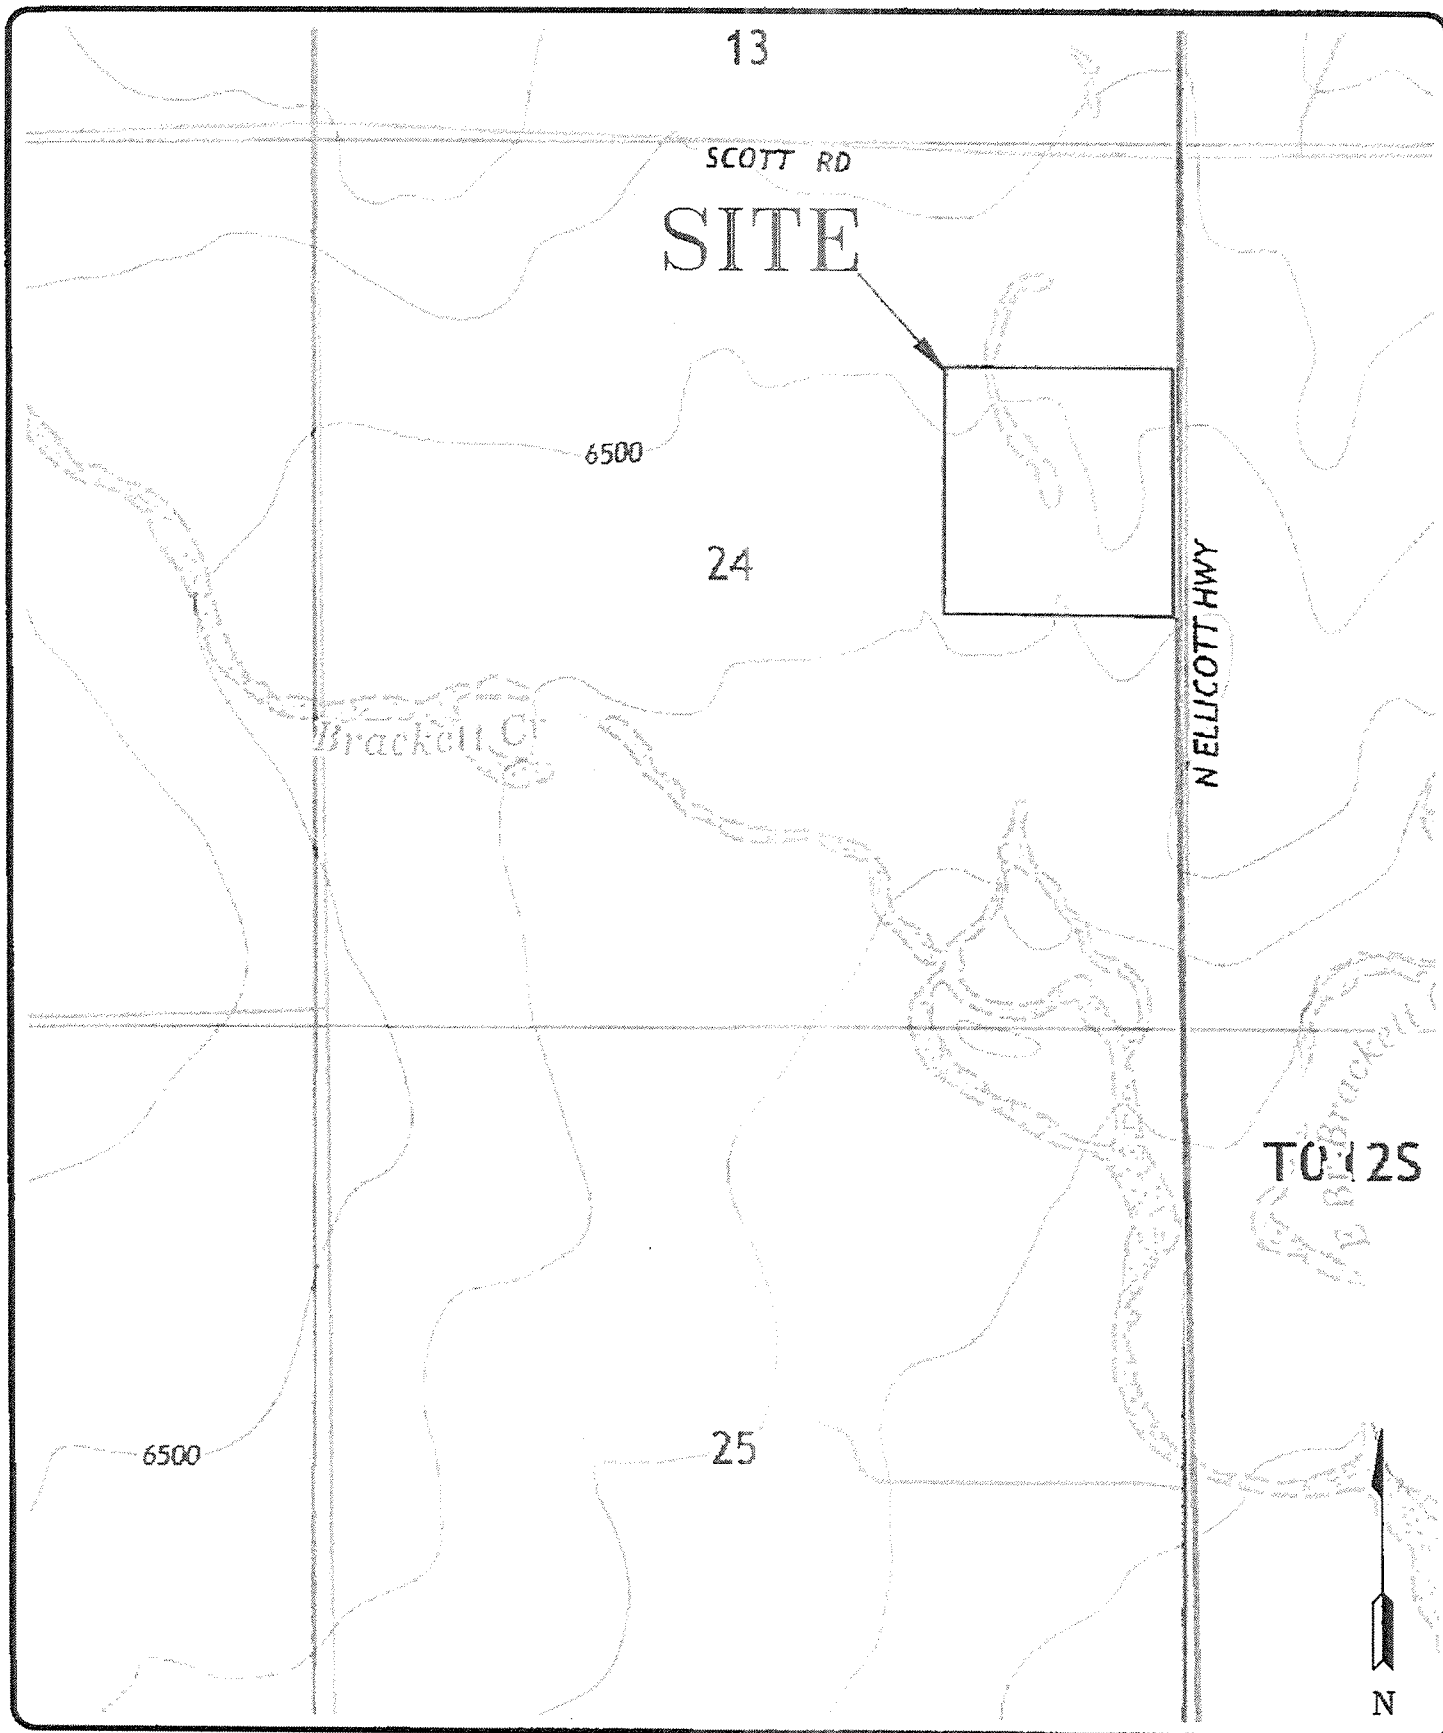
FIG NO.:  
1

USGS MAP  
MOUNTAINS TO VIEW ESTATES  
11150 NORTH ELICOTT HIGHWAY  
EL PASO COUNTY, CO.  
FOR: AVALAR REAL ESTATE

Figure 2: USGS Map

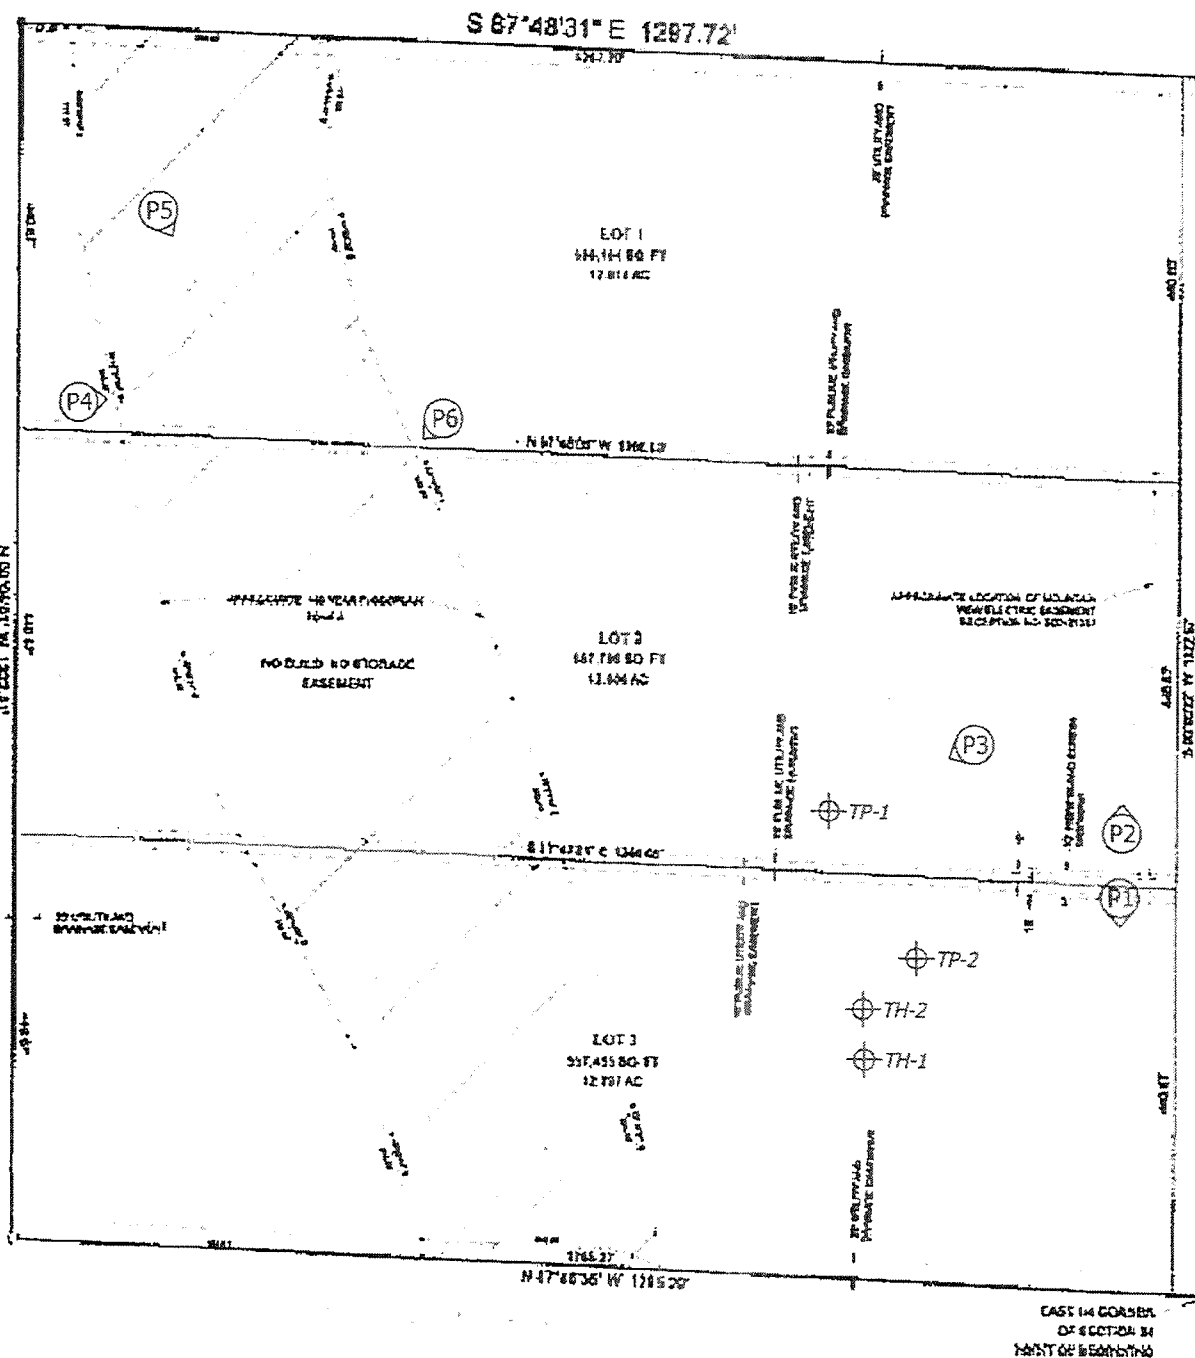
FIG NO.:  
4

- (P2) - APPROXIMATE PHOTOGRAPH LOCATION AND NUMBER
- ⊕ TP- APPROXIMATE TEST PIT LOCATION AND NUMBER
- ⊕ TH- APPROXIMATE TEST HOLE LOCATION AND NUMBER (GEOQUEST, LLC)

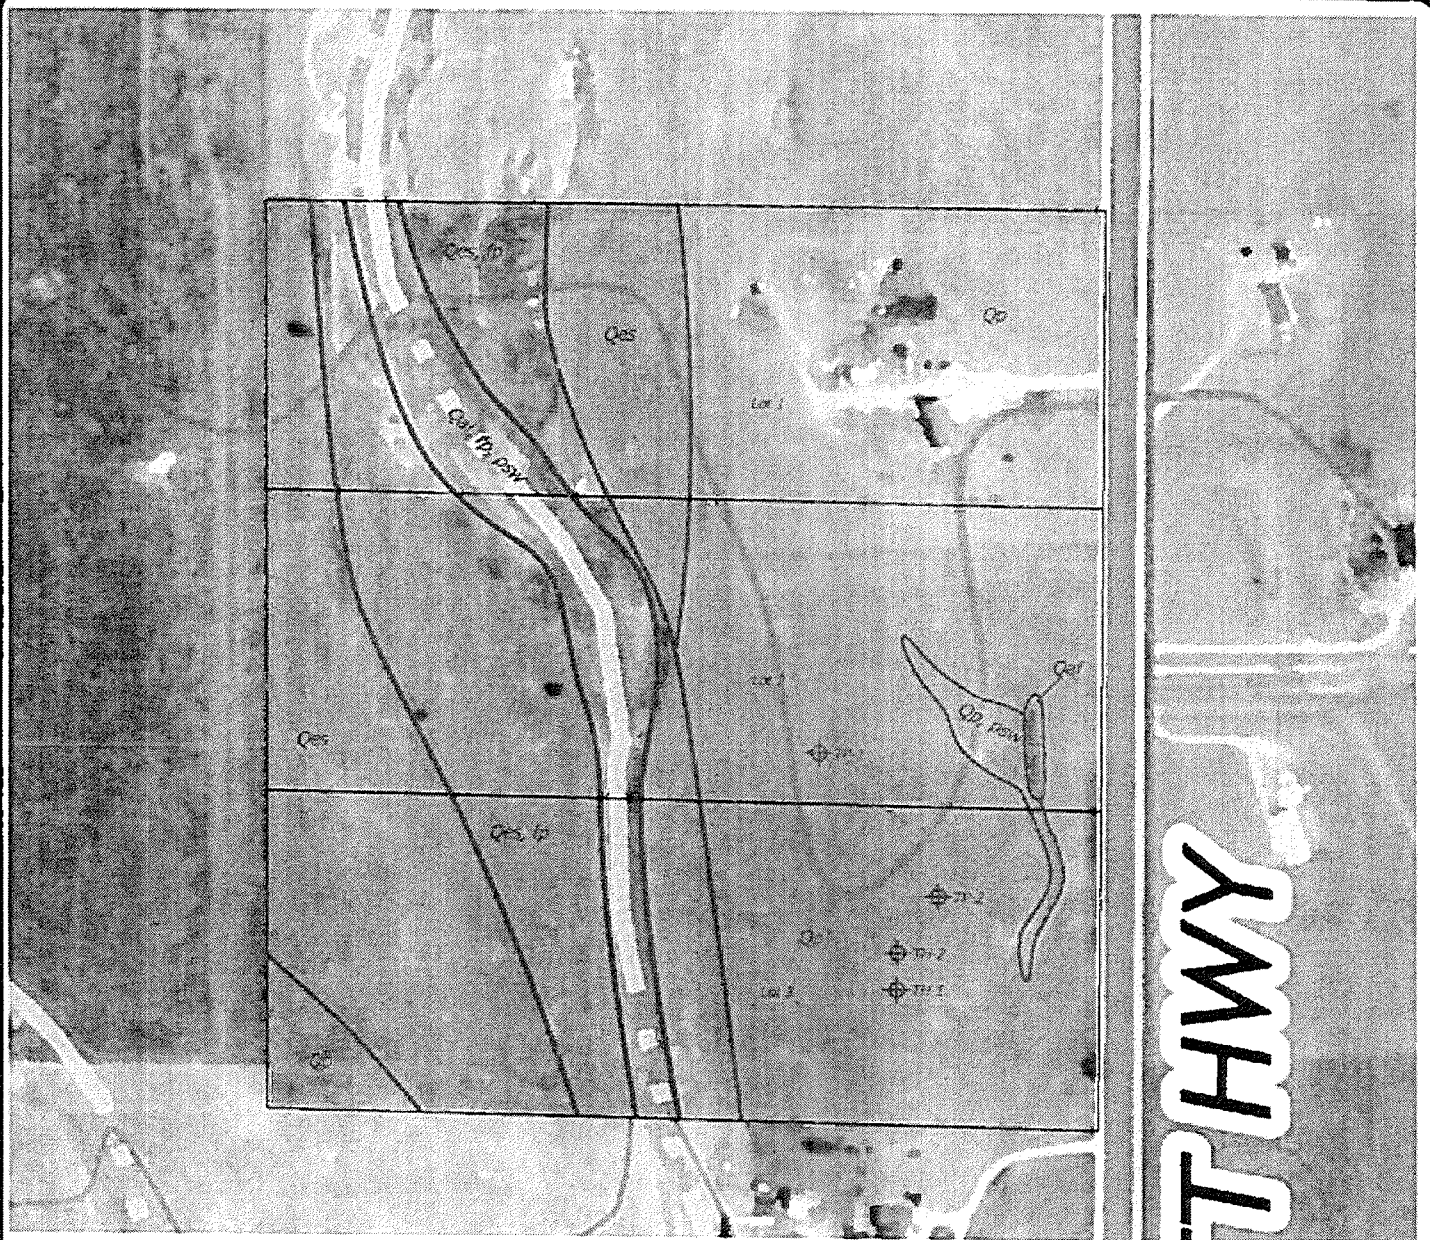
FIG NO:  
5

- Qal* - Recent Alluvium of Holocene Age:  
recent water deposited materials
- Qaf* - Artificial Fill of Holocene Age:  
recent man-made fill deposits
- Qp* - Piney Creek Alluvium of Quaternary Age:  
water deposited sands, and clays
- Qes* - Eolian Sand of Quaternary Age:  
wind blown sand deposits
- fp* - floodplain
- psw* - potential seasonal shallow water
-

Figure 6: Geology Map/Engineering Geology

As mentioned previously, detailed mapping has been performed on this site to produce an Engineering Geology Map Figure 6. This map shows the location of various geologic conditions of which the developers should be cognizant during the planning, design and construction stages of the project. These hazards and the recommended mitigation techniques are as follows:

Some of the sandy soils encountered on site exhibit low density and may be subject to settlement under a load. The potential for loose or collapsible soils exists anywhere in areas mapped as Eolian Sand (Qes) and may also exist in areas mapped as Piney Creek Alluvium (Qp).

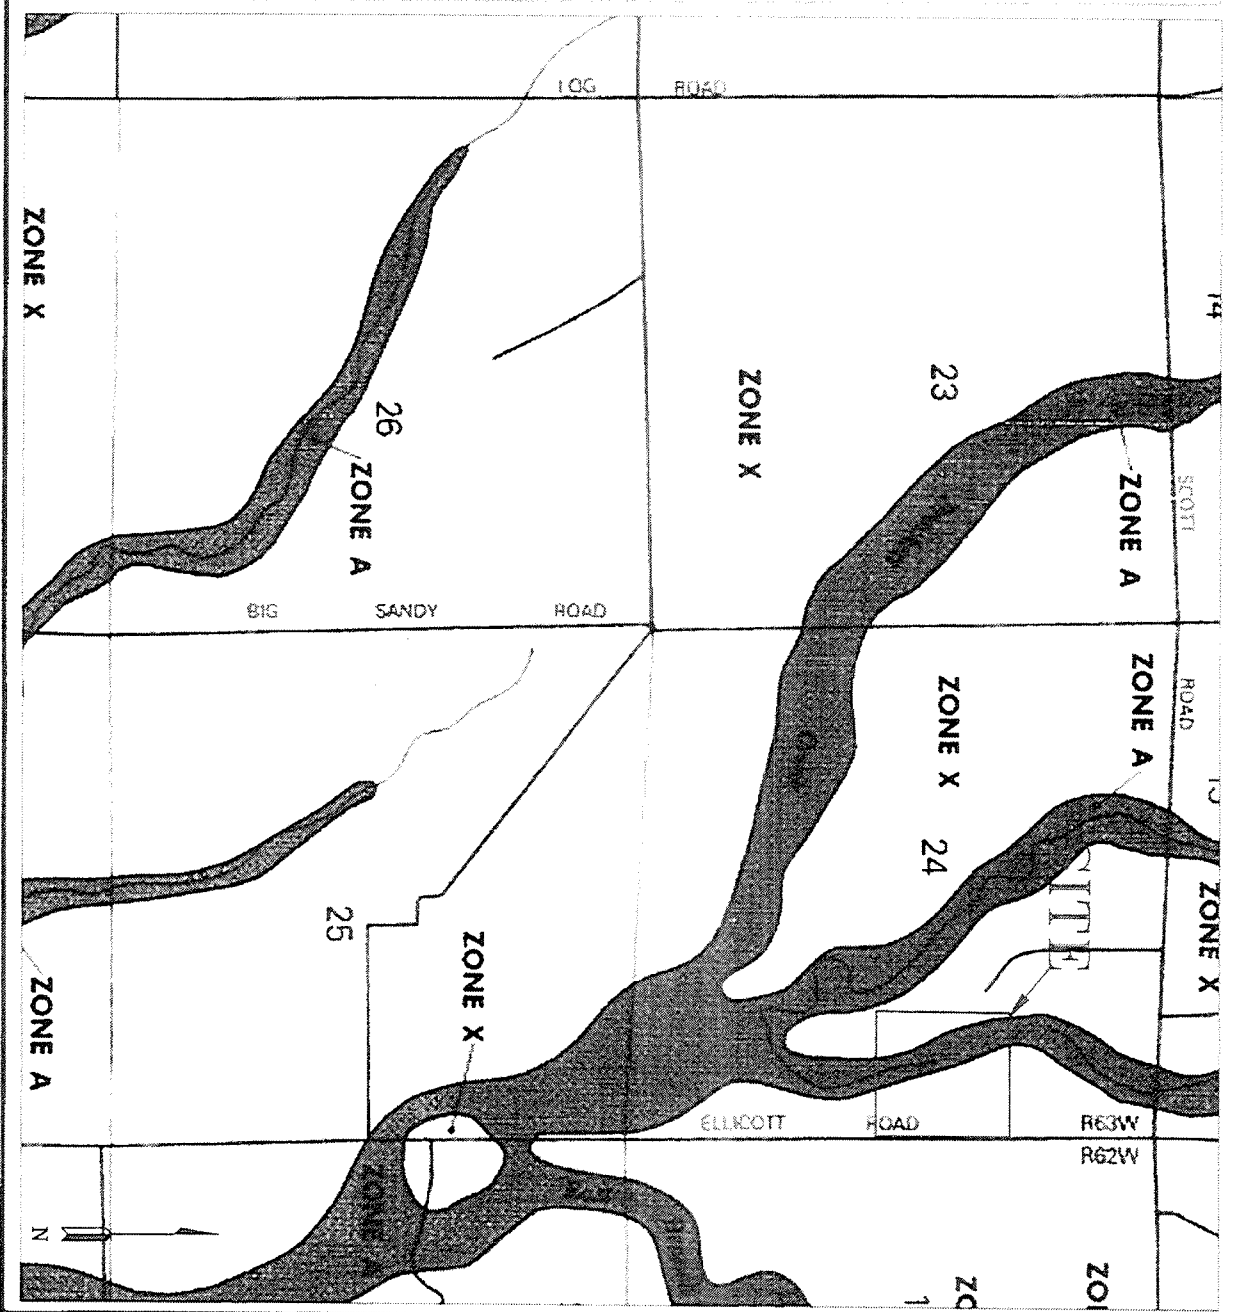
SPECIAL FLOOD HAZARD AREAS SUBJECT TO INUNDATION BY THE 1% ANNUAL CHANCE FLOOD

FLOODPLAIN MAP  
MOUNTAINS TO VIEW ESTATES  
11150 NORTH ELLICOTT HIGHWAY  
EL PASO COUNTY, CO.  
FOR: AVALAR REAL ESTATE

Figure 7: Floodplain Map

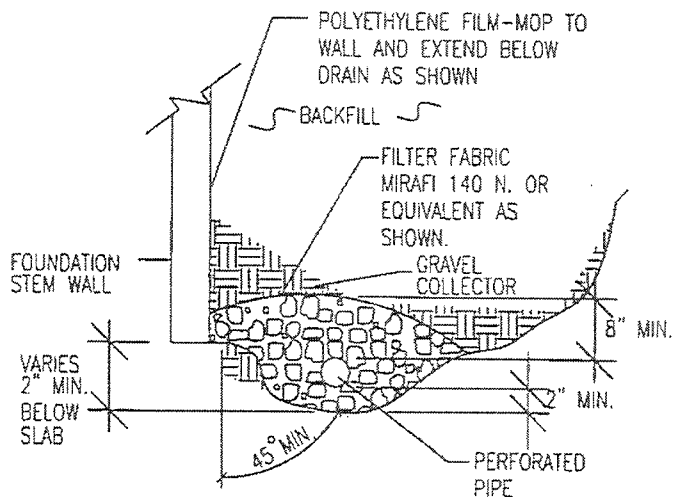
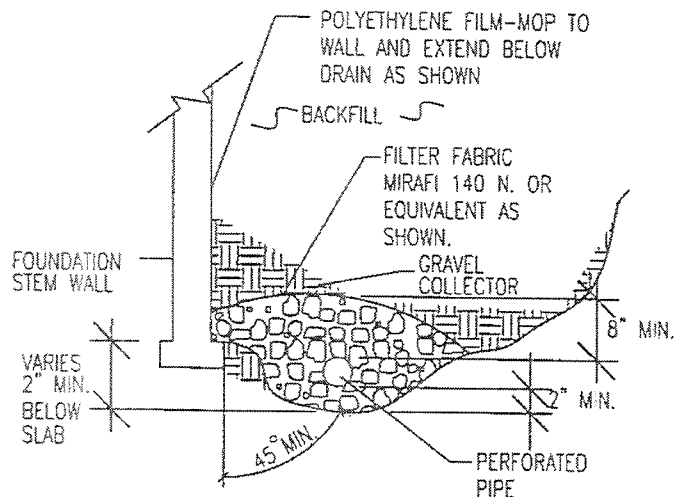
-GRAVEL SIZE IS RELATED TO DIAMETER OF PIPE PERFORATIONS-85% GRAVEL GREATER THAN 2x PERFORATION DIAMETER.

Mitigation: Foundations must have a minimum 30-inch depth for frost protection. In areas where high subsurface moisture conditions are anticipated periodically, subsurface perimeter drains are recommended to help prevent the intrusion of water into areas below grade. Typical drain details are presented in Figure 8. Any grading in these areas should be done to direct surface flow around construction to avoid areas of ponded water. Structures should not block drainages. All organic material should be completely removed prior to any fill placement.

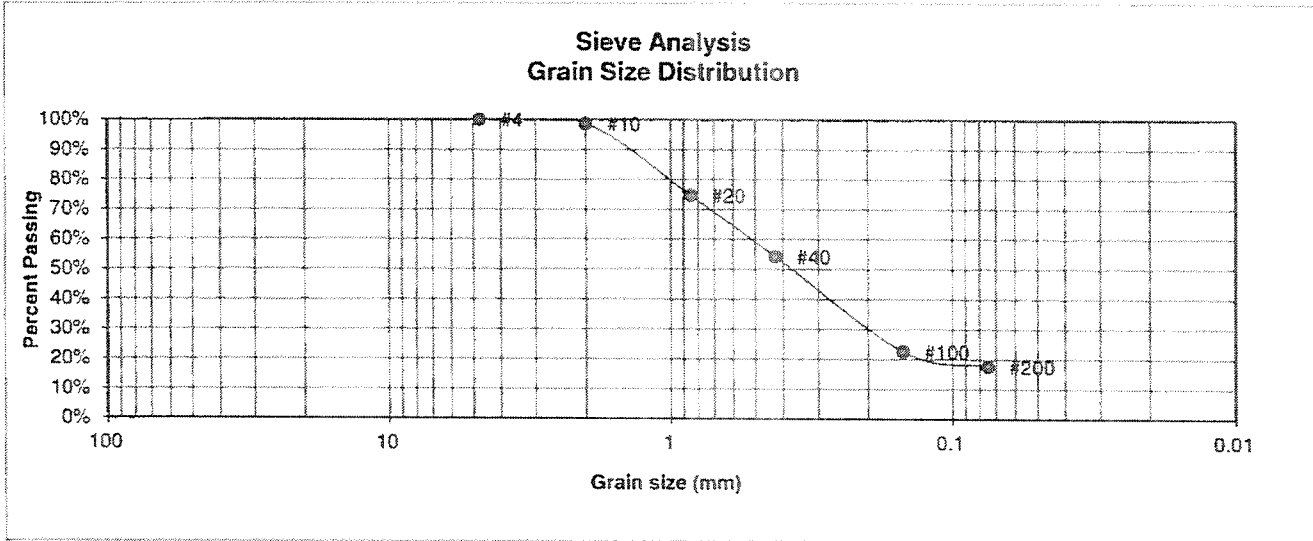
BORING NO.	TP-1	UNIFIED CLASSIFICATION	SM	TEST BY	BL
DEPTH(ft)	2-3	AASHTO CLASSIFICATION		JOB NO.	180343
CLIENT	AVALAR REAL ESTATE				
PROJECT	11150 N. ELLICOTT

<u>U.S.</u>	<u>Percent</u>	<u>Atterberg</u>
<u>Sieve #</u>	<u>Finer</u>	<u>Limits</u>
3"		Plastic Limit
1 1/2"		Liquid Limit
3/4"		Plastic Index
1/2"		
3/8"		
4	100.0%	<u>Swell</u>
10	98.7%	Moisture at start
20	74.7%	Moisture at finish
40	54.3%	Moisture increase
100	22.6%	Initial dry density (pcf)
200	17.8%	Swell (psf)

Soil Type 1 silty sand (SM), encountered in both of test holes and test pits at the existing ground surface and extending to depths ranging from 8 feet to 15 feet bgs. These soils were encountered at loose to medium dense states and at moist conditions. Samples tested had 10 to 18 percent passing the No. 200 Sieve.

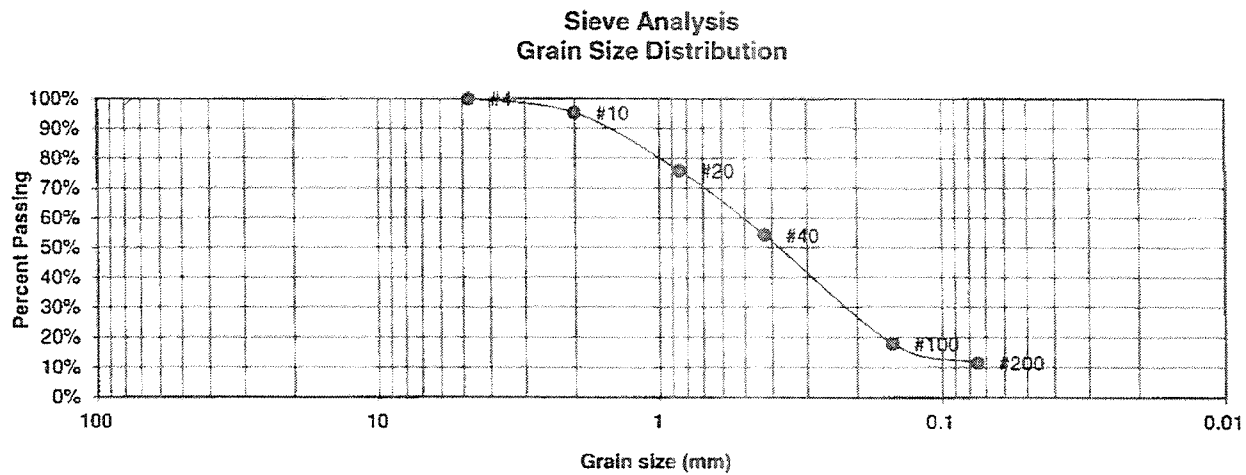
BORING NO.	TP-1	UNIFIED CLASSIFICATION	SM-SW	TEST BY	BL
DEPTH(ft)	5-6	AASHTO CLASSIFICATION		JOB NO.	180343
CLIENT	AVALAR REAL ESTATE				
PROJECT	11150 N. ELLICOTT

U.S. Sieve #	Percent Finer
3"	
1 1/2"	
3/4"	
1/2"	
3/8"	
4	100.0%
10	95.3%
20	75.9%
40	54.2%
100	18.0%
200	11.6%

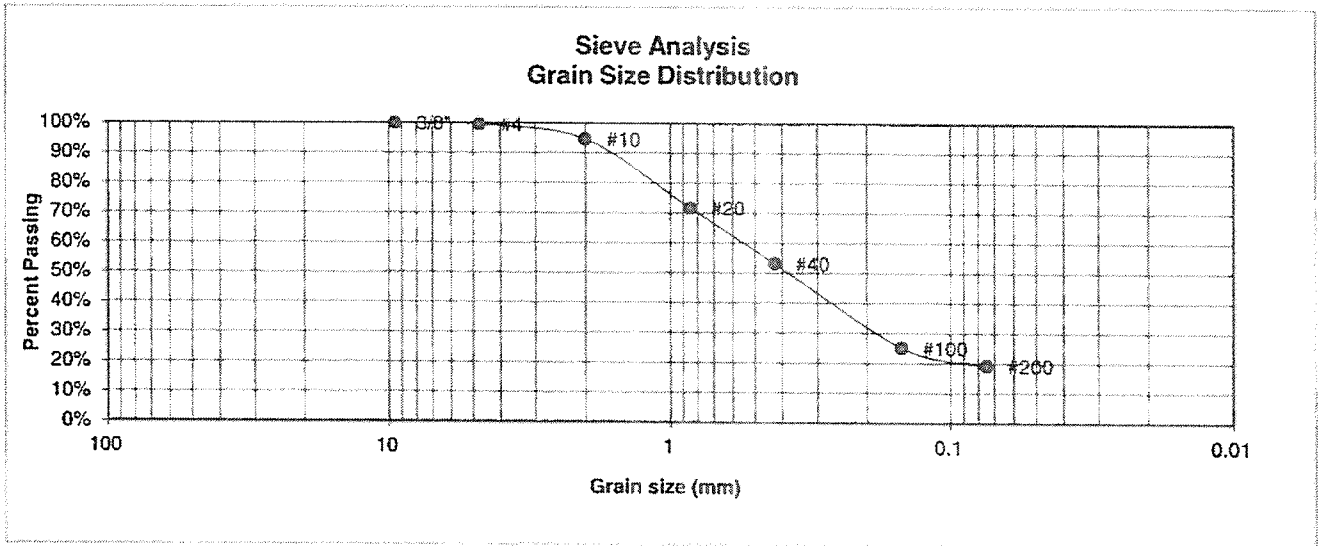
BORING NO.	TP-2	UNIFIED CLASSIFICATION	SM	TEST BY	BL
DEPTH(ft)	2-3	AASHTO CLASSIFICATION		JOB NO.	180343
CLIENT	AVALAR REAL ESTATE				
PROJECT	11150 N. ELLICOTT

U.S. Sieve #	Percent Finer
3"	
1 1/2"	
3/4"	
1/2"	
3/8"	100.0%
4	99.6%
10	94.6%
20	71.7%
40	53.2%
100	25.2%
200	19.3%

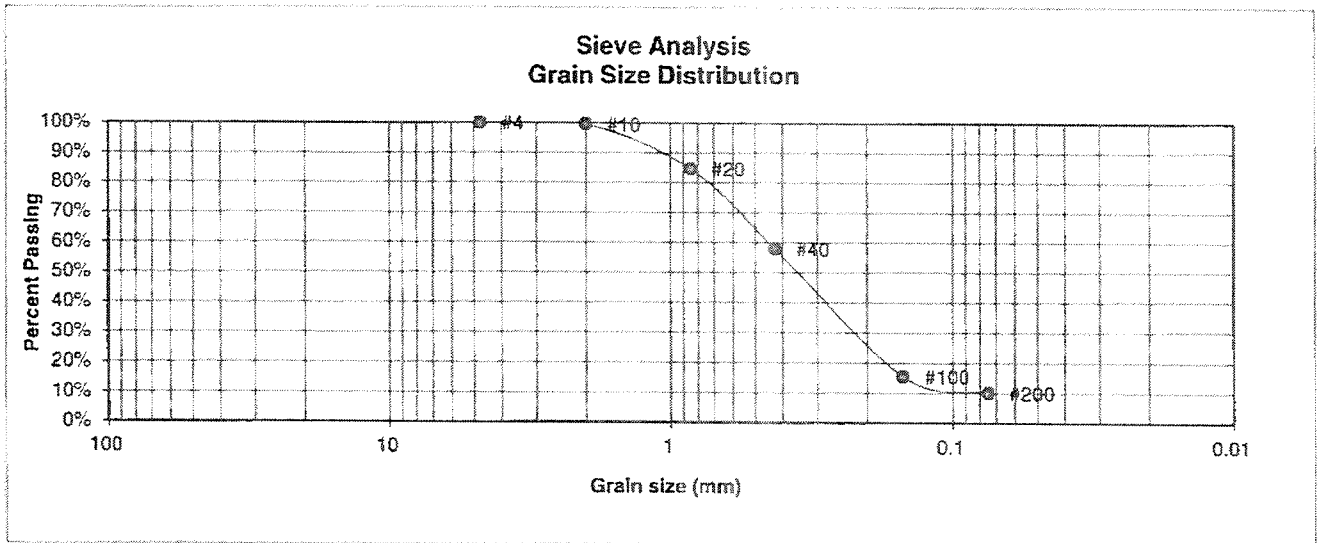
BORING NO.	TP-2	UNIFIED CLASSIFICATION	SM-SW	TEST BY	BL
DEPTH(ft)	5-6	AASHTO CLASSIFICATION		JOB NO.	180343
CLIENT	AVALAR REAL ESTATE				
PROJECT	11150 N. ELLICOTT

U.S. Sieve #	Percent Finer
3"	
1 1/2"	
3/4"	
1/2"	
3/8"	
4	100.0%
10	99.5%
20	84.7%
40	58.0%
100	15.7%
200	10.1%

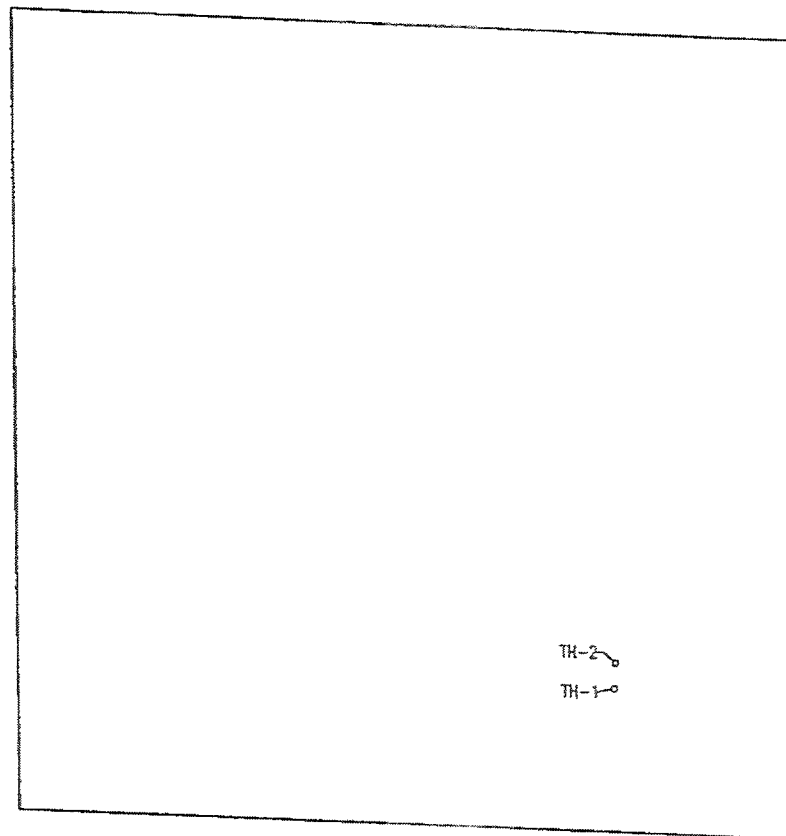
GEOQUEST LLC  
SITE MAP

11150 N Ellicott Hwy  
El Paso County,  
Colorado,  
Job #18-0058

SCALE: 1" = 300'

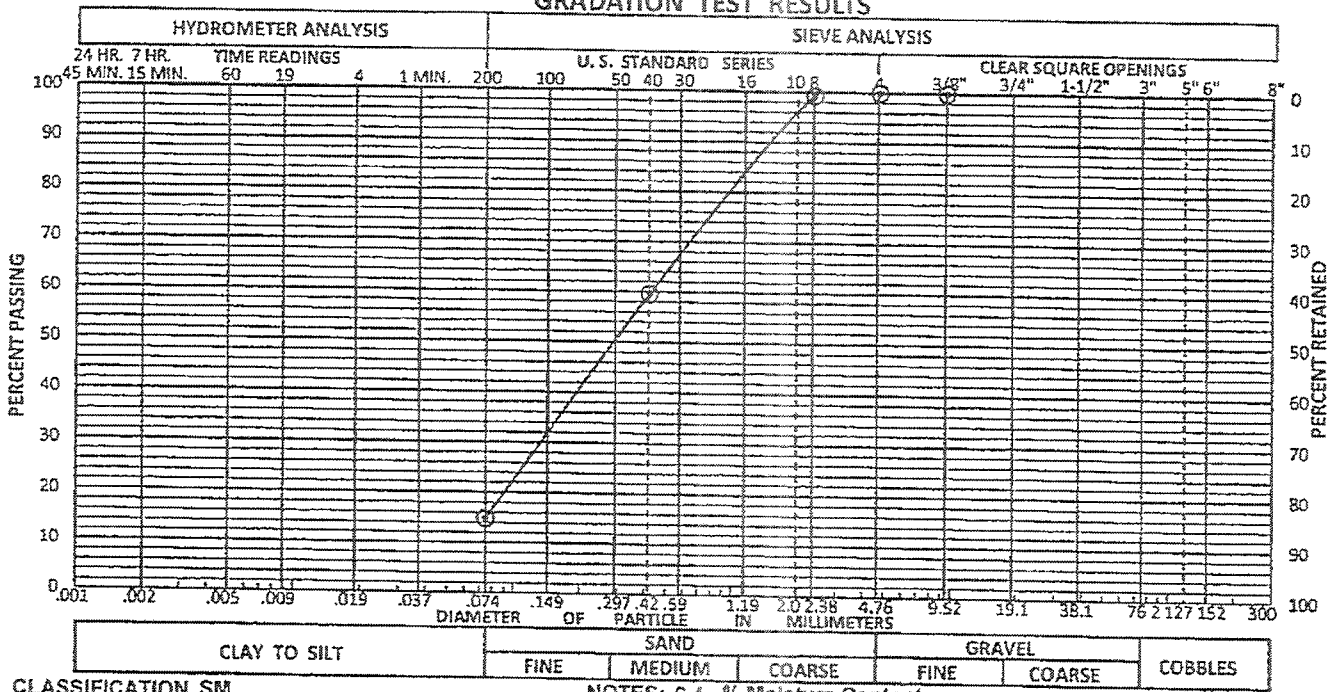
**GEOQUEST LLC  
GRADATION TEST RESULTS**

SAMPLE # 1 HOLE # TH-1 DEPTH 12 FEET

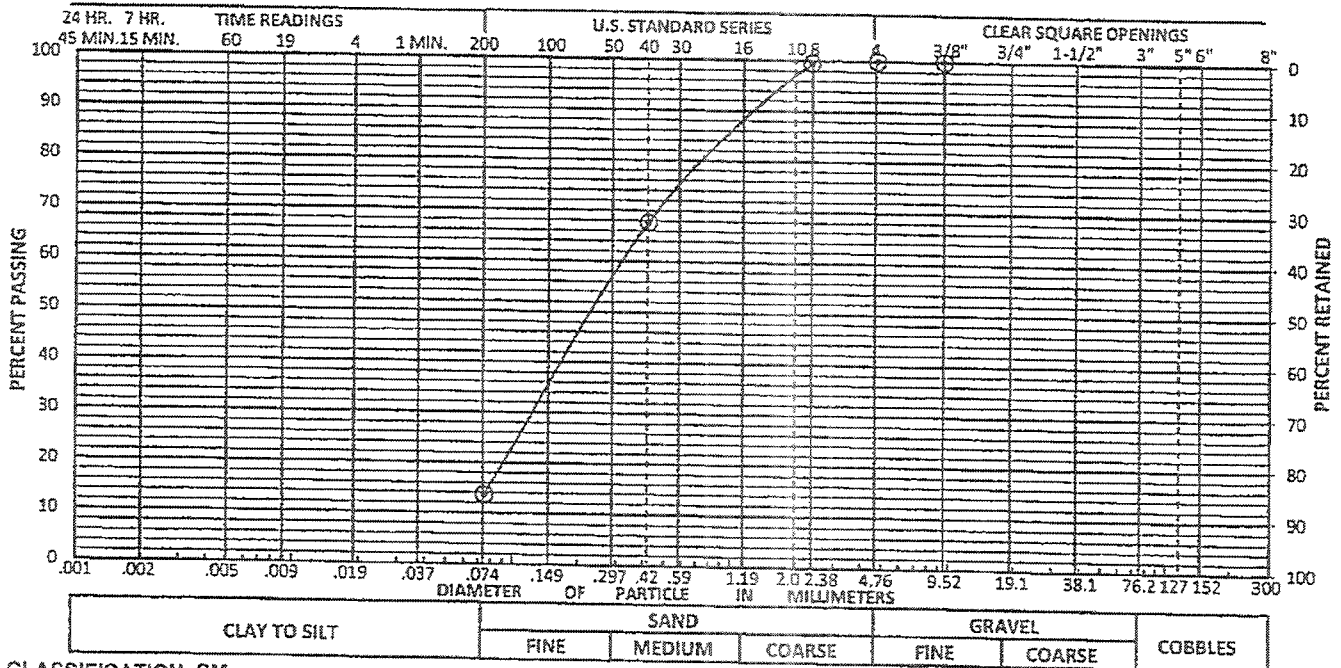
SAMPLE # 1 HOLE # TH-2 DEPTH 4 FEET

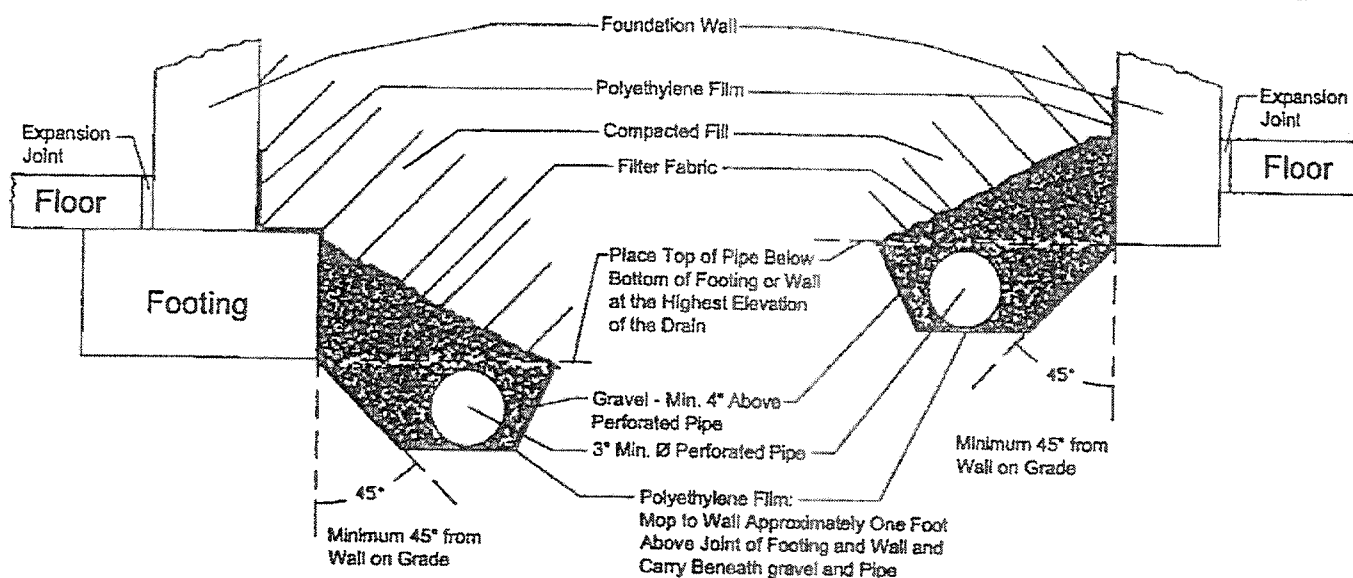
### SPREAD FOOTING TYPE

### WALL ON GRADE TYPE

1. Gravel to be Not More Than 1-1/2" and Not Less Than 1/2" Diameter.
2. Perforated Pipe Diameter Varies With Expected Seepage. 3"Ø and 4"Ø are Most Common. ABS and PVC are Most Common Materials for Pipe.

3. Pipe to be Laid out in a Minimum Slope of 1" in 10'.
4. Gravity Outfall is Desired if Possible. Portion of Pipe in Area Not Drained Shall be Non-Perforated. Daylight Must be Maintained Clear of Debris in Order to Function Properly.
