SOILS AND GEOLOGY STUDY

**15330 Chaparral Loop East
(a portion of Lot 104, 15550 Chaparral Loop East)
El Paso County, Colorado**

JOB NO. 176395

September 25, 2020

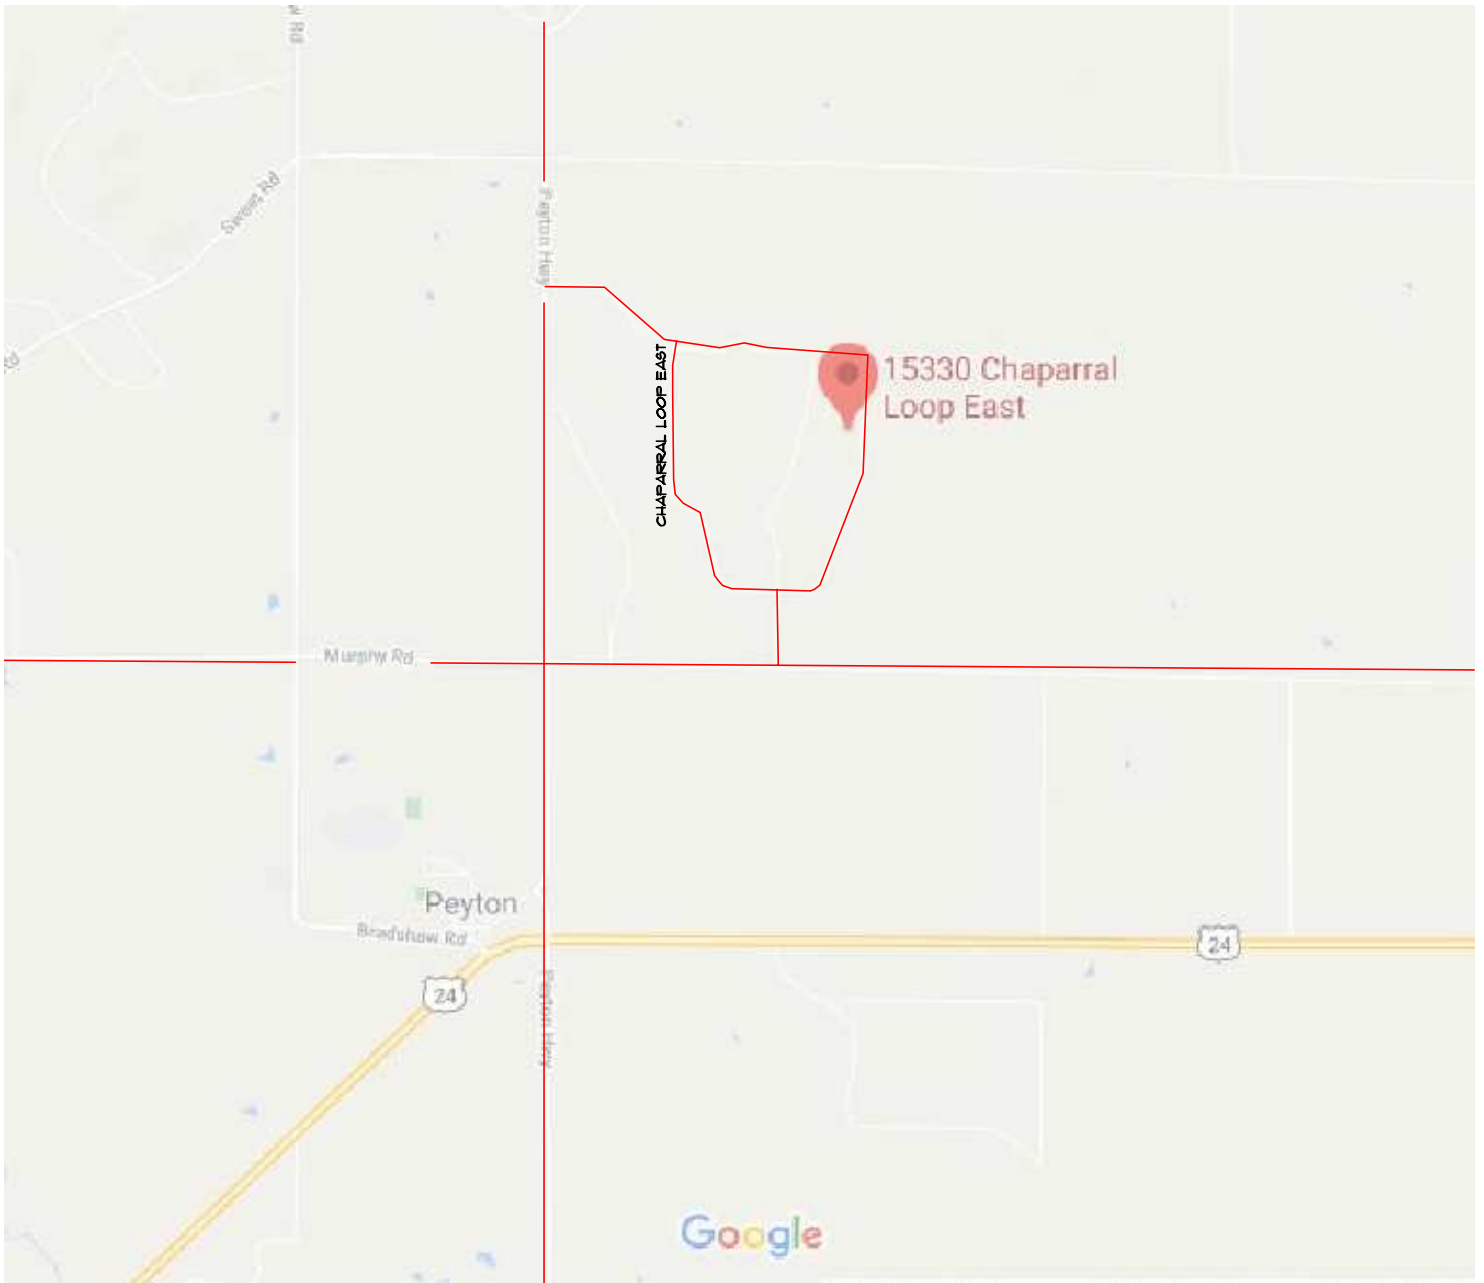
FIG No. 1

NOT TO SCALE

The project lies in the NW¼ of Section 33 and the SW1/4 of Section 28, Township 11 South, Range 63 West of the 6th Principal Meridian in El Paso County, Colorado. The site is located north and east of the intersection of Wagon Trail and Chaparral Loop East. The approximate location of the site is shown on the Site Vicinity Map, Figure 1.

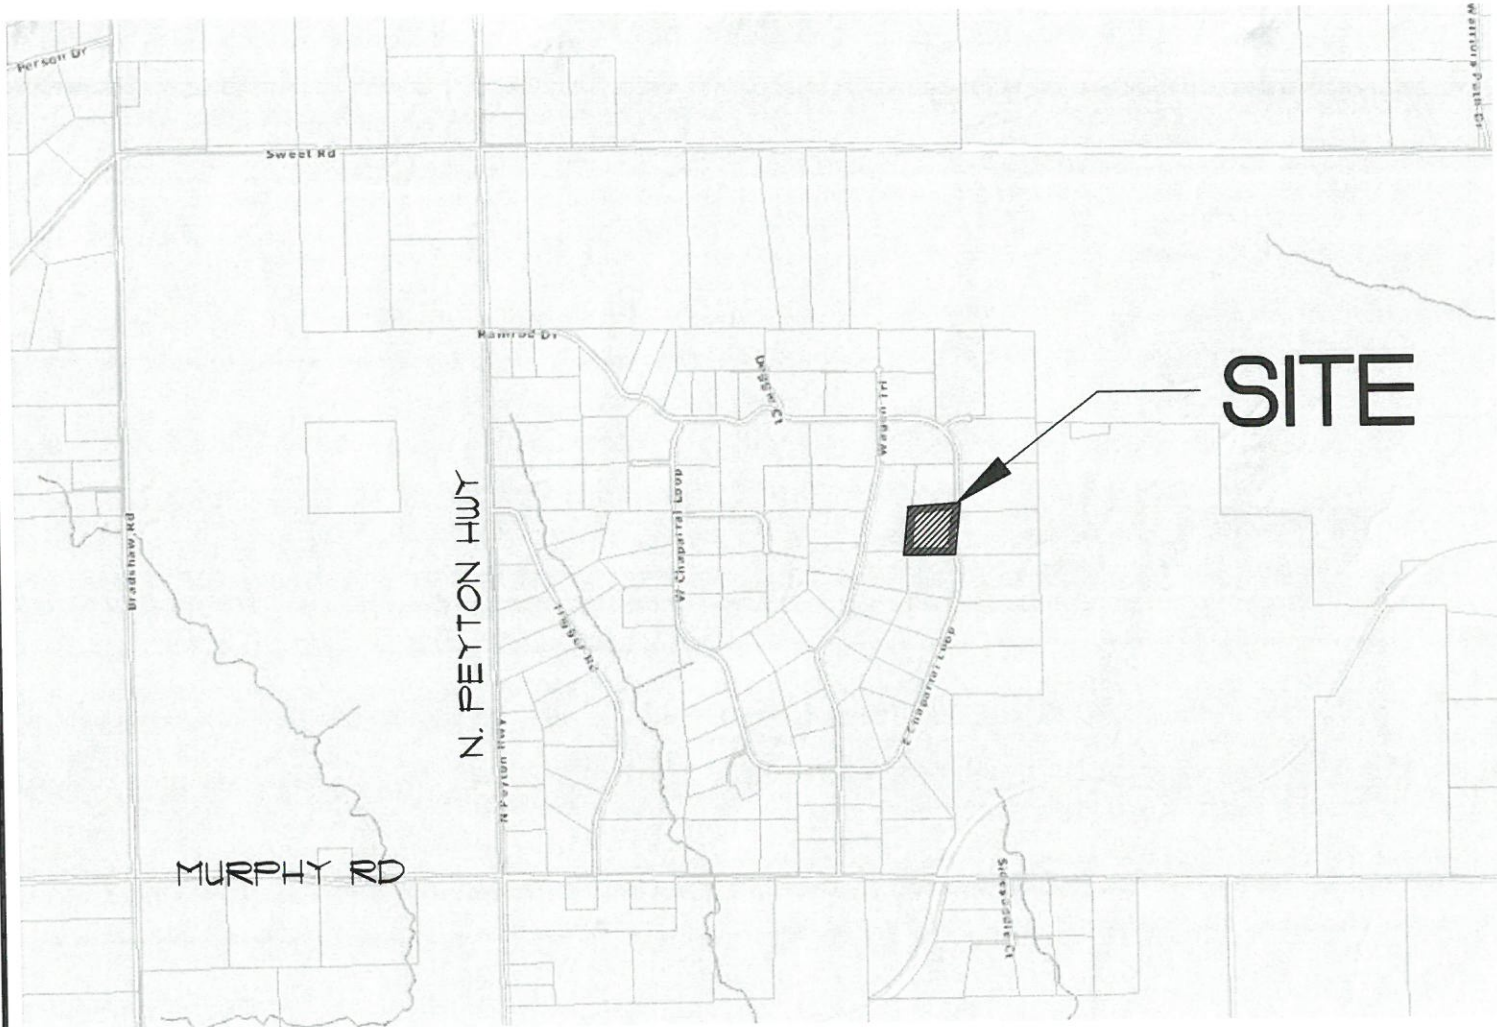
FIG No. 1

REFERENCE
 NOT TO SCALE

RMG – Rocky Mountain Group drilled two test borings at the above-referenced address on August 19, 2017. A Site Vicinity Map and Test Boring Location Plan are presented in Figures 1 and 2, respectively. Our findings, conclusions and recommendations are provided in this report.
