# STANDARD OPERATING PROCEDURES

## INSPECTION AND MAINTENANCE

### **Outlook Powers & Grinnell Pond 1**

Prepared: May 8, 2023

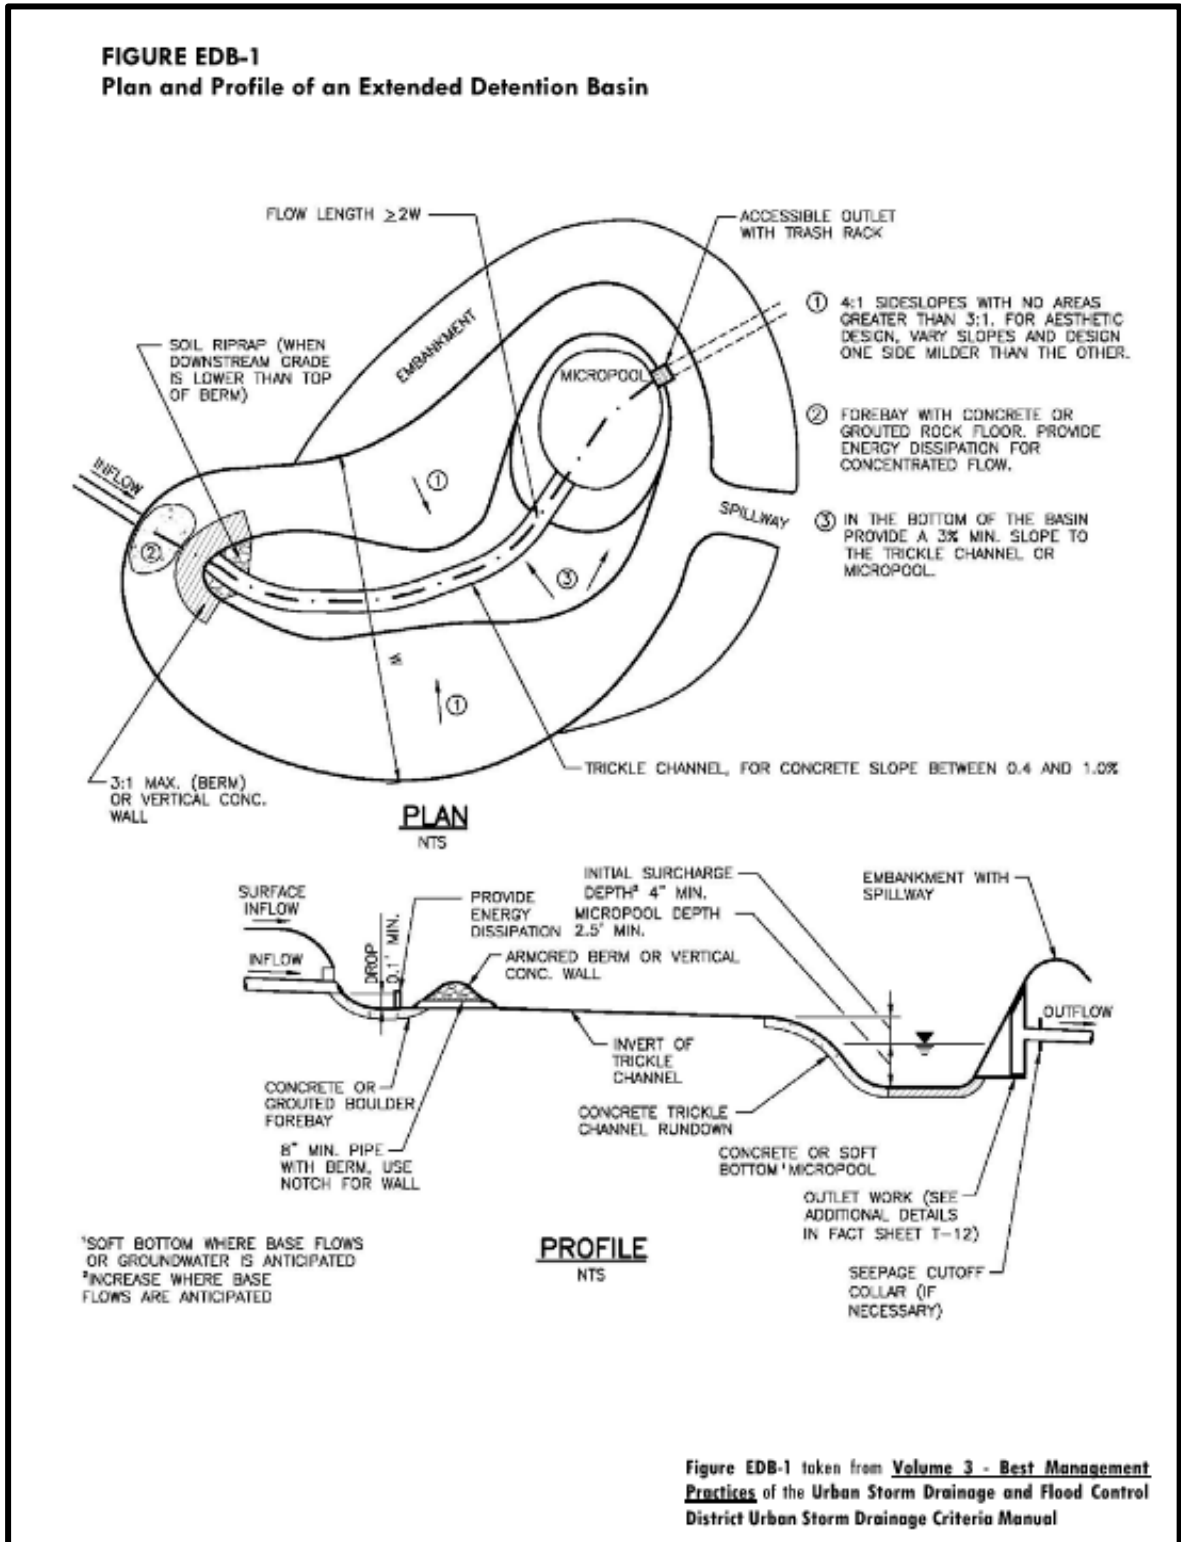
EDBs have a number of features that are designed to serve a particular function, (see Fig. EDB-1 Plan and Profile of an Extended Detention Basin on page 2). (*Note: Pond 6 does not contain a forebay, trickle-channel, or micro-pool*).
