GEOLOGY AND SOILS REPORT

**Creekside at Lorson Ranch, Filing No. 1
El Paso County, Colorado**

PUDSP-18-005

JOB NO. 164808

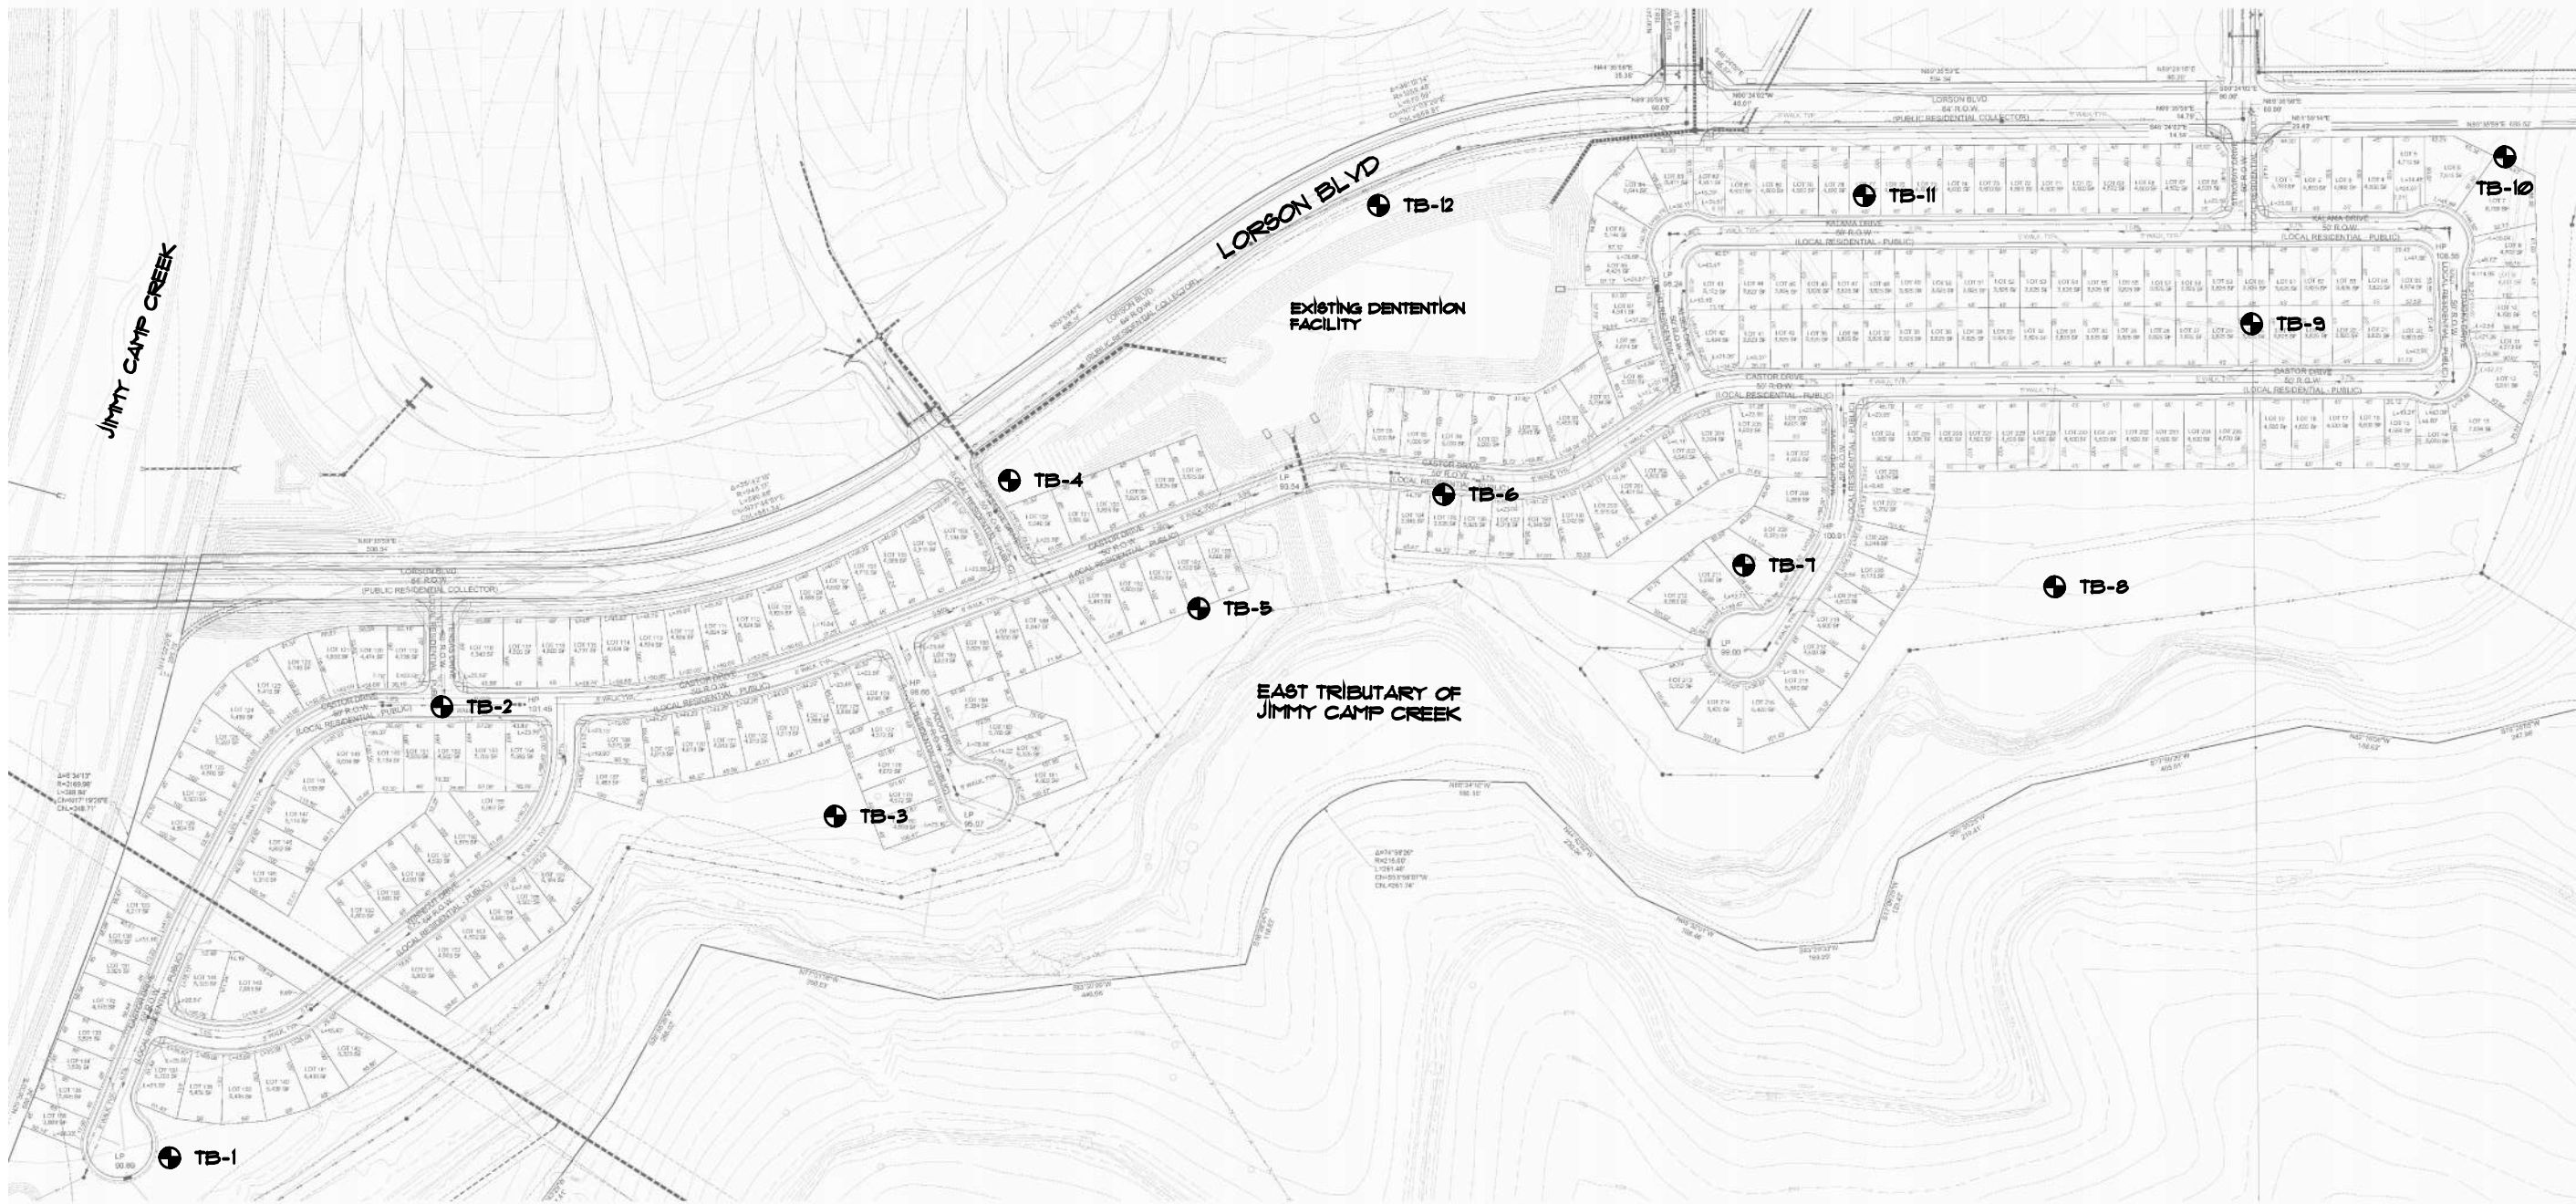
⊕ DENOTES APPROXIMATE
LOCATION OF TEST BORINGS

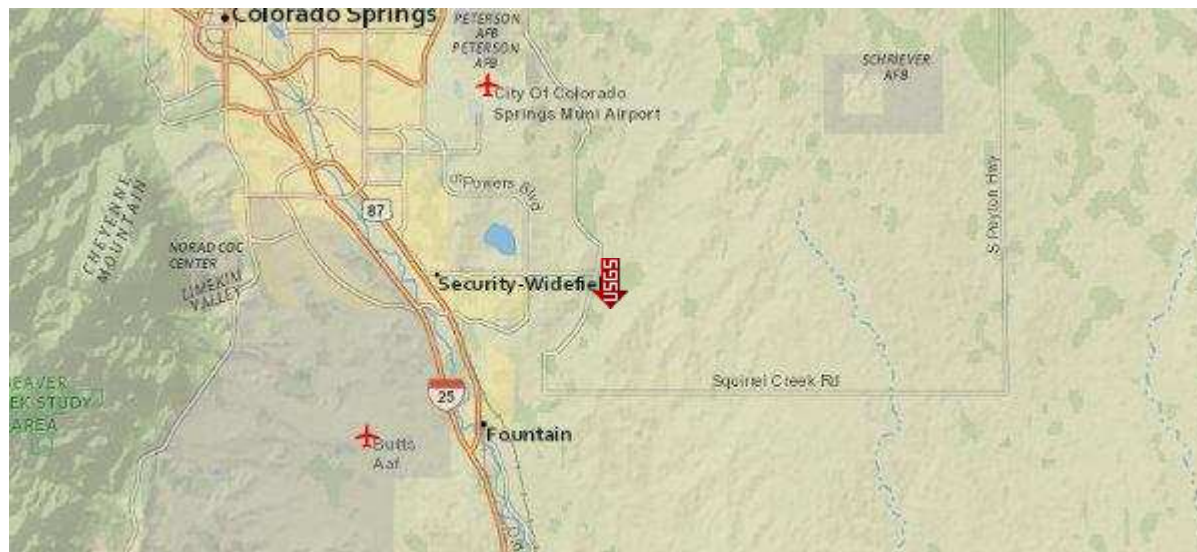
USGS-Provided Output

$S_s = 0.168 \text{ g}$	$S_{MS} = 0.268 \text{ g}$	$S_{DS} = 0.179 \text{ g}$
$S_1 = 0.059 \text{ g}$	$S_{M1} = 0.142 \text{ g}$	$S_{D1} = 0.095 \text{ g}$

Site Soil Classification Site Class D – “Stiff Soil”
