GEOLOGY AND SOILS REPORT

**Creekside at Lorson Ranch, Filing No. 1
El Paso County, Colorado**

JOB NO. 164808

**August 10, 2018
Revised October 16, 2018**

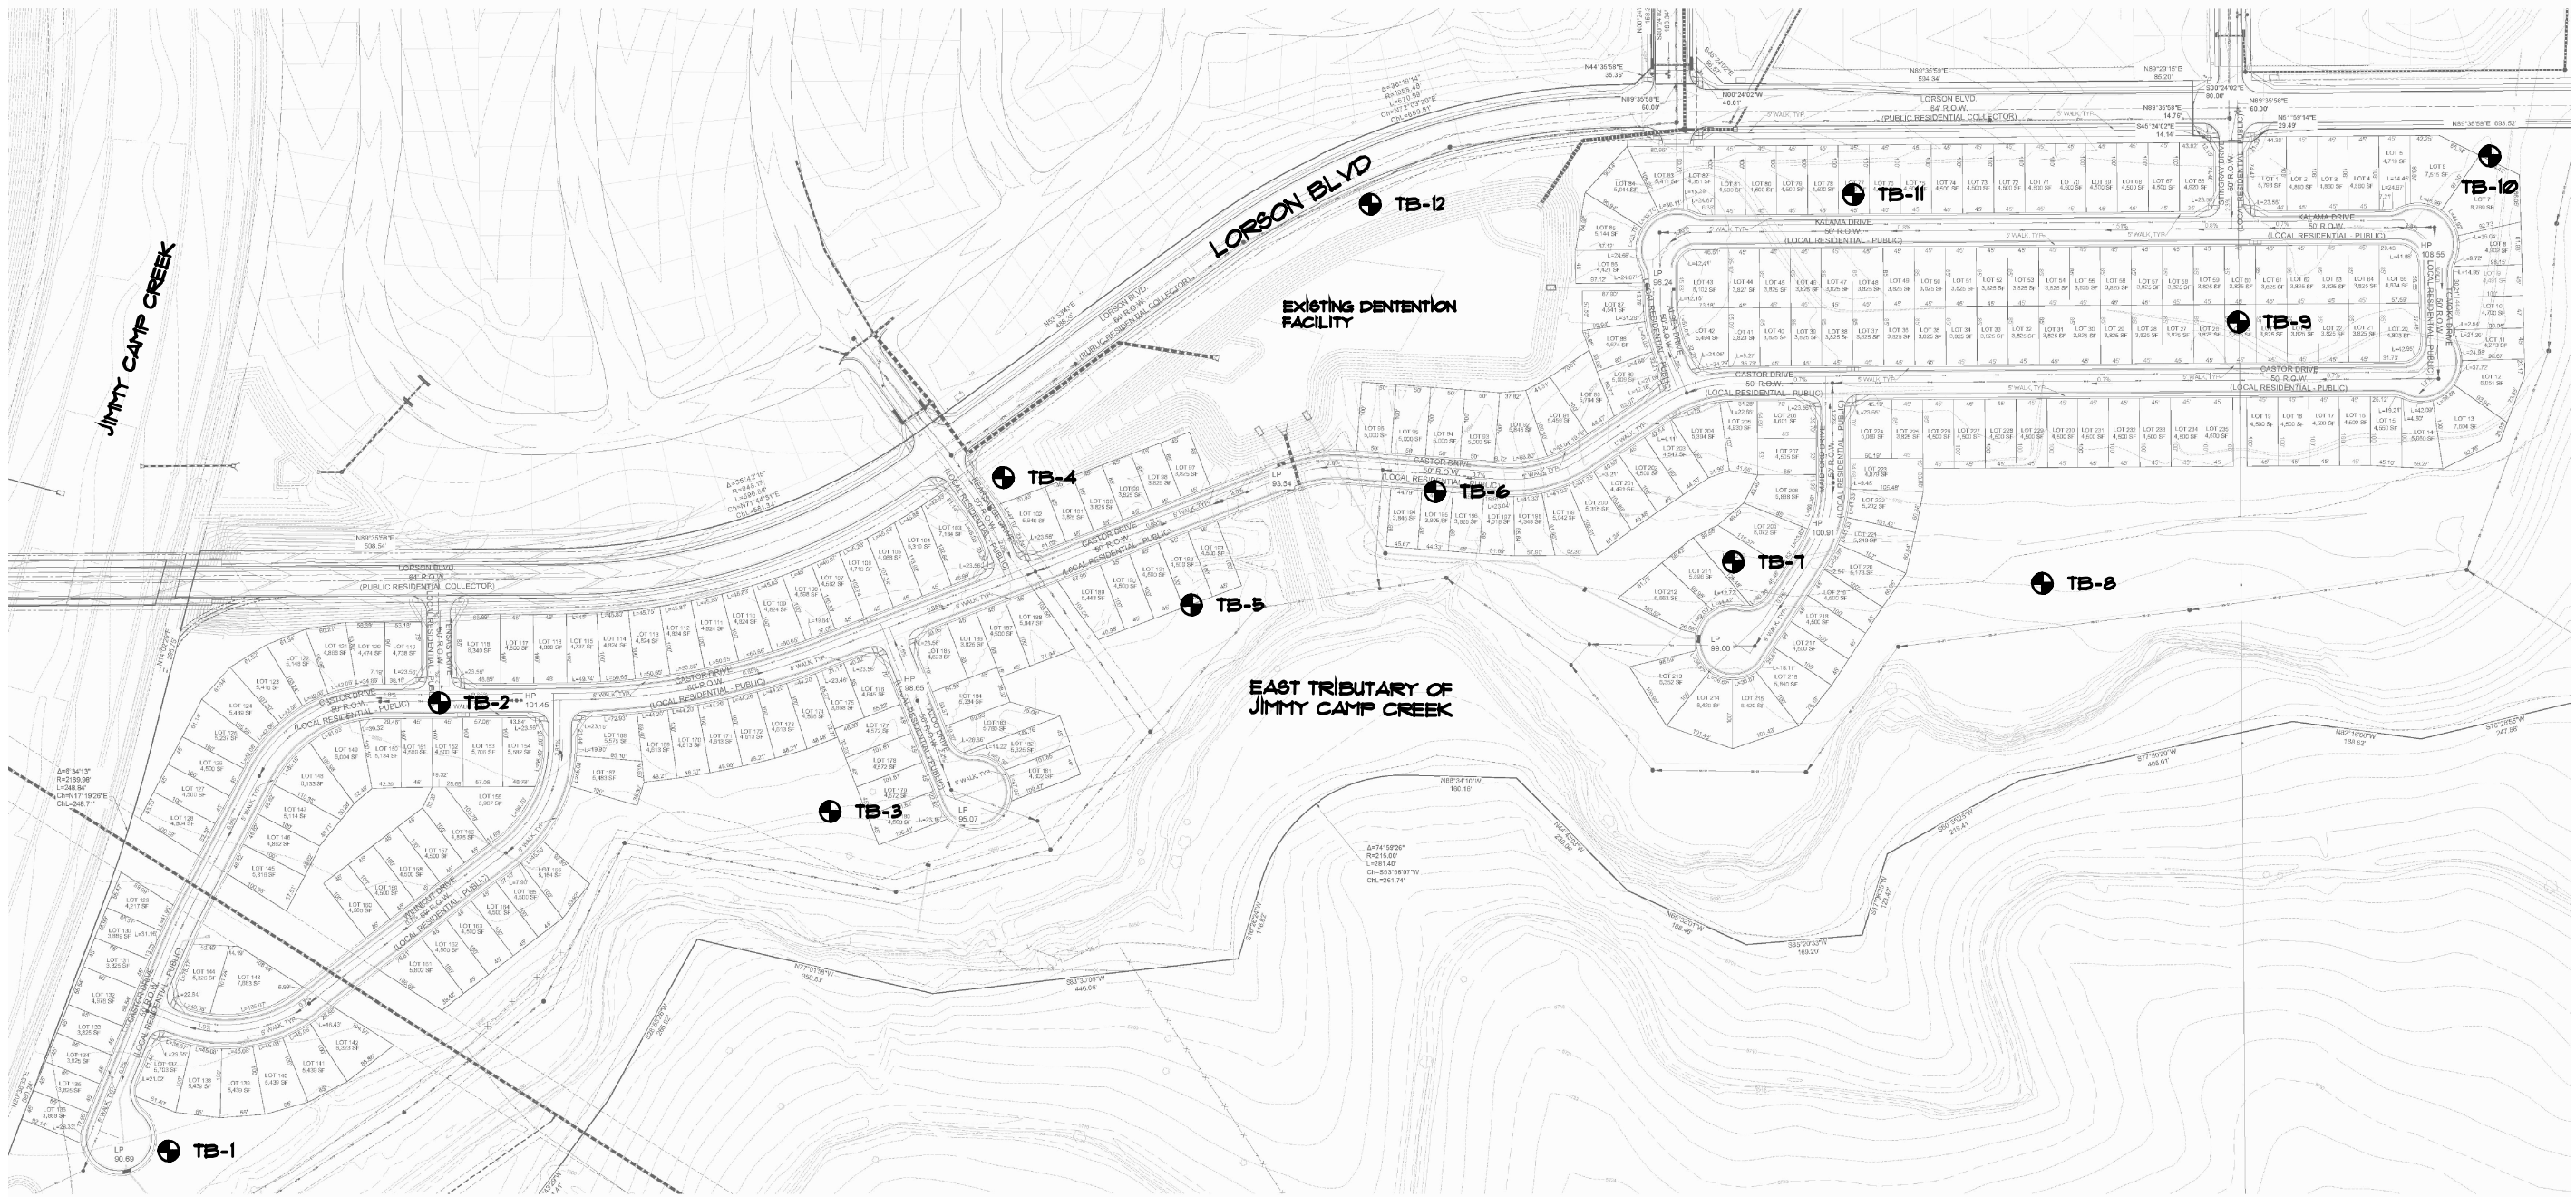
⊕ DENOTES APPROXIMATE LOCATION OF TEST BORINGS

The subsurface conditions within the property were explored by drilling twelve exploratory borings on June 25, 2018 extending to depths of approximately 25 to 30 feet below the existing ground surface. The test borings were performed to explore the subsurface soils underlying the site. The number of borings is in excess of the minimum one test boring per 10 acres of development up to 100 acres and one additional boring for every 25 acres of development above 100 acres as required by the ECM, Section C.3.3.

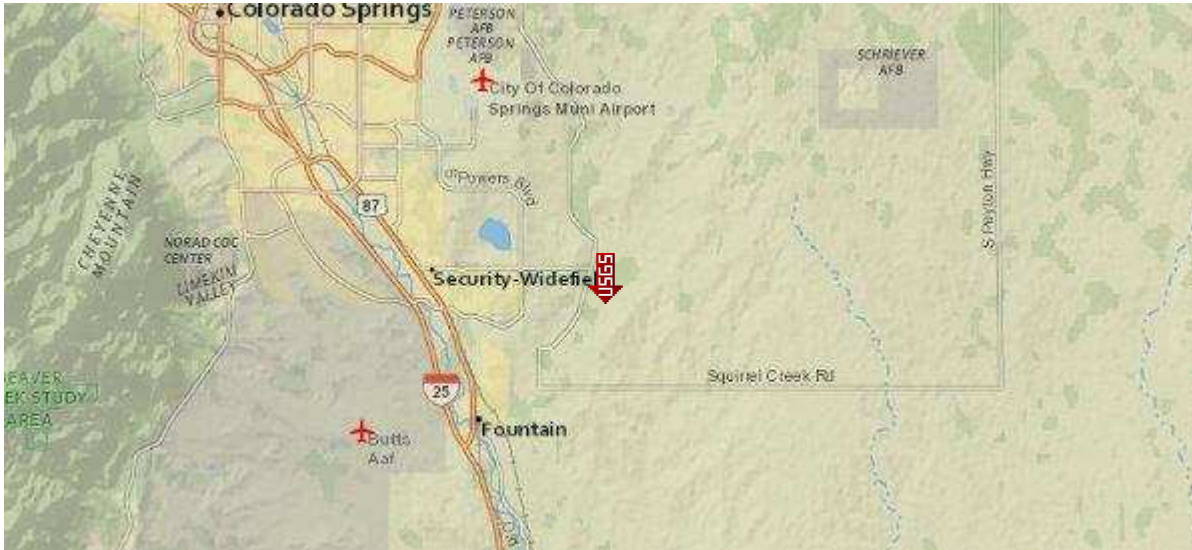
USGS-Provided Output

$S_S = 0.168 \text{ g}$	$S_{MS} = 0.268 \text{ g}$	$S_{DS} = 0.179 \text{ g}$
$S_1 = 0.059 \text{ g}$	$S_{M1} = 0.142 \text{ g}$	$S_{D1} = 0.095 \text{ g}$

Site Soil Classification Site Class D – “Stiff Soil”
