March 4, 2020
Revised December 10, 2020

ENTECH
ENGINEERING, INC.

Re: OWTS – Wastewater Study
Sedona Sun Acres
13235 Vollmer Road
Parcel No. 52000-00-303
El Paso County, Colorado

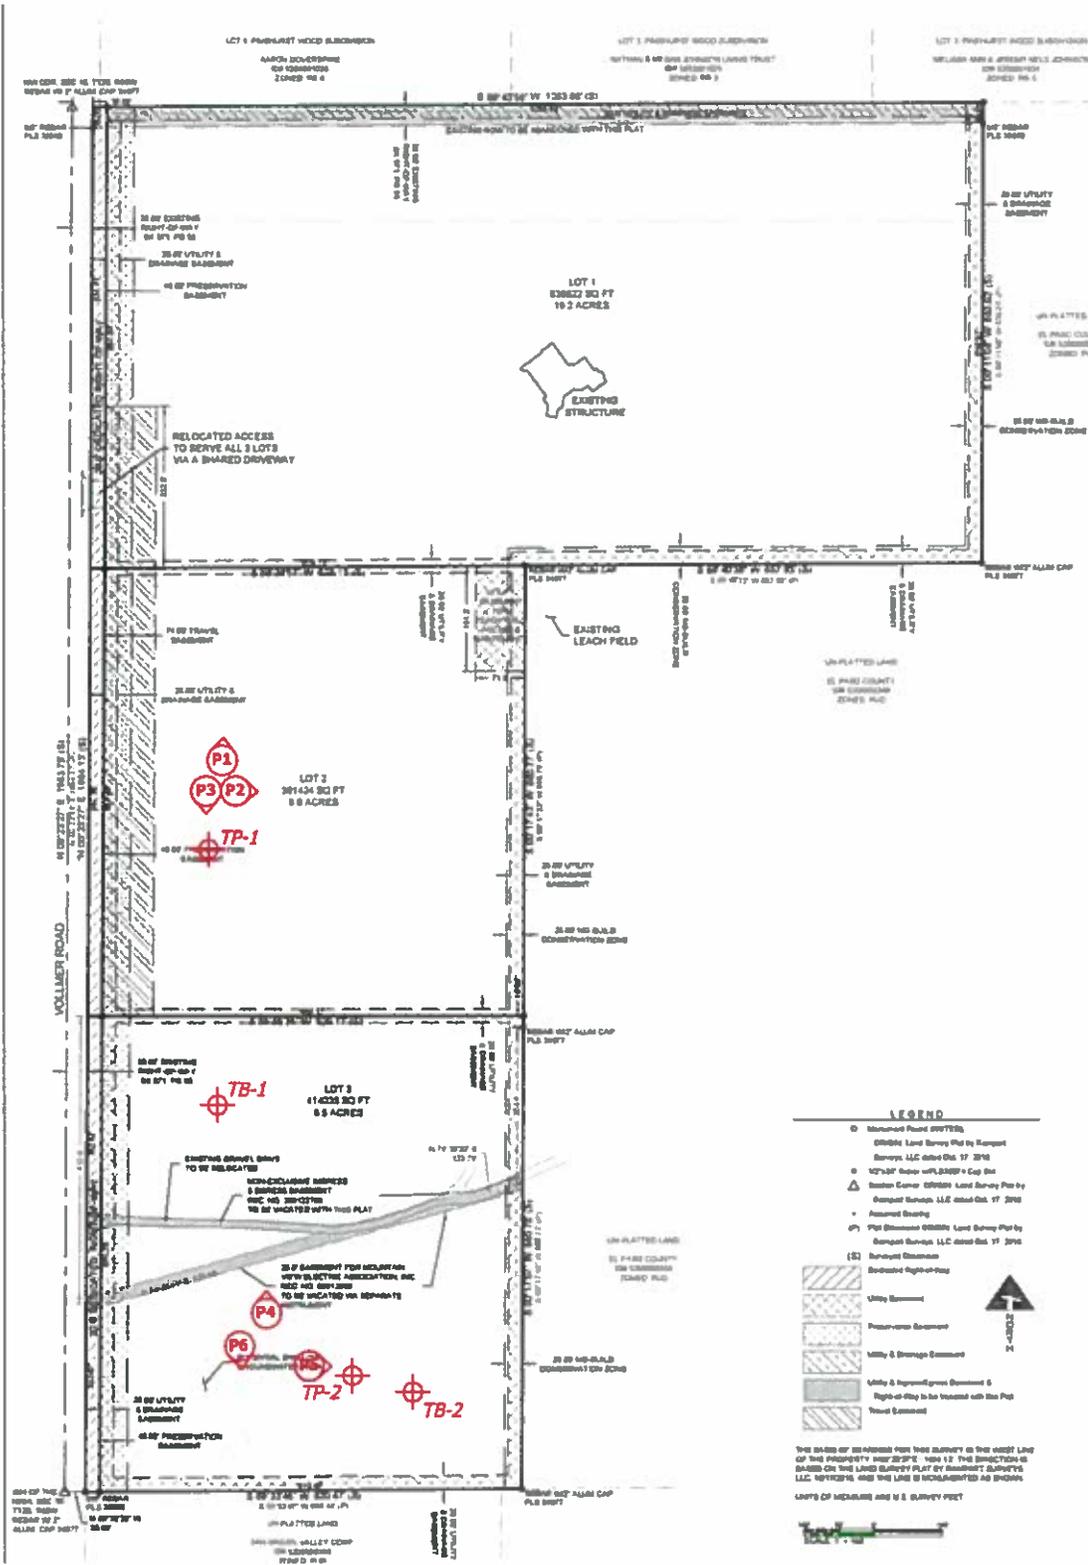
FIG NO.:
3

⊕ TP- APPROXIMATE TEST PIT LOCATION AND NUMBER
 ⊕ P2 - APPROXIMATE TEST PIT LOCATION AND NUMBER

SITE PLAN/TESTING LOCATION MAP
 SEDONA SUN ACRES
 12325 VOLLMER ROAD
 EL PASO COUNTY, CO.
 FOR: SMH CONSULTANTS

Total acreage involved in the proposed subdivision is 37.7-acres. Three rural residential lots are proposed as part of the replat. The proposed lot sizes range from 9-acres to 19.2-acres. An existing house is located on Lot 1 which will remain. The new lots will be serviced by individual wells and on-site wastewater treatment systems. The Site Plan with the proposed replat is presented in Figure 3.

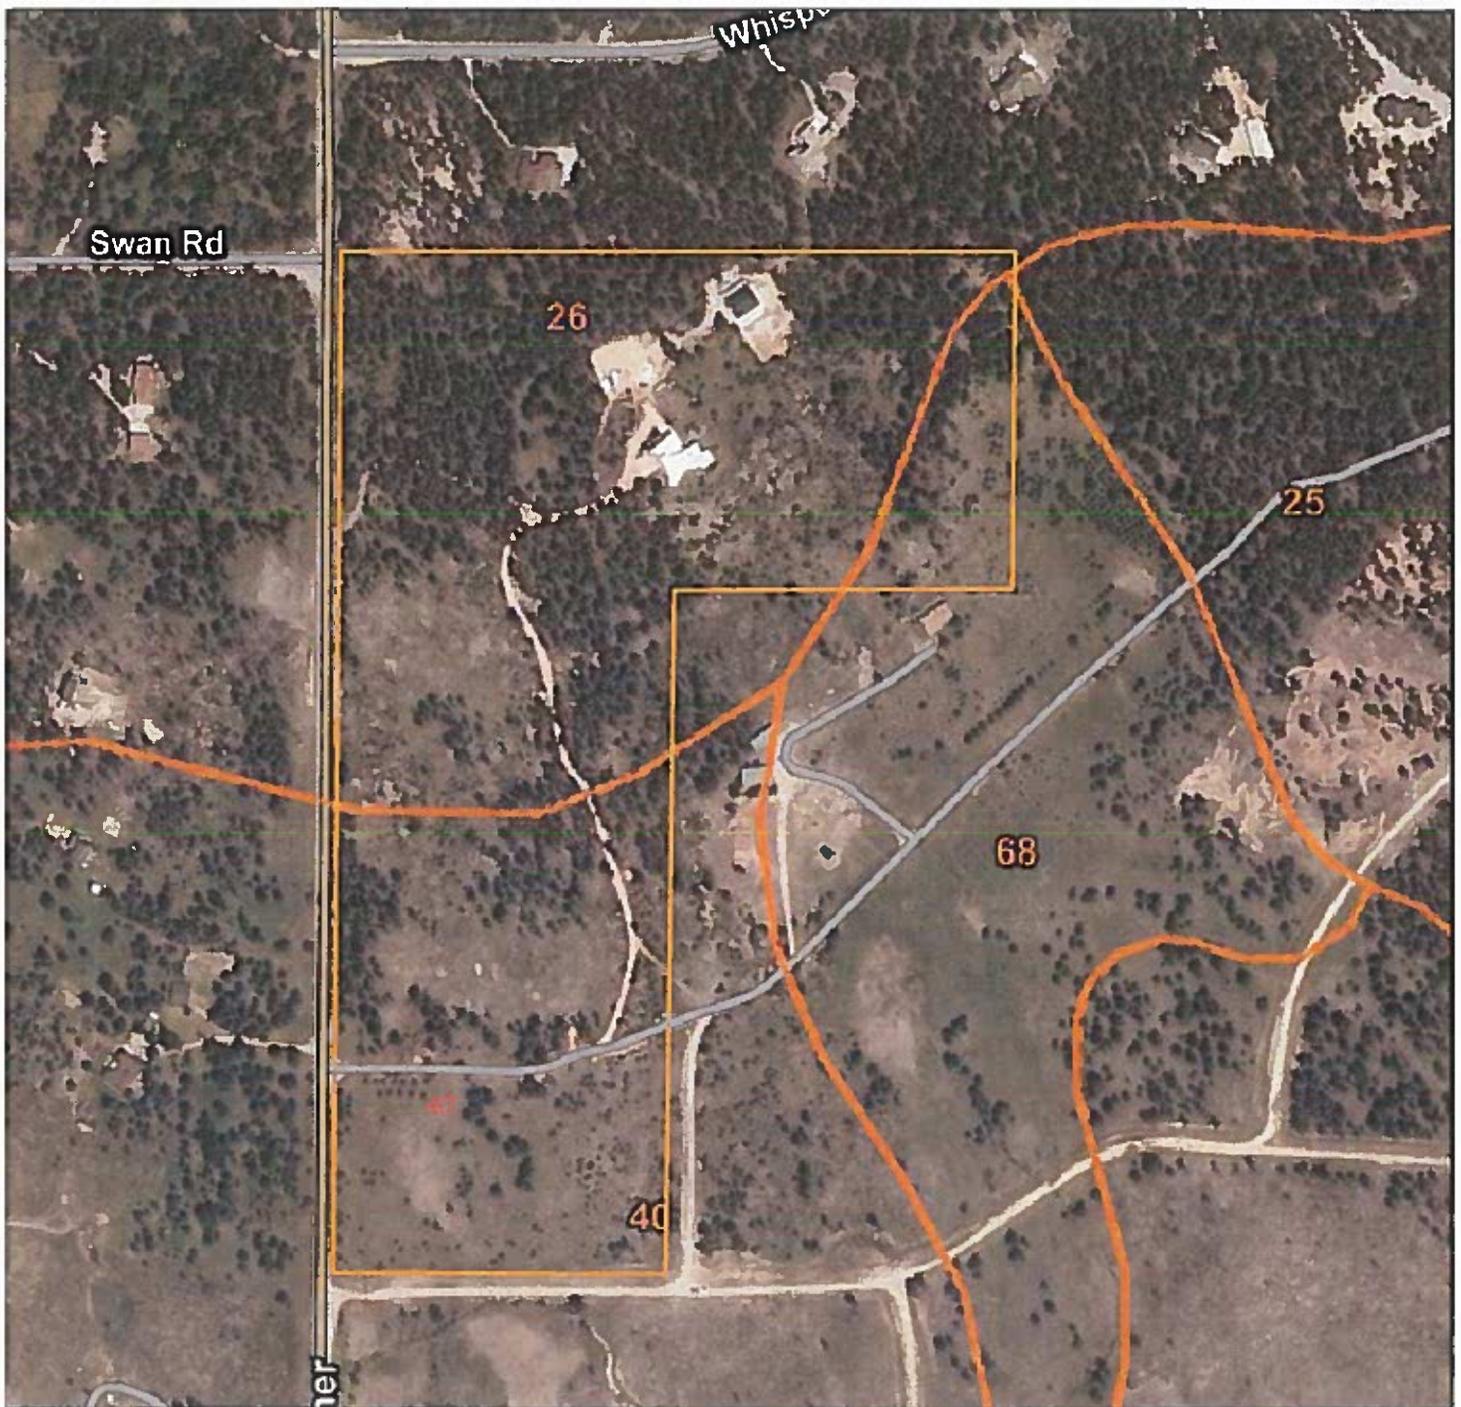
JOB NO.:
200160
FIG NO.:
 4

SOIL SURVEY MAP
SEDONA SUN ACRES
13235 VOLLMER ROAD
EL PASO COUNTY, CO.
SMH CONSULTANTS

The soils have been described to have moderate to rapid permeabilities. The soils are described as well suited for use as homesites. Possible hazards with soils erosion are present on the site. The erosion potential can be controlled with vegetation. The soils have been described to have moderate erosion hazards (Reference 2).

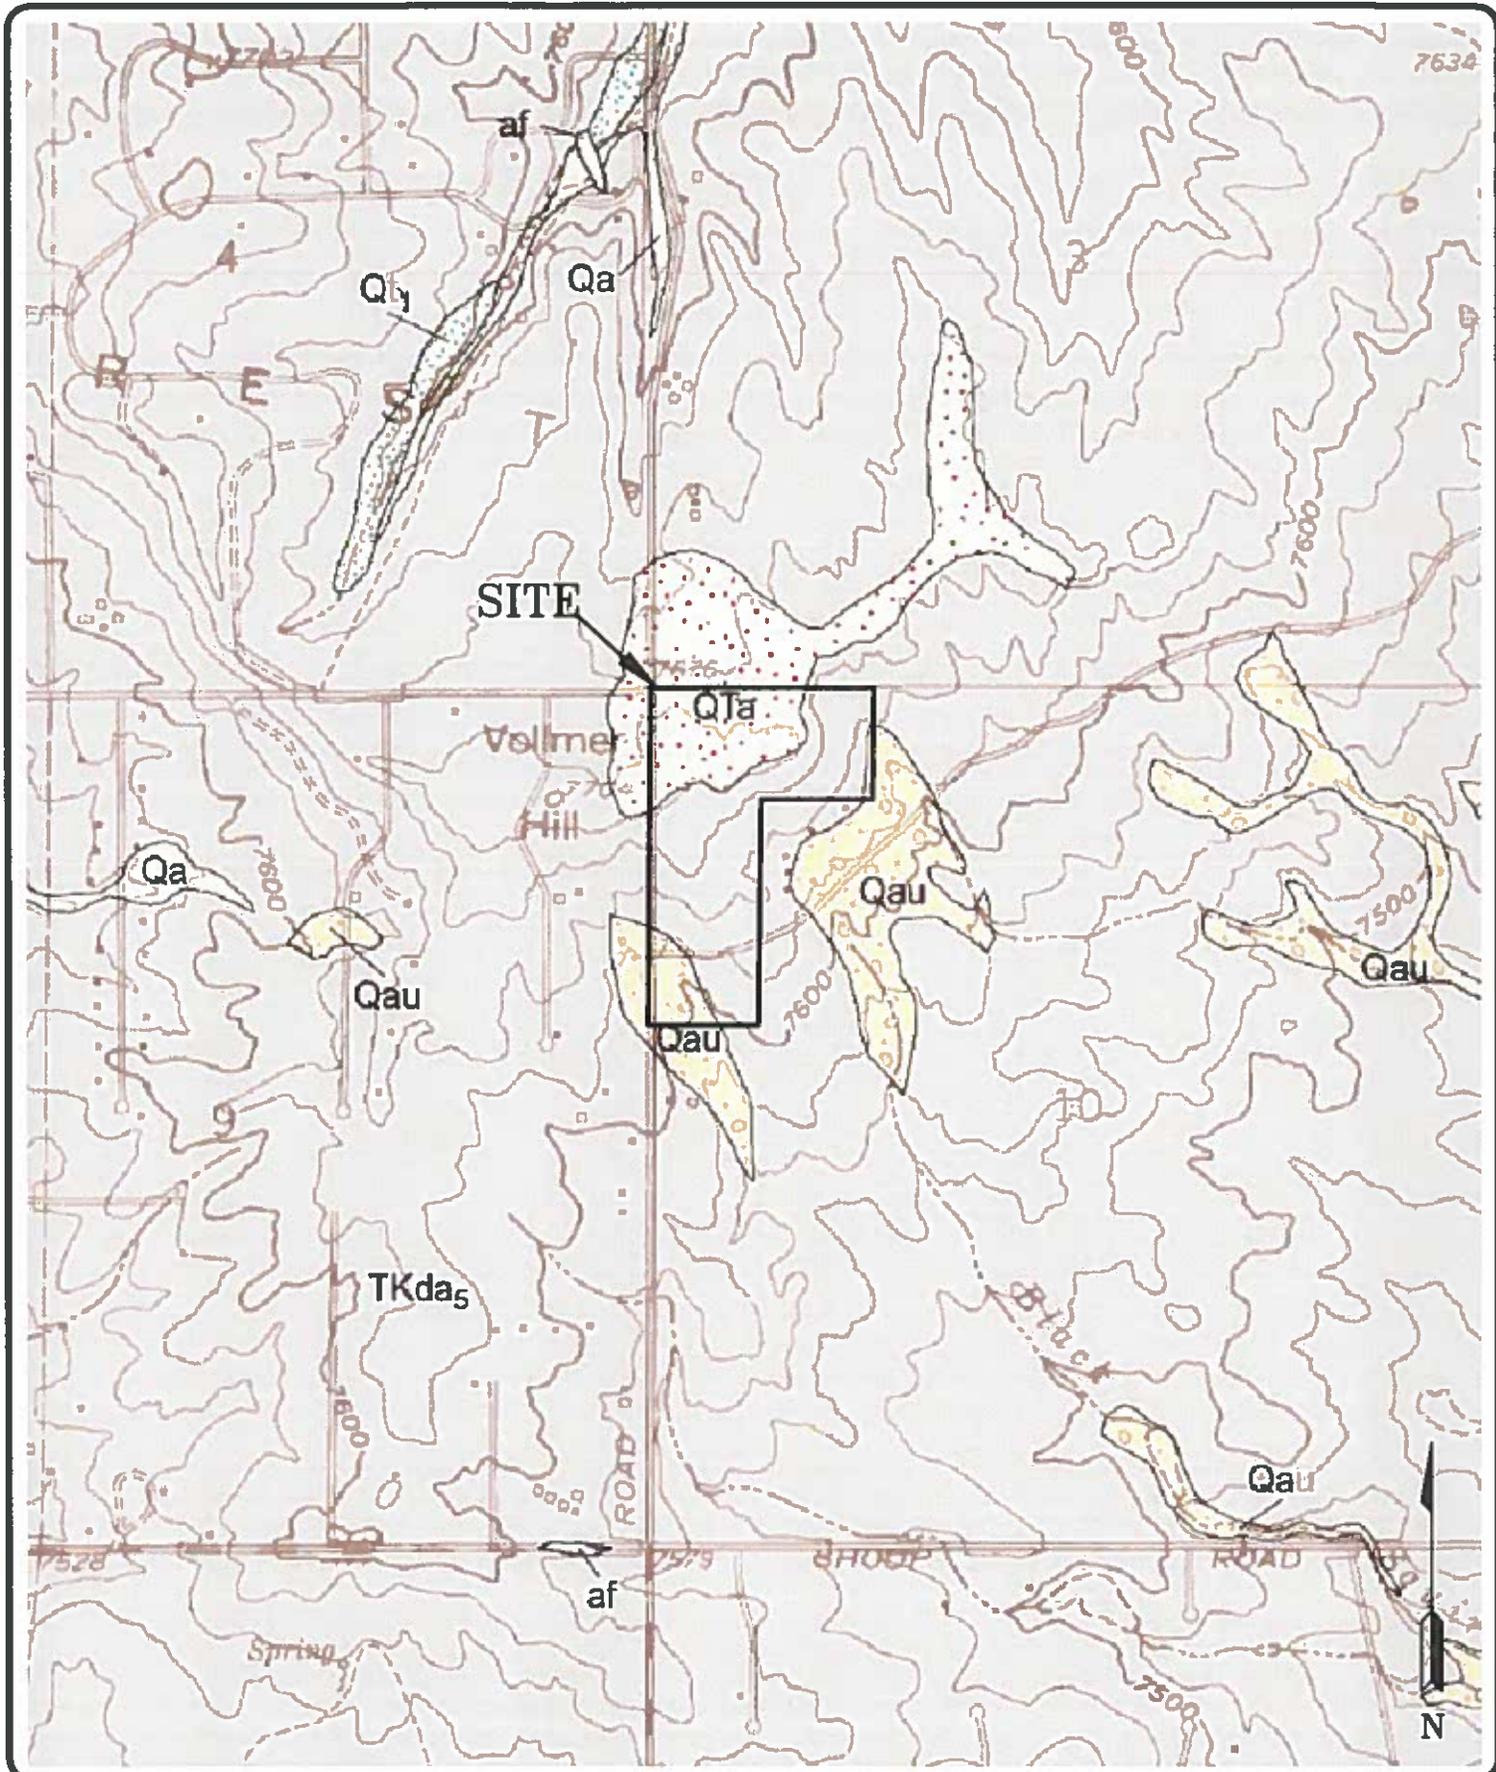
FIG NO.:
 5

BLACK FOREST QUADRANGLE GEOLOGIC MAP
 SEDONA SUN ACRES
 13235 VOLLMER ROAD
 EL PASO COUNTY, CO.
 SMH CONSULTANTS

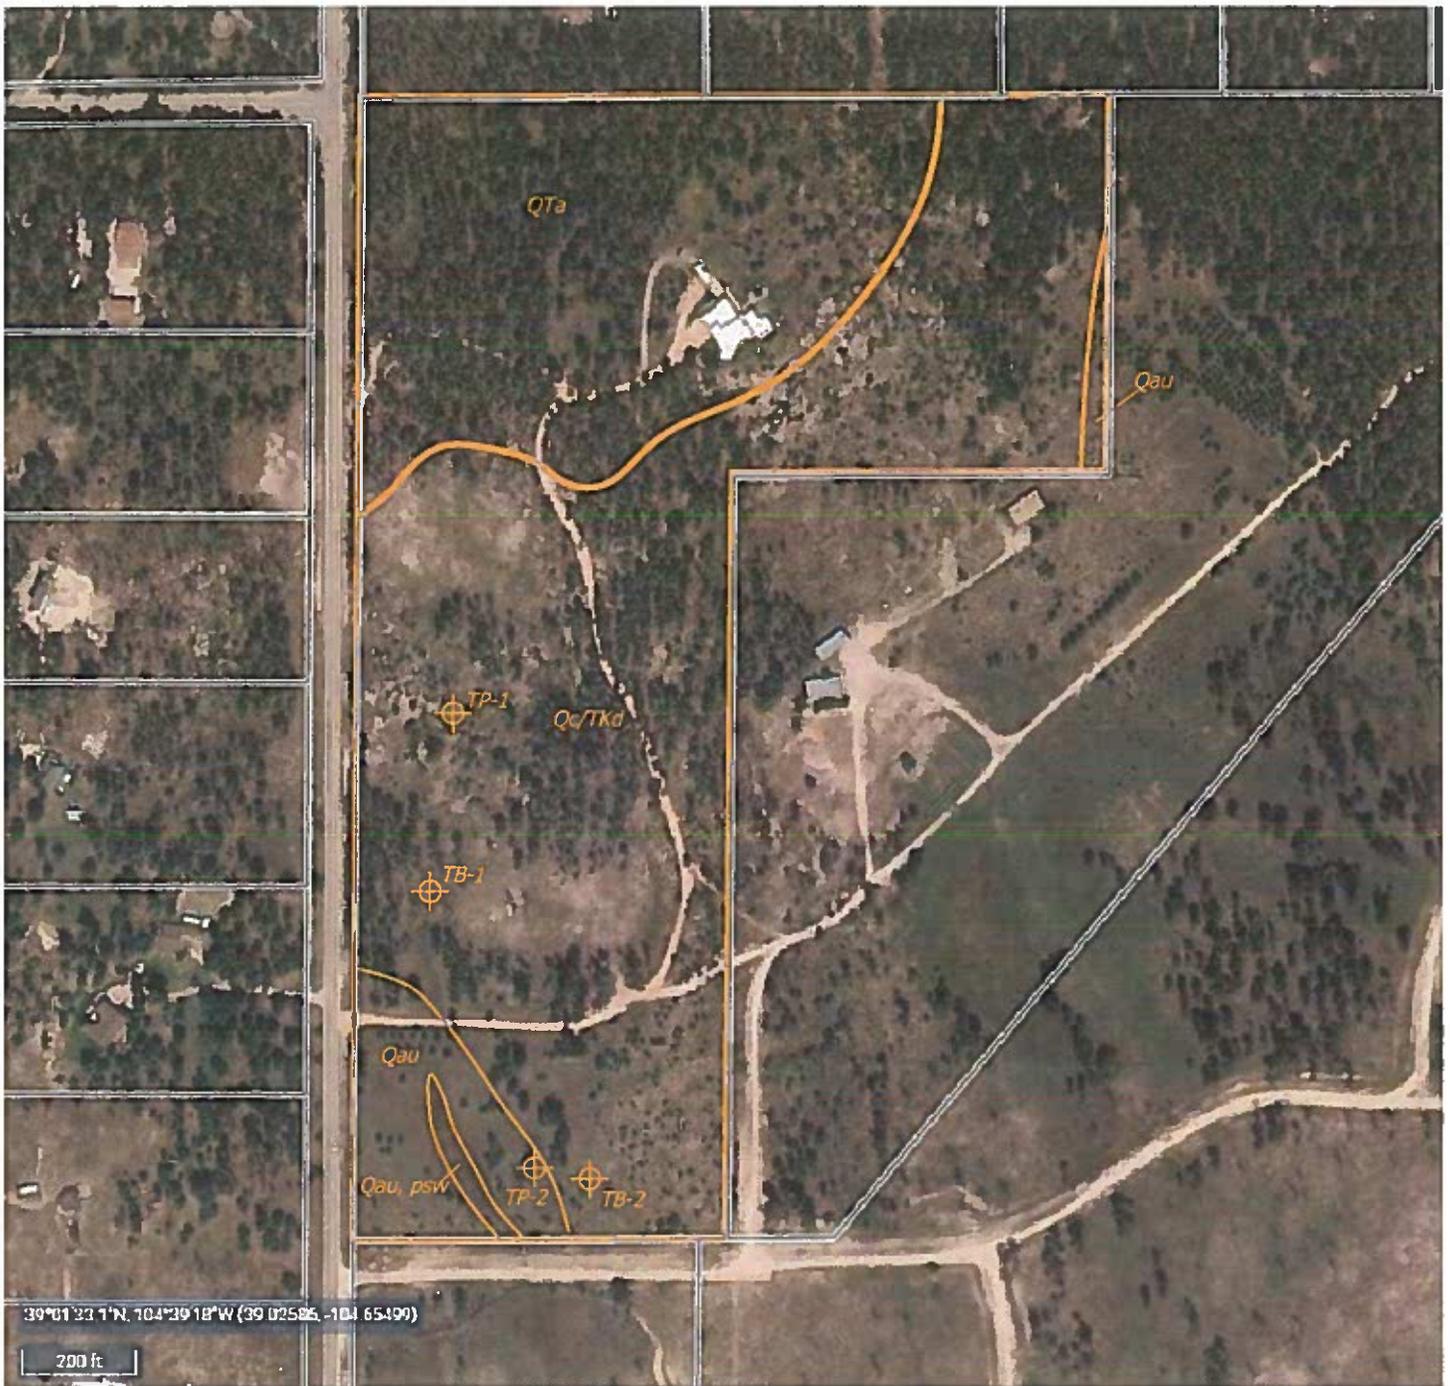
FIG NO.:
6

- Qau - Alluvium Undivided of Holocene and Pleistocene Age:
sheetwash and stream deposited alluvium associated with alluvial-filled valley heads
- QTa - Alluvium of Palmer Divide of Early Pleistocene or Pliocene Age:
stream terrace deposits located along the Palmer Divide
- QcTKd - Colluvium of Quaternary Age overlying Dawson Formation of Tertiary to Cretaceous Age:
colluvial and residual soils overlying arkosic sandstone with interbedded fine-grained sandstone, siltstone and claystone
- psw - potentially shallow groundwater area

The head of a minor drainage exists in the southern portion of the site (Lot 3) that flows in southeasterly direction. No water was observed flowing in the drainages at the time of the investigation. An area of potentially seasonal shallow groundwater has been mapped in the drainage (Figure 6).

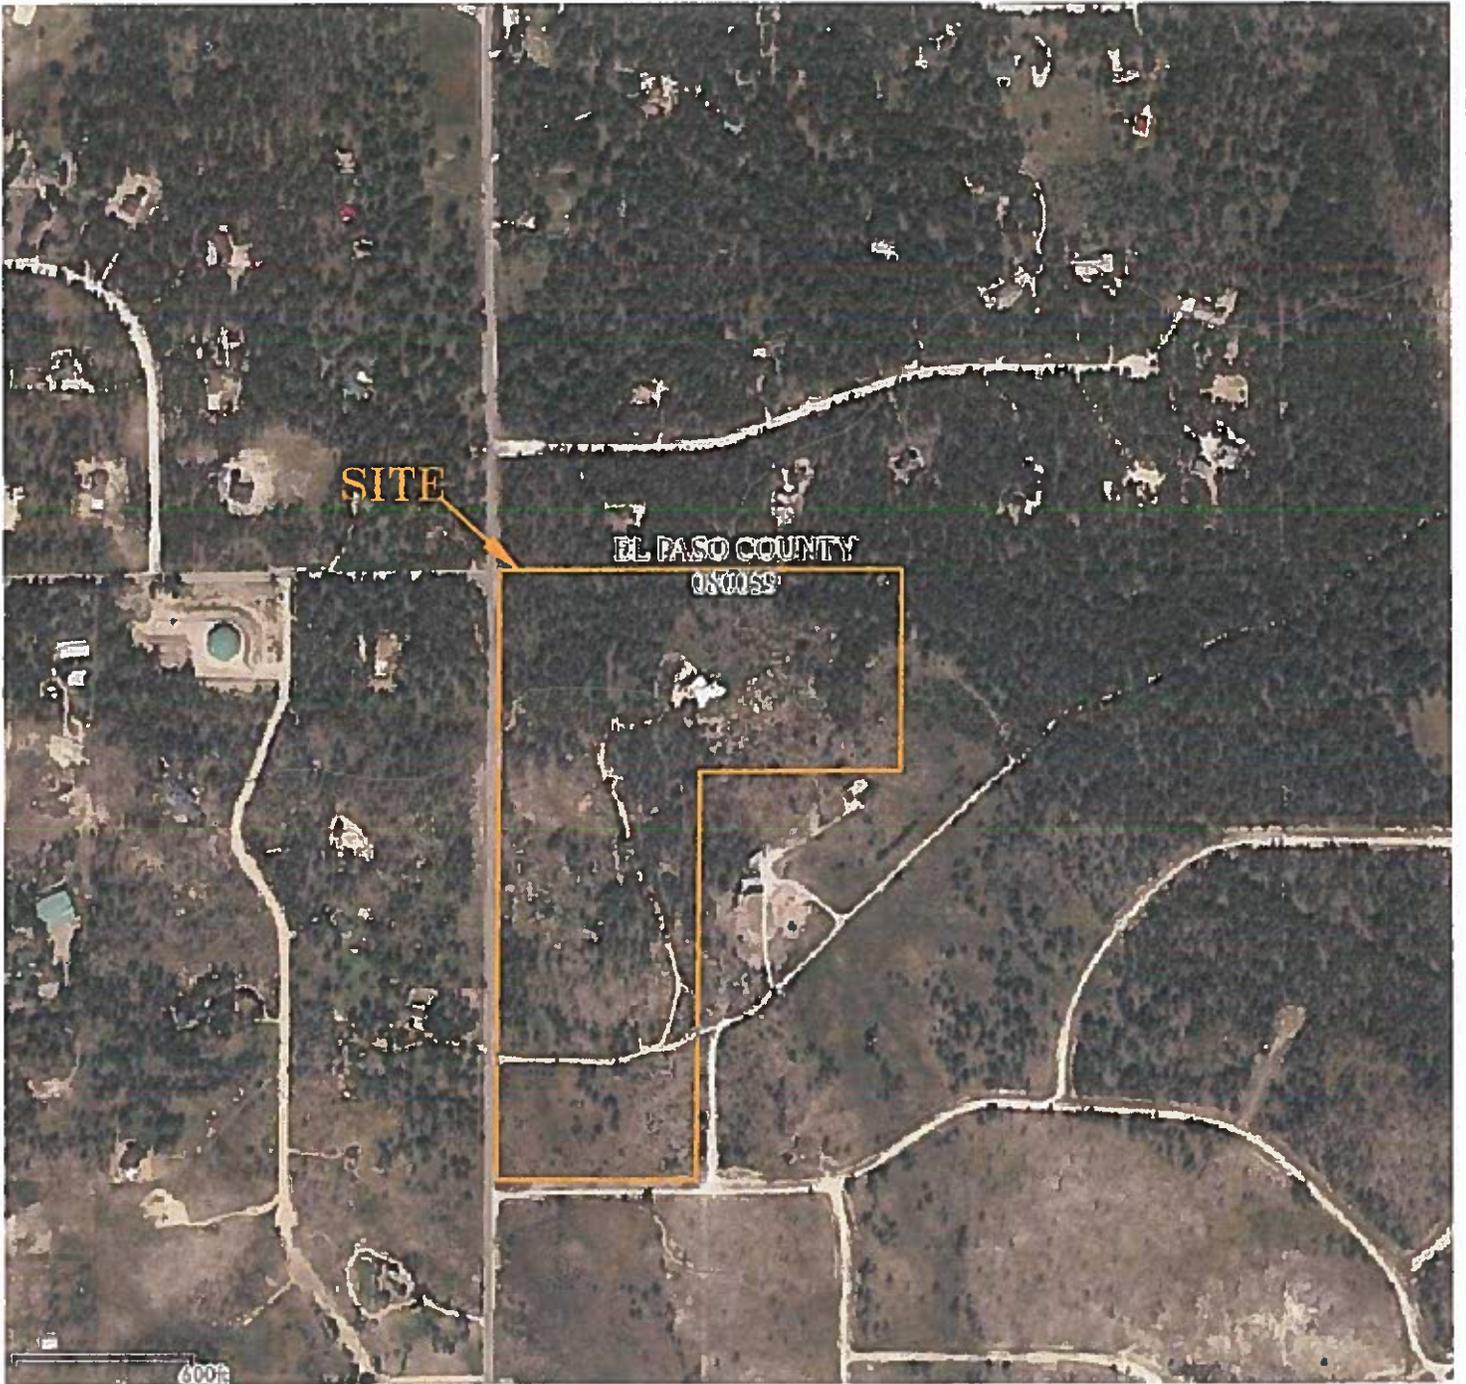
FIG NO.:
 7

FEMA FLOODPLAIN MAP
SEDONA SUN ACRES
13235 VOLLMER ROAD
EL PASO COUNTY, CO.
SMH CONSULTANTS

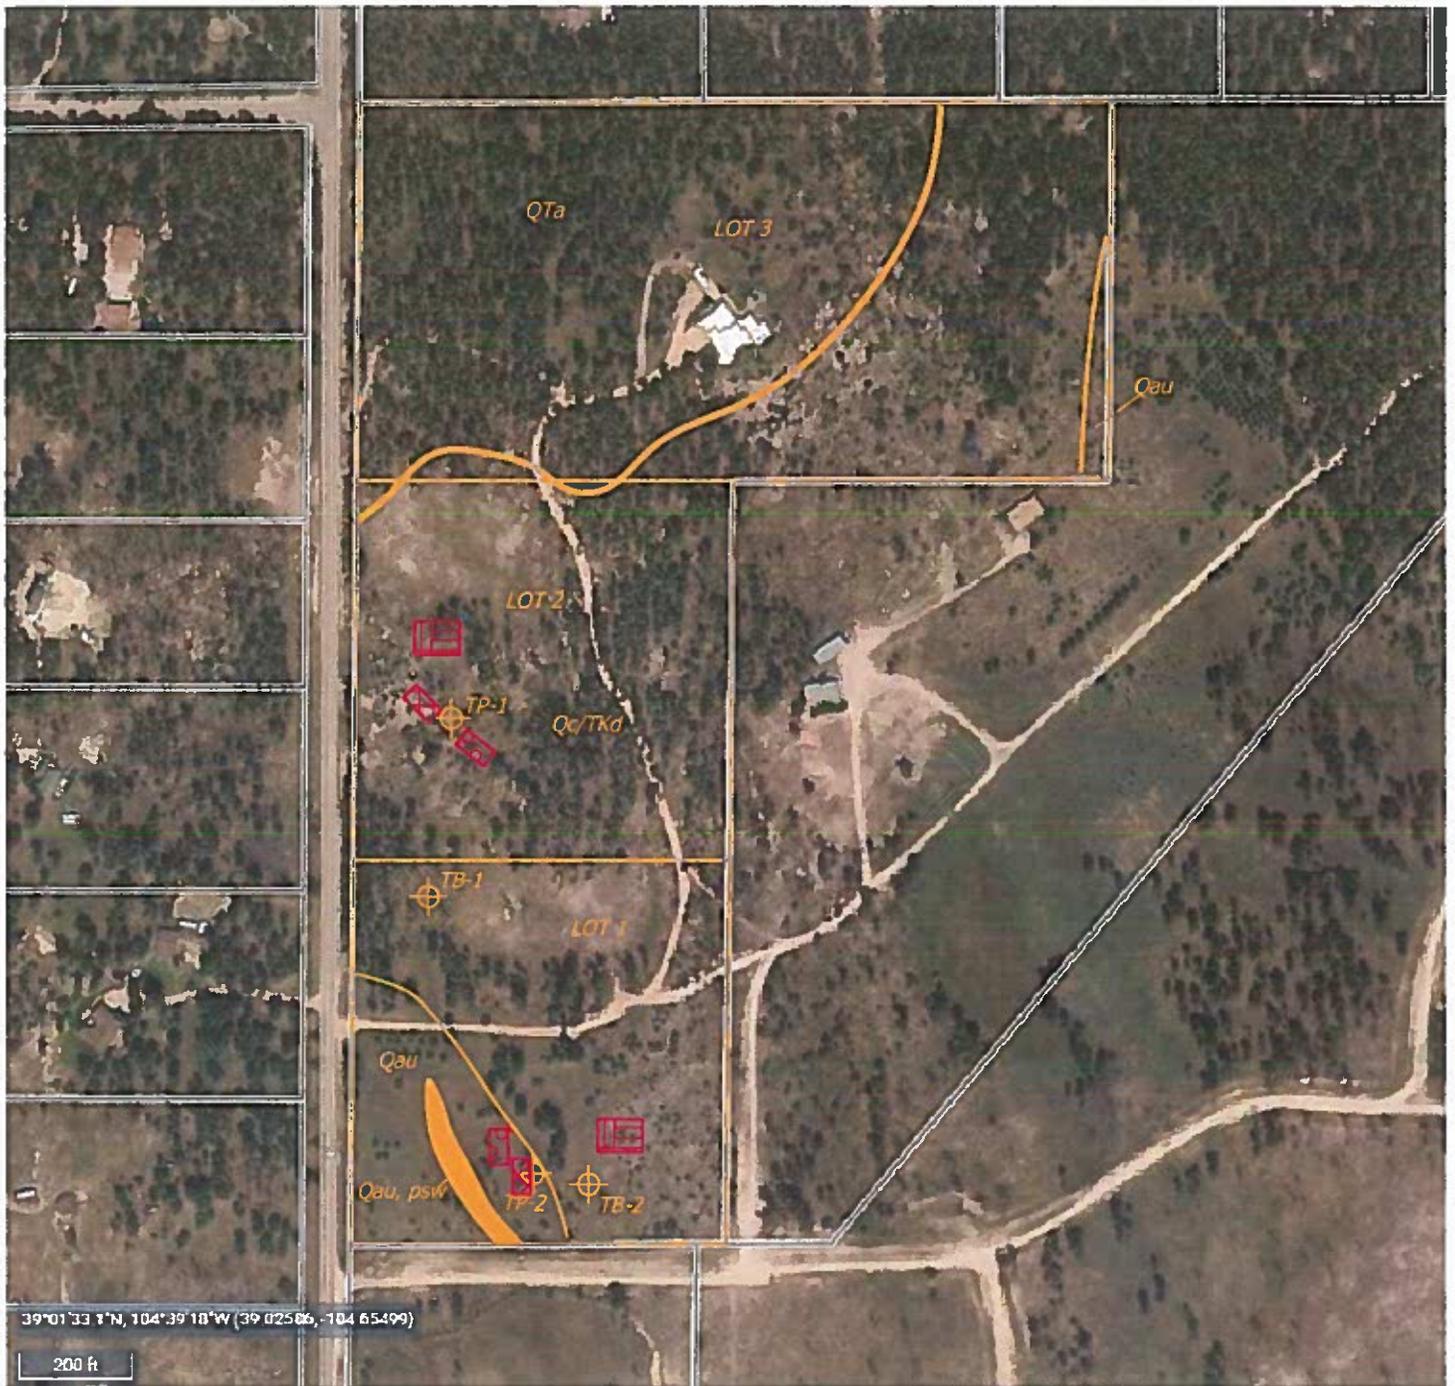
- AREAS WHERE OWTS ARE NOT RECOMMENDED

In potentially seasonal shallow groundwater areas, we would anticipate the potential for periodically high subsurface moisture conditions and highly organic soils. Due to the potential for seasonal high groundwater conditions, on-site wastewater treatment systems are not recommended in these areas. Due to lot sizes, it is anticipated these areas can be avoided. The site does not lie within any floodplain zones according to the FEMA Map No. 08041CO320 dated December 7, 2018 (Figure 7, Reference 7). Exact locations of floodplain and specific drainage studies are beyond the scope of this report. Individual wastewater treatment systems must be located a minimum of 25 feet from dry gulches and 50 feet from water courses or floodplains.

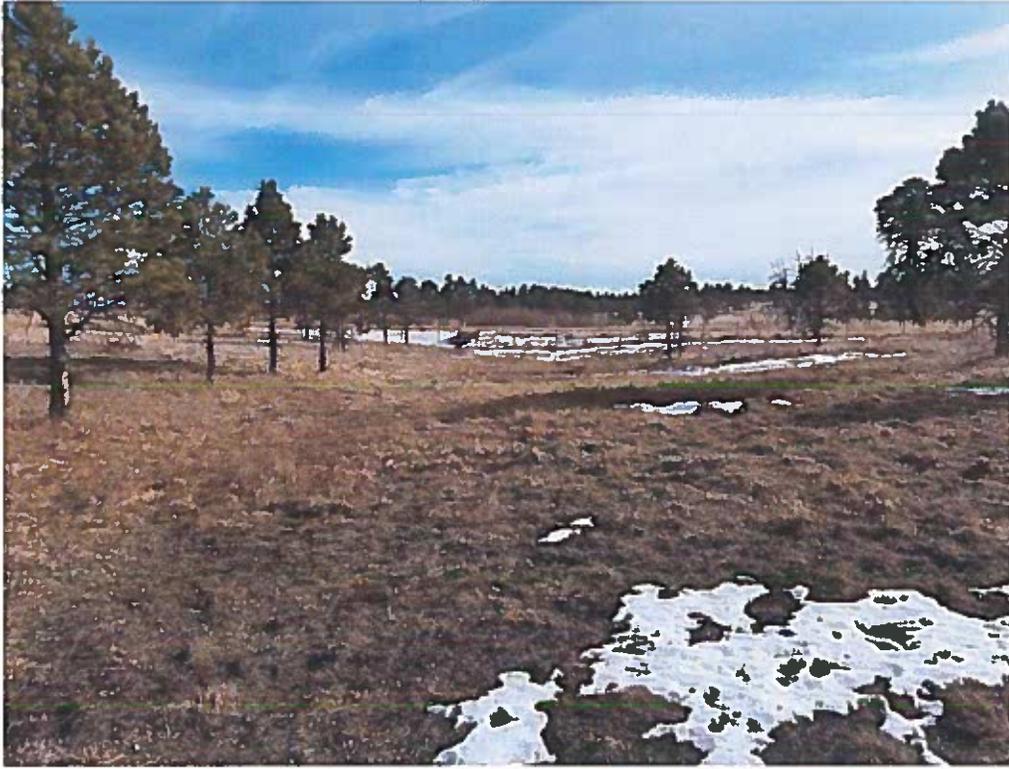
Looking south along head of minor drainage in the southern portion of the site.

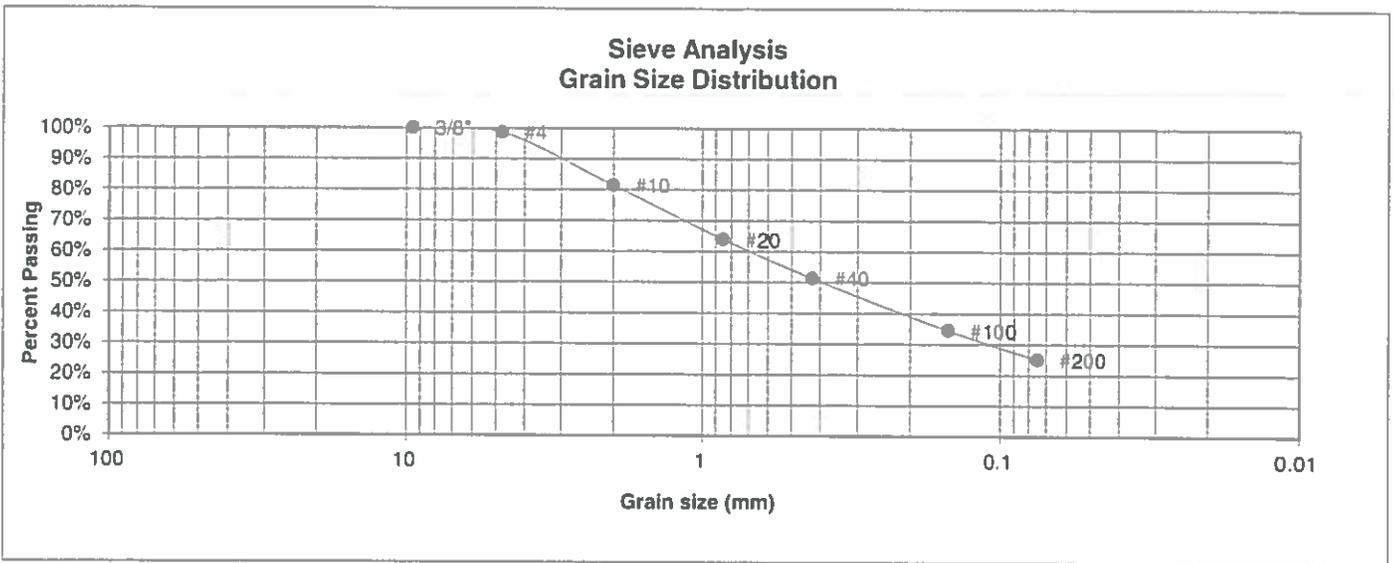
UNIFIED CLASSIFICATION SM
 SOIL TYPE # 1
 TEST BORING # 1
 DEPTH (FT) 2-3

U.S. Sieve #	Percent Finer
3"	
1 1/2"	
3/4"	
1/2"	
3/8"	100.0%
4	98.6%
10	81.4%
20	64.0%
40	51.3%
100	34.5%
200	25.1%

dense states and moderate moisture conditions. The samples of sand tested had approximately 8 to 25 percent of the soil size particles passing the No. 200 sieve. Atterberg Limits Testing resulted in the sand being non-plastic. The samples of sandstone tested had 17 to 23 percent of the soil size particles passing the No. 200 sieve. Atterberg Limits Testing on a sample of clayey sandstone resulted in a liquid limit of 41 and a plastic index of 20. FHA Swell Testing on a sample of the clayey sandstone resulted in an expansion pressure of 360 psf, which indicates a low expansion potential. Highly expansive claystone and siltstone lenses are commonly interbedded in the Dawson Formation.

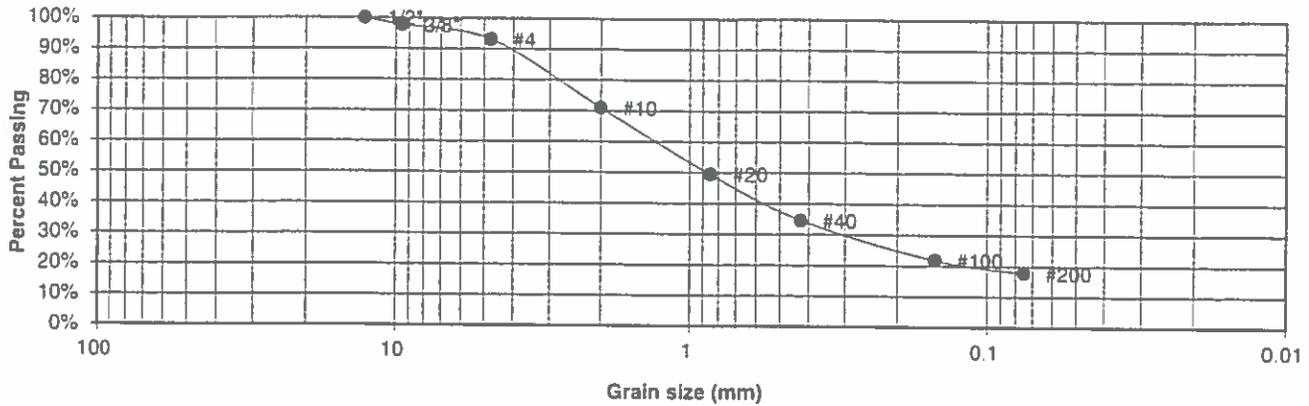
Sieve Analysis
 Grain Size Distribution

U.S. Sieve #	Percent Finer
3"	
1 1/2"	
3/4"	
1/2"	100.0%
3/8"	97.7%
4	93.1%
10	70.9%
20	49.5%
40	34.6%
100	21.9%
200	17.8%

Atterberg Limits	
Plastic Limit	NP
Liquid Limit	NV
Plastic Index	NP

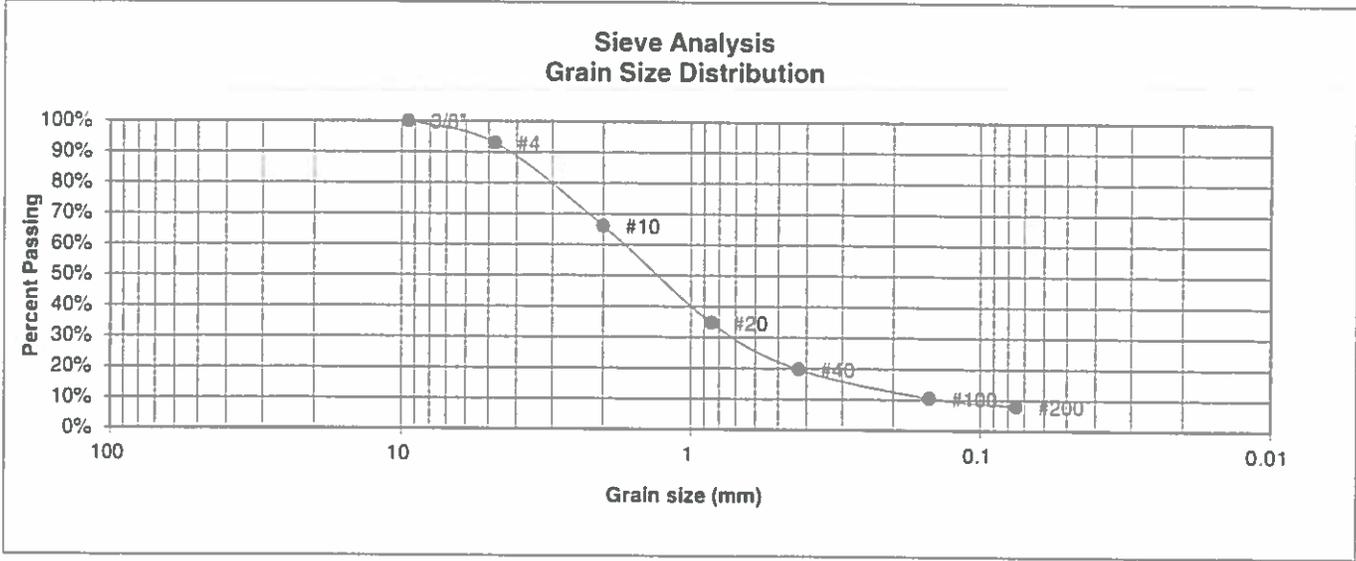
BORING NO.	TP-2	UNIFIED CLASSIFICATION	SM-SW	TEST BY	BL
DEPTH(ft)	5-6	AASHTO CLASSIFICATION		JOB NO.	200160
CLIENT	SMH CONSULTANTS				
PROJECT	13235 VOLLMER ROAD

U.S. Sieve #	Percent Finer
3"	
1 1/2"	
3/4"	
1/2"	
3/8"	100.0%
4	93.0%
10	66.1%
20	34.7%
40	19.7%
100	10.5%
200	8.0%

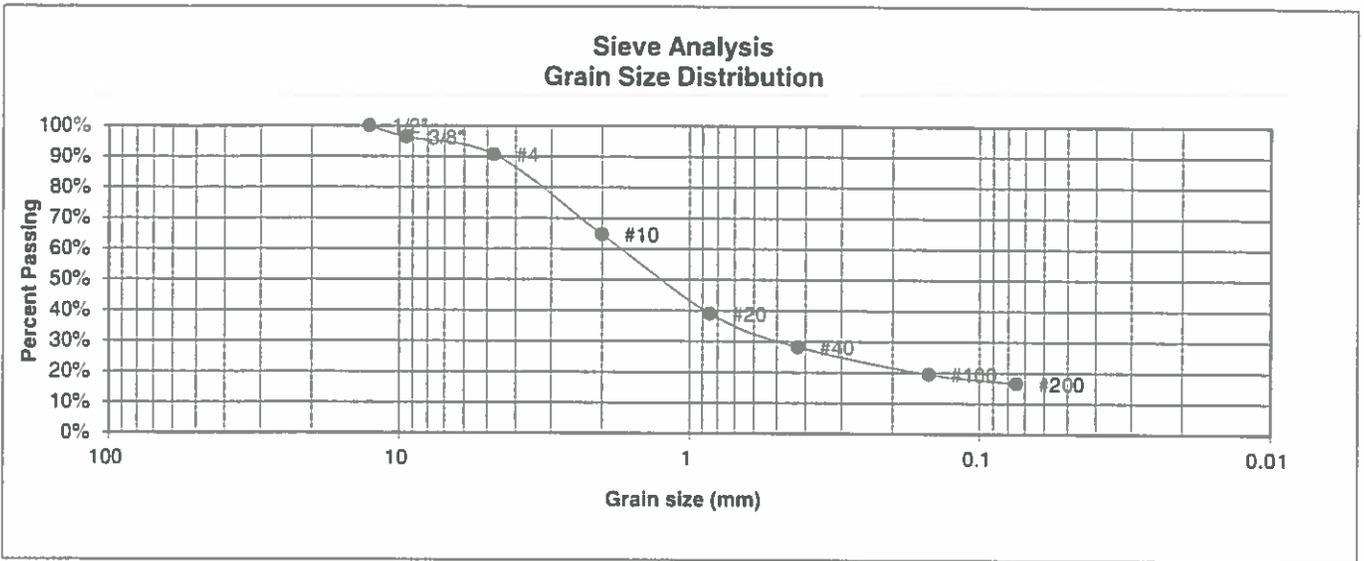
BORING NO.	TP-1	UNIFIED CLASSIFICATION	SC	TEST BY	BL
DEPTH(ft)	6-7	AASHTO CLASSIFICATION		JOB NO.	200160
CLIENT	SMH CONSULTANTS				
PROJECT	13235 VOLLMER ROAD

U.S. Sieve #	Percent Finer
3"	
1 1/2"	
3/4"	
1/2"	100.0%
3/8"	96.3%
4	90.7%
10	64.7%
20	39.0%
40	28.2%
100	19.5%
200	16.5%

Swell
 Moisture at start 12.3%
 Moisture at finish 20.5%
 Moisture increase 8.2%
 Initial dry density (pcf) 99
 Swell (psf) 360

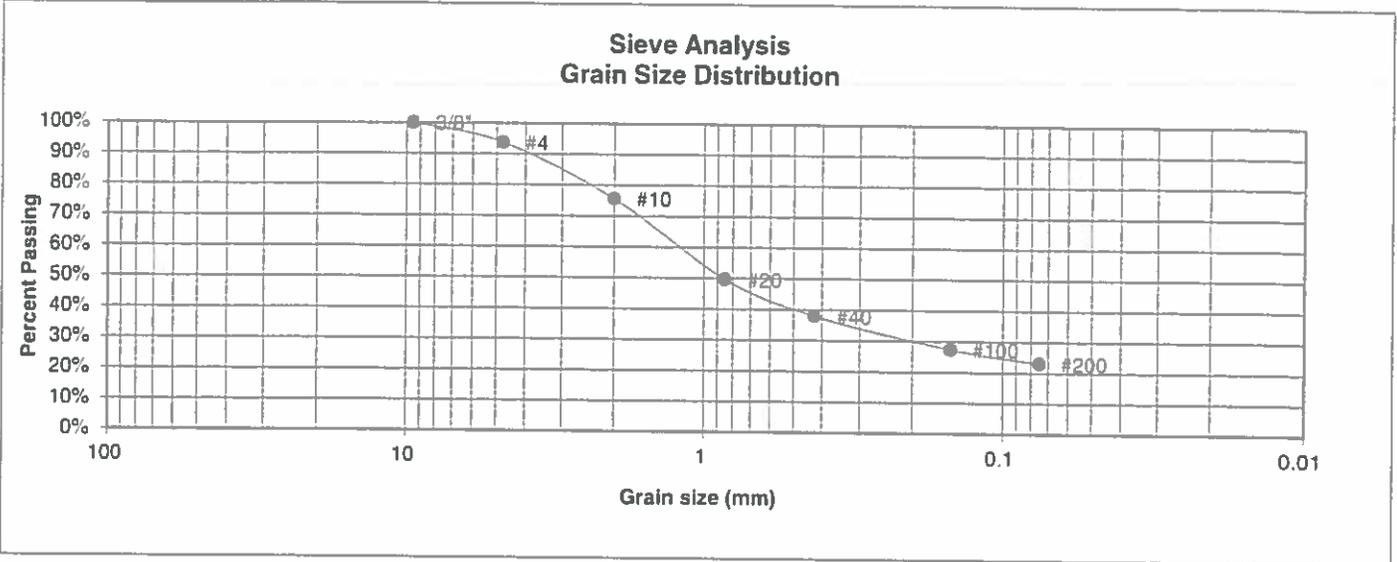
UNIFIED CLASSIFICATION	SC	CLIENT	SMH CONSULTANTS
SOIL TYPE #	2	PROJECT	13235 VOLLMER ROAD
TEST BORING #	1	JOB NO.	200160
DEPTH (FT)	15	TEST BY	BL

U.S. Sieve #	Percent Finer
3"	
1 1/2"	
3/4"	
1/2"	
3/8"	100.0%
4	93.7%
10	75.6%
20	49.6%
40	37.9%
100	27.4%
200	23.0%

Atterberg Limits	
Plastic Limit	21
Liquid Limit	41
Plastic Index	20

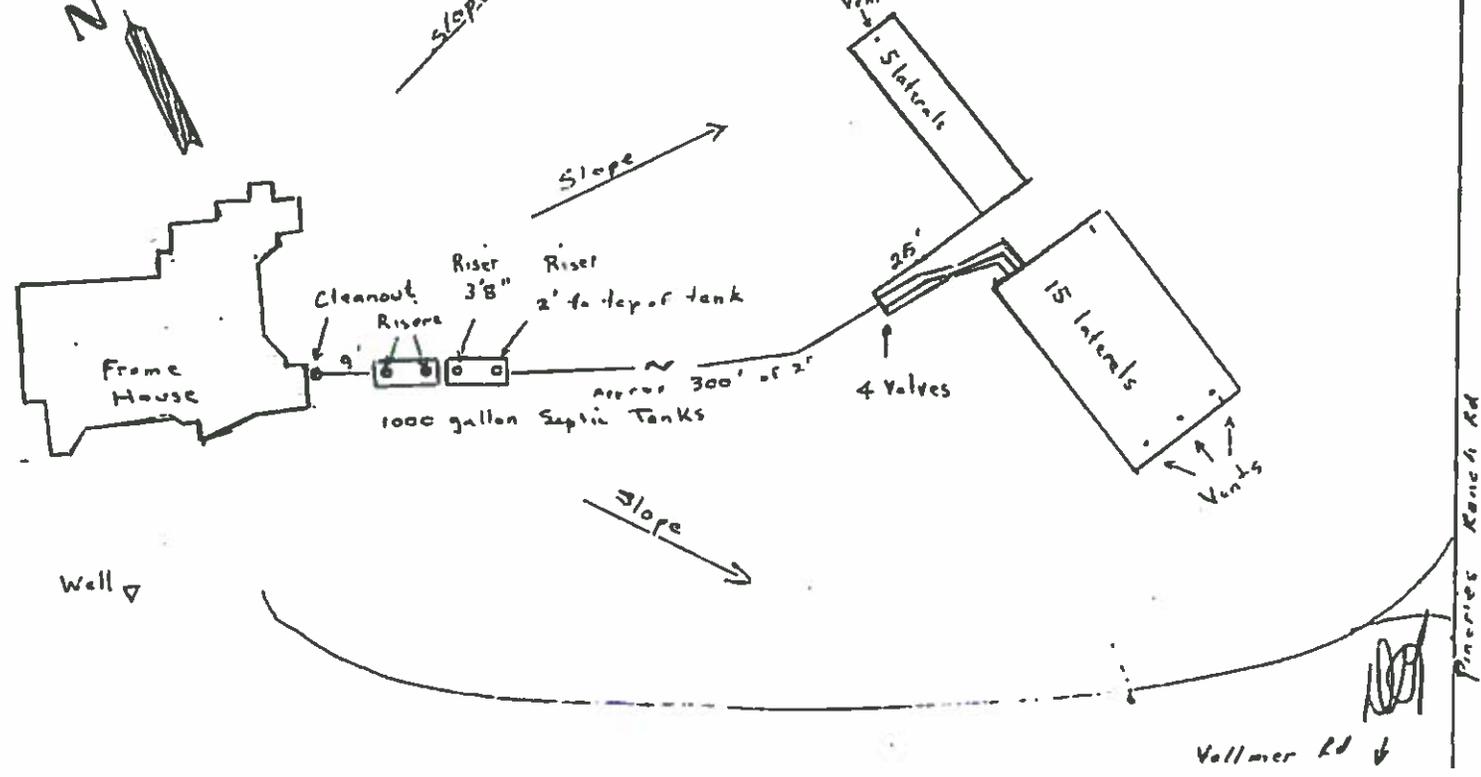
NOTES: Pump & Alarm to be installed in 2nd Chamber of 2nd septic tank.

Field zones were covered-backfilled plus snow covered at time of inspection with exception of ends. 2" sch 40 line from septic tank outlet to valves. 1 1/2" laterals.
