***WASTEWATER DISPOSAL REPORT***

***EAGLEVIEW SUBDIVISION***

***EPC Parcel #: 522600001 AND 522600002***

**December 2021**

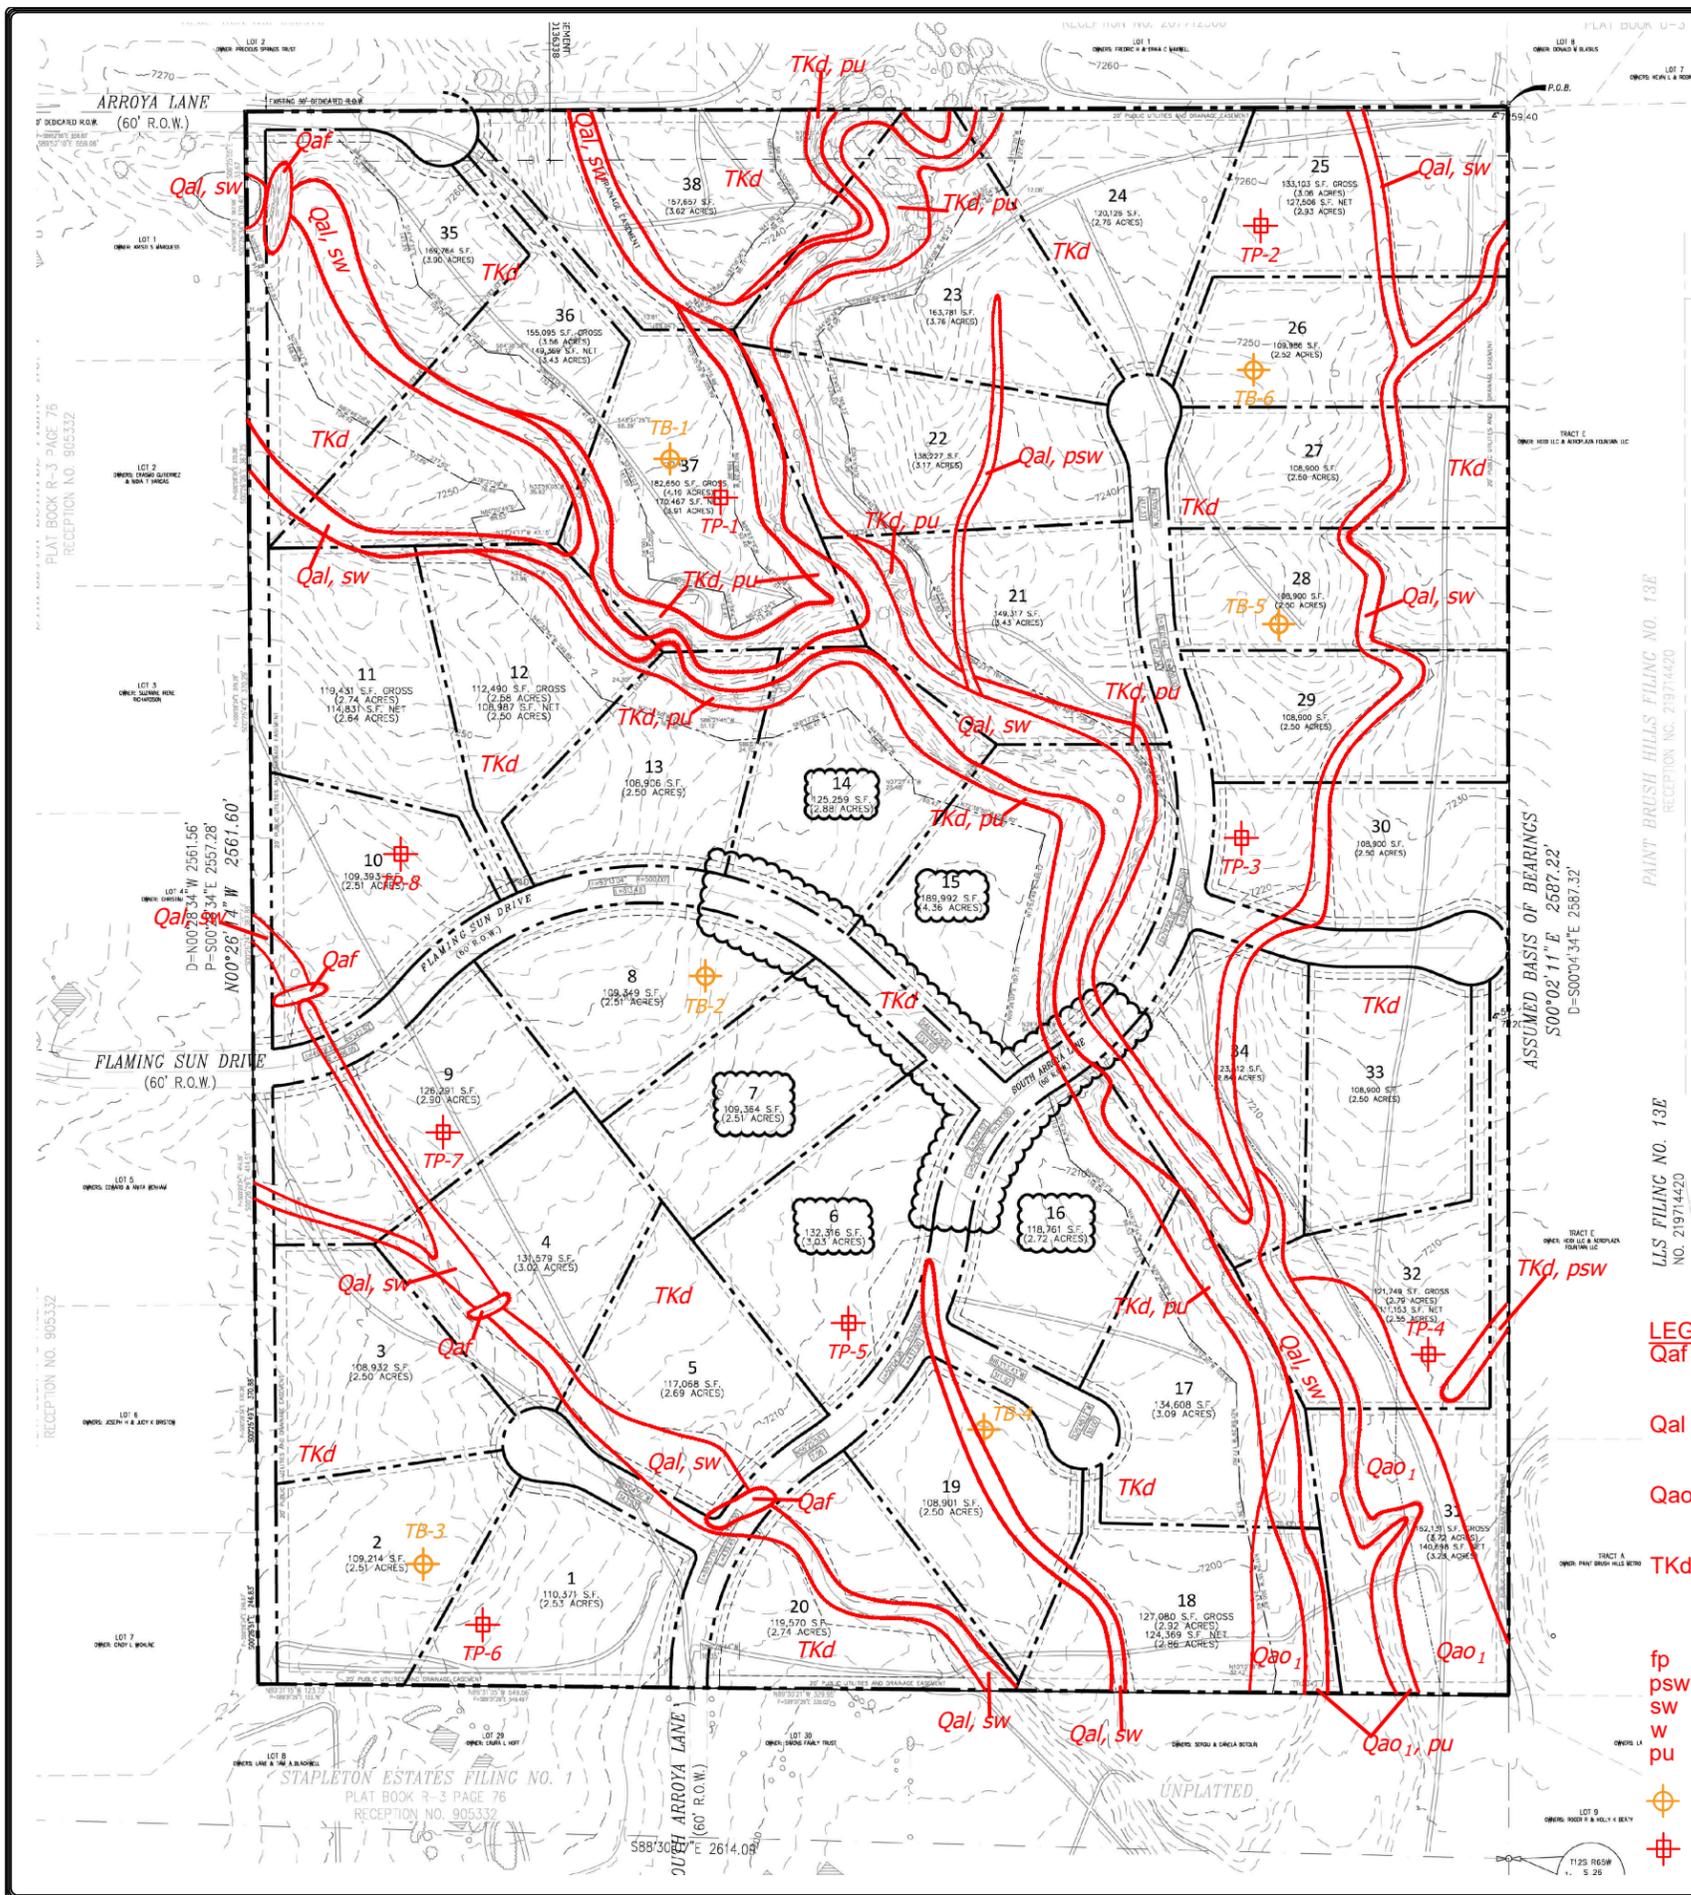
DRAWN  
JHR  
CHECKED  
L.L.L.  
DATE  
11/17/21  
SCALE  
AS SHOWN  
JOB NO.  
212684  
FIGURE No.  
**6**

- Qaf - Artificial Fill of Holocene Age: man-made fill deposits associated with erosion berms
- Qal - Alluvial Deposits of Holocene Age: recent water deposited sediment along minor drainage
- Qao<sub>1</sub> - Old Alluvium one of late-middle Pleistocene Age: recent water deposited sediment along minor drainage
- TKd - Dawson Formation of Tertiary to Cretaceous Age: arkosic sandstone with interbedded fine-grained sandstone, siltstone and claystone
- fp - floodplain
- psw - potentially seasonal shallow groundwater area
- sw - seasonal shallow groundwater area
- w - flowing water
- pu - potentially unstable slope
- ⊕ - approximate test boring location (Entech Job No. 80503)
- ⊕ - approximate test pit location

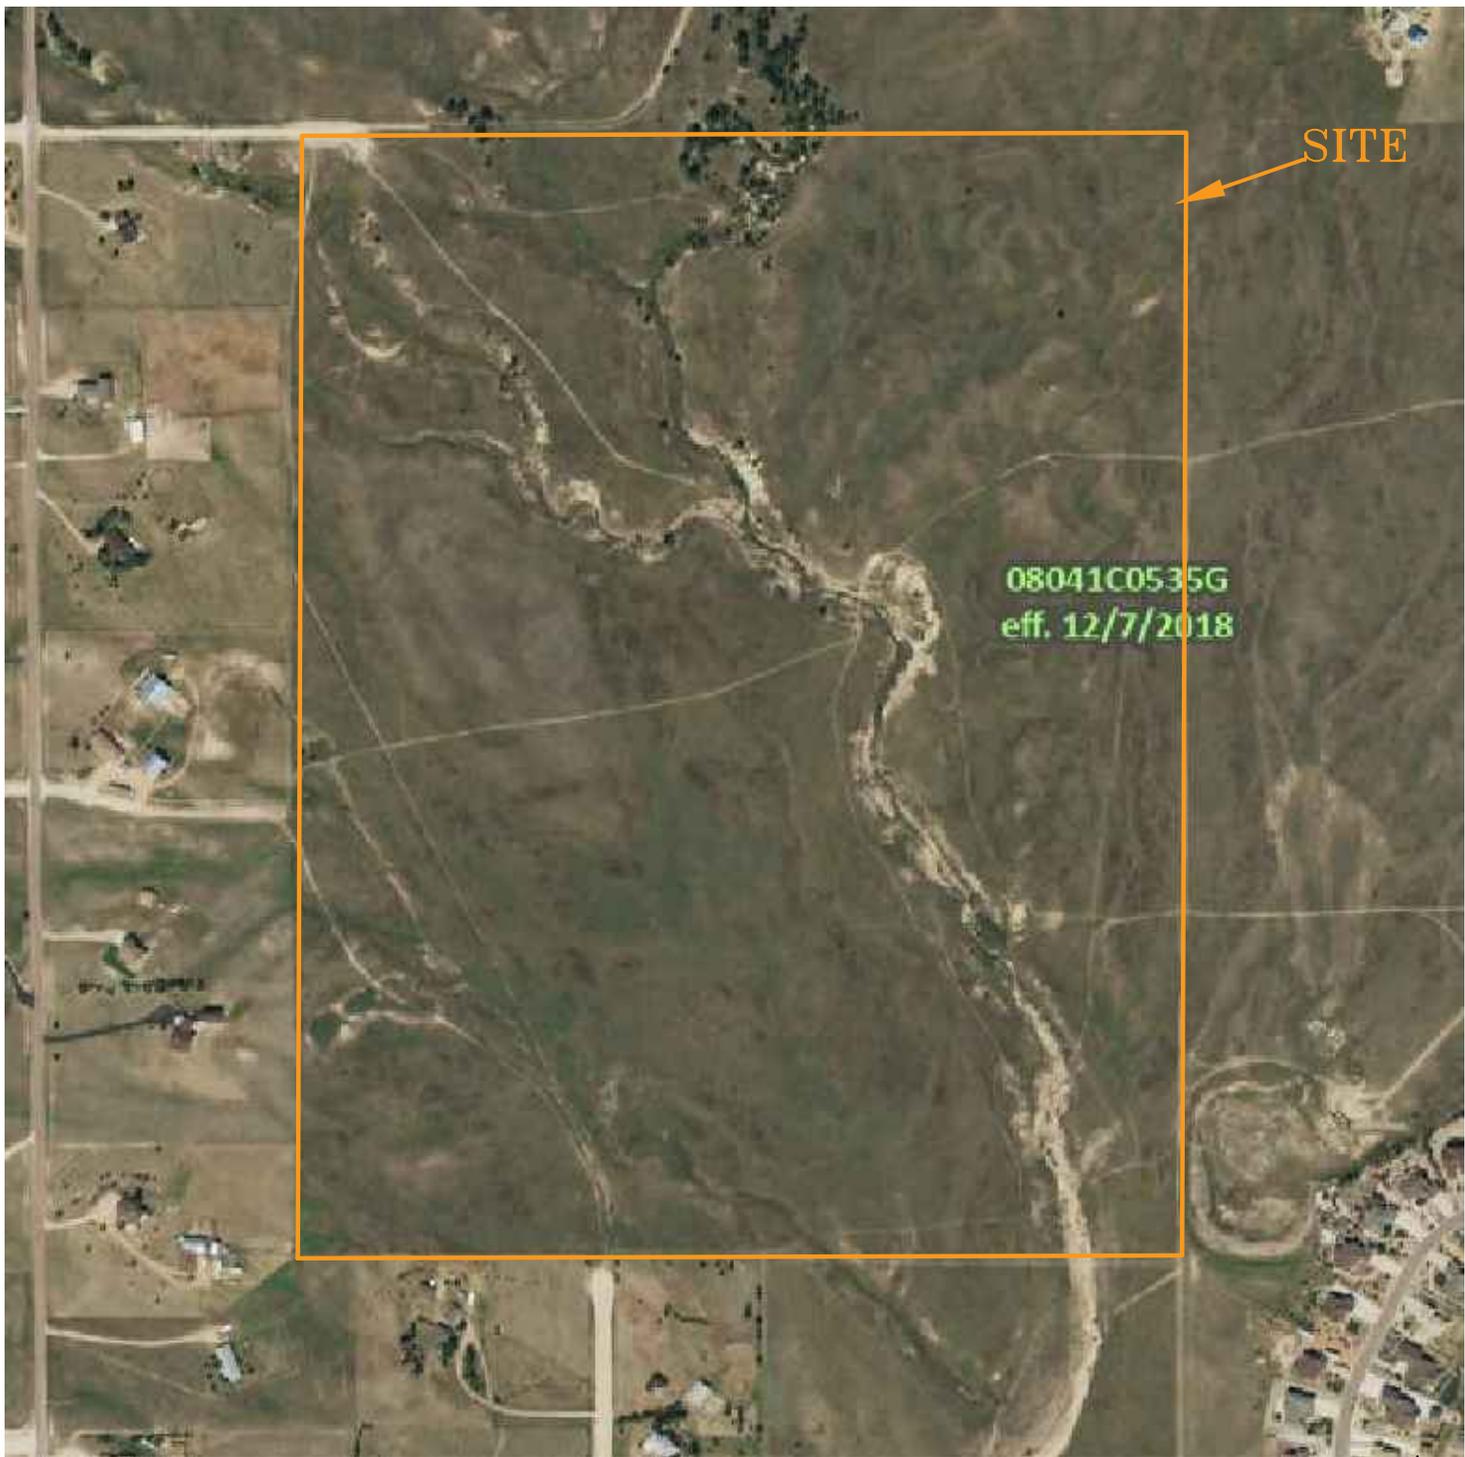
JOB NO.:  
212684  
FIG NO.:  
7

08041C0535G  
eff. 12/7/2018

The site is not mapped within a floodplain zone according to the FEMA Map No. 08041CO53G, dated December 7, 2018 (Figure 7, Reference 6). Some small areas of stagnant water were observed on this site. Additionally, areas of seasonal and potentially seasonal shallow groundwater were observed across the site. In these areas, we would anticipate the potential for periodically high subsurface moisture conditions and frost heave potential. These areas lie within low-lying areas along the drainage in the central portions of the subdivision and in the low-lying areas and minor drainages across the site. Water was not observed in any of the minor drainages at the time of our site investigation. These areas can likely be avoided or properly mitigated by development. Specific floodplain locations and drainage studies are beyond the scope of this report. Regrading can also mitigate some minor drainage swales on some of the lots. Structures should not block drainages. Any site grading should be done in such a manner as to not create areas of ponded water around structures or septic fields. Septic fields should not be located within 25 feet of drainage areas due to the potential for periodic high groundwater conditions.

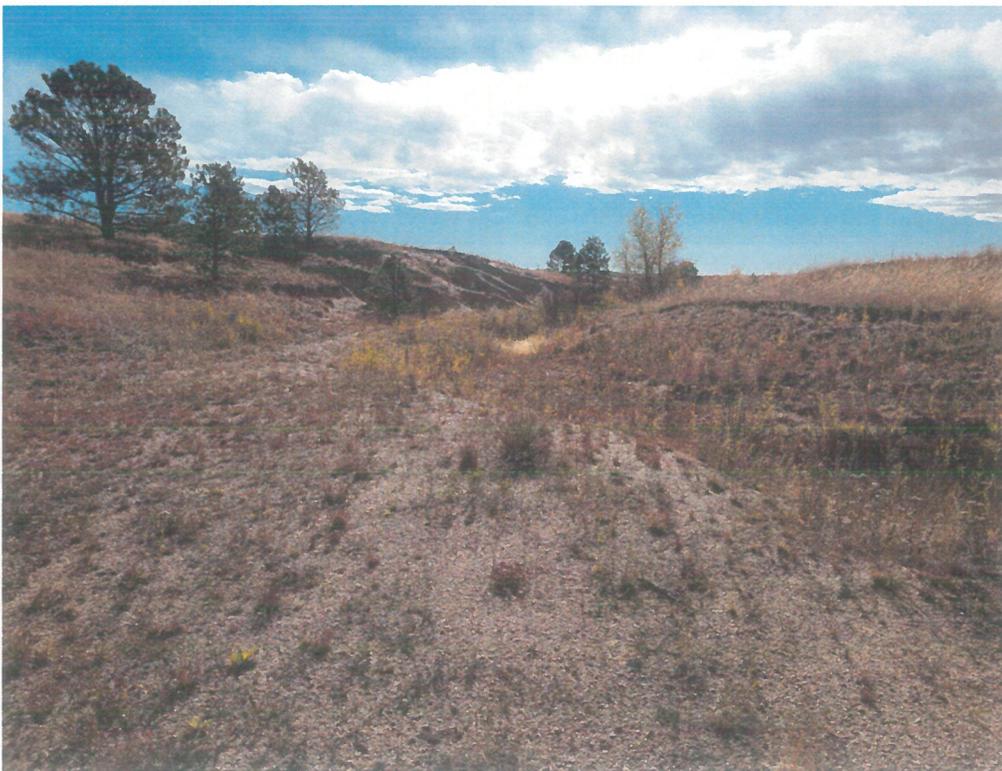
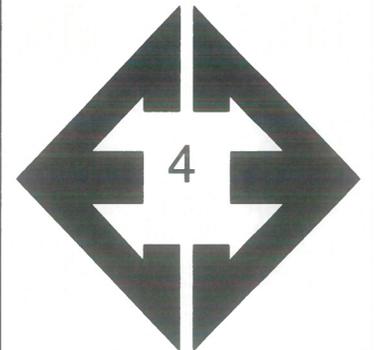
**Looking southeast  
along drainage with  
potentially unstable  
slopes.**

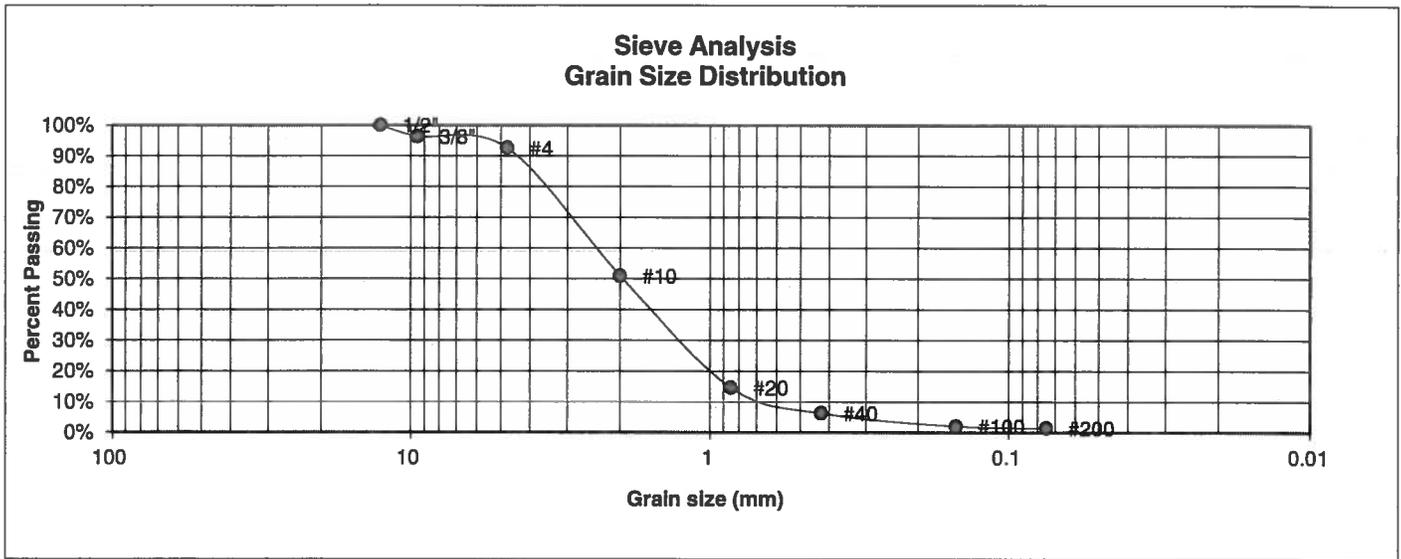
<b>UNIFIED CLASSIFICATION</b>	SW	<b>CLIENT</b>	PT EAGLEVIEW
<b>SOIL TYPE #</b>	1	<b>PROJECT</b>	ARROYA AND RAYGOR
<b>TEST BORING #</b>	TP-1	<b>JOB NO.</b>	212684
<b>DEPTH (FT)</b>	3	<b>TEST BY</b>	BL

U.S. Sieve #	Percent Finer
3"	
1 1/2"	
3/4"	
1/2"	100.0%
3/8"	96.3%
4	92.5%
10	51.0%
20	14.6%
40	6.3%
100	2.1%
200	1.4%

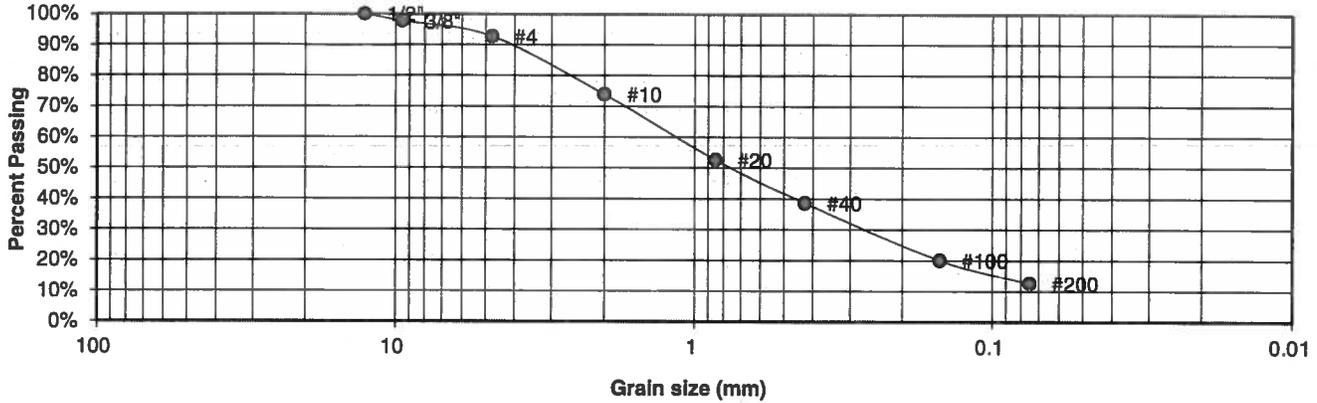
FIG NO.:  
C-2

<b>UNIFIED CLASSIFICATION</b>	SM	<b>CLIENT</b>	PT EAGLEVIEW
<b>SOIL TYPE #</b>	1	<b>PROJECT</b>	ARROYA AND RAYGOR
<b>TEST BORING #</b>	TP-2	<b>JOB NO.</b>	212684
<b>DEPTH (FT)</b>	1-2	<b>TEST BY</b>	BL

<u>U.S. Sieve #</u>	<u>Percent Finer</u>
3"	
1 1/2"	
3/4"	
1/2"	100.0%
3/8"	97.7%
4	92.7%
10	73.8%
20	52.6%
40	38.6%
100	20.0%
200	12.6%

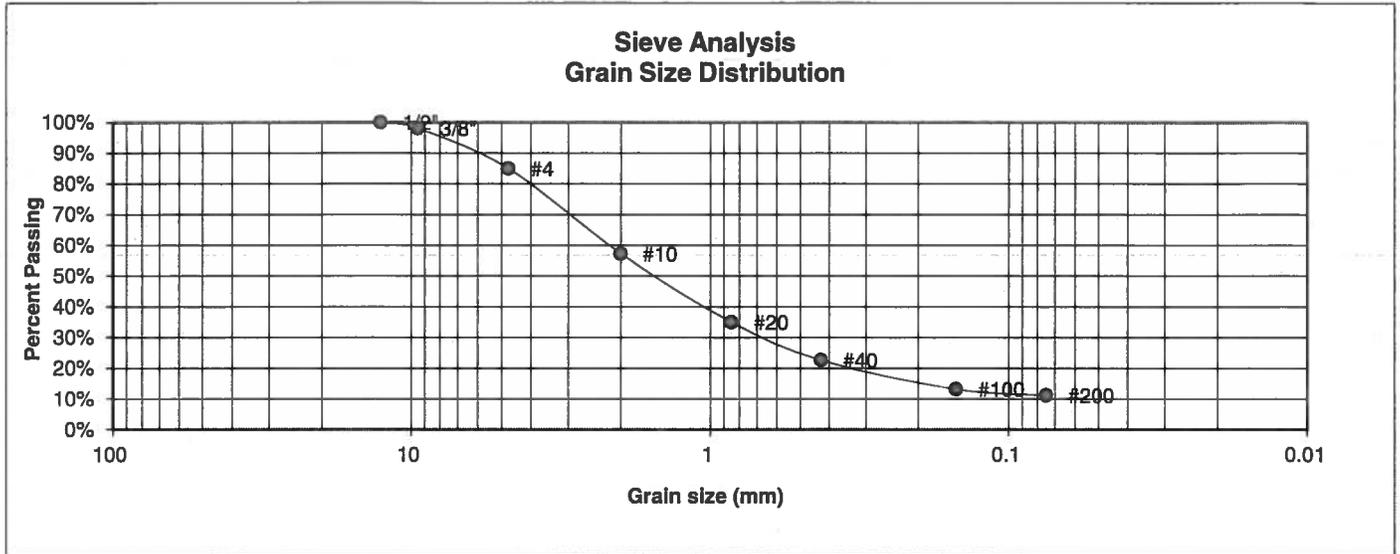
<b>UNIFIED CLASSIFICATION</b>	SM-SW	<b>CLIENT</b>	PT EAGLEVIEW
<b>SOIL TYPE #</b>	1	<b>PROJECT</b>	ARROYA AND RAYGOR
<b>TEST BORING #</b>	TP-4	<b>JOB NO.</b>	212684
<b>DEPTH (FT)</b>	3-4	<b>TEST BY</b>	BL

<u>U.S. Sieve #</u>	<u>Percent Finer</u>
3"	
1 1/2"	
3/4"	
1/2"	100.0%
3/8"	98.1%
4	85.0%
10	57.3%
20	35.0%
40	22.6%
100	13.2%
200	11.2%

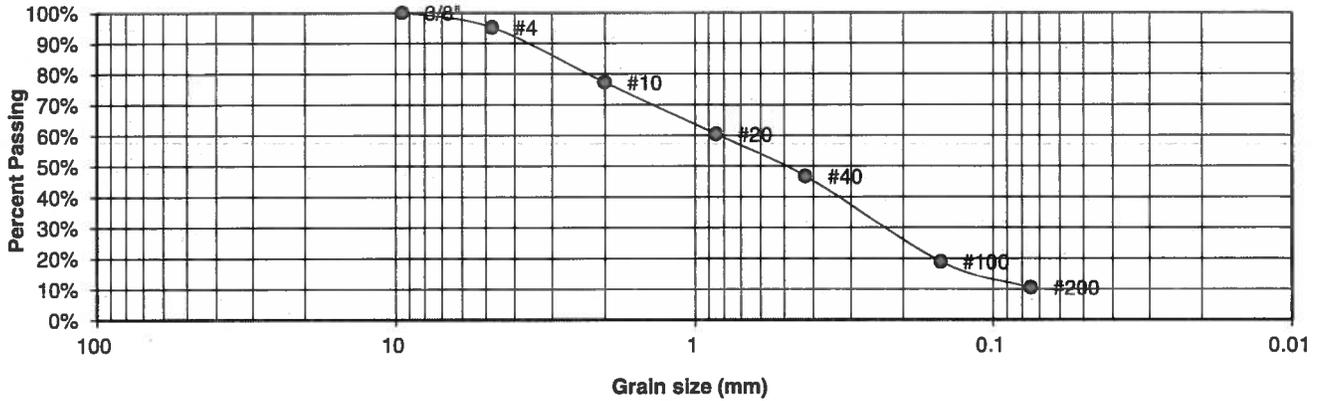
FIG NO.:  
*C-4*

<b>UNIFIED CLASSIFICATION</b>	SM-SW	<b>CLIENT</b>	PT EAGLEVIEW
<b>SOIL TYPE #</b>	1	<b>PROJECT</b>	ARROYA AND RAYGOR
<b>TEST BORING #</b>	TP-5	<b>JOB NO.</b>	212684
<b>DEPTH (FT)</b>	1-2	<b>TEST BY</b>	BL

<u>U.S. Sieve #</u>	<u>Percent Finer</u>
3"	
1 1/2"	
3/4"	
1/2"	
3/8"	100.0%
4	95.1%
10	77.2%
20	60.4%
40	46.7%
100	18.9%
200	10.5%

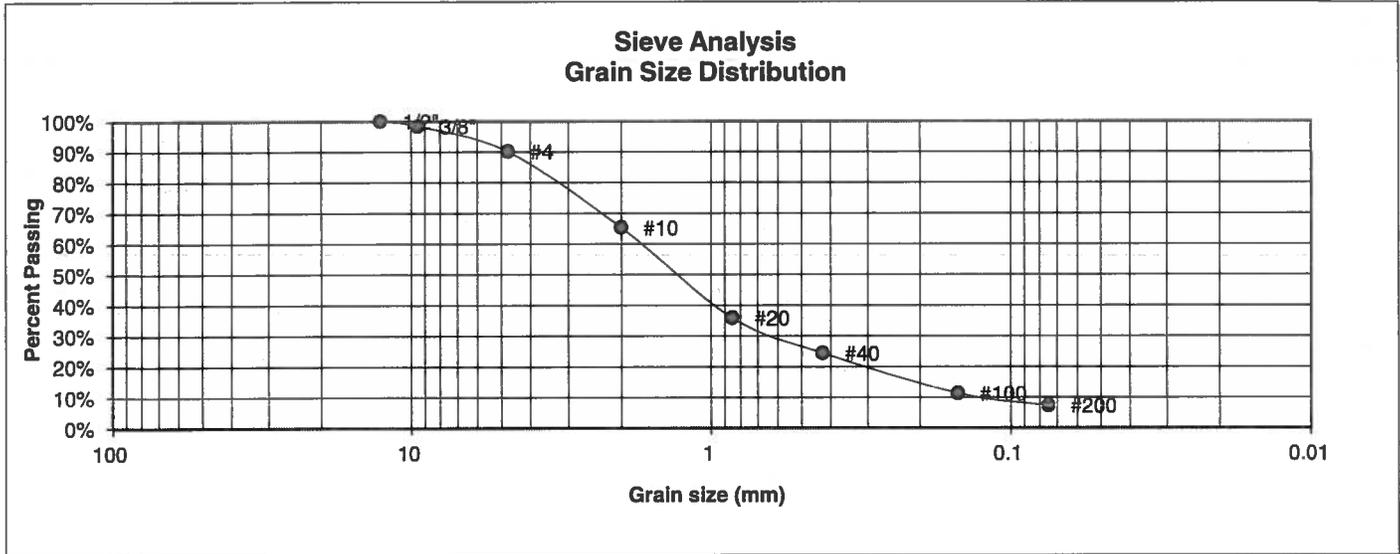
<b>UNIFIED CLASSIFICATION</b>	SM-SW	<b>CLIENT</b>	PT EAGLEVIEW
<b>SOIL TYPE #</b>	1	<b>PROJECT</b>	ARROYA AND RAYGOR
<b>TEST BORING #</b>	TP-5	<b>JOB NO.</b>	212684
<b>DEPTH (FT)</b>	3	<b>TEST BY</b>	BL

U.S. Sieve #	Percent Finer
3"	
1 1/2"	
3/4"	
1/2"	100.0%
3/8"	98.4%
4	90.1%
10	65.3%
20	35.9%
40	24.4%
100	11.3%
200	7.3%

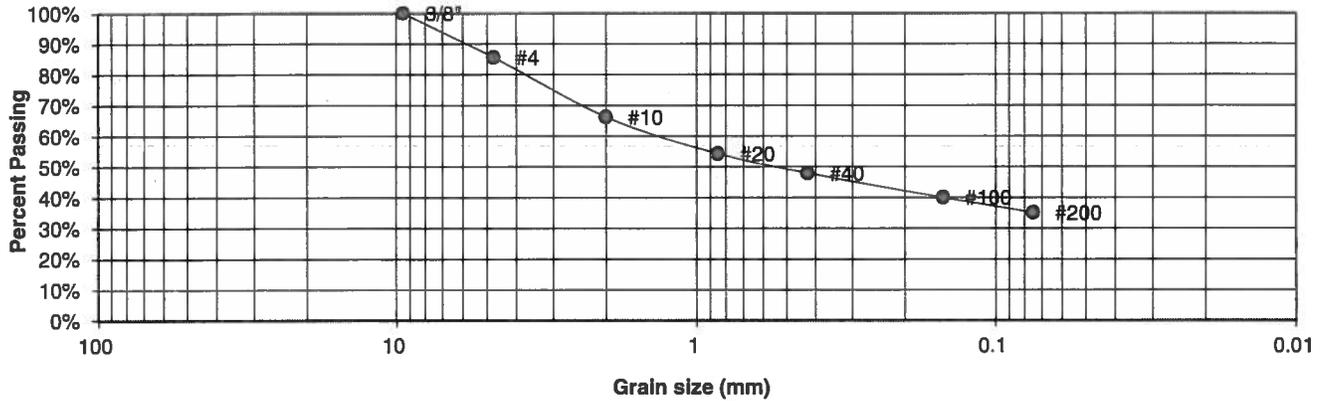
FIG NO.:  
*C-6*

UNIFIED CLASSIFICATION	SC	CLIENT	PT EAGLEVIEW
SOIL TYPE #	1	PROJECT	ARROYA AND RAYGOR
TEST BORING #	TP-6	JOB NO.	212684
DEPTH (FT)	1.5	TEST BY	BL

U.S. Sieve #	Percent Finer
3"	
1 1/2"	
3/4"	
1/2"	
3/8"	100.0%
4	85.6%
10	66.2%
20	54.3%
40	47.9%
100	40.0%
200	35.1%

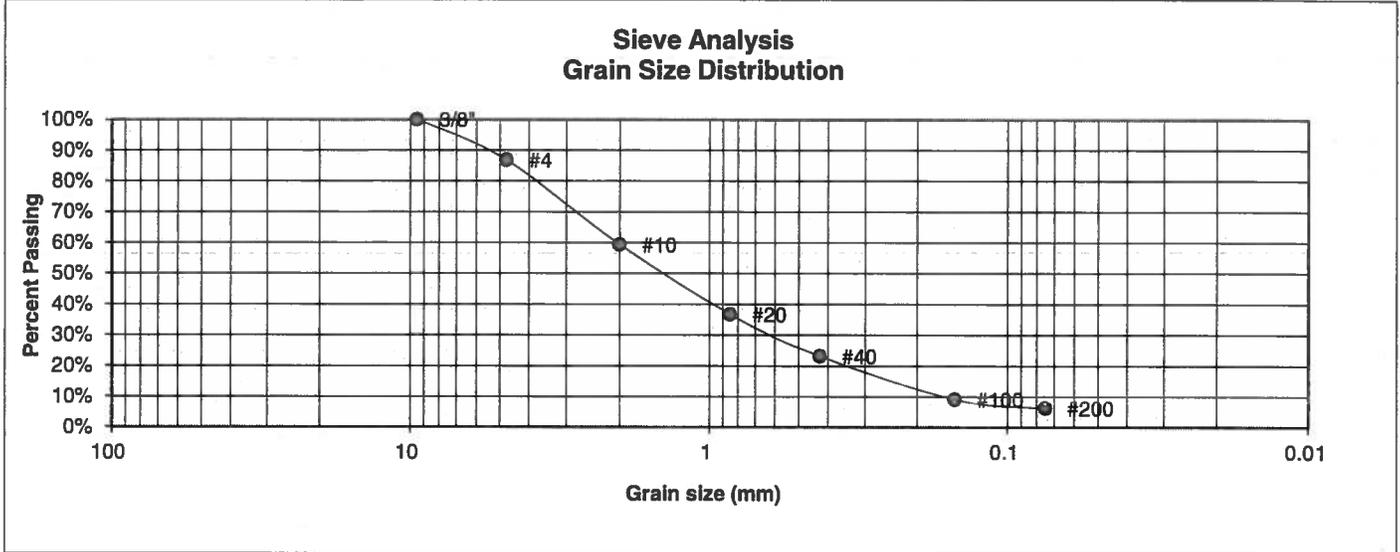
<b>UNIFIED CLASSIFICATION</b>	SM-SW	<b>CLIENT</b>	PT EAGLEVIEW
<b>SOIL TYPE #</b>	1	<b>PROJECT</b>	ARROYA AND RAYGOR
<b>TEST BORING #</b>	TP-6	<b>JOB NO.</b>	212684
<b>DEPTH (FT)</b>	2.5	<b>TEST BY</b>	BL

<u>U.S. Sieve #</u>	<u>Percent Finer</u>
3"	
1 1/2"	
3/4"	
1/2"	
3/8"	100.0%
4	86.8%
10	59.4%
20	36.7%
40	23.1%
100	9.1%
200	6.3%

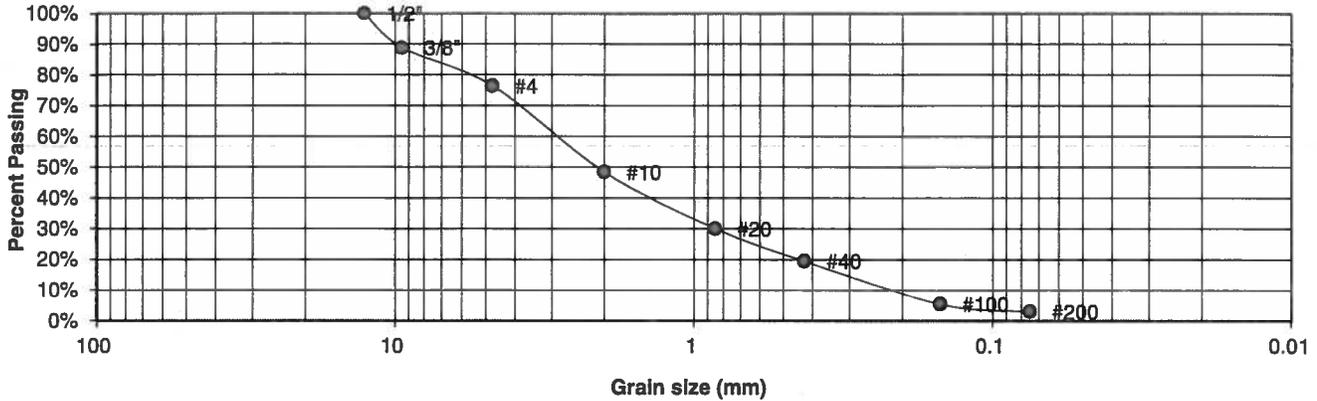
FIG NO.:  
C-8

UNIFIED CLASSIFICATION	SW	CLIENT	PT EAGLEVIEW
SOIL TYPE #	1	PROJECT	ARROYA AND RAYGOR
TEST BORING #	TP-7	JOB NO.	212684
DEPTH (FT)	2	TEST BY	BL

U.S. Sieve #	Percent Finer
3"	
1 1/2"	
3/4"	
1/2"	100.0%
3/8"	88.8%
4	76.4%
10	48.4%
20	30.0%
40	19.5%
100	5.6%
200	3.1%

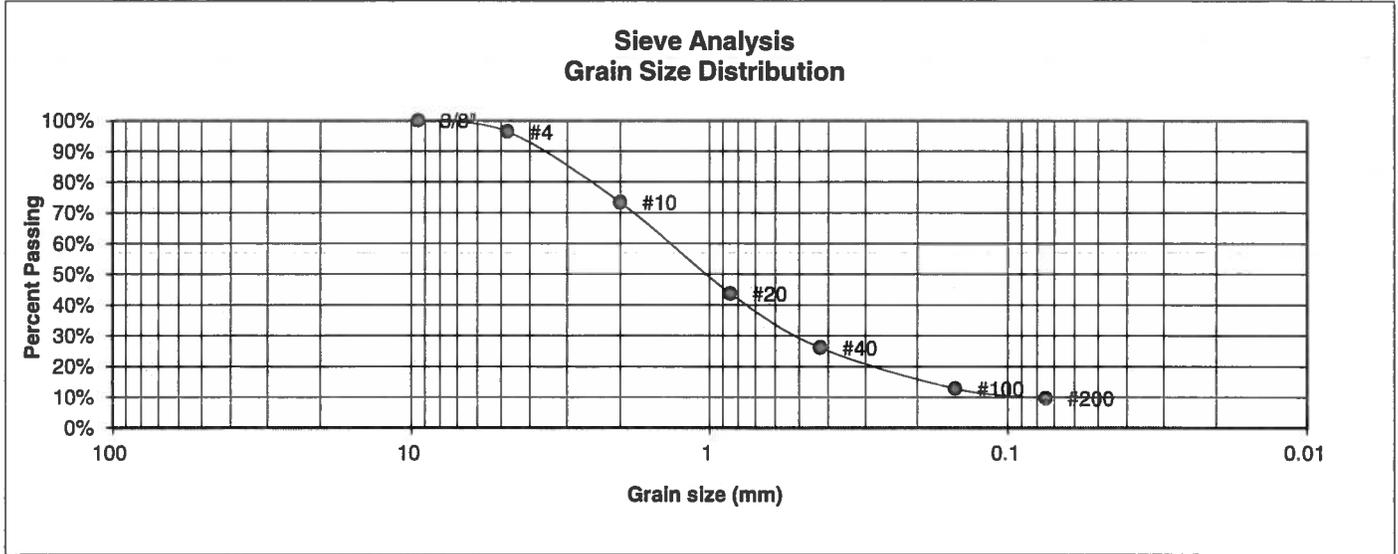
FIG NO.:  
C-9

<b>UNIFIED CLASSIFICATION</b>	SM-SW	<b>CLIENT</b>	PT EAGLEVIEW
<b>SOIL TYPE #</b>	1	<b>PROJECT</b>	ARROYA AND RAYGOR
<b>TEST BORING #</b>	TP-7	<b>JOB NO.</b>	212684
<b>DEPTH (FT)</b>	5	<b>TEST BY</b>	BL

<u>U.S. Sieve #</u>	<u>Percent Finer</u>
3"	
1 1/2"	
3/4"	
1/2"	
3/8"	100.0%
4	96.3%
10	73.3%
20	43.7%
40	26.1%
100	12.8%
200	9.6%

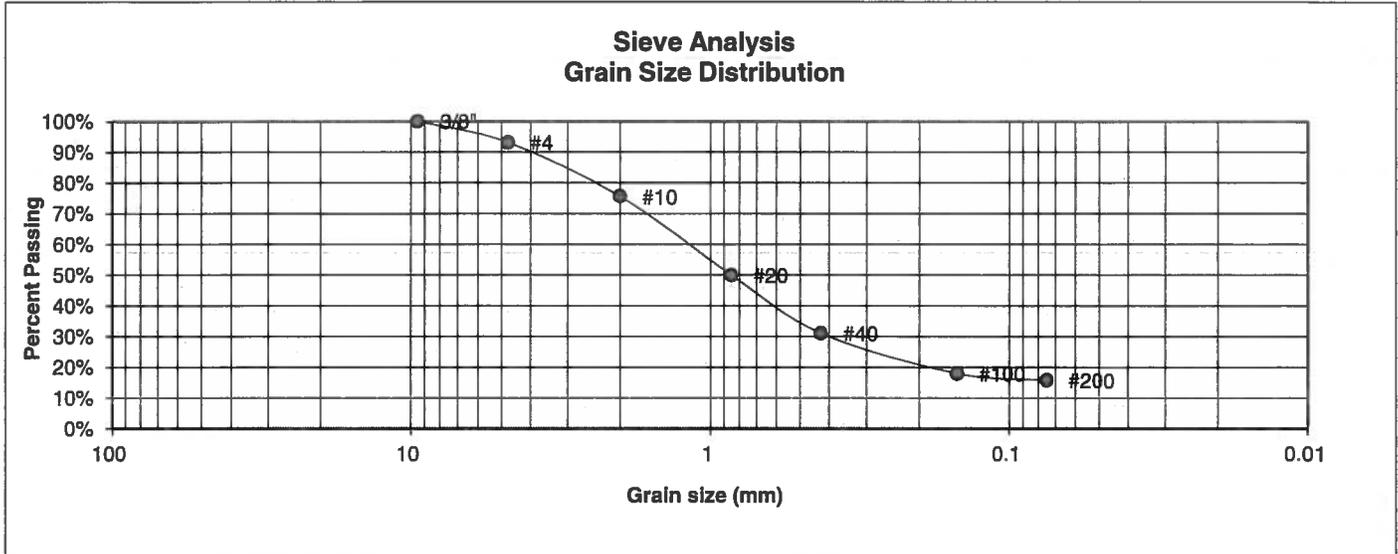
FIG NO.:  
*C-10*

<b>UNIFIED CLASSIFICATION</b>	SM	<b>CLIENT</b>	PT EAGLEVIEW
<b>SOIL TYPE #</b>	1	<b>PROJECT</b>	ARROYA AND RAYGOR
<b>TEST BORING #</b>	TP-8	<b>JOB NO.</b>	212684
<b>DEPTH (FT)</b>	4	<b>TEST BY</b>	BL

U.S. Sieve #	Percent Finer
3"	
1 1/2"	
3/4"	
1/2"	
3/8"	100.0%
4	93.1%
10	75.6%
20	49.9%
40	31.0%
100	18.0%
200	15.8%

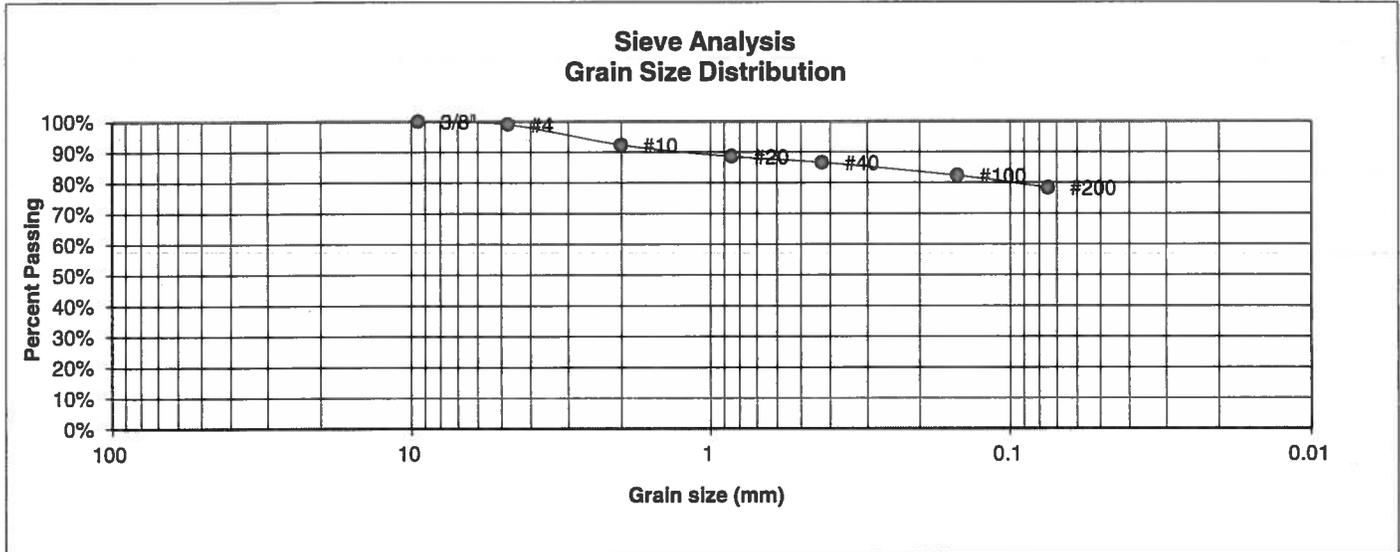
<b>UNIFIED CLASSIFICATION</b>	CL	<b>CLIENT</b>	PT EAGLEVIEW
<b>SOIL TYPE #</b>	2	<b>PROJECT</b>	ARROYA AND RAYGOR
<b>TEST BORING #</b>	TP-3	<b>JOB NO.</b>	212684
<b>DEPTH (FT)</b>	2-3	<b>TEST BY</b>	BL

U.S. Sieve #	Percent Finer
3"	
1 1/2"	
3/4"	
1/2"	
3/8"	100.0%
4	99.0%
10	92.3%
20	88.6%
40	86.5%
100	82.3%
200	78.3%

- Atterberg Limits**  
 Plastic Limit  
 Liquid Limit  
 Plastic Index
- Swell**  
 Moisture at start  
 Moisture at finish  
 Moisture increase  
 Initial dry density (pcf)  
 Swell (psf)

Soil Type 2: is a sandy to silty clay soil (CL), encountered in the upper soil profile in Test Boring No. 2 and Profile Hole Nos. 2 and 4. The clays were encountered at soft to stiff consistencies and moist conditions. A swell pressure of 2060 psf was measured in the FHA Swell Test. This swell is in the high expansion range.

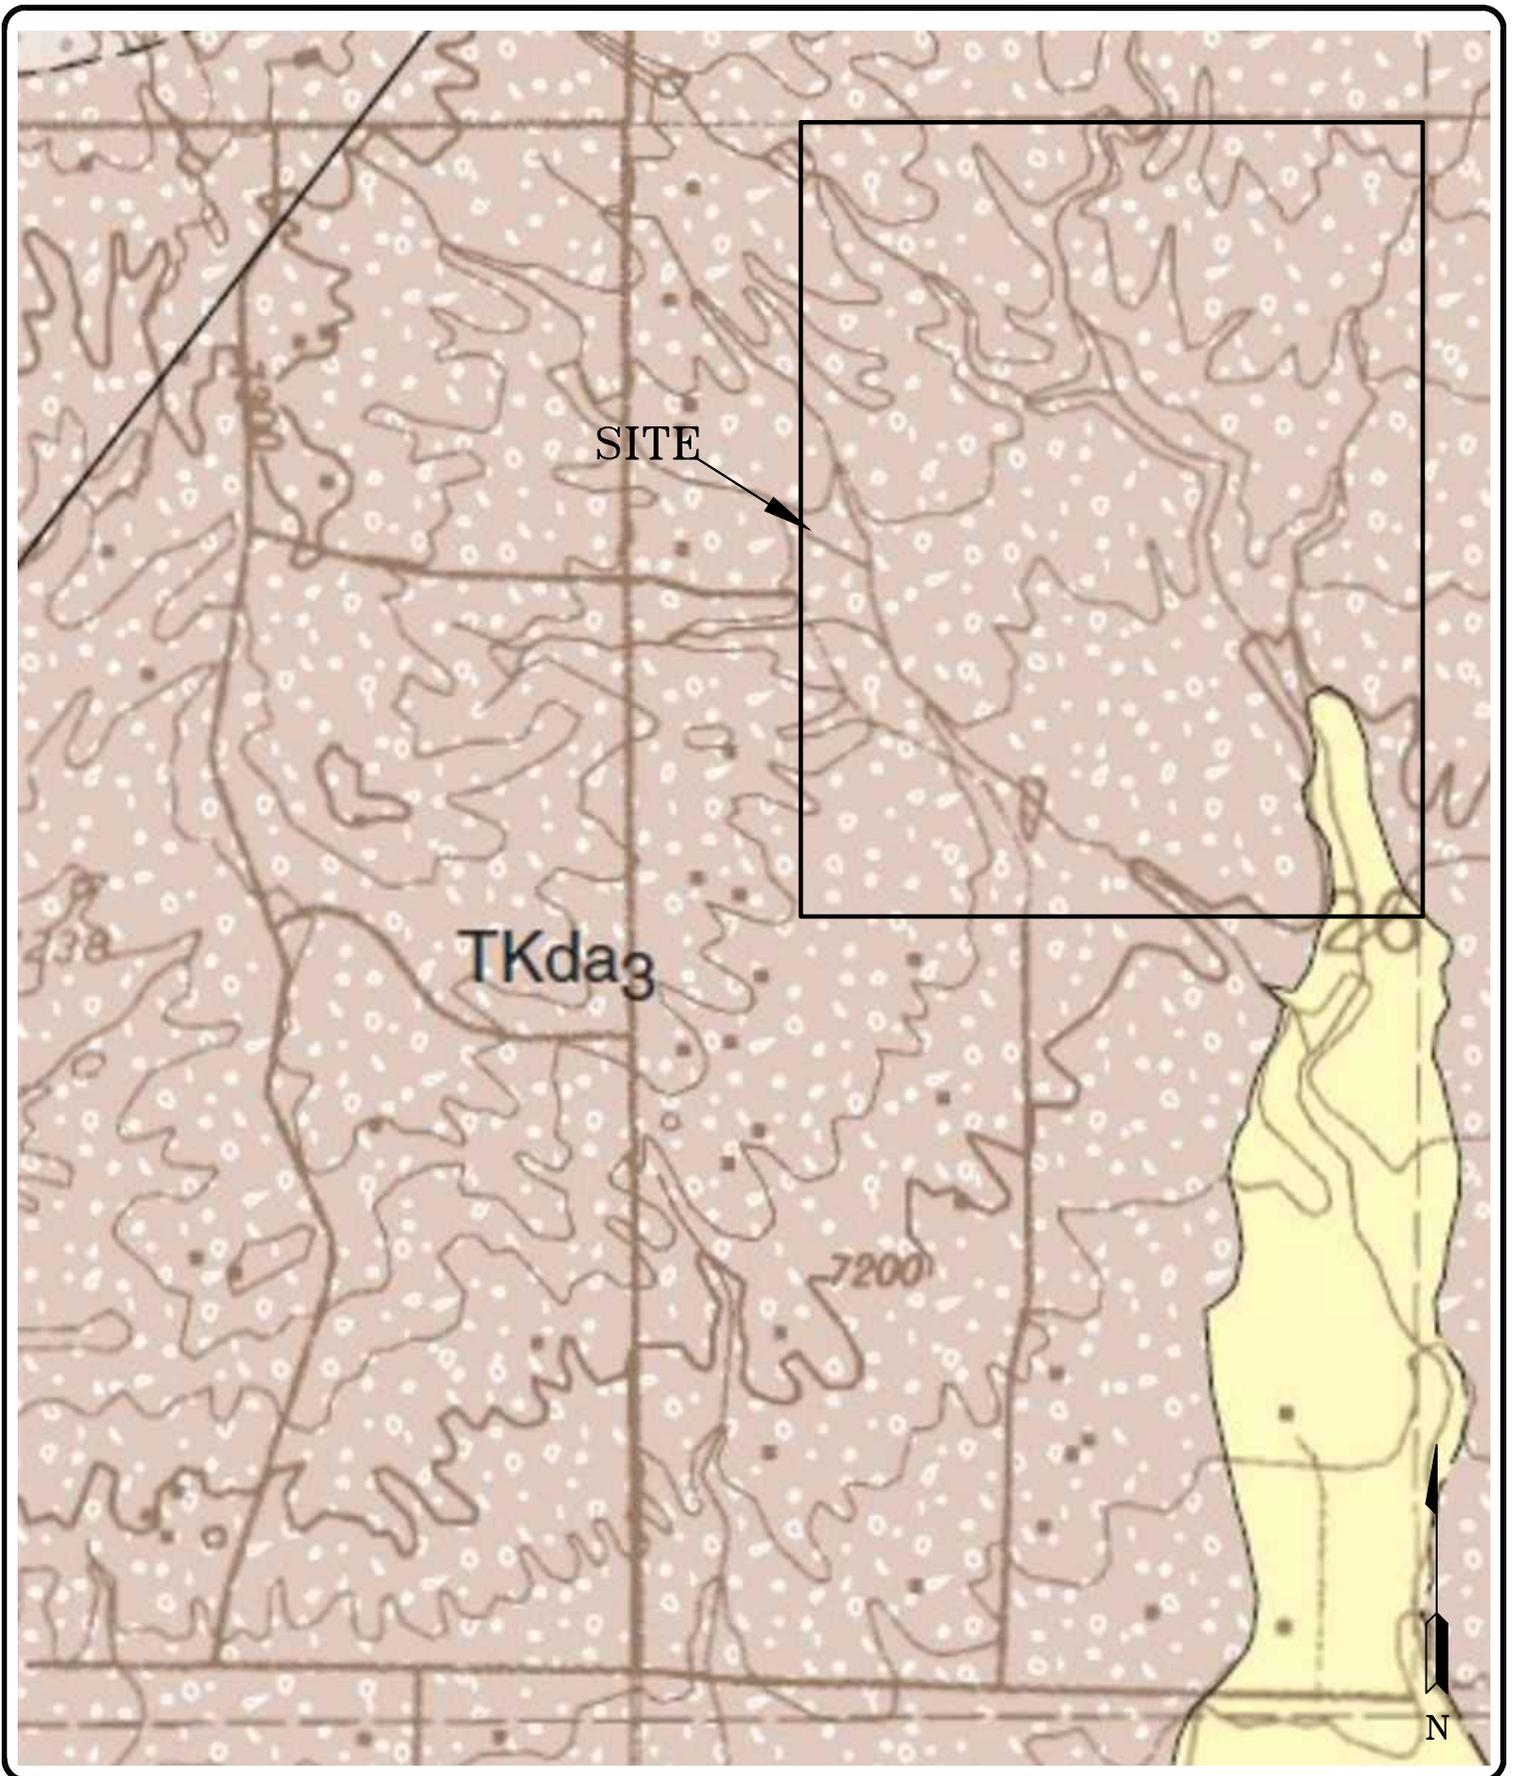
FIG NO.:  
**4**

NW FALCON QUADRANGLE GEOLOGIC MAP  
EAGLEVIEW SUBDIVISION  
ARROYA LANE & RAYGOR ROAD  
EL PASO COUNTY, CO.  
FOR: PT EAGLEVIEW, LLC

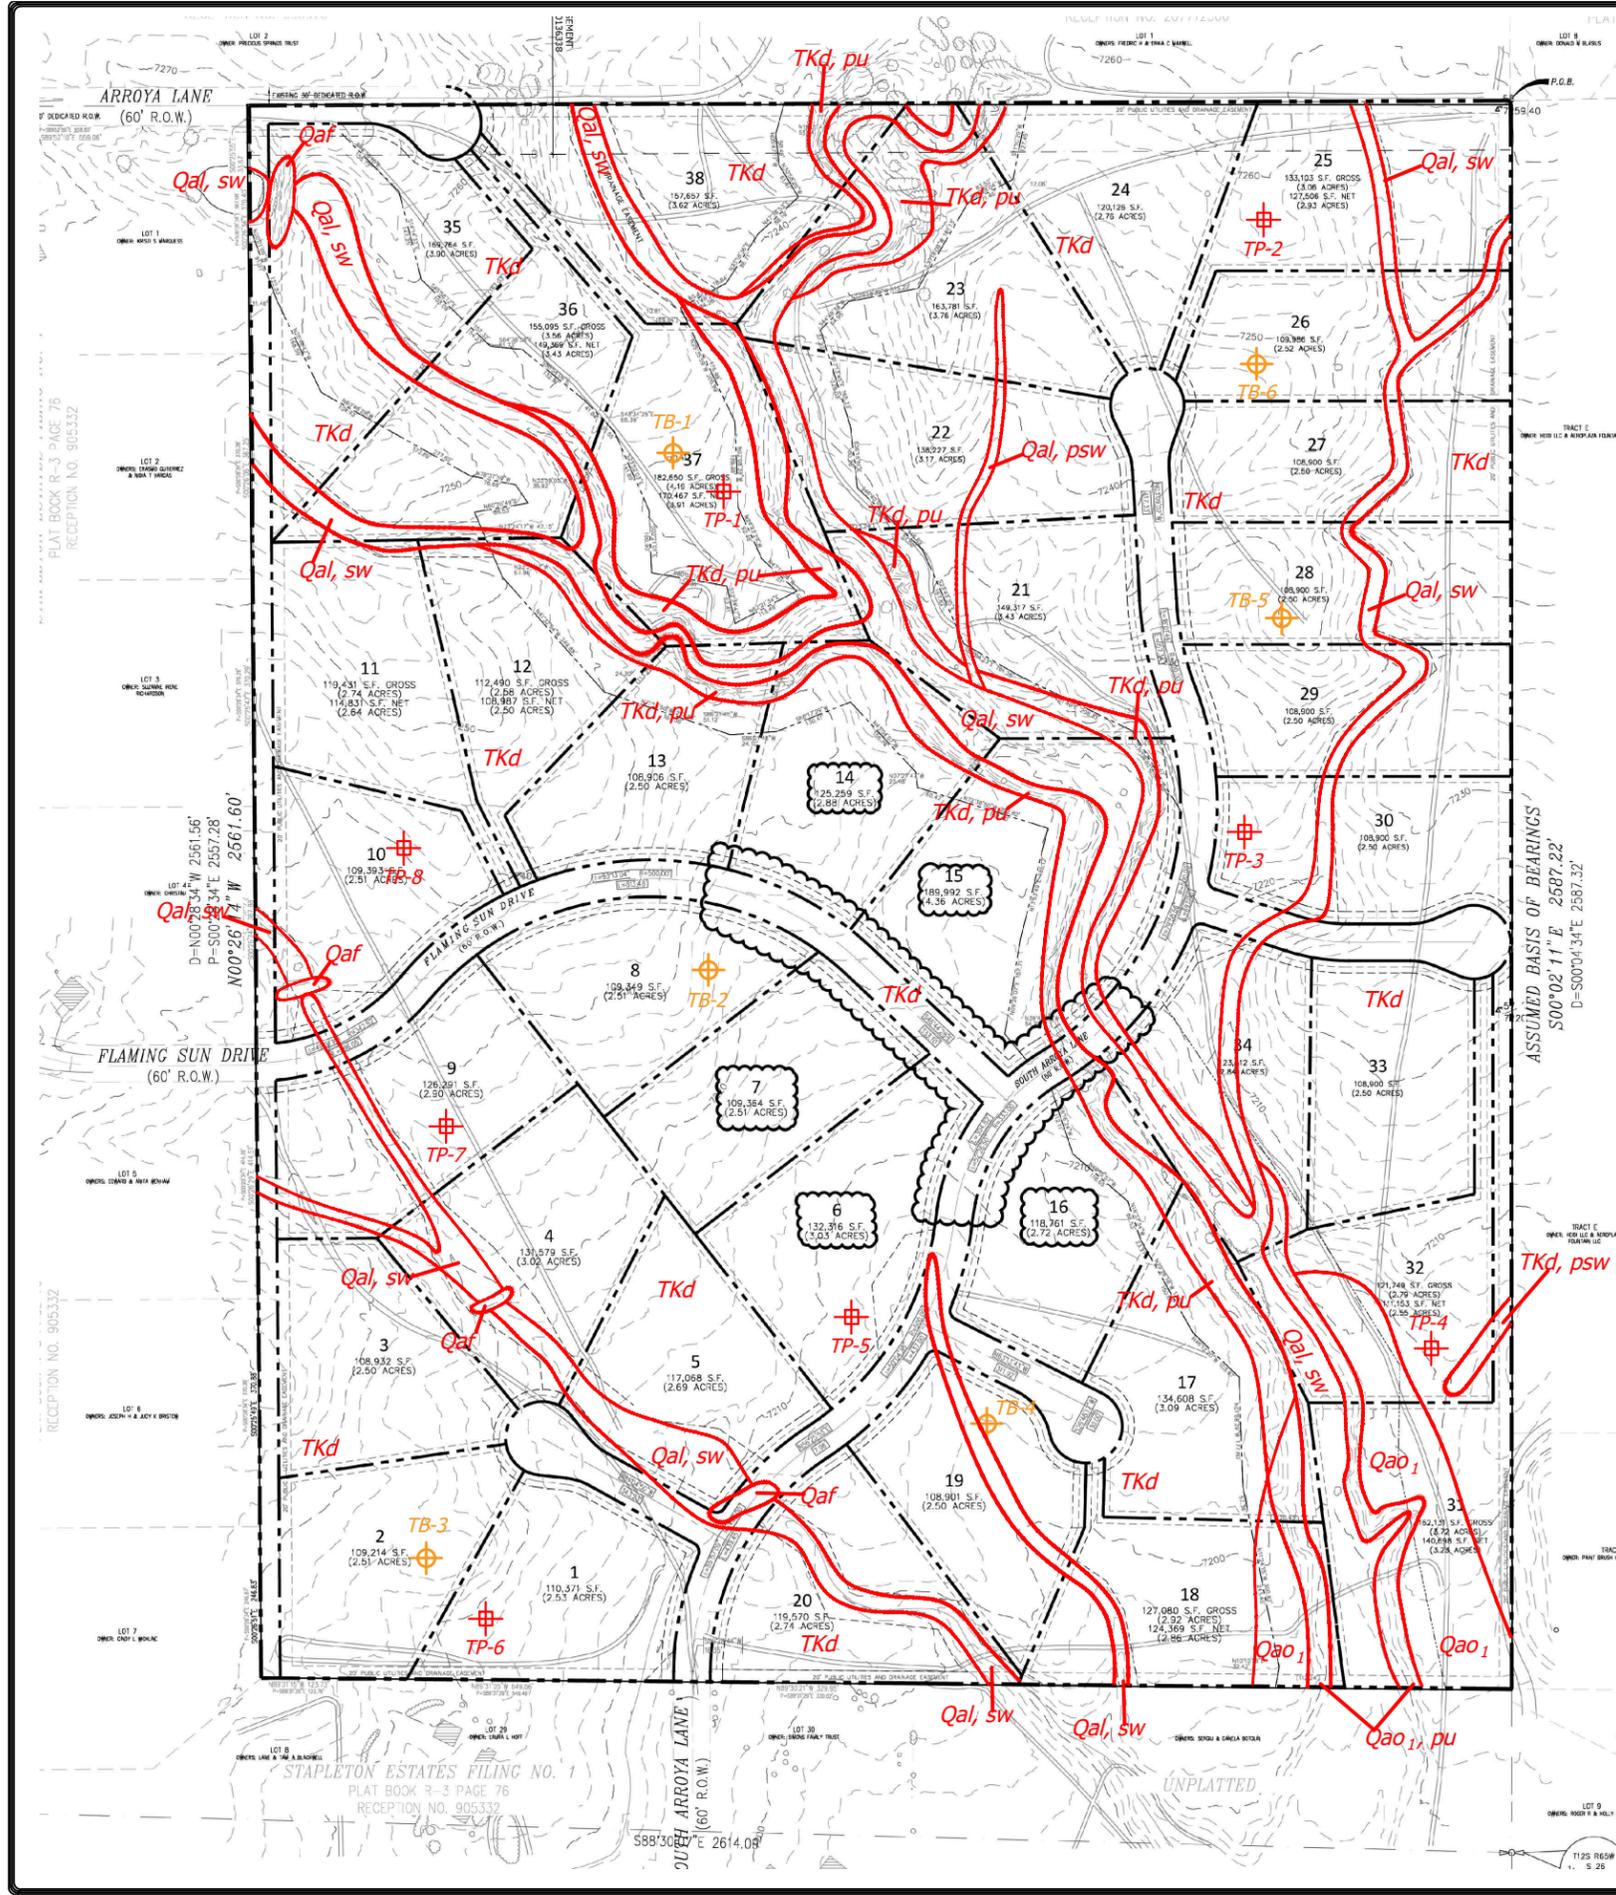
FIG NO.:  
5

- LEGEND:**
- Qaf - Artificial Fill of Holocene Age:  
man-made fill deposits associated with erosion berms
  - Qal - Alluvial Deposits of Holocene Age:  
recent water deposited sediment along minor drainage
  - Qao<sub>1</sub> - Old Alluvium one of late-middle Pleistocene Age:  
recent water deposited sediment along minor drainage
  - TKd - Dawson Formation of Tertiary to Cretaceous Age:  
arkosic sandstone with interbedded fine-grained sandstone, siltstone and claystone
  - fp - floodplain
  - psw - potentially seasonal shallow groundwater area
  - sw - seasonal shallow groundwater area
  - w - flowing water
  - pu - potentially unstable slope
  - ⊕ - approximate test boring location (Entech Job No. 80503)
  - ⊕ - approximate test pit location

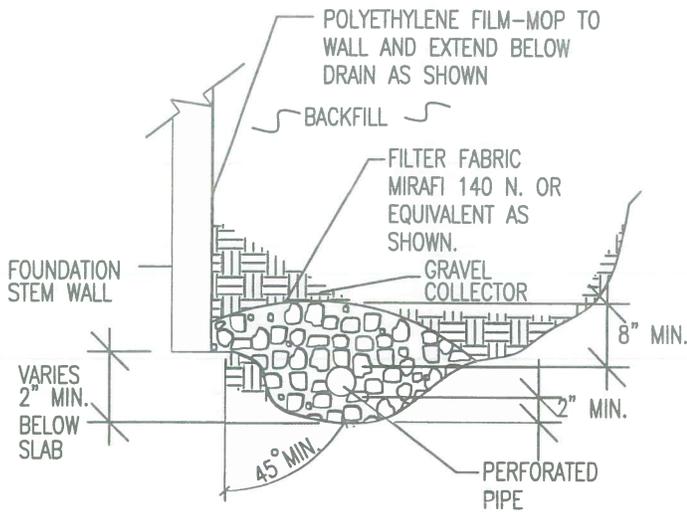
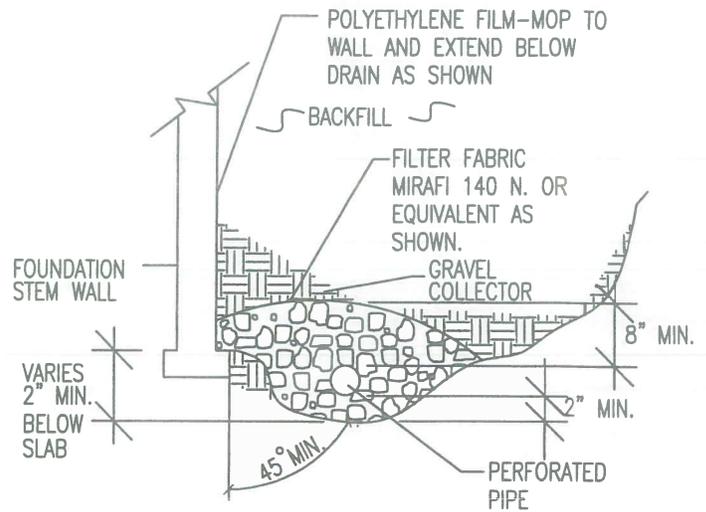
JOB NO.:  
212684  
FIG NO.:  
7

-GRAVEL SIZE IS RELATED TO DIAMETER OF PIPE PERFORATIONS-85% GRAVEL GREATER THAN 2x PERFORATION DIAMETER.
