***WASTEWATER DISPOSAL REPORT***

***EAGLEVIEW SUBDIVISION***

***EPC Parcel #: 522600001 AND 522600002***

**December 2021**

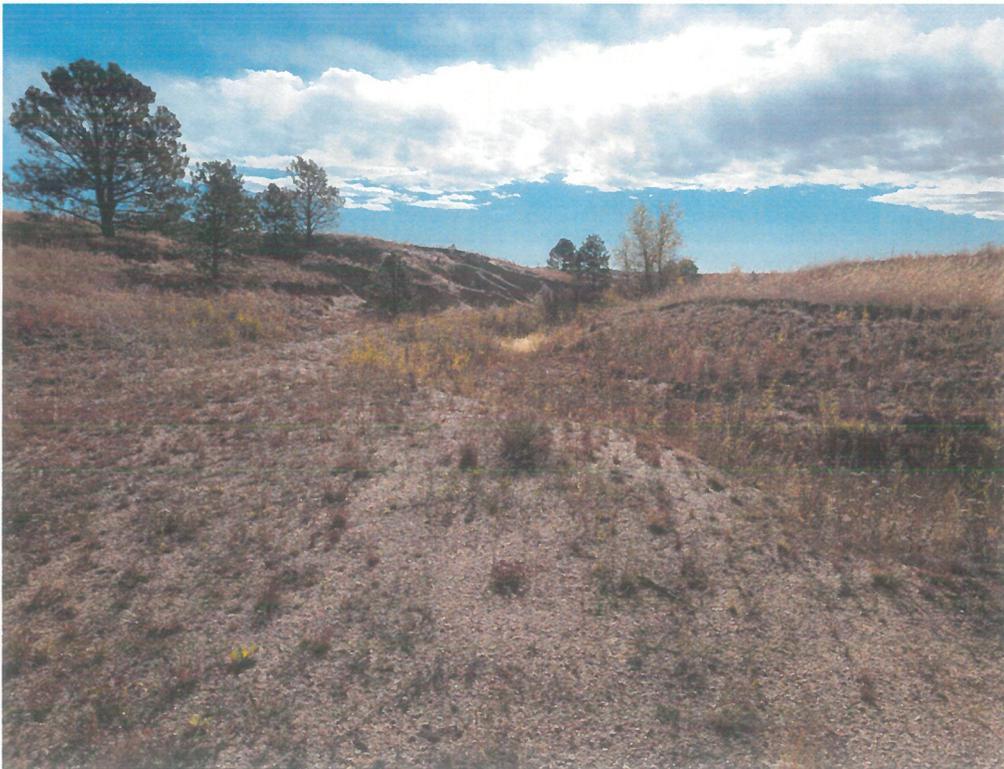
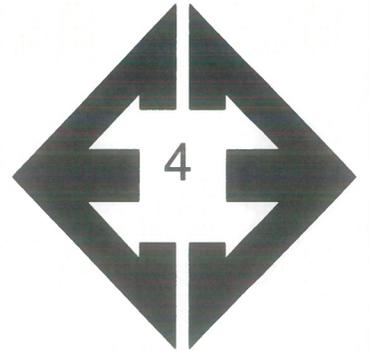
**Looking southeast  
along drainage with  
potentially unstable  
slopes.**

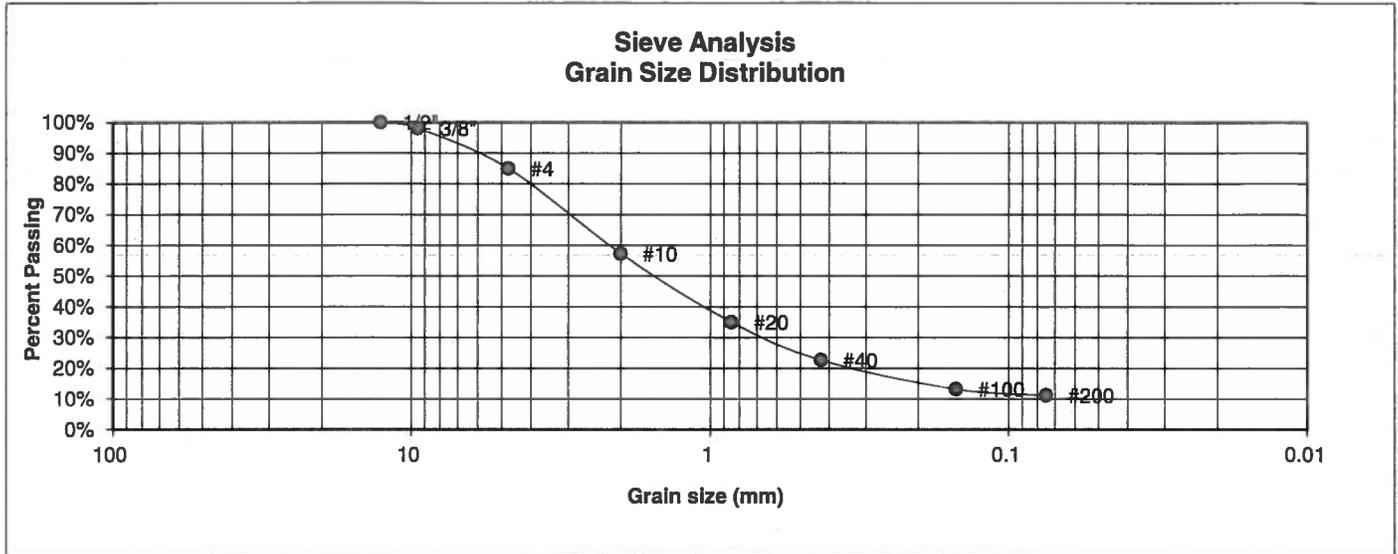
FIG NO.:  
*C-2*

<b>UNIFIED CLASSIFICATION</b>	SM-SW	<b>CLIENT</b>	PT EAGLEVIEW
<b>SOIL TYPE #</b>	1	<b>PROJECT</b>	ARROYA AND RAYGOR
<b>TEST BORING #</b>	TP-4	<b>JOB NO.</b>	212684
<b>DEPTH (FT)</b>	3-4	<b>TEST BY</b>	BL

U.S. Sieve #	Percent Finer
3"	
1 1/2"	
3/4"	
1/2"	100.0%
3/8"	98.1%
4	85.0%
10	57.3%
20	35.0%
40	22.6%
100	13.2%
200	11.2%

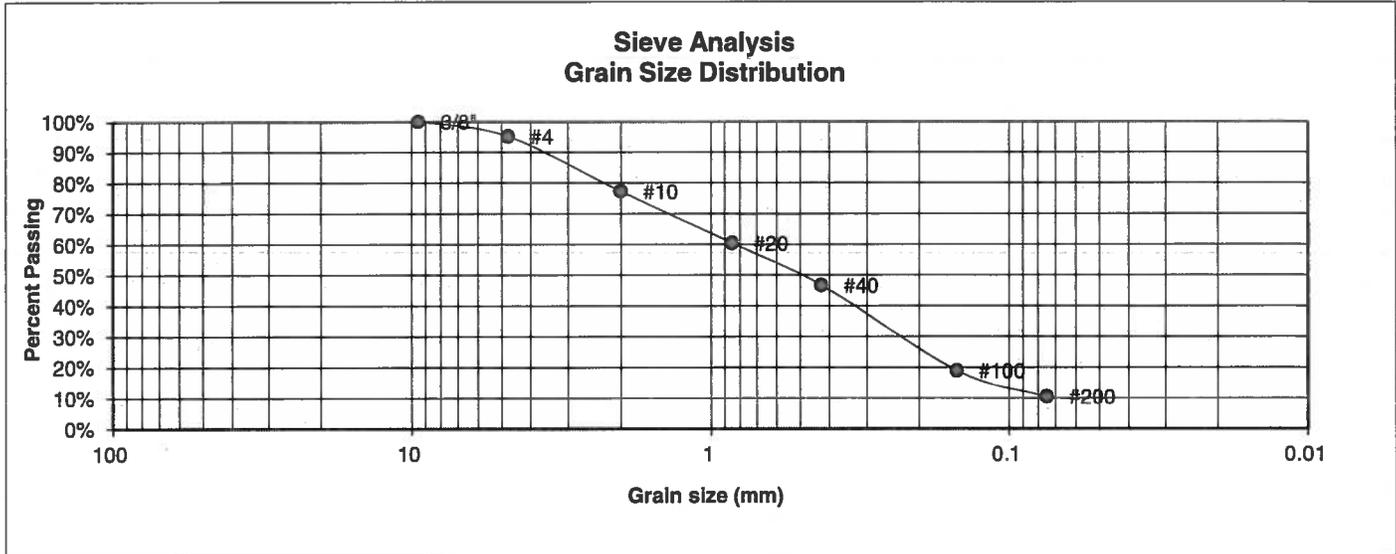
FIG NO.:  
C-3

<b>UNIFIED CLASSIFICATION</b>	SM-SW	<b>CLIENT</b>	PT EAGLEVIEW
<b>SOIL TYPE #</b>	1	<b>PROJECT</b>	ARROYA AND RAYGOR
<b>TEST BORING #</b>	TP-5	<b>JOB NO.</b>	212684
<b>DEPTH (FT)</b>	1-2	<b>TEST BY</b>	BL

<u>U.S. Sieve #</u>	<u>Percent Finer</u>
3"	
1 1/2"	
3/4"	
1/2"	
3/8"	100.0%
4	95.1%
10	77.2%
20	60.4%
40	46.7%
100	18.9%
200	10.5%

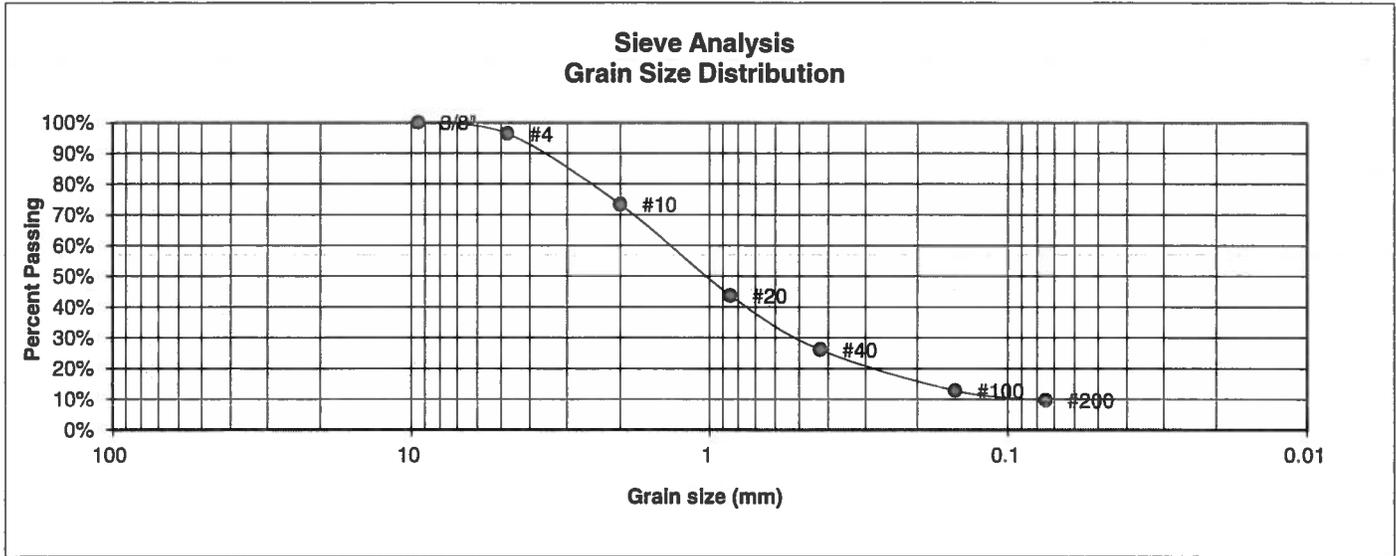
FIG NO.:  
C-8

UNIFIED CLASSIFICATION	SM-SW	CLIENT	PT EAGLEVIEW
SOIL TYPE #	1	PROJECT	ARROYA AND RAYGOR
TEST BORING #	TP-7	JOB NO.	212684
DEPTH (FT)	5	TEST BY	BL

U.S. Sieve #	Percent Finer
3"	
1 1/2"	
3/4"	
1/2"	
3/8"	100.0%
4	96.3%
10	73.3%
20	43.7%
40	26.1%
100	12.8%
200	9.6%

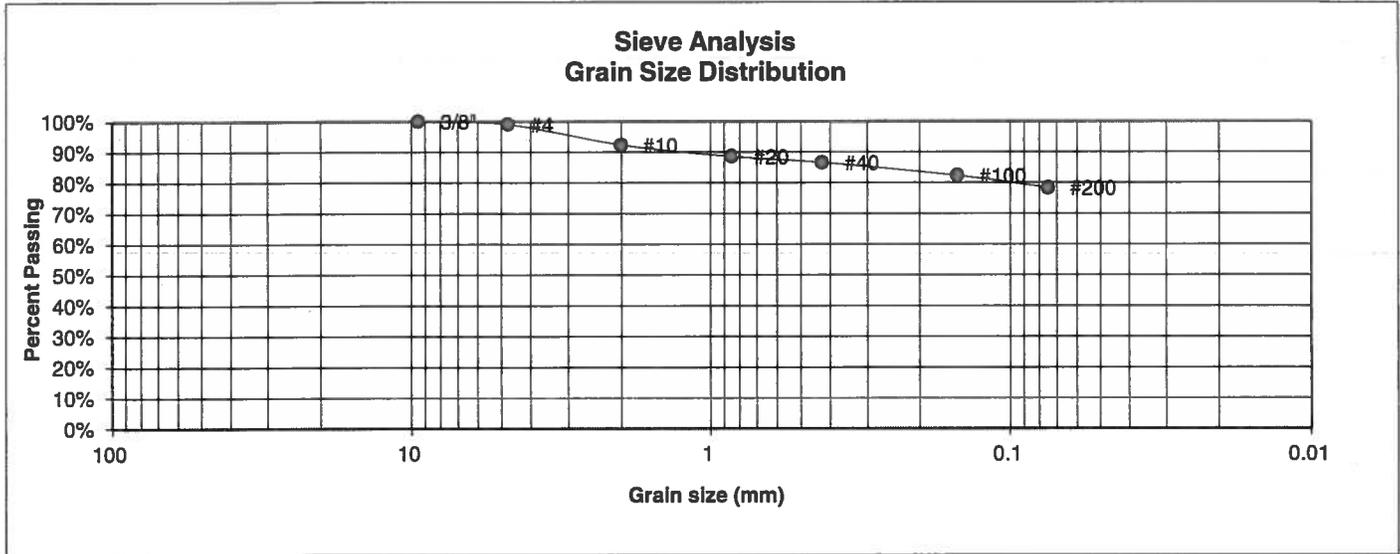
*C-10*

<b>UNIFIED CLASSIFICATION</b>	CL	<b>CLIENT</b>	PT EAGLEVIEW
<b>SOIL TYPE #</b>	2	<b>PROJECT</b>	ARROYA AND RAYGOR
<b>TEST BORING #</b>	TP-3	<b>JOB NO.</b>	212684
<b>DEPTH (FT)</b>	2-3	<b>TEST BY</b>	BL

U.S. Sieve #	Percent Finer
3"	
1 1/2"	
3/4"	
1/2"	
3/8"	100.0%
4	99.0%
10	92.3%
20	88.6%
40	86.5%
100	82.3%
200	78.3%

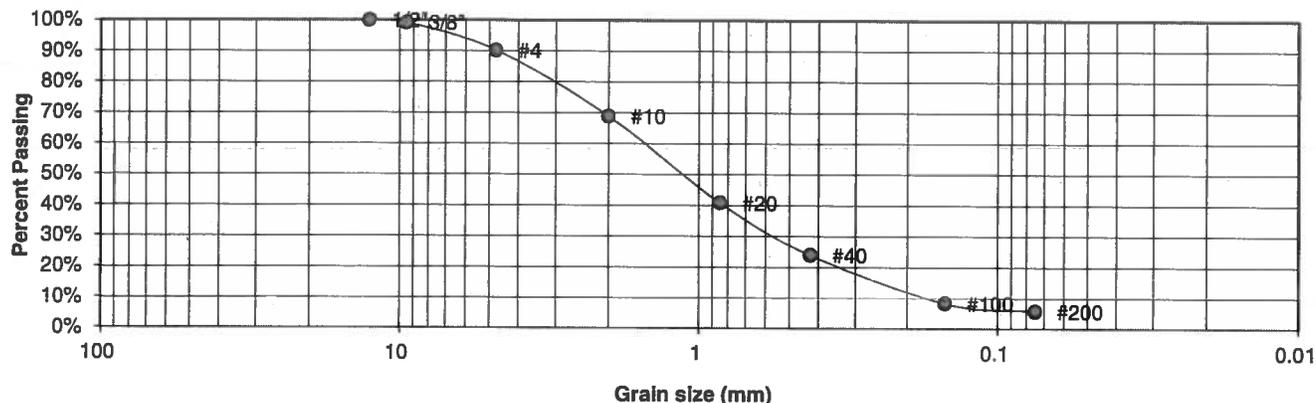
<b>UNIFIED CLASSIFICATION</b>	SM-SW	<b>CLIENT</b>	PROLAND GROUP, LLC
<b>SOIL TYPE #</b>	1	<b>PROJECT</b>	ARROYA AND RAYGOR
<b>TEST BORING #</b>	PH-5	<b>JOB NO.</b>	80503
<b>DEPTH (FT)</b>	5	<b>TEST BY</b>	BL

U.S. Sieve #	Percent Finer
3"	
1 1/2"	
3/4"	
1/2"	100.0%
3/8"	99.2%
4	90.2%
10	68.9%
20	40.8%
40	23.9%
100	8.4%
200	5.8%

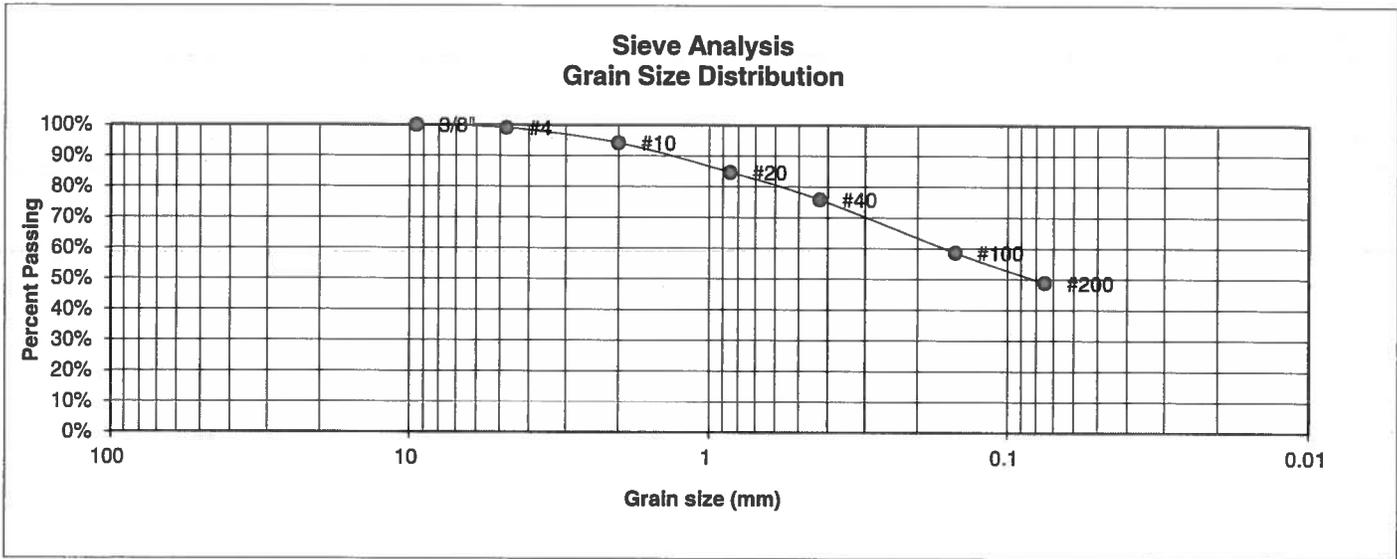
FIG NO.:  
D-4

<b>UNIFIED CLASSIFICATION</b>	SC	<b>CLIENT</b>	PROLAND GROUP, LLC
<b>SOIL TYPE #</b>	1	<b>PROJECT</b>	ARROYA AND RAYGOR
<b>TEST BORING #</b>	PH-7	<b>JOB NO.</b>	80503
<b>DEPTH (FT)</b>	2-5	<b>TEST BY</b>	BL

U.S. Sieve #	Percent Finer
3"	
1 1/2"	
3/4"	
1/2"	
3/8"	100.0%
4	99.1%
10	94.2%
20	84.7%
40	75.8%
100	58.6%
200	48.8%

Atterberg Limits	
Plastic Limit	19
Liquid Limit	41
Plastic Index	22

Swell	
Moisture at start	12.5%
Moisture at finish	20.8%
Moisture increase	8.3%
Initial dry density (pcf)	105
Swell (psf)	2230

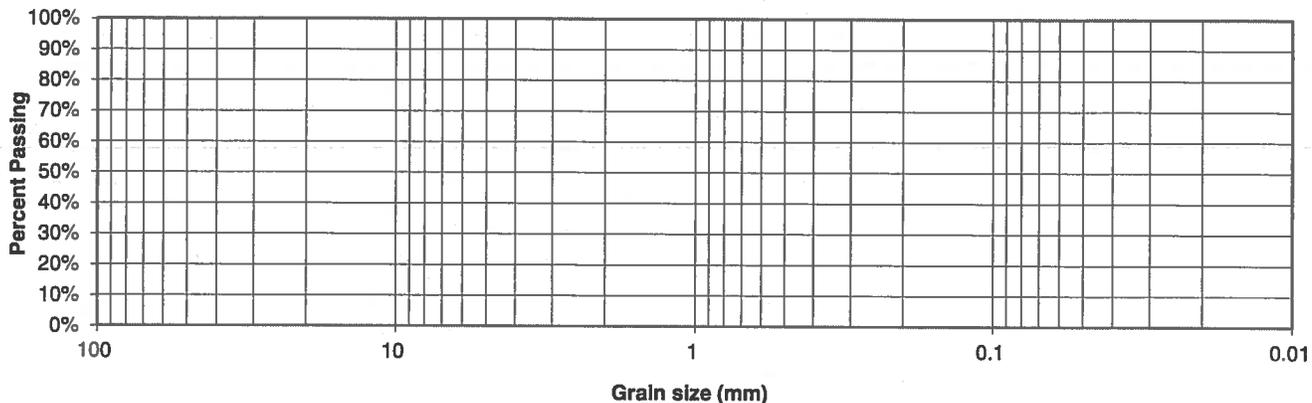
<b>UNIFIED CLASSIFICATION</b>	SC	<b>CLIENT</b>	PROLAND GROUP, LLC
<b>SOIL TYPE #</b>	1	<b>PROJECT</b>	ARROYA AND RAYGOR
<b>TEST BORING #</b>	4	<b>JOB NO.</b>	80503
<b>DEPTH (FT)</b>	2-5	<b>TEST BY</b>	BL

Moisture at start           6.7%  
Moisture at finish       17.6%  
Moisture increase       10.9%  
Initial dry density (pcf)   106  
Swell (psf)               690

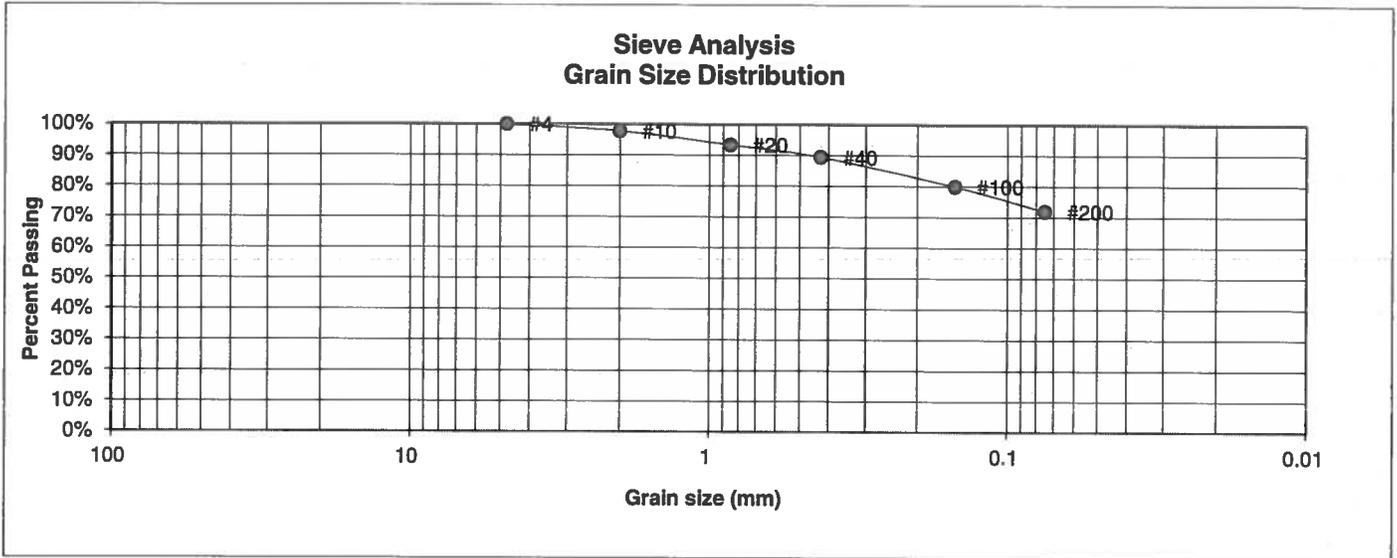
0-7

<b>UNIFIED CLASSIFICATION</b>	CL	<b>CLIENT</b>	PROLAND GROUP, LLC
<b>SOIL TYPE #</b>	2	<b>PROJECT</b>	ARROYA AND RAYGOR
<b>TEST BORING #</b>	PH-2	<b>JOB NO.</b>	80503
<b>DEPTH (FT)</b>	5	<b>TEST BY</b>	BL

U.S. Sieve #	Percent Finer
3"	
1 1/2"	
3/4"	
1/2"	
3/8"	
4	100.0%
10	97.7%
20	93.4%
40	89.4%
100	80.0%
200	71.9%

Atterberg Limits	
Plastic Limit	22
Liquid Limit	40
Plastic Index	18

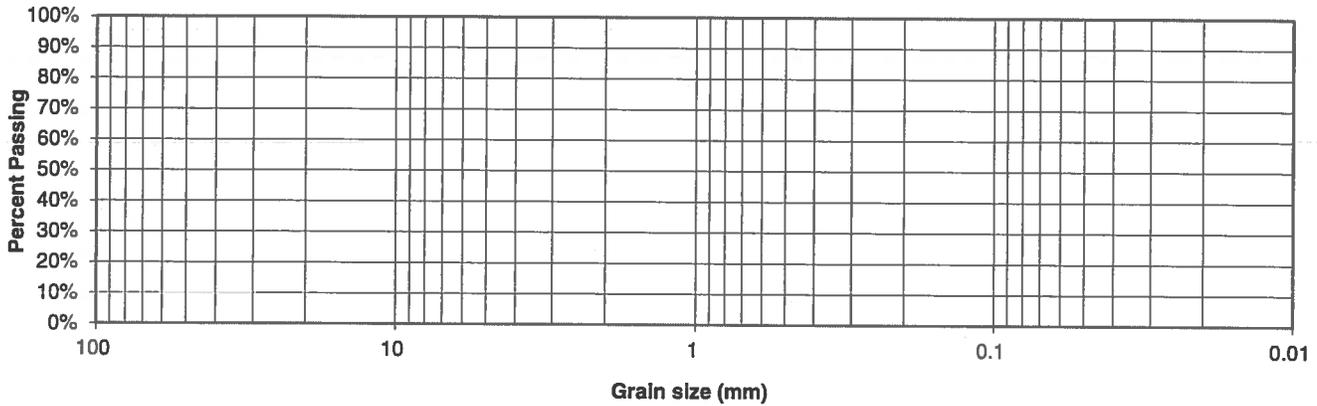
<b>UNIFIED CLASSIFICATION</b>	CL	<b>CLIENT</b>	PROLAND GROUP, LLC
<b>SOIL TYPE #</b>	2	<b>PROJECT</b>	ARROYA AND RAYGOR
<b>TEST BORING #</b>	2	<b>JOB NO.</b>	80503
<b>DEPTH (FT)</b>	3	<b>TEST BY</b>	BL

<b>U.S. Sieve #</b>	<b>Percent Finer</b>	<b>Atterberg Limits</b>	
3"		Plastic Limit	
1 1/2"		Liquid Limit	
3/4"		Plastic Index	
1/2"			
3/8"		<b>Swell</b>	
4		Moisture at start	8.7%
10		Moisture at finish	19.2%
20		Moisture increase	10.6%
40		Initial dry density (pcf)	106
100		Swell (psf)	2060
200

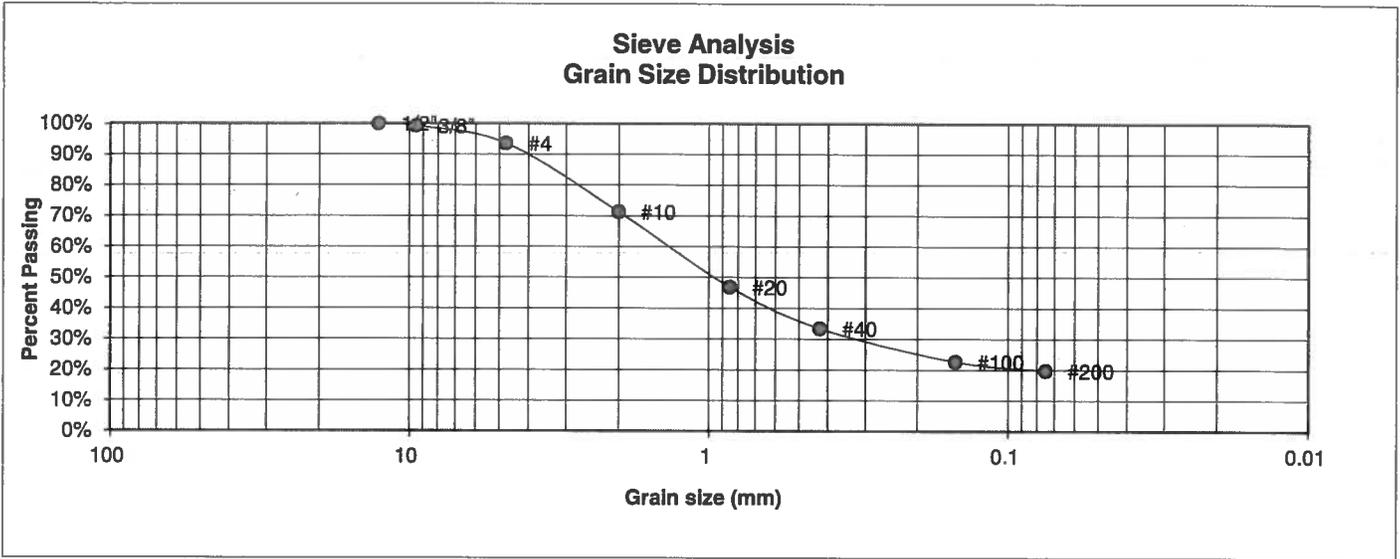
FIG NO.:  
09

<b>UNIFIED CLASSIFICATION</b>	SC	<b>CLIENT</b>	PROLAND GROUP, LLC
<b>SOIL TYPE #</b>	3	<b>PROJECT</b>	ARROYA AND RAYGOR
<b>TEST BORING #</b>	2	<b>JOB NO.</b>	80503
<b>DEPTH (FT)</b>	10	<b>TEST BY</b>	BL

U.S. Sieve #	Percent Finer
3"	
1 1/2"	
3/4"	
1/2"	100.0%
3/8"	99.2%
4	93.5%
10	71.2%
20	46.8%
40	33.4%
100	22.6%
200	19.7%

**Swell**  
 Moisture at start 9.3%  
 Moisture at finish 18.3%  
 Moisture increase 9.0%  
 Initial dry density (pcf) 111  
 Swell (psf) 430

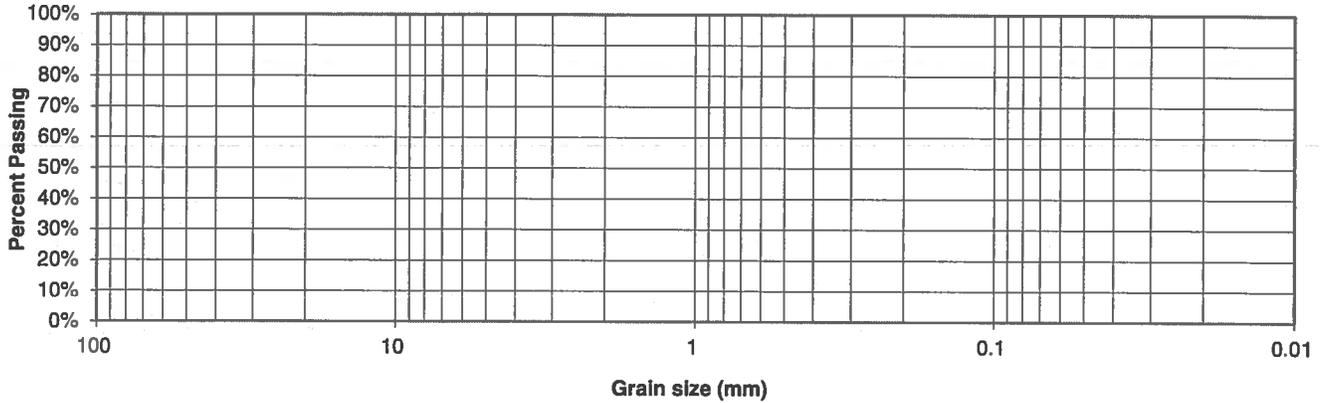
<b>UNIFIED CLASSIFICATION</b>	SC	<b>CLIENT</b>	PROLAND GROUP, LLC
<b>SOIL TYPE #</b>	3	<b>PROJECT</b>	ARROYA AND RAYGOR
<b>TEST BORING #</b>	3	<b>JOB NO.</b>	80503
<b>DEPTH (FT)</b>	5-10	<b>TEST BY</b>	BL

<u>Atterberg Limits</u>	
Plastic Limit	18
Liquid Limit	28
Plastic Index	10

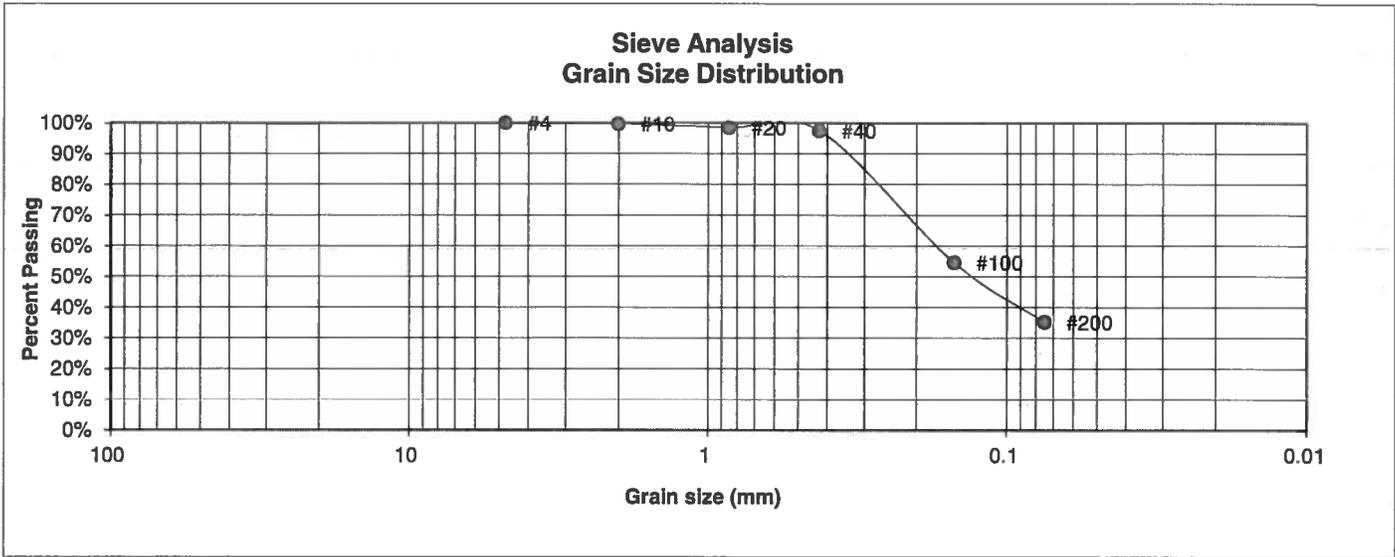
FIG NO.:  
D-11

<b>UNIFIED CLASSIFICATION</b>	SC-SM	<b>CLIENT</b>	PROLAND GROUP, LLC
<b>SOIL TYPE #</b>	3	<b>PROJECT</b>	ARROYA AND RAYGOR
<b>TEST BORING #</b>	6	<b>JOB NO.</b>	80503
<b>DEPTH (FT)</b>	5	<b>TEST BY</b>	BL

<u>U.S. Sieve #</u>	<u>Percent Finer</u>
3"	
1 1/2"	
3/4"	
1/2"	
3/8"	
4	100.0%
10	99.7%
20	98.5%
40	97.4%
100	54.6%
200	35.2%

<u>Swell</u>	
Moisture at start	18.9%
Moisture at finish	22.5%
Moisture increase	3.6%
Initial dry density (pcf)	102
Swell (psf)	450
