AMENDED June 25, 2022

- REVISED FIG 2 – PRELIMINARY GEOLOGIC
- REVISED FIG 3 – SEWAGE DISPOSAL CHAR
- LETTER REQUEST TO PCD DIRECTOR

PRELIMINARY GEOLOGY, SURFACE SOILS, AND SEWAGE DISPOSAL EVALUATION

WALDEN PRESERVE 2 - FILING NO. 5
 OWNED & DEVELOPED BY: WALDEN HOLDINGS I LLC, 17145 COLONIAL PARK DR, MONUMENT, CO 80132
 PORTIONS OF SEC 14, 15, 22 & 23, T11S, R66W, 6TH PM IN EL PASO COUNTY COLORADO

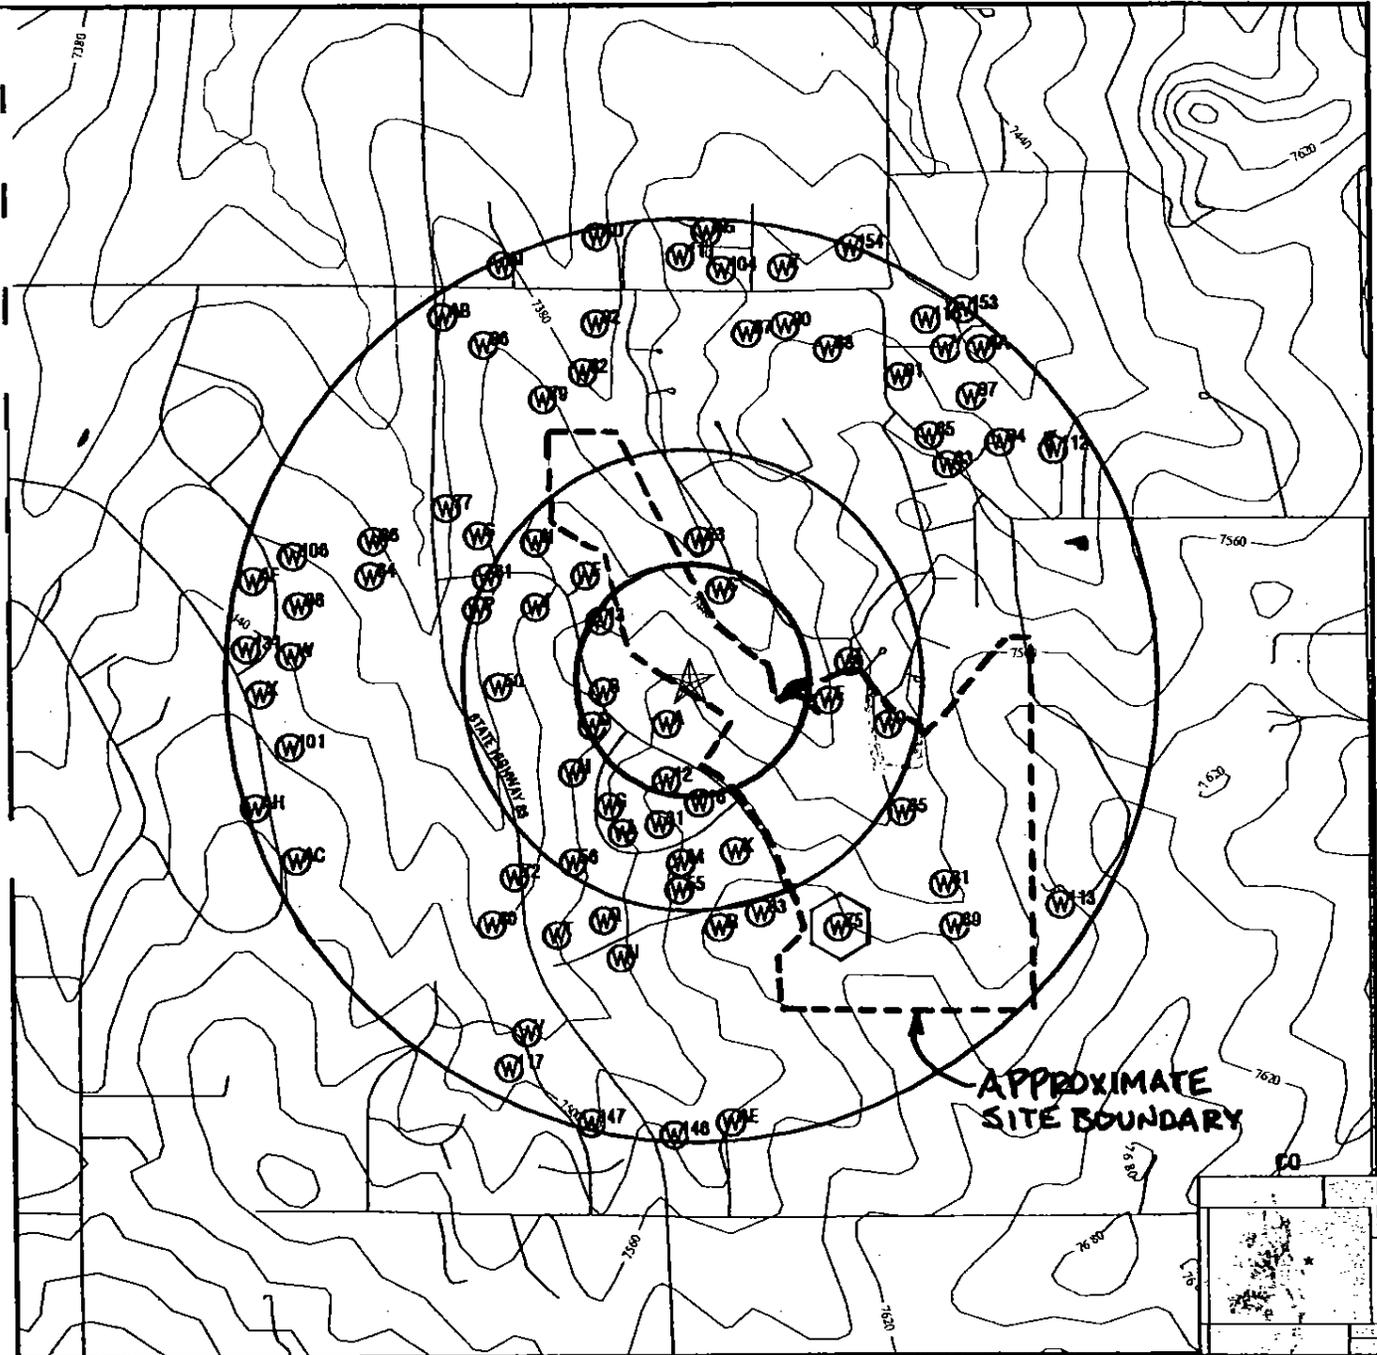
FIGURE 4

- ↘ County Boundary
- ↘ Major Roads
- ↘ Contour Lines
- ⊙ Earthquake epicenter, Richter 5 or greater
- ⊙ Water Wells
- ⊙ Public Water Supply Wells
- Cluster of Multiple Icons

- ↓ Groundwater Flow Direction
- (GI) Indeterminate Groundwater Flow at Location
- (GY) Groundwater Flow Varies at Location
- Oil, gas or related wells

Individual wells are proposed for the larger lots in the subdivision. The smaller lots will be served by a central water supply from wells within the area. The locations of listed wells in the immediate area are shown on Figure 4. The well data for these wells indicates that most (if not all) of the wells withdraw water from the bedrock aquifer. Our experience indicates that the Dawson is not recharged by surface waters (like sewage effluent). As long as adequate surface seals are (were) provided during well design and construction to prevent surface water from impacting the bedrock aquifers, and required setbacks are maintained, it appears that the potential for sewage effluent to contaminate the bedrock aquifers is low. As indicated previously, sewage effluent is likely to impact surface water and/or shallow groundwater. If any domestic-use wells in the immediate area withdraw from the alluvial aquifer, the water may have to be treated for parameters such as nitrates and phosphates.

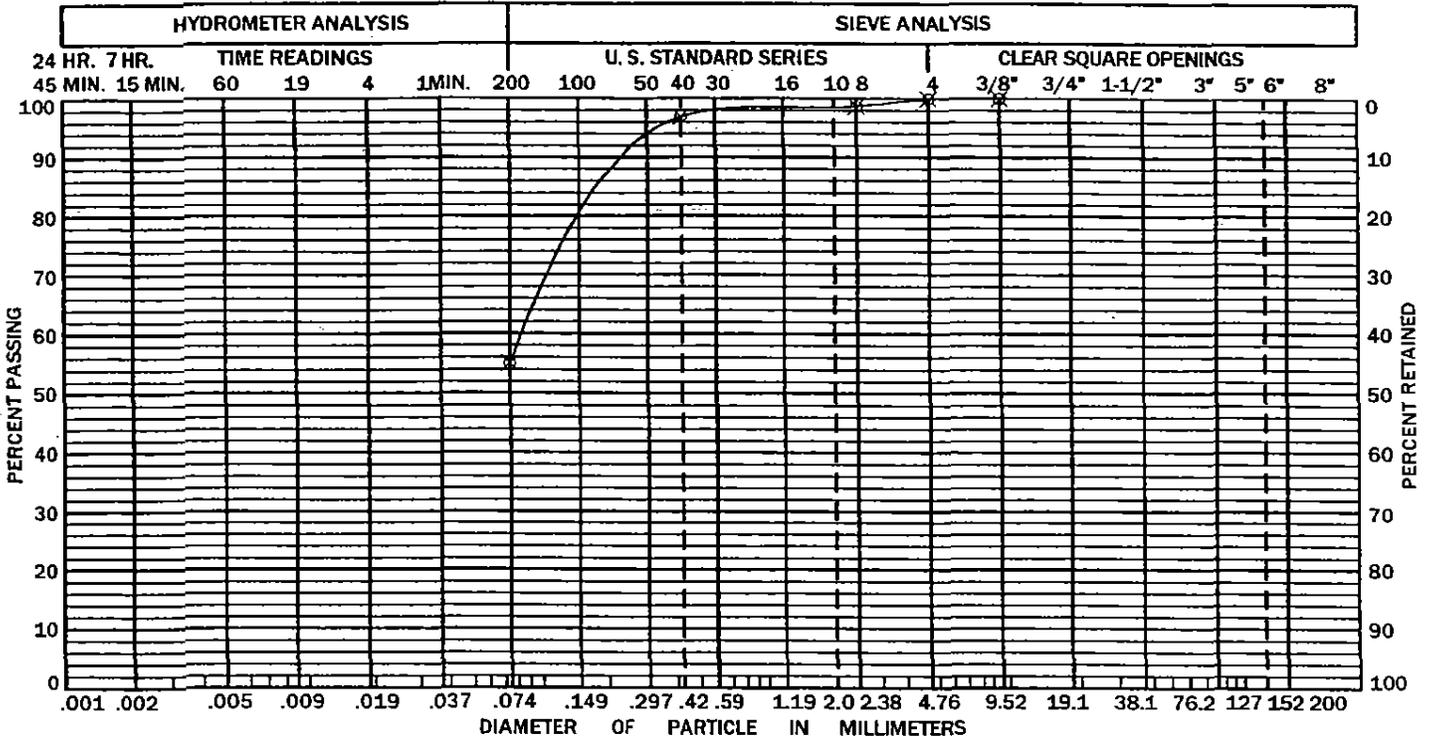
GRADATION TEST RESULTS

CLAY TO SILT	SAND			GRAVEL		COBBLES
	FINE	MEDIUM	COARSE	FINE	COARSE	
CLASSIFICATION <u>ML</u>	NOTES: <u>6.0 % Moisture content</u>					
GRAVEL <u>0.0 %</u>	<u>LL = 23.6 %</u>					
SAND <u>45.5 %</u>	<u>PL = 20.7 %</u>					
FINES <u>54.5 %</u>	<u>PI = 2.9 %</u>					
SAMPLE# <u>1</u> HOLE# <u>TH-1</u> DEPTH <u>10</u> FEET	<u>Job #: 11411 By: KO 05/13/2003</u>

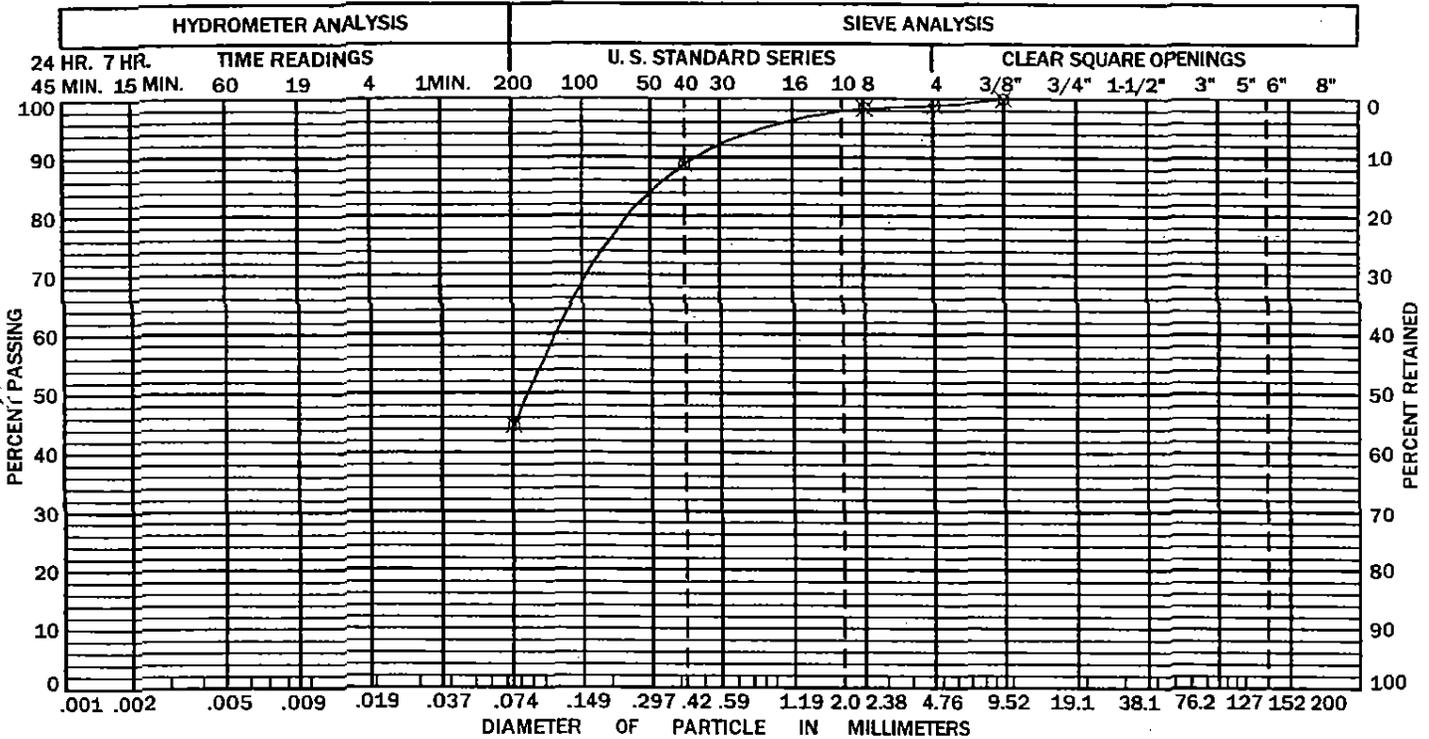
GRADATION TEST RESULTS

CLASSIFICATION	SM/SC	SAND			GRAVEL		COBBLES
		FINE	MEDIUM	COARSE	FINE	COARSE	
GRAVEL	0.2 %						
SAND	55.3 %						
FINES	44.5 %						
SAMPLE# <u>1</u> HOLE# <u>TH-2</u> DEPTH <u>4</u> FEET		NOTES: <u>13.4 % Moisture content</u>					
		<u>LL = 23.4 %</u>					
		<u>PL = 18.6 %</u>					
		<u>PI = 4.8 %</u>					
		<u>Job #: 11411</u>		<u>By: KO</u>		<u>05/13/2003</u>

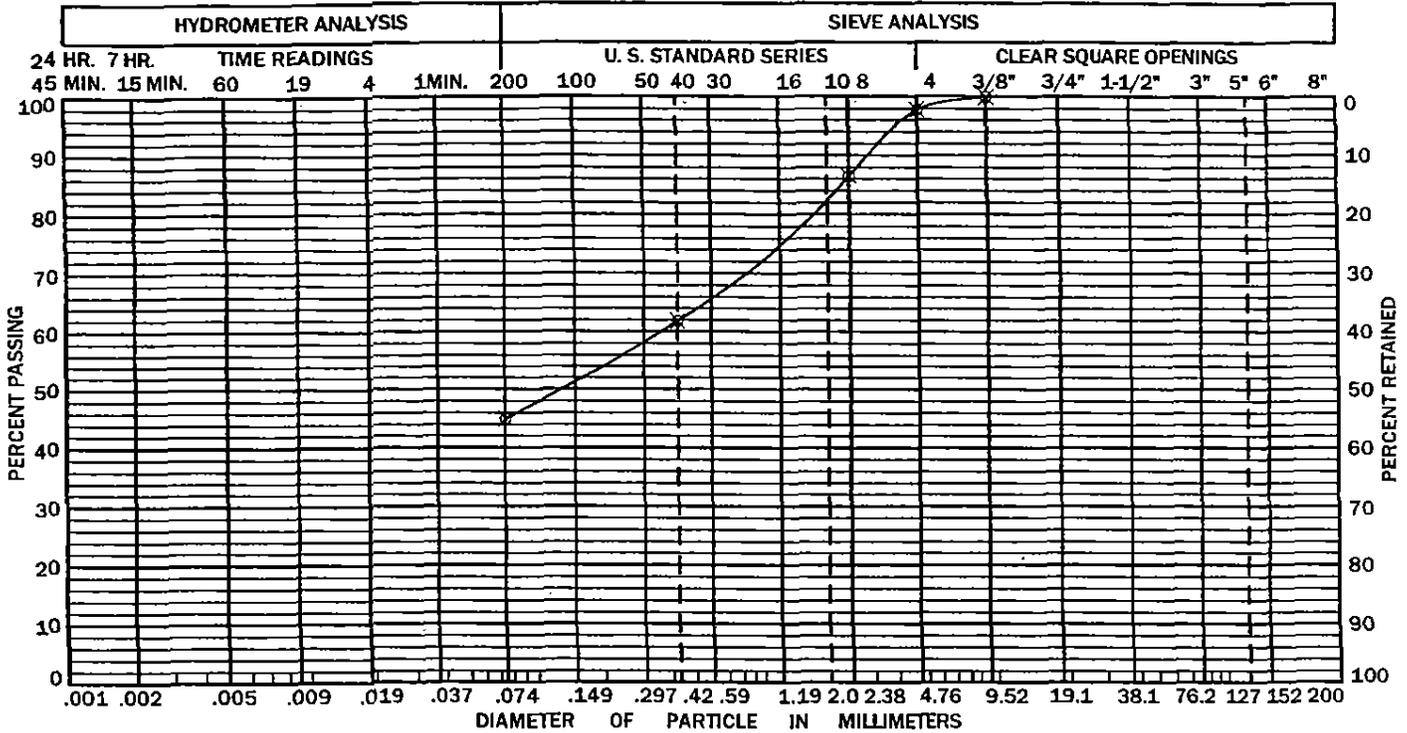
GRADATION TEST RESULTS

CLASSIFICATION SC
 GRAVEL 2.3 %
 SAND 52.8 %
 FINES 44.9 %
 SAMPLE# 1 HOLE# TH-4 DEPTH 10 FEET

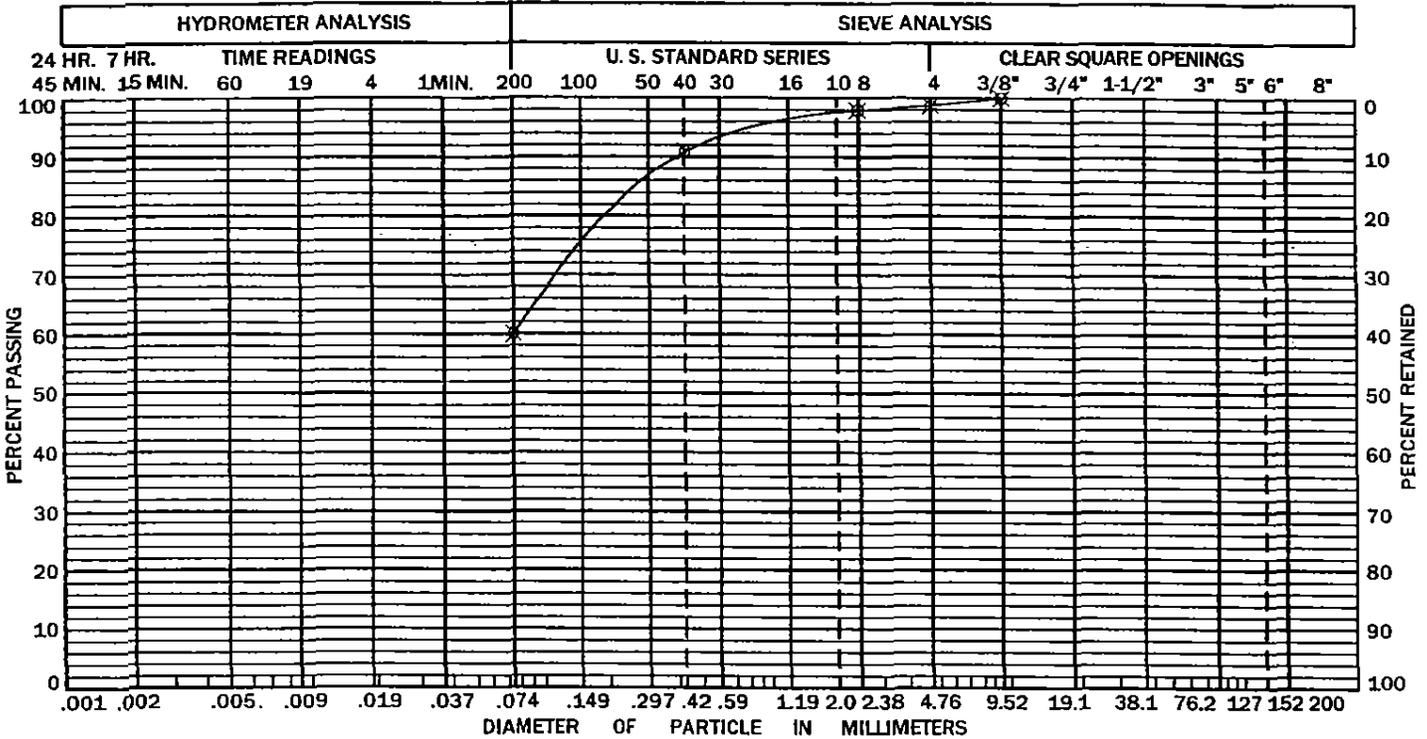
GRADATION TEST RESULTS

CLASSIFICATION CL
 GRAVEL 0.3 %
 SAND 39.5 %
 FINES 60.2 %
 SAMPLE# 1 HOLE# TH-6 DEPTH 10 FEET

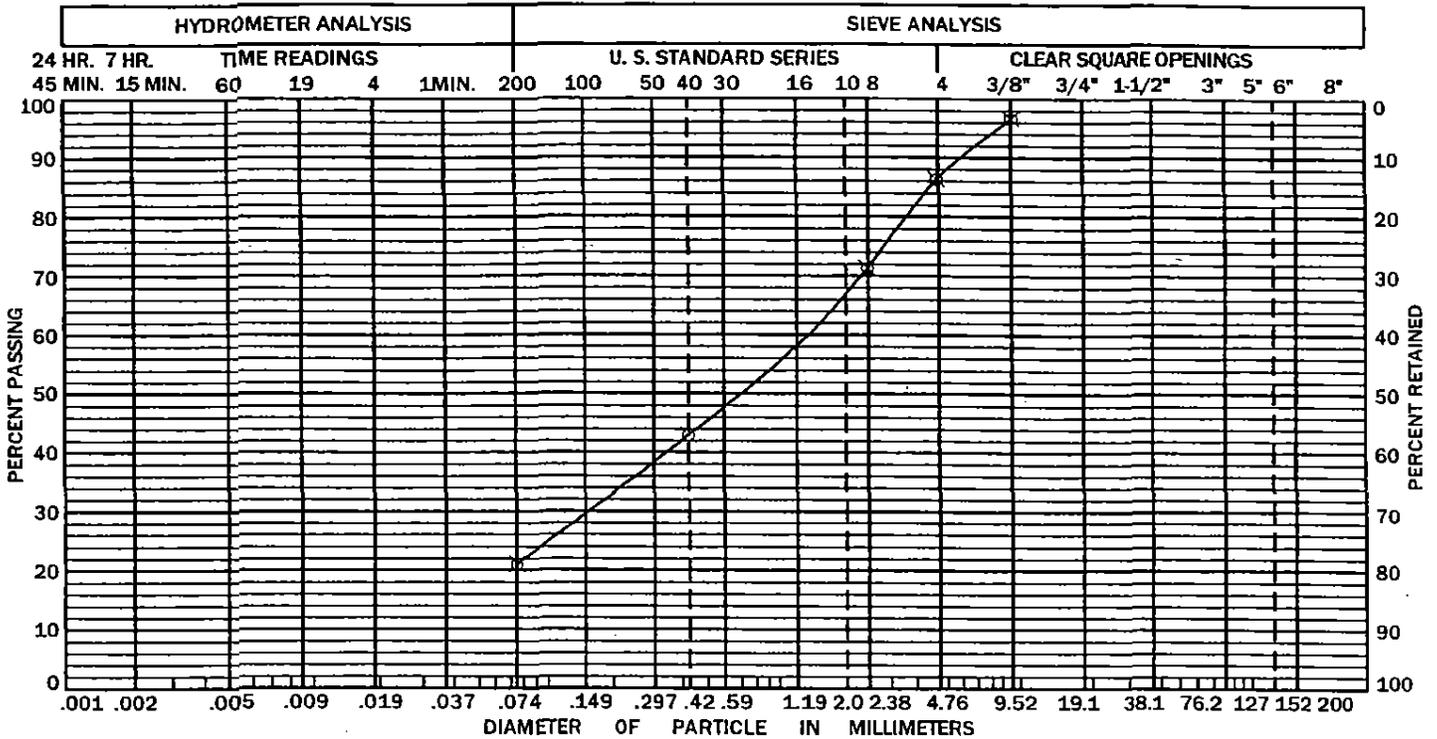
GRADATION TEST RESULTS

CLASSIFICATION SM
 GRAVEL 14.3 %
 SAND 64.7 %
 FINES 21.0 %
 SAMPLE# 1 HOLE# TH-8 DEPTH 4 FEET

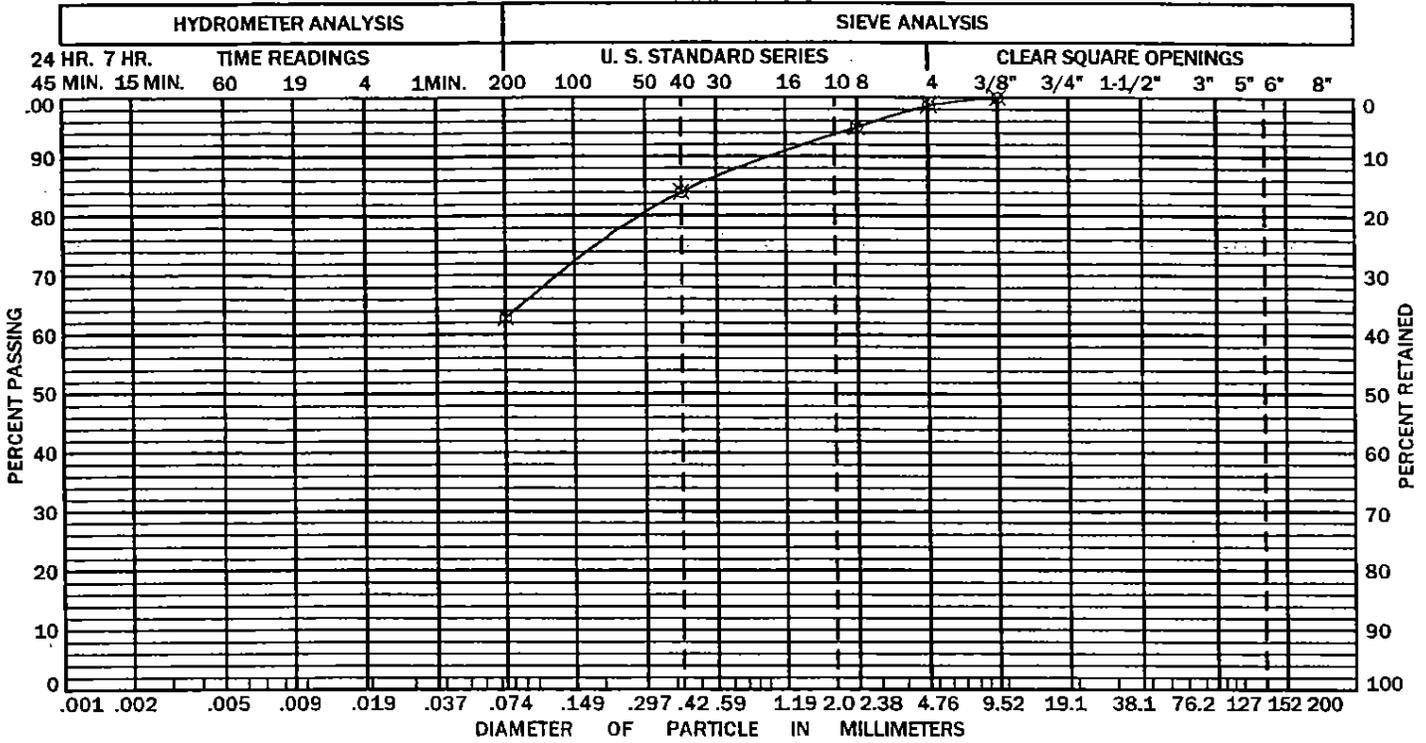
GRADATION TEST RESULTS

CLASSIFICATION	CLAY TO SILT	SAND			GRAVEL		COBBLES
		FINE	MEDIUM	COARSE	FINE	COARSE	
CL							
GRAVEL	1.0 %						
SAND	36.2 %						
FINES	62.8 %						
SAMPLE#	1	HOLE#	TH-9	DEPTH	10	FEET

NOTES: 15.8 % Moisture content

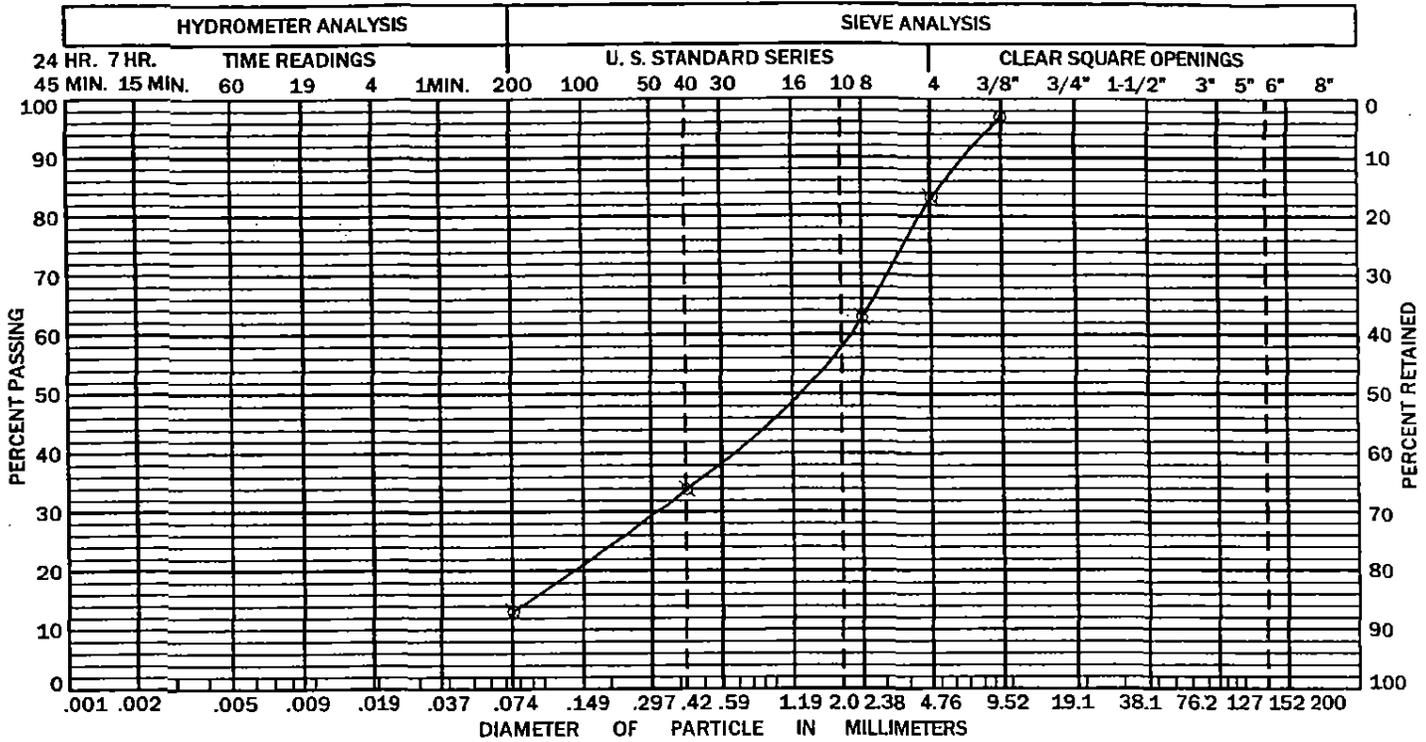
GRADATION TEST RESULTS

CLASSIFICATION SC
 GRAVEL 16.9 %
 SAND 60.3 %
 FINES 22.8 %

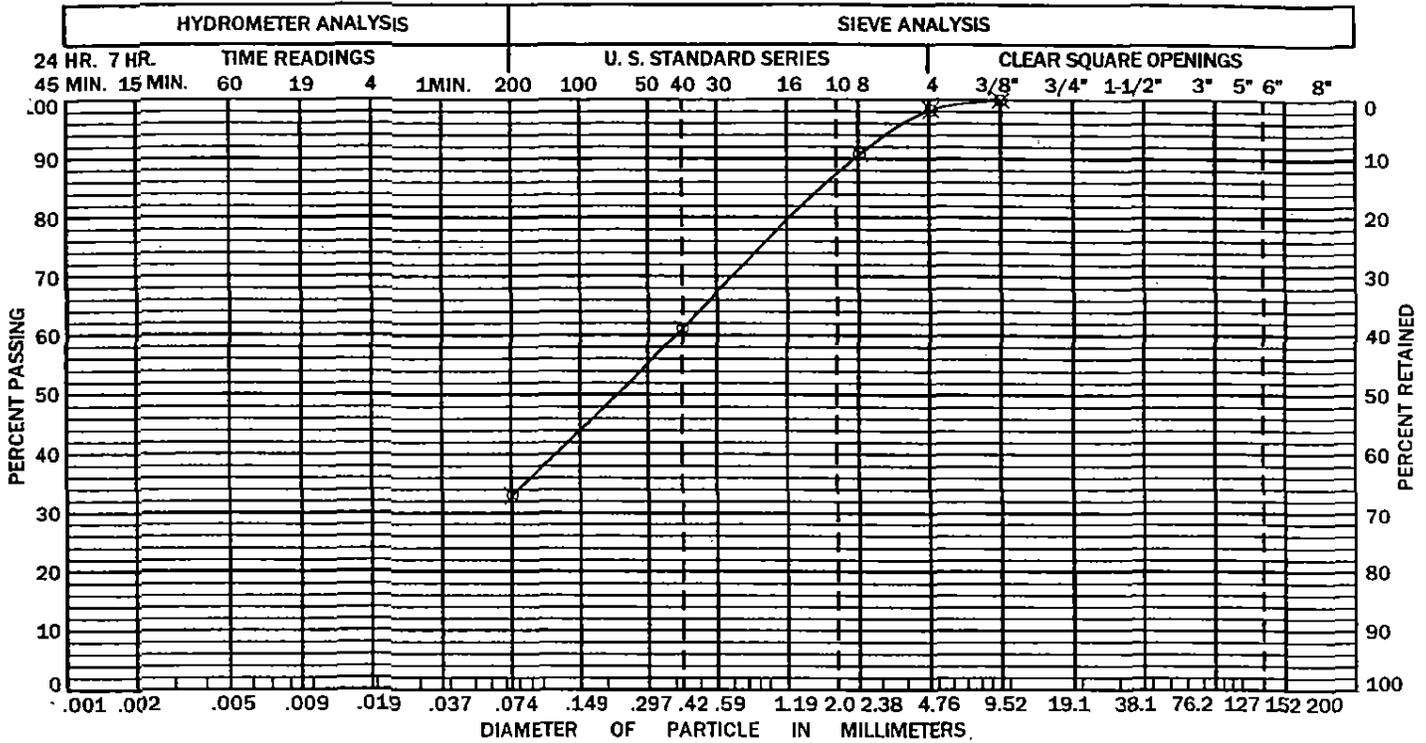
GRADATION TEST RESULTS

CLASSIFICATION	SM	SAND			GRAVEL		COBBLES
		FINE	MEDIUM	COARSE	FINE	COARSE	
GRAVEL	1.5 %						
SAND	65.3 %						
FINES	33.2 %						
SAMPLE#	1	HOLE# TH-13		DEPTH 4 FEET

NOTES:	6.7 % Moisture content
	LL = 15.8 %
	PL = 15.5 %
	PI = 0.3 %
Job #:	11411
By:	KO
	05/13/2003

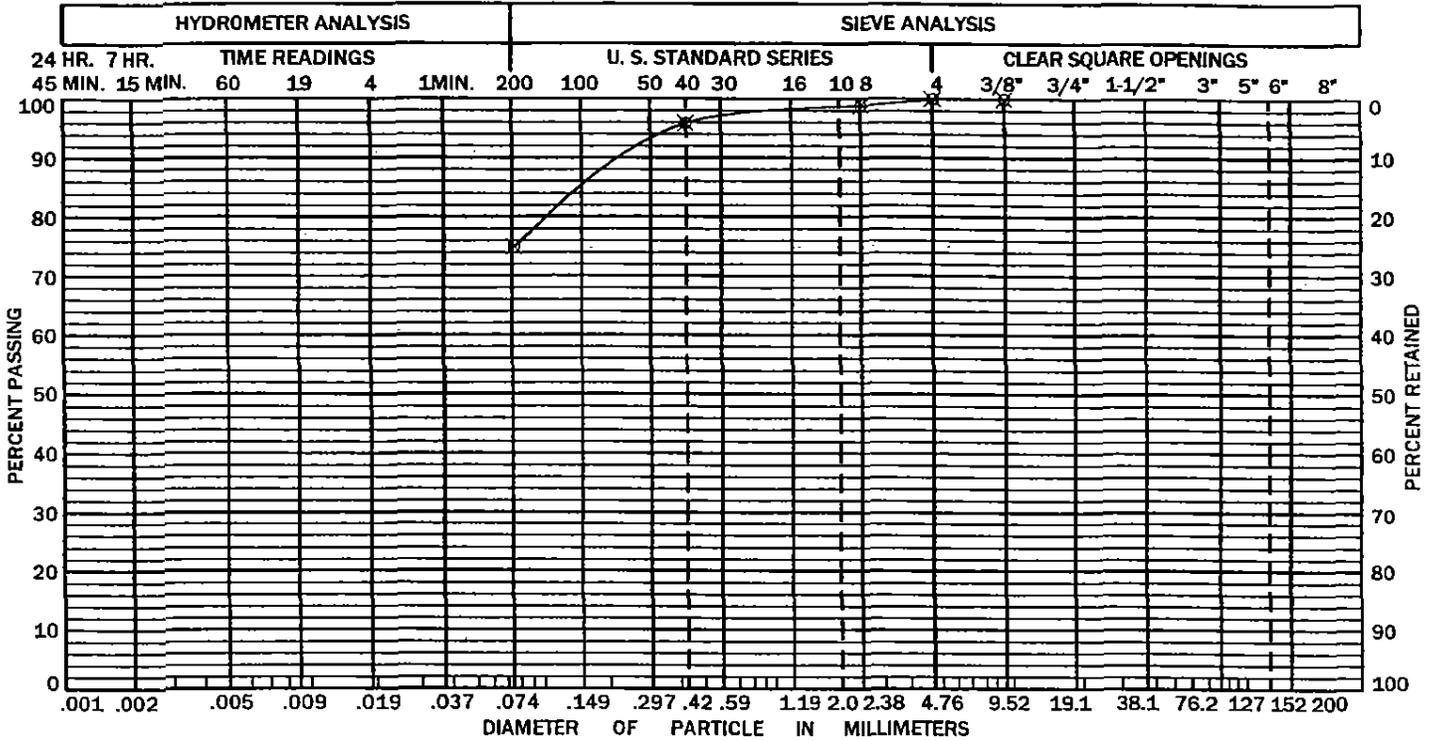
GRADATION TEST RESULTS

CLASSIFICATION CL
 GRAVEL 0.0 %
 SAND 25.0 %
 FINES 75.0 %
 SAMPLE# 1 HOLE# TH-14 DEPTH 10 FEET

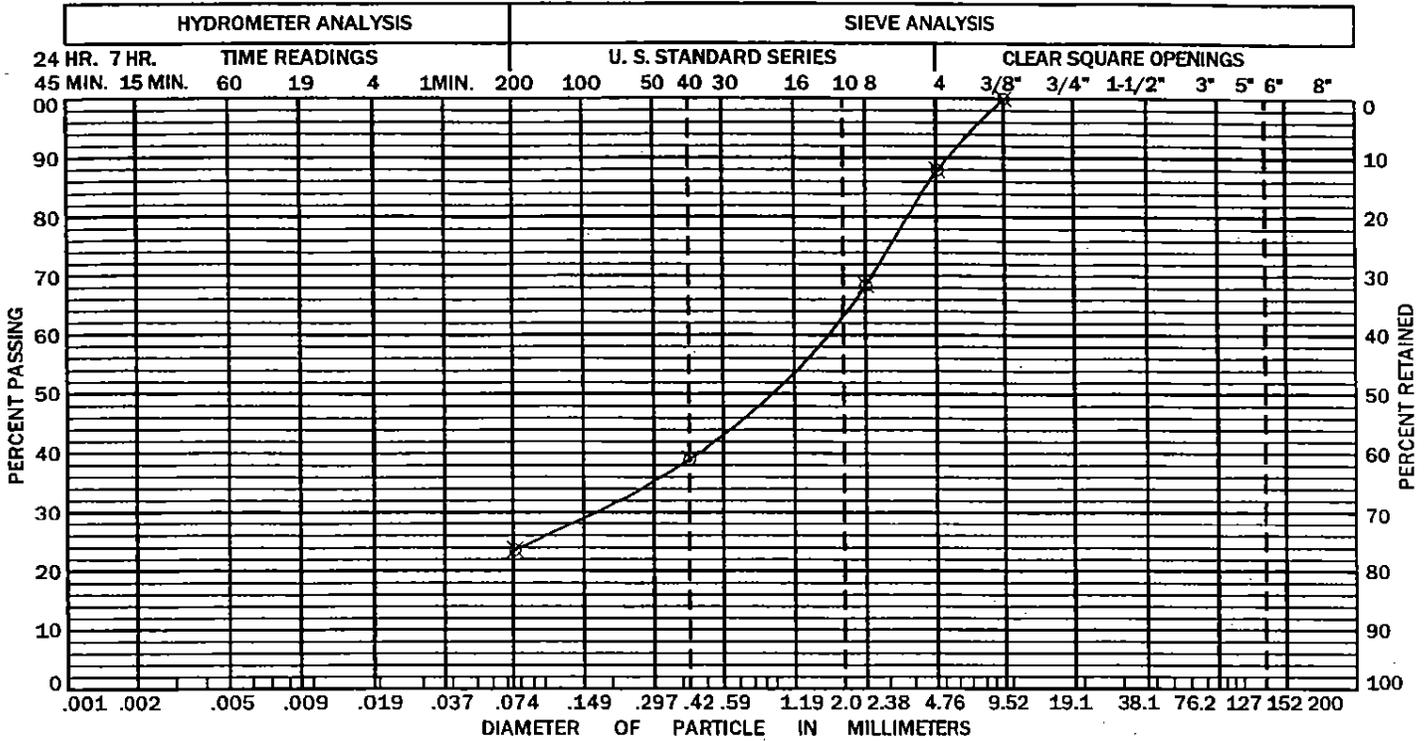
GRADATION TEST RESULTS

CLASSIFICATION SC
 GRAVEL 12.2 %
 SAND 64.3 %
 FINES 23.5 %

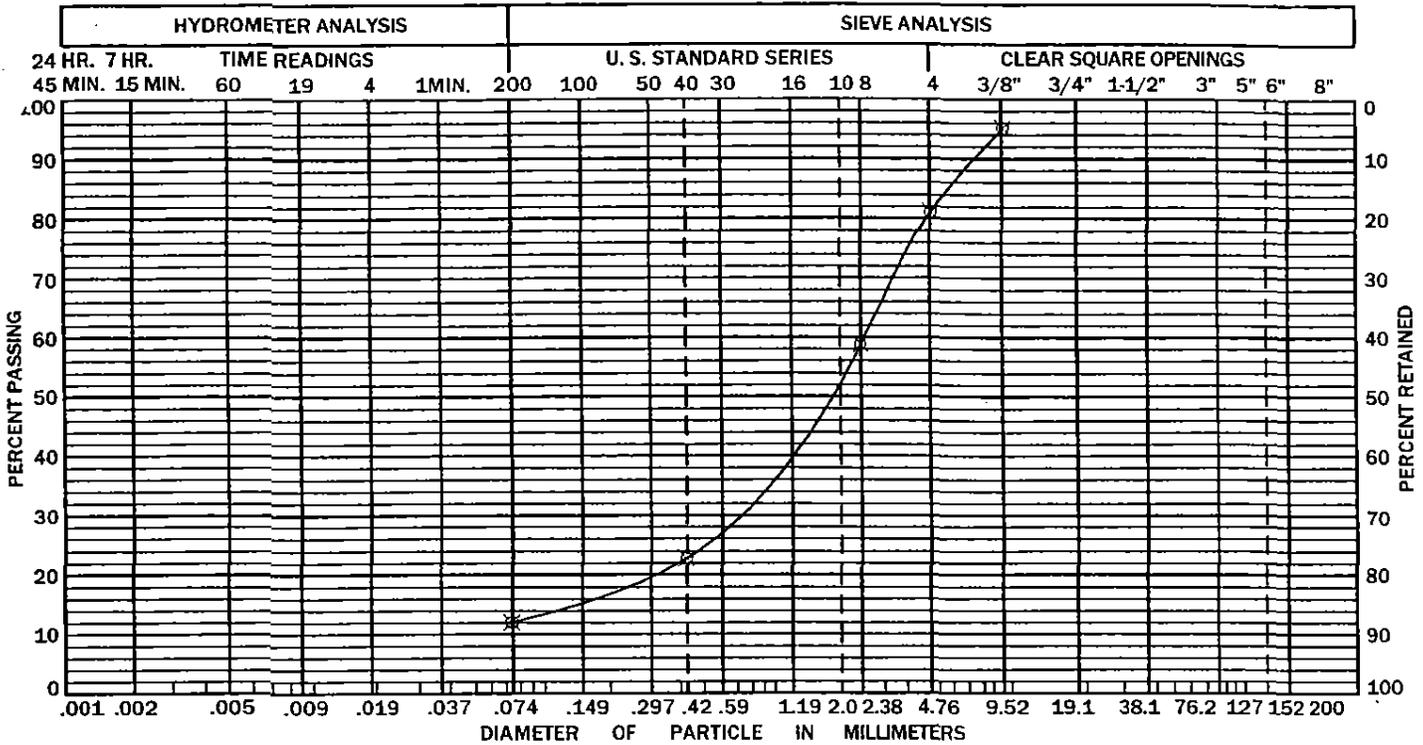
GRADATION TEST RESULTS

CLAY TO SILT	SAND			GRAVEL		COBBLES
	FINE	MEDIUM	COARSE	FINE	COARSE	
CLASSIFICATION	SC					
GRAVEL	6.4 %					
SAND	68.6 %					
FINES	25.0 %					
SAMPLE#	1 HOLE# TH-16 DEPTH 10 FEET					
NOTES:	9.1 % Moisture content					
	LL = 30.9 %					
	PL = 20.8 %					
	PI = 10.1 %					
	Job #: 11411 By: KO 05/13/2003

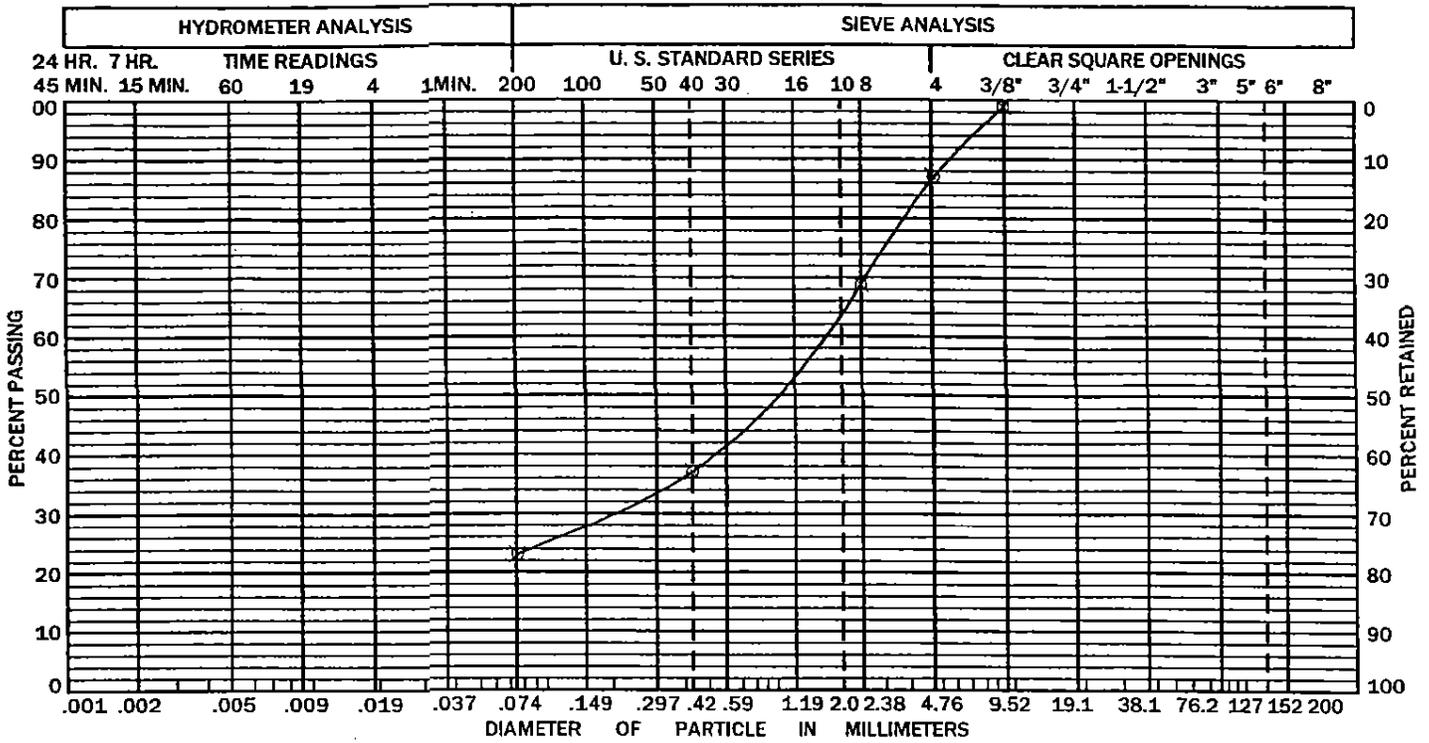
GRADATION TEST RESULTS

CLASSIFICATION	SC
GRAVEL	13.3 %
SAND	63.8 %
FINES	22.9 %
SAMPLE#	1 HOLE# TH-17 DEPTH 10 FEET

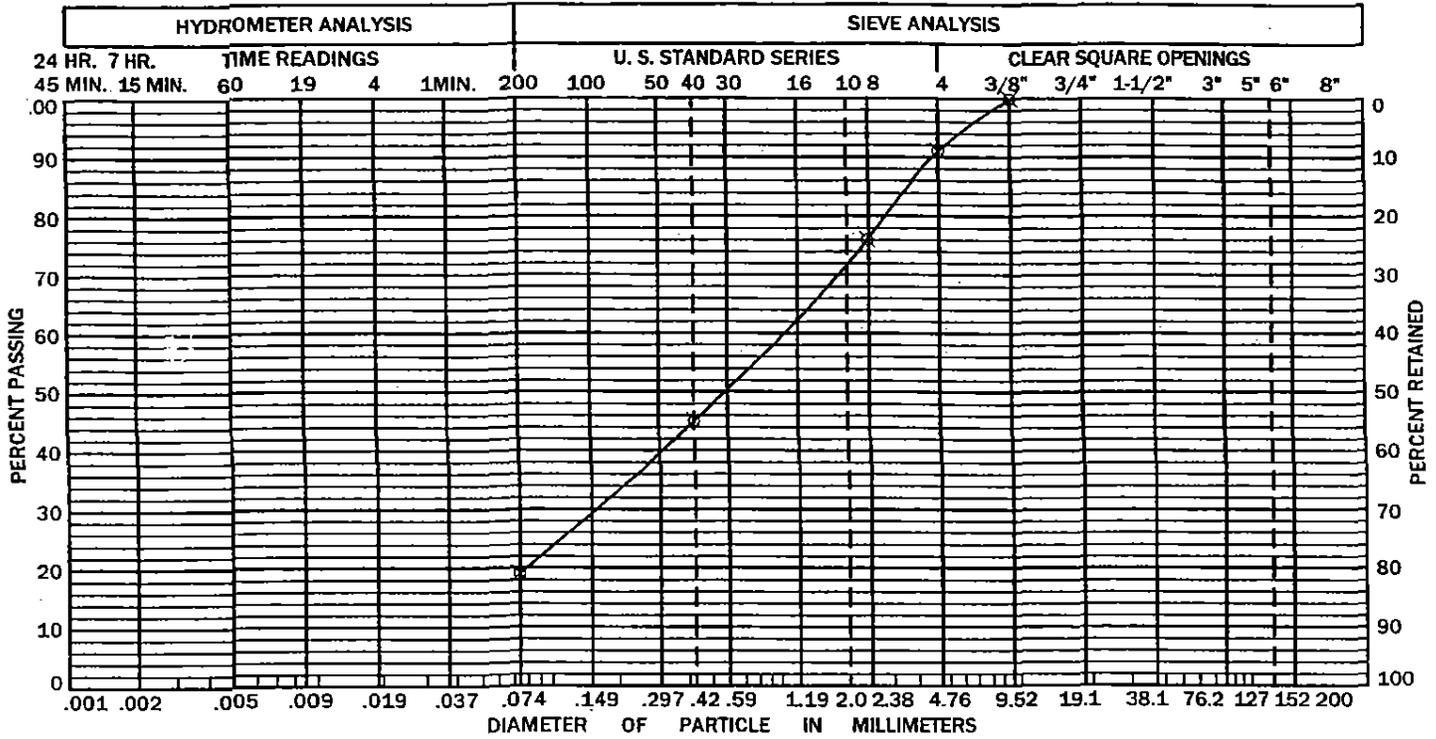
GRADATION TEST RESULTS

CLAY TO SILT	SAND			GRAVEL		COBBLES
	FINE	MEDIUM	COARSE	FINE	COARSE	
CLASSIFICATION <u>SM</u>	NOTES: <u>4.5 % Moisture content</u>					
GRAVEL <u>8.8 %</u>	<u>LL = 24.3 %</u>					
SAND <u>72.5 %</u>	<u>PL = 21.2 %</u>					
FINES <u>18.7 %</u>	<u>PI = 3.1 %</u>					
SAMPLE# <u>1</u> HOLE# <u>TH-18</u> DEPTH <u>4</u> FEET	<u>Job #: 11411 By: KO 05/13/2003</u>

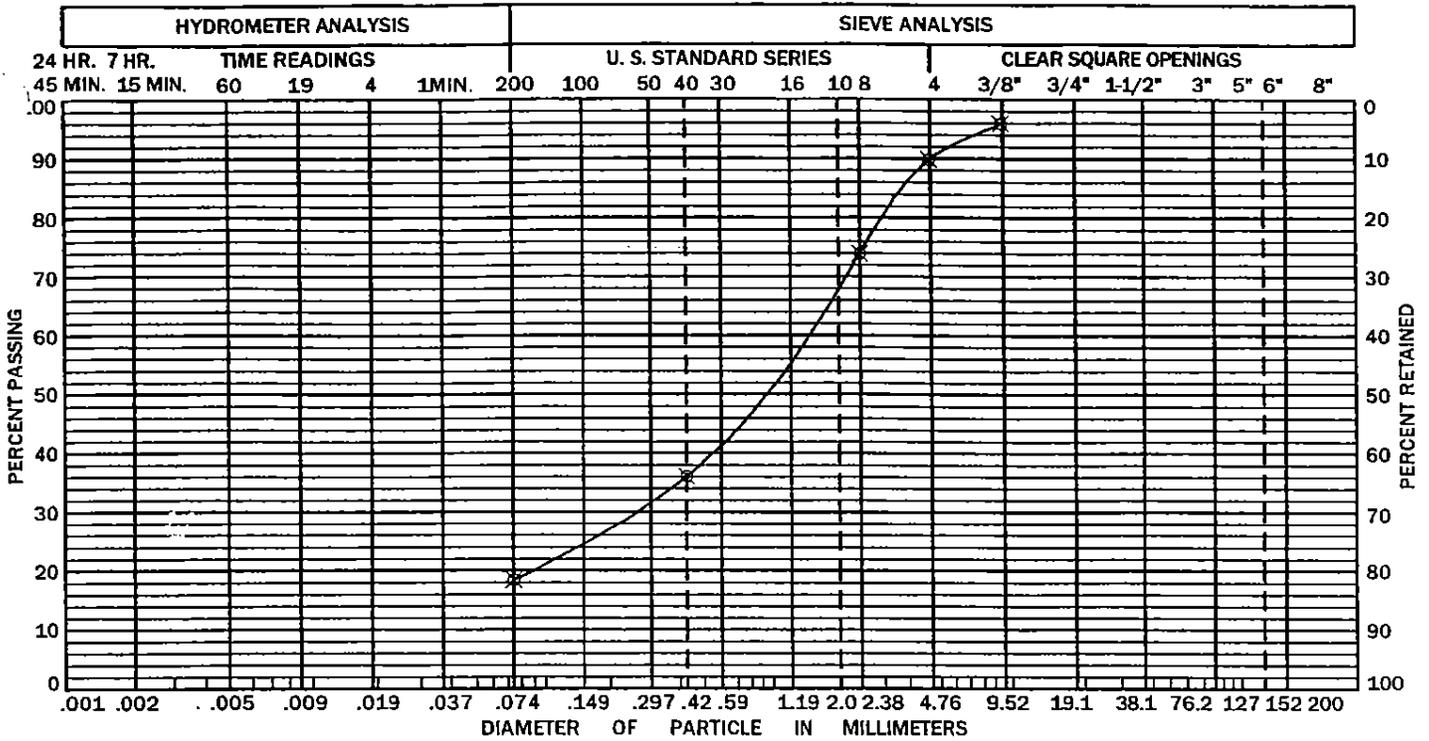
GRADATION TEST RESULTS

CLASSIFICATION SC
 GRAVEL 10.2 %
 SAND 71.2 %
 FINES 18.6 %
 SAMPLE# 1 HOLE# TH-19 DEPTH 4 FEET

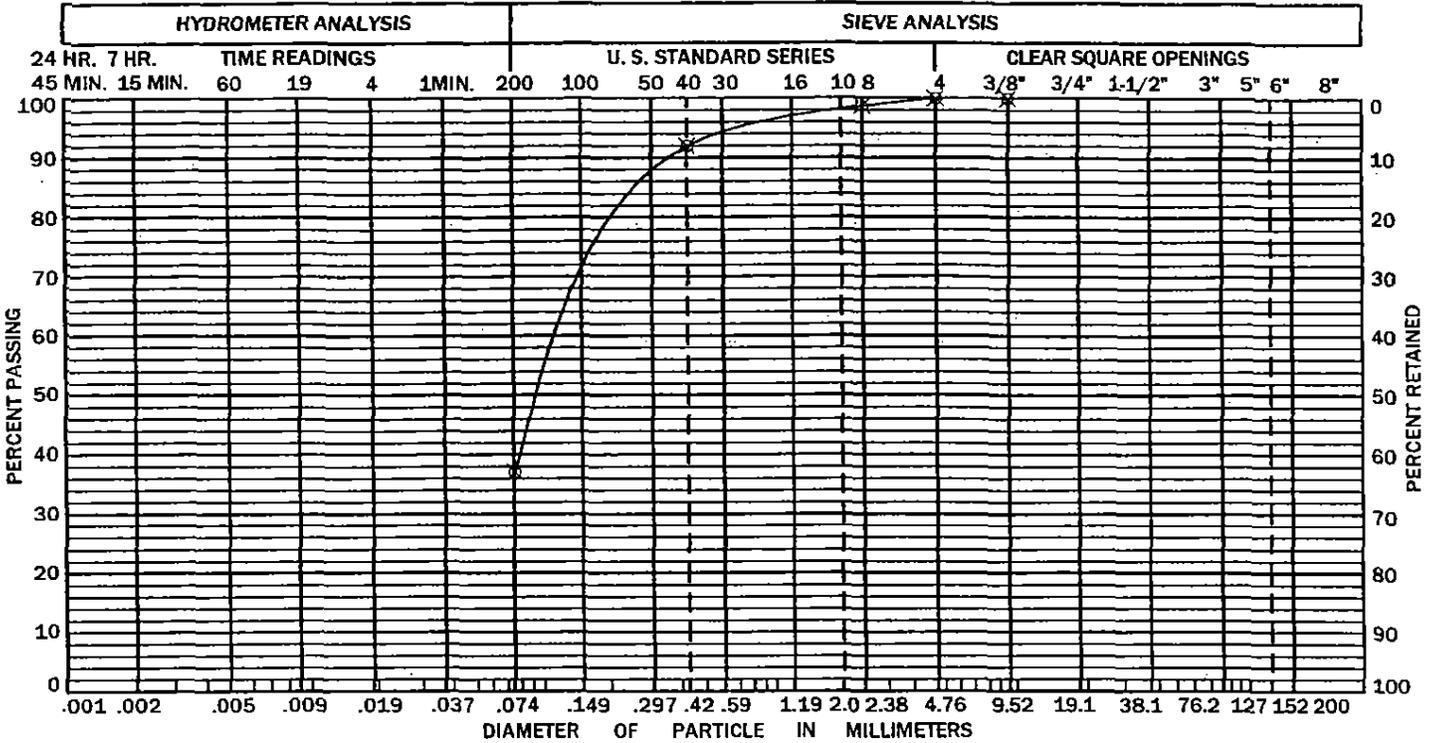
GRADATION TEST RESULTS

CLASSIFICATION SM
 GRAVEL 0.0 %
 SAND 62.3 %
 FINES 37.7 %

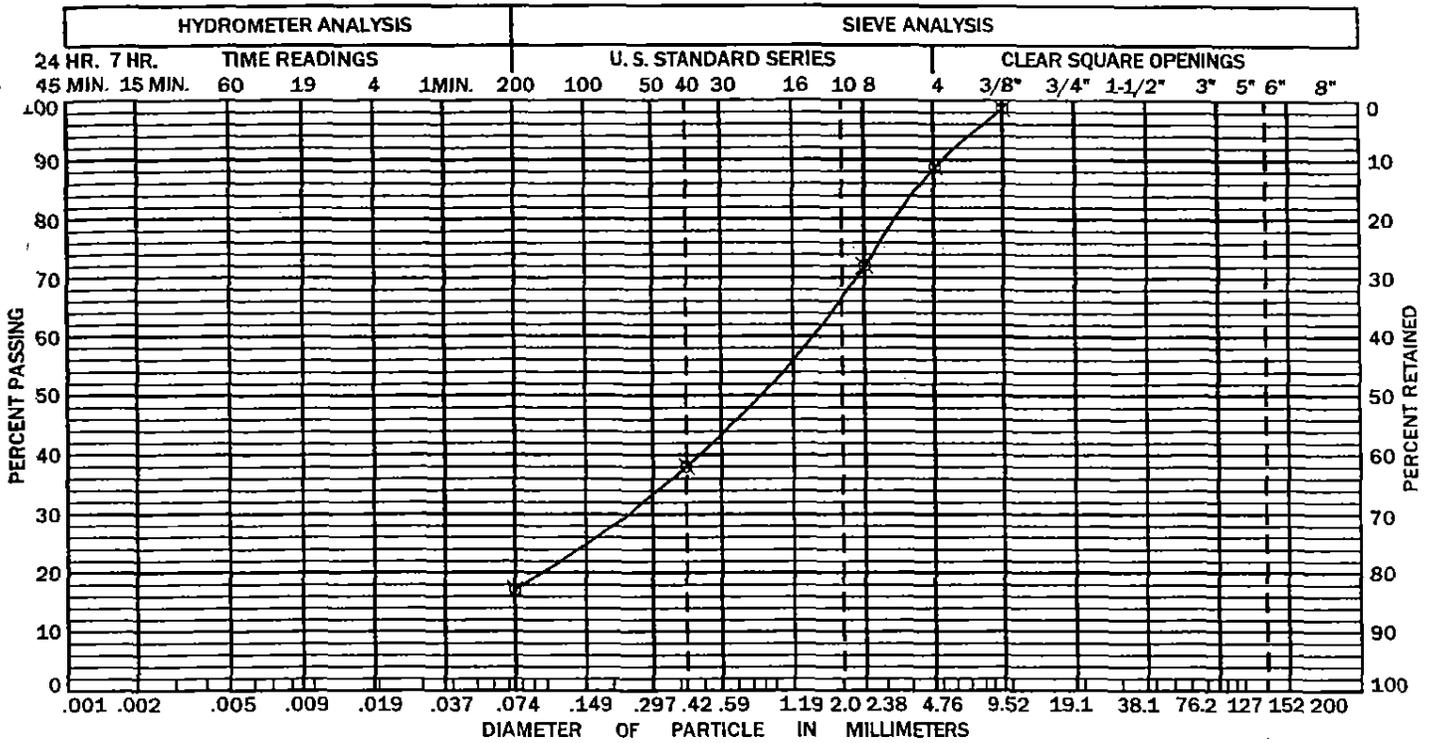
GRADATION TEST RESULTS

CLASSIFICATION SM
 GRAVEL 10.6 %
 SAND 72.2 %
 FINES 17.2 %
 SAMPLE# 1 HOLE# TH-21 DEPTH 4 FEET

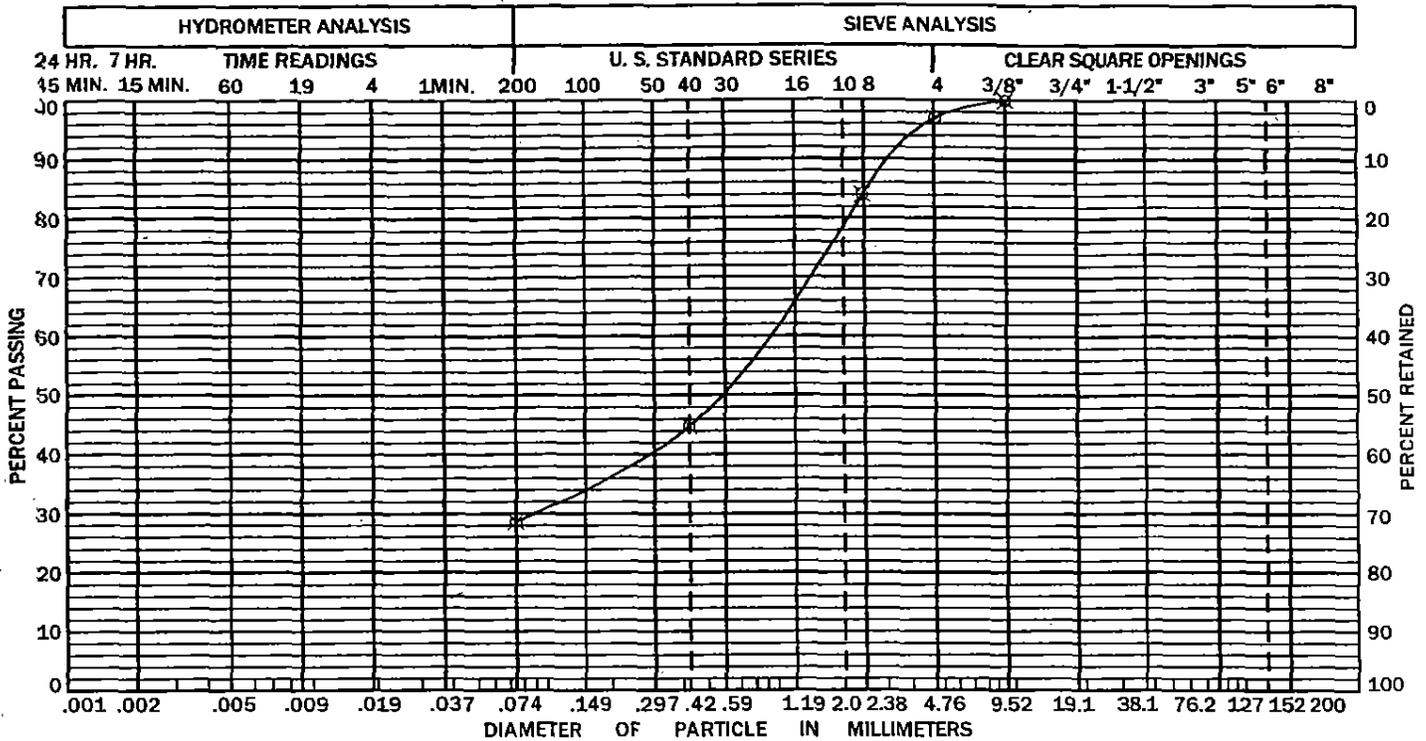
GRADATION TEST RESULTS

CLAY TO SILT	SAND			GRAVEL		COBBLES
	FINE	MEDIUM	COARSE	FINE	COARSE	
CLASSIFICATION	SC					
GRAVEL	3.0 %					
SAND	68.6 %					
FINES	28.4 %					
SAMPLE#	1 HOLE# TH-22 DEPTH 4 FEET

NOTES:	12.0 % Moisture content
	LL = 29.4 %
	PL = 18.4 %
	PI = 11.0 %
Job #:	11411
By:	KO
	05/13/2003
