AMENDED June 25, 2022

- REVISED FIG 2 – PRELIMINARY GEOLOGIC
- REVISED FIG 3 – SEWAGE DISPOSAL CHAR
- LETTER REQUEST TO PCD DIRECTOR

PRELIMINARY GEOLOGY, SURFACE SOILS, AND SEWAGE DISPOSAL EVALUATION

WALDEN PRESERVE 2 - FILING NO. 5
 OWNED & DEVELOPED BY: WALDEN HOLDINGS I LLC, 17145 COLONIAL PARK DR, MONUMENT, CO 80132
 PORTIONS OF SEC 14, 15, 22 & 23, T11S, R66W, 6TH PM IN EL PASO COUNTY COLORADO

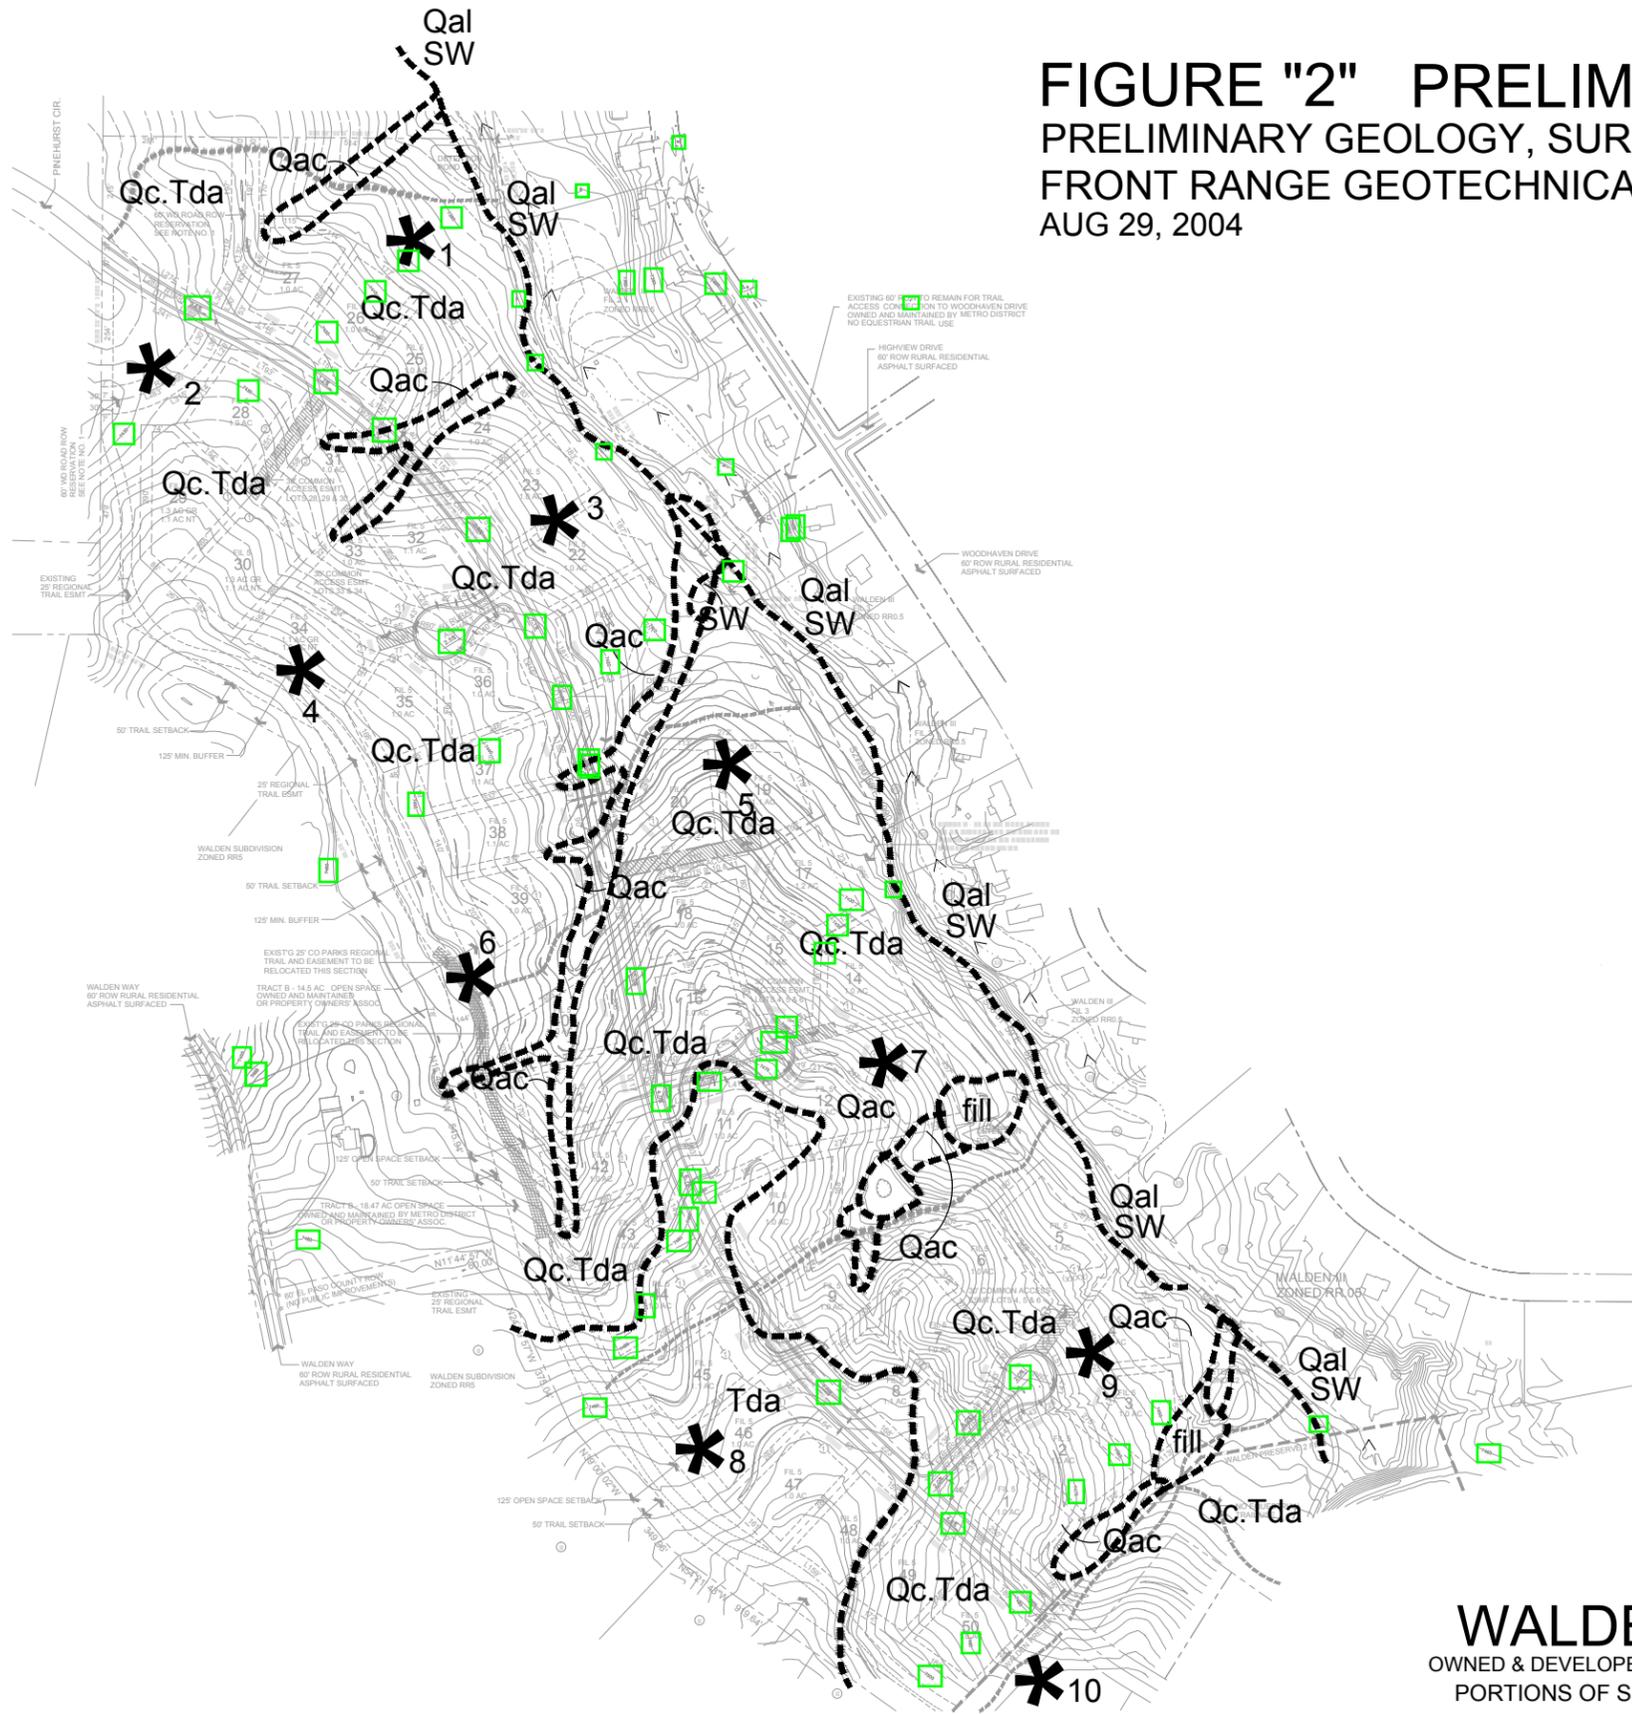
FIGURE "2" PRELIMINARY GEOLOGIC MAP

- Qal - RECENT ALLUVIUM IN FLOODPLAIN
- Qc - COLLUVIUM (SLOPEWASH)
- Qac - MIXED ALLUVIUM AND COLLUVIUM
- Tda - DAWSON ARKOSE FORMATION
- SW - SEASONALLY WET AREAS
- DA - DISTURBED AREAS
- fill - MAN-PLACED FILL
- 2 * - LOCATION AND NUMBER OF PERCOLATION TEST

The site is underlain by bedrock consisting of the Dawson Arkose (Figure 2). This formation consists primarily of discontinuous and lenticular beds of arkosic sandstone and claystone. Although the Dawson sandstones are commonly only slightly to moderately cemented, they are typically very dense. Few good outcrops (bedrock exposures) were observed on-site. The regional dip of the strata is very gentle to the north. Our experience in this area indicates the rocks are not highly fractured.

As shown on the Preliminary Geologic Map (Figure 2), alluvium/colluvium is found in a band paralleling the swales and drainageways on site. Although the smaller drainageways do not appear to carry surface water most of the time, it appears that erosion and flooding from thunderstorm runoff occasionally occurs. It should be noted that no drainage study was performed as part of this report and the flood plain and hazard zone should be defined by a more detailed drainage report. The simplest mitigation for flooding is avoidance, although channelization or elevation of structures may be appropriate in some areas. The larger drainageway on the site is being avoided by development except for two road crossings.

In order to evaluate site characteristics geologic mapping was performed and 20 percolation tests were performed (22% of the 87 lots). Drill Hole and test locations are shown on the attached Figure 2. Visual logs of the profile holes, a summary of percolation test results, and soil laboratory testing data can be found in Appendix A. Figure 3 is "Sewage Disposal Characteristics Map" and also shows slopes of 30% and greater.

Area I (Qc-Tda): Area I consists of that portion of the site characterized by thin to thicker surficial deposits and variable (but generally acceptable) percolation rates. These areas has been mapped as Qc-Tda on the enclosed Figure2 and are characterized by colluvial soils over the Dawson Arkose. With some exploration, it is felt that in most cases it will be possible to locate an acceptable soil absorption system in the Area I lots, although local slow percolation rates or shallow soils may be encountered in these areas and thus will require some form of alternate system.

Area II (Tda): Area II consists of that portion of the site interpreted to be underlain by shallow soils over weathered bedrock (mapped as Tda on Figure 2). In most of this area it is felt that bedrock may be too shallow and/or too impermeable for conventional soil absorption systems, and alternate systems will be required.

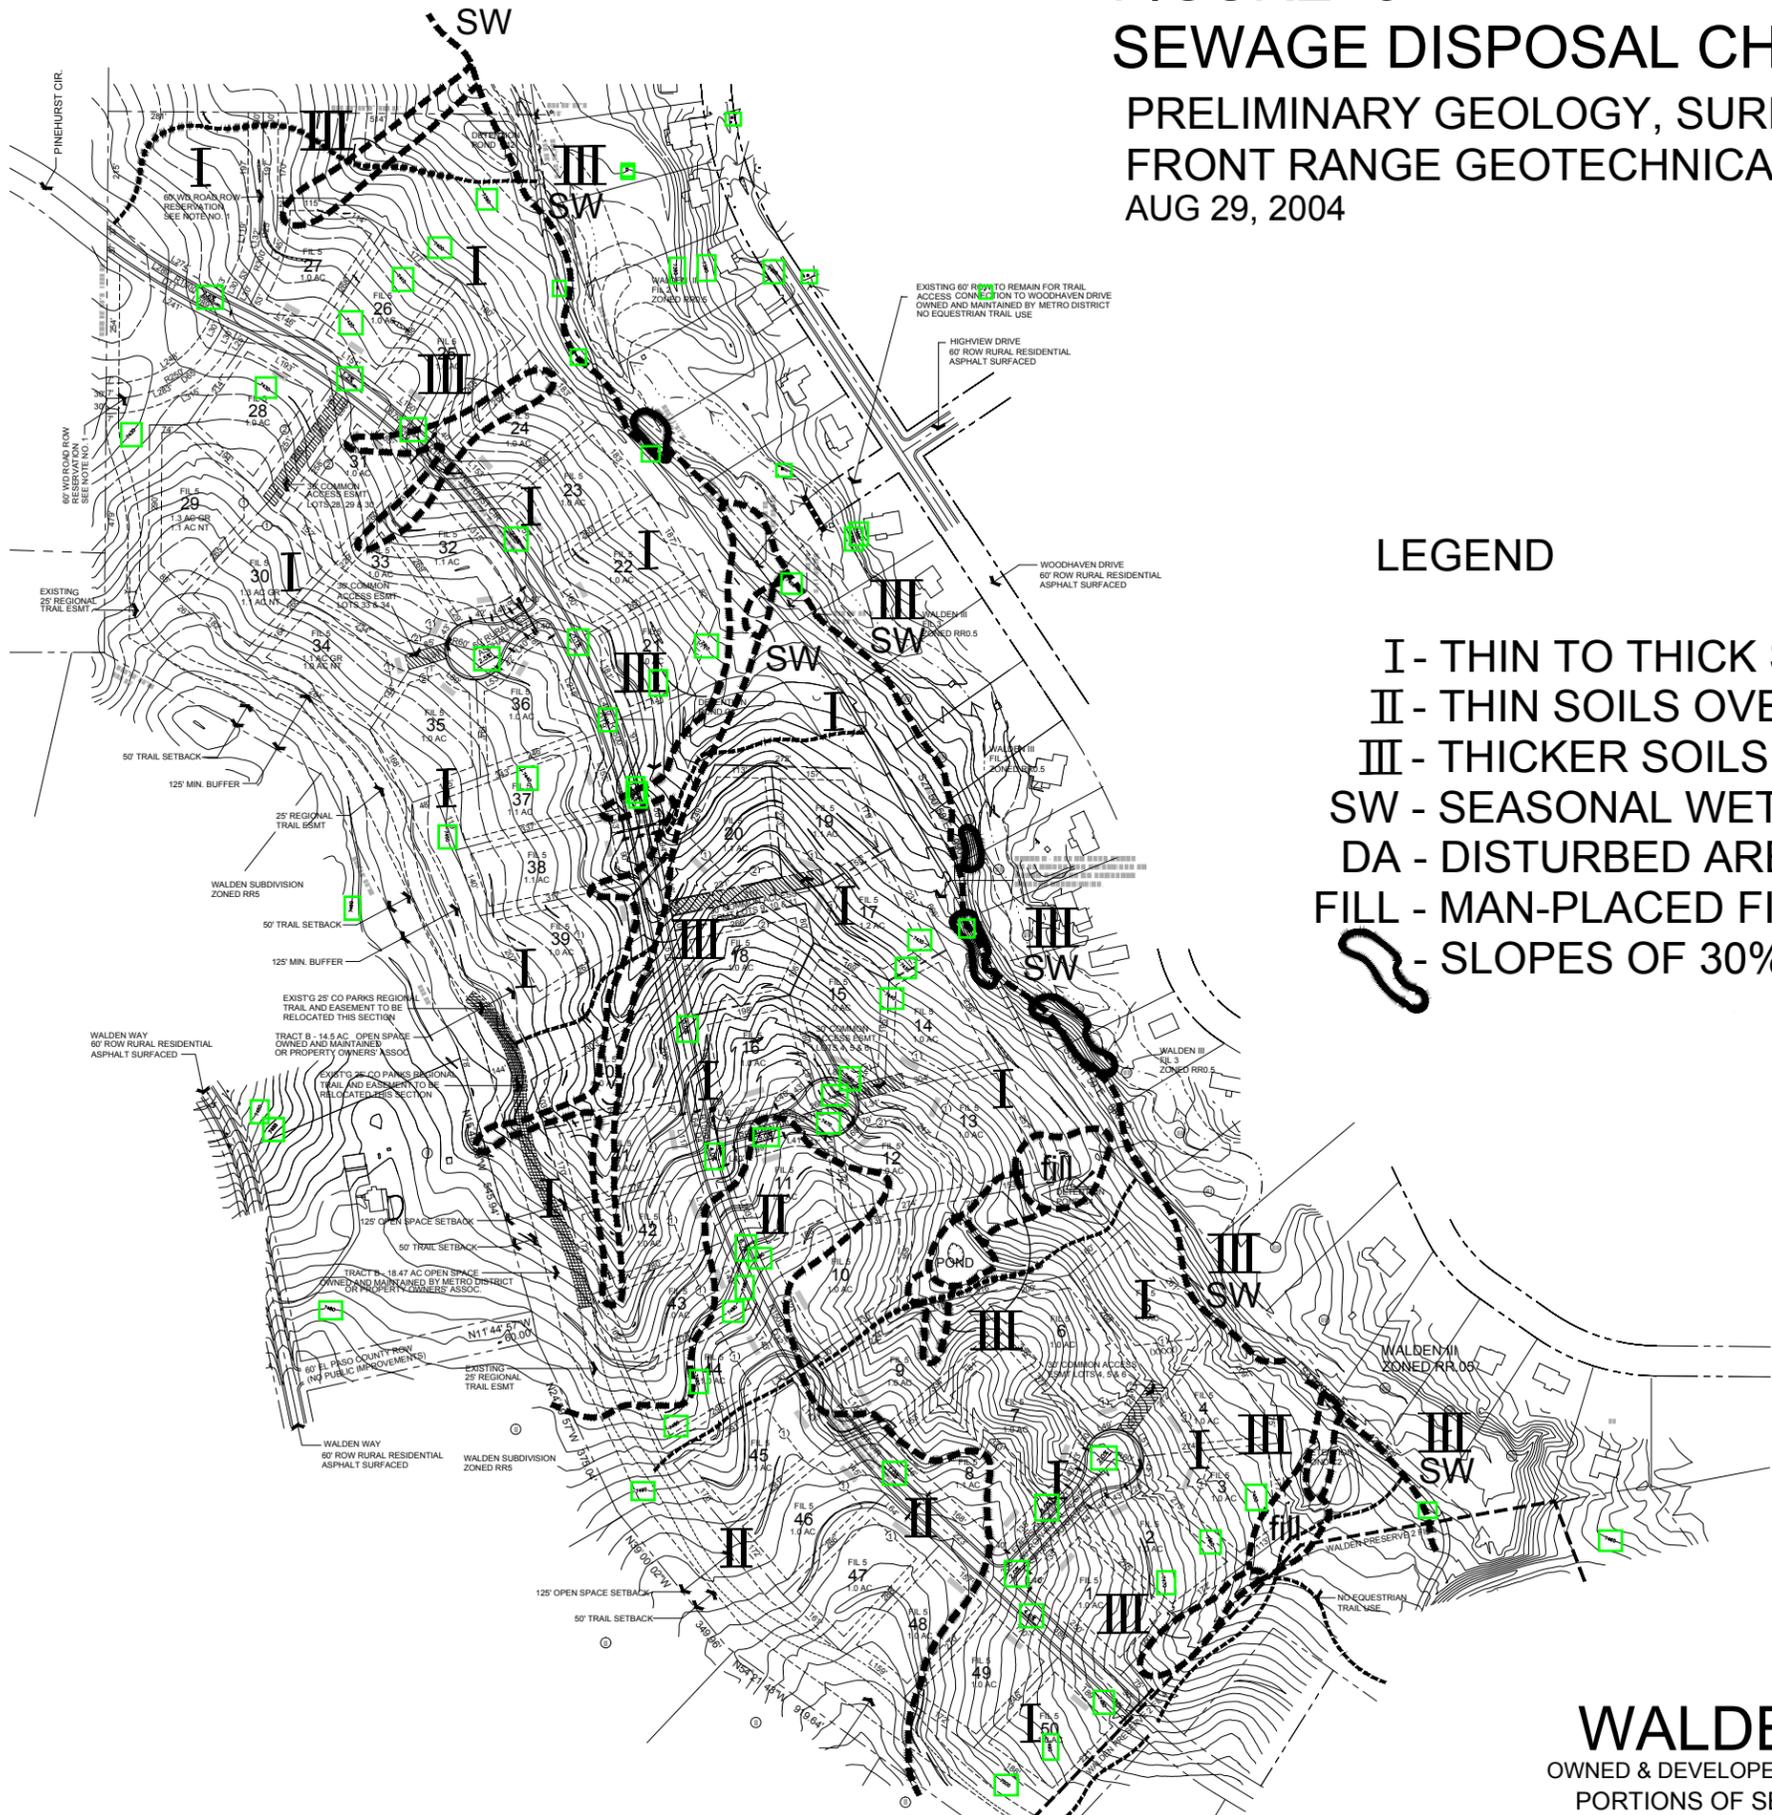
FIGURE "3" SEWAGE DISPOSAL CHARACTERISTICS MAP

- I - THIN TO THICK SURFICIAL EPOSITS OVR AWSON ARKOSE BEDROCK
- II - THIN SOILS OVER DAWSON ARKOSE BEDROCK
- III - THICKER SOILS IN SWAILS AND DRAINAGES
- SW - SEASONAL WET AREAS
- DA - DISTURBED AREAS
- FILL - MAN-PLACED FILL
- SLOPES OF 30% OR GREATER

Based upon the geologic characteristics and constraints as observed, profile holes, and experience, sewage disposal characteristics and limitations have been analyzed. These various areas and limitations are shown on Figure 2 and 3, and a discussion of these follows.
