FRONT RANGE GEOTECHNICAL INC.

PRELIMINARY GEOLOGY, SURFACE SOILS, AND SEWAGE DISPOSAL EVALUATION  
**WALDEN PRESERVE SUBDIVISION**  
EL PASO COUNTY, CO

AUGUST 29, 2004

AMENDED June 25, 2022

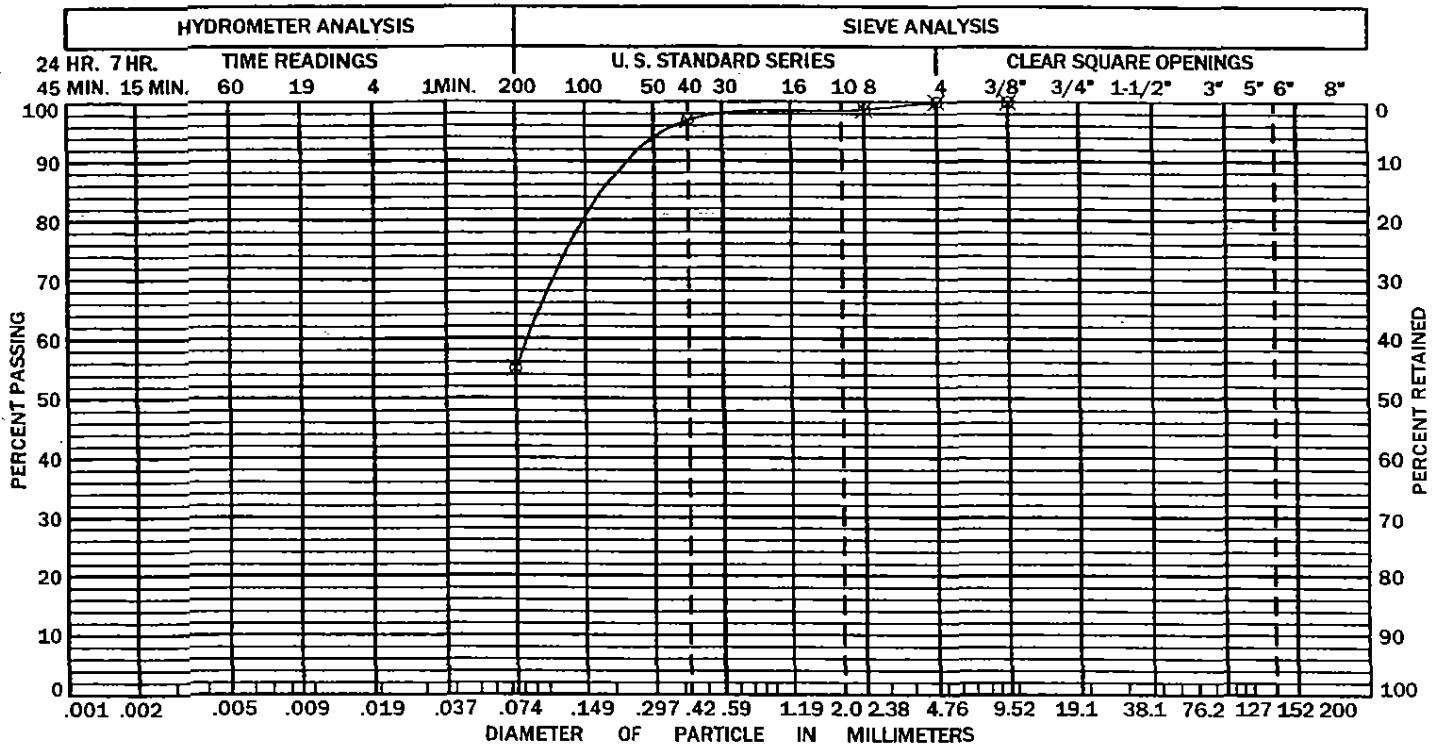
## GRADATION TEST RESULTS

CLAY TO SILT			SAND			GRAVEL		COBBLES
			FINE	MEDIUM	COARSE	FINE	COARSE	
CLASSIFICATION	ML		NOTES: 6.0 % Moisture content					
GRAVEL	0.0 %		LL = 23.6 %					
SAND	45.5 %		PL = 20.7 %					
FINES	54.5 %		PI = 2.9 %					
SAMPLE#	1	HOLE#	TH-1	DEPTH	10	FEET	Job #:	11411 By: KO 05/13/2003

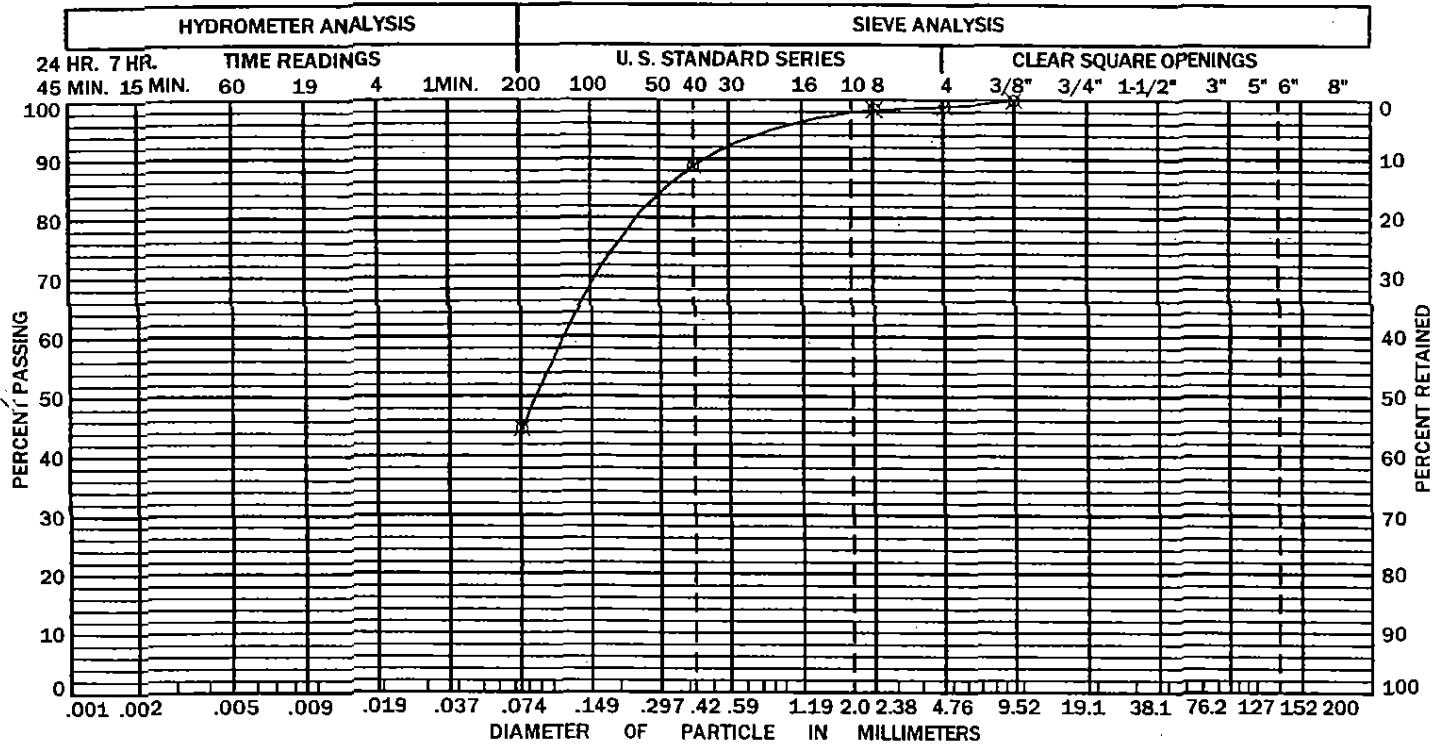
## GRADATION TEST RESULTS

CLAY TO SILT		SAND			GRAVEL		COBBLES
		FINE	MEDIUM	COARSE	FINE	COARSE	
CLASSIFICATION	SM/SC	NOTES: 13.4 % Moisture content					
GRAVEL	0.2 %	LL = 23.4 %					
SAND	55.3 %	PL = 18.6 %					
FINES	44.5 %	PI = 4.8 %					
SAMPLE#	1	HOLE#	TH-2	DEPTH	4	FEET	Job #: 11411 By: KO 05/13/2003

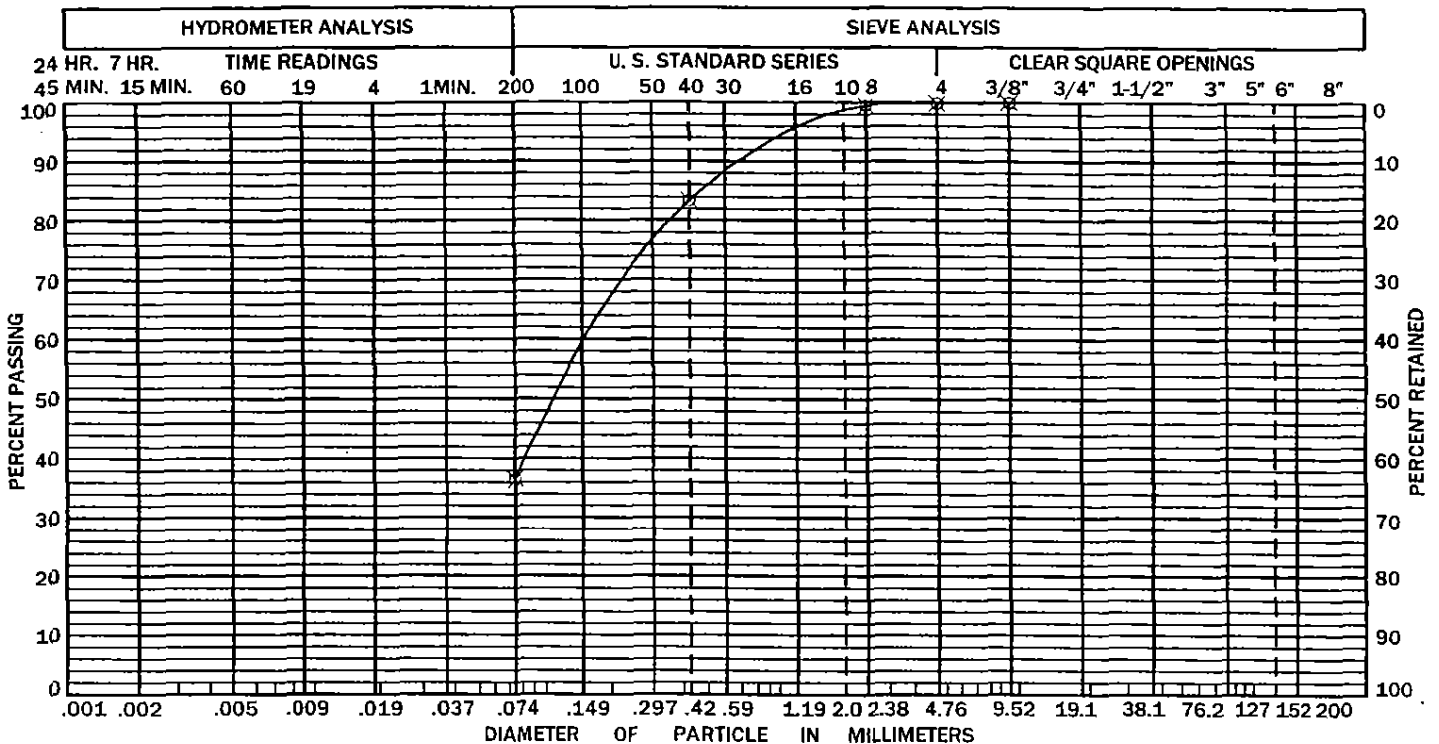
## GRADATION TEST RESULTS

CLAY TO SILT		SAND			GRAVEL		COBBLES
		FINE	MEDIUM	COARSE	FINE	COARSE	
CLASSIFICATION	SM	NOTES: 7.9 % Moisture content					
GRAVEL	0.1 %	LL = COULD NOT BE DETERMINED					
SAND	63.4 %	PL = NON PLASTIC					
FINES	36.5 %						
SAMPLE#	1	HOLE#	TH-3	DEPTH	4	FEET

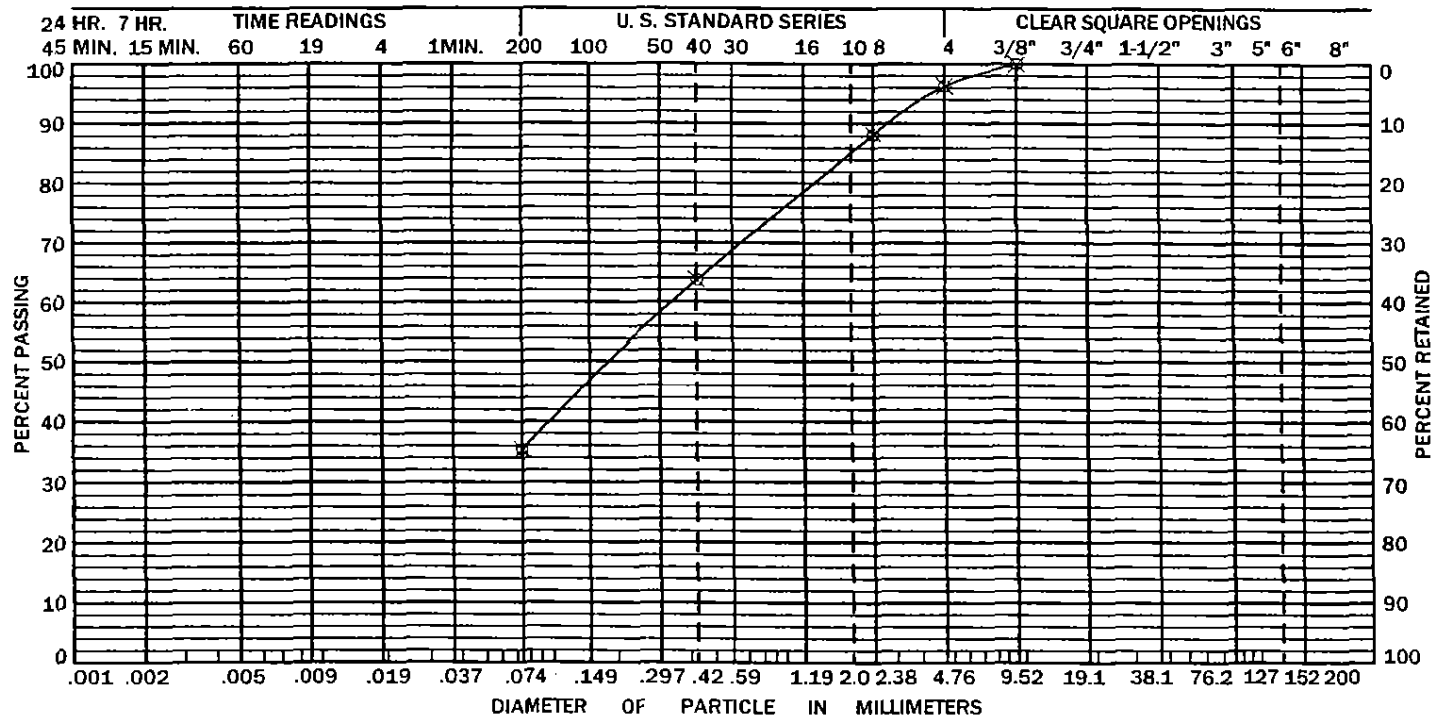
CLAY TO SILT		SAND			GRAVEL		COBBLES				
		FINE	MEDIUM	COARSE	FINE	COARSE					
CLASSIFICATION	SM	NOTES: 10.9 % Moisture content									
GRAVEL	3.7 %	LL = 20.4 %									
SAND	61.0 %	PL = 16.8 %									
FINES	35.3 %	PI = 3.6 %									
SAMPLE#	1	HOLE#	TH-3	DEPTH	10	FEET	Job #:	11411	By:	KO	5/13/2003

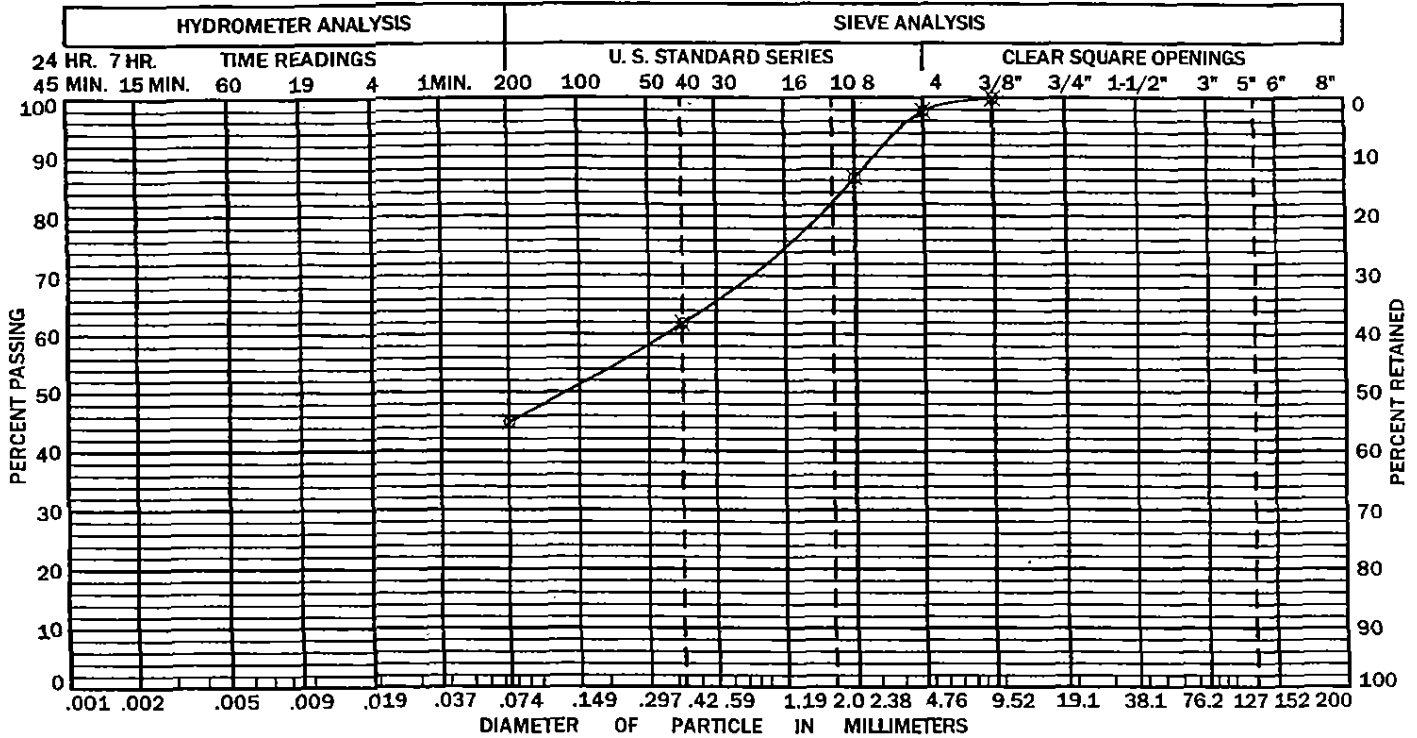
## GRADATION TEST RESULTS

CLAY TO SILT		SAND			GRAVEL		COBBLES
		FINE	MEDIUM	COARSE	FINE	COARSE	
CLASSIFICATION	SC	NOTES: 10.0 % Moisture content					
GRAVEL	2.3 %	LL = 28.2 %					
SAND	52.8 %	PL = 20.0 %					
FINES	44.9 %	PI = 8.2 %					
SAMPLE#	1	HOLE#	TH-4	DEPTH	10	FEET	Job #: 11411 By: KO 5/13/2003

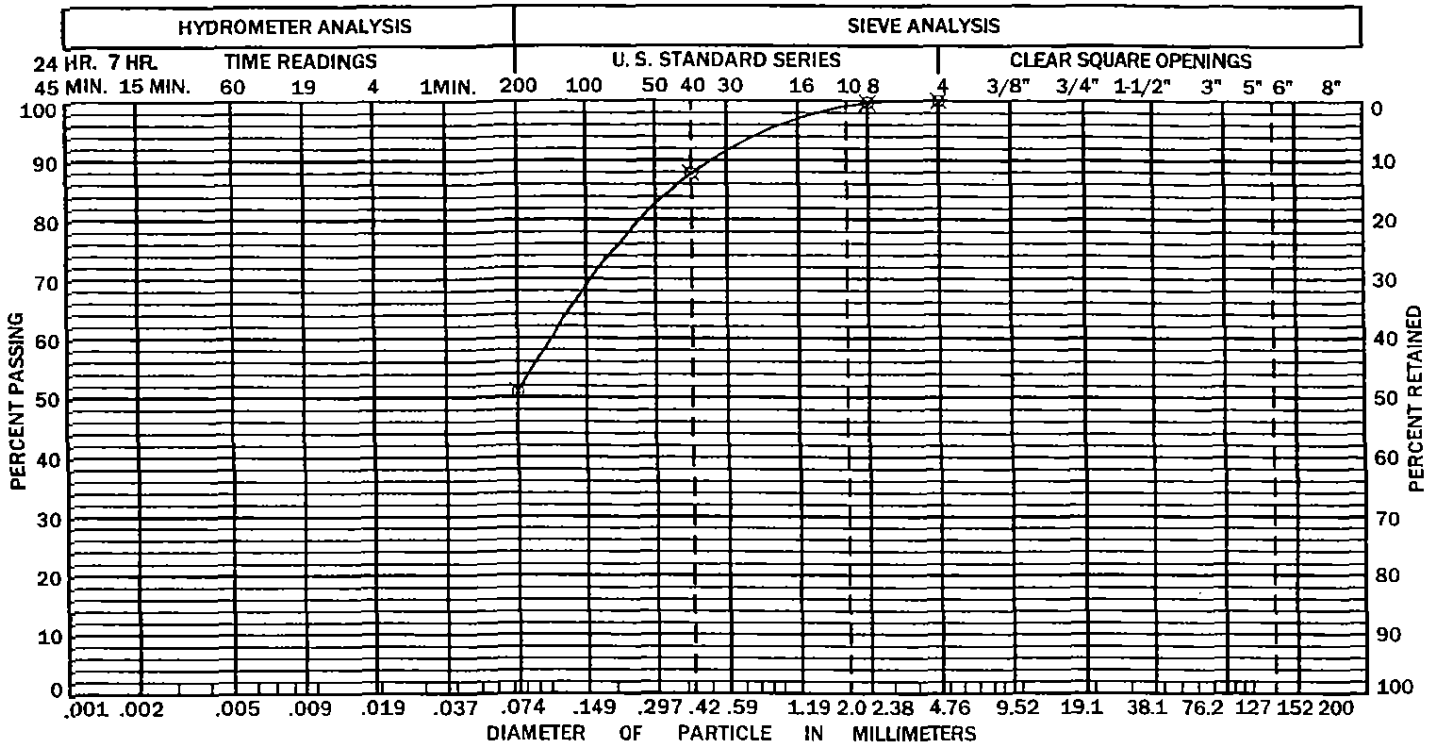
## GRADATION TEST RESULTS

CLAY TO SILT		SAND			GRAVEL		COBBLES
		FINE	MEDIUM	COARSE	FINE	COARSE	
CLASSIFICATION	ML	NOTES: 13.7 % Moisture content					
GRAVEL	0.0 %	LL = 21.6 %					
SAND	49.1 %	PL = 18.7 %					
FINES	50.9 %	PL = 2.9 %					
SAMPLE#	1	HOLE#	TH-5	DEPTH	2	FEET

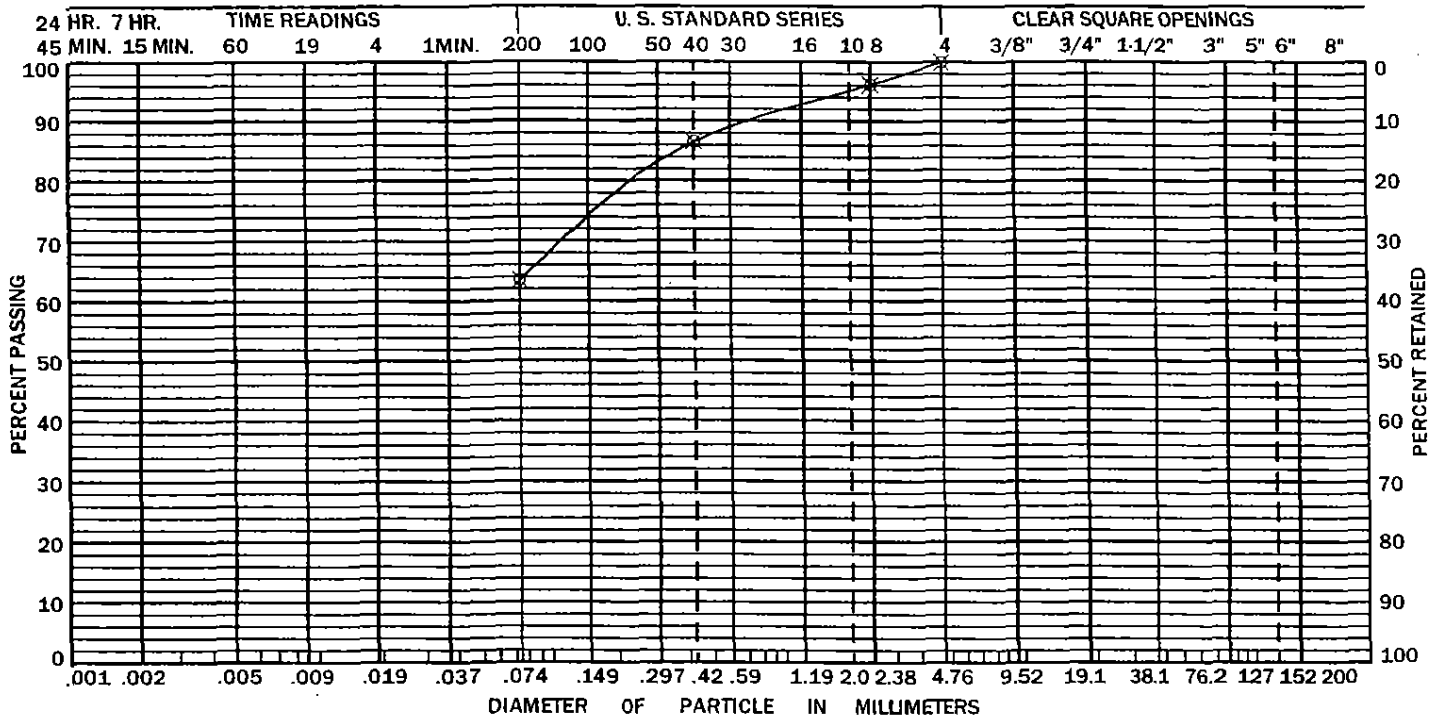
CLAY TO SILT		SAND			GRAVEL		COBBLES
		FINE	MEDIUM	COARSE	FINE	COARSE	
CLASSIFICATION	CL/ML	NOTES: 14.5 % Moisture content					
GRAVEL	0.0 %	LL = 27.0 %					
SAND	36.5 %	PL = 21.0 %					
FINES	63.5 %	PI = 6.0 %					
SAMPLE#	1	HOLE#	TH-5	DEPTH	10	FEET	
		Job #:		11411	By:	KO	5/13/2003

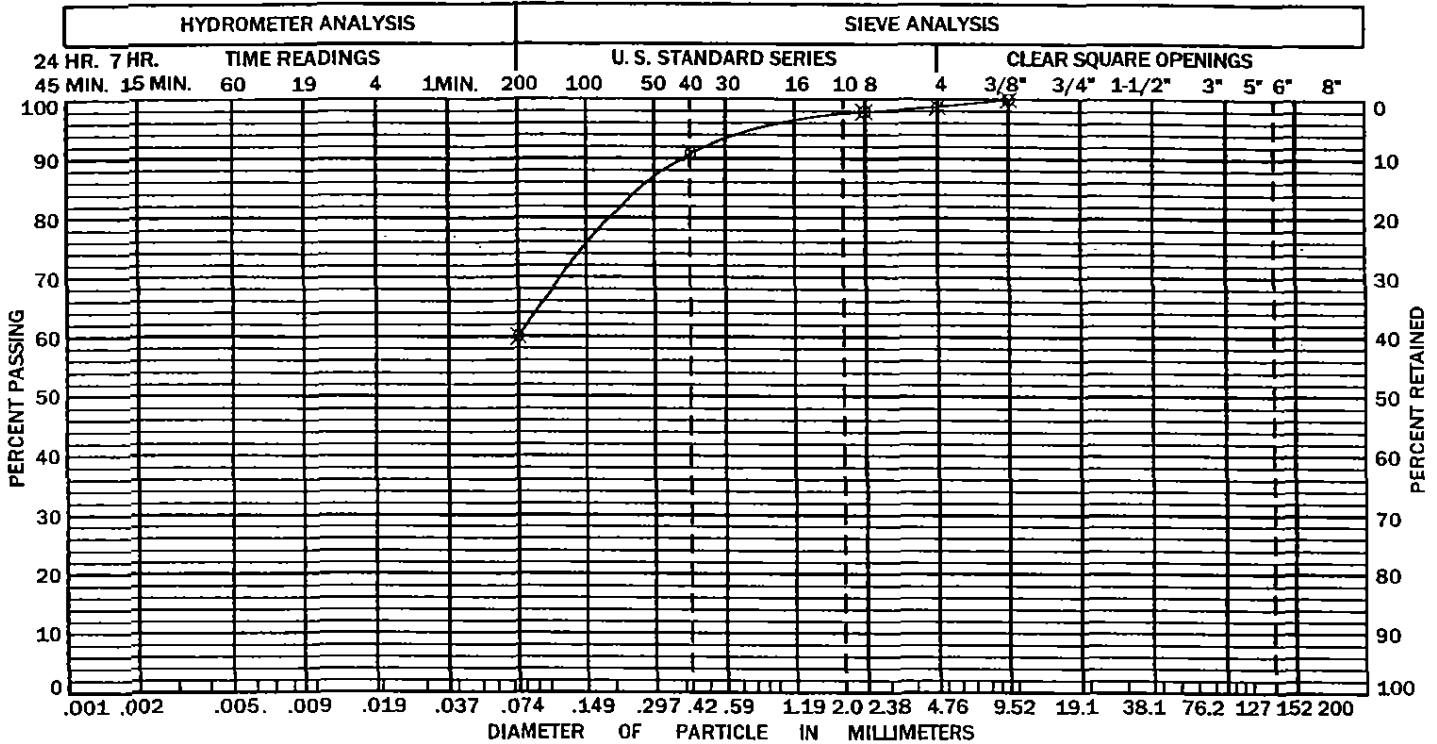
## GRADATION TEST RESULTS

CLAY TO SILT		SAND			GRAVEL		COBBLES
		FINE	MEDIUM	COARSE	FINE	COARSE	
CLASSIFICATION	CL	NOTES: 14.4 % Moisture content					
GRAVEL	0.3 %	LL = 26.3 %					
SAND	39.5 %	PL = 17.9 %					
FINES	60.2 %	PI = 8.4 %					
SAMPLE#	1	HOLE#	TH-6	DEPTH	10	FEET	Job #: 11411 By: KO 05/13/2003

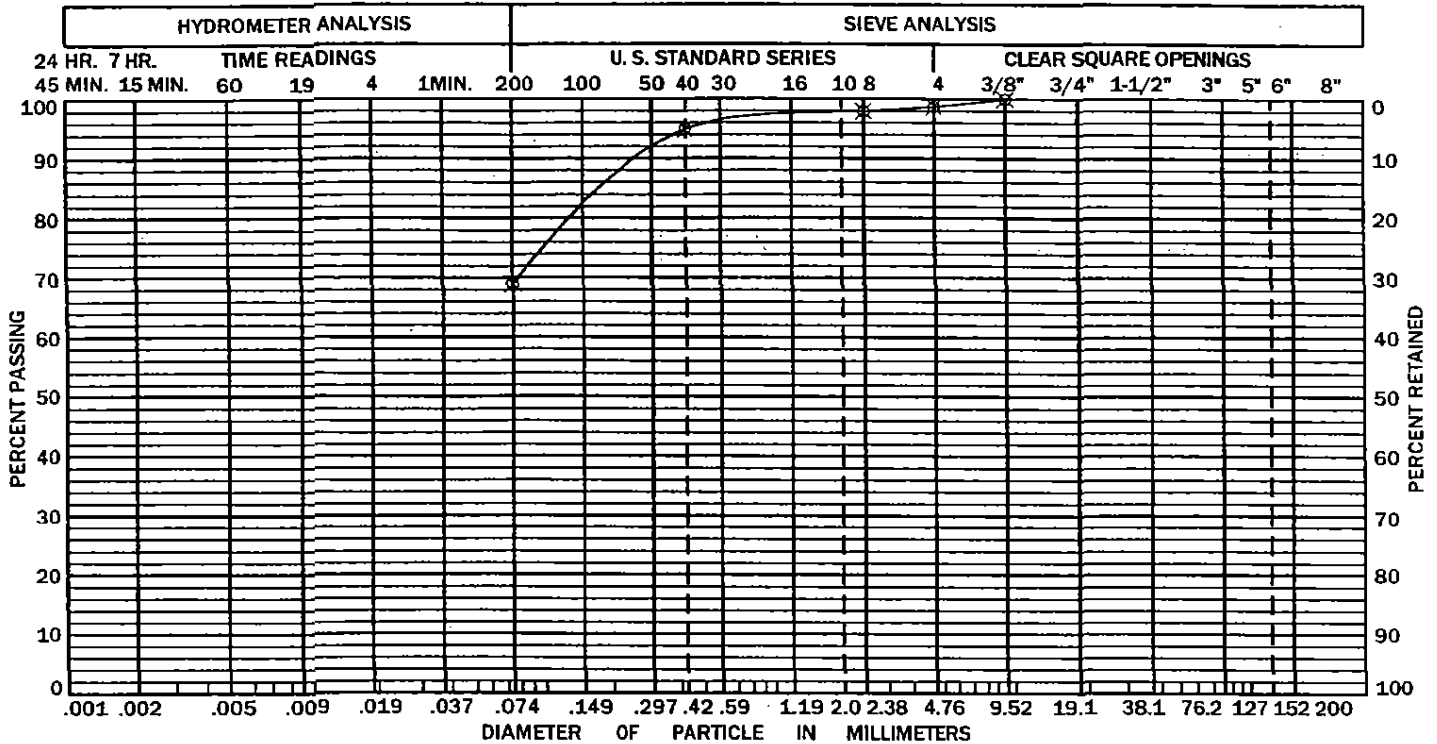
## GRADATION TEST RESULTS

CLAY TO SILT		SAND			GRAVEL		COBBLES
		FINE	MEDIUM	COARSE	FINE	COARSE	
CLASSIFICATION	ML	NOTES: 9.6 % Moisture content					
GRAVEL	0.5 %	LL = 25.4 %					
SAND	30.2 %	PL = 24.0 %					
FINES	69.3 %	PI = 1.4 %					
SAMPLE#	1	HOLE#	TH-7	DEPTH	4	FEET	Job #: 11411 By: KO 05/13/2003

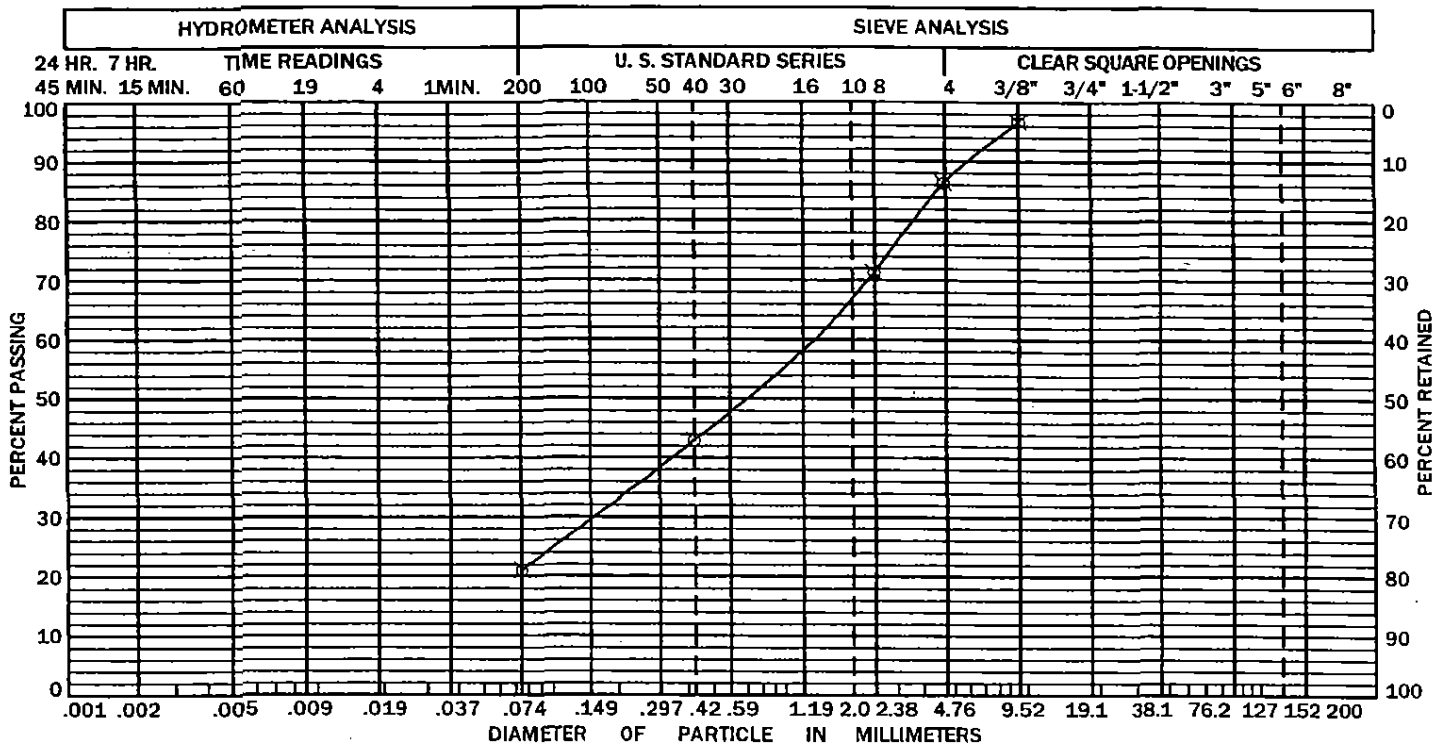
## GRADATION TEST RESULTS

CLAY TO SILT		SAND			GRAVEL		COBBLES
		FINE	MEDIUM	COARSE	FINE	COARSE	
CLASSIFICATION	SM	NOTES: 6.5 % Moisture content					
GRAVEL	14.3 %	LL = 20.6 %					
SAND	64.7 %	PL = 17.9 %					
FINES	21.0 %	PI = 2.7 %					
SAMPLE#	1	HOLE#	TH-8	DEPTH	4	FEET	Job #: 11411 By: KO 05/13/2003

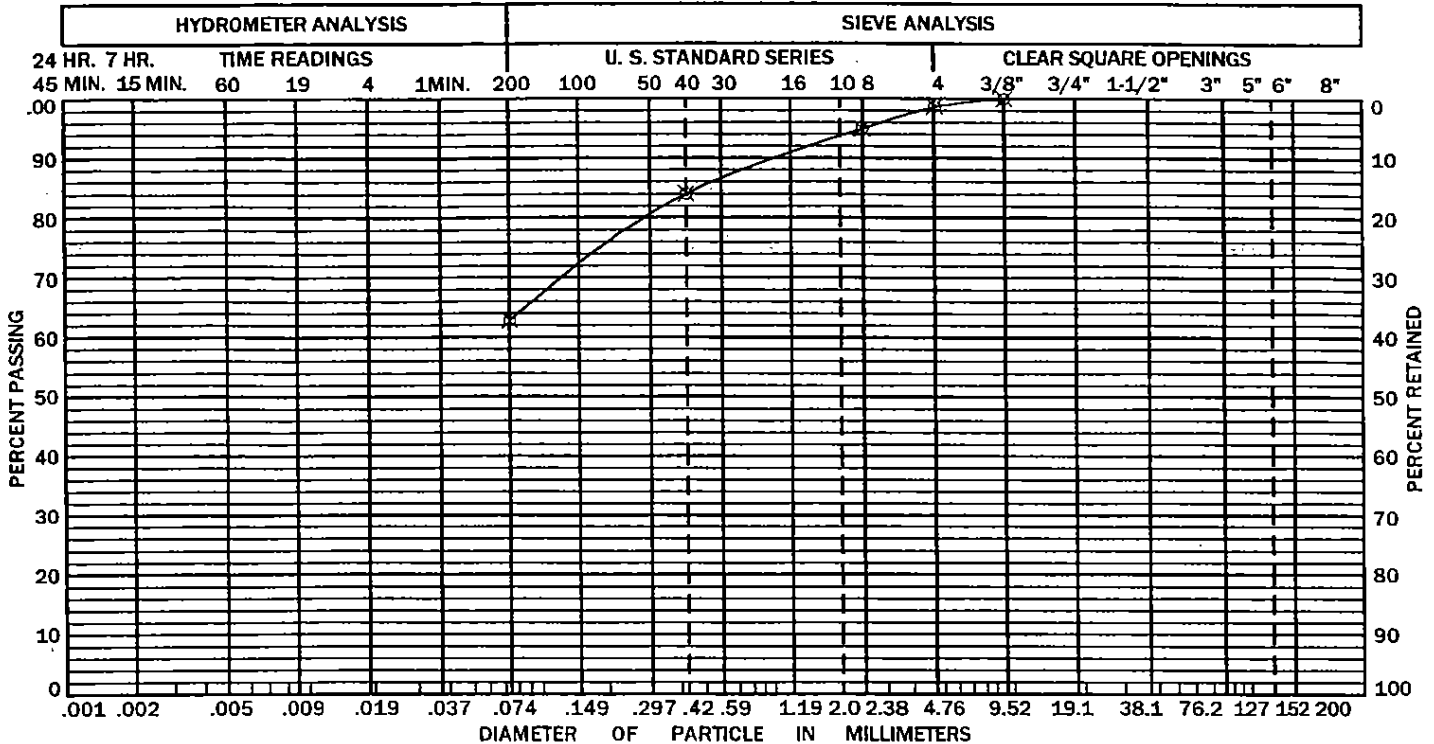
## GRADATION TEST RESULTS

CLAY TO SILT		SAND			GRAVEL		COBBLES	
		FINE	MEDIUM	COARSE	FINE	COARSE		
CLASSIFICATION	CL	NOTES: 15.8 % Moisture content						
		LL = 28.6 %						
		PL = 21.1 %						
		PI = 7.5 %						
		Job #: 11411 By: KO 05/11/2003						
GRAVEL	1.0 %							
SAND	36.2 %							
FINES	62.8 %							
SAMPLE#	1	HOLE#	TH-9	DEPTH	10	FEET

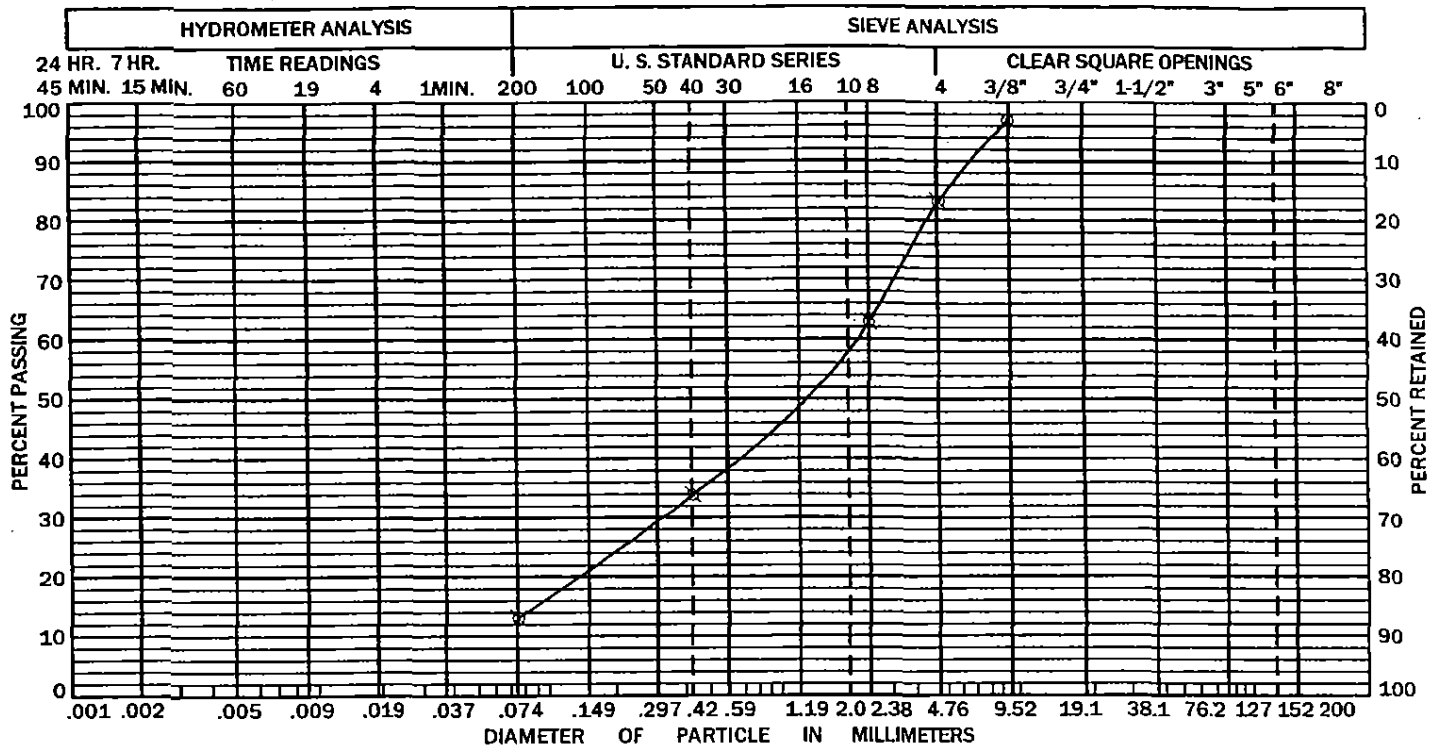
## GRADATION TEST RESULTS

CLAY TO SILT	SAND			GRAVEL		COBBLES
	FINE	MEDIUM	COARSE	FINE	COARSE	
CLASSIFICATION	SC					NOTES: 9.7 % Moisture content
GRAVEL	16.9 %					LL = 26.4 %
SAND	60.3 %					PL = 19.2 %
FINES	22.8 %					PI = 7.2 %
SAMPLE#	1	HOLE#	TH-10	DEPTH	10 FEET	Job #: 11411 By: KO 05/13/2003

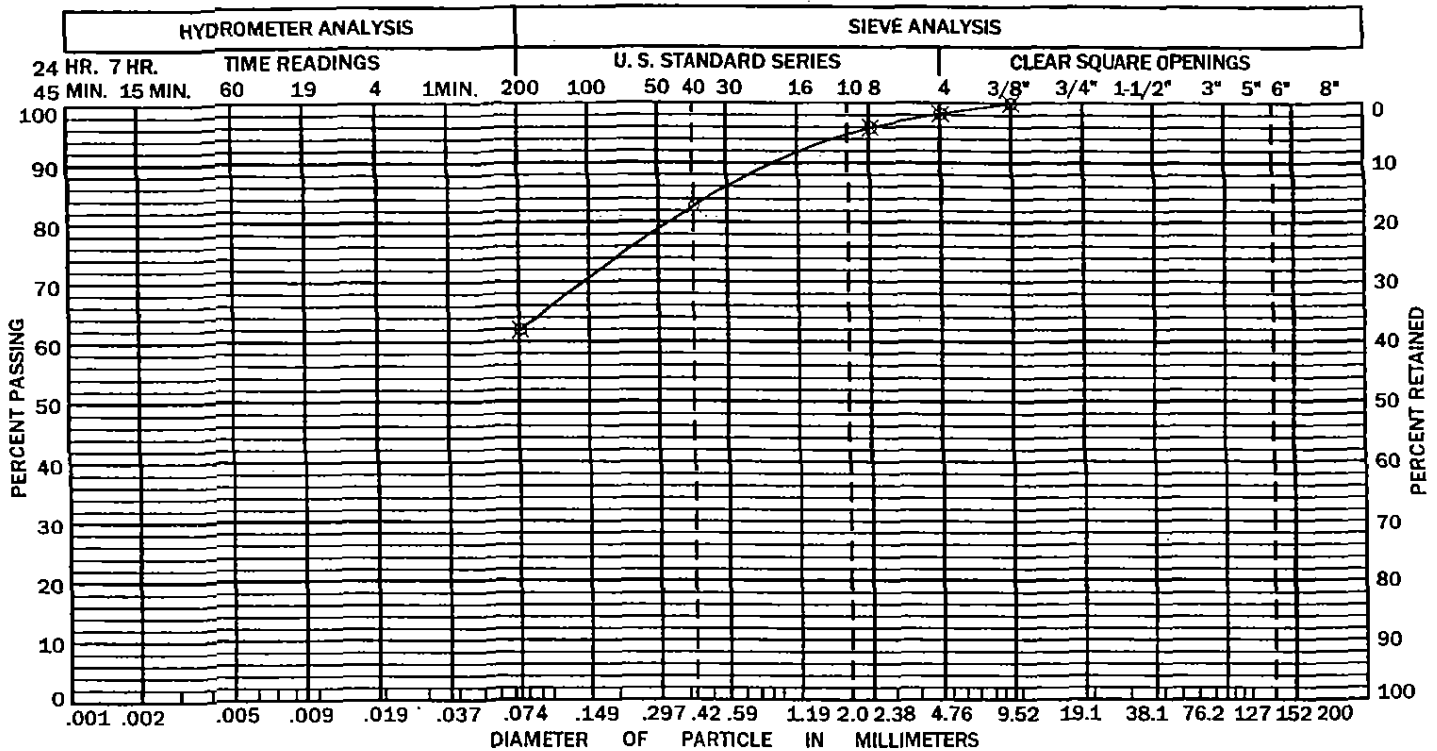
## GRADATION TEST RESULTS

CLAY TO SILT		SAND			GRAVEL		COBBLES
		FINE	MEDIUM	COARSE	FINE	COARSE	
CLASSIFICATION	CL/ML	NOTES: 12.5 % Moisture content					
GRAVEL	1.5 %	LL = 23.4 %					
SAND	36.6 %	PL = 18.1 %					
FINES	61.9 %	PI = 5.3 %					
SAMPLE#	1	HOLE#	TH-12	DEPTH	4	FEET	Job #: 11411 By: KO 05/13/2003

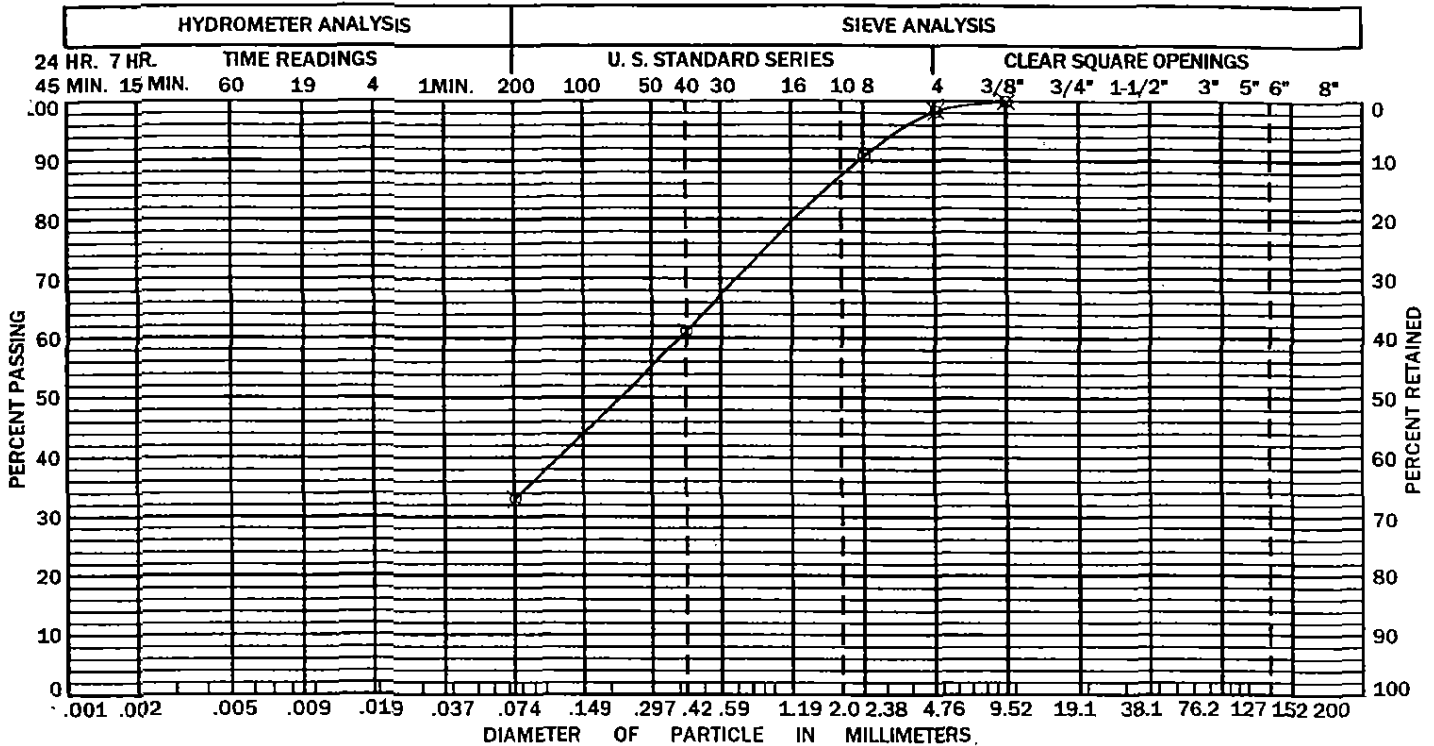
## GRADATION TEST RESULTS

CLAY TO SILT		SAND			GRAVEL		COBBLES				
		FINE	MEDIUM	COARSE	FINE	COARSE					
CLASSIFICATION	SM	NOTES: 6.7 % Moisture content									
GRAVEL	1.5 %	LL = 15.8 %									
SAND	65.3 %	PL = 15.5 %									
FINES	33.2 %	PI = 0.3 %									
SAMPLE#	1	HOLE#	TH-13	DEPTH	4	FEET	Job #:	11411	By:	KO	05/13/2003

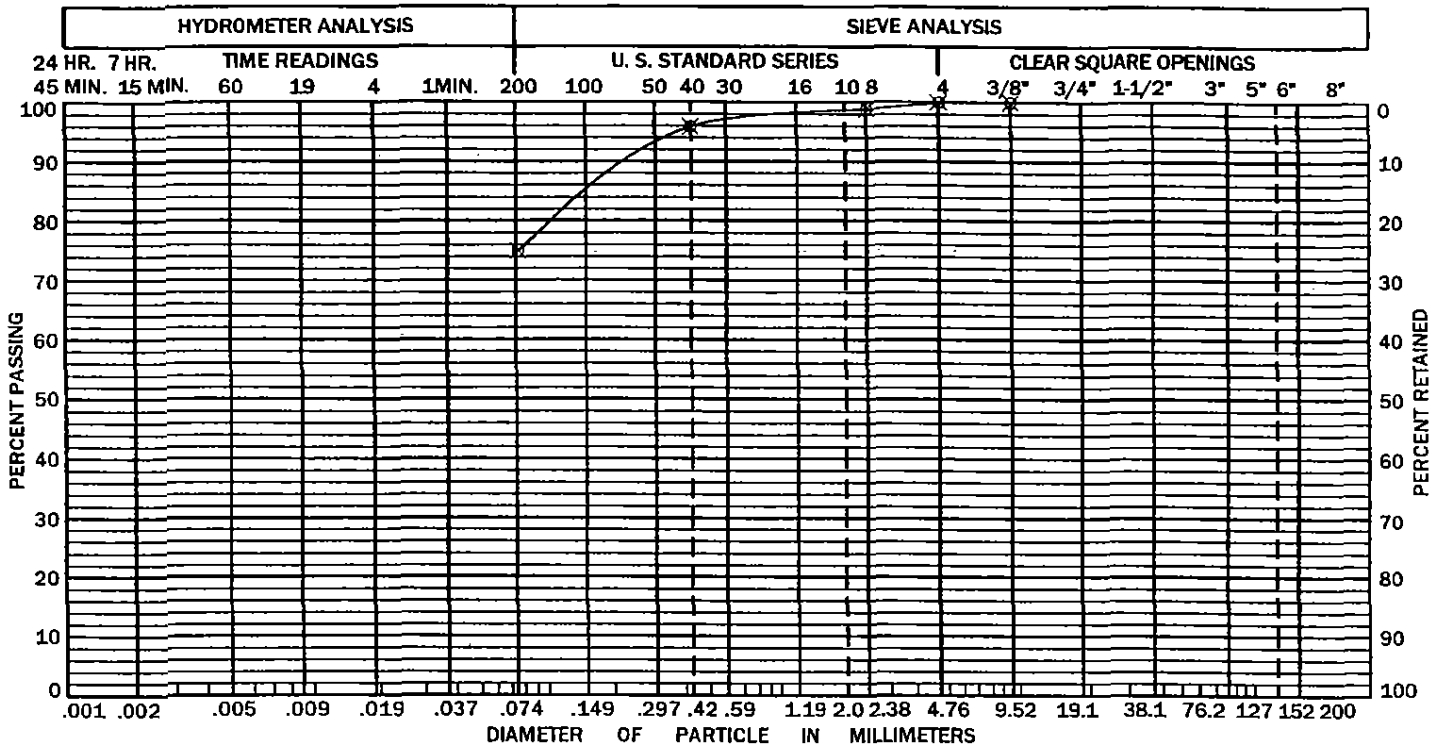
## GRADATION TEST RESULTS

CLAY TO SILT		SAND			GRAVEL		COBBLES
		FINE	MEDIUM	COARSE	FINE	COARSE	
CLASSIFICATION	CL	NOTES: 14.3 % Moisture content					
GRAVEL	0.0 %	LL = 27.7 %					
SAND	25.0 %	PL = 19.2 %					
FINES	75.0 %	PI = 8.5 %					
SAMPLE#	1	HOLE#	TH-14	DEPTH	10	FEET	Job #: 11411 By: K0 05/13/2003

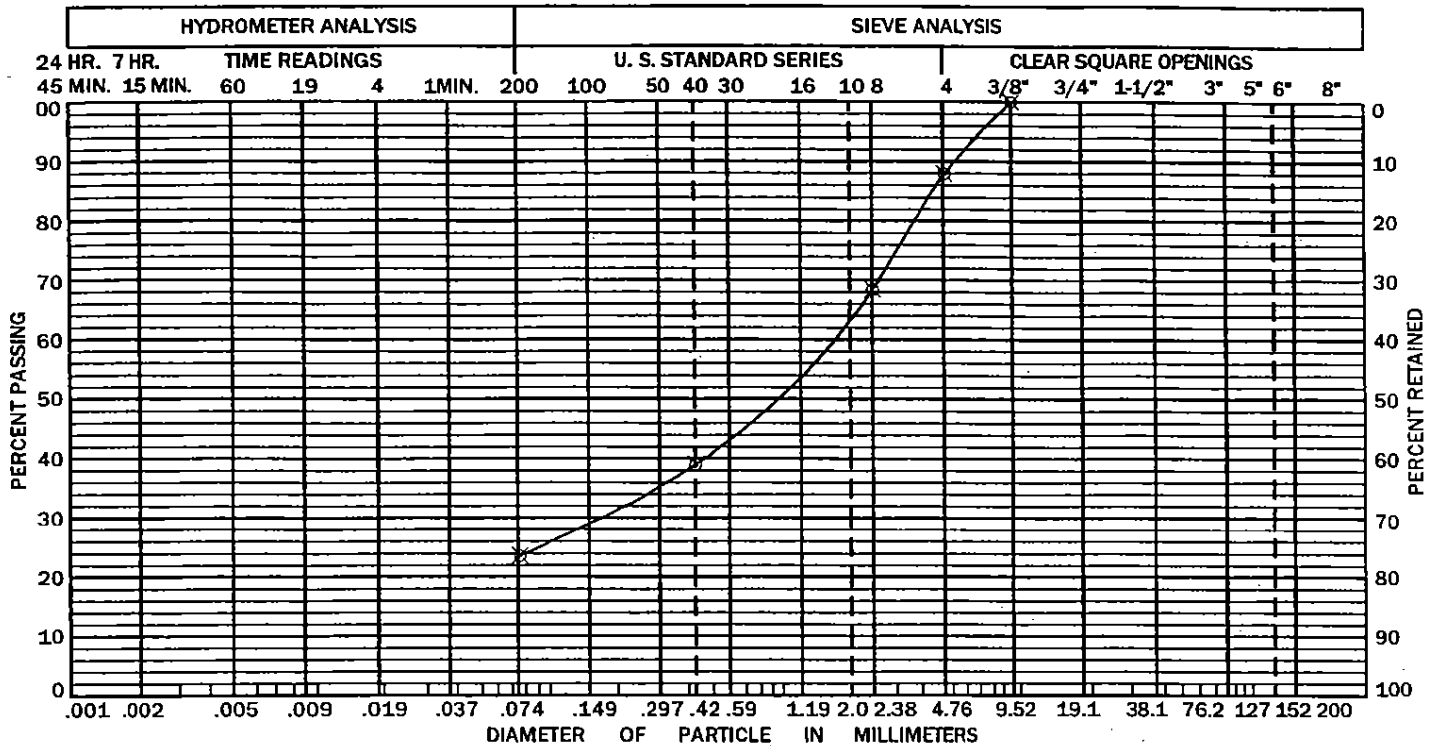
## GRADATION TEST RESULTS

CLAY TO SILT		SAND			GRAVEL		COBBLES			
		FINE	MEDIUM	COARSE	FINE	COARSE				
CLASSIFICATION	SC	NOTES: 8.2 % Moisture content								
GRAVEL	12.2 %	LL = 33.6 %								
SAND	64.3 %	PL = 21.5 %								
FINES	23.5 %	PI = 12.1 %								
SAMPLE#	1	HOLE# TH-15		DEPTH 10 FEET		Job #:		11411	By:	KO

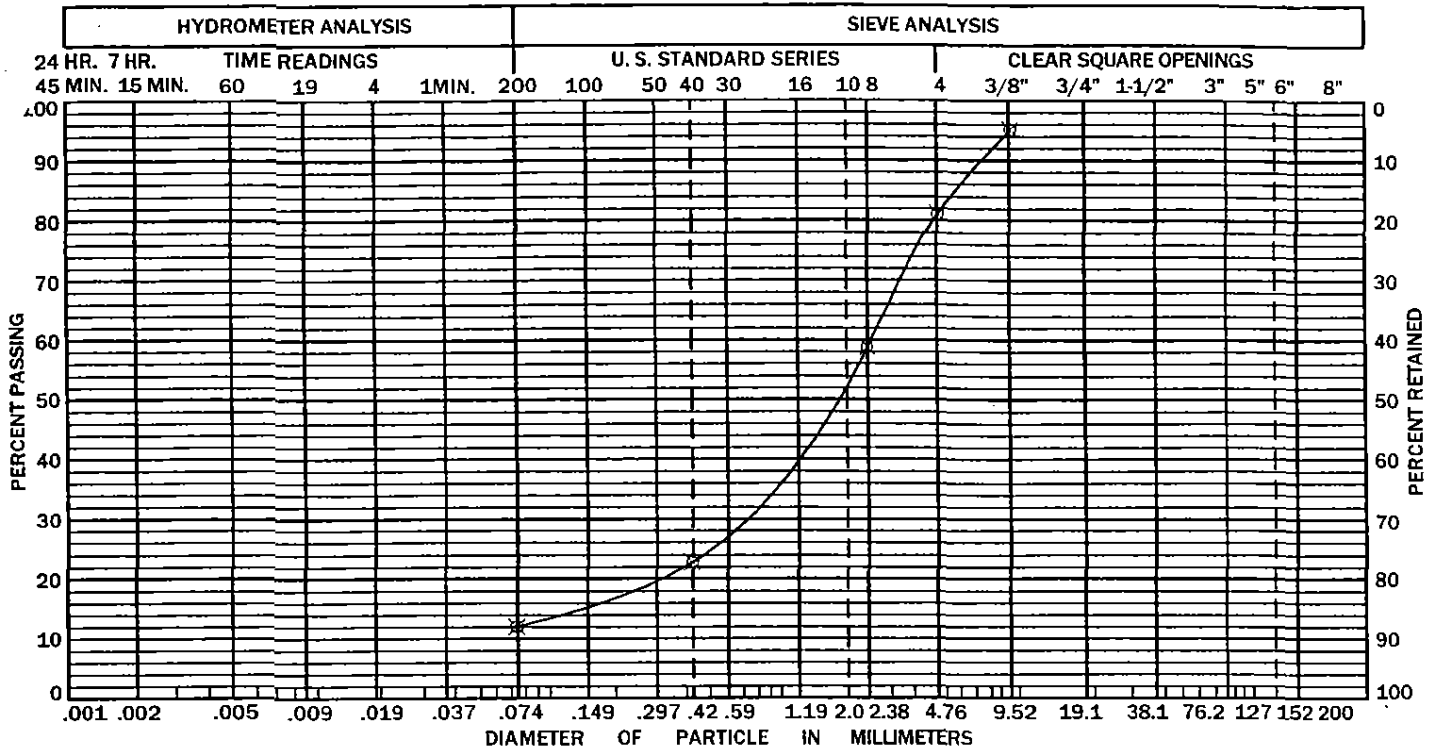
## GRADATION TEST RESULTS

CLASSIFICATION SC  
GRAVEL 19.4 %  
SAND 68.6 %  
FINES 12.0 %

NOTES: 4.9 % Moisture content  
LL = 31.4 %  
PL = 23.0 %  
PI = 8.4 %

SAMPLE# 1 HOLE# TH-16 DEPTH 4 FEET

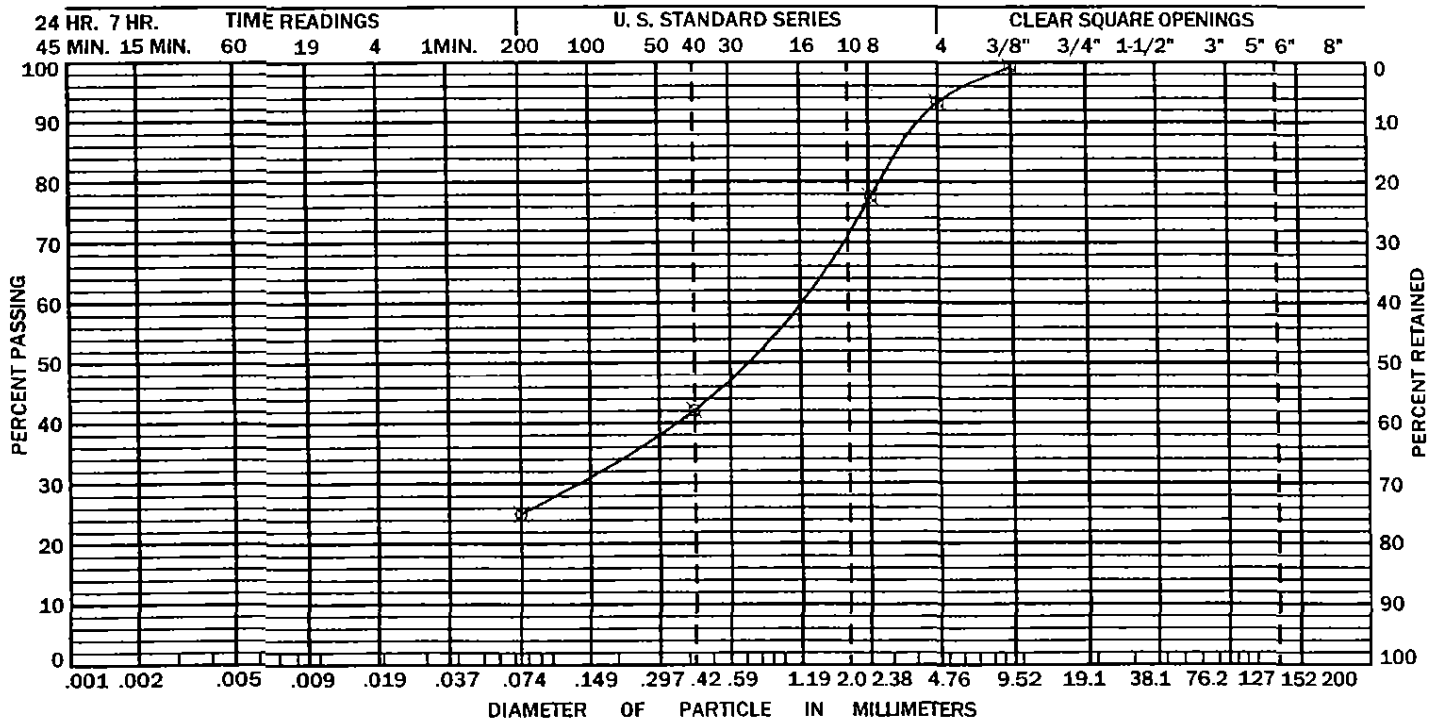
CLASSIFICATION SC  
GRAVEL 6.4 %  
SAND 68.6 %  
FINES 25.0 %

NOTES: 9.1 % Moisture content  
LL = 30.9 %  
PL = 20.8 %  
PI = 10.1 %

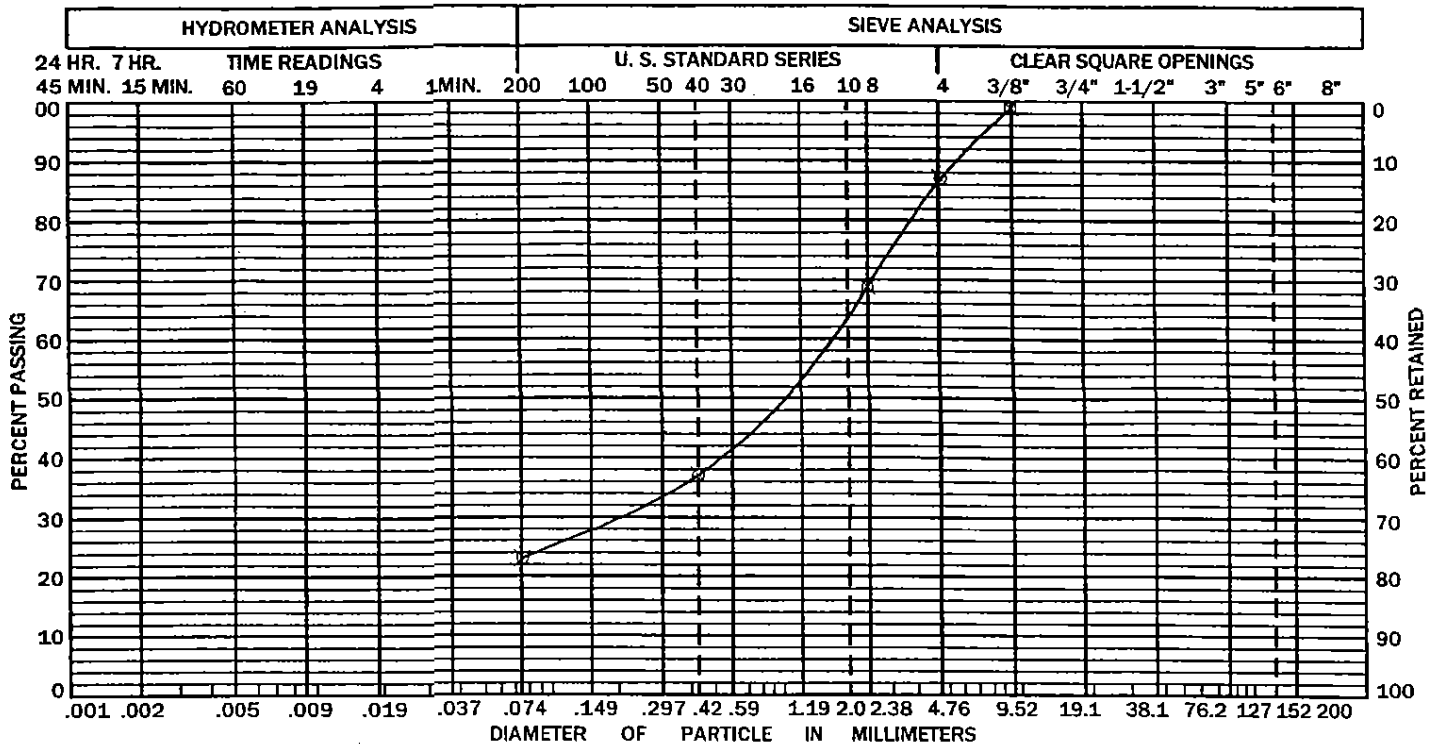
## GRADATION TEST RESULTS

CLAY TO SILT			SAND			GRAVEL		COBBLES			
			FINE	MEDIUM	COARSE	FINE	COARSE				
CLASSIFICATION	SC	NOTES: 7.6 % Moisture content									
GRAVEL	13.3 %	LL = 31.3 %									
SAND	63.8 %	PL = 20.3 %									
FINES	22.9 %	PI = 11.0 %									
SAMPLE#	1	HOLE#	TH-17	DEPTH	10	FEET	Job #:	11411	By:	KO	05/13/2003

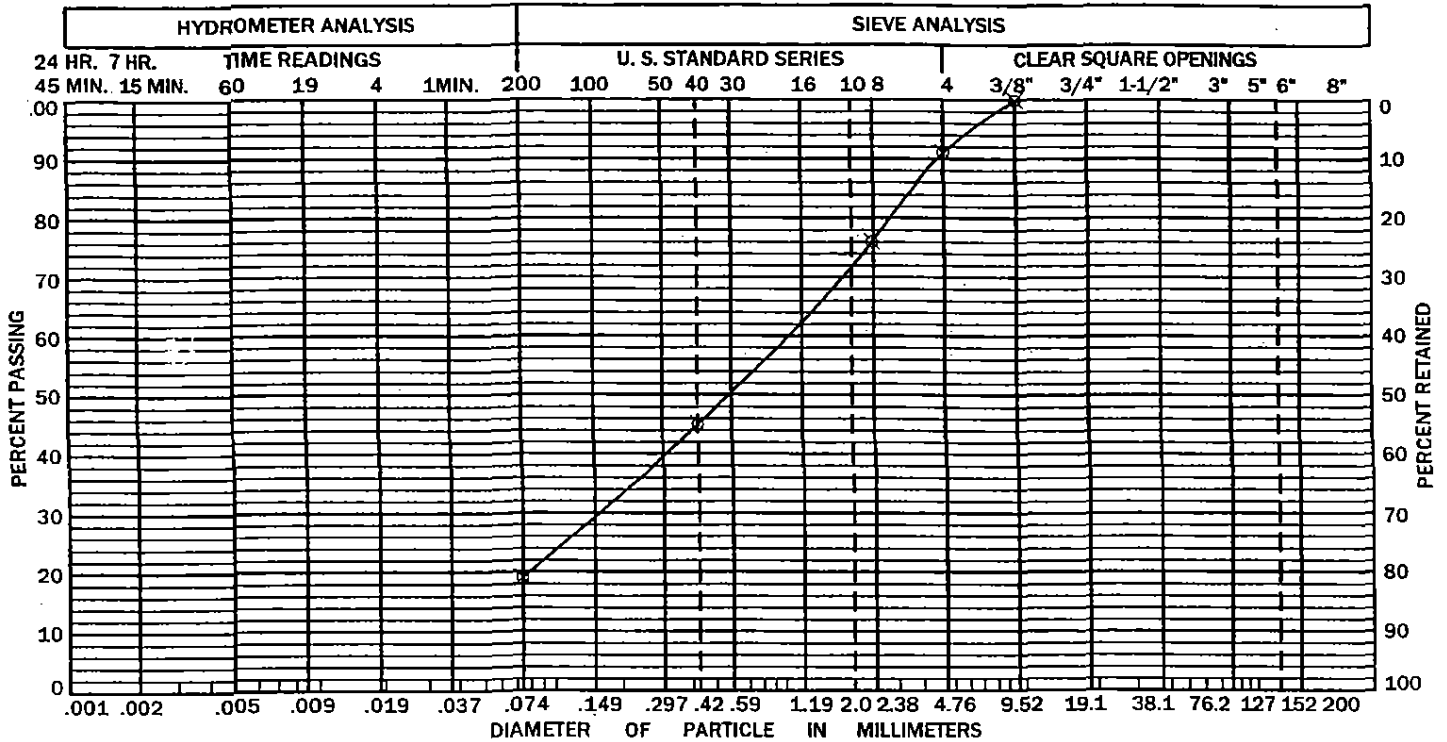
## GRADATION TEST RESULTS

CLAY TO SILT		SAND			GRAVEL		COBBLES				
		FINE	MEDIUM	COARSE	FINE	COARSE					
CLASSIFICATION	SM	NOTES: 4.5 % Moisture content									
GRAVEL	8.8 %	LL = 24.3 %									
SAND	72.5 %	PL = 21.2 %									
FINES	18.7 %	PI = 3.1 %									
SAMPLE#	1	HOLE#	TH-18	DEPTH	4	FEET	Job #:	11411	By:	KO	05/13/2003
