FRONT RANGE GEOTECHNICAL INC.

PRELIMINARY GEOLOGY, SURFACE SOILS, AND SEWAGE DISPOSAL EVALUATION  
**WALDEN PRESERVE SUBDIVISION**  
EL PASO COUNTY, CO

AUGUST 29, 2004

AMENDED June 25, 2022

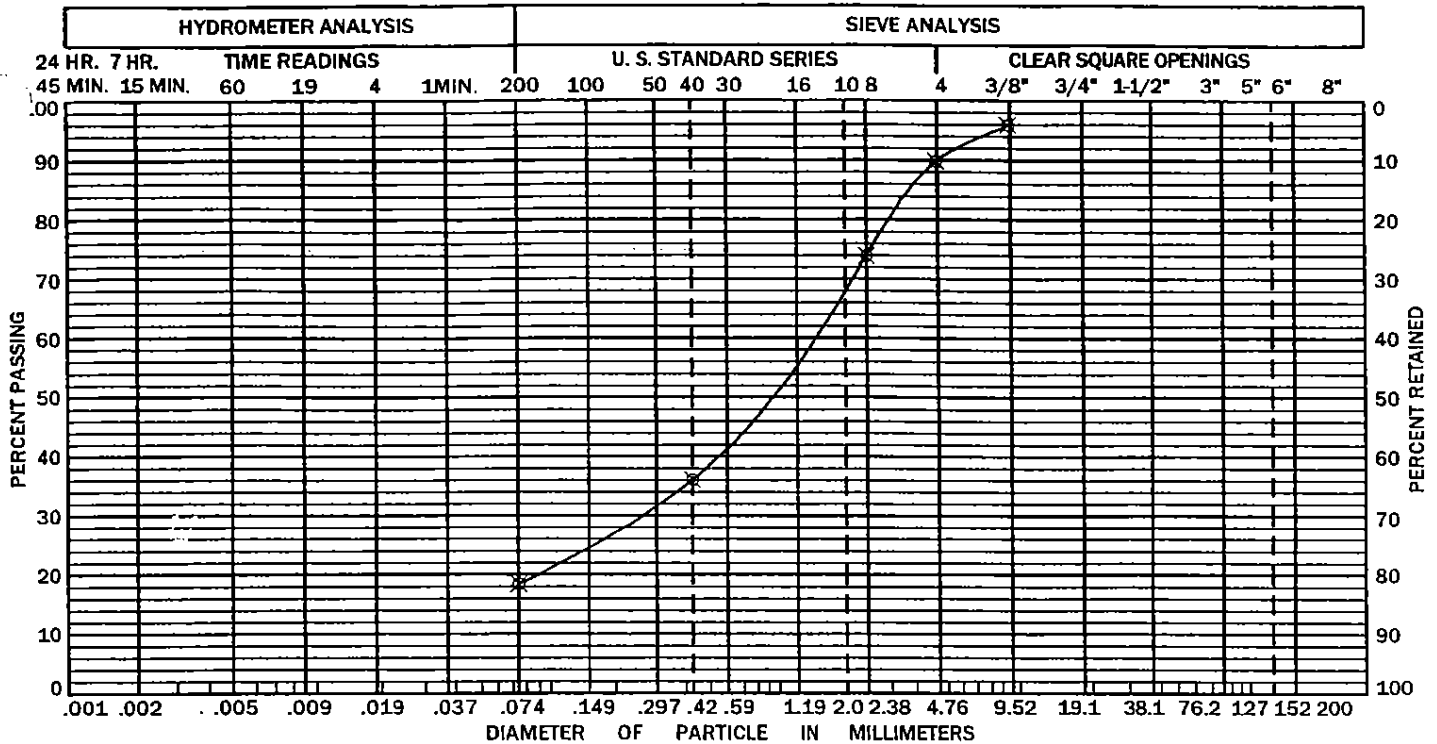
## GRADATION TEST RESULTS

CLAY TO SILT			SAND			GRAVEL		COBBLES	
			FINE	MEDIUM	COARSE	FINE	COARSE		
CLASSIFICATION	SC		NOTES: 8.5 % Moisture content						
GRAVEL	10.2 %		LL = 30.3 %						
SAND	71.2 %		PL = 21.1 %						
FINES	18.6 %		PI = 9.2 %						
SAMPLE#	1	HOLE# TH-19	DEPTH	4	FEET	Job #:	11411	By: KO	05/13/2003

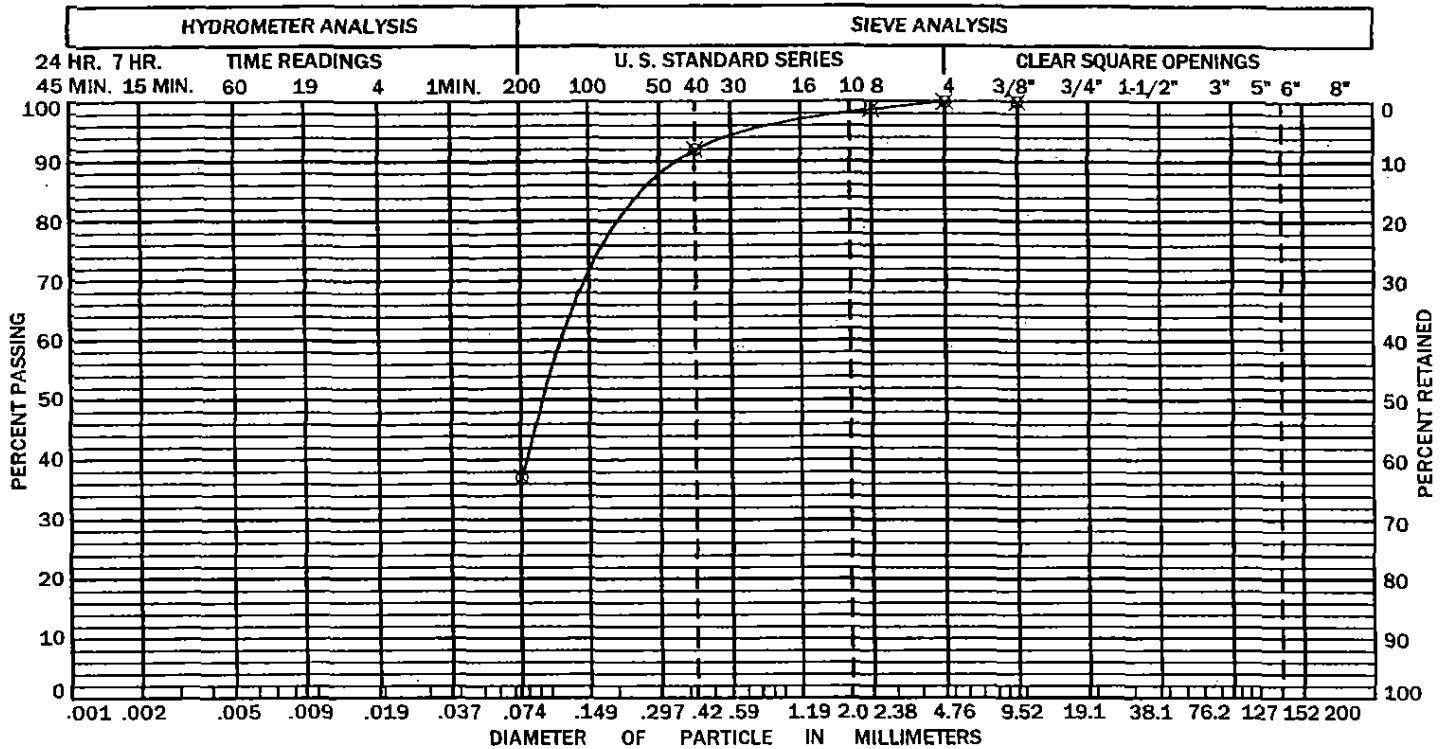
## GRADATION TEST RESULTS

CLASSIFICATION SM  
GRAVEL 0.0 %  
SAND 62.3 %  
FINES 37.7 %

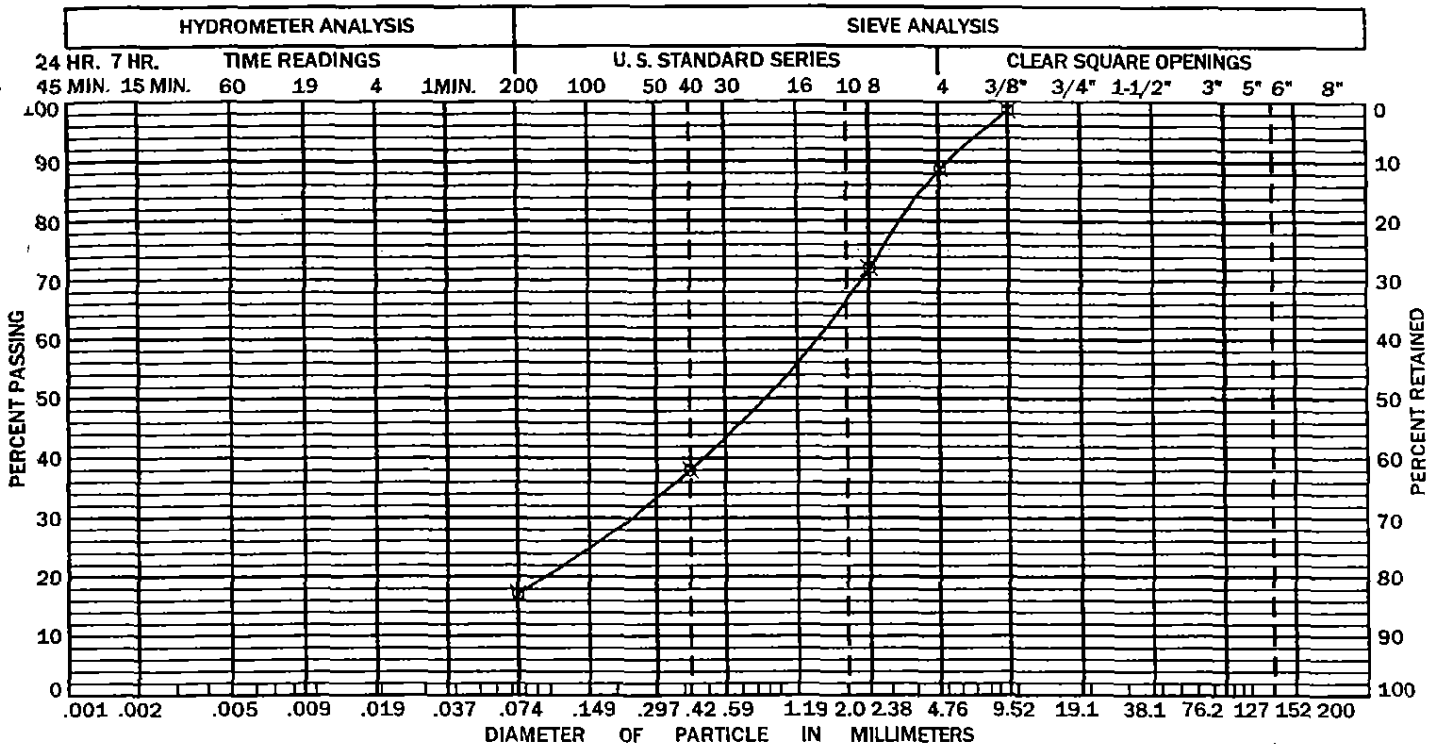
## GRADATION TEST RESULTS

CLASSIFICATION SM  
GRAVEL 10.6 %  
SAND 72.2 %  
FINES 17.2 %  
SAMPLE# 1 HOLE# TH-21 DEPTH 4 FEET

NOTES: 6.5 % Moisture content  
LL = Could Not Be Determined  
PL = Non-Plastic  
Job #: 11411 By: KO 05/13/2003

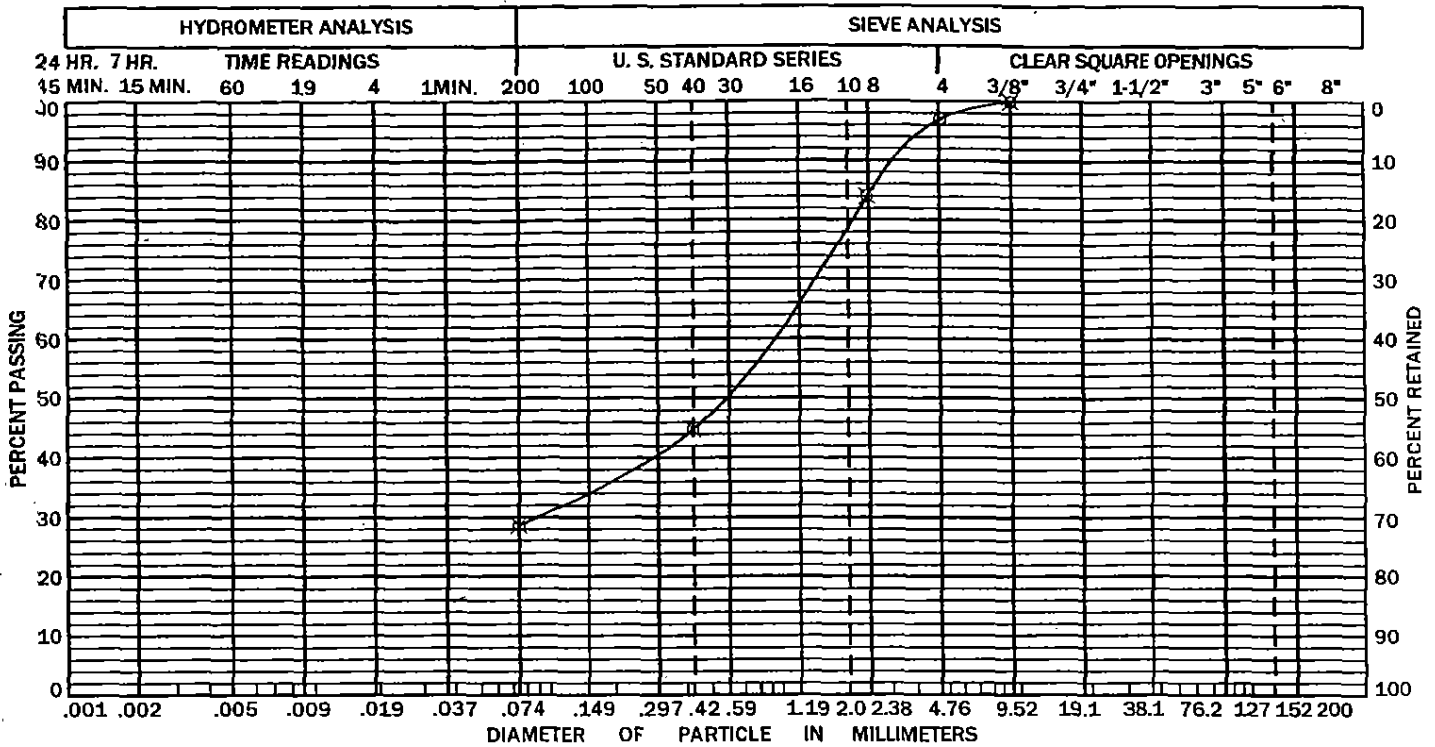
## GRADATION TEST RESULTS

CLAY TO SILT		SAND			GRAVEL		COBBLES				
		FINE	MEDIUM	COARSE	FINE	COARSE					
CLASSIFICATION	SC	NOTES: 12.0 % Moisture content									
GRAVEL	3.0 %	LL = 29.4 %									
SAND	68.6 %	PL = 18.4 %									
FINES	28.4 %	PI = 11.0 %									
SAMPLE#	1	HOLE#	TH-22	DEPTH	4	FEET	Job #:	11411	By:	KO	05/13/2003

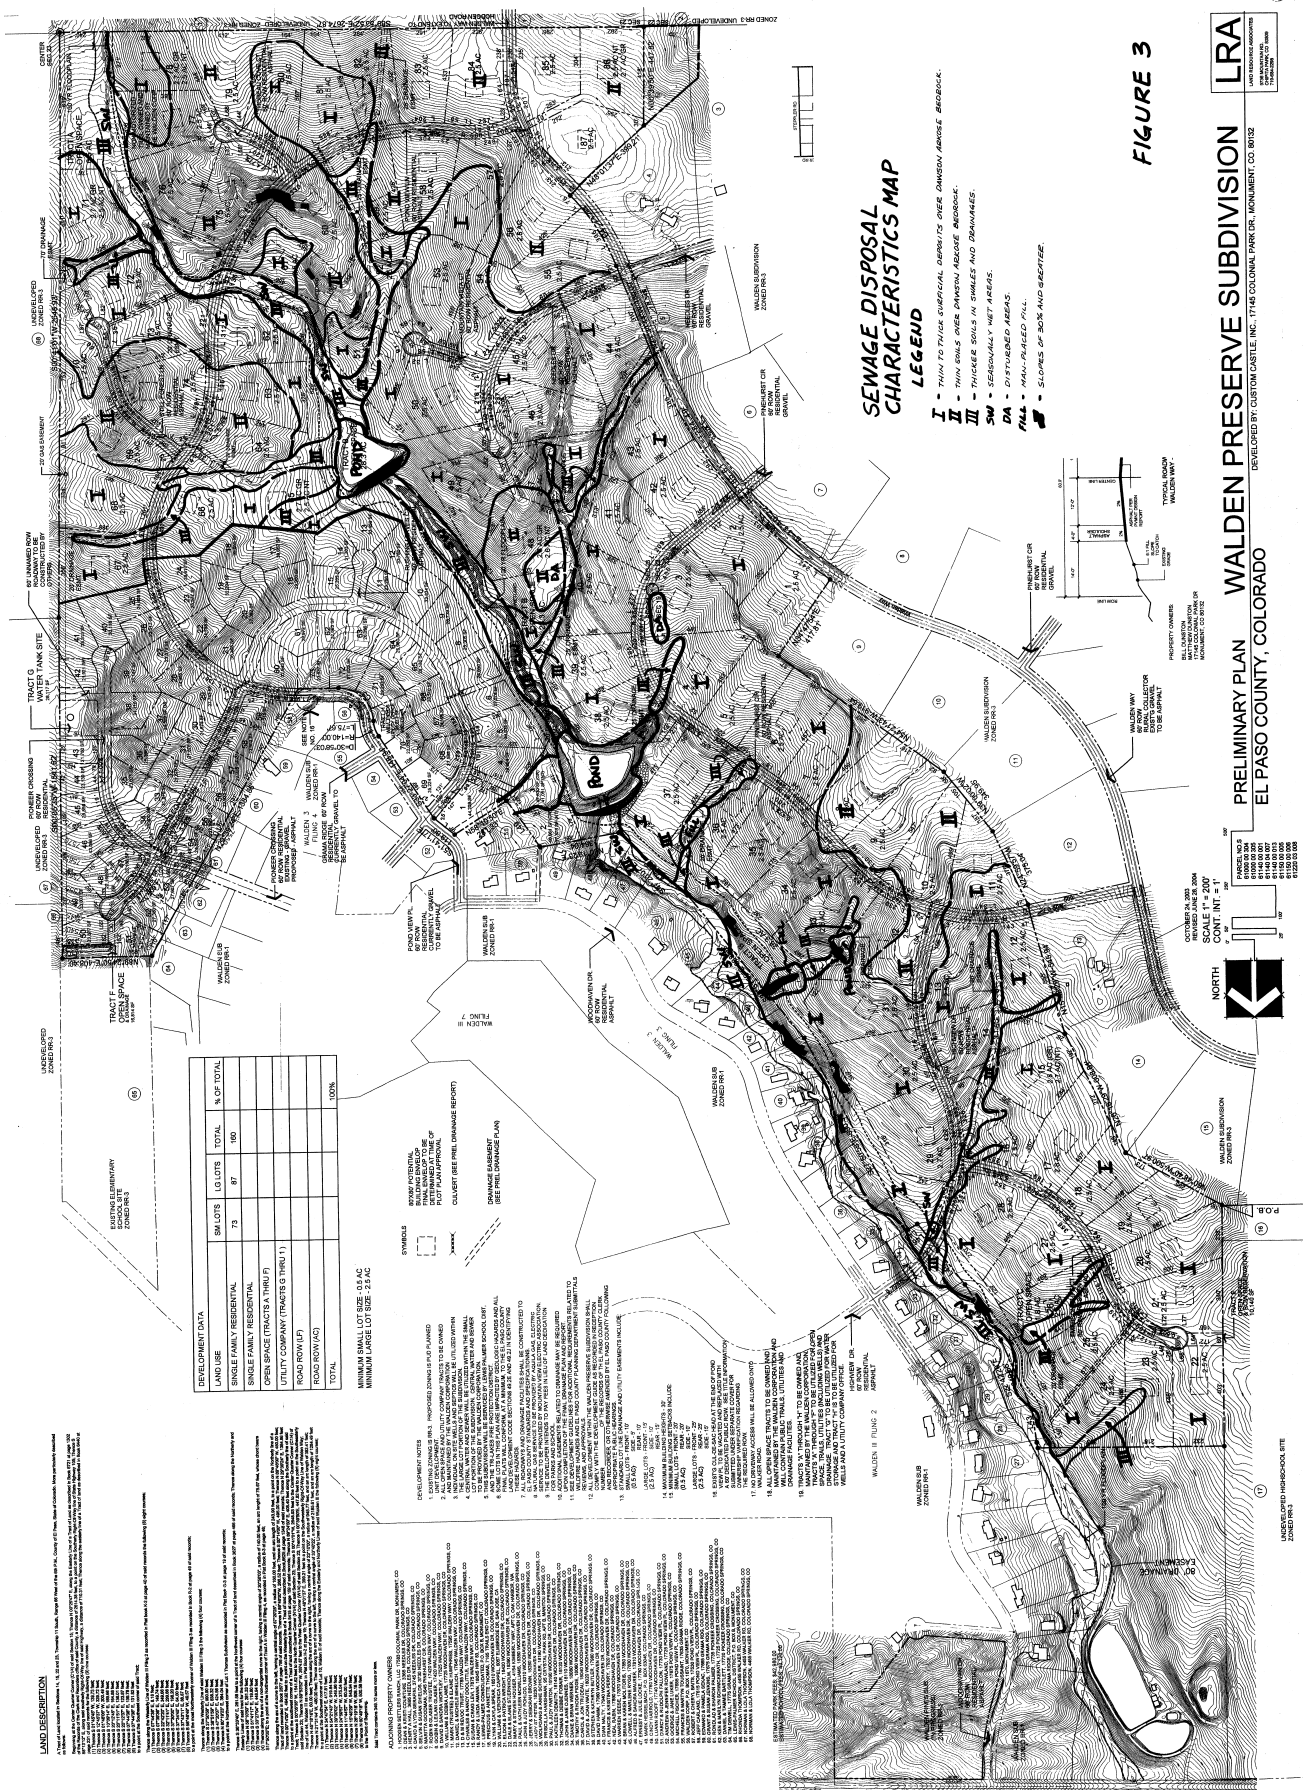
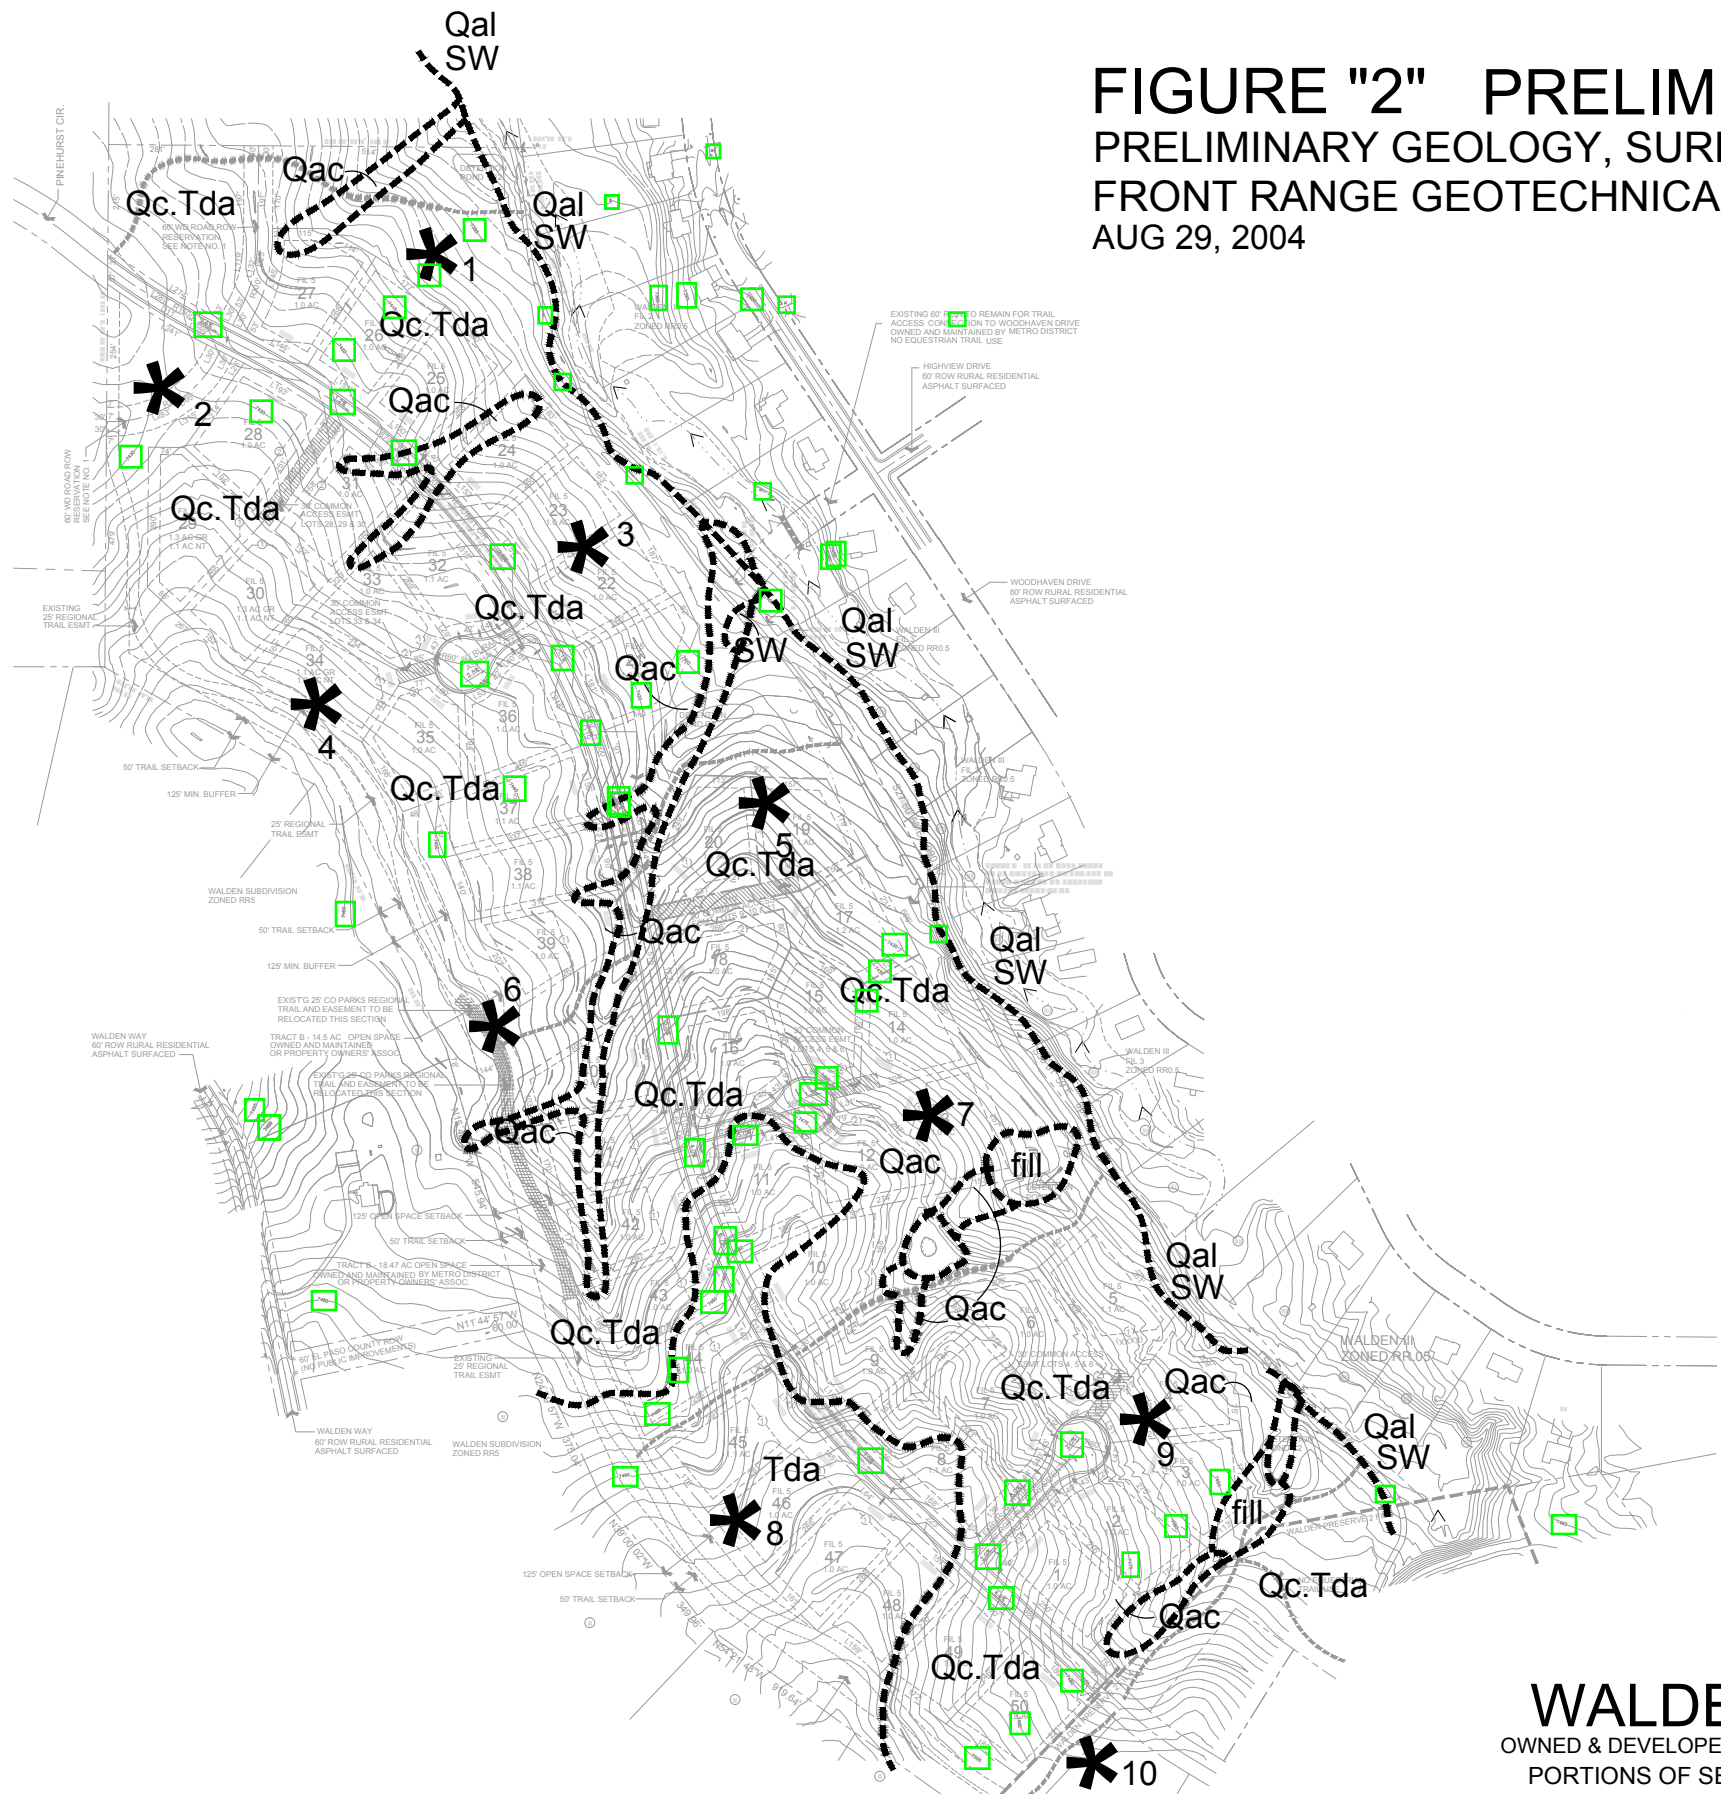
FIGURE "2" PRELIMINARY GEOLOGIC MAP  
PRELIMINARY GEOLOGY, SURFACE SOILS, AND SEWAGE DISPOSAL EVALUATION  
FRONT RANGE GEOTECHNICAL, INC  
AUG 29, 2004

- Qal - RECENT ALLUVIUM IN FLOODPLAIN
- Qc - COLLUVIUM (SLOPEWASH)
- Qac - MIXED ALLUVIUM AND COLLUVIUM
- Tda - DAWSON ARKOSE FORMATION
- SW - SEASONALLY WET AREAS
- DA - DISTURBED AREAS
- fill - MAN-PLACED FILL
- 2 \* - LOCATION AND NUMBER OF PERCOLATION TEST

- Figures 2 & 3 within the report have been updated to reflect Front Range Geotechnical’s identified constraints on the current lot and roadway layout.
- No geologic hazards or constraints have been identified within Filing 5’s lots or roadways.
- The subdivision will be served by both central water and sewer eliminating geologic concerns and constraints related to onsite septic systems.
- The report has been utilized in obtaining numerous land use approvals including; Preliminary Plan, PUD Development Plan and Final Plat approvals for Filings 1 through 4.
- The Filing 5 Final Plat approval is the last of the Walden Preserve 2 development applications.

The site is proposed for construction of a residential subdivision, with 87 residential lots with sizes of about 2.5 acres, and 73 smaller lots (see Figure 2). The larger (2.5-acre) lots will be served by individual wells and individual sewage disposal systems. The smaller lots will be served by both central water and wastewater systems.

The site is underlain by bedrock consisting of the Dawson Arkose (Figure 2). This formation consists primarily of discontinuous and lenticular beds of arkosic sandstone and claystone. Although the Dawson sandstones are commonly only slightly to moderately cemented, they are typically very dense. Few good outcrops (bedrock exposures) were observed on-site. The regional dip of the strata is very gentle to the north. Our experience in this area indicates the rocks are not highly fractured.

As shown on the Preliminary Geologic Map (Figure 2), alluvium/colluvium is found in a band paralleling the swales and drainageways on site. Although the smaller drainageways do not appear to carry surface water most of the time, it appears that erosion and flooding from thunderstorm runoff occasionally occurs. It should be noted that no drainage study was performed as part of this report and the flood plain and hazard zone should be defined by a more detailed drainage report. The simplest mitigation for flooding is avoidance, although channelization or elevation of structures may be appropriate in some areas. The larger drainageway on the site is being avoided by development except for two road crossings.

In order to evaluate site characteristics geologic mapping was performed and 20 percolation tests were performed (22% of the 87 lots). Drill Hole and test locations are shown on the attached Figure 2. Visual logs of the profile holes, a summary of percolation test results, and soil laboratory testing data can be found in Appendix A. Figure 3 is "Sewage Disposal Characteristics Map" and also shows slopes of 30% and greater.

**Area I (Qc-Tda):** Area I consists of that portion of the site characterized by thin to thicker surficial deposits and variable (but generally acceptable) percolation rates. These areas has been mapped as Qc-Tda on the enclosed Figure2 and are characterized by colluvial soils over the Dawson Arkose. With some exploration, it is felt that in most cases it will be possible to locate an acceptable soil absorption system in the Area I lots, although local slow percolation rates or shallow soils may be encountered in these areas and thus will require some form of alternate system.

**Area II (Tda):** Area II consists of that portion of the site interpreted to be underlain by shallow soils over weathered bedrock (mapped as Tda on Figure 2). In most of this area it is felt that bedrock may be too shallow and/or too impermeable for conventional soil absorption systems, and alternate systems will be required.

**Area III (Qac), (sw):** Area III consists of that portion of the site identified as being underlain by deeper soils (Qac on Figure 2), but might be characterized by seasonally wet conditions (sw) or shallow ground water, at least on a seasonal basis. In areas that are found to be outside the flood plain and possess shallow ground water, alternate systems will be required. Percolation rates are likely to be variable. The seasonally wet areas were mapped based on analysis of aerial photographs and
