## PAVEMENT DESIGN REPORT

**Ponderosa at Lorson Ranch Filing No. 3  
El Paso County, Colorado**

**SF-20-016**

**JOB NO. 178680**

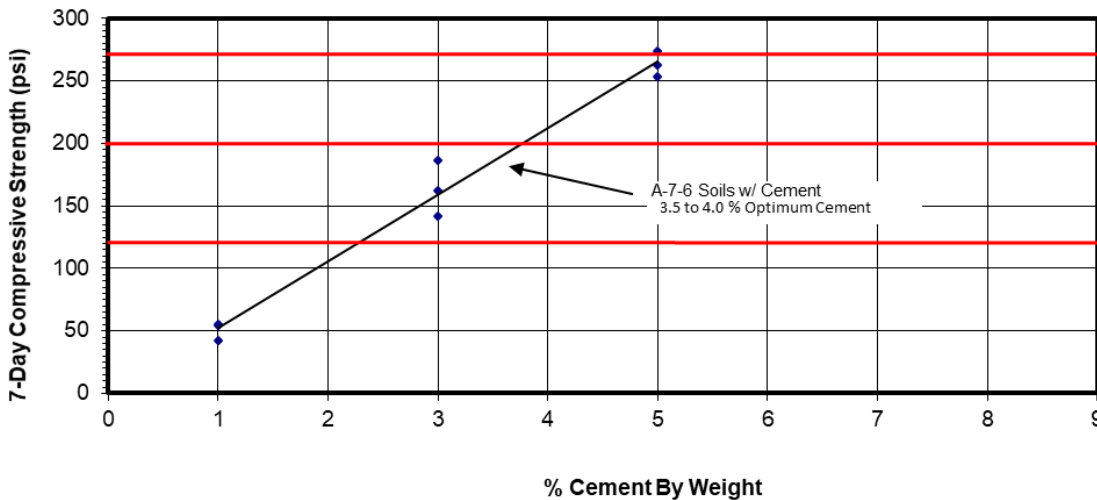
**Compressive Strength vs. Cement Content**  
**Ponderosa at Lorson Ranch Filing 3**  
**RMG Job No. 178680**  
**CTS Mix Design Target Values A-7-6 Soil**

The data values were then plotted as a function of “7-day Compressive Strength versus Percent Cement by Weight”. In accordance with the El Paso County Engineering Criteria Manual, a target CTS Strength Coefficient = 0.11 is used for CTS soil in the pavement design procedure presented below. Based upon an evaluation of the test data, a target range of **3.5 to 4** percent cement is recommended to maintain strengths above 160-psi and below a 275-psi threshold. Results are presented below.

CTS: Specimens of soil composed of the A-7-6 subgrade materials and Portland cement were prepared by varying the “percent cement by weight” at target values of 1, 3, and 5 percent cement. Three specimens (pucks) were prepared for each target cement value, compacted to 95% of the maximum Standard Proctor density and cured in a saturated condition for 7-days. The compressive strength of each specimen was then determined upon completion of the 7-day curing process. The compressive strengths are presented in the table below:

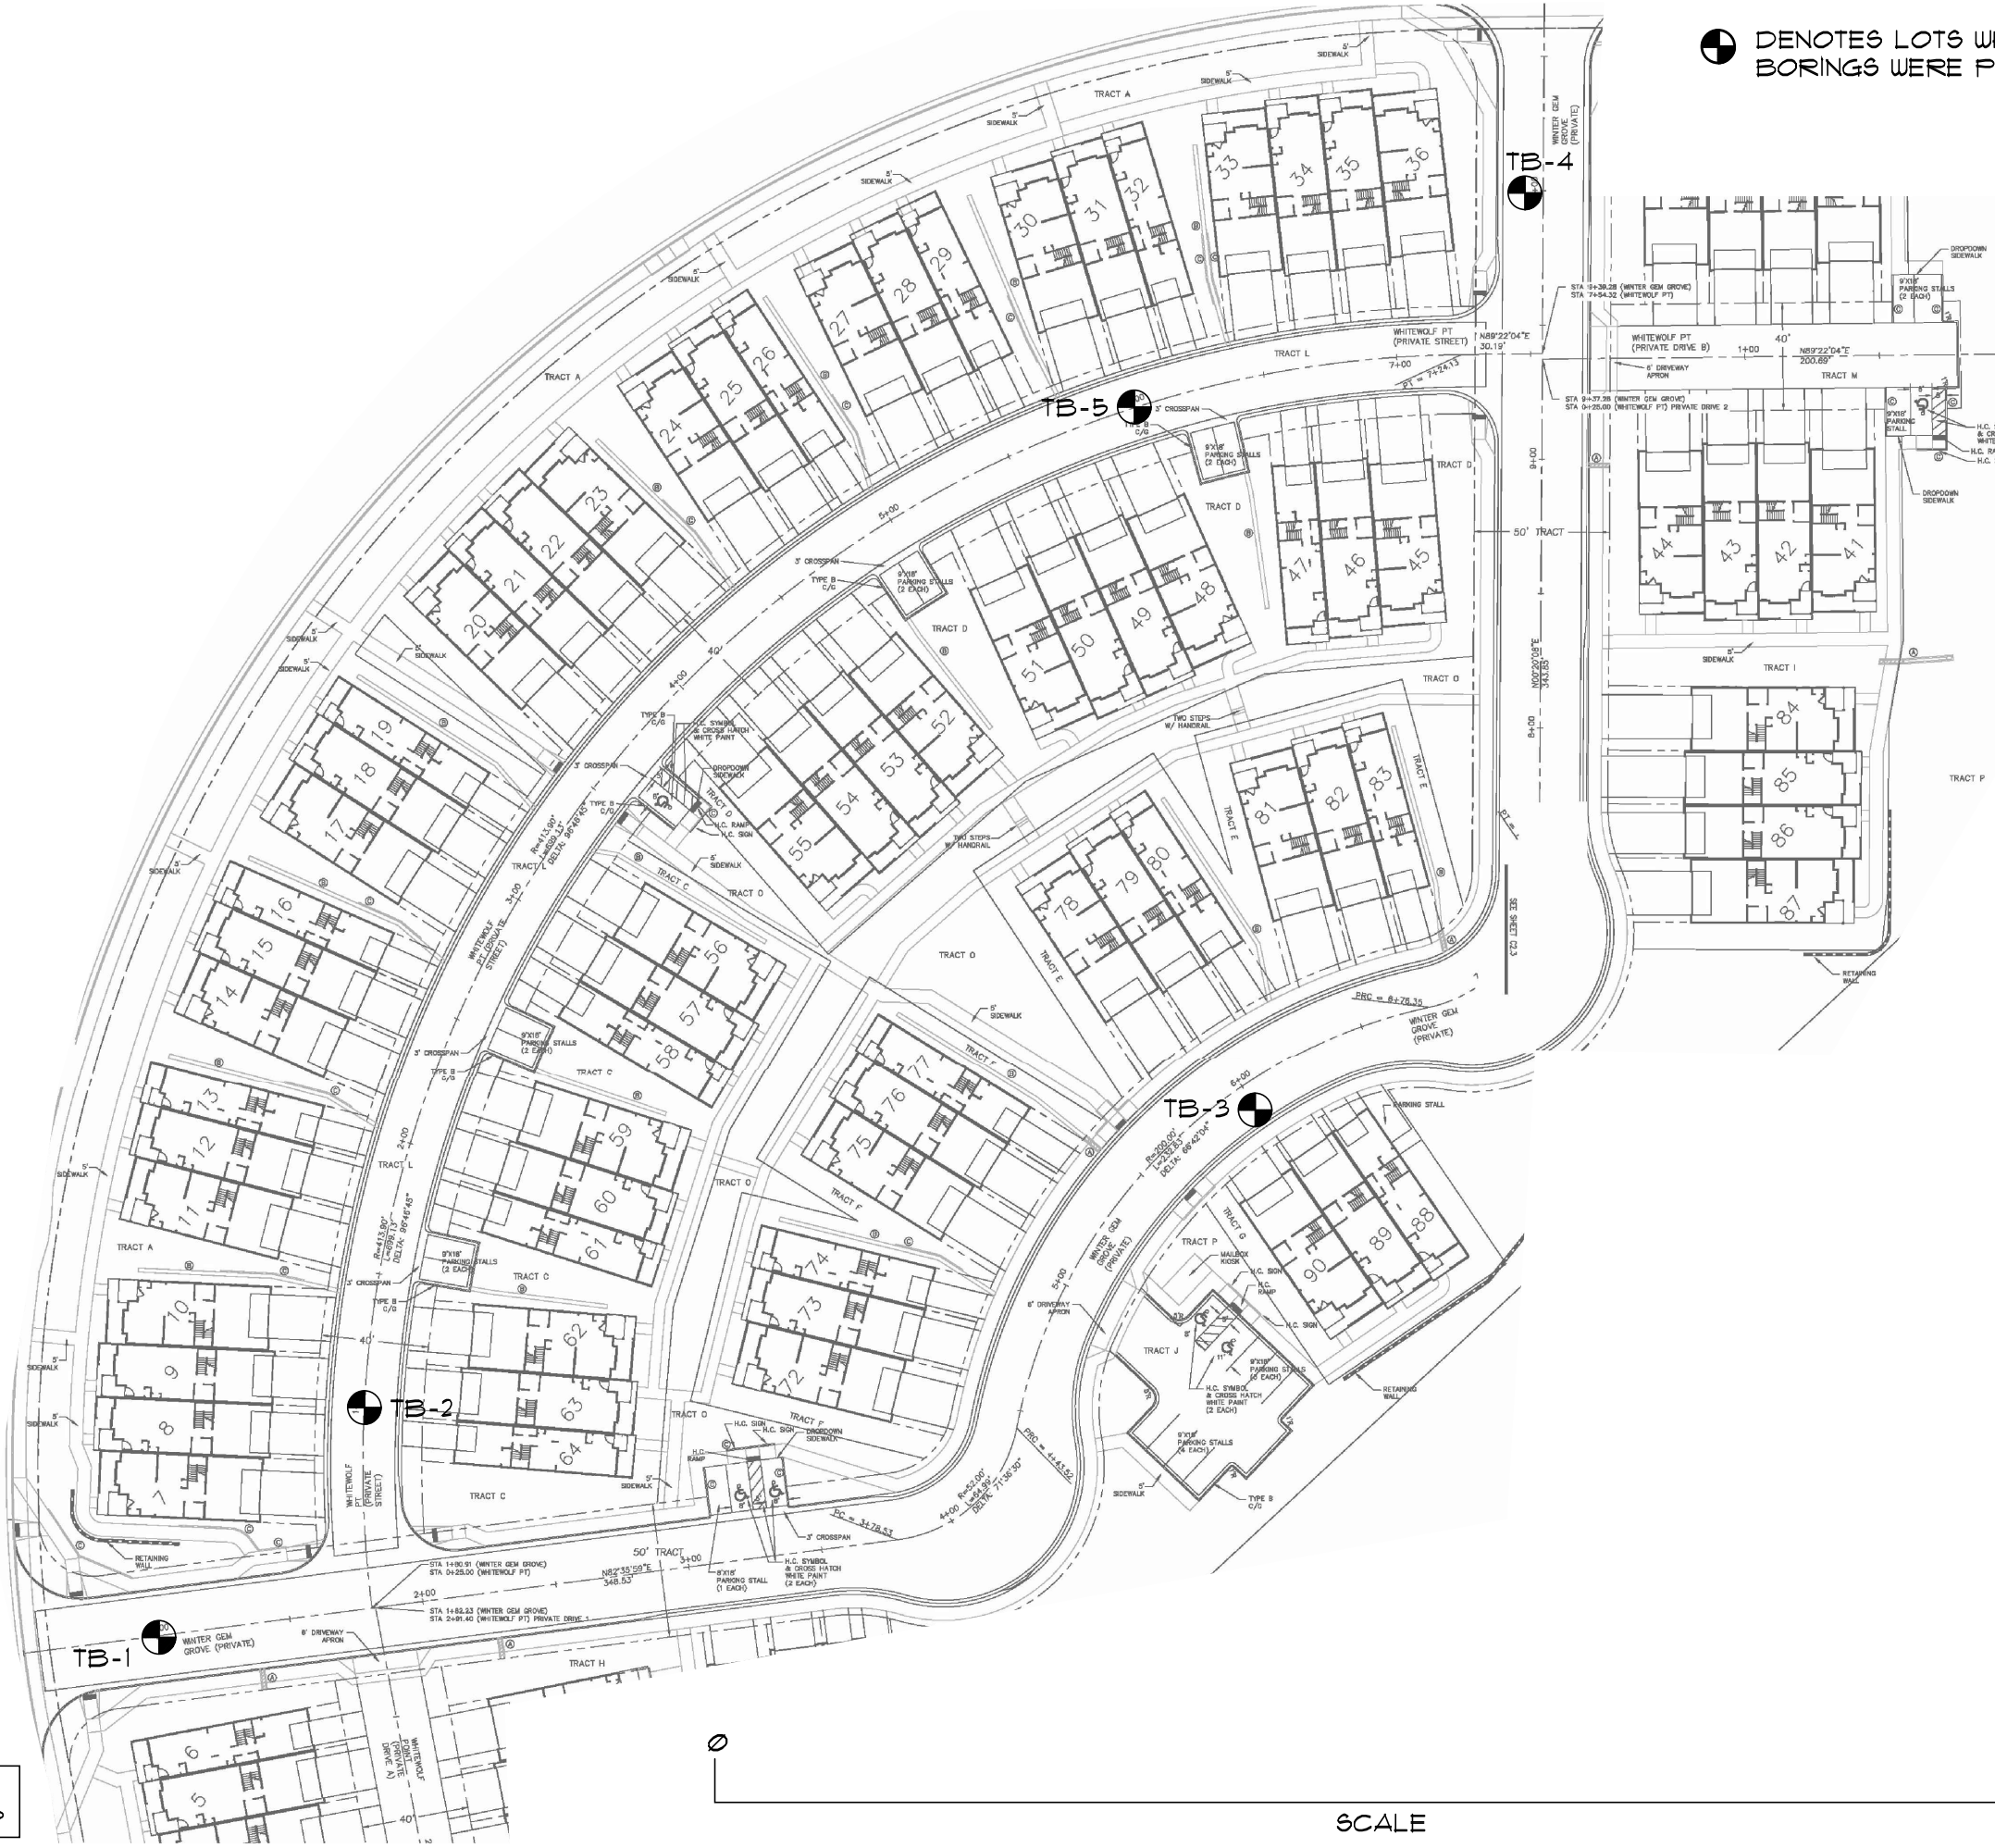
SHEET No.  
**FIG-2**

⊕ DENOTES LOTS WHERE TEST BORINGS WERE PERFORMED

TEST BORING  
LAYOUT PLAN

The proposed streets included in this investigation are shown on Figure 2. The Development Plans indicate the roadways are to be *Private*, but for pavement design, the streets considered below are classified as Residential Local. Streets include Winter Gem Grove and Whitewolf Point as shown on Figure 2. White Gem Grove is classified as Residential Local with a 50-foot Right-of-Way (ROW) and two 15-foot drive lanes. Whitewolf Point is classified as Residential Local – Low Volume, with a 40-foot ROW and two 12-foot drive lanes. A portion of Whitewolf Point serving Lots 37 through 44 shall be constructed with concrete pavement.

The subsurface conditions on the site were investigated by drilling five (5) exploratory test borings. The approximate locations of the test borings are presented in the Test Boring Location Plan, Figure 2.

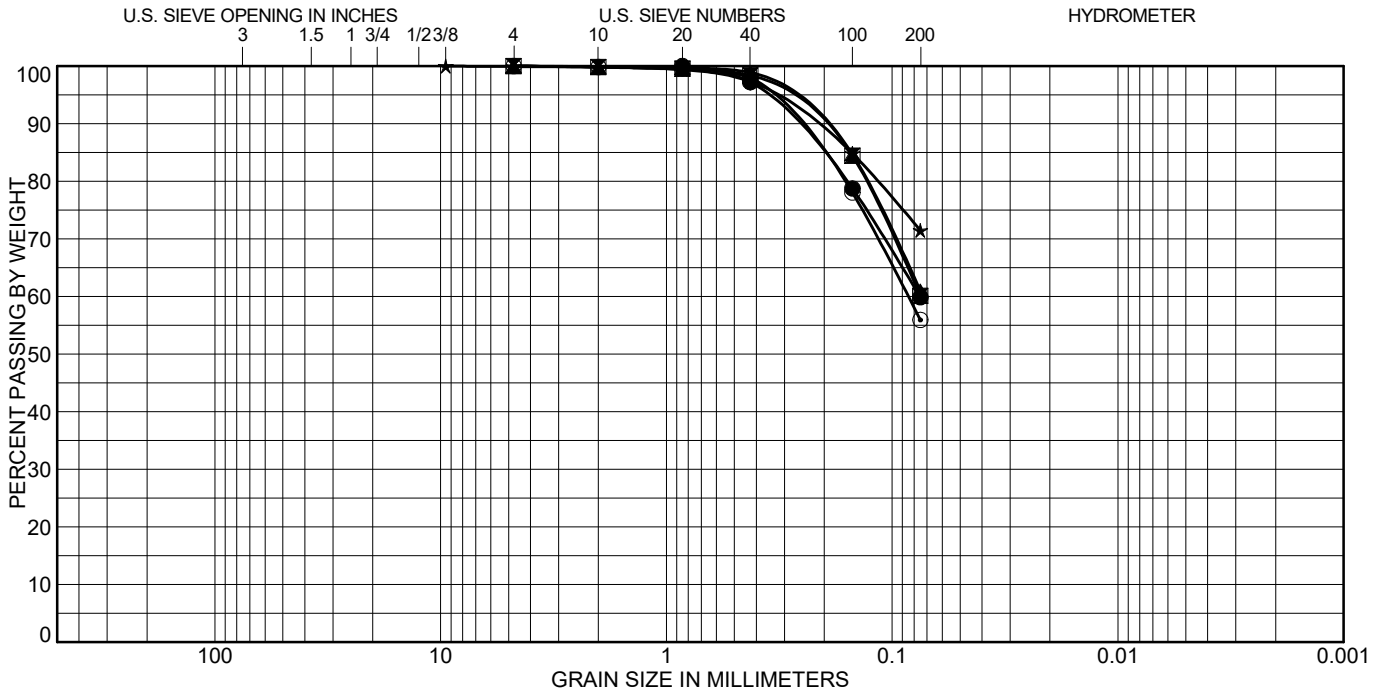
FIGURE No. 8

COBBLES	GRAVEL		SAND			SILT OR CLAY
	coarse	fine	coarse	medium	fine

Test Boring	Depth (ft)	Classification	LL	PL	PI	Cc	Cu
● 1	2.0	A-6 (8)	36	18	18		
☒ 2	2.0	A-7-6 (13)	46	20	26		
▲ 3	2.0	A-7-6 (15)	48	18	30		
★ 4	2.0	A-7-6 (22)	53	21	32		
⊙ 5	2.0	A-7-6 (12)	45	17	28

The moisture content for the recovered samples was obtained in the laboratory. Grain-size analysis and Atterberg Limits tests were performed on selected samples to classify the soil and to develop pertinent engineering properties. A Summary of Laboratory Test Results is presented in Figure 7. Soil Classification Data are presented in Figure 8. Swell/Consolidation Test Results are presented in Figure 9 through 11.

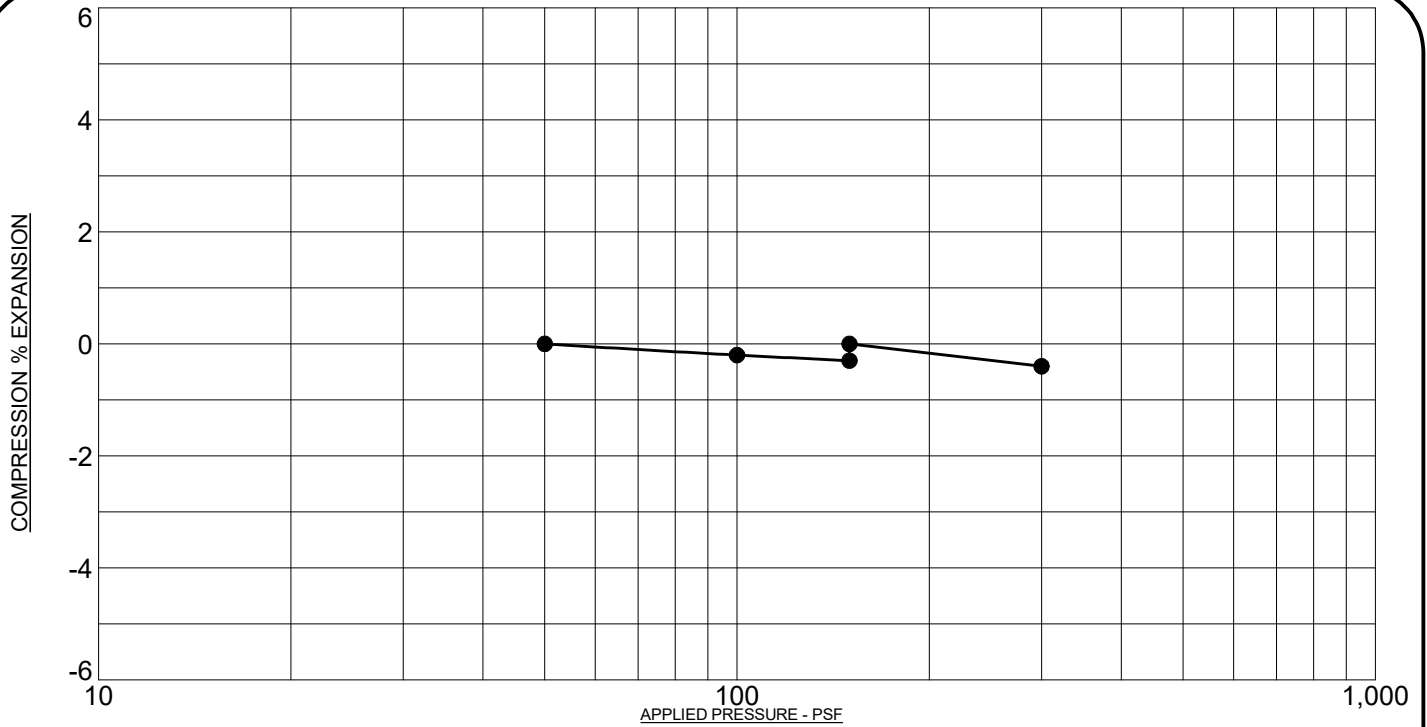
PROJECT: Ponderosa at Lorson Ranch, Filing No. 3, El Paso County, Colorado  
 SAMPLE DESCRIPTION: FILL: CLAY, SANDY  
 NOTE: SAMPLE WAS INUNDATED WITH WATER AT 150 PSF

SAMPLE LOCATION: 1 @ 2 FT  
 NATURAL DRY UNIT WEIGHT: 97.0 PCF  
 NATURAL MOISTURE CONTENT: 9.8%  
 PERCENT SWELL/COMPRESSION: 0.3

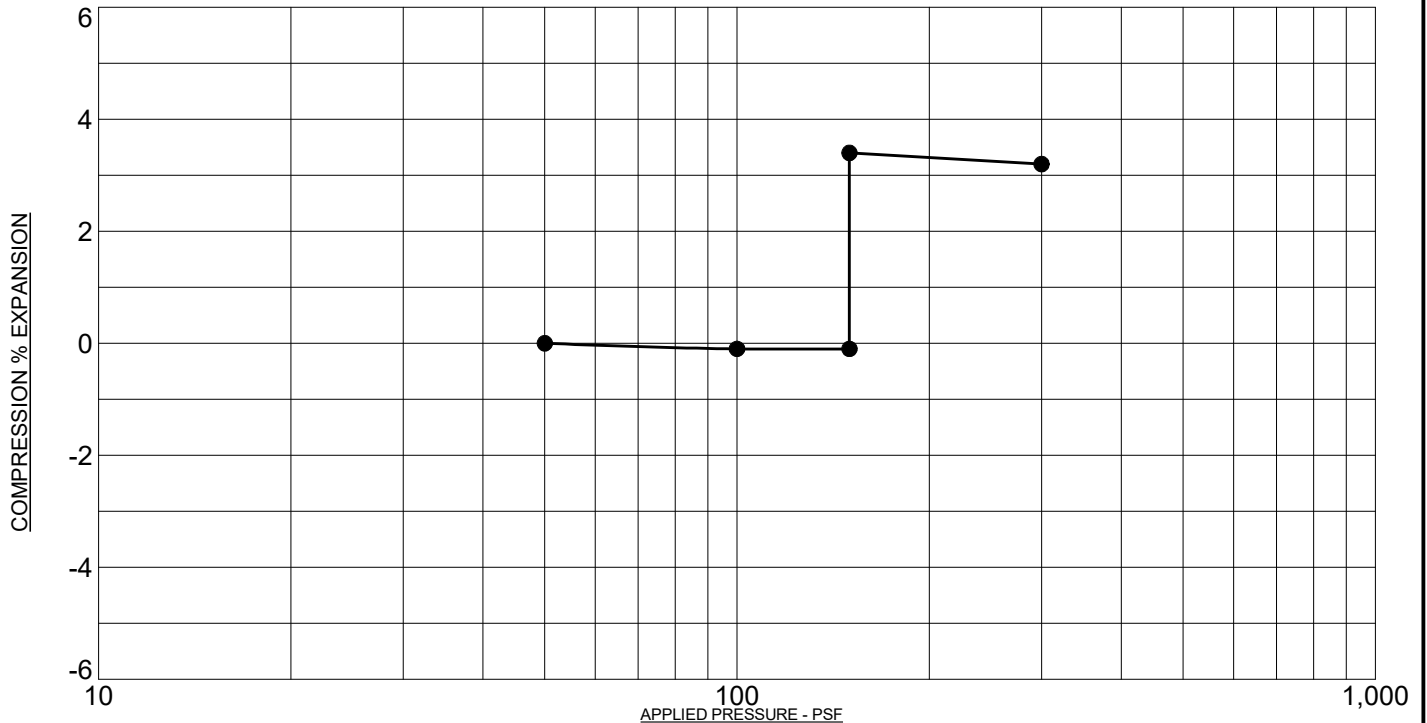
PROJECT: Ponderosa at Lorson Ranch, Filing No. 3, El Paso County, Colorado  
 SAMPLE DESCRIPTION: FILL: CLAY, SANDY  
 NOTE: SAMPLE WAS INUNDATED WITH WATER AT 150 PSF

SAMPLE LOCATION: 2 @ 2 FT  
 NATURAL DRY UNIT WEIGHT: 88.2 PCF  
 NATURAL MOISTURE CONTENT: 22.3%  
 PERCENT SWELL/COMPRESSION: 3.5

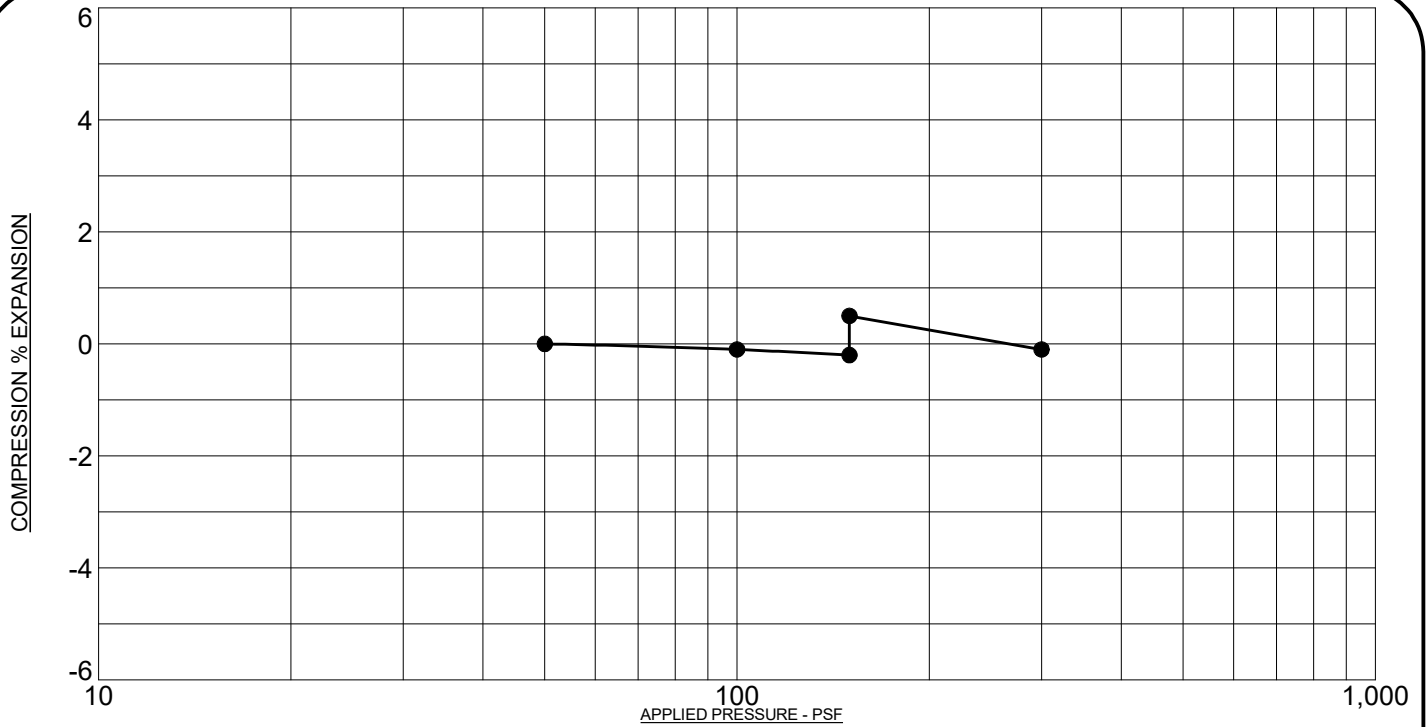
PROJECT: Ponderosa at Lorson Ranch, Filing No. 3, El Paso County, Colorado  
 SAMPLE DESCRIPTION: FILL: CLAY, SANDY  
 NOTE: SAMPLE WAS INUNDATED WITH WATER AT 150 PSF

SAMPLE LOCATION: 3 @ 2 FT  
 NATURAL DRY UNIT WEIGHT: 73.8 PCF  
 NATURAL MOISTURE CONTENT: 20.2%  
 PERCENT SWELL/COMPRESSION: 0.7

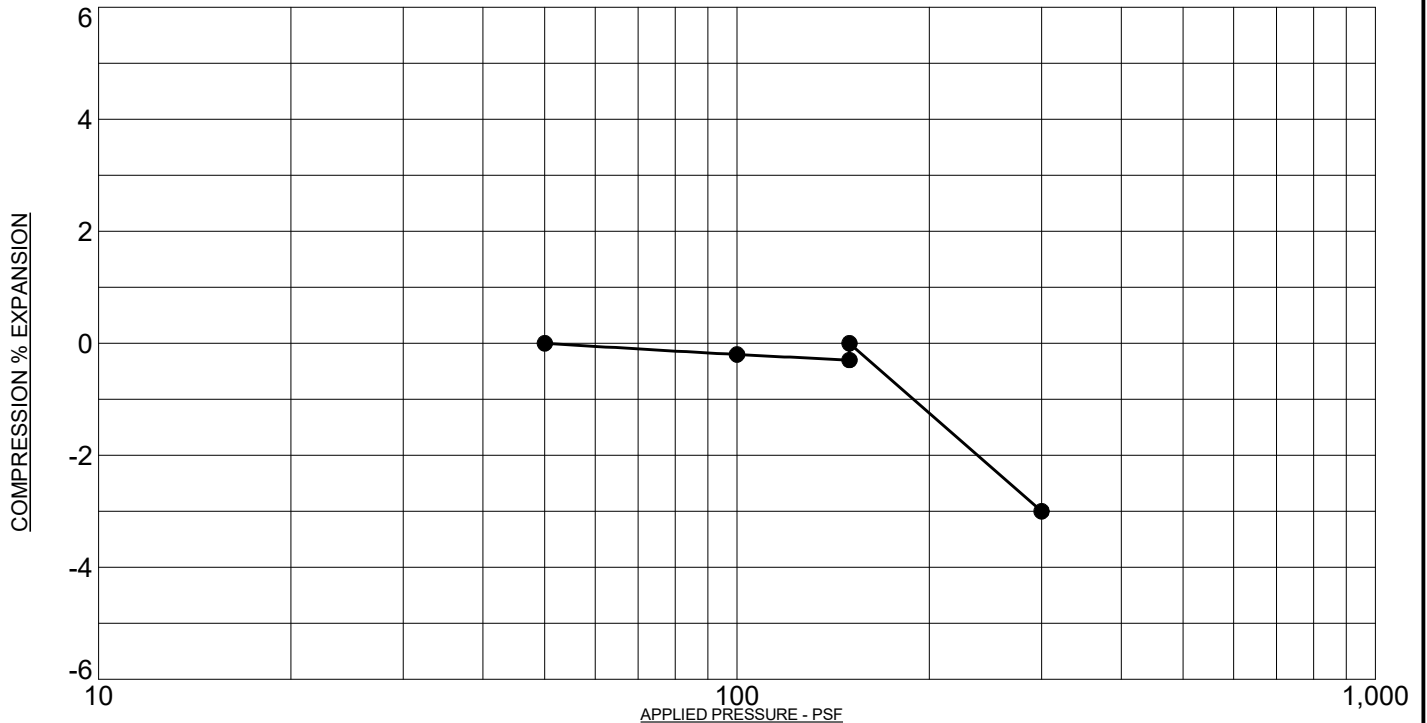
PROJECT: Ponderosa at Lorson Ranch, Filing No. 3, El Paso County, Colorado  
 SAMPLE DESCRIPTION: FILL: CLAY, SANDY  
 NOTE: SAMPLE WAS INUNDATED WITH WATER AT 150 PSF

SAMPLE LOCATION: 4 @ 2 FT  
 NATURAL DRY UNIT WEIGHT: 78.1 PCF  
 NATURAL MOISTURE CONTENT: 14.9%  
 PERCENT SWELL/COMPRESSION: 0.3

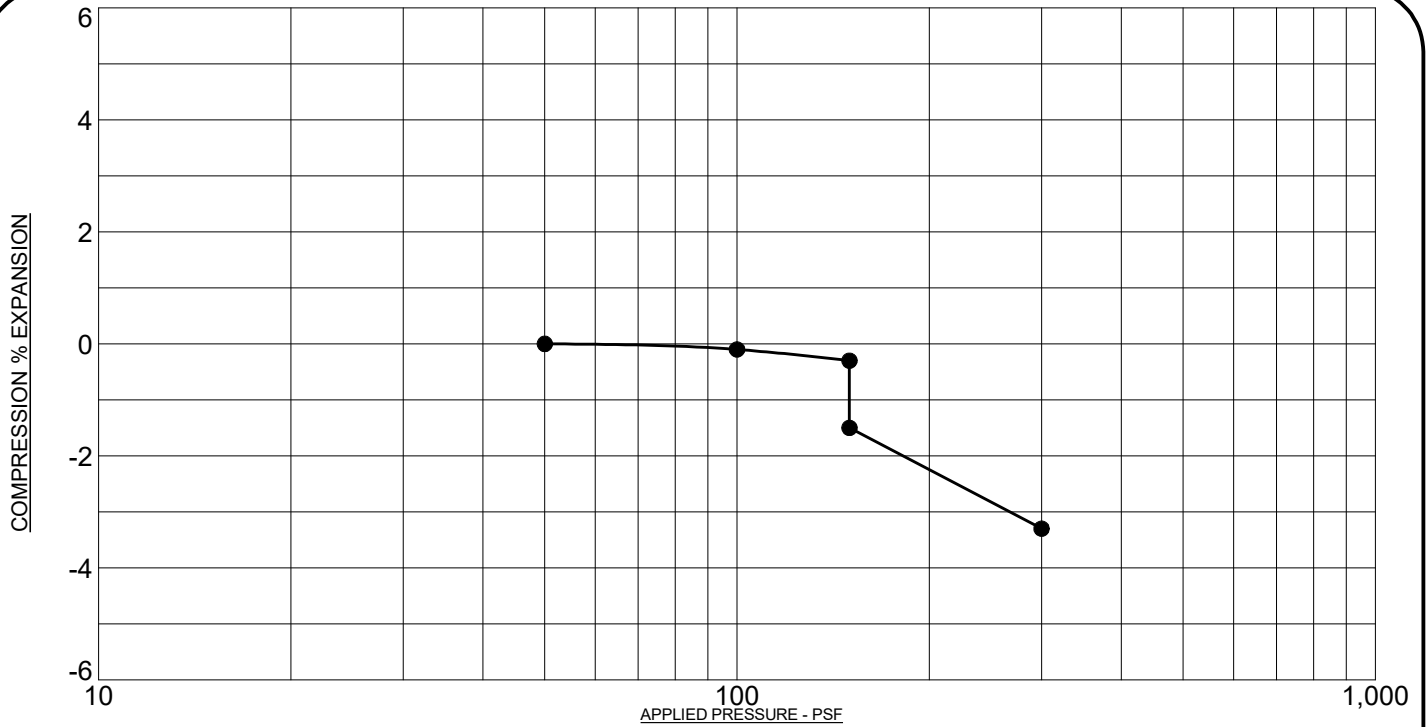
PROJECT: Ponderosa at Lorson Ranch, Filing No. 3, El Paso County, Colorado  
 SAMPLE DESCRIPTION: FILL: CLAY, SANDY  
 NOTE: SAMPLE WAS INUNDATED WITH WATER AT 150 PSF

SAMPLE LOCATION: 5 @ 2 FT  
 NATURAL DRY UNIT WEIGHT: 72.8 PCF  
 NATURAL MOISTURE CONTENT: 19.6%  
 PERCENT SWELL/COMPRESSION: - 1.2

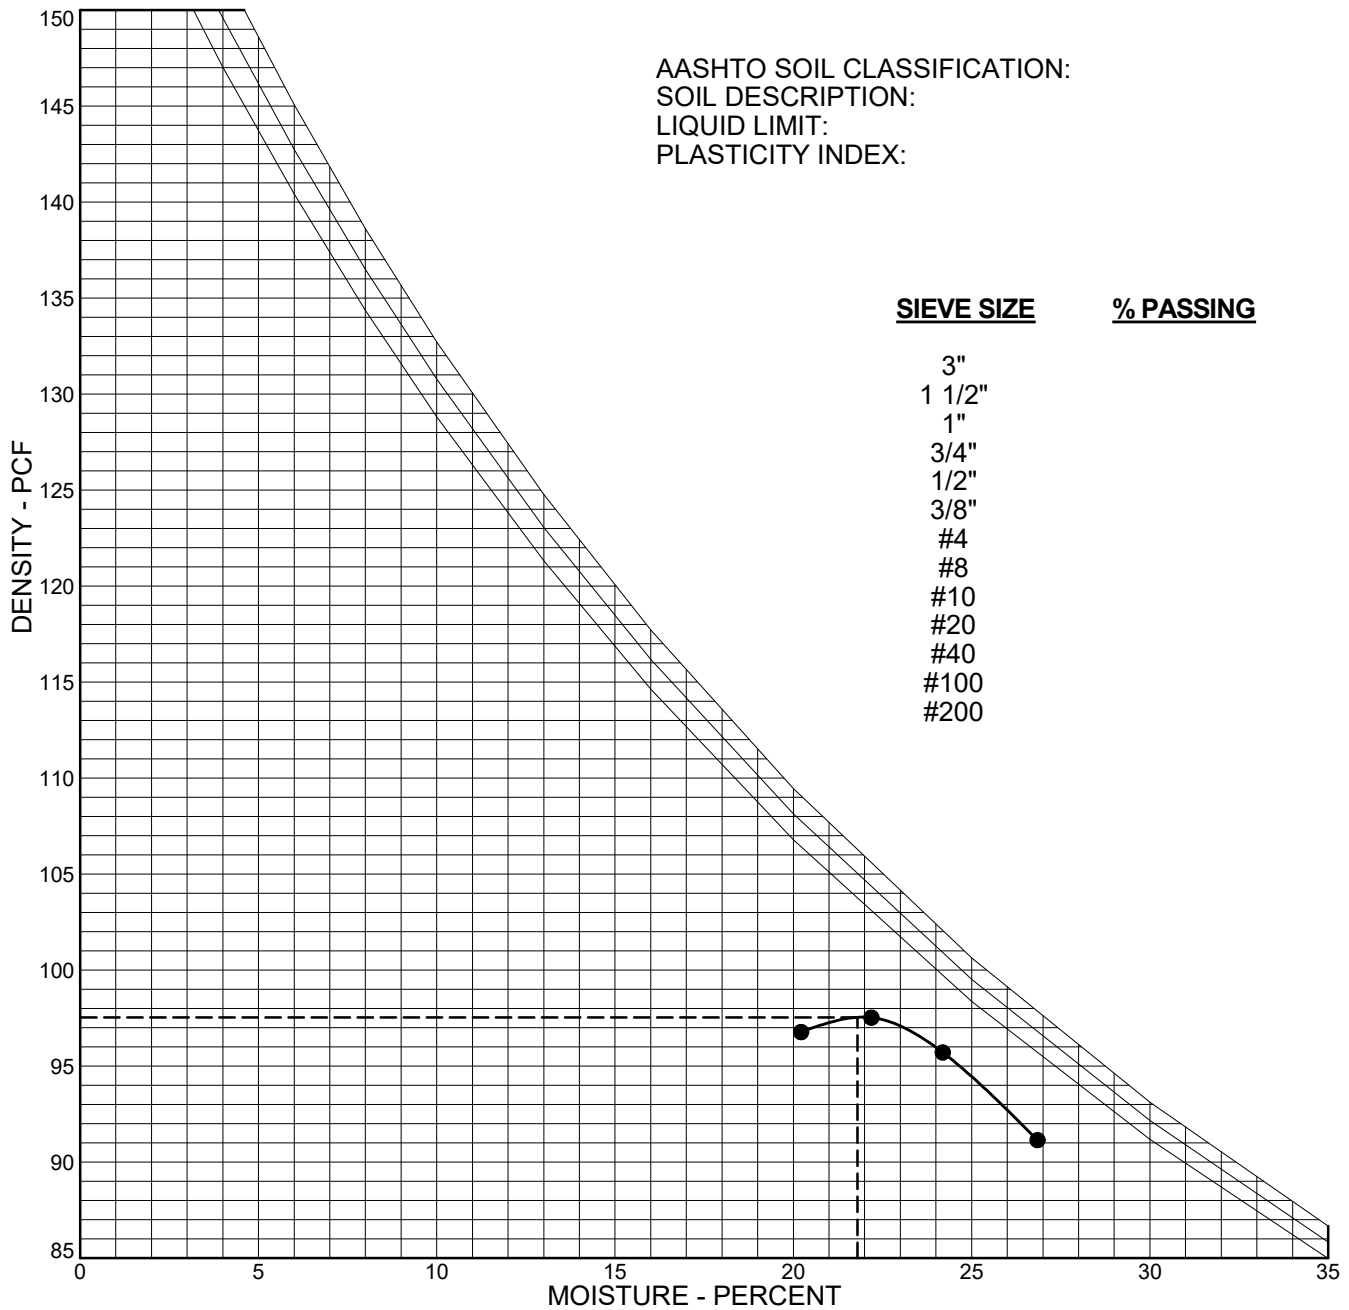
AASHTO SOIL CLASSIFICATION:  
SOIL DESCRIPTION:  
LIQUID LIMIT:  
PLASTICITY INDEX:

DESIGNATION **AASHTO 698A**  
MAX. DRY DENSITY **97.6 pcf**  
OPTIMUM MOISTURE **21.8 %**  
FRACTION USED **#4**  
MOLD VOLUME **0.0332 cu.ft.**

NOTE:  
ZERO AIR VOIDS CURVES  
PLOTTED FOR:  
Gs = 2.60  
Gs = 2.65  
Gs = 2.70

A combined bulk sample of A-7-6 soil was tested to determine the optimum moisture-density relationship in accordance with ASTM D698 (Standard Proctor compaction test). California Bearing Ratio, CBR tests were performed at varying densities with moisture content near optimum. At 95% of the Maximum Modified Proctor density (97.6 pcf), the CBR of the bulk sample was 4. The Moisture-Density Relation Curve is presented in Figure 12. The CBR Test Results are presented in Figures 13 and 14.

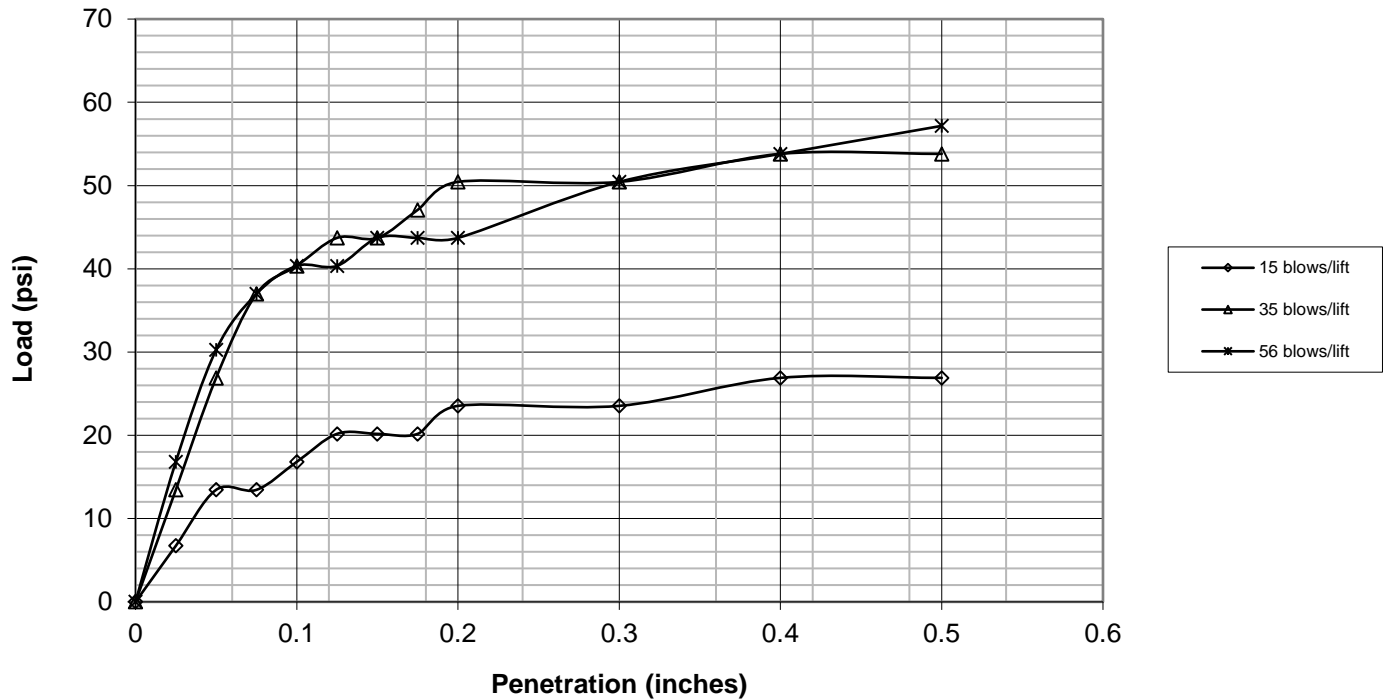
PROJECT: Ponderosa at Lorson Ranch Filing No. 3  
 JOB NUMBER: 173661 TEST DATE: 11/5/2020  
 AASHTO: A-7-6  
 SAMPLE NUMBER: CBR  
 SAMPLE LOCATION: Combined Bulk Sample  
 SOIL DESCRIPTION: Lean Sandy Clay

15 blows/lift	35 blows/lift	56 blows/lift
Penetration (in)	Load (psi)	Load (psi)	Load (psi)
0.000	0.0	0.0	0.0
0.025	6.7	13.5	16.8
0.050	13.5	26.9	30.3
0.075	13.5	37.0	37.0
0.100	16.8	40.4	40.4
0.125	20.2	43.7	40.4
0.150	20.2	43.7	43.7
0.175	20.2	47.1	43.7
0.200	23.5	50.4	43.7
0.300	23.5	50.4	50.4
0.400	26.9	53.8	53.8
0.500	26.9	53.8	57.2

15 blows/lift	35 blows/lift	56 blows/lift
Corrected Penetration (in)	Corrected Load (psi)	Corrected Load (psi)	Corrected Load (psi)
0.1	1.7	4.0	4.0
0.2	1.6	3.4	2.9

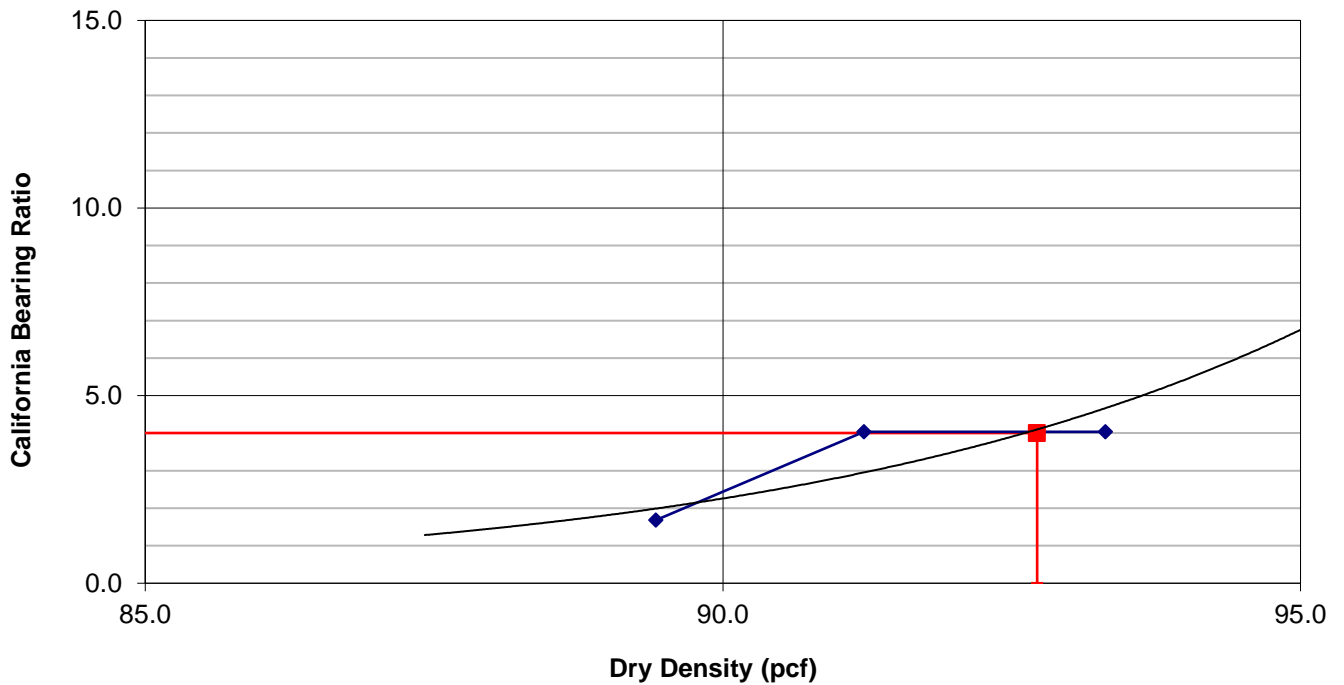
PROJECT: Ponderosa at Lorson Ranch Filing No. 3  
 JOB NUMBER: 173661 TEST DATE: 11/5/2020  
 AASHTO CLASSIFICATION: A-7-6  
 SAMPLE NUMBER: CBR  
 SAMPLE LOCATION: Combined Bulk Sample  
 SOIL DESCRIPTION: Lean Sandy Clay

15 blows/lift	35 blows/lift	56 blows/lift
Corrected California Bearing Ratio	1.7	4.0	4.0
Dry Density (pcf)	89.4	91.2	93.3
Percent Compaction	92	93	96
Percent Moisture After Soaking	41.4	35.3	33.9
Percent Expansion/Compression	3.1	2.2	2.2
Surcharge Weight (lbs)	12.60	12.60	12.60

<b>California Bearing Ratio</b>	<b>4.0</b>
Dry Density (pcf)	97.6
Percent Compaction	95.00%
Target Dry Density	92.7
Compaction Test Method	ASTM D-698
Condition of sample	Soaked
