**ENTECH**  
ENGINEERING, INC.

**SOILS AND GEOLOGY STUDY  
RISING MOON – HABITAT FOR HUMANITY  
PARCEL NO. 55031-01-010  
PEACEFUL MEADOW STREET  
EL PASO COUNTY, COLORADO**

March 27, 2024

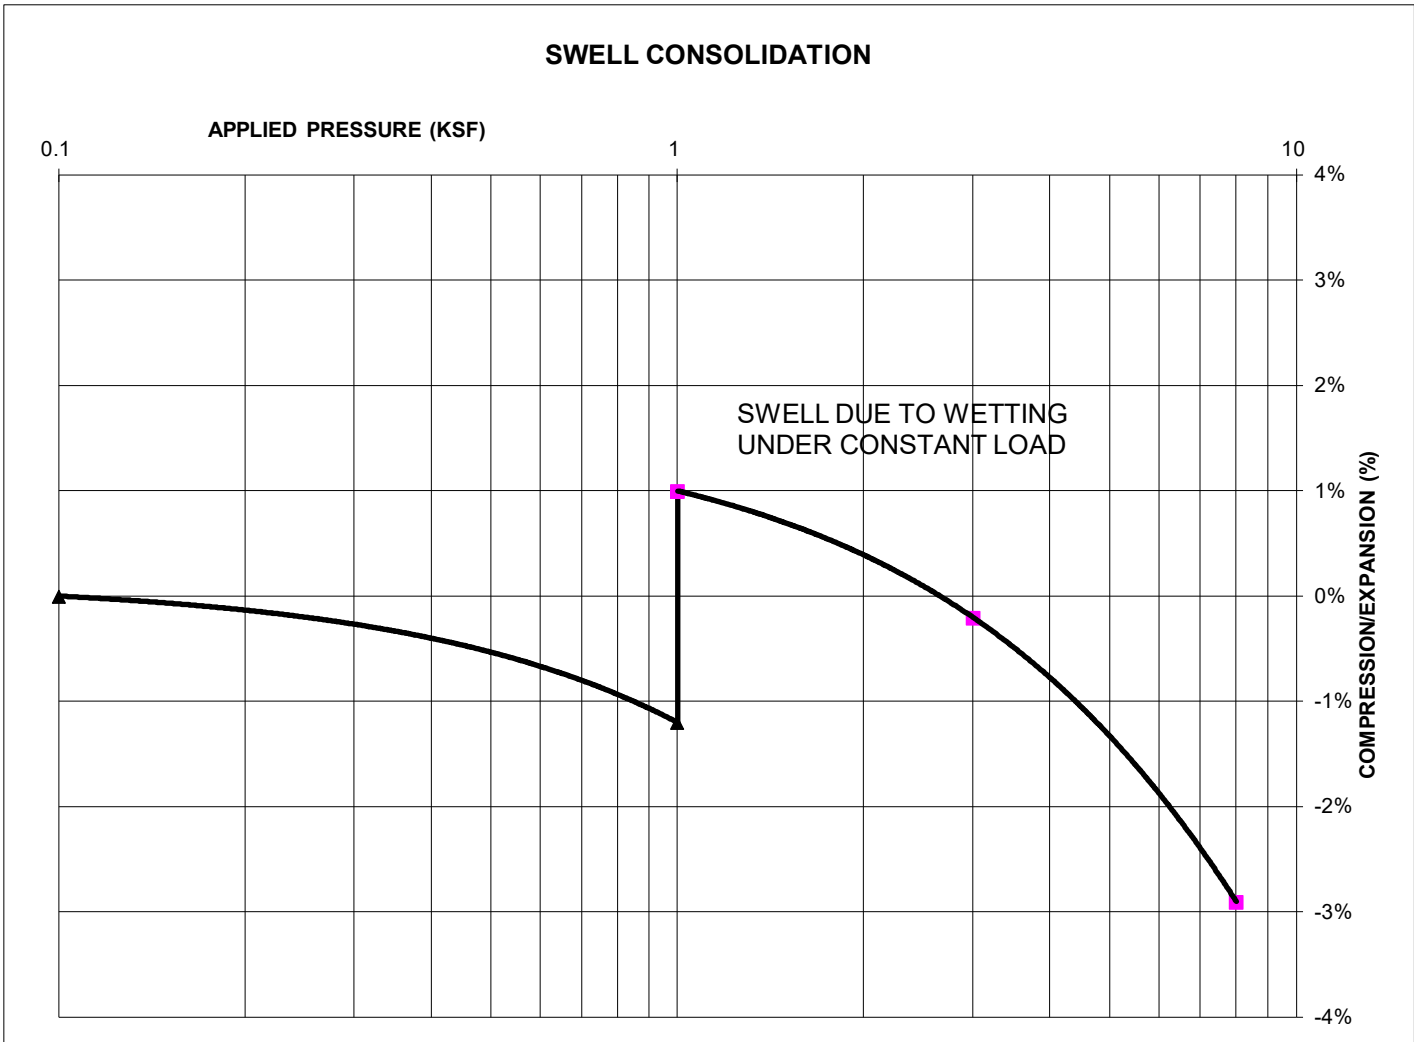
TEST BORING 1  
DEPTH (FT) 10

SOIL DESCRIPTION CLAY, SANDY  
SOIL TYPE 1

**SWELL/COLLAPSE TEST RESULTS**

NATURAL UNIT DRY WEIGHT (PCF): 86  
NATURAL MOISTURE CONTENT: 22.7%  
SWELL/COLLAPSE (%): 2.2%

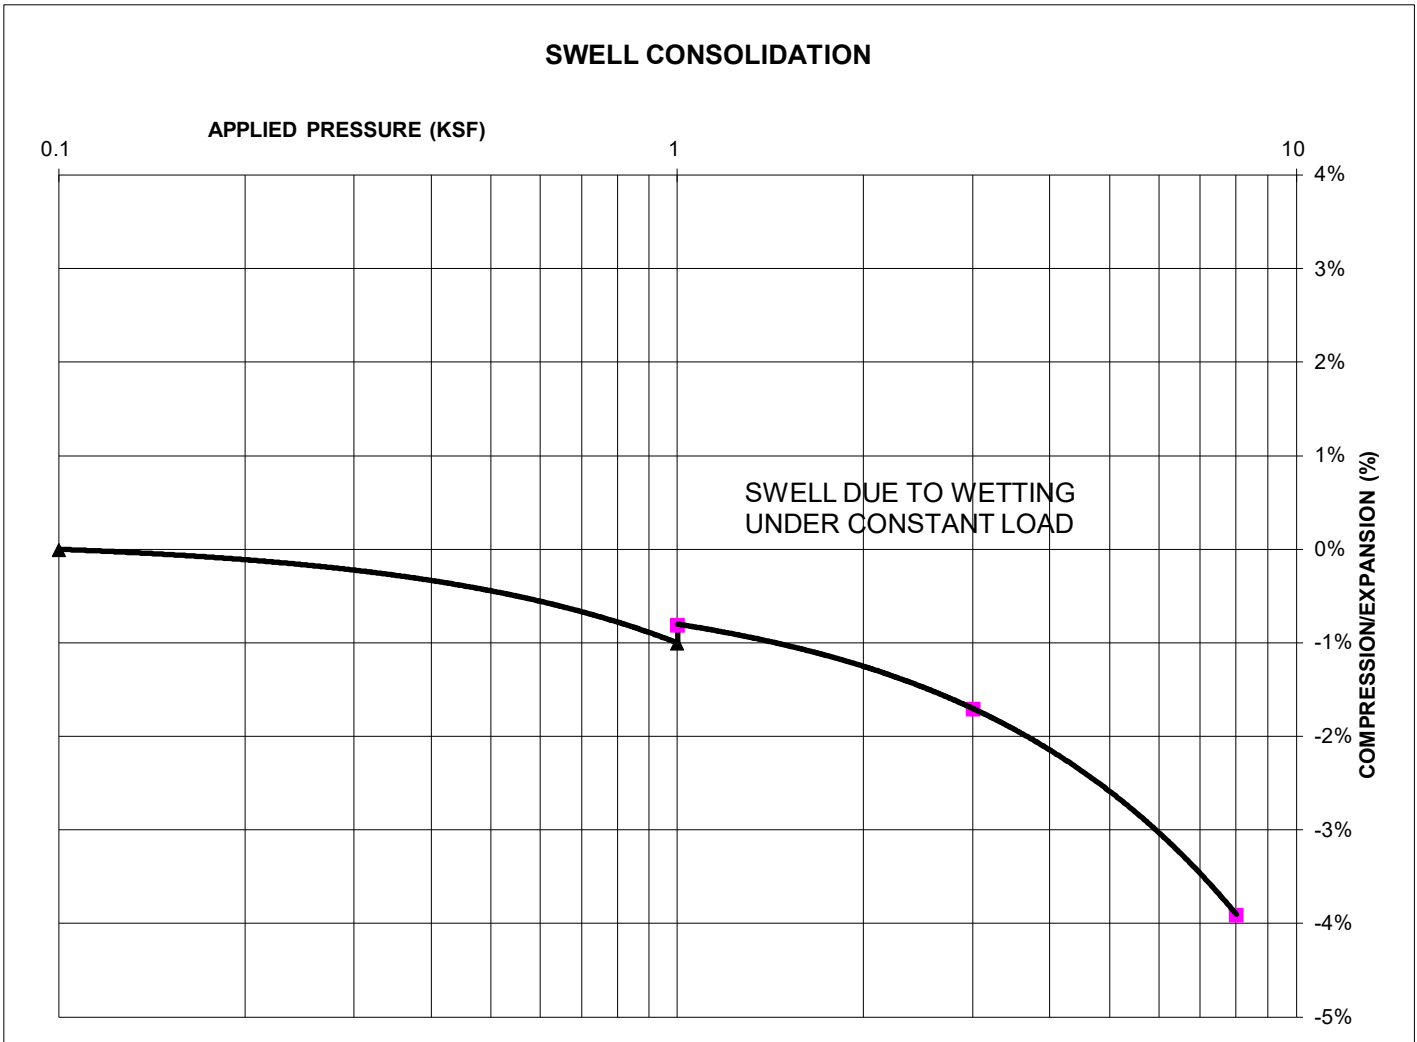
TEST BORING 3  
DEPTH (FT) 10

SOIL DESCRIPTION CLAY, SANDY  
SOIL TYPE 1

**SWELL/COLLAPSE TEST RESULTS**

NATURAL UNIT DRY WEIGHT (PCF): 89  
NATURAL MOISTURE CONTENT: 13.5%  
SWELL/COLLAPSE (%): 0.2%

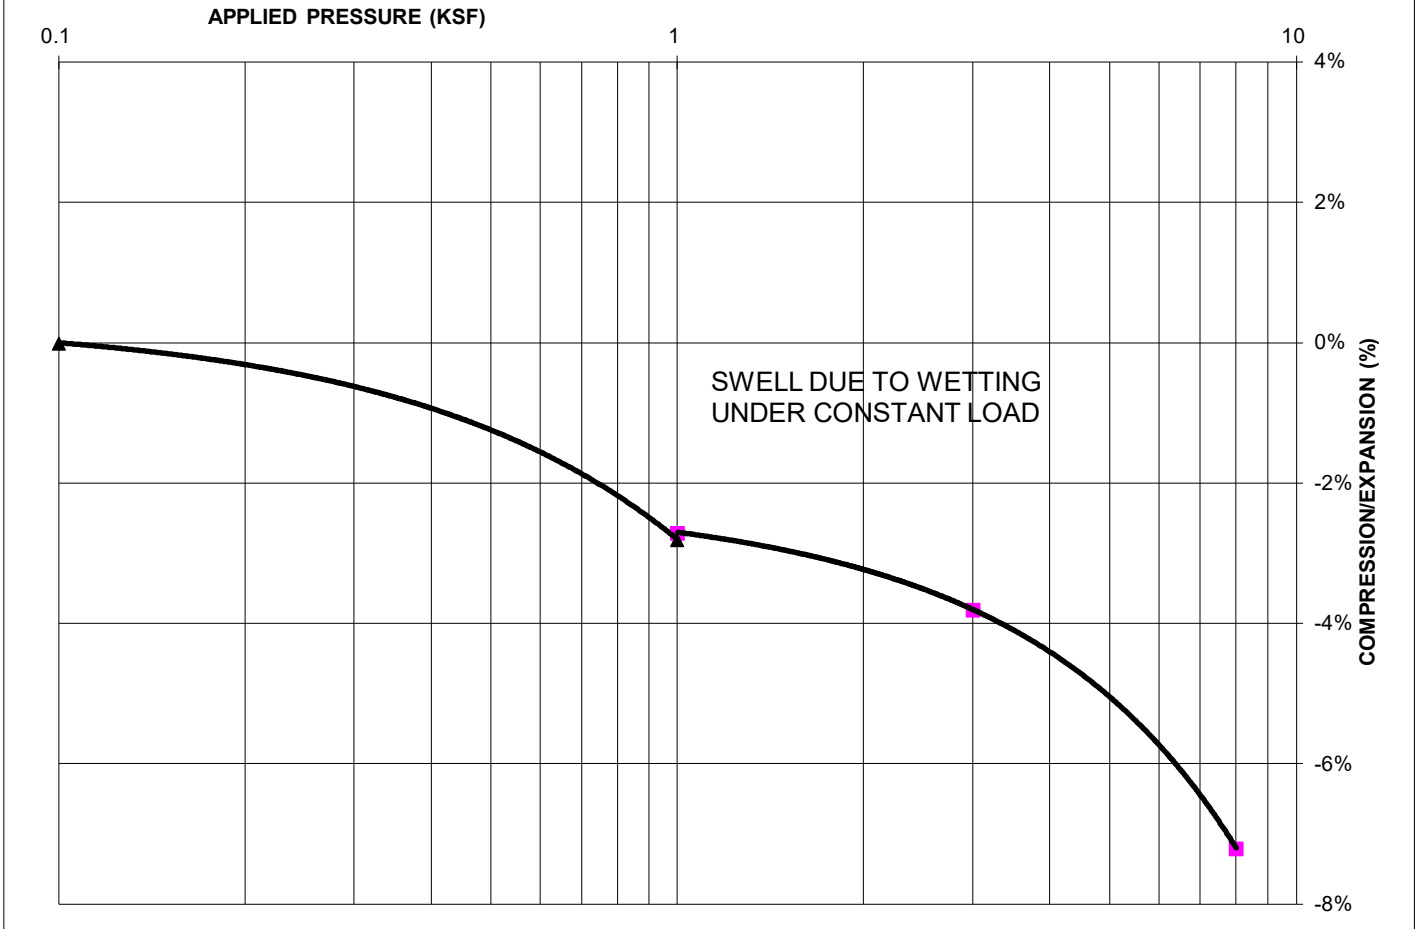
SOIL DESCRIPTION CLAY, SANDY  
SOIL TYPE 1

### SWELL CONSOLIDATION

#### **SWELL/COLLAPSE TEST RESULTS**

NATURAL UNIT DRY WEIGHT (PCF): 95  
NATURAL MOISTURE CONTENT: 25.3%  
SWELL/COLLAPSE (%): 0.1%
