Kumar & Associates, Inc.®
Geotechnical and Materials Engineers
and Environmental Scientists

GEOLOGIC HAZARDS STUDY
RAMAH WASTEWATER TREATMENT PLANT
IMPROVEMENT PROJECT
RAMAH, COLORADO

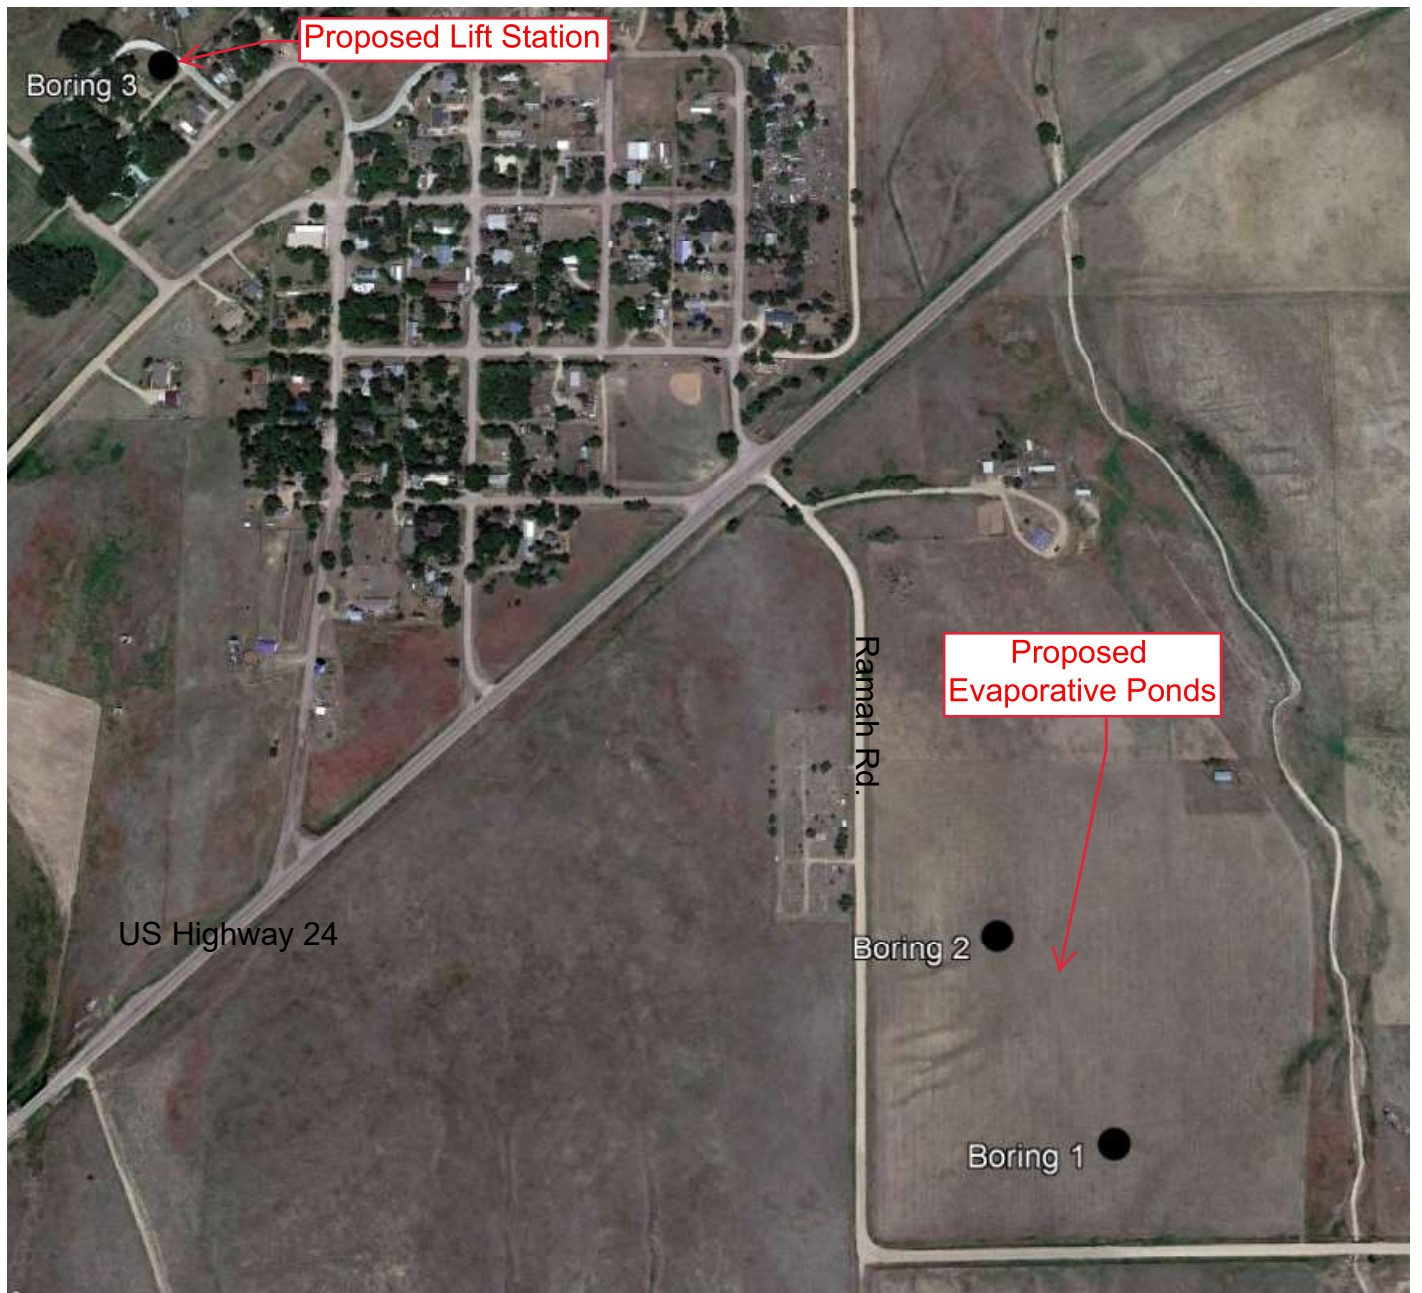
22-2-102.A	Kumar & Associates	SUBJECT SITE	Fig. 1
------------	--------------------	--------------	--------

200 0 200 400
 APPROXIMATE SCALE - FEET

This report presents the results of a Geologic Hazards Study for the proposed Town of Ramah Wastewater System Improvements. The proposed development is shown on Figure 1. The purpose of the study was to evaluate the geologic conditions and assess their potential impact on the project and surrounding properties. The study was conducted in accordance with our proposal for geotechnical engineering services, proposal no. C22-104, dated January 10, 2022, in addition to our email communications with Element Engineering, dated October 21, 2022
