**ENTECH**  
ENGINEERING, INC.

**SOILS AND GEOLOGY STUDY  
ROCKY MOUNTIAN CALVARY ELLICOTT CAMPUS  
PARCEL NO. 34000-00-207  
2150 NORTH ELLICOTT HIGHWAY  
EL PASO COUNTY, COLORADO**

March 19, 2024

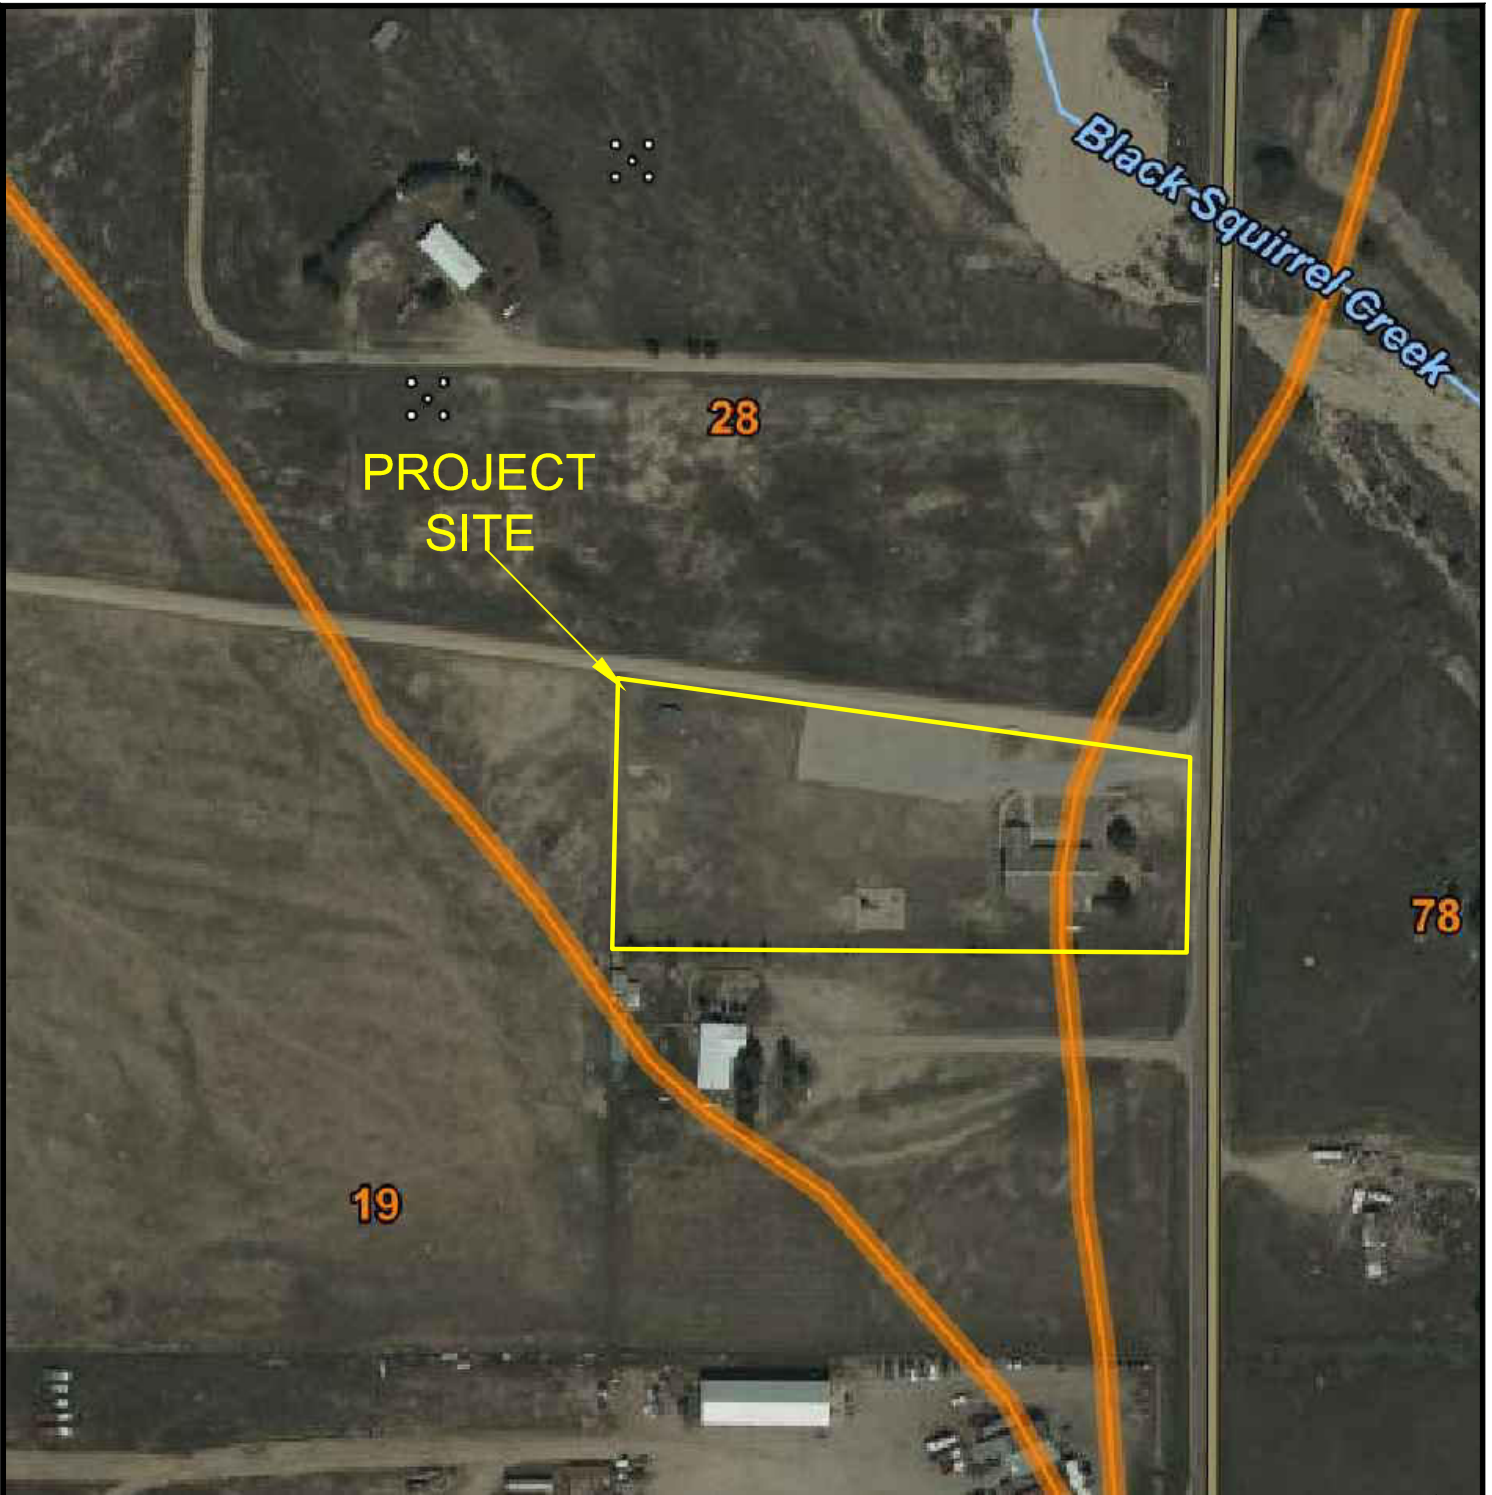
**FIG. 4**

**SOIL SURVEY MAP**

The Natural Resource Conservation Service (Reference 3), previously the Soil Conservation Service (Reference 4) has mapped two soil types on the site (Figure 4). In general, the soils classify as fine sandy loam. The soils are described as follows:

Complete descriptions of each soil type are presented in Appendix D. The soils have generally been described to have moderate permeabilities. Possible hazards with soil erosion are present on the site. The erosion potential can be controlled with vegetation. The majority of the soils have been described to have moderate erosion hazards.

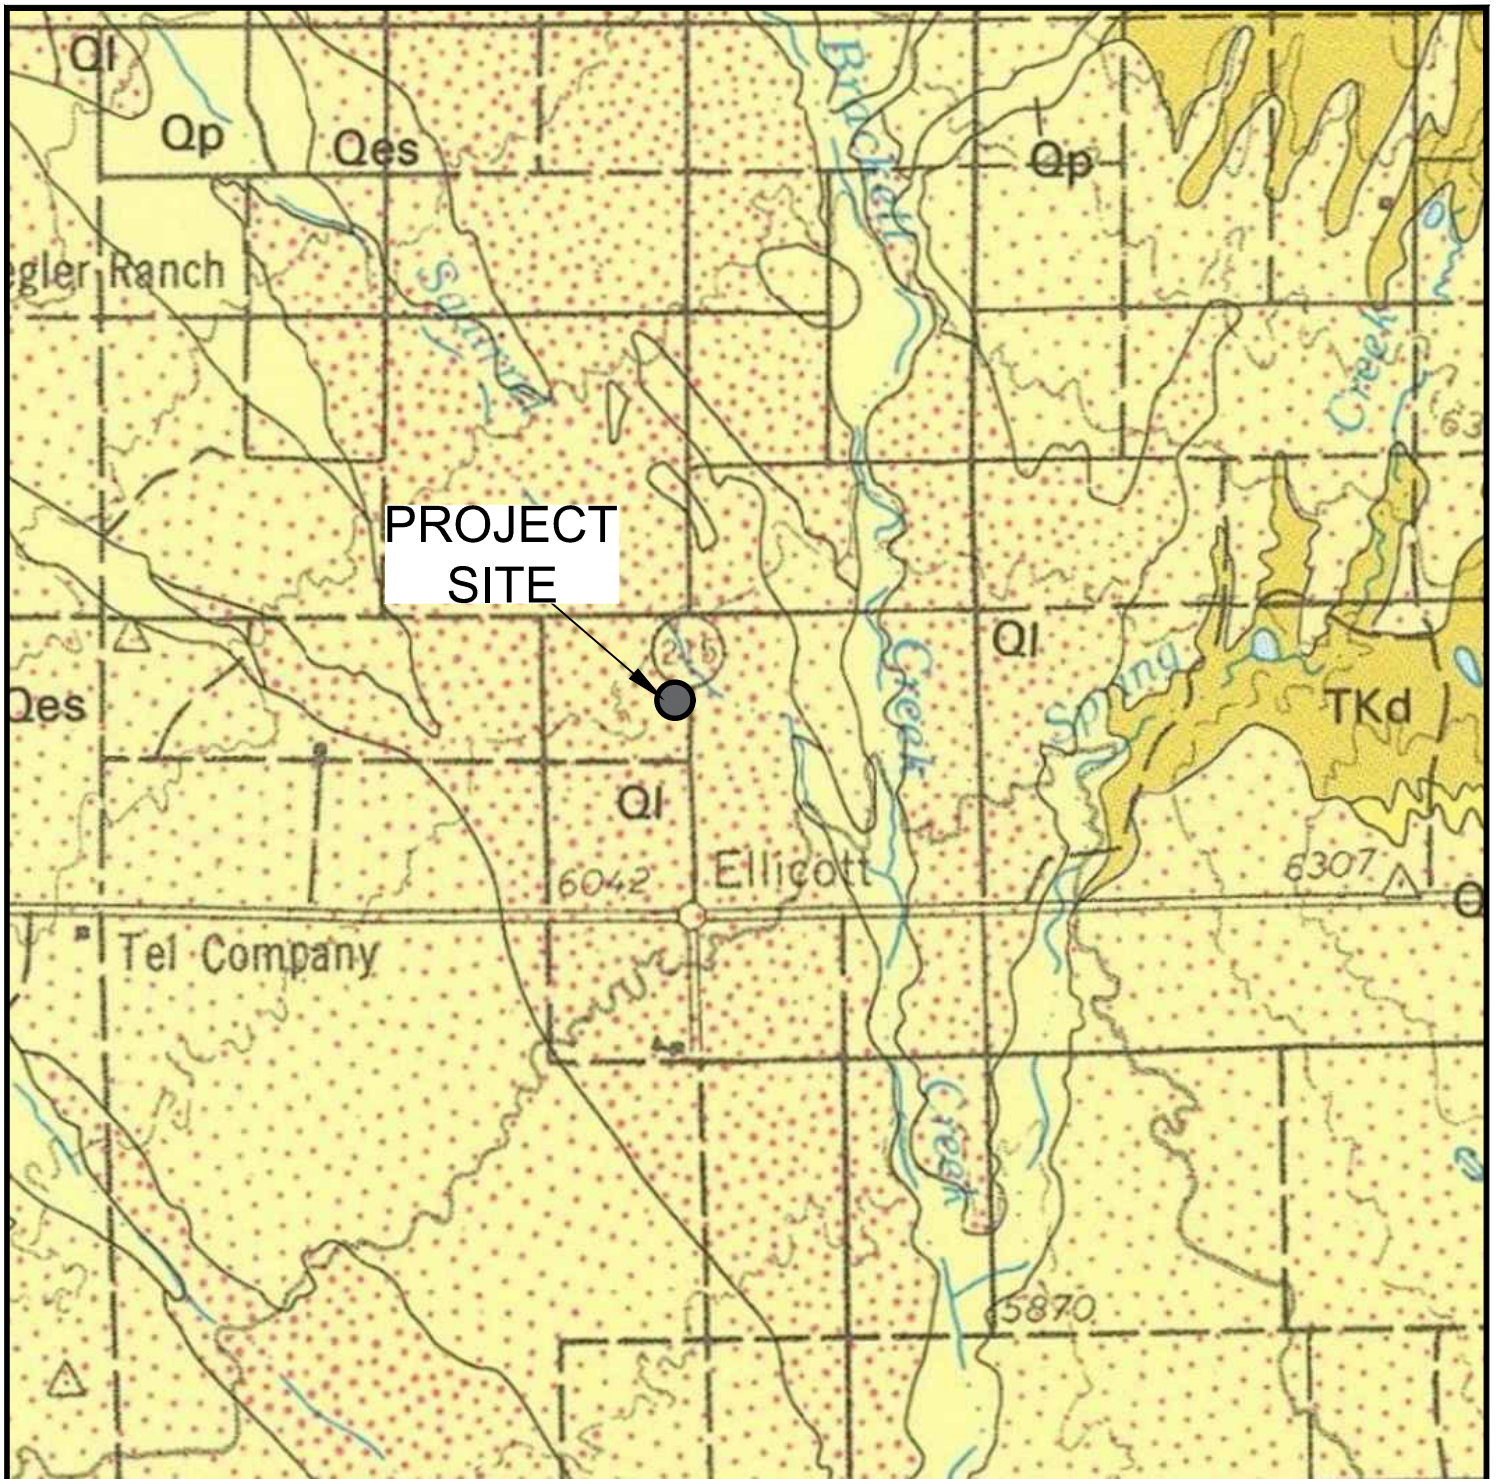
**FIG. 5**

**GEOLOGIC MAP OF THE PUEBLO  
1°X2° QUADRANGLE**  
2150 N ELLICOTT HWY  
ROCKY MOUNTAIN CALVARY CHURCH

The *Geologic Map of the Pueblo 1°x2° Quadrangle* showing the site is presented in (Figure 5, Reference 5). The Geology/Engineering Geology Map prepared for the site is presented in Figure 6. Two mappable units were identified on this site which are described as follows:

The soils listed above were mapped from site-specific mapping, the *Geologic Map of the Pueblo 1°x2° Quadrangle* distributed by the United States Geological Survey in 1978 (Reference 5). The test borings and test pits were also used in evaluating the site and are included in Appendix B. The Geology Map prepared for the site is presented in Figure 6.

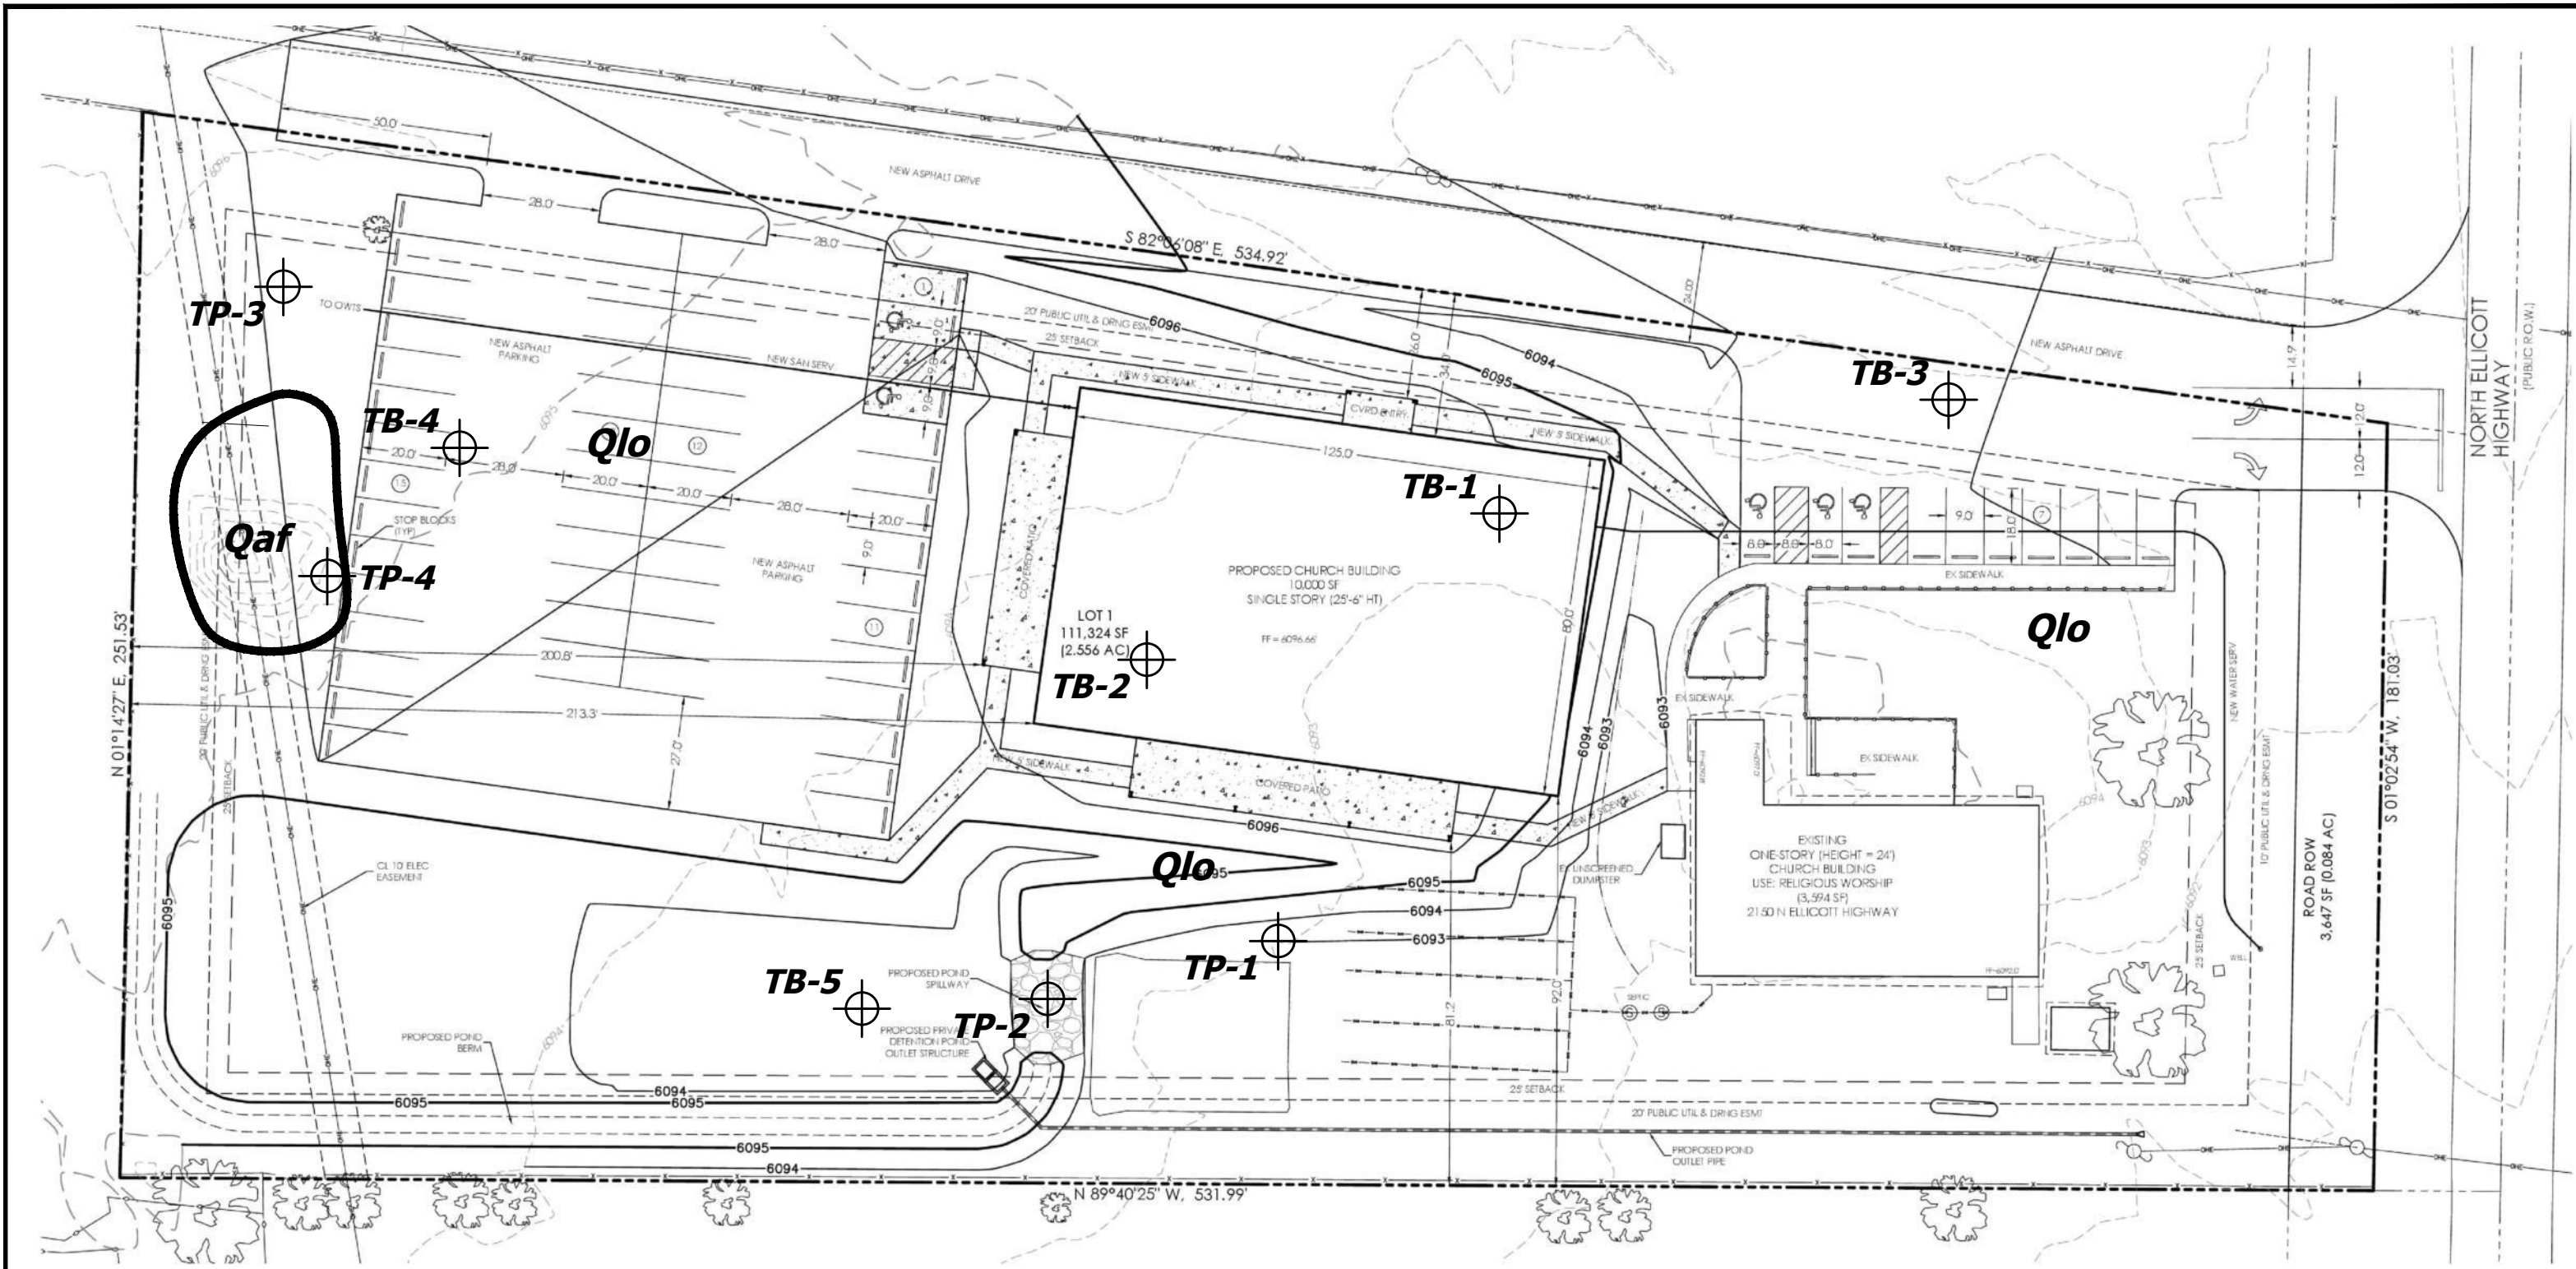
**FIG. 6**

**Legend:**  
 Qaf - Artificial Fill of Holocene Age:  
 man-placed fill deposits  
 Qlo - Louviers Alluvium of Quaternary Age:  
 stream terrace deposits

Detailed mapping has been performed on this site to produce an Engineering Geology Map Figure 6. This map shows the location of various geologic conditions of which the developers should be cognizant during the planning, design and construction stages of the project. These hazards and the recommended mitigation techniques are as follows:

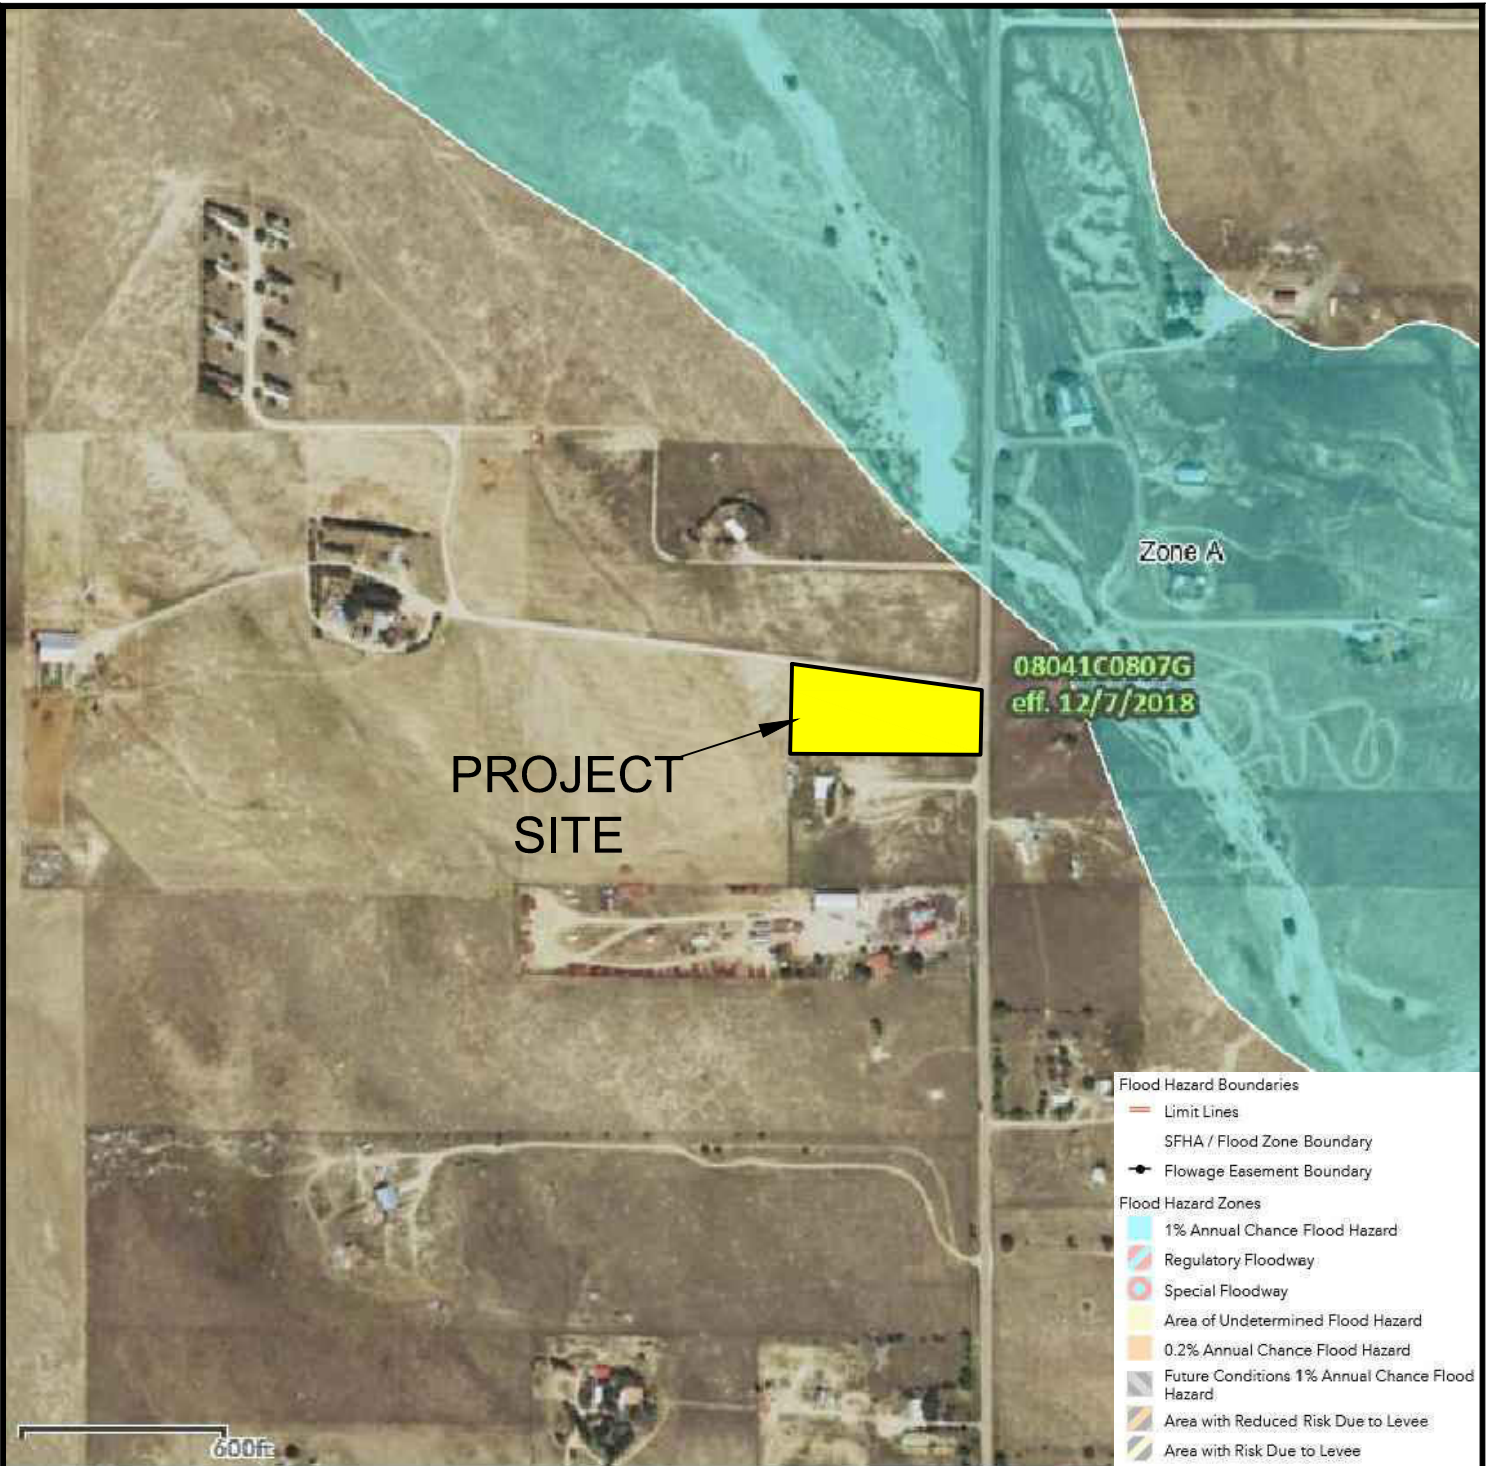
**FIG. 7**

## FEMA FLOODPLAIN MAP

No drainages were observed on the site, and the site is not mapped within floodplain zones according to the FEMA Map No. 08041CO807G, (Figure 7, Reference 6). Black Squirrel Creek and associated floodplain are located north of the site. Groundwater was not encountered in the

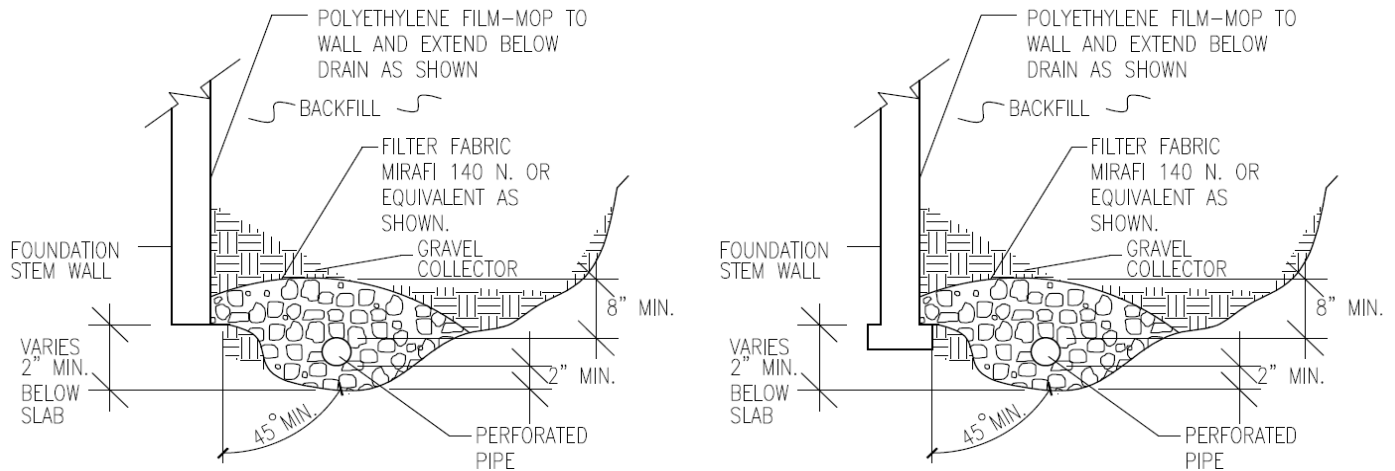
**FIG. 3**

NOTES:

-GRAVEL SIZE IS RELATED TO DIAMETER OF PIPE PERFORATIONS-85% GRAVEL GREATER THAN 2x PERFORATION DIAMETER.

Perimeter drains are recommended for usable space below grade (areas where the interior slab or bottom of the crawl space is below the exterior grade). A typical perimeter drain detail is shown in Figure 3.

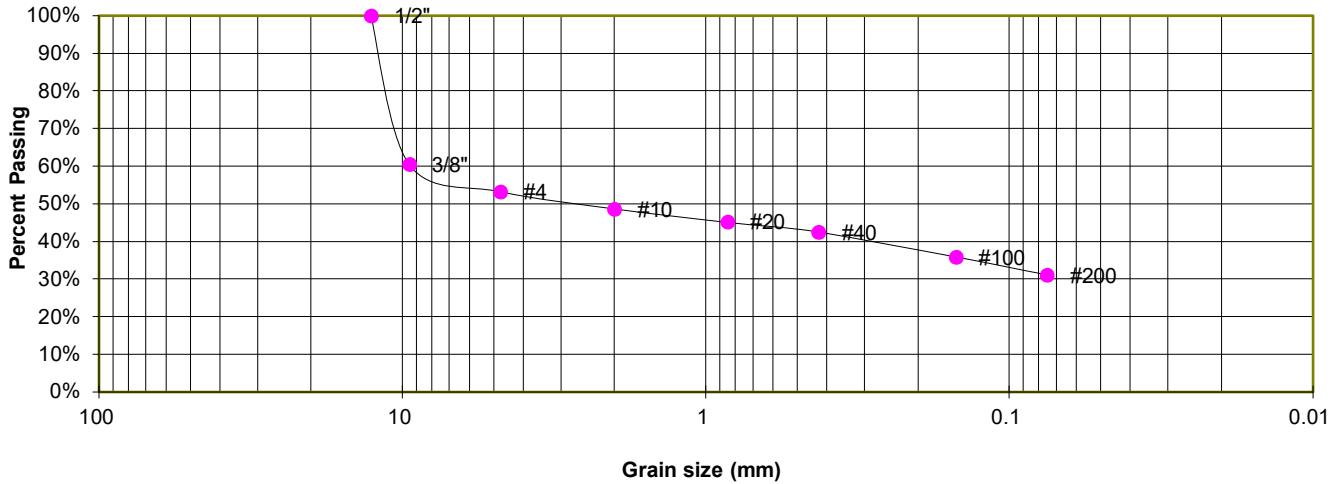
SOIL DESCRIPTION SAND, SILTY  
 SOIL TYPE 1, CBR

**Sieve Analysis  
 Grain Size Distribution**

**GRAIN SIZE ANALYSIS**

U.S. Sieve #	Percent Finer
3"	
1 1/2"	
3/4"	
1/2"	100.0%
3/8"	60.5%
4	53.2%
10	48.7%
20	45.2%
40	42.5%
100	35.9%
200	31.1%

Laboratory testing was performed on select samples of the soils to classify and determine the soils engineering characteristics. Laboratory tests included grain-size analysis, ASTM D-422, and Atterberg Limits, ASTM D-4318. Swell/Consolidation and FHA Swell Testing to evaluate expansion potential. Sulfate testing was performed on selected samples to evaluate potential for below grade concrete degradation due to sulfate attack. A Summary of Laboratory Test Results is included in Appendix B.

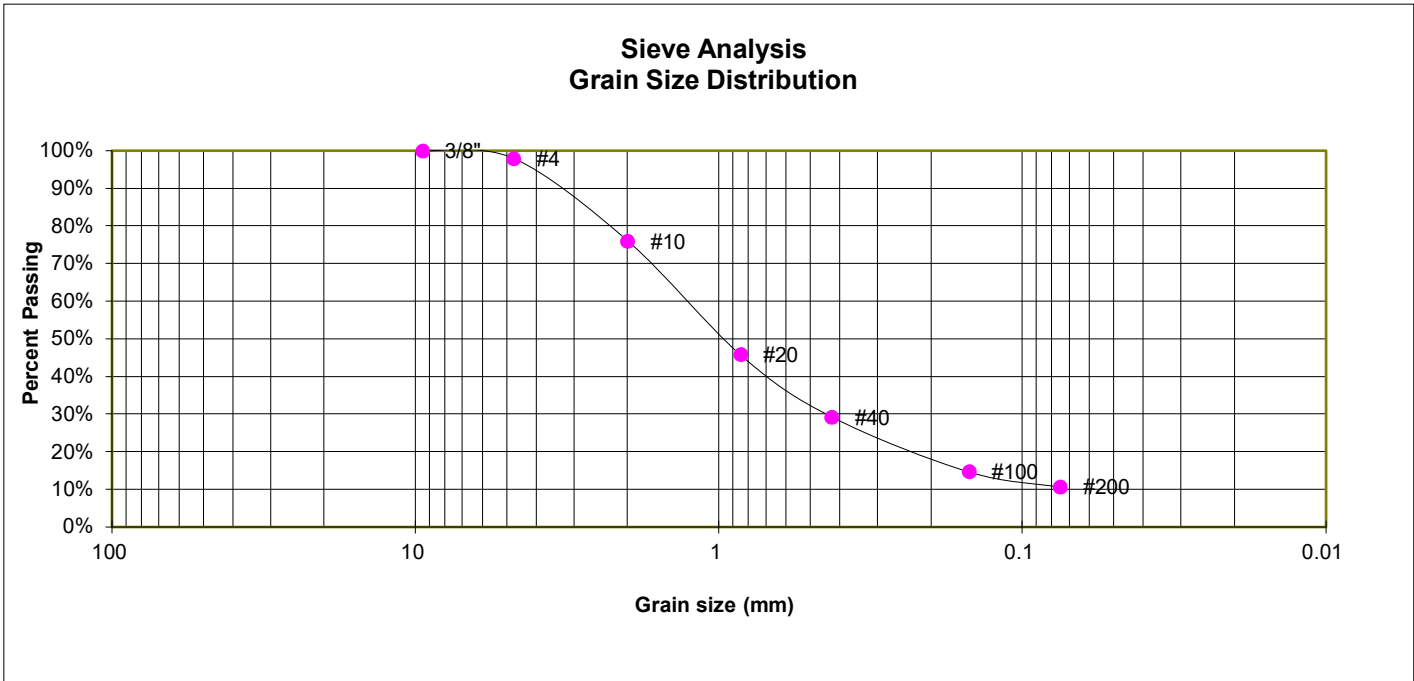
TEST BORING 2  
 DEPTH (FT) 10

SOIL DESCRIPTION SAND, WITH SILT  
 SOIL TYPE 1

**GRAIN SIZE ANALYSIS**

U.S. Sieve #	Percent Finer
3"	
1 1/2"	
3/4"	
1/2"	
3/8"	100.0%
4	98.0%
10	76.0%
20	45.8%
40	29.3%
100	14.7%
200	10.6%

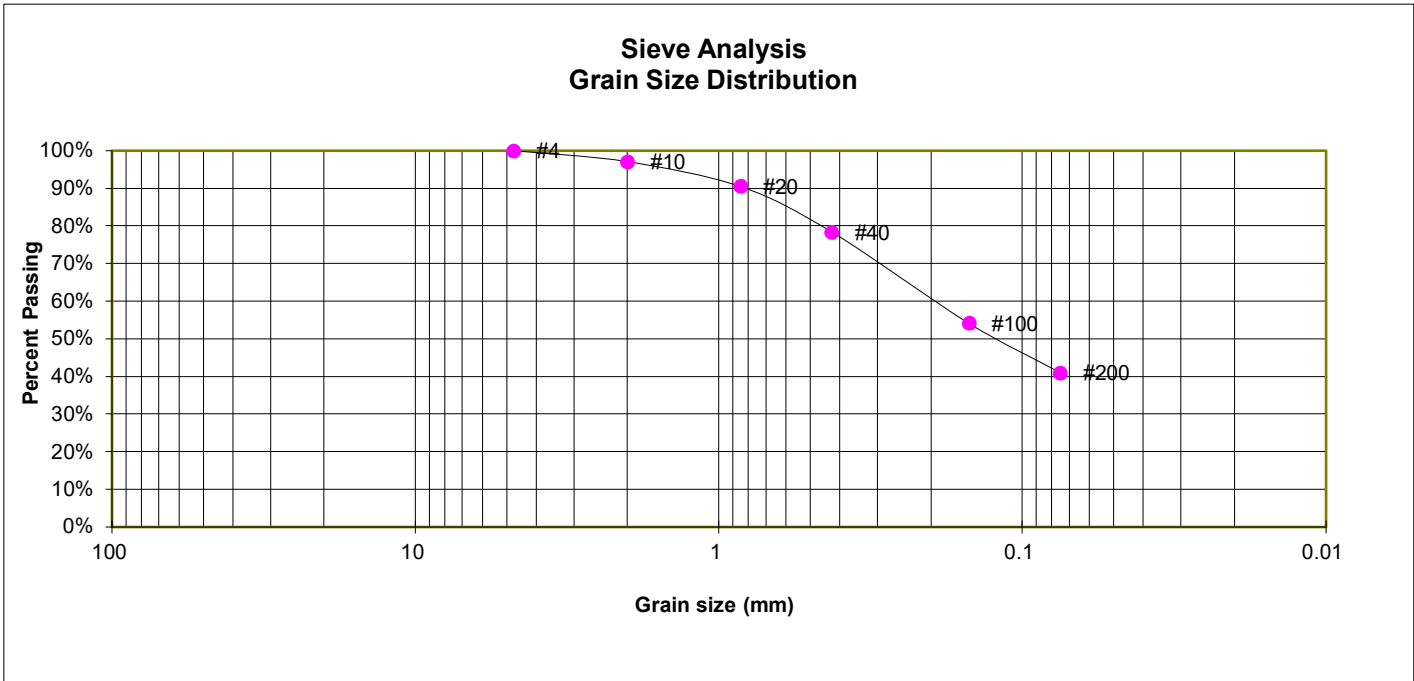
TEST BORING 3  
 DEPTH (FT) 1-2

SOIL DESCRIPTION SAND, CLAYEY  
 SOIL TYPE 1

**GRAIN SIZE ANALYSIS**

U.S. Sieve #	Percent Finer
3"	
1 1/2"	
3/4"	
1/2"	
3/8"	
4	100.0%
10	97.1%
20	90.5%
40	78.4%
100	54.2%
200	41.0%

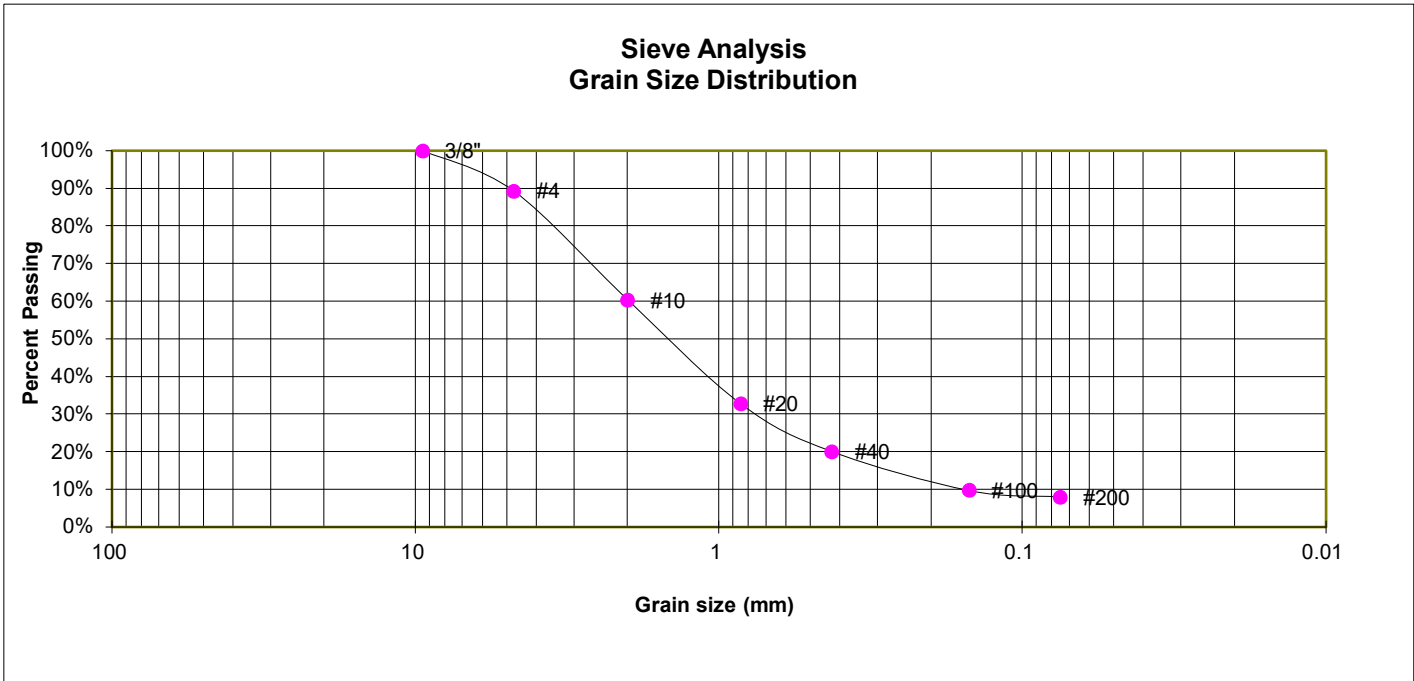
TEST BORING 3  
 DEPTH (FT) 10

SOIL DESCRIPTION SAND, WITH SILT  
 SOIL TYPE 1

**GRAIN SIZE ANALYSIS**

U.S. Sieve #	Percent Finer
3"	
1 1/2"	
3/4"	
1/2"	
3/8"	100.0%
4	89.3%
10	60.3%
20	32.8%
40	20.1%
100	9.8%
200	8.0%

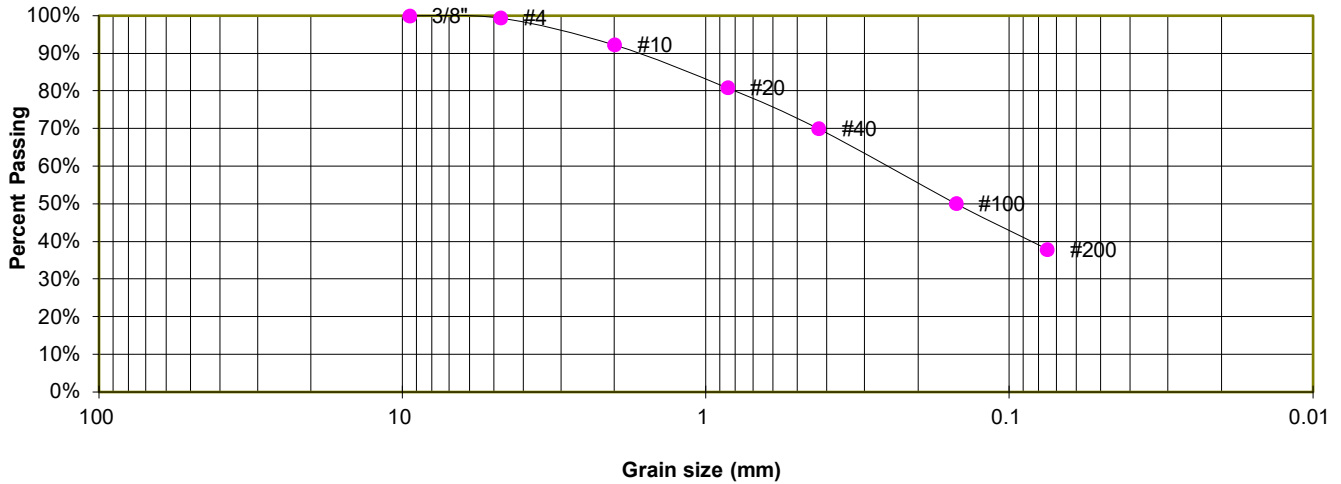
SOIL DESCRIPTION SAND, SILTY  
 SOIL TYPE 1

**Sieve Analysis  
 Grain Size Distribution**

**GRAIN SIZE ANALYSIS**

U.S. Sieve #	Percent Finer
3"	
1 1/2"	
3/4"	
1/2"	
3/8"	100.0%
4	99.4%
10	92.2%
20	80.9%
40	70.0%
100	50.1%
200	38.0%

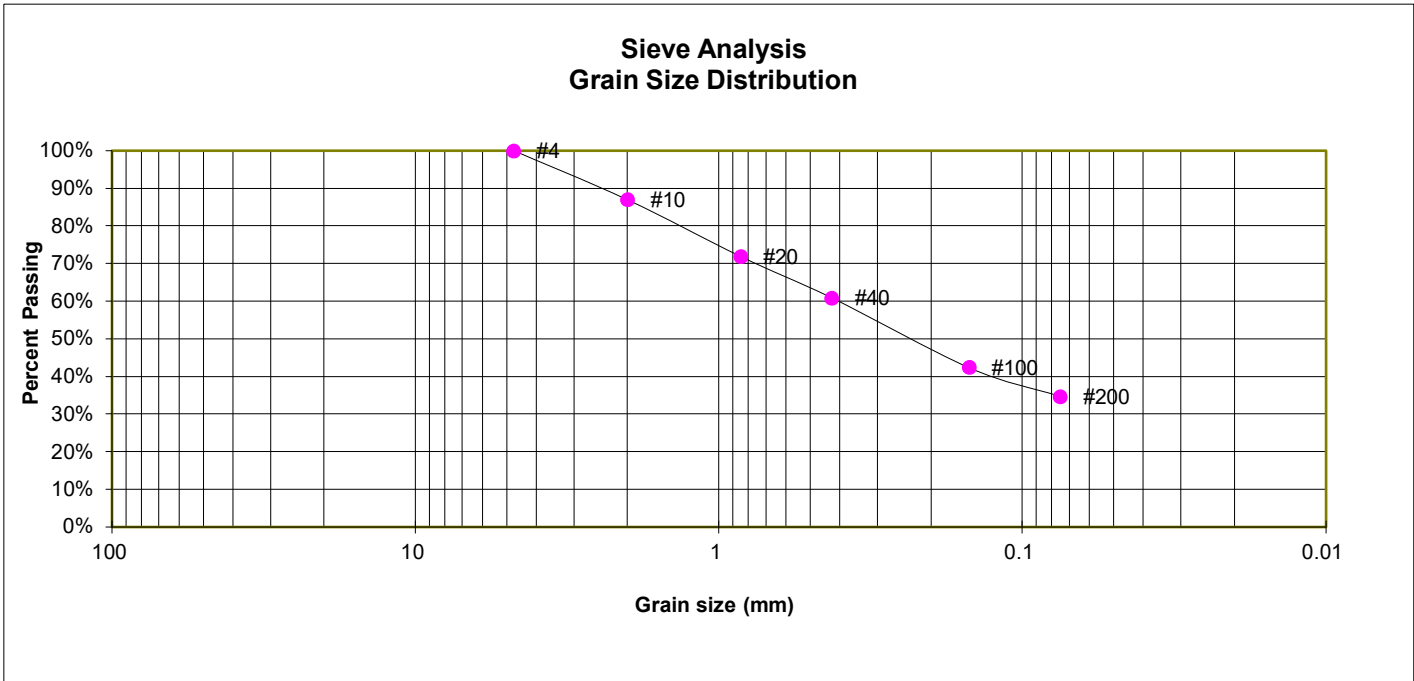
TEST BORING 5  
 DEPTH (FT) 2-3

SOIL DESCRIPTION SAND, SILTY  
 SOIL TYPE 1

**GRAIN SIZE ANALYSIS**

U.S. Sieve #	Percent Finer
3"	
1 1/2"	
3/4"	
1/2"	
3/8"	
4	100.0%
10	87.0%
20	72.0%
40	60.9%
100	42.4%
200	34.7%

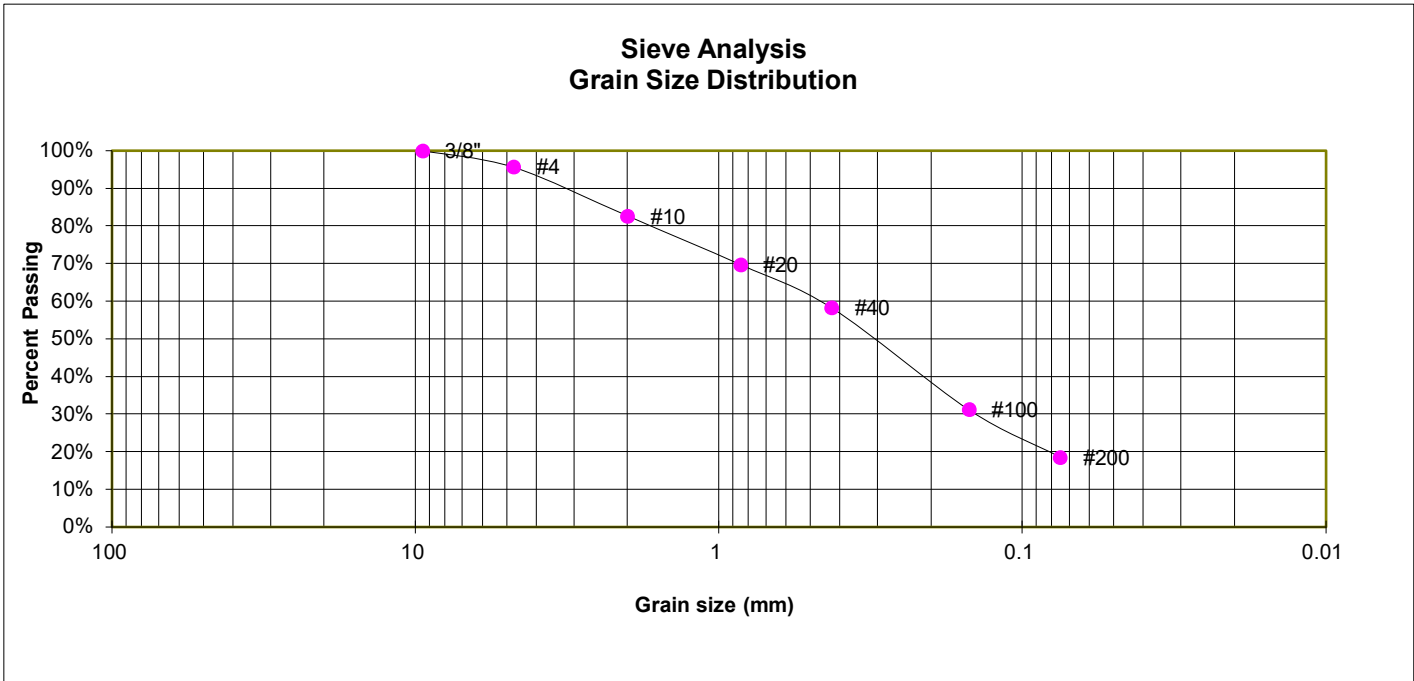
TEST BORING 5  
DEPTH (FT) 10

SOIL DESCRIPTION SAND, SILTY  
SOIL TYPE 1

**GRAIN SIZE ANALYSIS**

U.S. Sieve #	Percent Finer
3"	
1 1/2"	
3/4"	
1/2"	
3/8"	100.0%
4	95.7%
10	82.7%
20	69.7%
40	58.3%
100	31.2%
200	18.6%

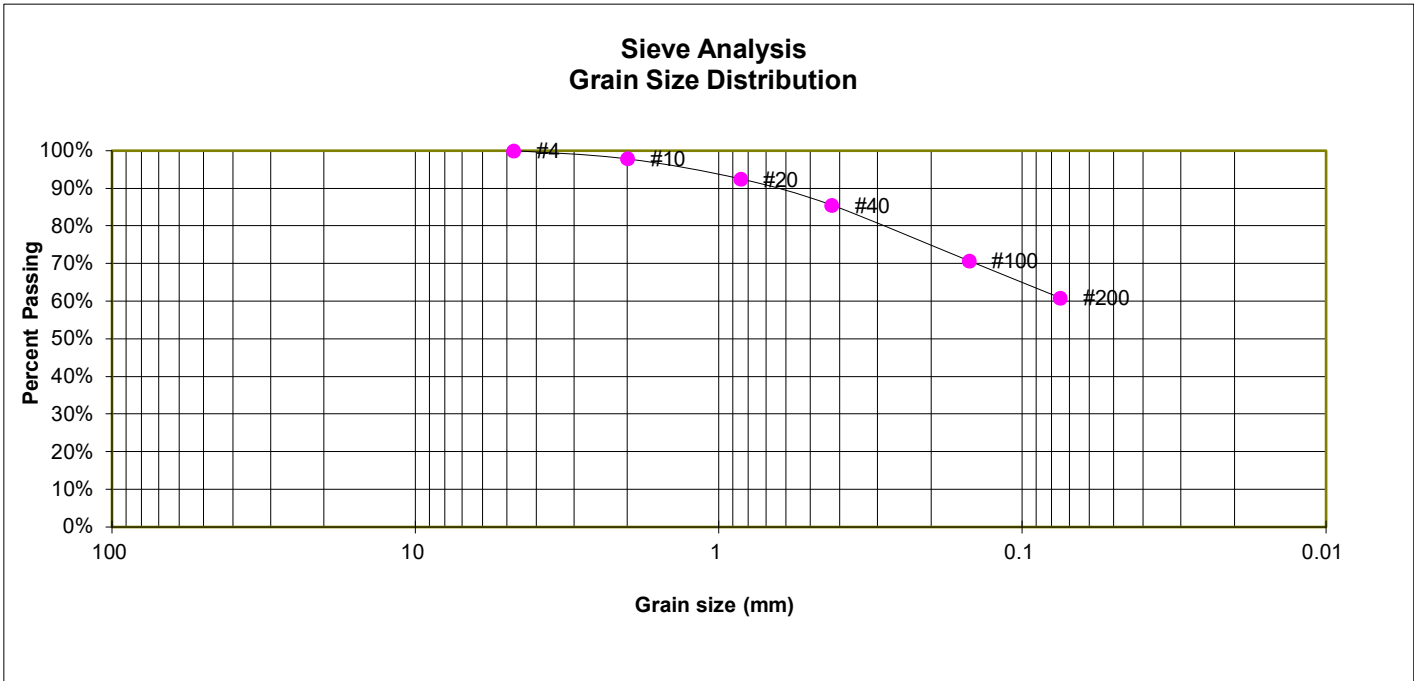
TEST BORING 1  
 DEPTH (FT) 2-3

SOIL DESCRIPTION CLAY, SANDY  
 SOIL TYPE 2

**GRAIN SIZE ANALYSIS**

U.S. Sieve #	Percent Finer
3"	
1 1/2"	
3/4"	
1/2"	
3/8"	
4	100.0%
10	97.9%
20	92.5%
40	85.5%
100	70.8%
200	60.9%

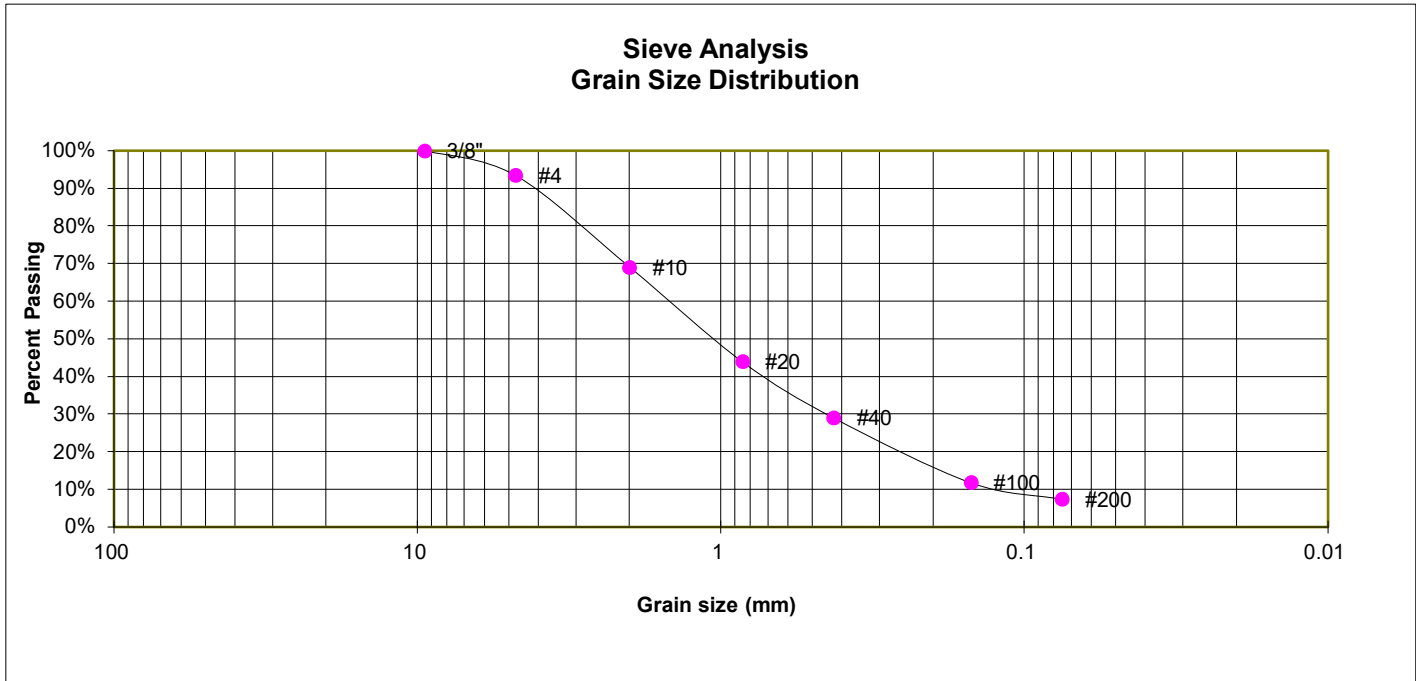
TEST BORING 1  
 DEPTH (FT) 20

SOIL DESCRIPTION SANDSTONE (SAND, WITH SILT)  
 SOIL TYPE 3

**GRAIN SIZE ANALYSIS**

U.S. Sieve #	Percent Finer
3"	
1 1/2"	
3/4"	
1/2"	
3/8"	100.0%
4	93.5%
10	69.1%
20	43.9%
40	29.0%
100	11.8%
200	7.4%

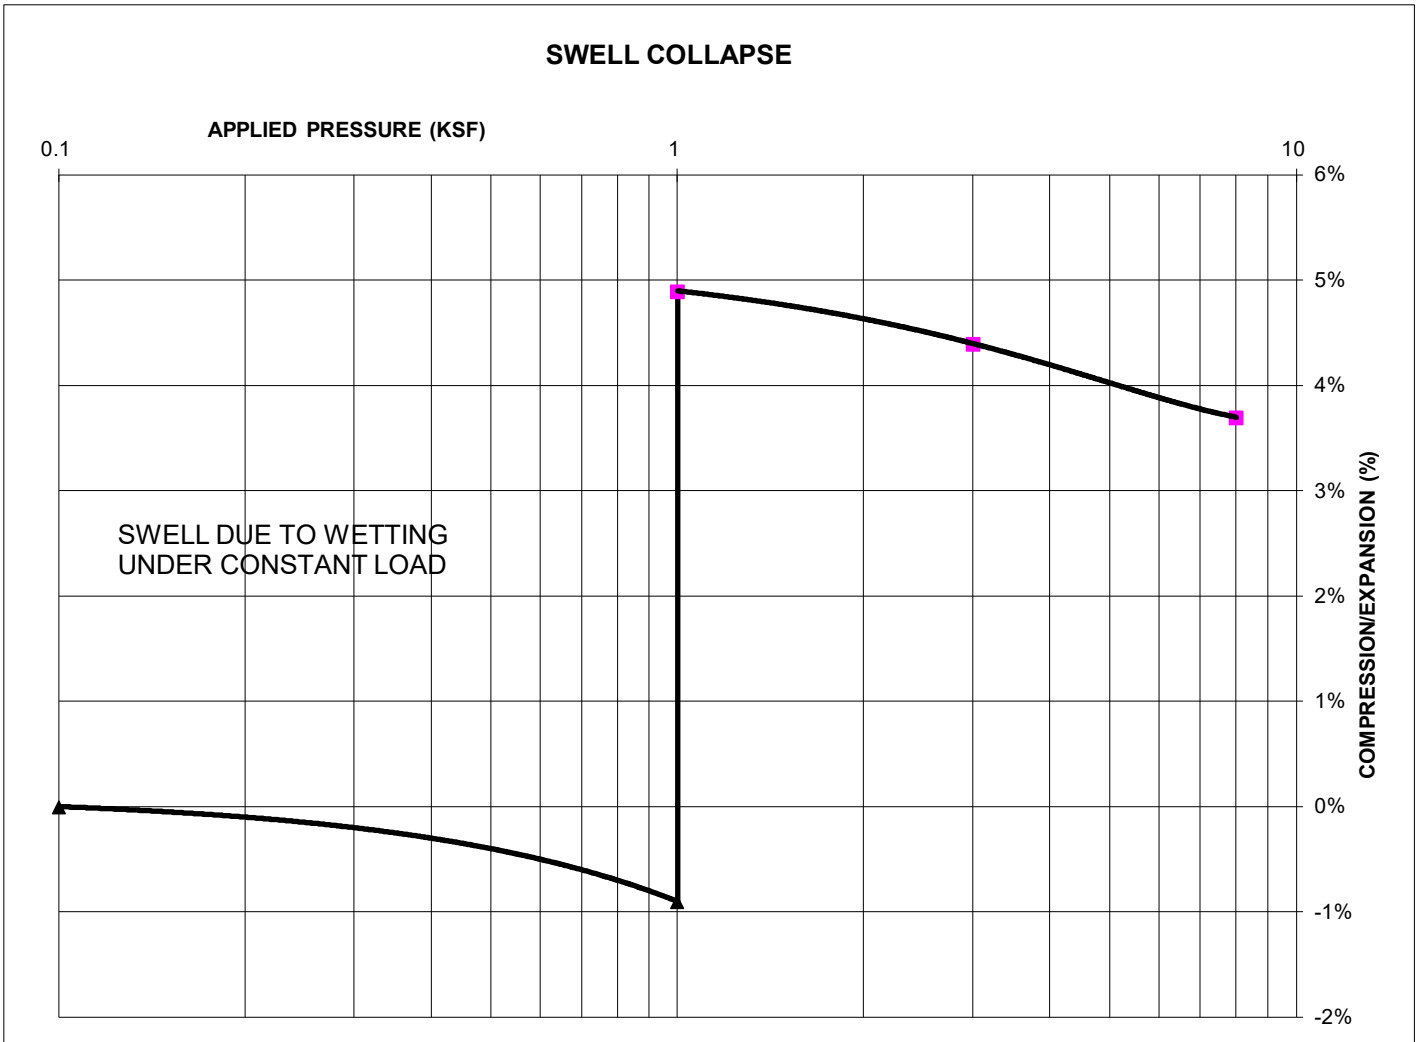
TEST BORING 1  
DEPTH (FT) 2-3

SOIL DESCRIPTION CLAY, SANDY  
SOIL TYPE 2

**SWELL/COLLAPSE TEST RESULTS**

NATURAL UNIT DRY WEIGHT (PCF): 104  
NATURAL MOISTURE CONTENT: 16.2%  
SWELL/COLLAPSE (%): 5.8%

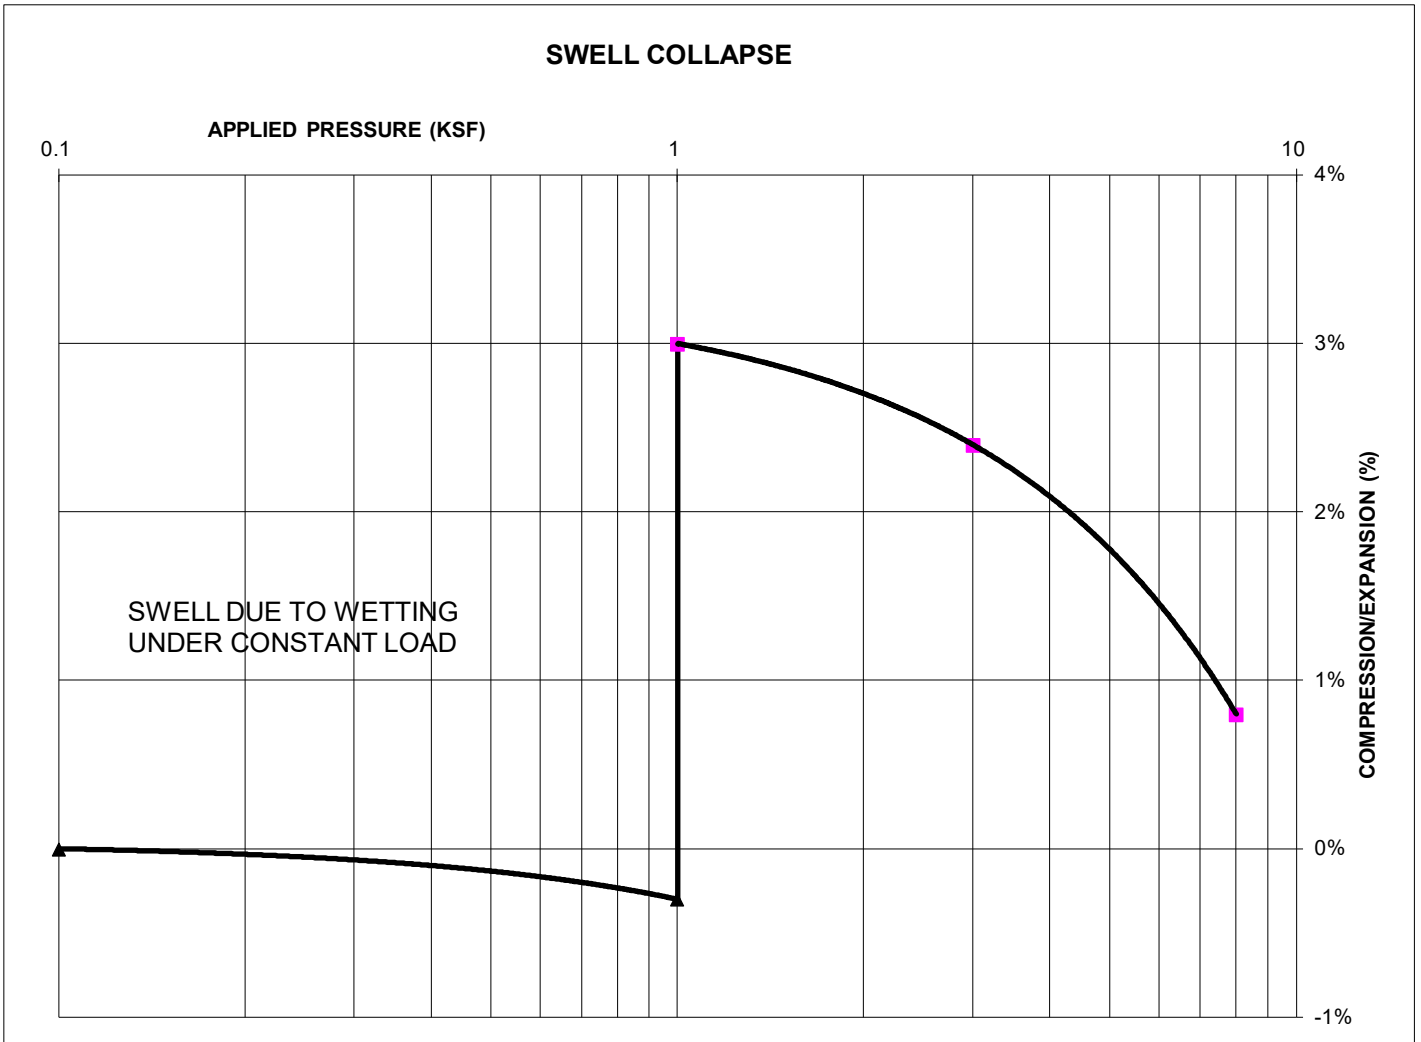
TEST BORING 3  
DEPTH (FT) 1-2

SOIL DESCRIPTION SAND, CLAYEY  
SOIL TYPE 1

**SWELL/COLLAPSE TEST RESULTS**

NATURAL UNIT DRY WEIGHT (PCF): 110  
NATURAL MOISTURE CONTENT: 11.0%  
SWELL/COLLAPSE (%): 3.3%
