**ENTECH**  
ENGINEERING, INC.

**SOILS AND GEOLOGY STUDY  
ROCKY MOUNTIAN CALVARY ELLICOTT CAMPUS  
PARCEL NO. 34000-00-207  
2150 NORTH ELLICOTT HIGHWAY  
EL PASO COUNTY, COLORADO**

March 19, 2024

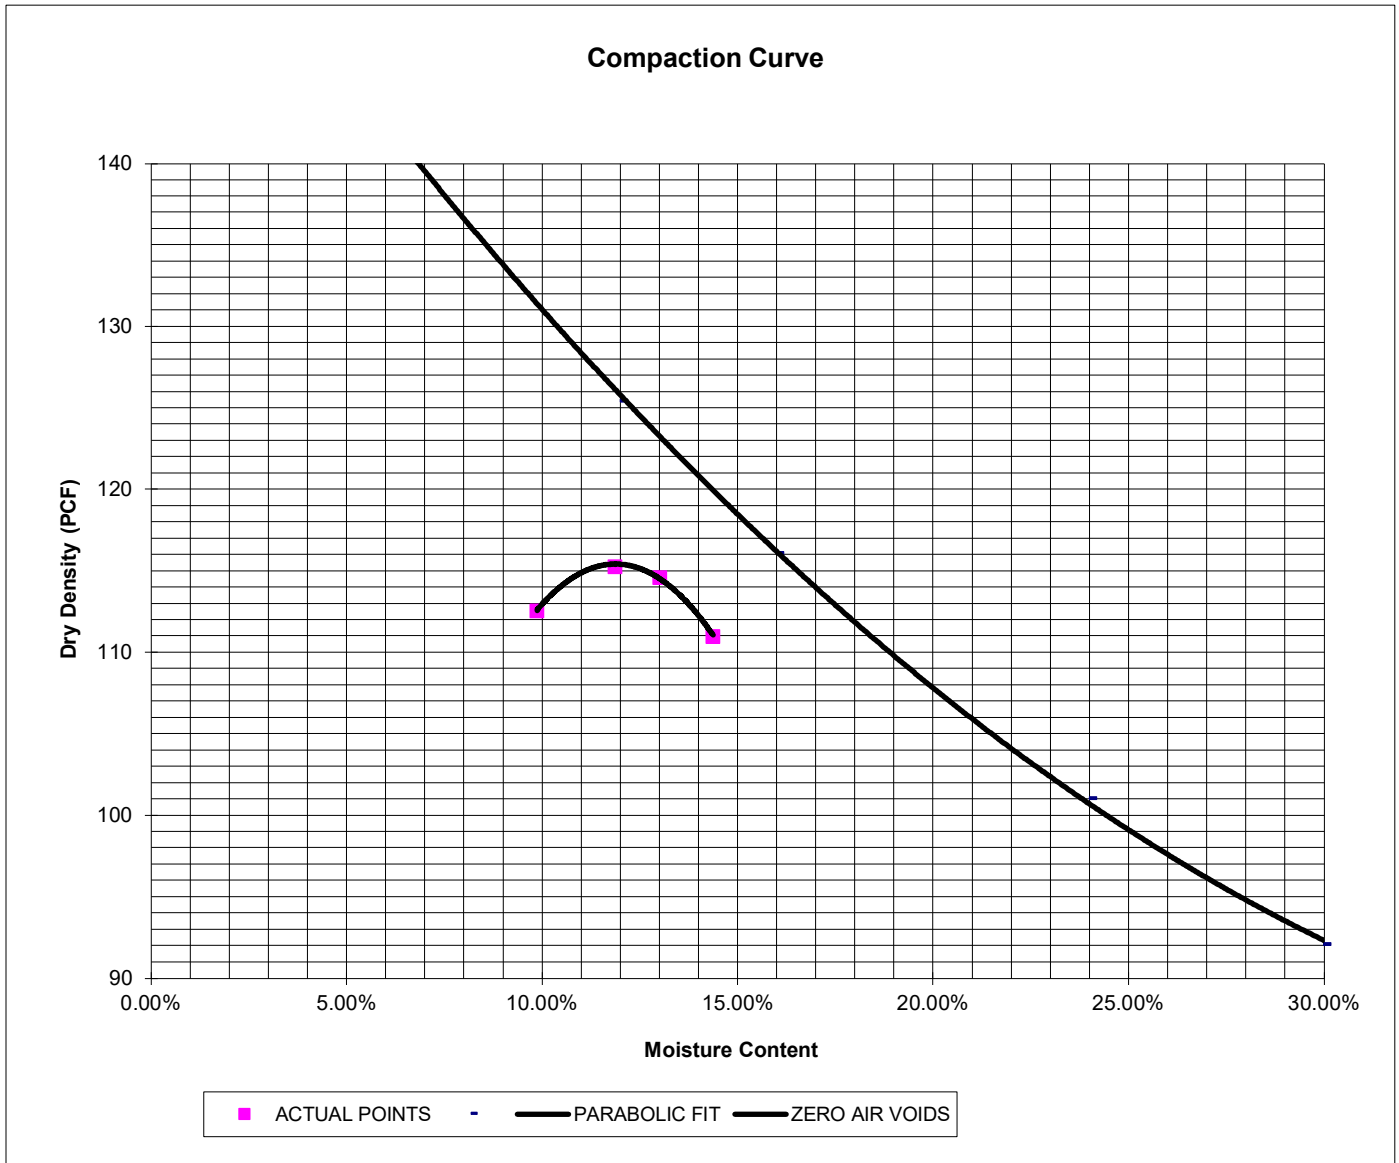
**PROCTOR DATA**

IDENTIFICATION: SM  
PROCTOR TEST #: 1  
TEST BY: DK  
TEST DESIGNATION: ASTM-1557-A  
MAXIMUM DRY DENSITY (PCF): 115.4  
OPTIMUM MOISTURE: 11.9

**LABORATORY TEST RESULTS**

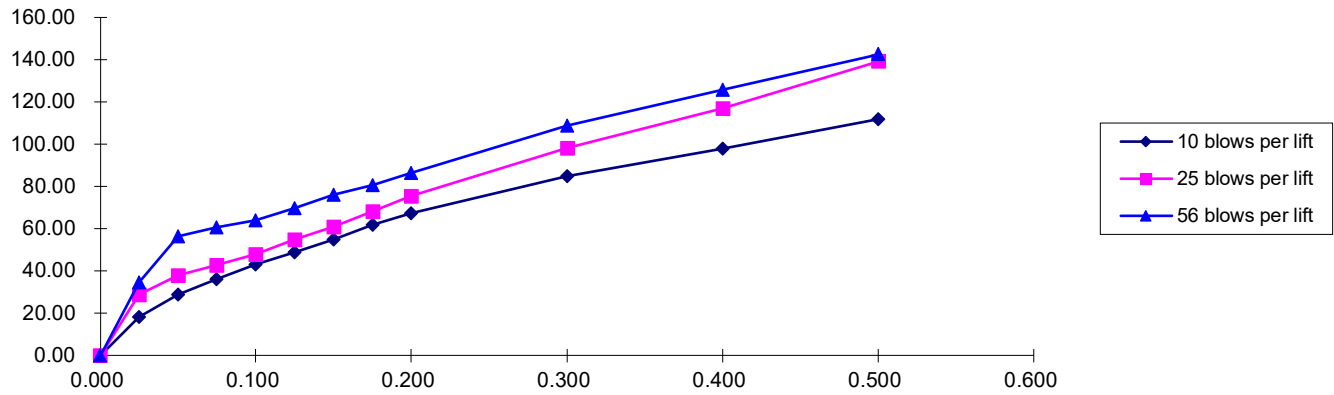
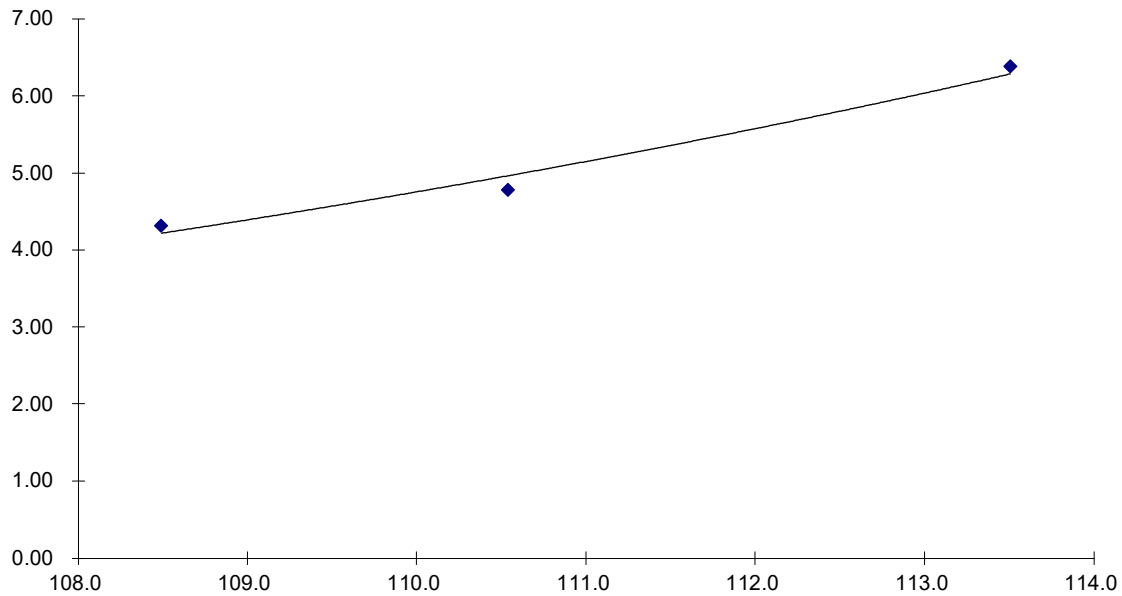
SOIL DESCRIPTION SAND, SILTY, BROWN  
SOIL TYPE 1

Stress VS Penetration

Bearing Ratio VS Dry Density

LABORATORY TEST RESULTS

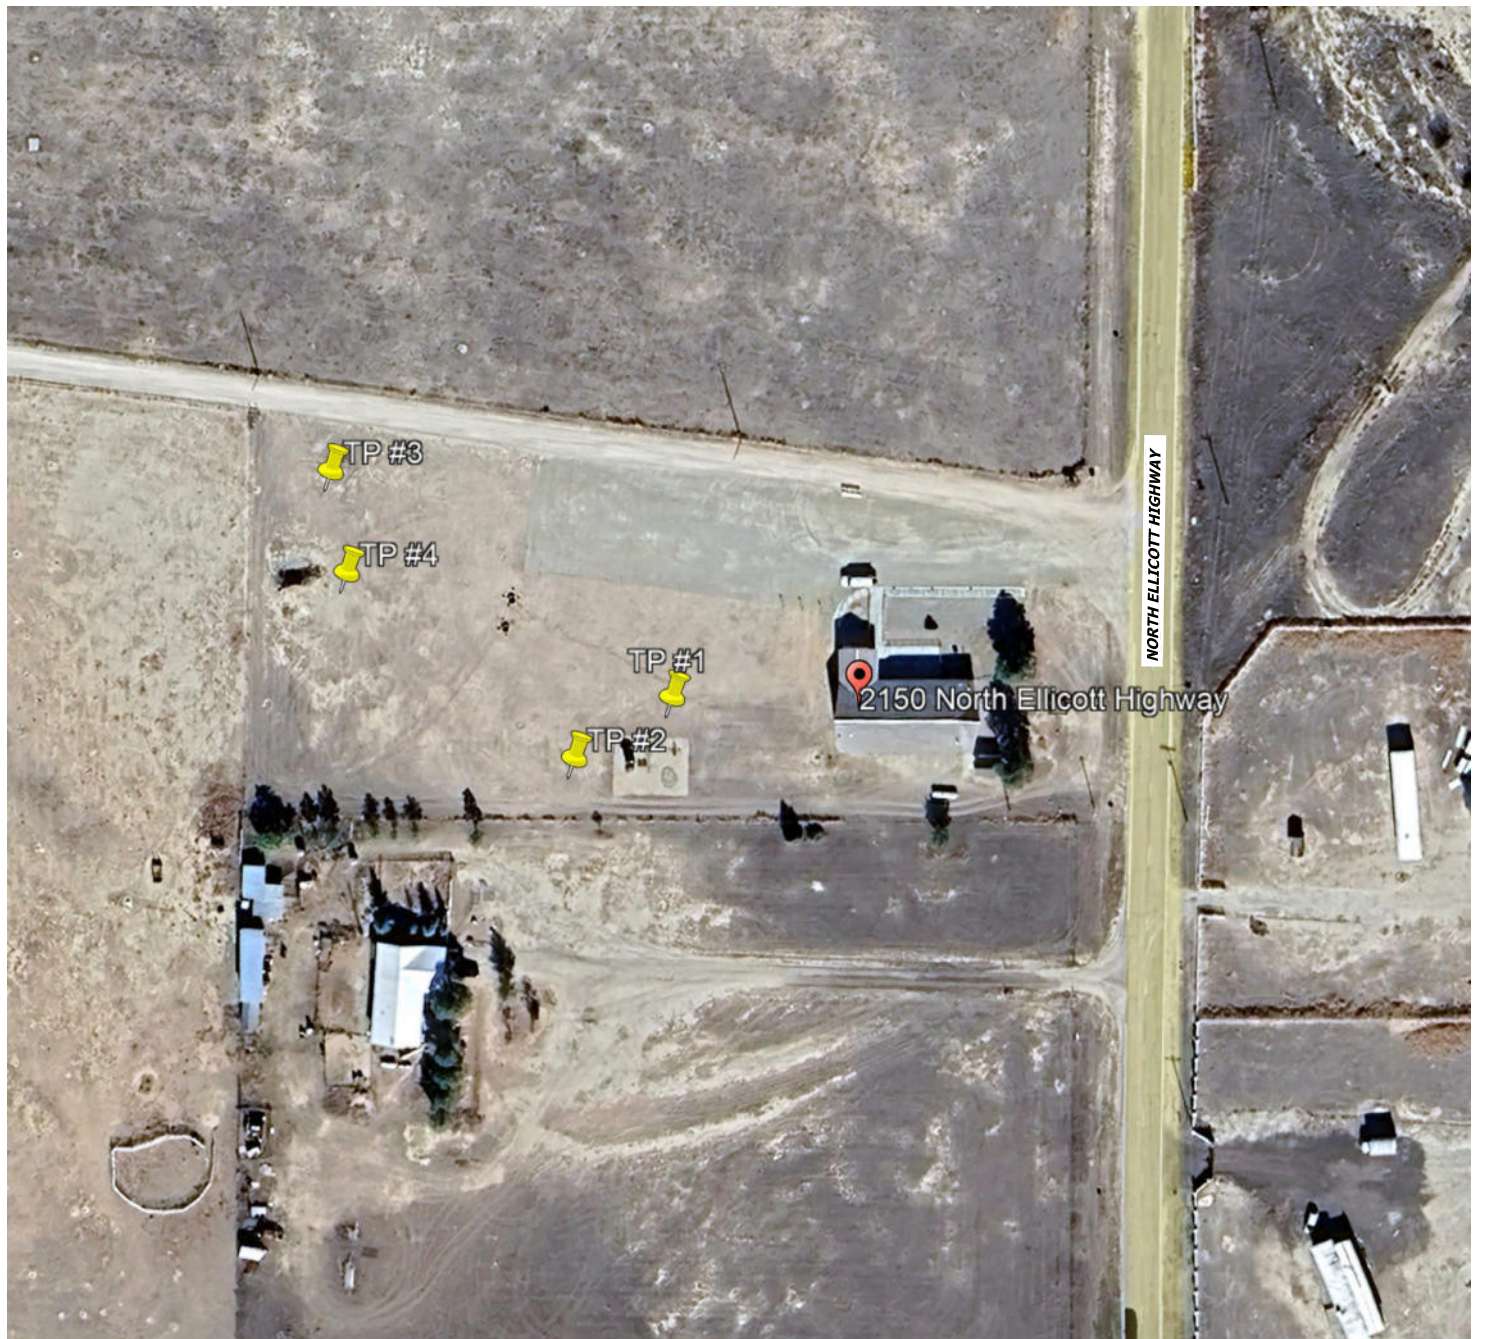
TP- APPROXIMATE TEST PIT LOCATION AND NUMBER

The locations of the test pits are shown in Figure 1. The test pits were excavated on February 14, 2024, to approximate depths of 8 feet. Soils encountered in the test pits consisted of sandy clay with underlying sandy loam. The Test Pit Logs and Laboratory Test Results are shown in Figures 2 through 8. Bedrock was not encountered in the test pits. Redoximorphic features were encountered in Test Pit No. 3 at approximately 7.5 feet below grade.

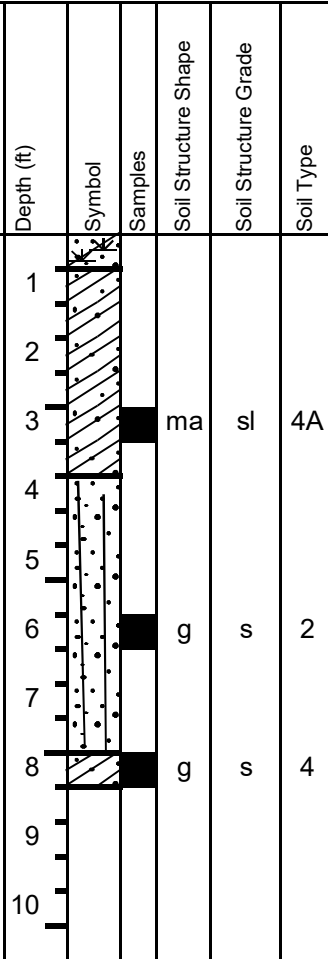
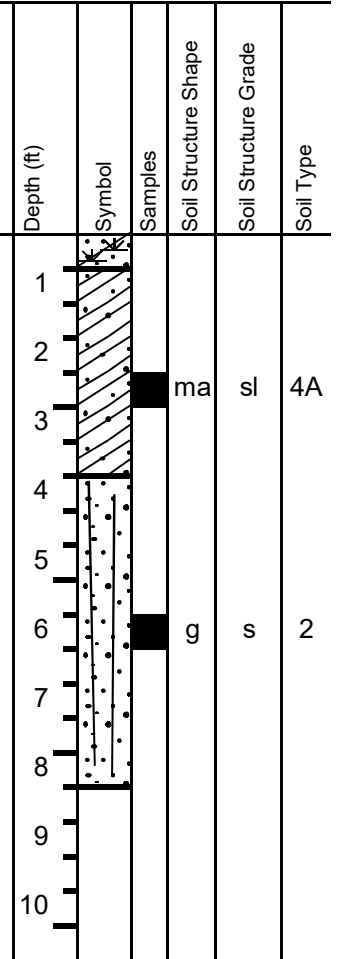
sandy loam, fine to coarse  
grained, light brown, moist

sandy clay, fine to medium  
grained, yellowish brown, moist

topsoil, sandy clay loam,  
brown, moist

sandy clay, fine to medium  
grained, dark brown, moist

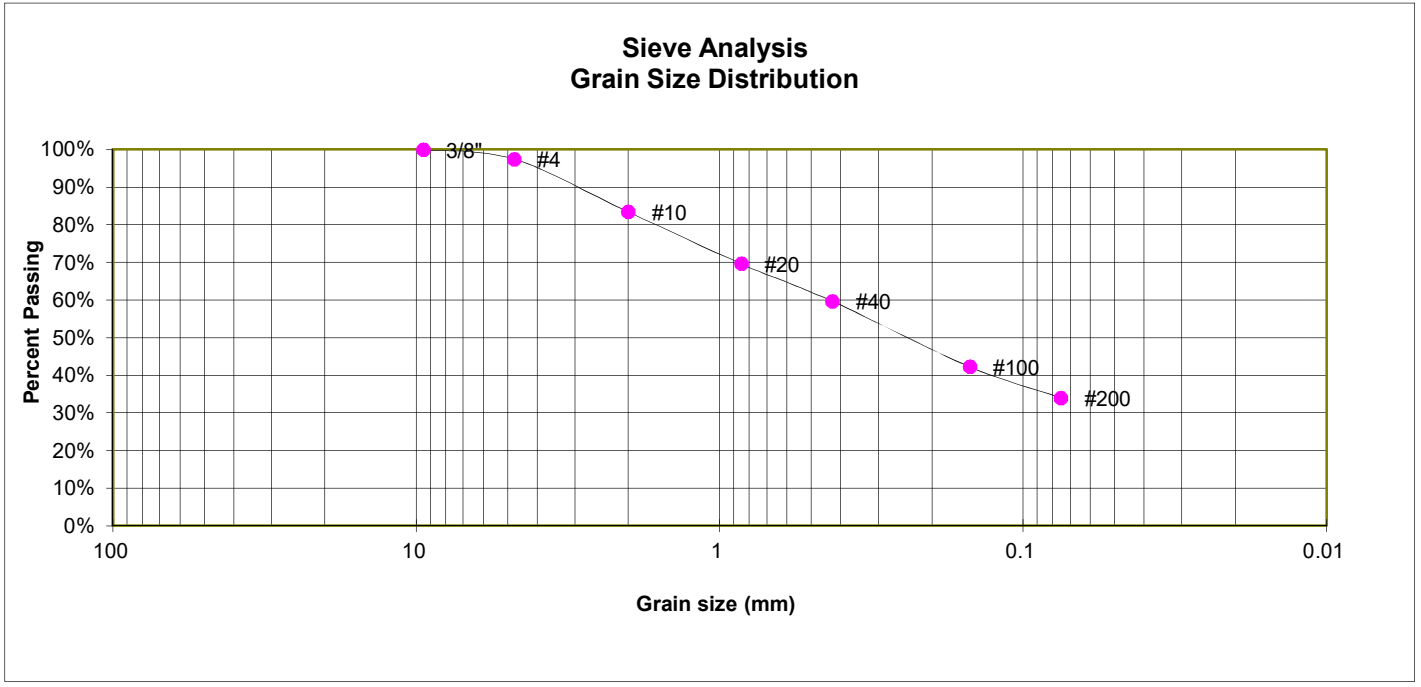
TEST PIT TP-1  
DEPTH (FT) 2.5

SOIL DESCRIPTION SAND, CLAYEY  
SOIL TYPE 4A

**GRAIN SIZE ANALYSIS**

U.S. Sieve #	Percent Finer
3"	
1 1/2"	
3/4"	
1/2"	
3/8"	100.0%
4	97.4%
10	83.4%
20	69.6%
40	59.7%
100	42.3%
200	34.0%

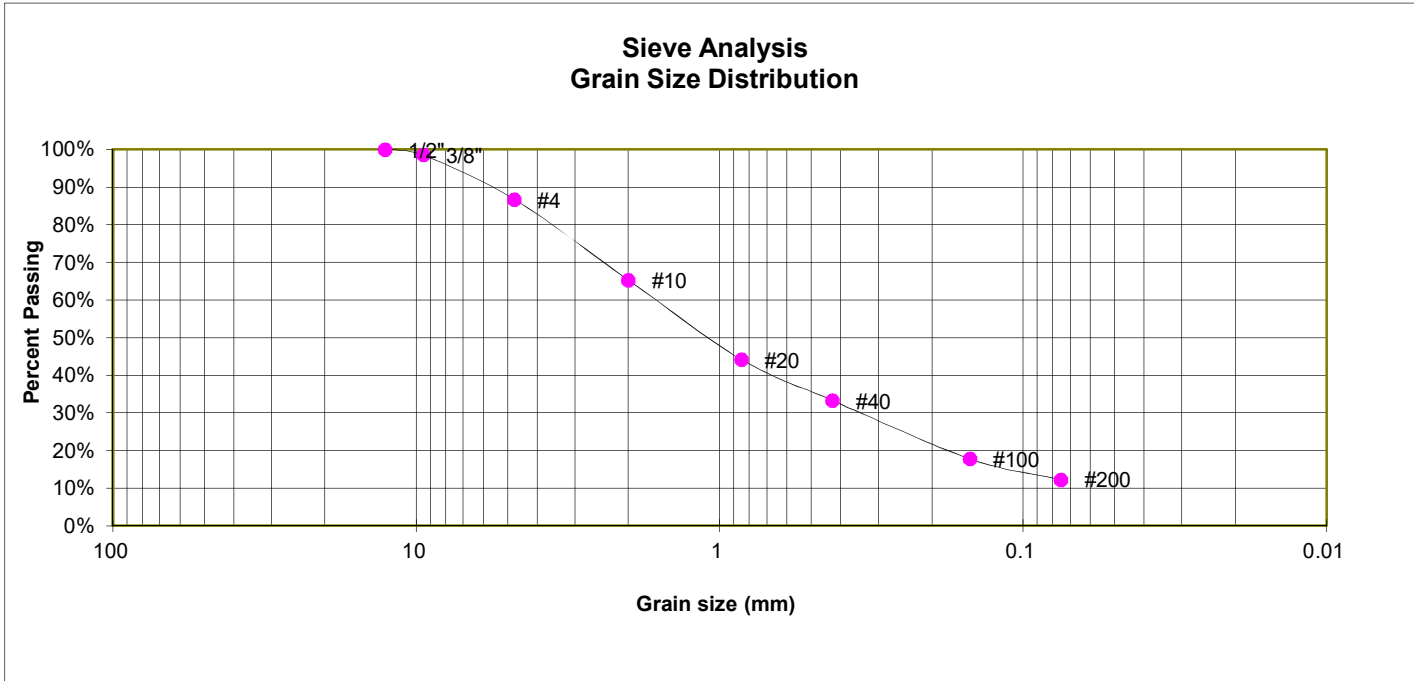
<u>TEST PIT</u>	TP-2	<u>SOIL DESCRIPTION</u> SAND, SILTY
<u>DEPTH (FT)</u>	5.5	<u>SOIL TYPE</u> 2

**GRAIN SIZE ANALYSIS**

U.S. Sieve #	Percent Finer
3"	
1 1/2"	
3/4"	
1/2"	100.0%
3/8"	98.5%
4	86.7%
10	65.3%
20	44.2%
40	33.3%
100	17.8%
200	12.3%

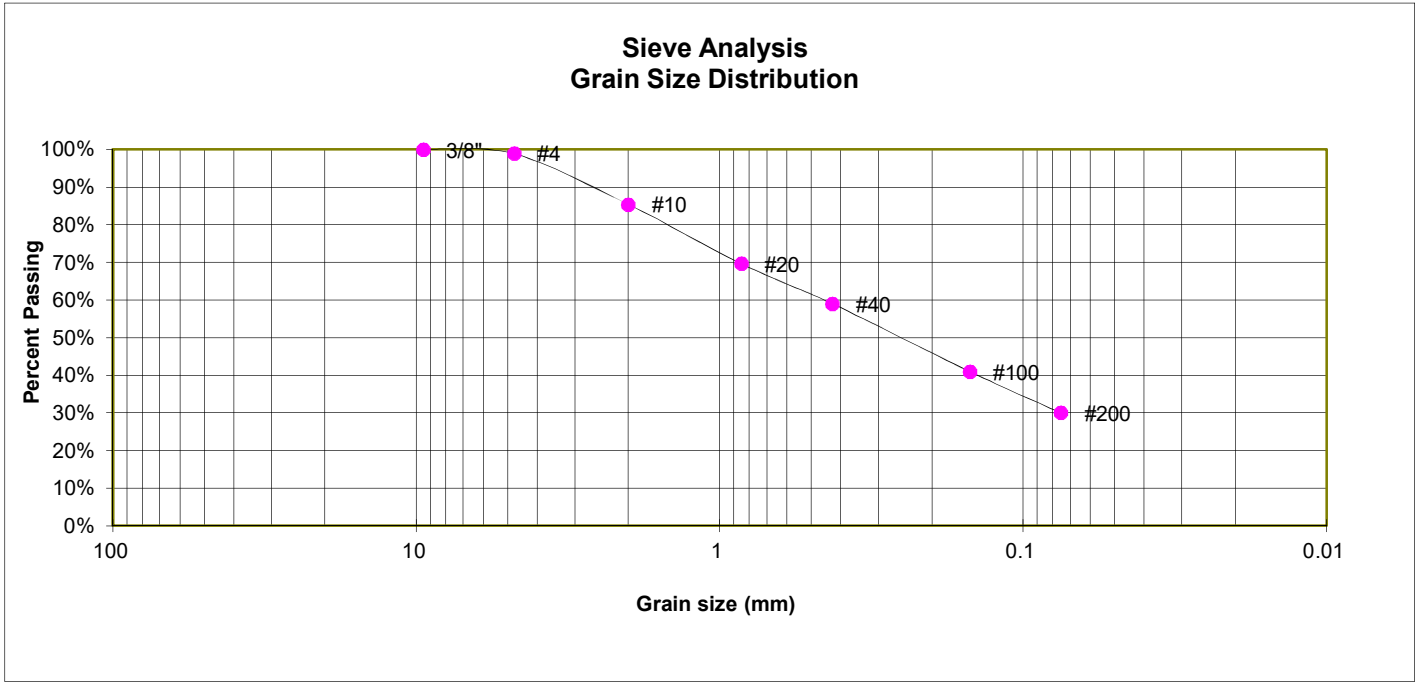
TEST PIT TP-3  
DEPTH (FT) 3

SOIL DESCRIPTION SAND, CLAYEY  
SOIL TYPE 4A

**GRAIN SIZE ANALYSIS**

U.S. Sieve #	Percent Finer
3"	
1 1/2"	
3/4"	
1/2"	
3/8"	100.0%
4	98.9%
10	85.4%
20	69.7%
40	59.0%
100	41.0%
200	30.0%

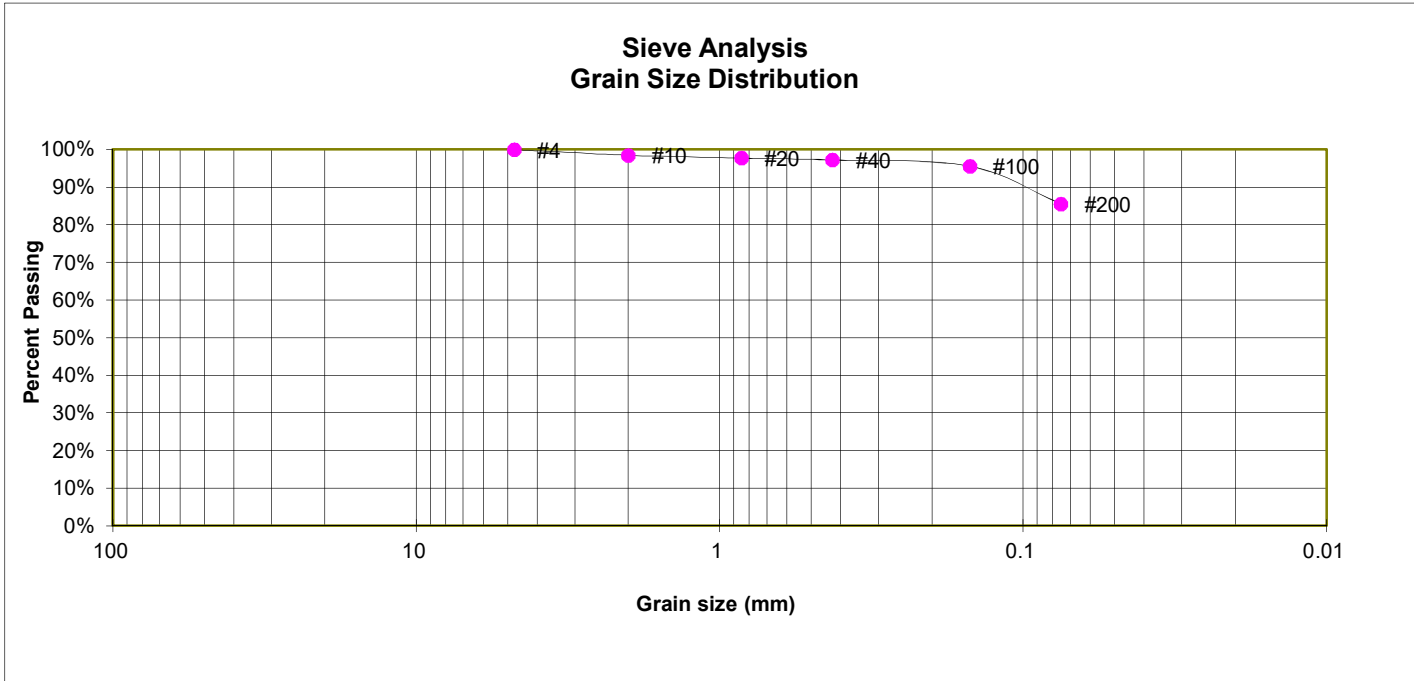
<u>TEST PIT</u>	TP-3	<u>SOIL DESCRIPTION</u>	CLAY, WITH SAND
<u>DEPTH (FT)</u>	7.5	<u>SOIL TYPE</u>	4

**GRAIN SIZE ANALYSIS**

U.S. Sieve #	Percent Finer
3"	
1 1/2"	
3/4"	
1/2"	
3/8"	
4	100.0%
10	98.5%
20	97.7%
40	97.2%
100	95.6%
200	85.6%

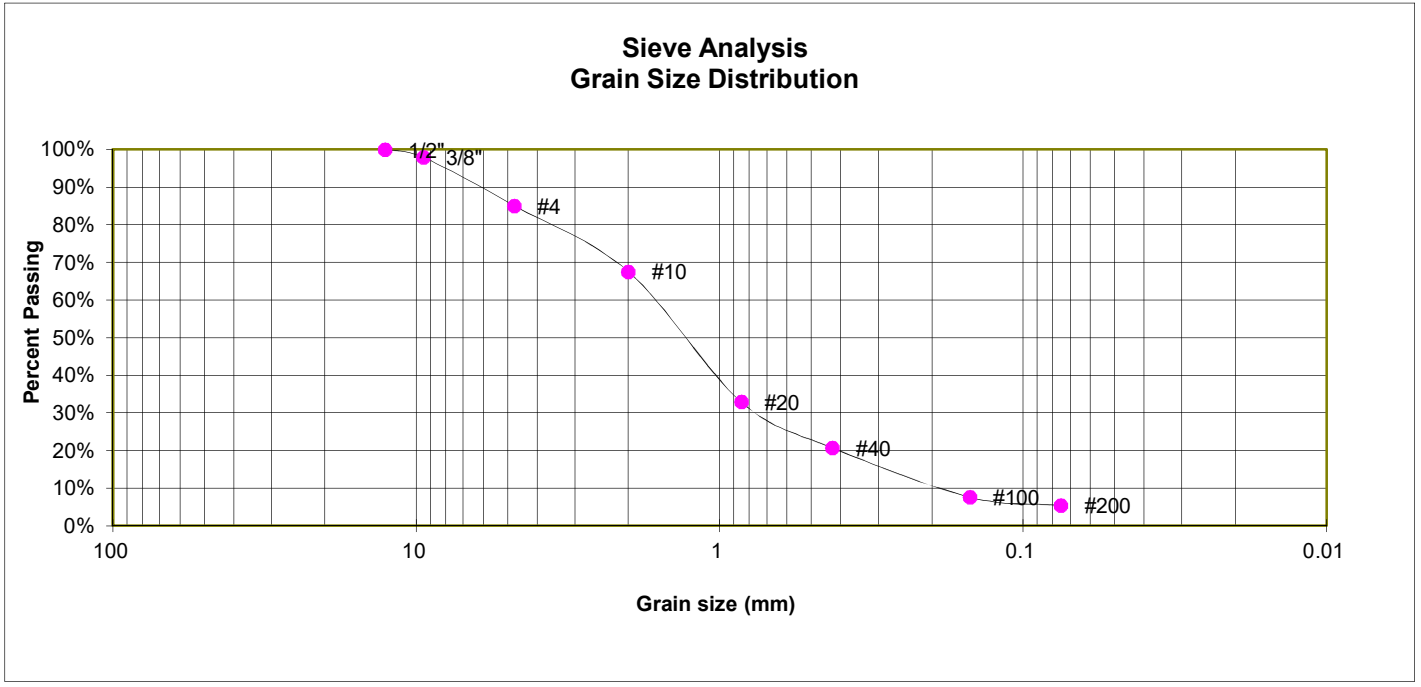
TEST PIT TP-4  
DEPTH (FT) 6

SOIL DESCRIPTION SAND, WITH SILT  
SOIL TYPE 2

**GRAIN SIZE ANALYSIS**

U.S. Sieve #	Percent Finer
3"	
1 1/2"	
3/4"	
1/2"	100.0%
3/8"	98.0%
4	85.0%
10	67.6%
20	32.9%
40	20.7%
100	7.6%
200	5.4%

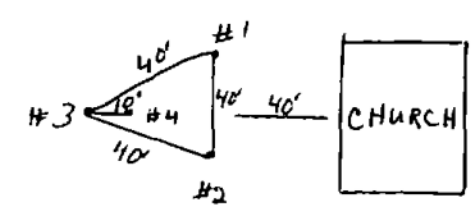
#4	Depth	Soil Description	Ground Water: None
	0 - 4"	Top soil	Bedrock: None
	4" - 4'	Fine sand w/tr clay	Grade of Site: flat
	4' - 8'	Sand, gravel
