Wastewater Evaluation Report

**Proposed Grandwood Subdivision
NE of Higby Road and Fairplay Drive
El Paso County, Colorado
VIVID Project No.: D18-2-175**

WASTEWATER EVALUATION REPORT
Proposed Grandwood Subdivision
NE of Higby Road and Fairplay Drive
El Paso County, Colorado
VIVID Project No. D18-2-175

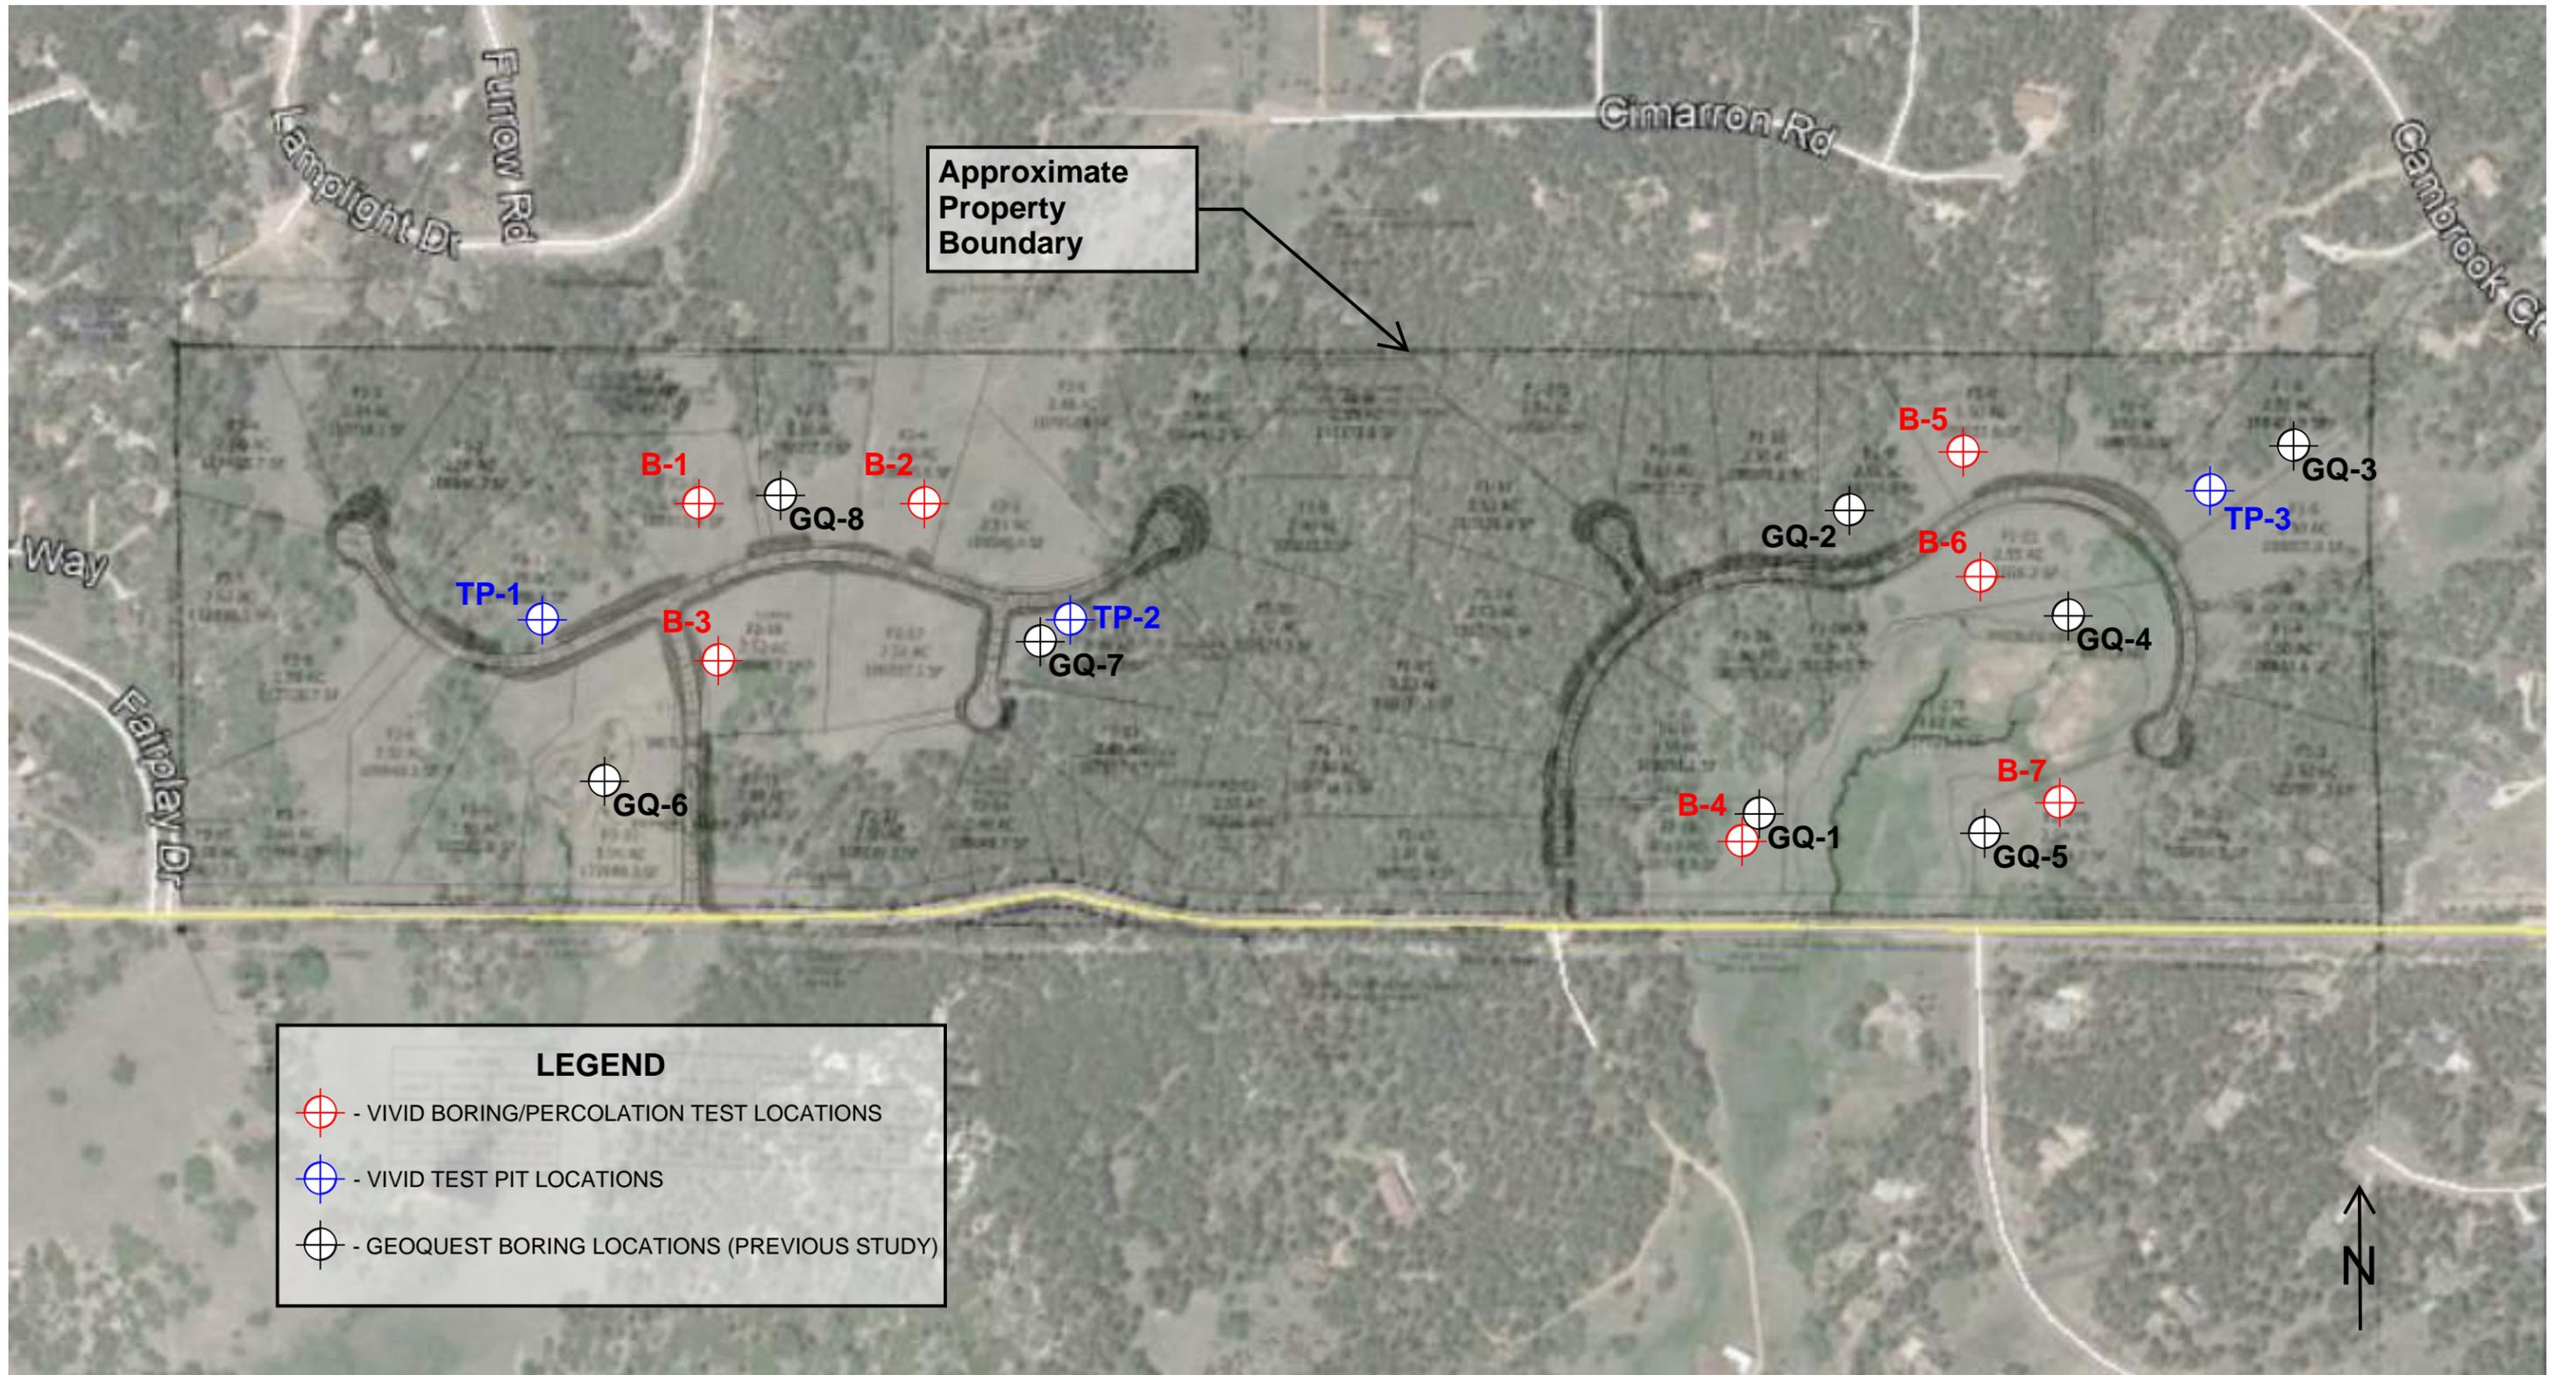
Not to Scale. Base image dated 06/09/2017 and obtained from Google Earth, 2019.

The proposed project includes the development of a 151-acre parcel into a residential subdivision. 48 lots are planned, that will be approximately 2.5 acres in size. The property has no current improvements and is in a generally native condition. The development will include construction of access roadways and utilities. Residential lots will require individual water well and septic systems. A preliminary site layout is shown on Figure 2, attached to this report.

A field exploration performed on December 20, 2018 included the drilling of seven exploratory borings (including percolation testing), and excavation of three test pits for tactile evaluation of the soils at the locations presented on Figure 2 – Exploration Location Plan. This exploration and some of the basic information are presented in Table 1, below.

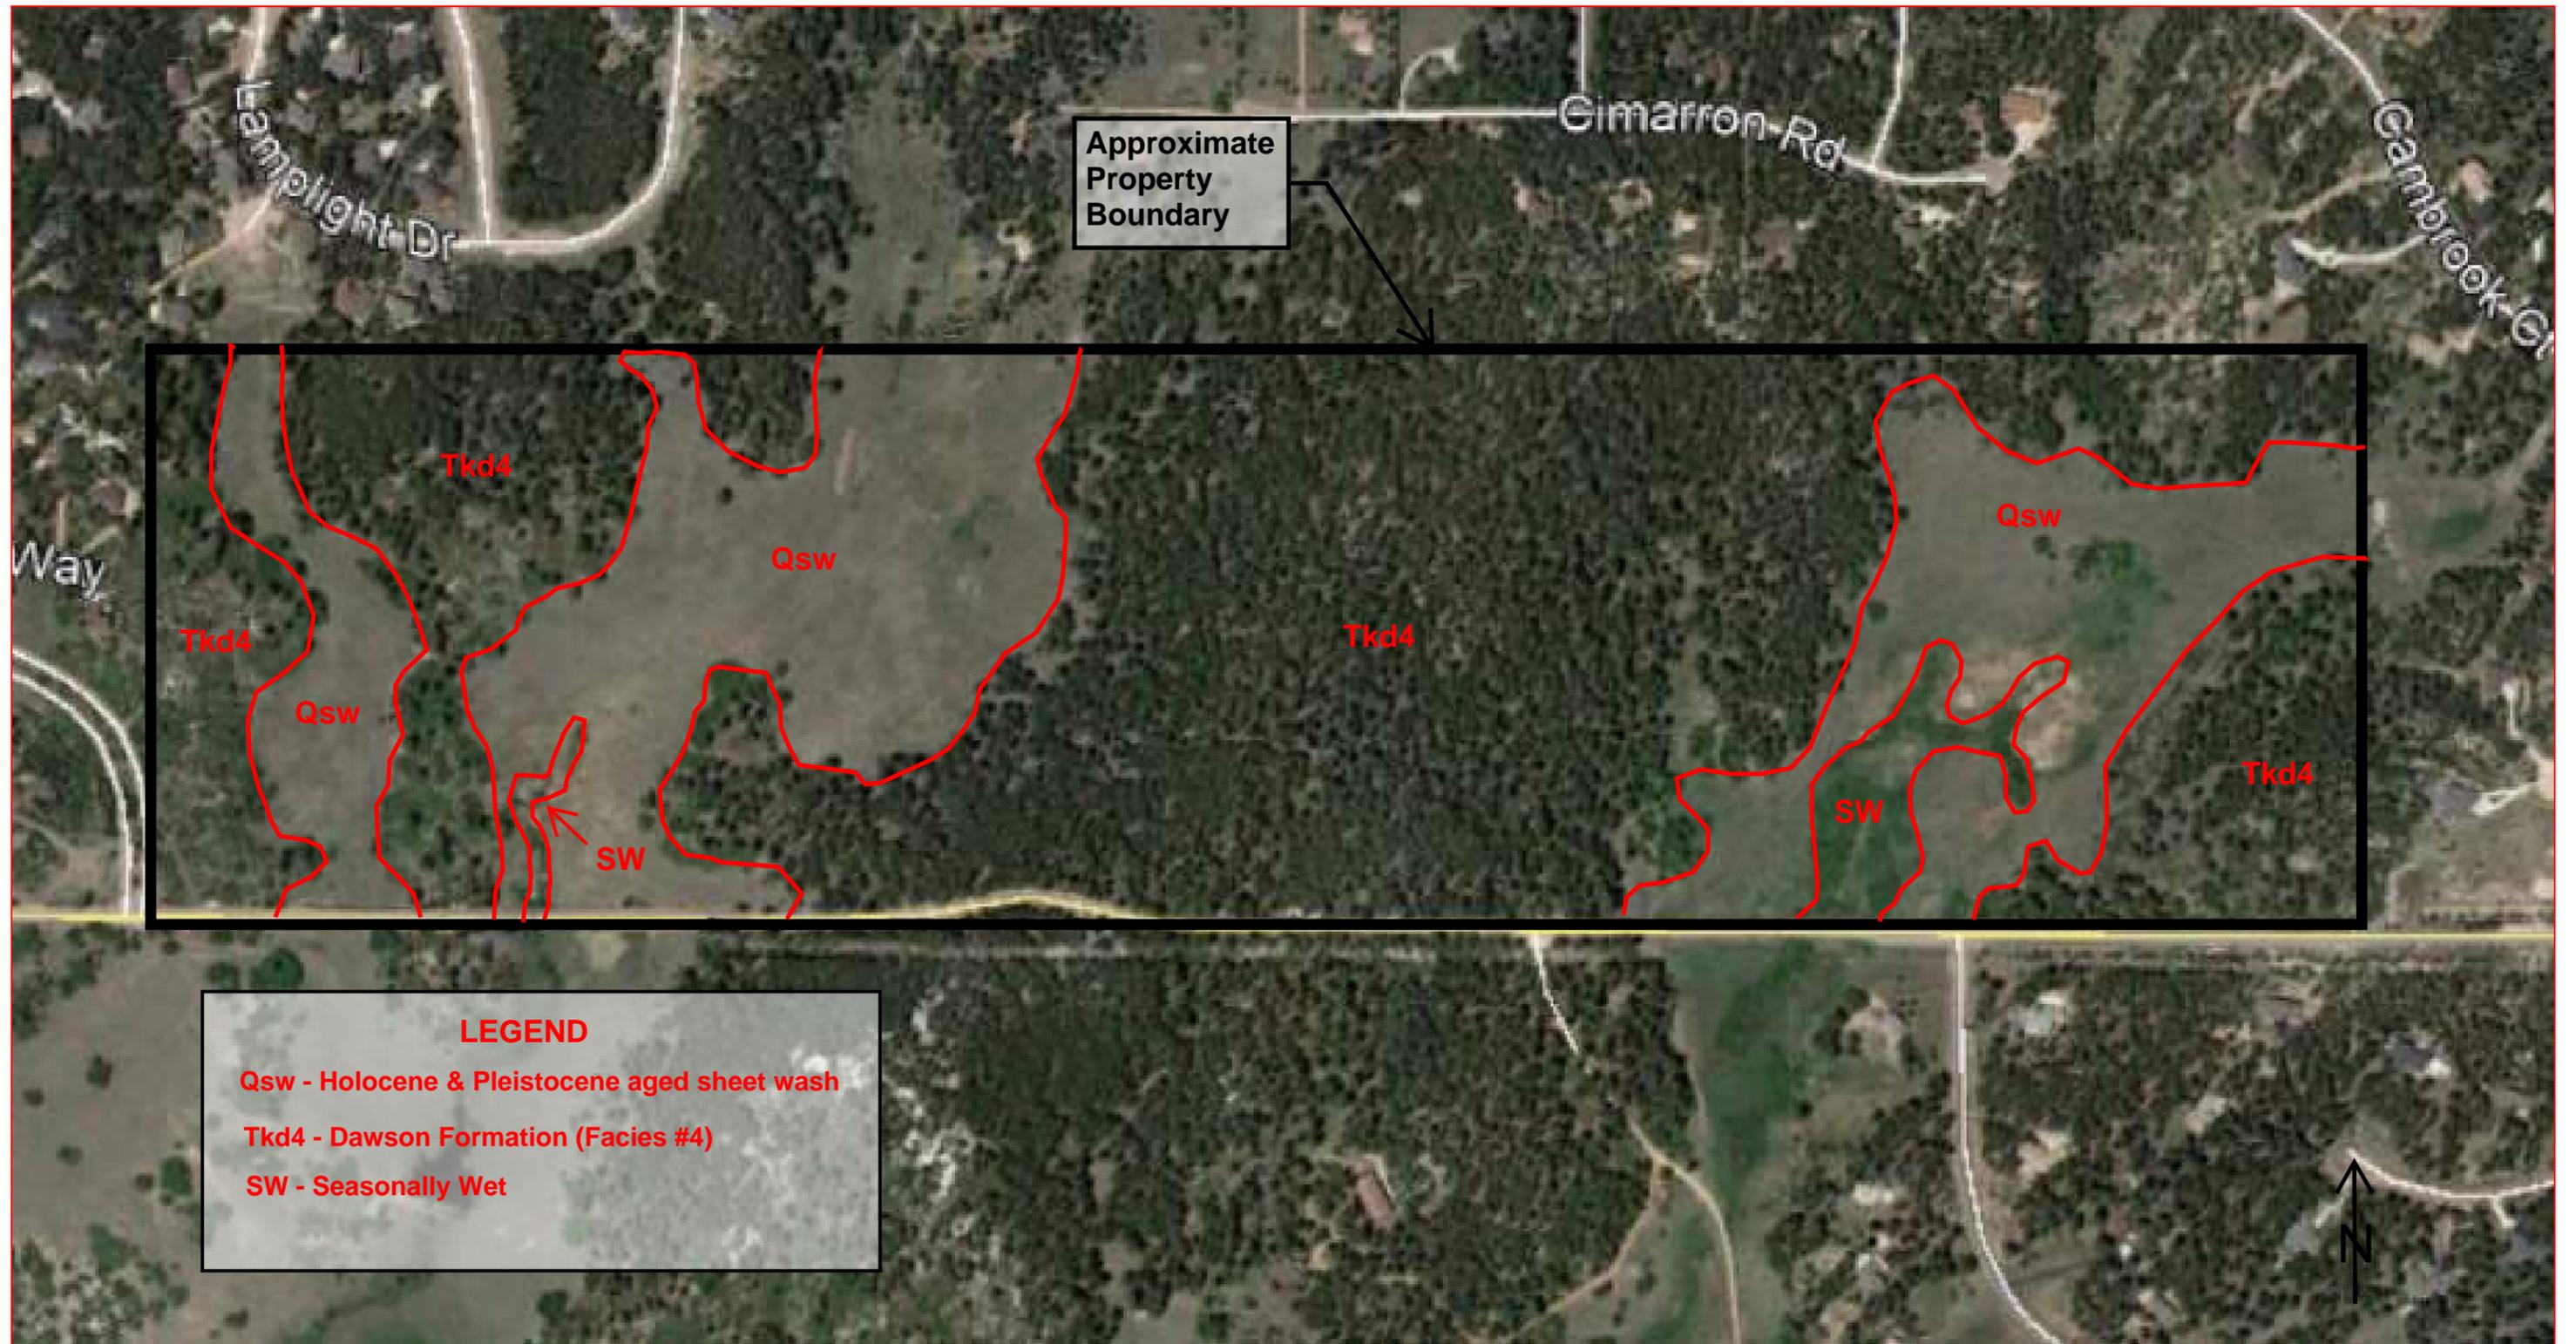
Figure
3b

Not to Scale. Base image dated 06/09/2017 and obtained from Google Earth, 2019.
 Site-specific Geology Mapping by Jim Frohbieter, Professional Geologist

Geologic maps are presented as Figures 3a-Regional Geology Map and Figure 3b-Site Specific Geology Map, attached to this report. An NRCS Soil Survey Map and associated Soil Descriptions are presented as Figures 4a, and 4b. A USGS Topographic Map is attached as Figure 5.

The locations evaluated as part of this study generally found soils and percolation rates that are favorable for conventional septic system construction. Geologic mapping as presented on Figures 3a and 3b indicate that shallower bedrock of the Dawson Formation (see areas of Tkd4 on Figure 3a) will be encountered at various locations that were outside accessible limits of this evaluation. These areas are anticipated to have higher occurrences of shallow bedrock and lower percolation rates that would require engineered systems.

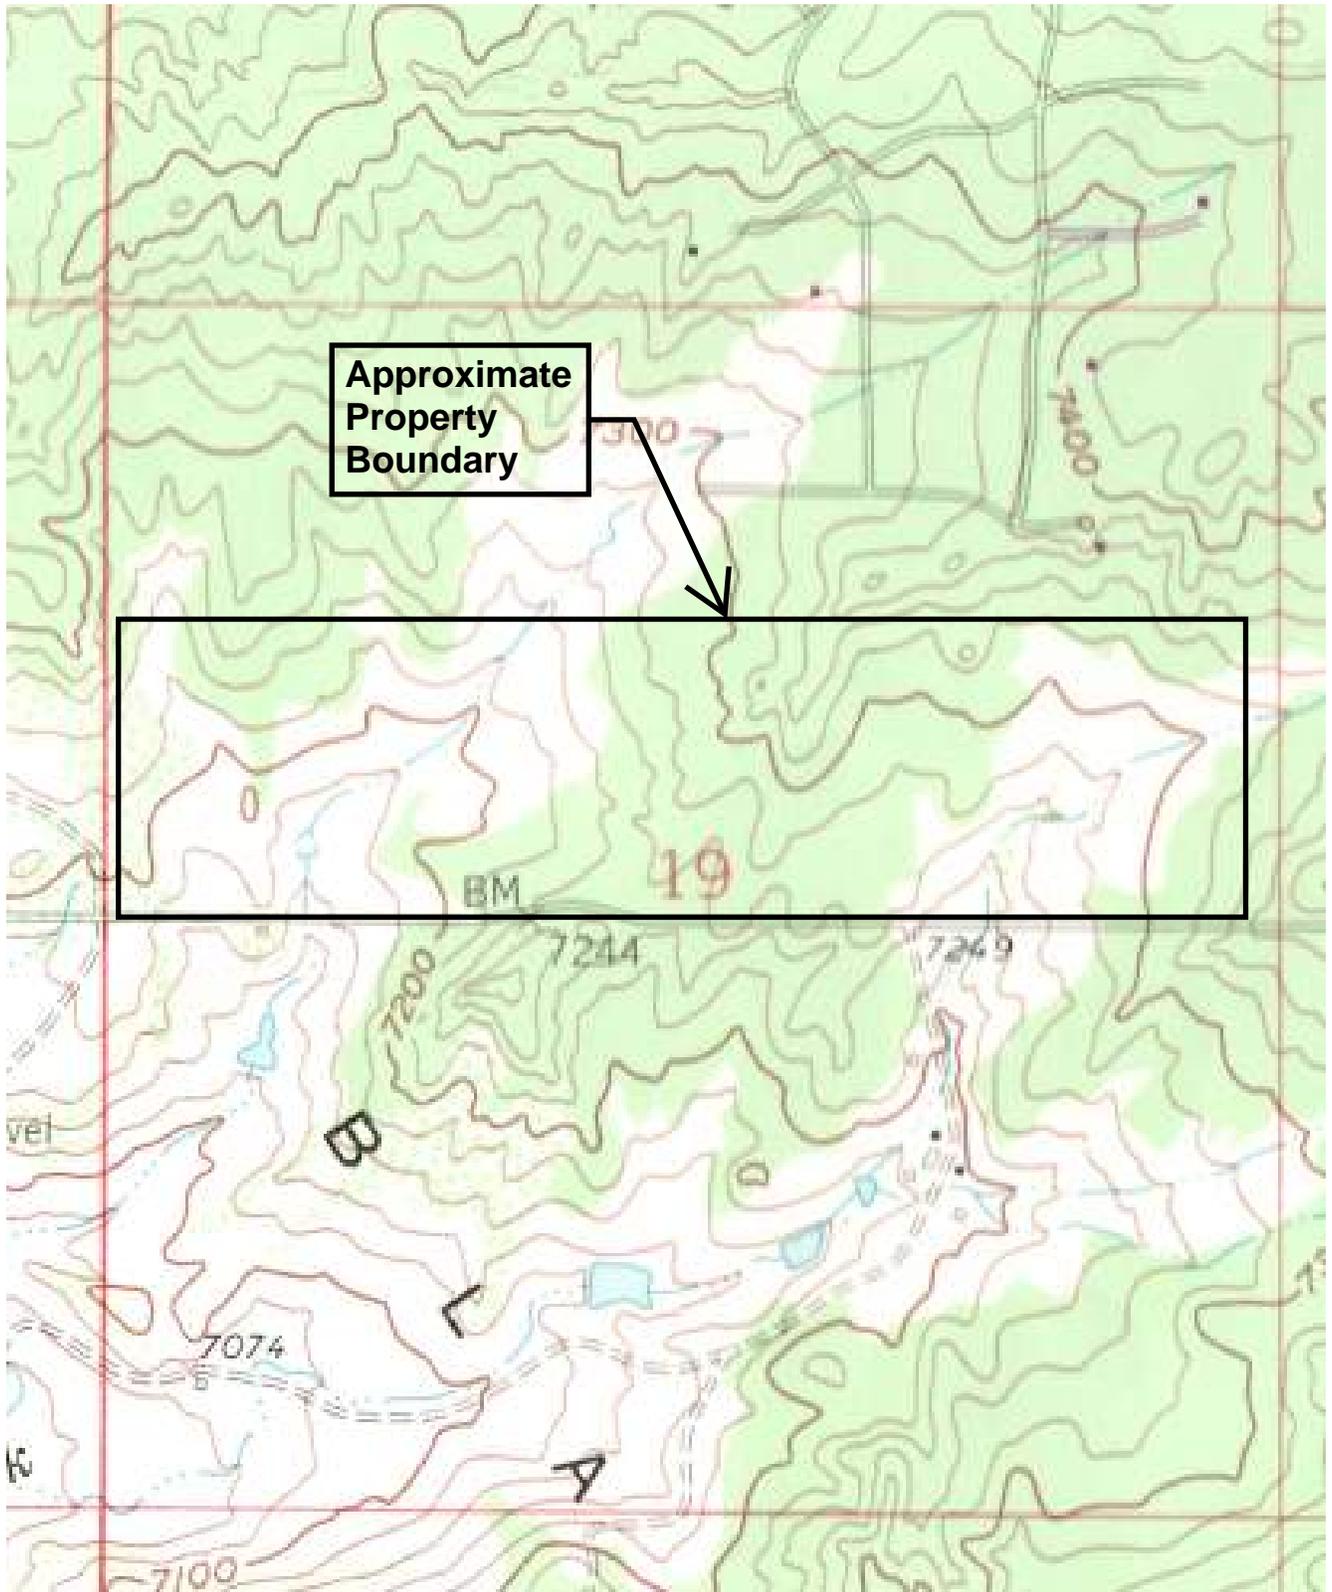
Project No: D18-2-175	TOPOGRAPHIC MAP	Figure 5
	Date: 1/15/19		
	Drawn by: WJB	Grandwood Subdivision El Paso County, Colorado	
	Reviewed by: BTM

Not to Scale. Base image obtained from USGS 7.5 Minute Quadrangle, 1961

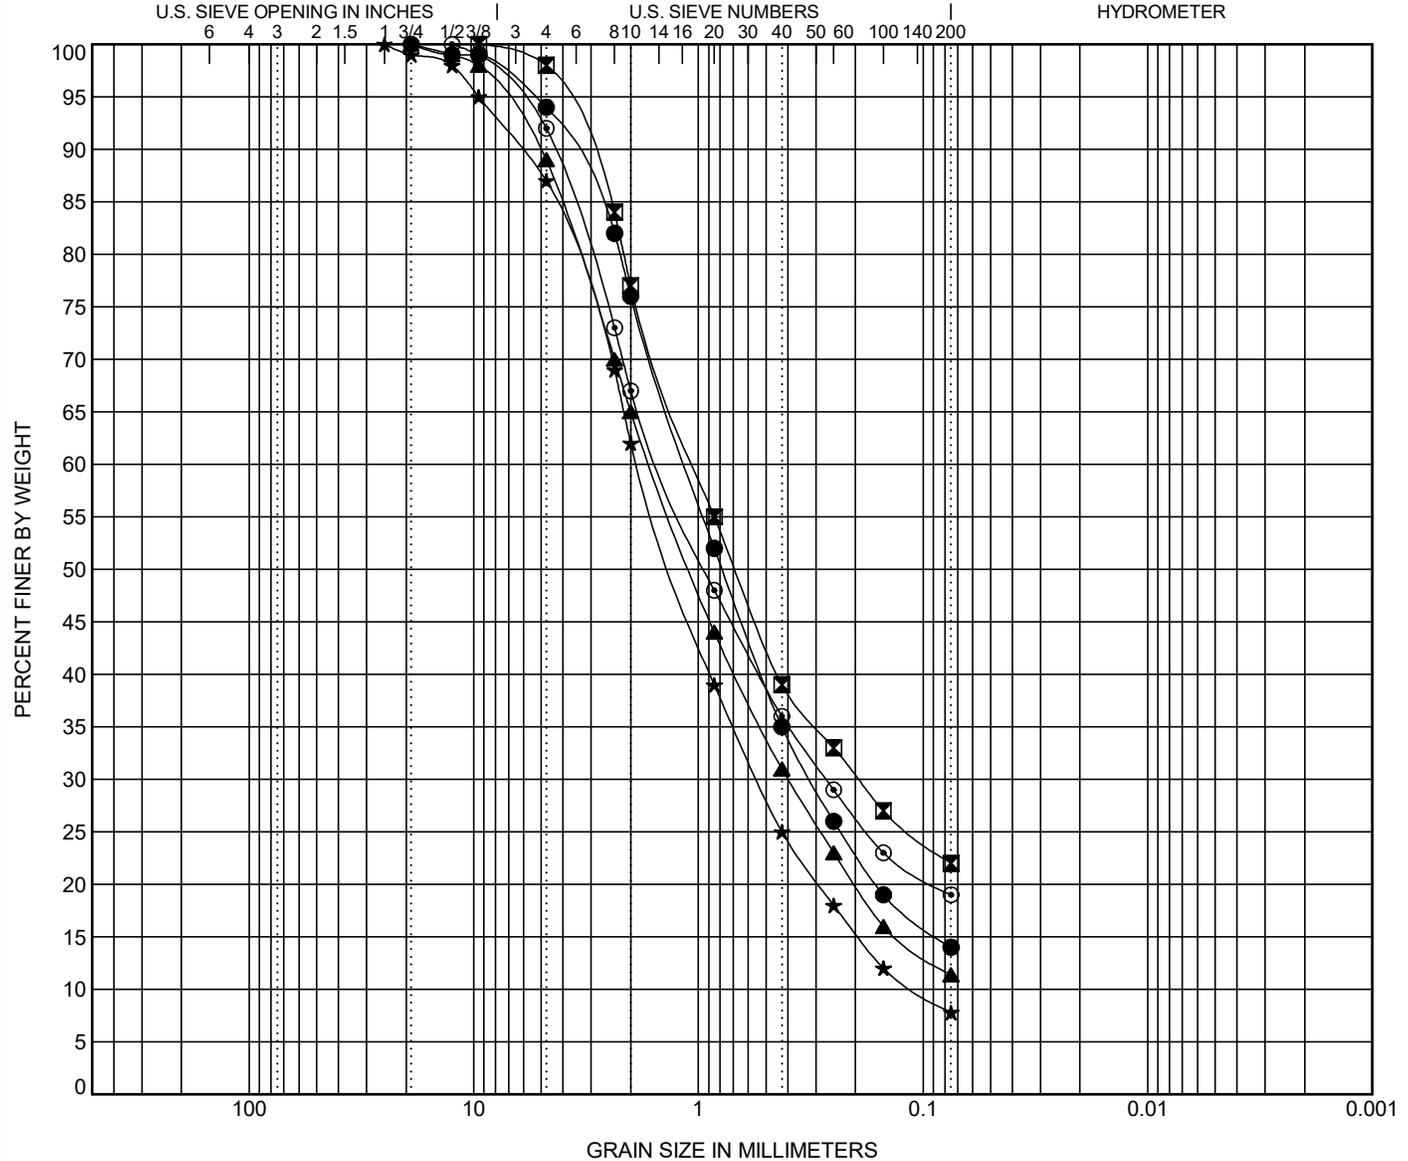
COBBLES	GRAVEL		SAND			SILT OR CLAY
	coarse	fine	coarse	medium	fine

BOREHOLE	DEPTH	Classification					LL	PL	PI	Cc	Cu
● B-1	9.0	SILTY SAND(SM)					NP	NP	NP		
☒ B-2	9.0	CLAYEY SAND(SC)					43	26	17		
▲ B-3	4.0	WELL-GRADED SAND with SILT(SW-SM)					NP	NP	NP	1.60	26.86
★ B-3	14.0	WELL-GRADED SAND with SILT(SW-SM)					NP	NP	NP	1.48	17.22
◎ B-4	2.0	SILTY SAND(SM)					NP	NP	NP		
BOREHOLE	DEPTH	D100	D60	D30	D10	%Gravel	%Sand	%Silt	%Clay		
● B-1	9.0	19	1.131	0.316		6.0	80.0	14.0			
☒ B-2	9.0	9.5	1.032	0.194		2.0	76.0	22.0			
▲ B-3	4.0	19	1.631	0.398		11.0	77.6	11.4			
★ B-3	14.0	25	1.857	0.544	0.108	13.0	79.2	7.8			
◎ B-4	2.0	12.5	1.459	0.27		8.0	73.0	19.0
