**ENTECH**  
ENGINEERING, INC.

**SOILS AND GEOLOGY STUDY  
THE COMMONS AT FALCON FIELD, FILING NO. 1  
DEVELOPMENT PLAN AND FINAL PLAT  
EL PASO COUNTY, COLORADO**

May 1, 2025

**PCD No. SF2435**

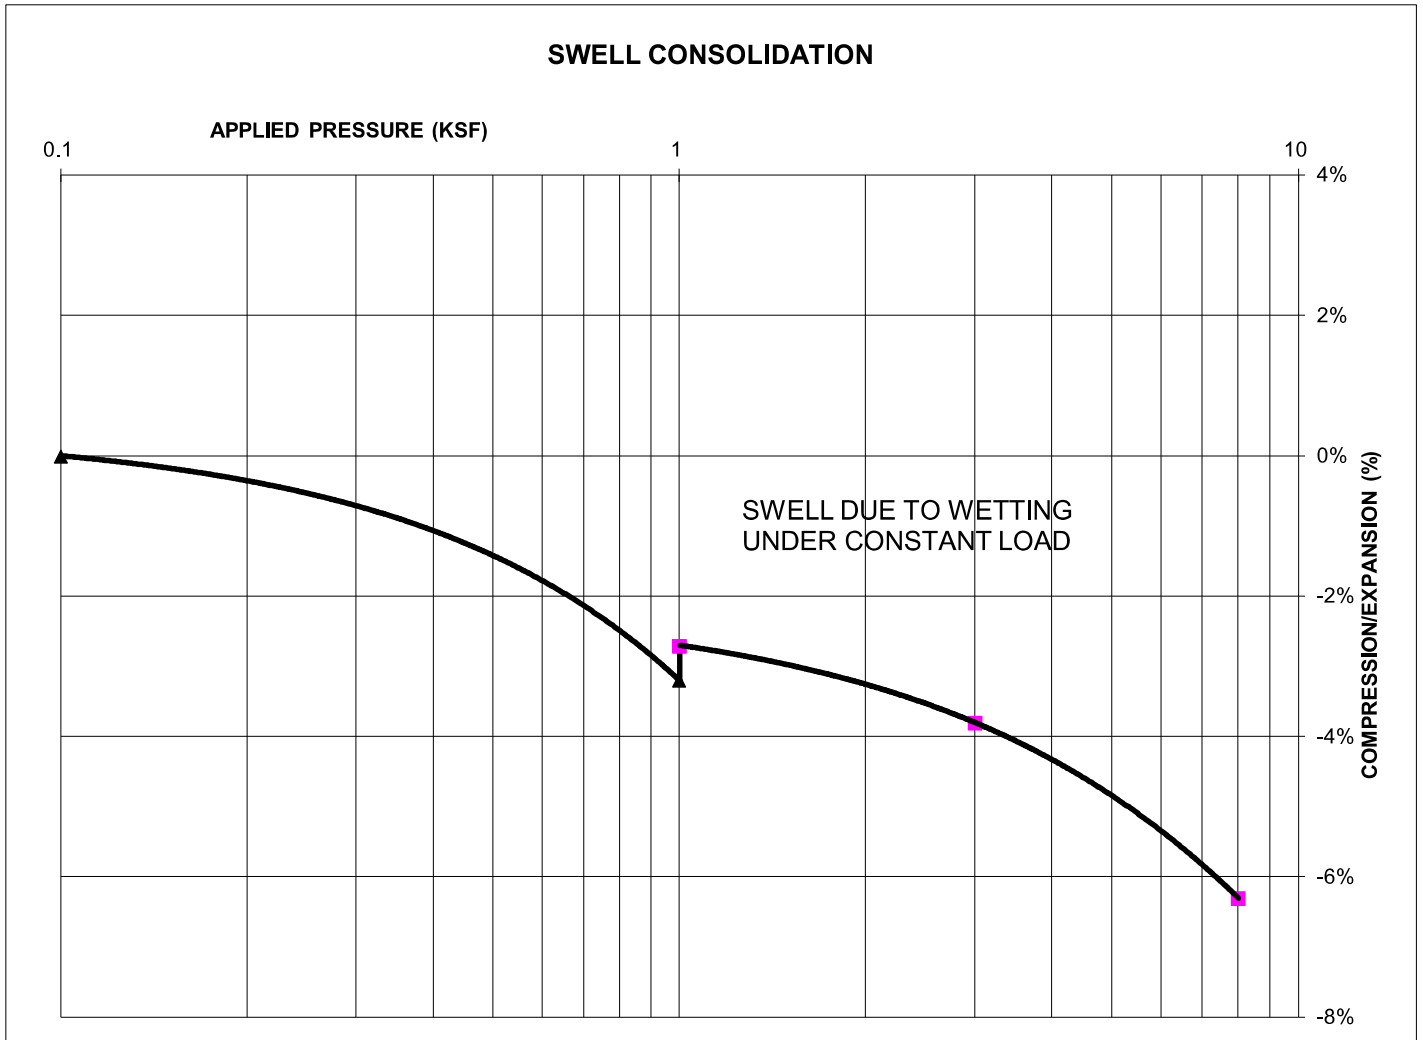
**SWELL/COLLAPSE TEST RESULTS**

TEST BORING P8  
DEPTH (FT) 2-3

SOIL DESCRIPTION CLAY, SANDY  
SOIL TYPE 2

NATURAL UNIT DRY WEIGHT (PCF): 104  
NATURAL MOISTURE CONTENT: 18.2%  
SWELL/COLLAPSE (%): 0.5%
